**Bottom Ash Pond – Trimble County
Station Assessment Report**

Lockheed Martin

June 2009

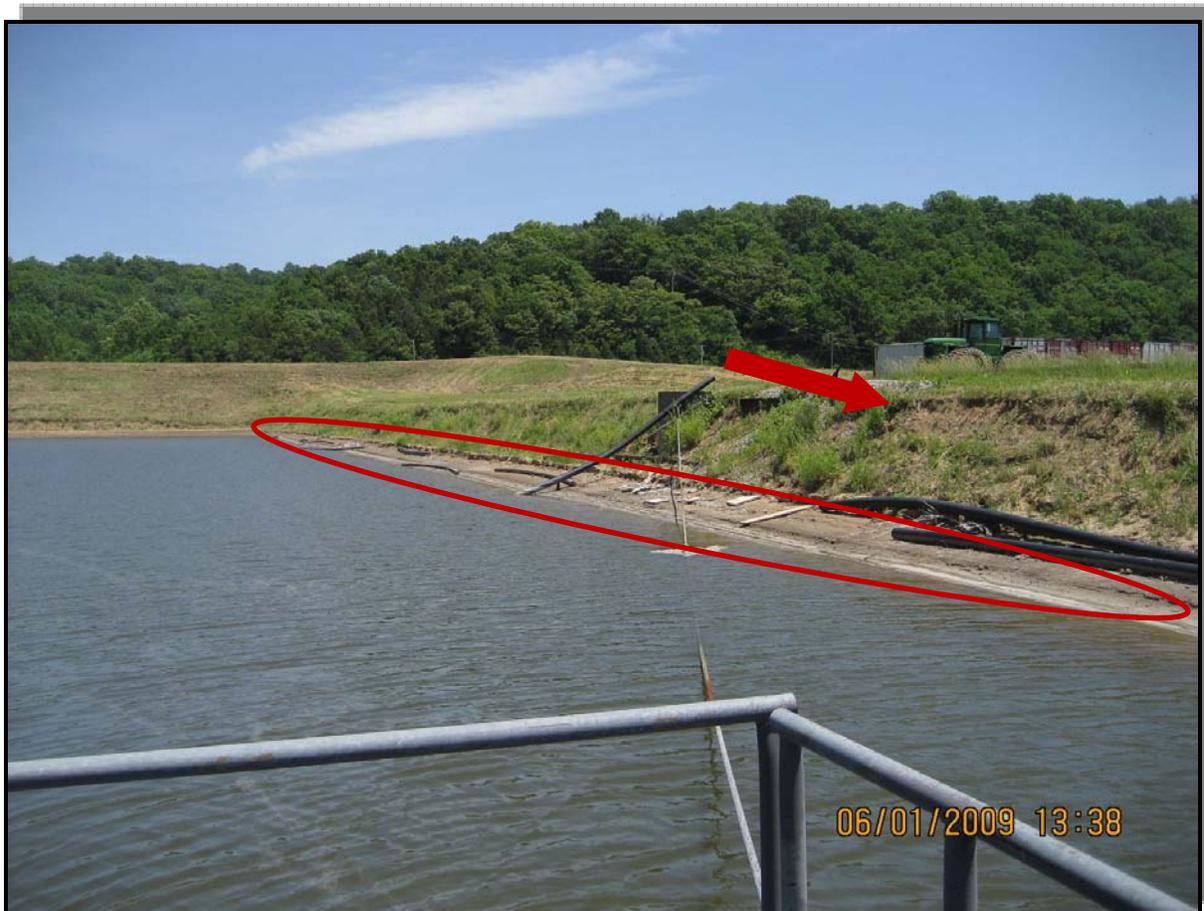
Wave action erosion was observed on the unarmored upstream slopes of both the south and east embankment and was more noticeable with the lower pool elevation. This erosion and some minor

Photo 2 – View of South Dike with erosion and sloughing of upstream slope freeboard caused by wave action

1. Upstream slope – repair eroded and sloughed areas near the top of the east and south embankments. Repairs should be completed in accordance with an engineered design. Consider armoring of upper portion of interior eastern and southern slopes to protect against wave action erosion.

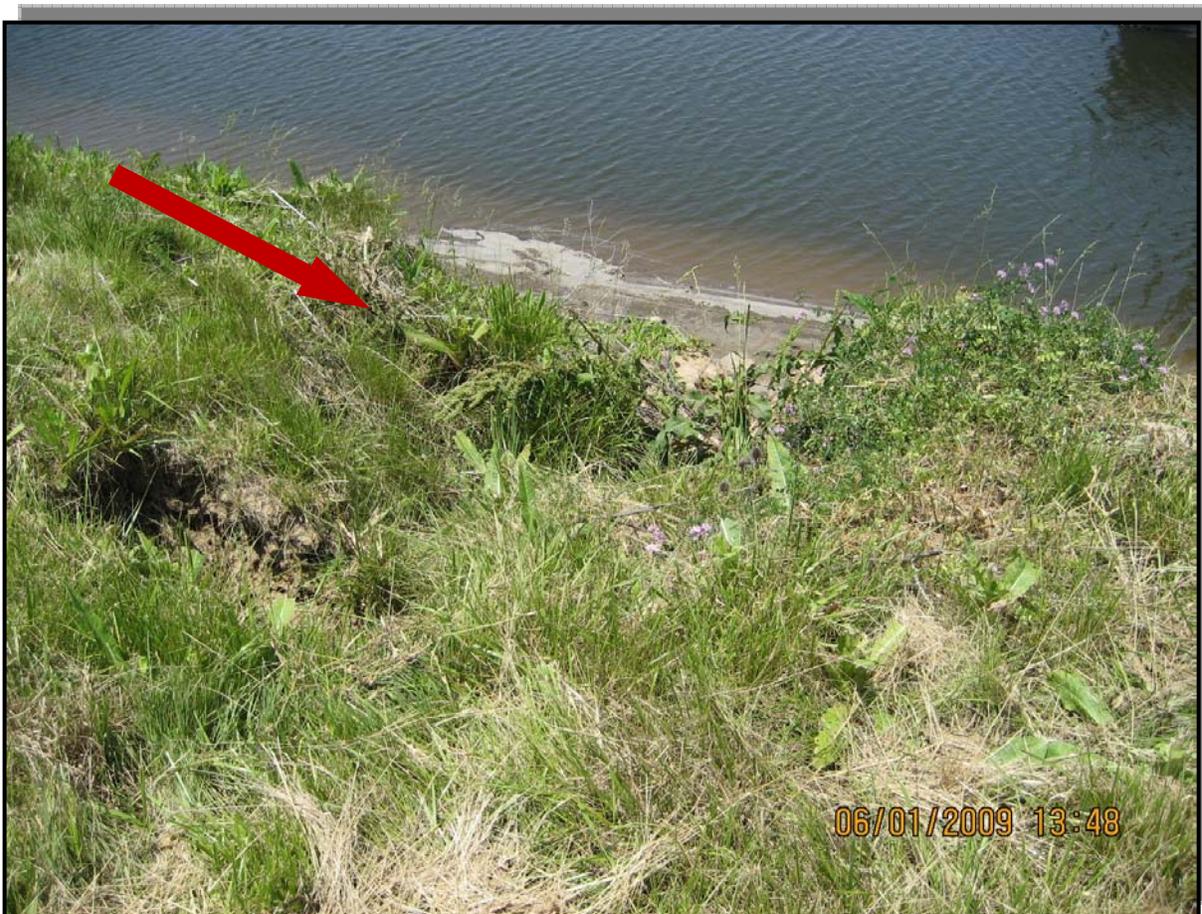
gully erosion occurring near the influent/effluent piping were the only deficiencies found on the upstream slope.

Photo 4 – View of typical erosion gullies in freeboard area along upstream slope near Floating Dock

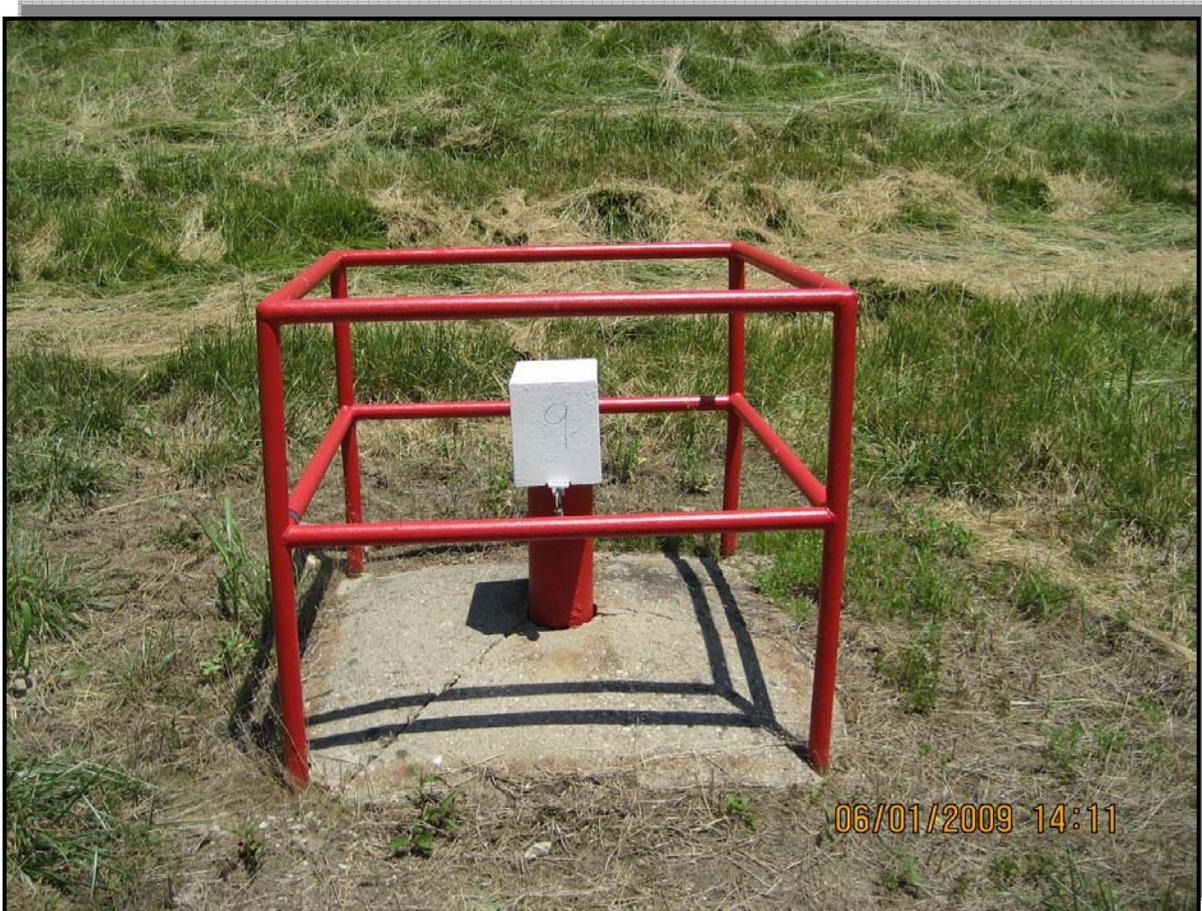
Several groundwater monitoring wells were observed and originally placed around the BAP because the original intent was to have a landfill at the premises for the CCW in lieu of the “wet management unit”. While the KDEP requires groundwater monitoring for landfills, they do not require monitoring wells for surface water impoundments. Several piezometers were observed along the east dike but were only installed for the analysis and design of the vertical extension project and are now mostly abandoned.

Photo 7 – Typical view of groundwater monitoring well (Not used for seepage or pore pressure monitoring)

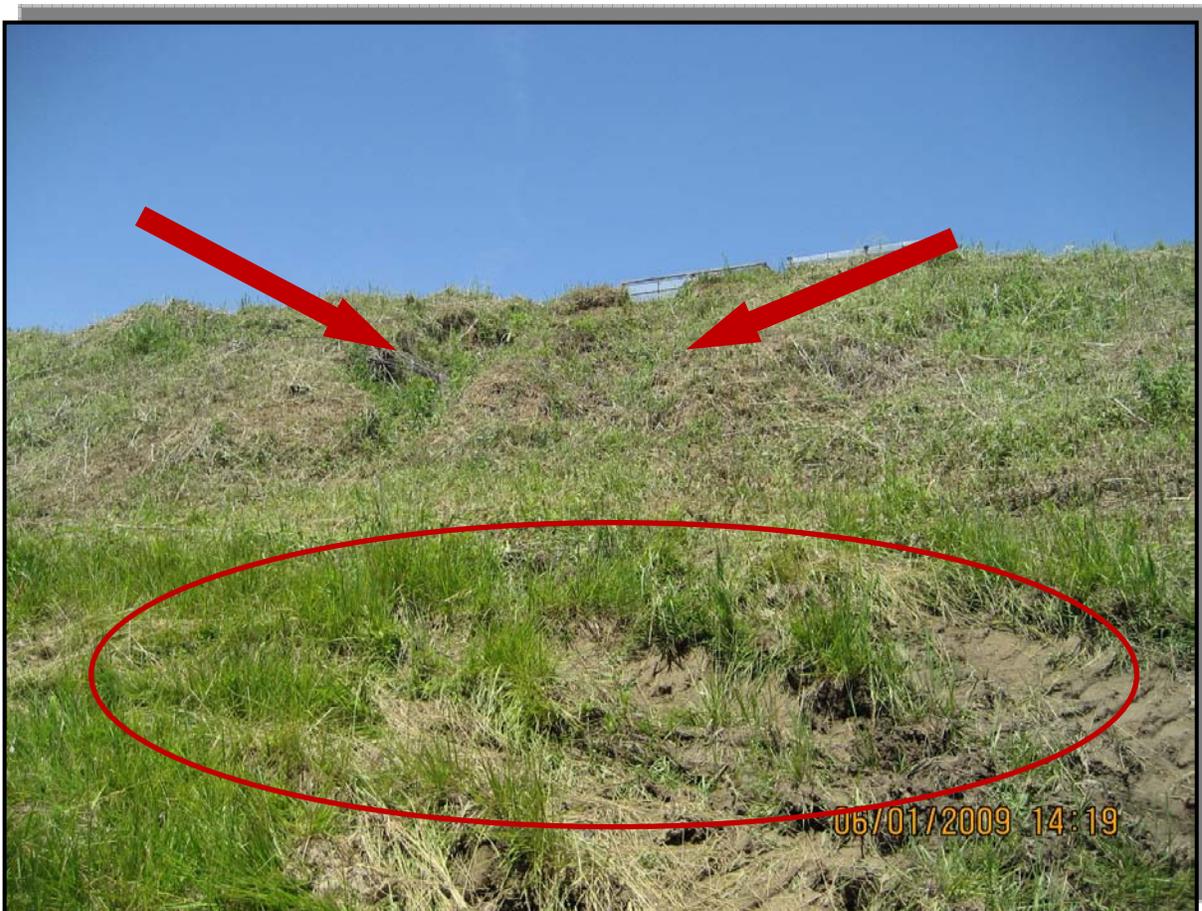
Several erosion gullies were observed on the downstream slopes of the west and north embankments. This erosion appears to be occurring due to concentrated storm water discharge due to rutting of the crest by equipment and irregular grading of the crest toward the downstream slope.

Photo 8 – Typical erosion gullies along western downstream slope near inside curved slope of embankment

3. Downstream slopes – fill erosion gullies on the downstream slopes of the north, east, and west embankments. Repair sloughs, and re-grade irregular areas of slopes to avoid concentrated runoff channels or saturation of portions of slope. Repairs should be performed in accordance with an engineered design. Avoid mowing during wet conditions to reduce rutting by heavy tractor, which may be causing some minor slope sloughing. Place turf reinforcement erosion control matting over repaired areas to reduce the potential for future erosion gullies.

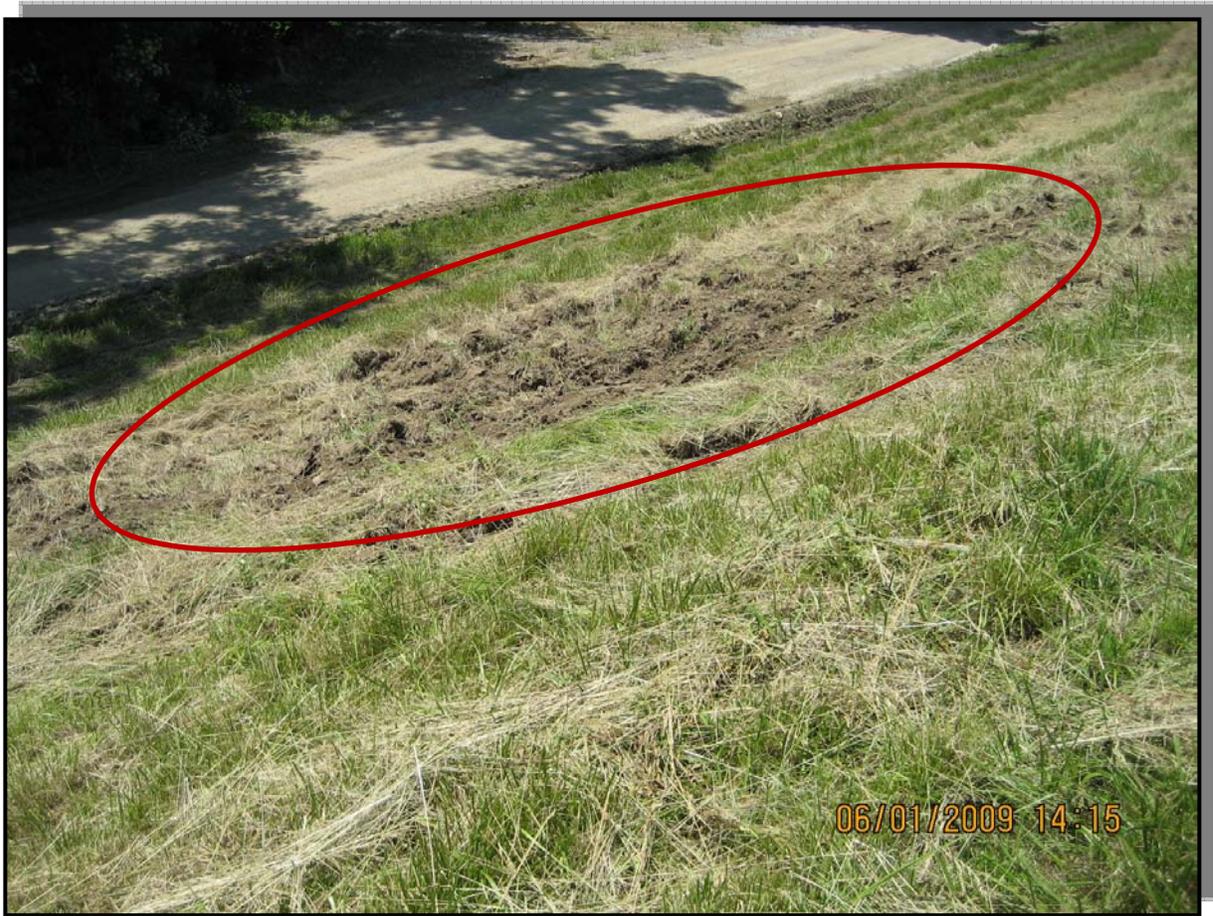
Photo 9 – Typical rutting and slope sloughing due to heavy mowing tractor, western downstream slope

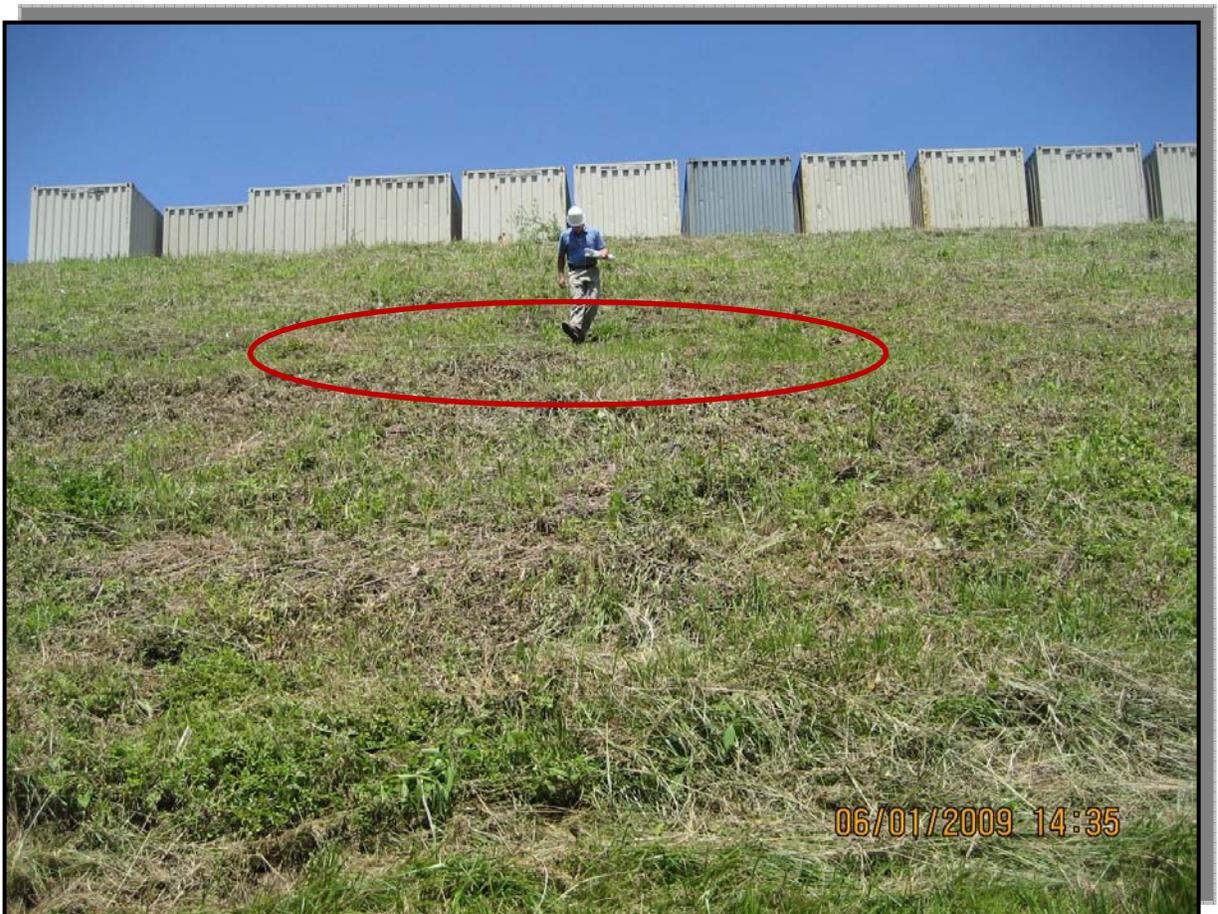
The downstream slope had recently been mowed, which allowed for better observation of the slope. Several shallow sloughs were noticed along the downstream slopes, but it was evident that they were old occurrences due to the vegetative growth around the sloughs. No new sloughs or depressions were found during this inspection.

Photo 10 – Old slough on western downstream slope

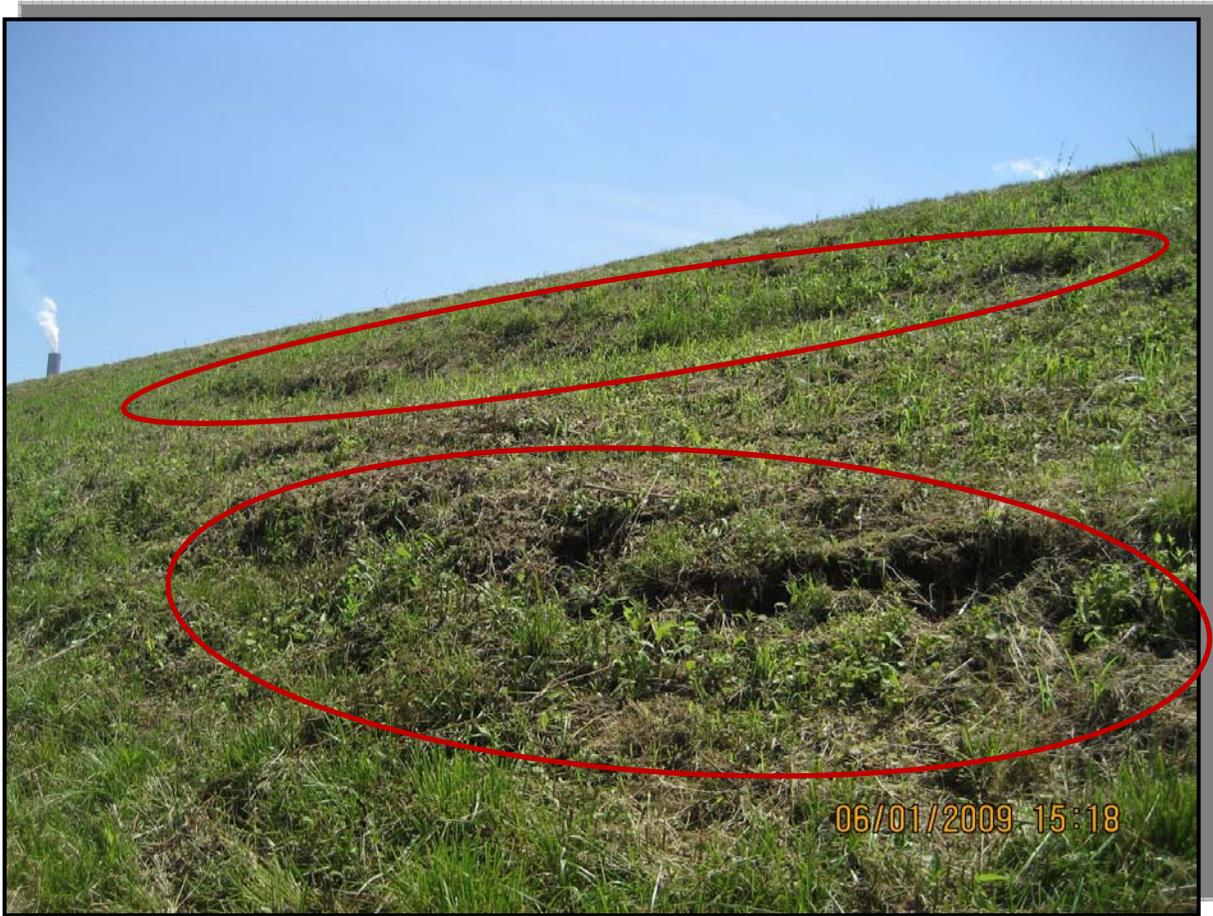
Photo 13 – Old slough on eastern downstream slope

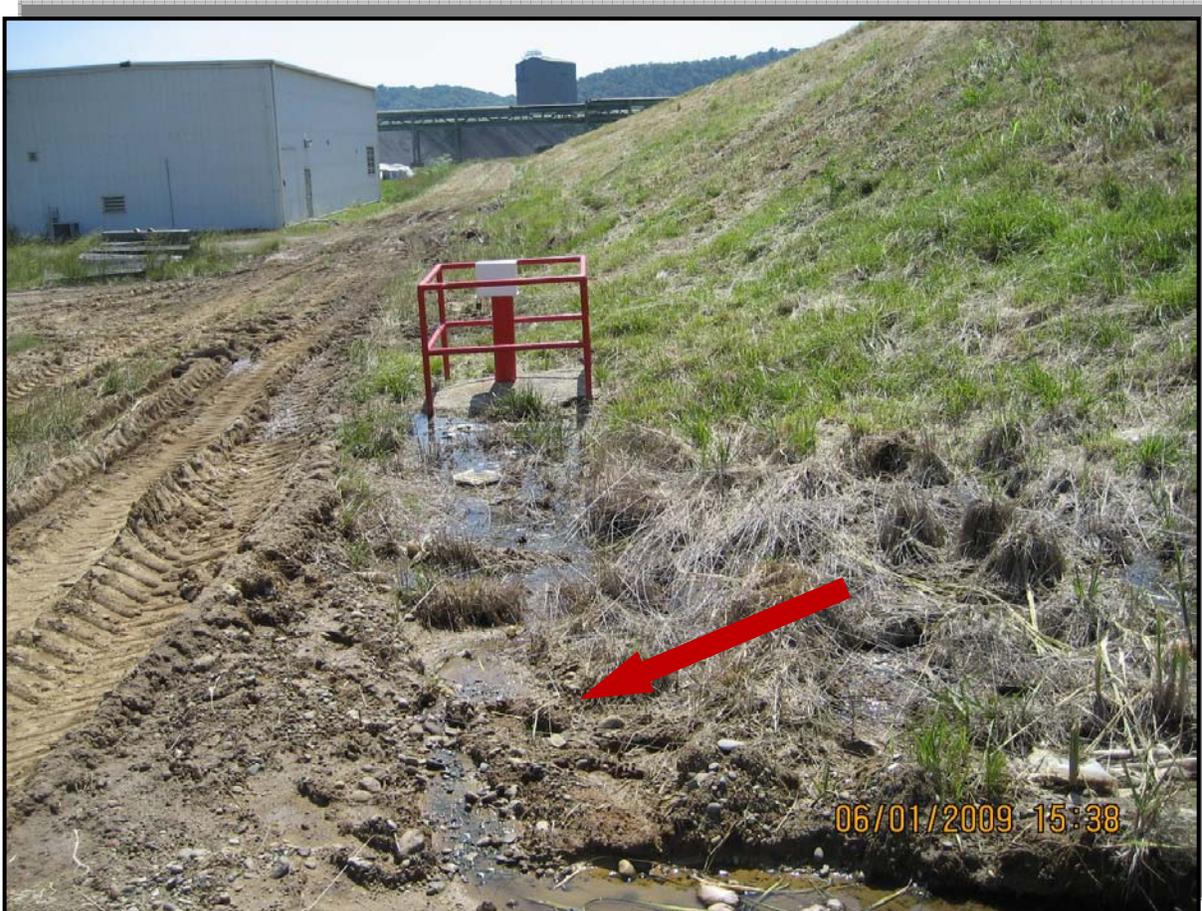
19.	A few significant erosion rills observed that require maintenance in the near future, during proposed embankment raising.
21	Minor seepage estimated at < 1 gallon/min was observed at mid-point of toe of south embankment. Seepage believed to be discharge from gravel blanket drain at toe. A few very minor wet areas were observed at isolated areas on downstream slopes. No observed flow from these wet areas. Not a safety concern
24	Photos were taken and will be presented in Final Report.

Photo 15 – Wet Area or minor seepage at toe of south embankment possibly due to discharge from gravel toe drain (View looking west)

Although the minor seepage/wetness at the downstream toe of the south embankment is believed to be the result of controlled discharge from an engineered toe drain, this seepage area should be monitored for increased seepage volume, transport of fine-grained soils, or other changed conditions that may indicate a potential problem. Installation of a small gravel blanket drain in the area with an outlet channel or pipe would help to alleviate the poor drainage conditions in the area and provide a means to measure seepage flow rate at a convenient discharge point.

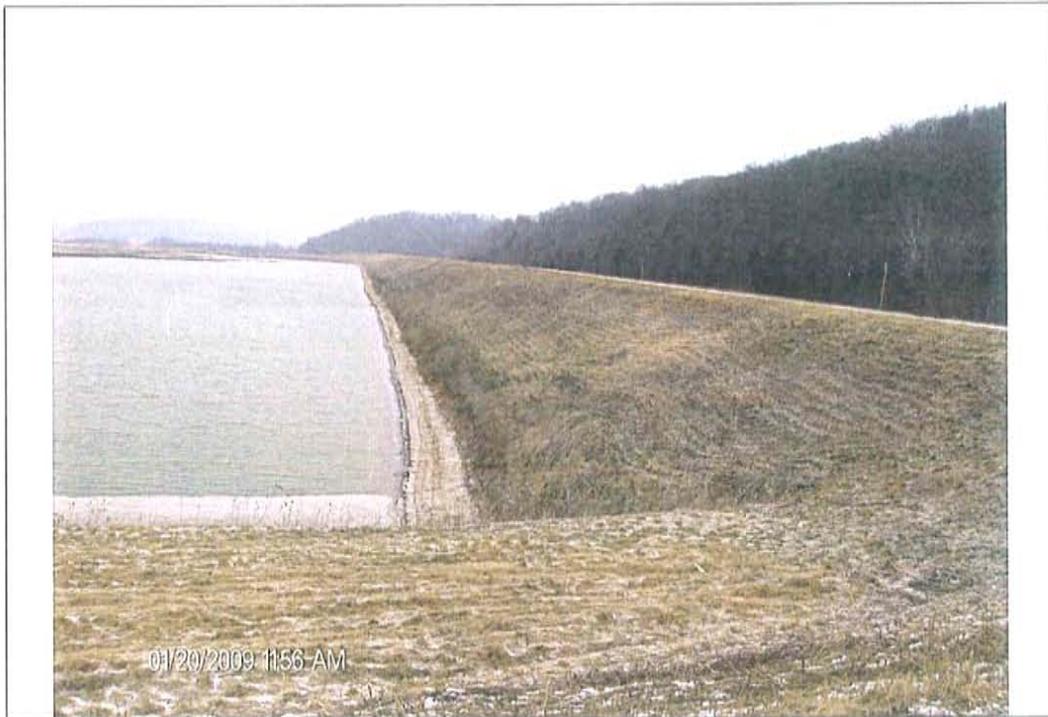
Photo #1: Wave erosion, East embankment, downstream slope, looking North

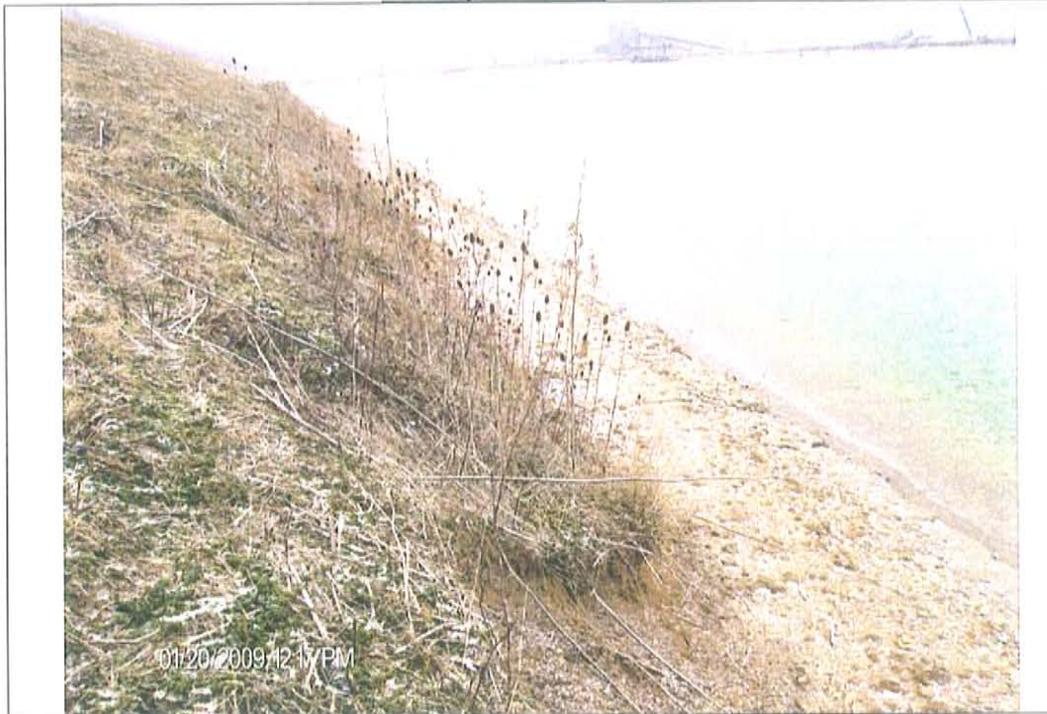
Photo #5: Wave erosion, steep drop near water surface, East embankment, upstream slope, directly across from bottom ash reclaim, looking South

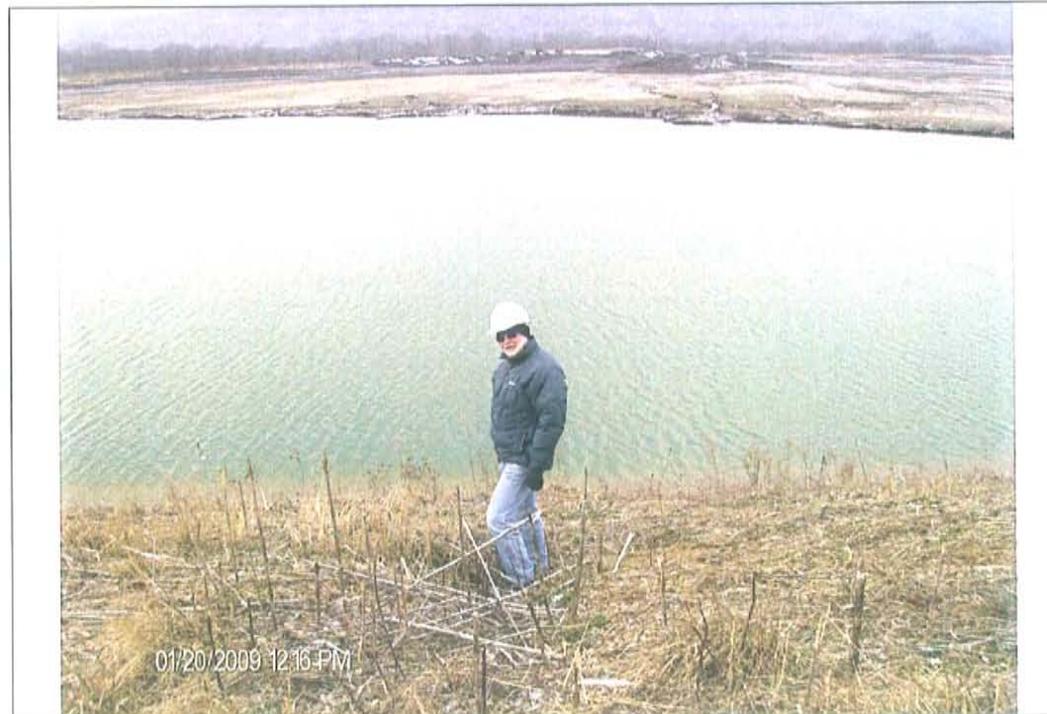
Photo #6: Appears to be filled in gully, East embankment, upstream slope, directly across from bottom ash reclaim, looking West

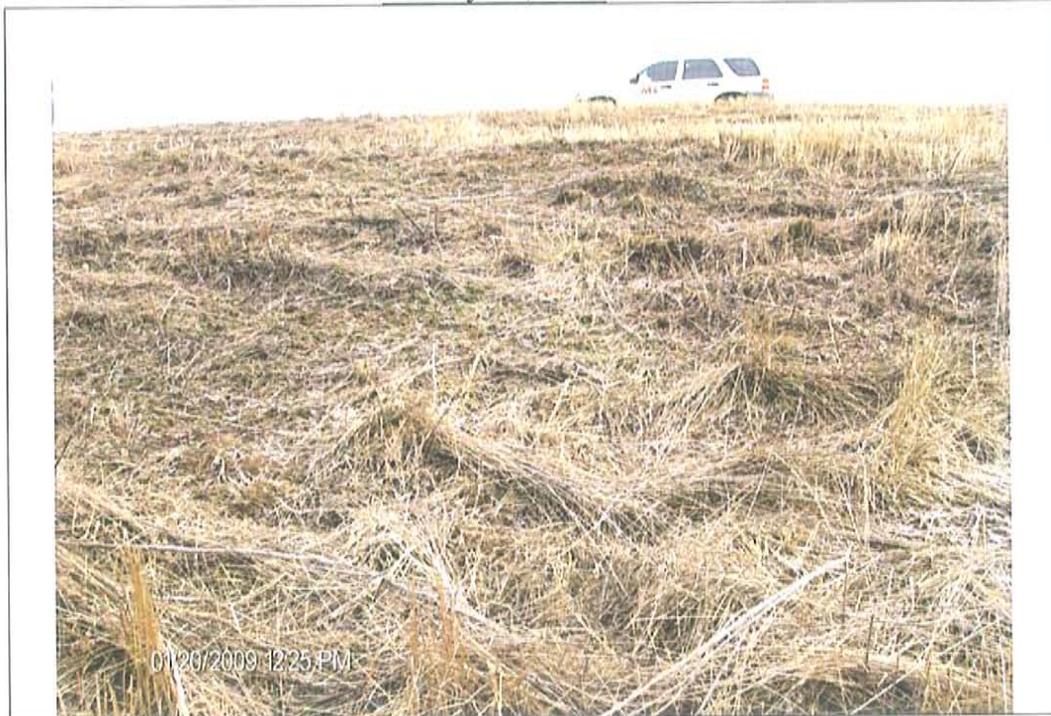
Photo #7: Old slough, East embankment, downstream slope, looking East near NE corner of pond

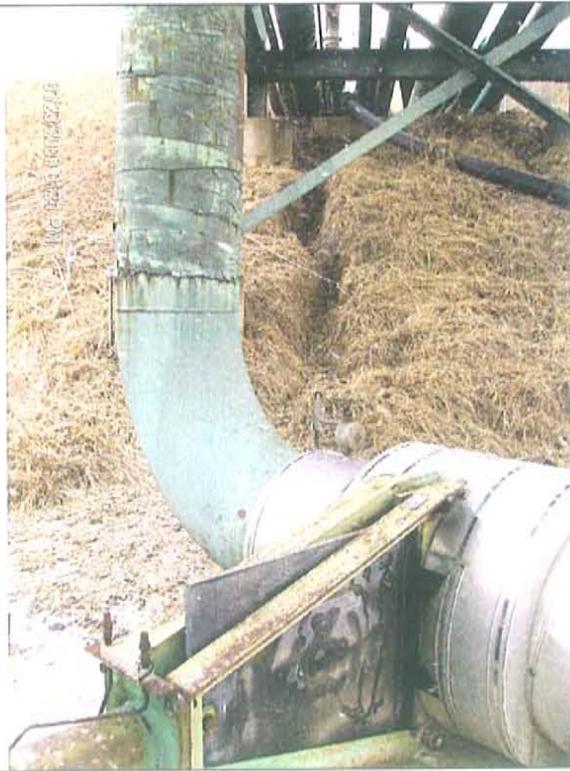
Photo #10: Minor erosion below piping, South embankment downstream slope
