Coal Combustion Residue Impoundment

Round 12 - Dam Assessment Report

Big Brown Steam Electric Station

Bottom Ash Pond

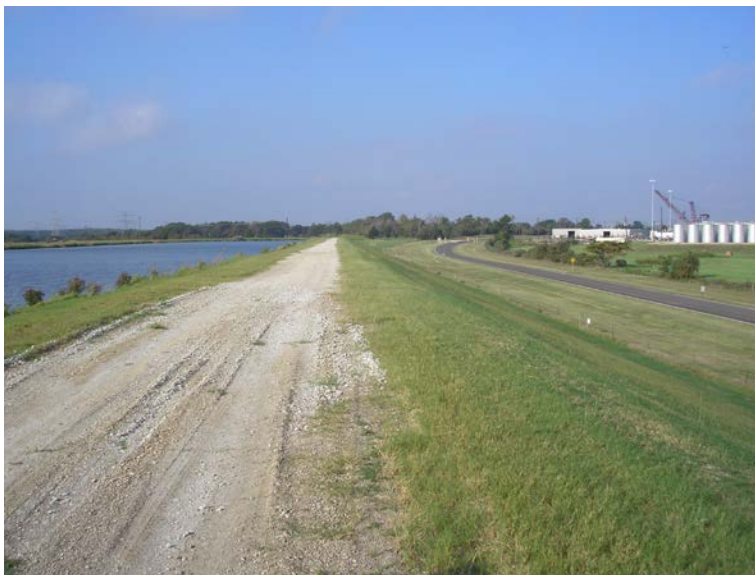
**Figure 5.2.1-1 North Dike Crest View West
Along Bottom Ash Pond**

Overall, there were no signs of rutting, depressions, tension cracking, or other indications of settlement or shear failure and the crest appeared to be in satisfactory condition (see Figure 5.2.1-1).

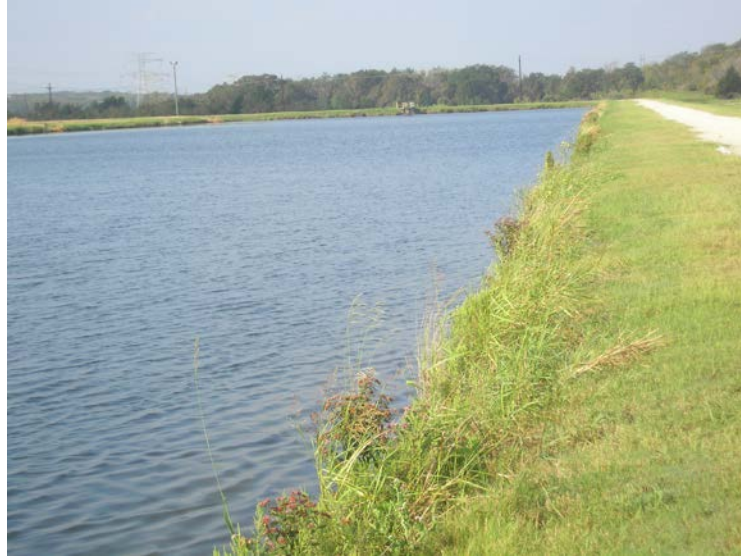
Figure 5.2.2-1 Interior Slope South Embankment

No scarps, sloughs, depressions, bulging or other indications of slope instability were observed (see Figure 5.2.2-1). Vegetation along the interior slope generally consisted of various types of grass and weeds.

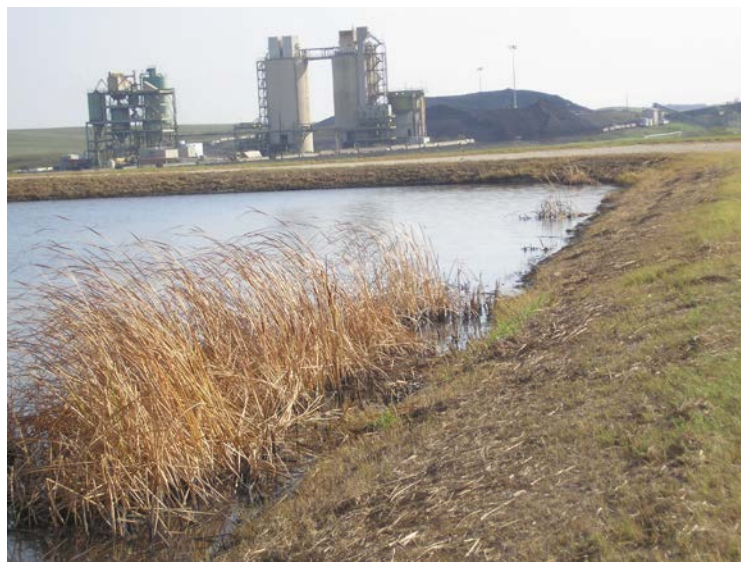
**Figure 5.2.2-2 Area of Interior Slope Erosion
– West Embankment**

Isolated areas of erosion from wind generated waves were observed on the interior slopes of the east and west embankments. It appears that recent lack of rain has had an adverse impact on vegetation planted to mitigate wave erosion. (See Figure 5.2.2-2)

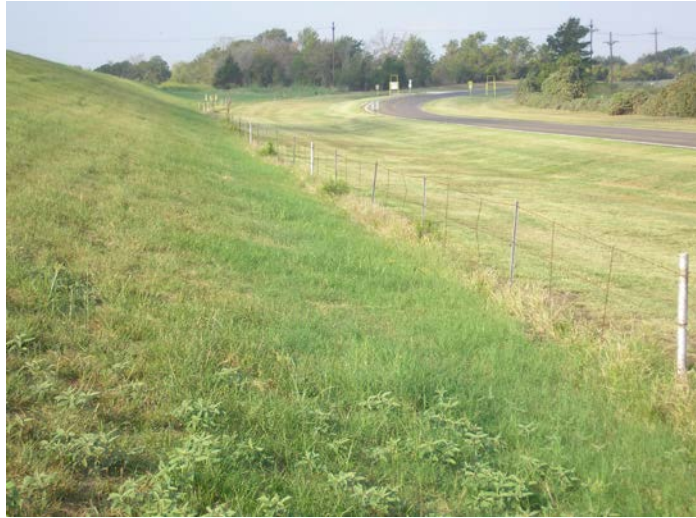
Figure 5.2.3-1 North Embankment Outside Slope and Toe

No scarps, sloughs, depressions, bulging or other indications of slope instability or signs of erosion were observed. Exterior slopes were vegetated with grass, and weeds (See Figure 5.2.3-1).

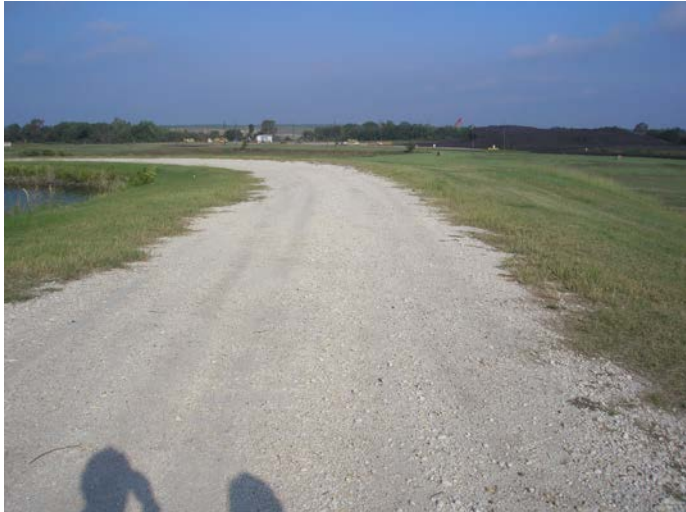
Figure 5.2.4-1: Bottom Ash Pond Northeast Groin

The Bottom Ash Pond is a fully diked impoundment with no abutments. Groins were found to be in satisfactory condition with no signs of distress (See Figure 5.2.4-1)

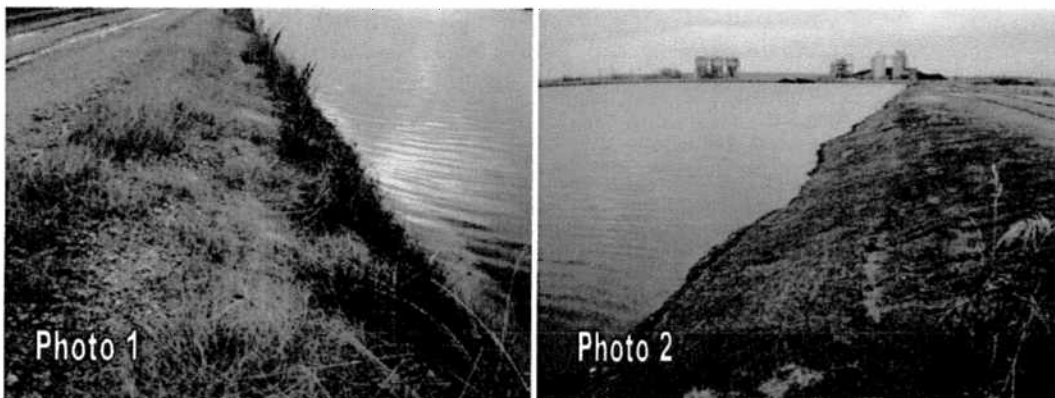
Photos 1 and 2 show the Recyclax along the upstream slopes. Photo 1 is representative of the South Pond where the vegetation has been established. The North Pond (Photo 2) depicts the Recyclax on the North Pond where the vegetation is not widely established. This should take hold once the spring growth season starts.

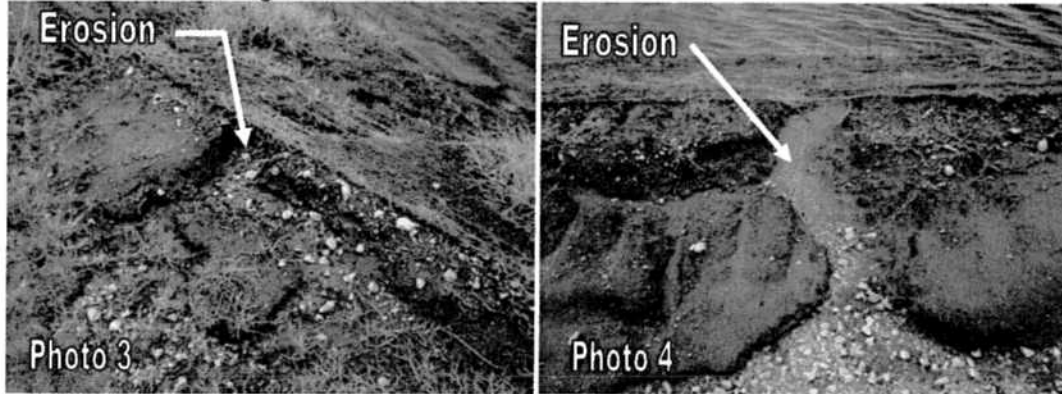
Photos 3 and 4 show the two locations on the north side of the North Pond where erosion has occurred under the Recyclex. It is recommended these areas be filled in and allowed to re-vegetate.

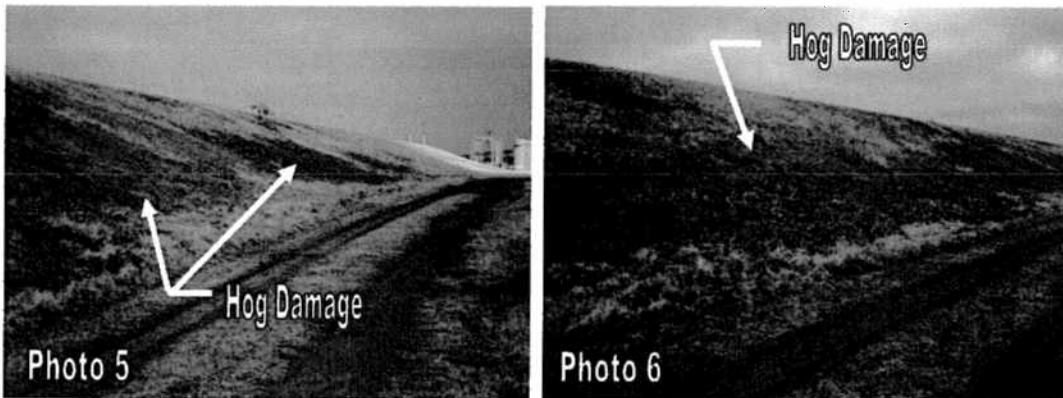
Photos 5 and 6 depict the hog damage that was prevalent along the downstream embankment of the South Pond. This needs to be re-vegetated to prevent erosion.

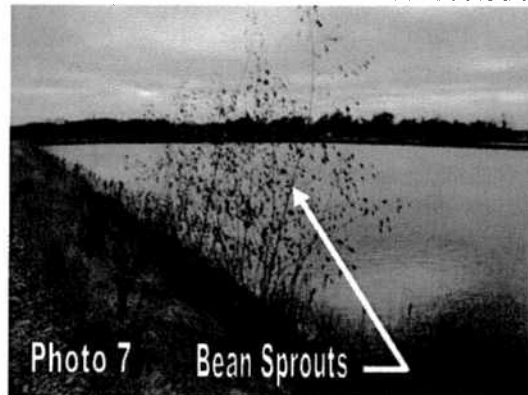
Photo 7 shows bean sprouts on the center of the upstream embankment of the South Pond. This needs to be removed at the next routine scheduled maintenance.

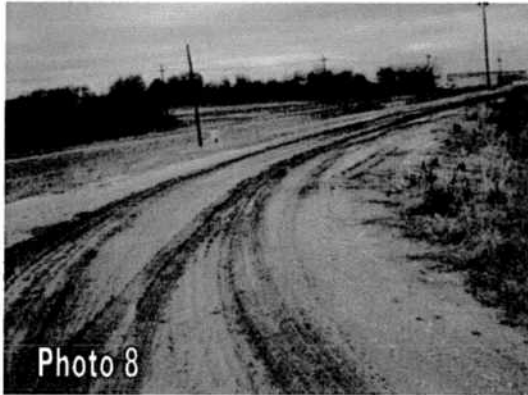
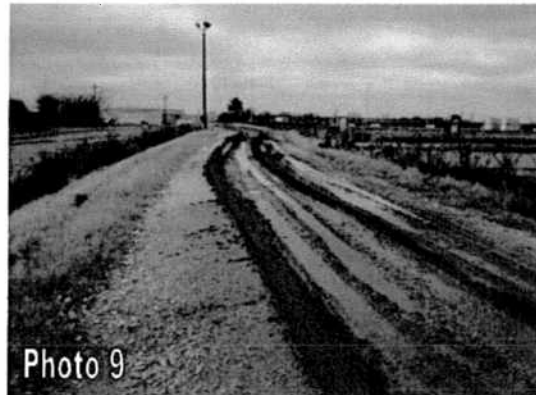
Photos 8 and 9 are rutting along the crest. The ruts allow rainwater to collect, penetrate and potentially weaken the embankment. These should be repaired and care should be taken to avoid driving on the crest when the embankment has been softened by wet conditions. See SK-1 for the locations of the ruts.

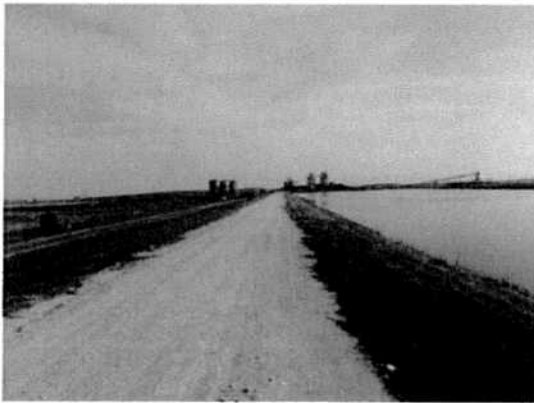
Figure 2: Crest of North Impoundment

In general, the crest of the impoundment was in good condition (Figures 2 and 3).

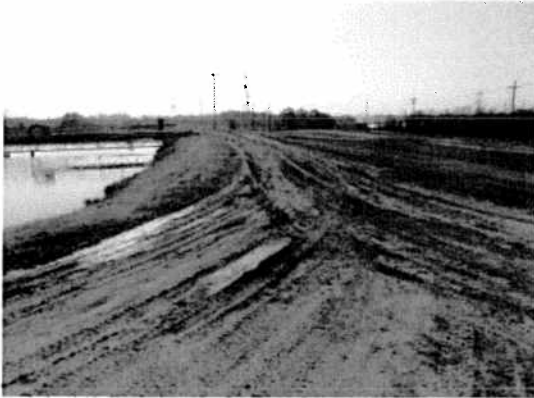
Figure 4: Crest Rutting North Pond

Recommendation 2: Discourage vehicular traffic from driving on impoundment crests after storm events.

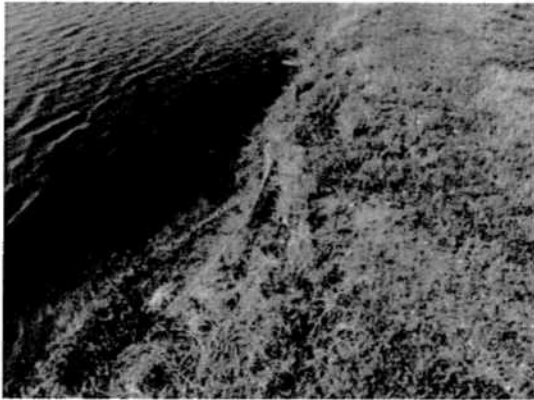
Figure 6: North Pond Embankment (Note geotextile separation and erosion).

Recommendation 2: Continue to monitor erosion to protective cover over liner and repair as needed with riprap.

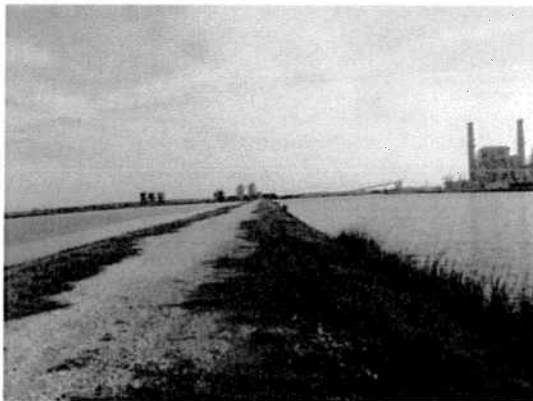
Figure 8: Cattails South Pond

Recommendation 1: Remove cattails and undesirable vegetation (bushes) from upstream embankment. Repair surface areas disturbed by removal of large vegetation (bushes).

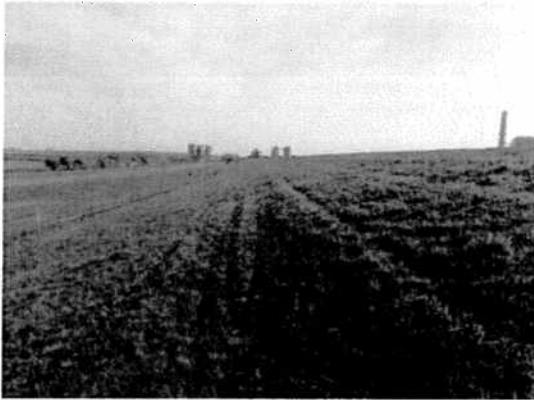
Figure 10: Downstream Embankment North Pond

In general, the downstream side of the impoundment embankment was in good condition (Figures 10 and 11).

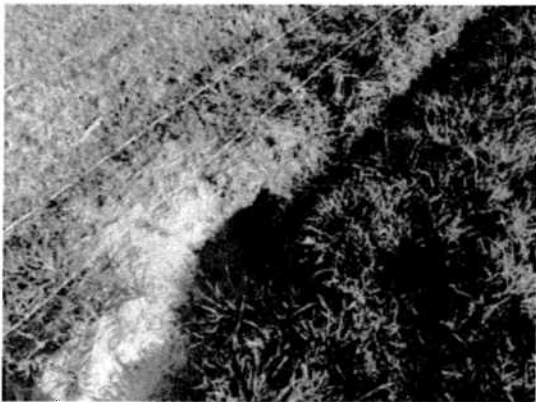
Figure 12: North Pond Animal Burrow

Recommendation 2: Continue to monitor for burrow reestablishment or erosion to restored areas.

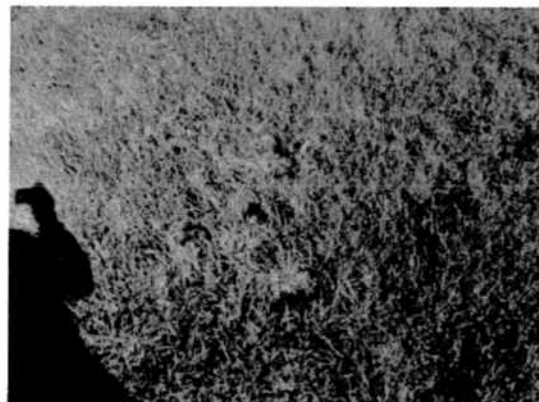
Figure 13: South Pond Animal Burrows

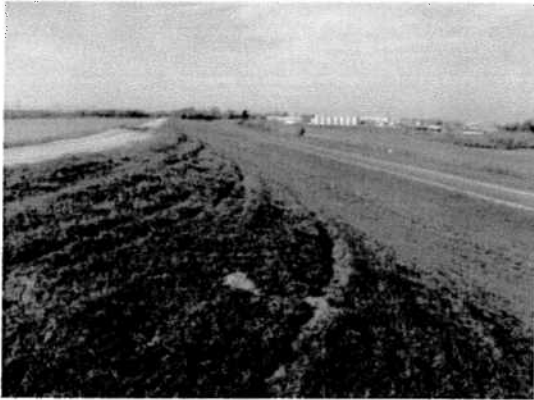
Figure 14: Bare Area North Pond

Recommendation 2: Continue to monitor for additional erosion after re-vegetation.

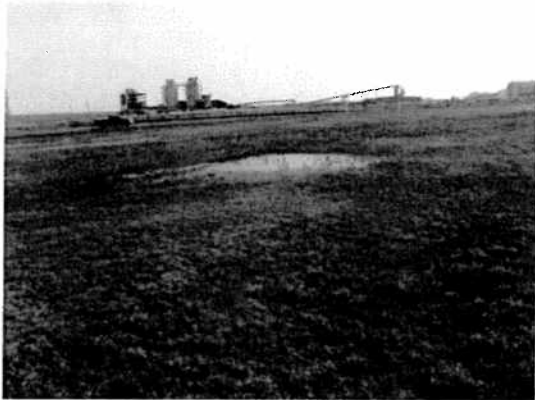
Figure 16: North Pond Standing Water at Toe

Recommendation 2: Provide compacted cohesive fill soil and grade to eliminate the ponding areas.

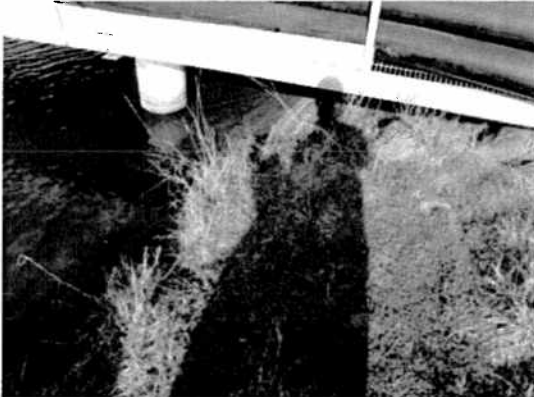
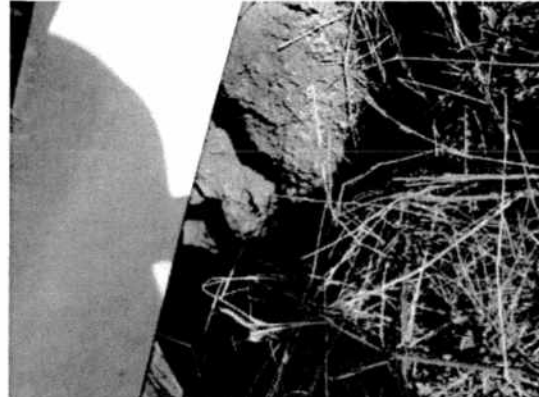
Figure 18: North Pond Pipe Rack Erosion

Figure 19: North Pond Pipe Rack Erosion

Recommendation 3: Continue to monitor areas after repairs for additional erosion.
