Re: Task 3 Dam Assessment Report
Project #0-381
Marshall Steam Station Coal Ash Retention Dam
Catawba County, North Carolina

Final Report

EXECUTIVE SUMMARY

This Phase I Inspection/Evaluation Report details the results of a visual dam inspection of the Marshall Steam Station Coal Ash Retention Dam (MA01161) located on State Route 150 in Catawba County, North Carolina. The inspection was performed on May 28, 2009 by GZA GeoEnvironmental, Inc (GZA).

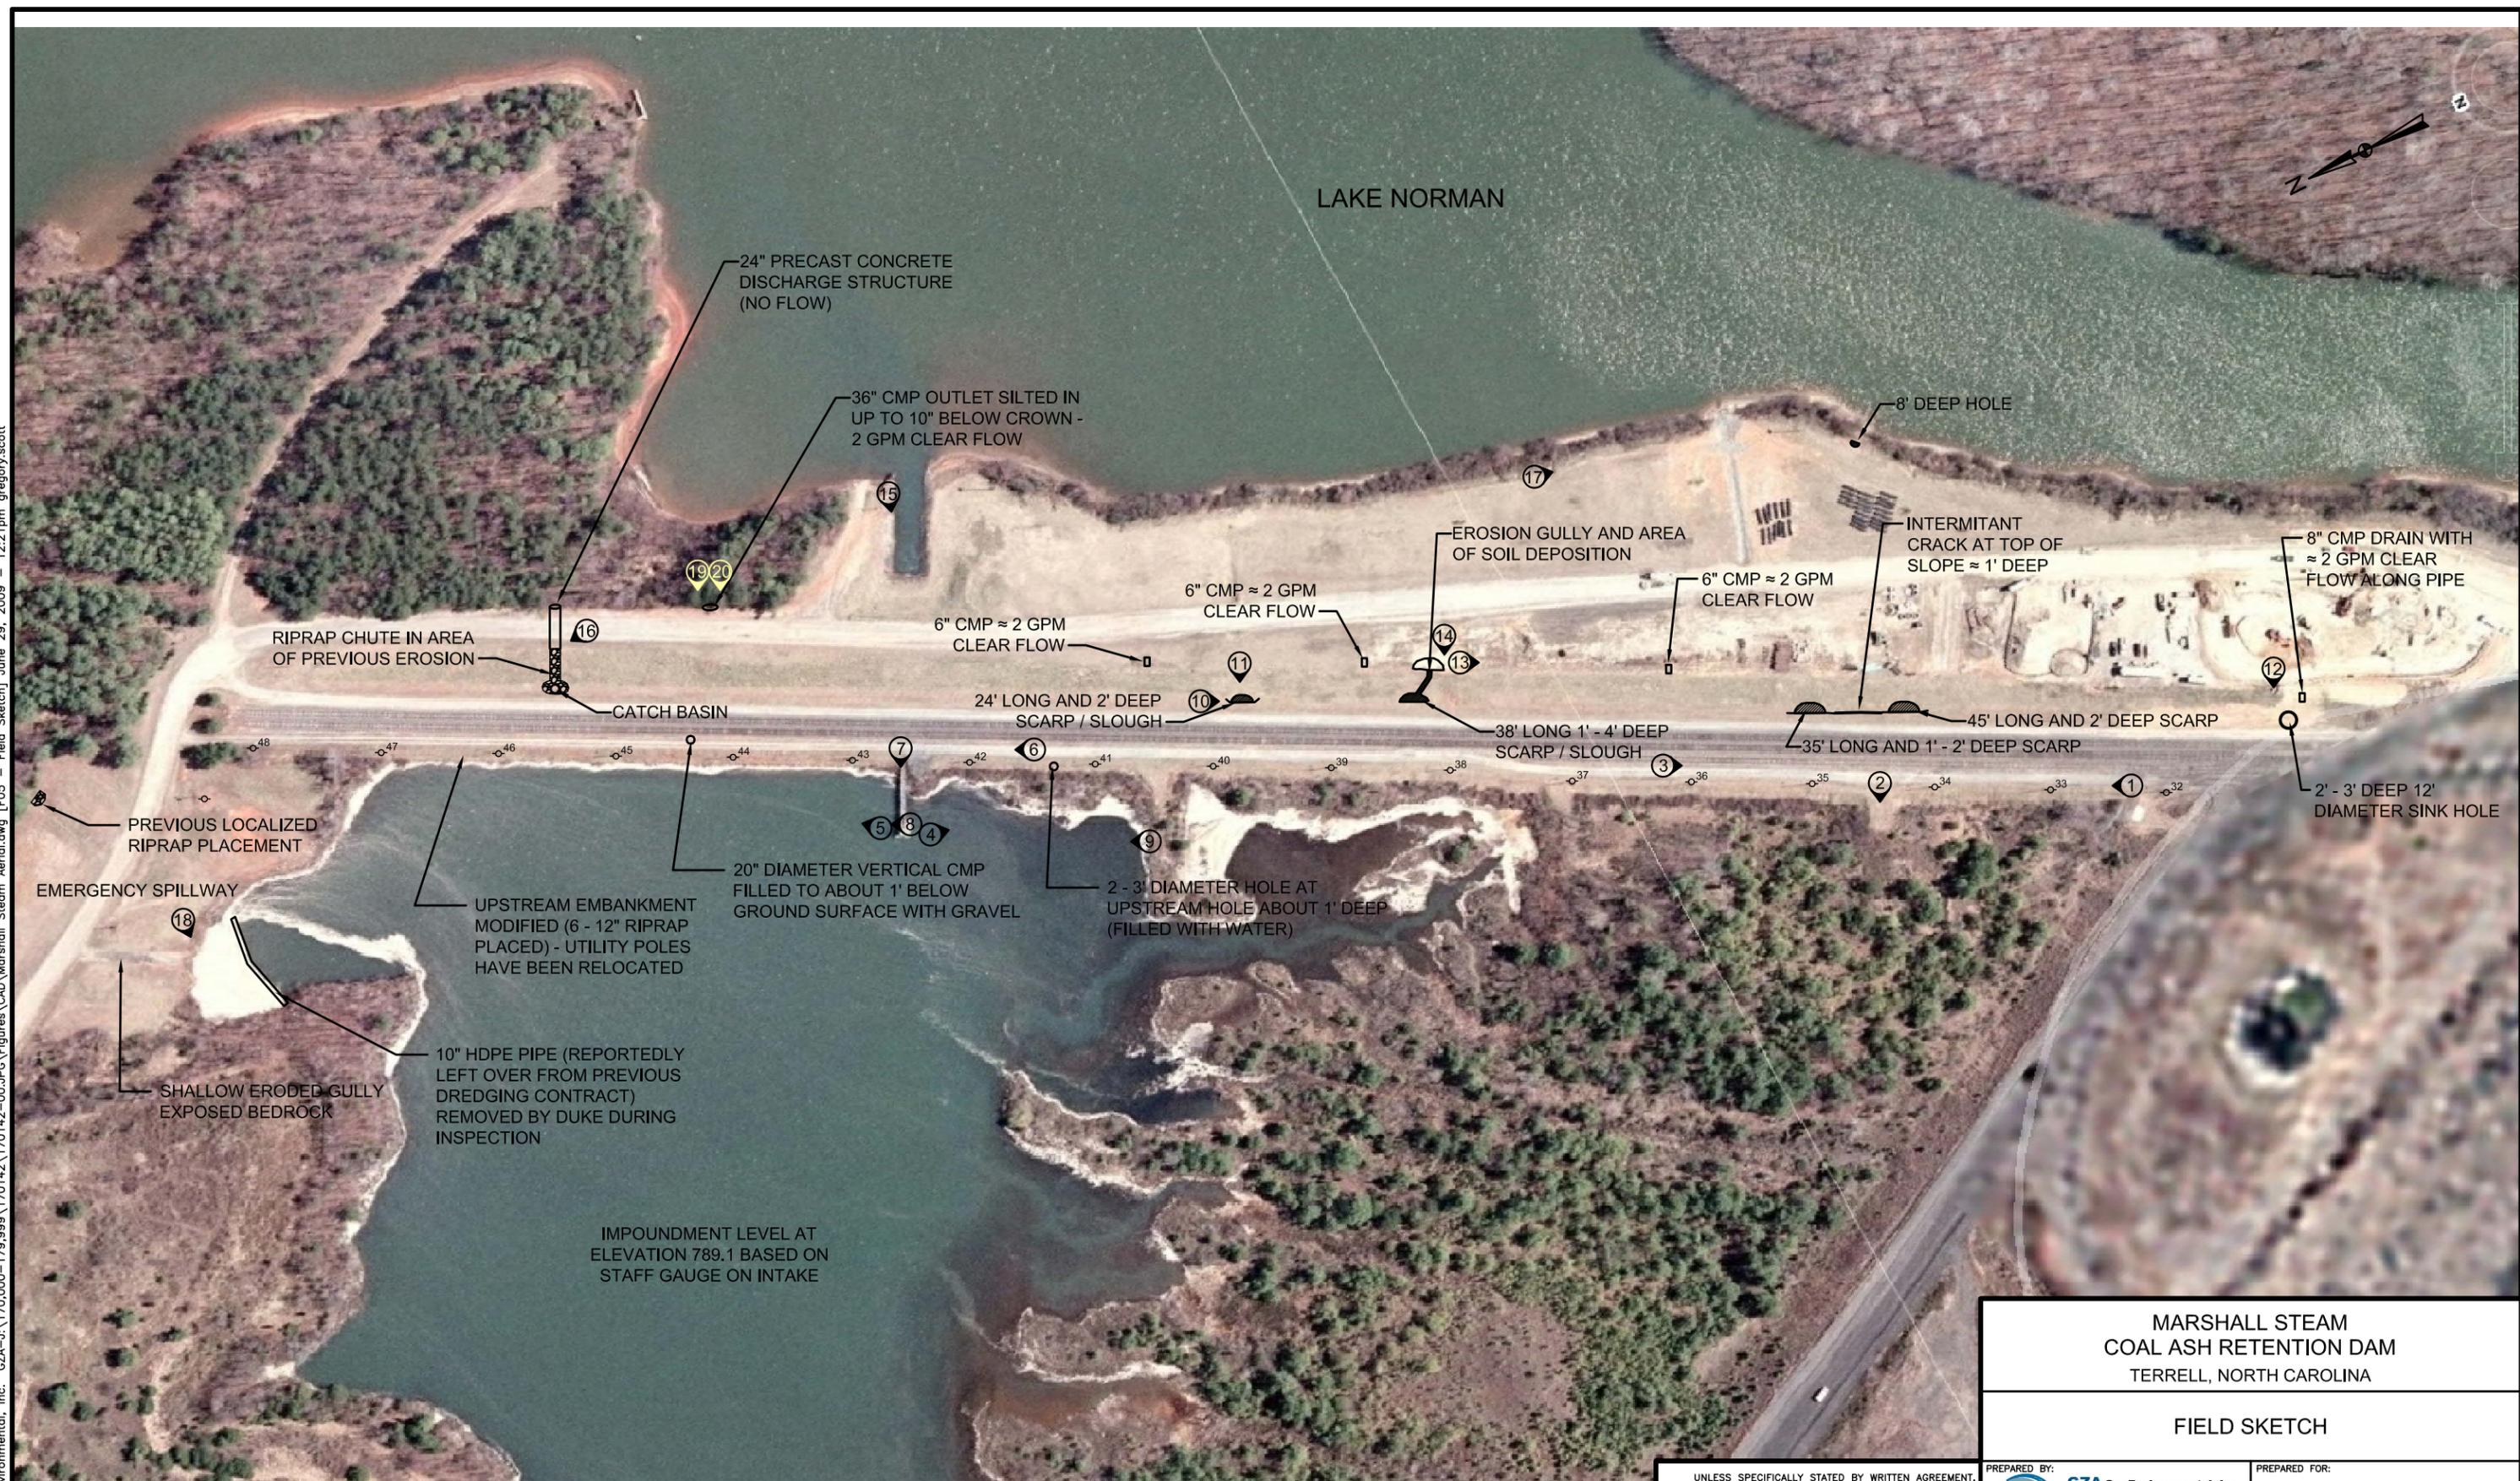
FIELD SKETCH

In general, Marshall Steam Station Coal Ash Retention Dam was found to be in **FAIR** condition. The specific concerns are identified in more detail in the sections below. A sketch showing the dam in plan and noting areas of observed deficiencies is contained in **Figure 5**. Locations of photos are also shown in **Figure 5**.

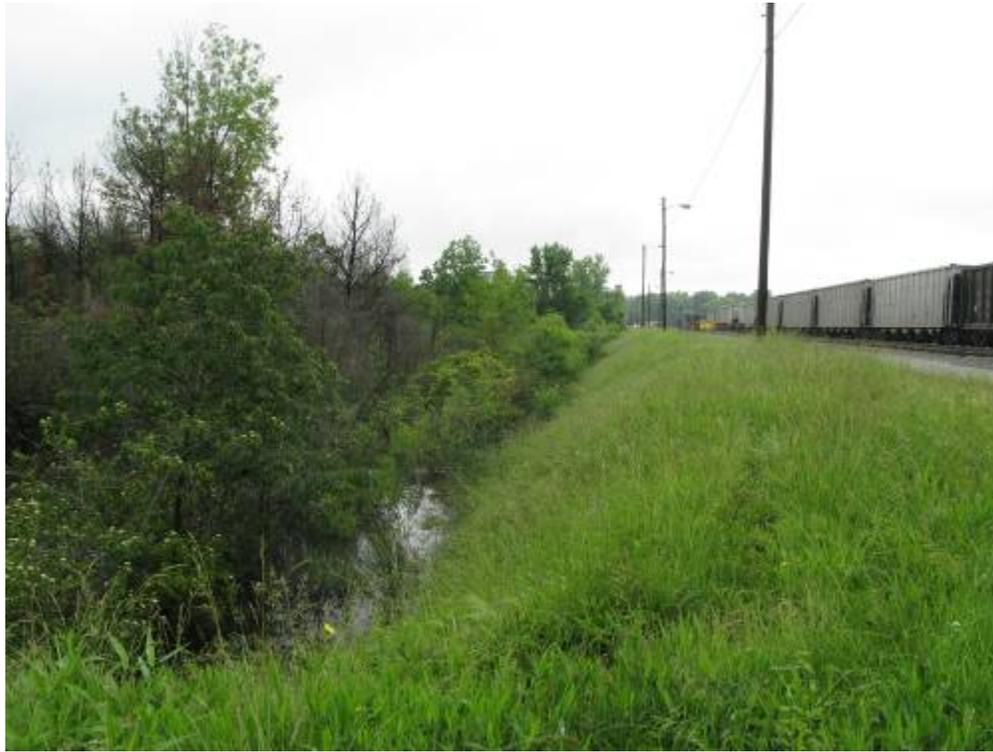
Photo 1: Upstream view of dam from south end of impoundment. Note heavy vegetation at upstream toe.

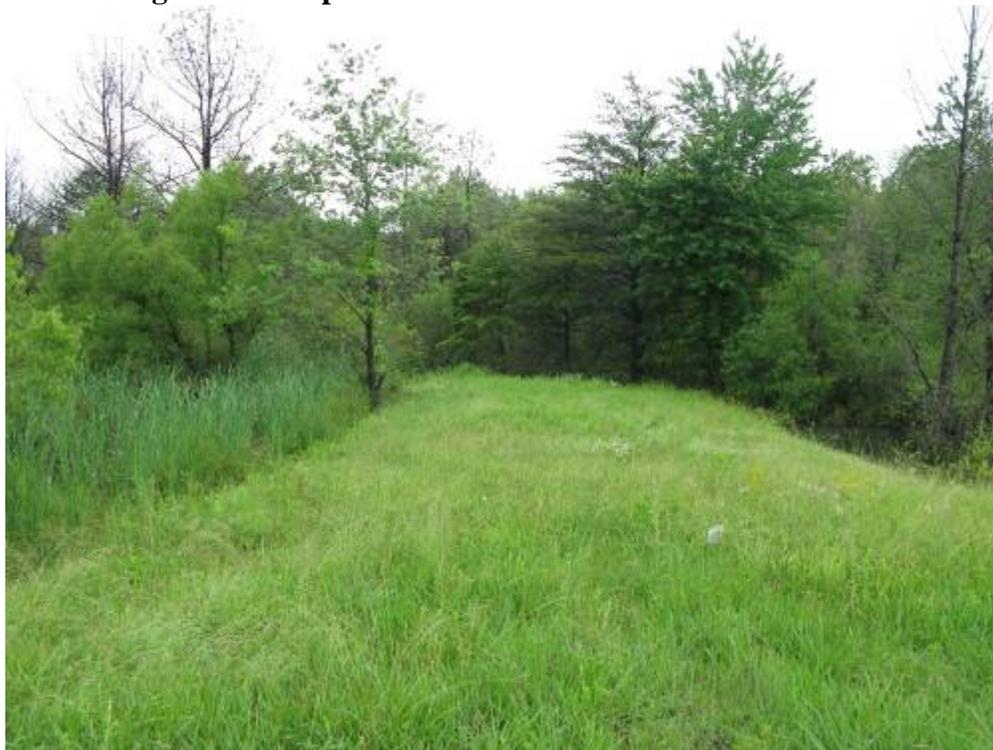
Photo 2: Finger dike extending from upstream slope near the south end of embankment. Note heavy vegetation.

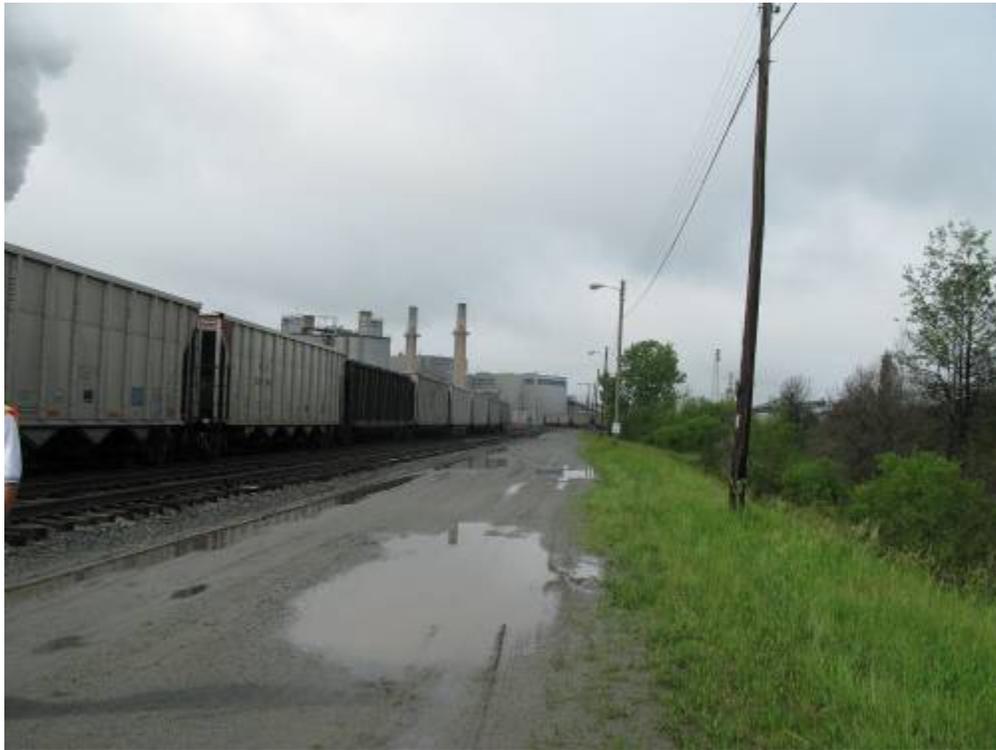
Photo 3: South end of crest road, looking south towards the plant. Note the coal cars, the elevation of track w/r to the crest road, and the ponding of surface water.

1. Repair of surface drainage system and grading including minor depressions found on the crest.
2. Investigate seeps at the downstream toe in dry weather, with repairs designed by a professional engineer and construction by a contractor experienced in dam repair.

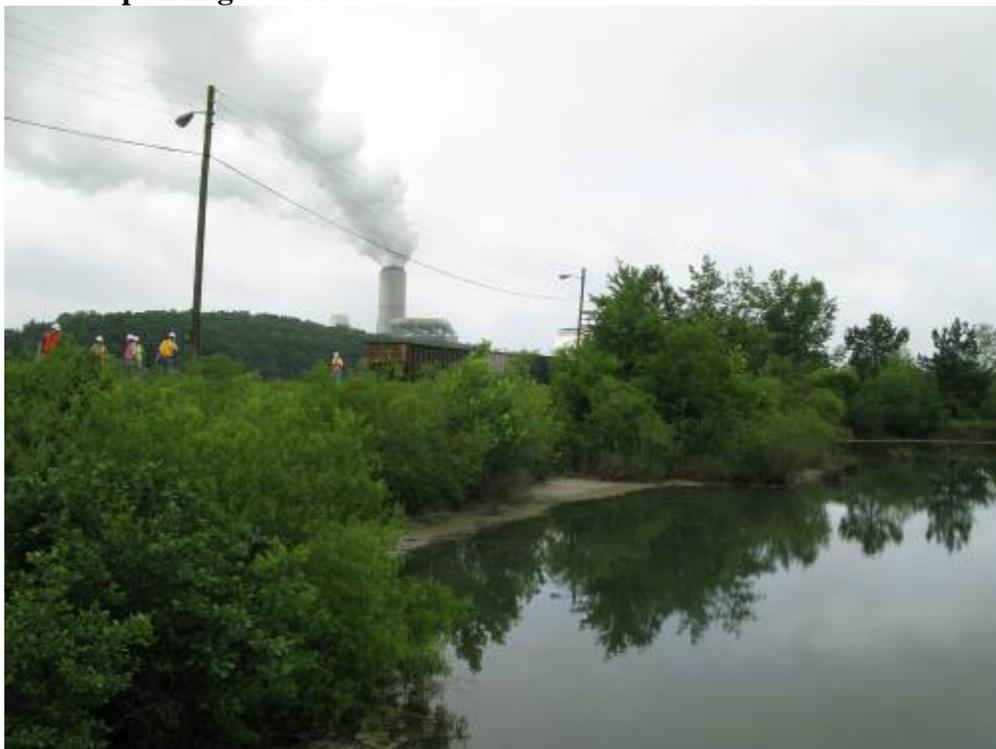
Photo 4: Upstream face on southern end of dam. Note vegetation growth at toe and finger dike on right.

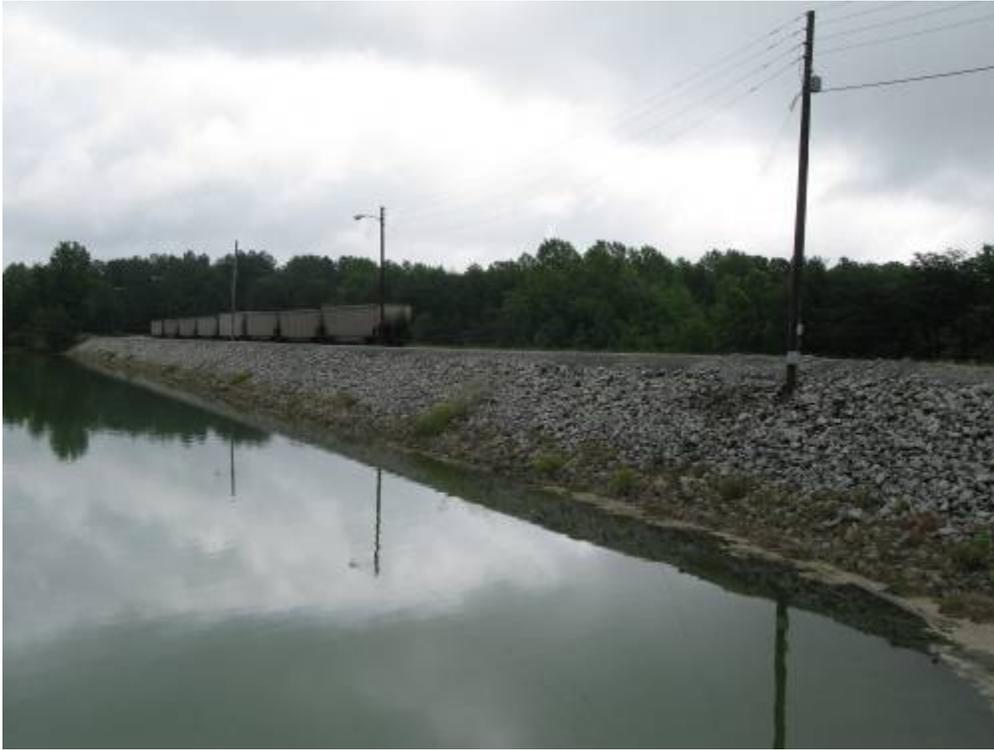
Photo 5: Upstream slope north of Discharge Tower. Note the rip rap slope.

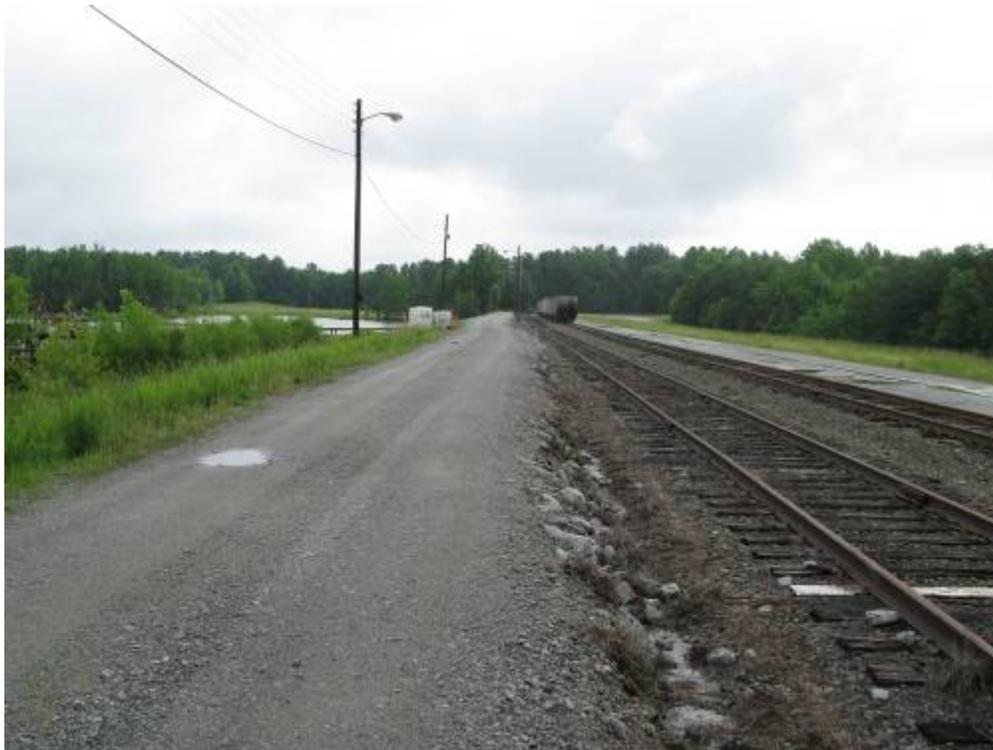
Photo 6: View of crest road and rail tracks looking north

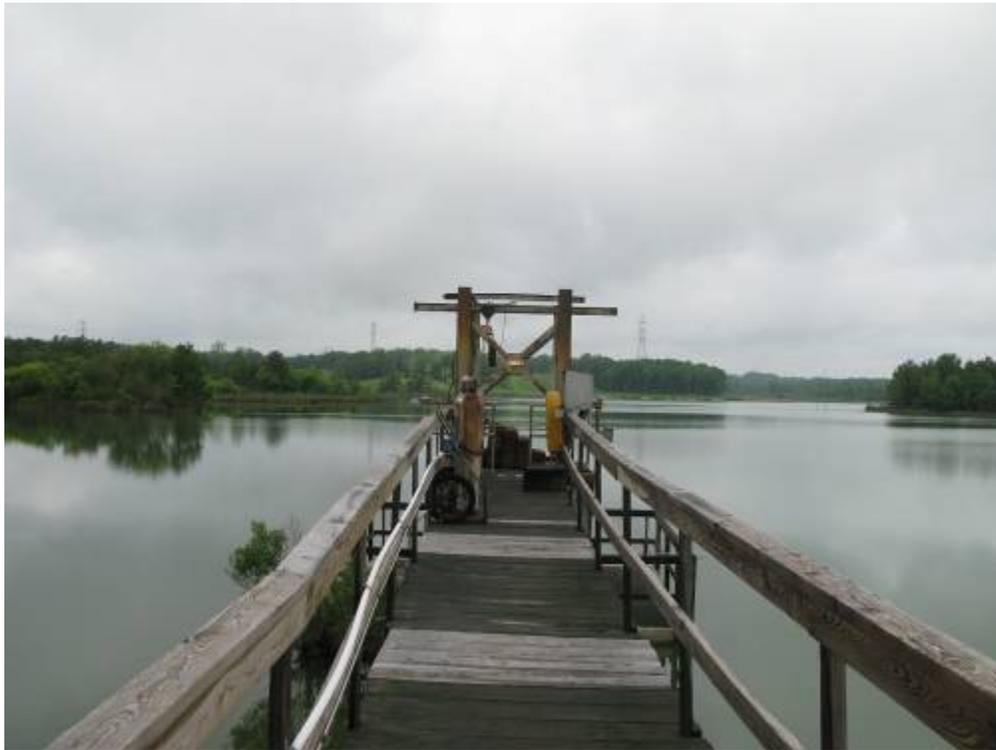
Photo 7: View of walkway to Discharge Tower, with stoplog structure at the end of the walkway.

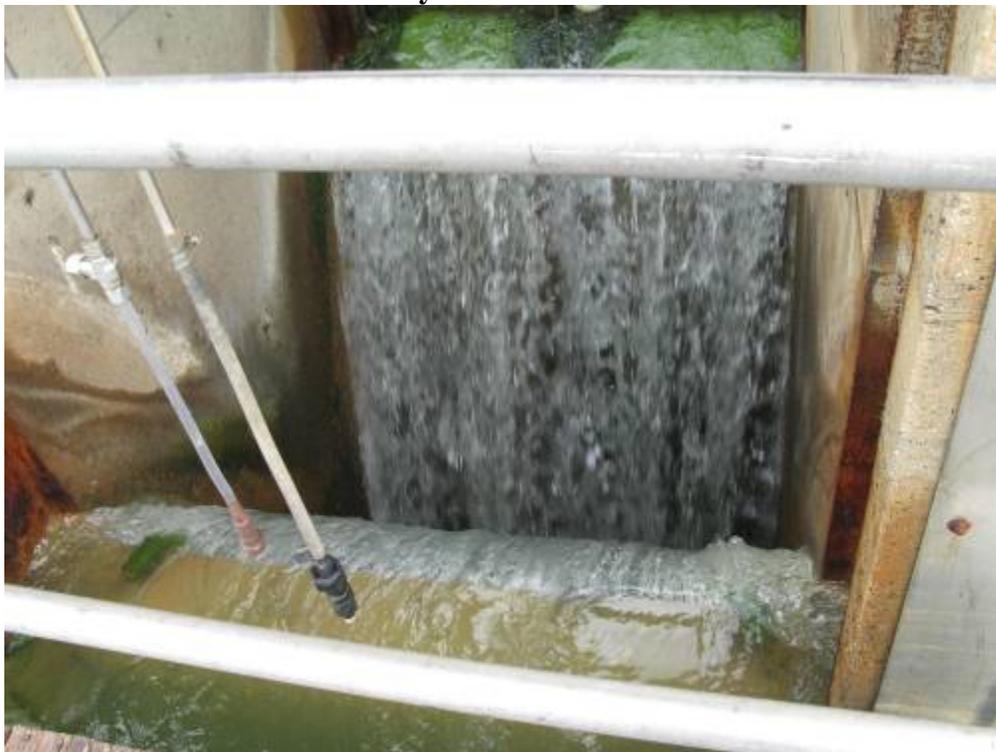
The water level in the pond is controlled by a square concrete drop inlet structure that has two 5-foot-long stoplog-controlled weirs and two 5-foot long fixed weirs. This structure, referred to as the Discharge Tower, was observed to be in good condition. The stoplog-controlled weirs are on the north and south (left and right) side of the drop inlet and have steel sleeves for precast concrete stop logs on two sides. The fixed weirs are on the upstream and downstream (west and east) sides of the drop inlet at approximately elevation 792 feet. The concrete appeared intact, and the stop logs had little signs of wear or spalling.

Photo 8: View of water flowing over the stoplogs at the Discharge Tower. Pipes to left are used to add chemicals for pH correction.

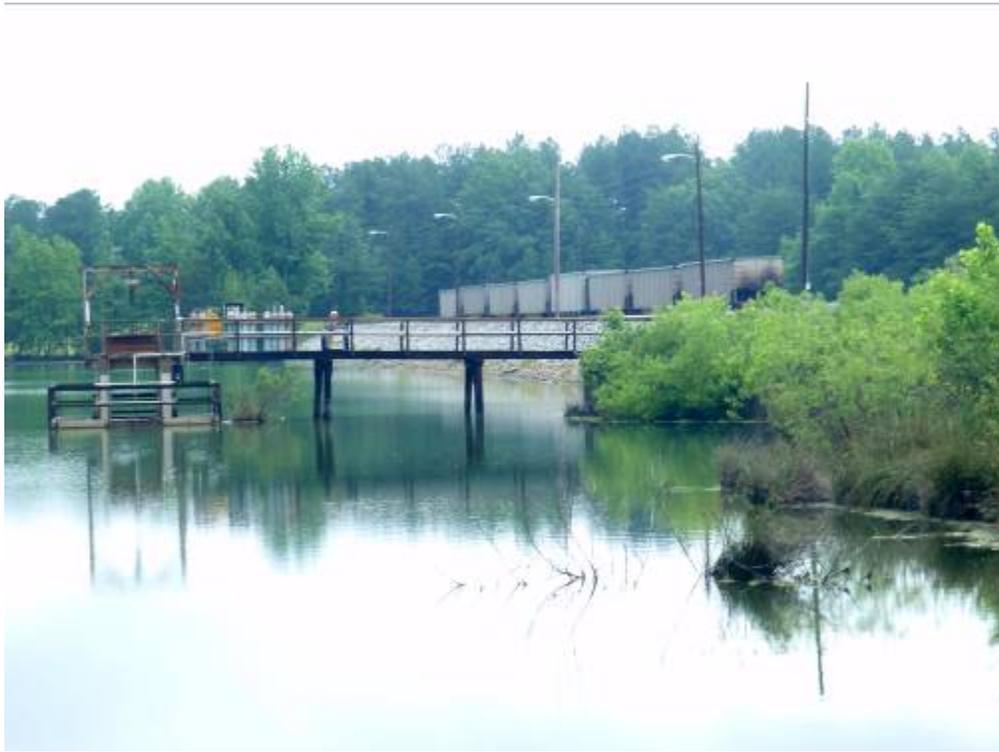
Photo 9: Discharge Tower, looking north.

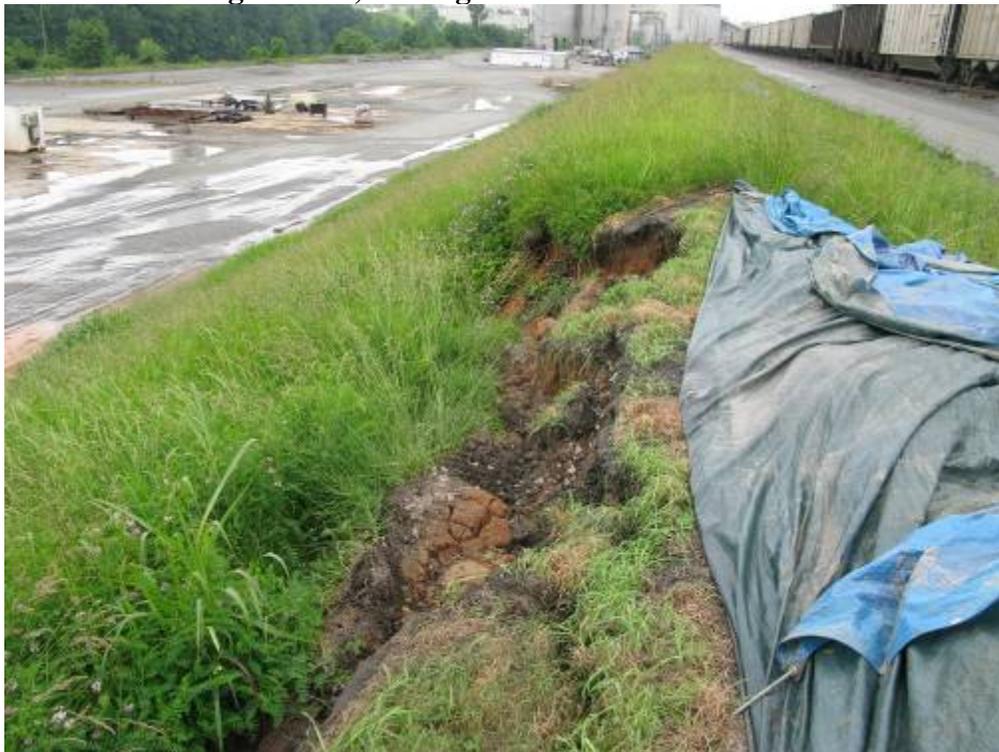
The slope was generally in good condition, except for at least five scarps that have formed near the crest. These scarps have formed at the crest, and appear to be due to localized slope failures due to the steep slope near the crest. The scarps vary in length from about 10 feet to 45 feet, and average about 3 feet in height. Duke Energy has retained Mactec to design and oversee a localized repair for the scarps. The repair plan was reviewed during the inspection, and the design appeared adequate in GZA's opinion. However, the historical problems with surficial slope stability and the current presence of five scarps in need of repair raises the issue of whether a localized repair will provide a permanent solution, or whether further investigations are needed to evaluate the cause and provide a more permanent solution.

Photo 10: Scarp on downstream slope at crest road, near the Discharge Tower. Lower berm on left.

2. Duke Energy has retained an outside consultant to provide an engineered repair of the scarps, but rather than approach this issue as an isolated repair, GZA recommends investigating the cause of the scarps more thoroughly (including but not necessarily limited to item 1 above).

1. Investigation and repair of the scarps and potential improvements required to meet required factors of safety for embankment stability if found necessary by the analysis recommended above.
2. Trees and their root system and undergrowth within approximately 10 feet of the toe of the downstream slope (north of the boat ramp adjacent to the outlet channel) and along the southern upstream slope should be removed. The trees and root systems growing along the downstream slope of the berm are not considered to be a major dam safety issue given the 200 to 300 foot wide berm. However, erosion and vegetation along the downstream slope of the berm should be maintained.

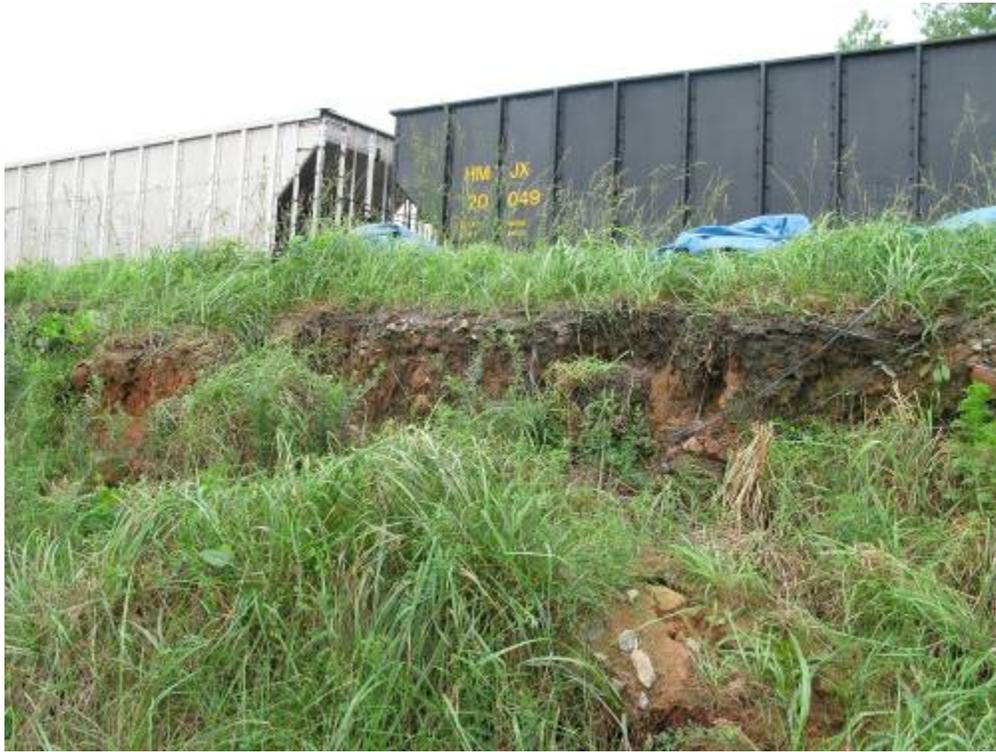
Photo 11: Frontal view of scarp on downstream slope near the Discharge Tower.

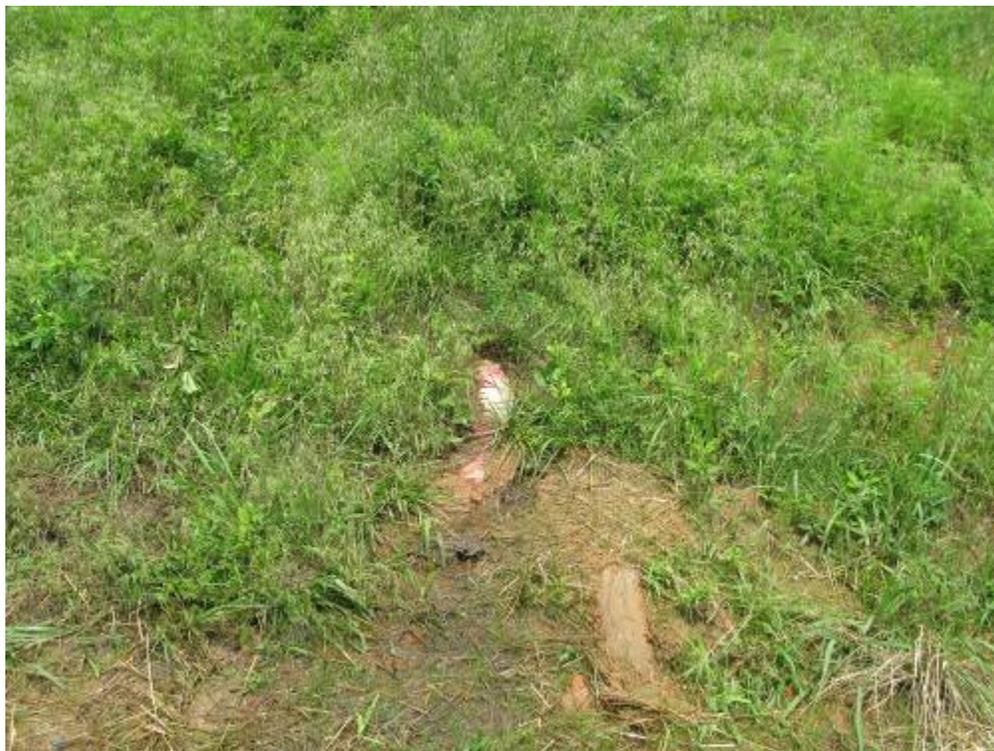
Water was observed flowing from the toe of the upper downstream slope approximately 500 feet south of the discharge canal. The flow is just below a scarp, but appears to be related to a drain that extends from the crest that exits near the toe. A deltaic deposit of red soil, similar to the embankment material had formed on the berm. It is possible that this deposition is a result of surficial erosion in a scarped area immediately upslope. A large part of the toe was wet and spongy, but because

Photo 12: Seepage at base of upper downstream slope.

3. Observations of the upper downstream toe should be made during periods of low rainfall to determine whether the wet and spongy conditions observed at the toe were due to surface water runoff or internal seepage. Further study should be conducted to correct the migration of dam core material that is being deposited on the berm.

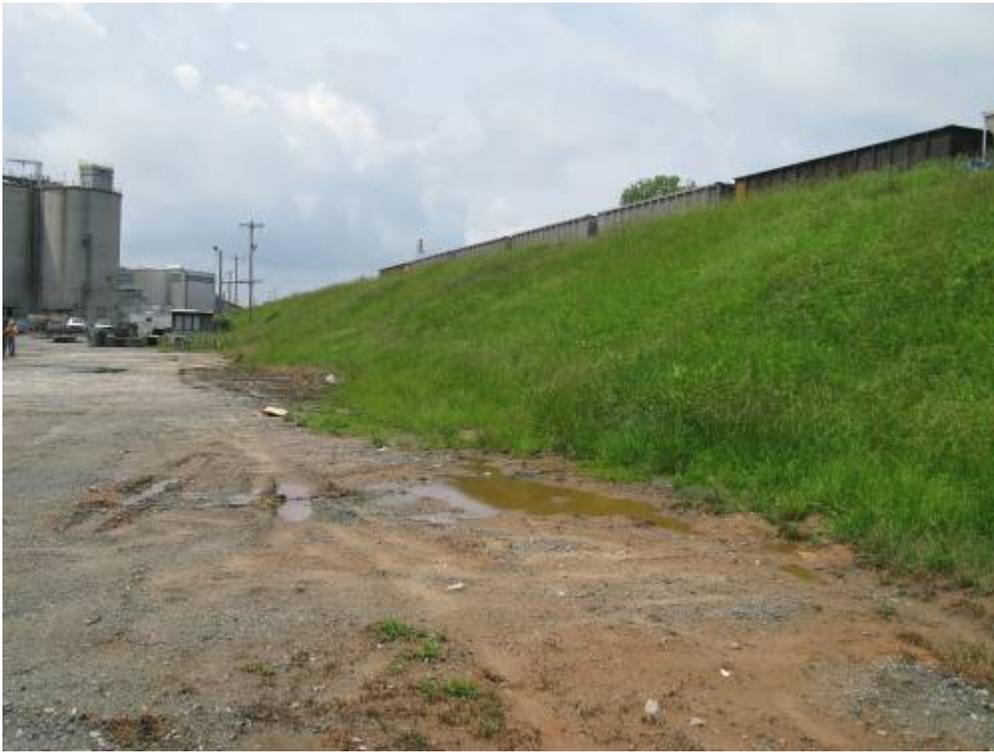
Photo 13: Water at base of upper downstream slope.

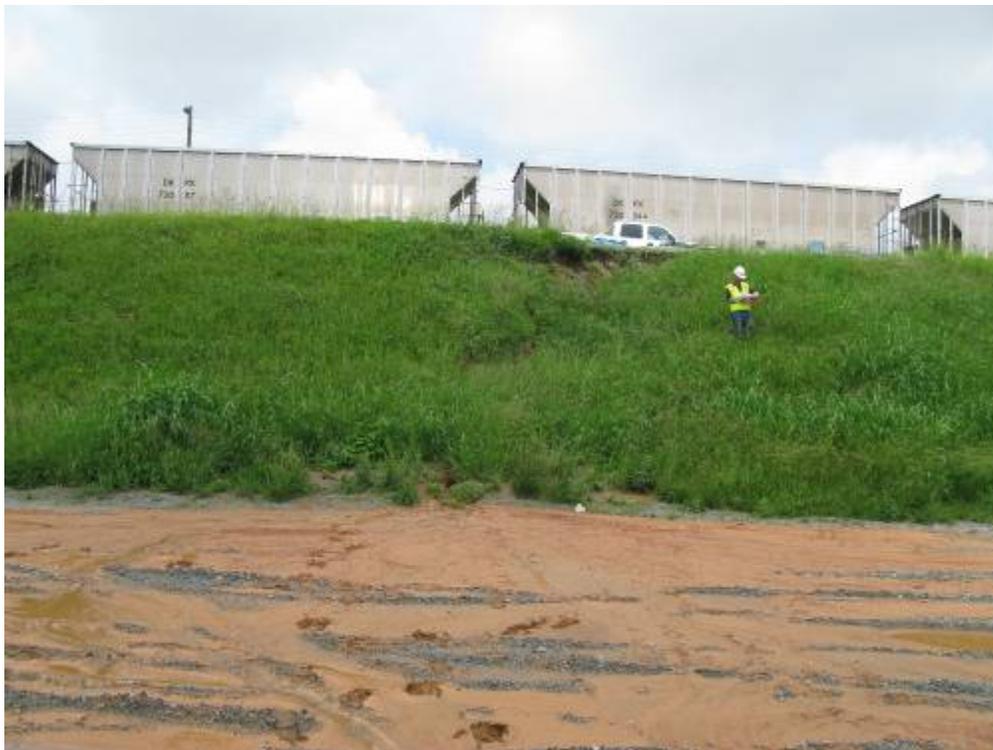
Photo 14: Deltaic deposits at base of scarp. Note the surface erosional path from the crest to the berm

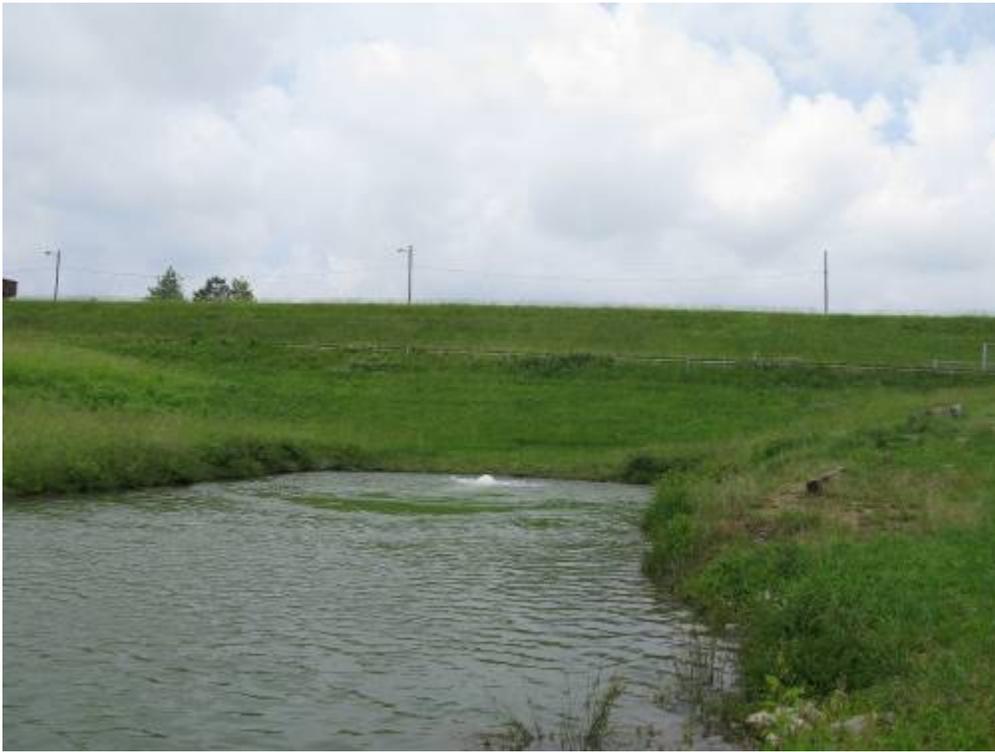
Photo 15: Discharge canal. Note the water bubbling at the submerged discharge point.

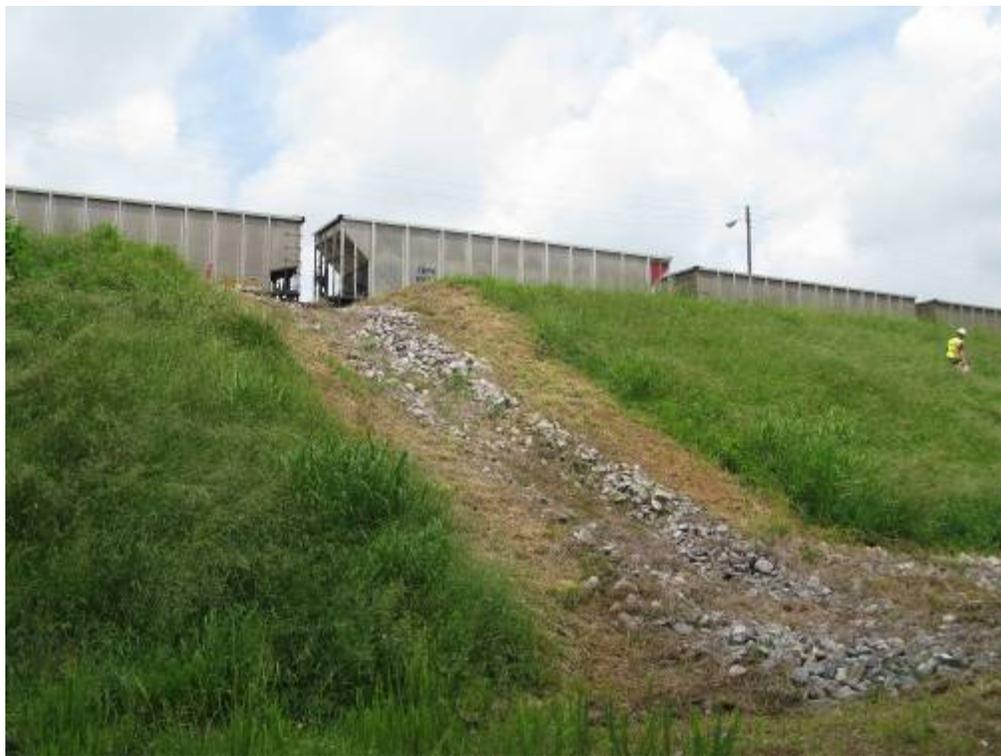
Photo 16: Repaired scarp .

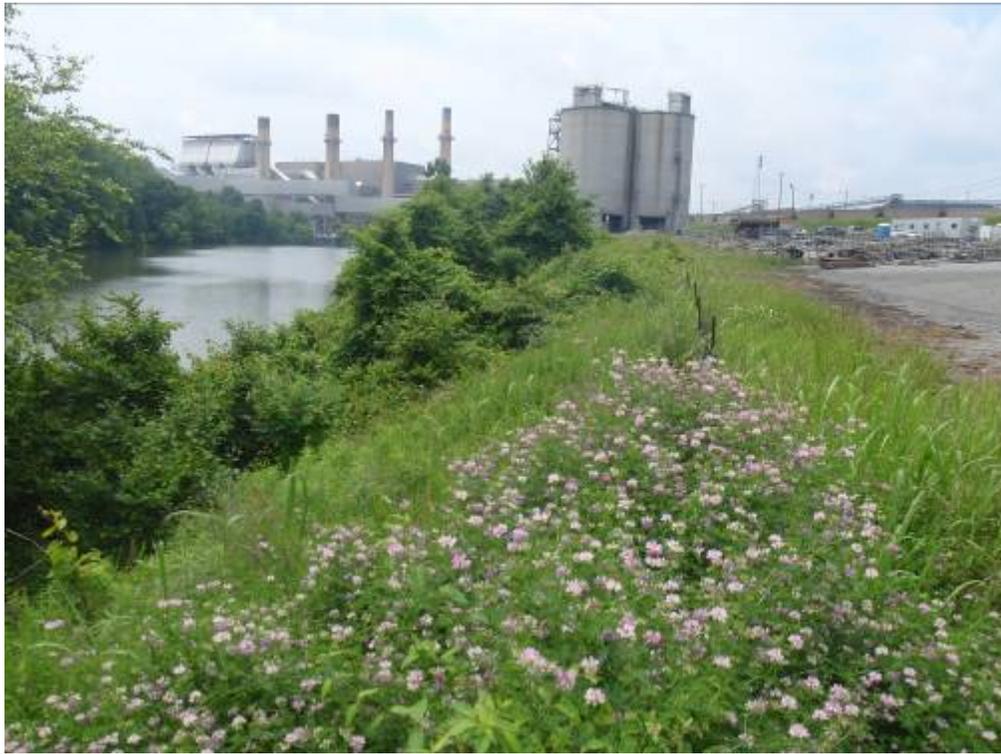
GZA attempted to inspect the lower downstream slope from the berm to Lake Norman however due to heavy vegetation and the steep slope our ability to do so was limited. In general the condition of this slope was found to be in poor condition. The vegetation on the slope is quite heavy with significant tree growth. There are several drainage swales cut into the berm that direct surface water to the lake. A large (approximately 8-foot) erosional hole was found near the scrap yard and several smaller ones were observed. Given the width of the berm and the distance from the lower downstream slope to the upper embankment, the poor condition of the lower slope is not considered to be a major dam safety issue.

Photo 17: Downstream slope to Lake Norman. Note heavy vegetation near water line.

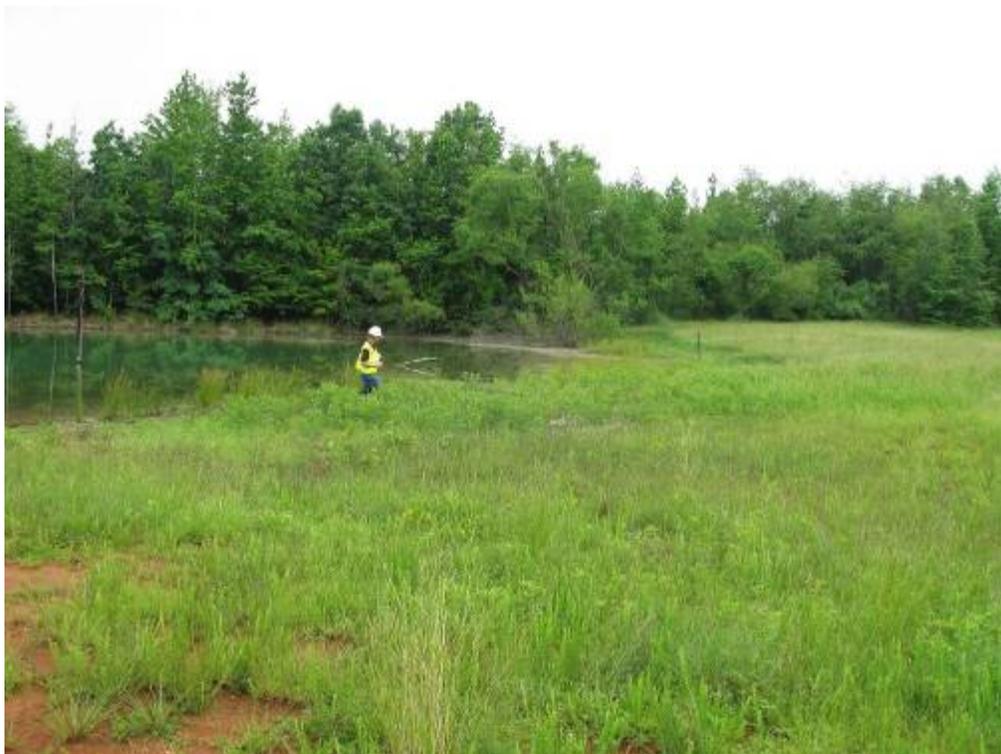
The trees do not appear as if they would impede the overland flow, although there might be significant tree damage if a large volume of water were released. Duke Energy personnel had no recollection of flow over the Emergency Spillway.

Photo 18: Emergency Spillway

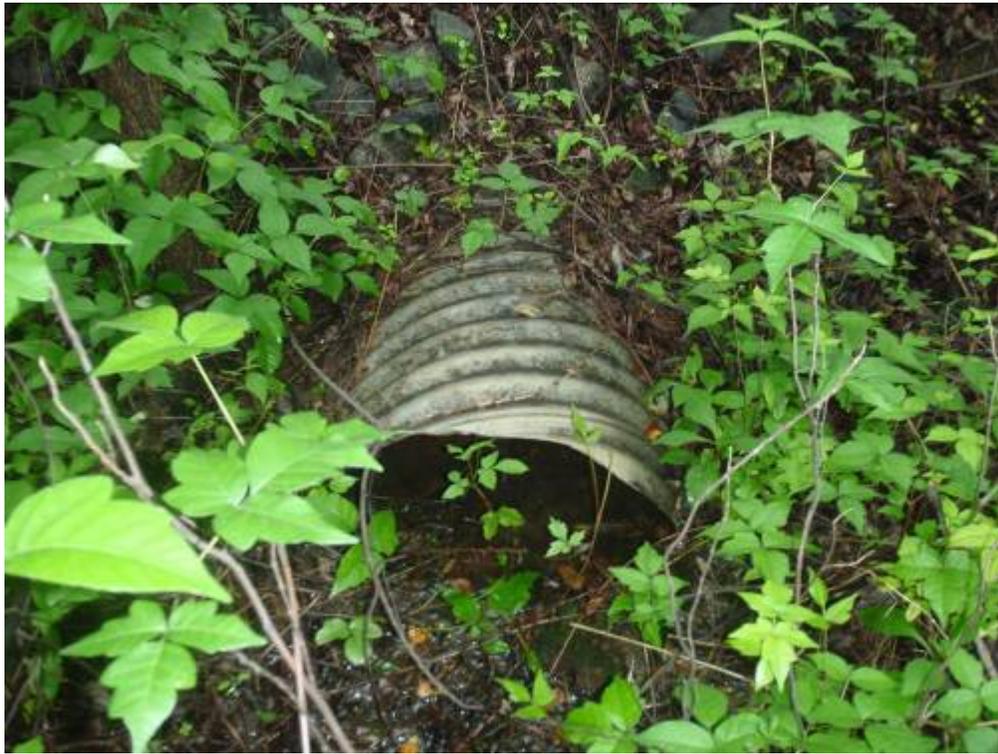
Two drainage outlets were located at the toe of the northern (left) section of the downstream embankment. A relatively new precast concrete discharge structure was located downstream of the new riprap chute constructed between poles 45 and 46. There was no flow or debris in this structure. An older 36-inch diameter CMP drain was located at the toe of slope downstream of a hole exposing a 20-inch vertical CMP observed on the crest of the dam. This pipe was silted in to approximately 6 inches below the crown but still had roughly 2 gallons per minute (gpm) of clear flow discharging through it (Photo No. 19).

Photo 19: Old 36-inch CMP drain outlet at Toe of the Downstream Slope of the Northern Embankment.

4. Surface grading and the extent and condition of the drainage system (including video camera survey of pipe interiors and related drainage infrastructure where appropriate) at and adjacent to the dam should be evaluated.

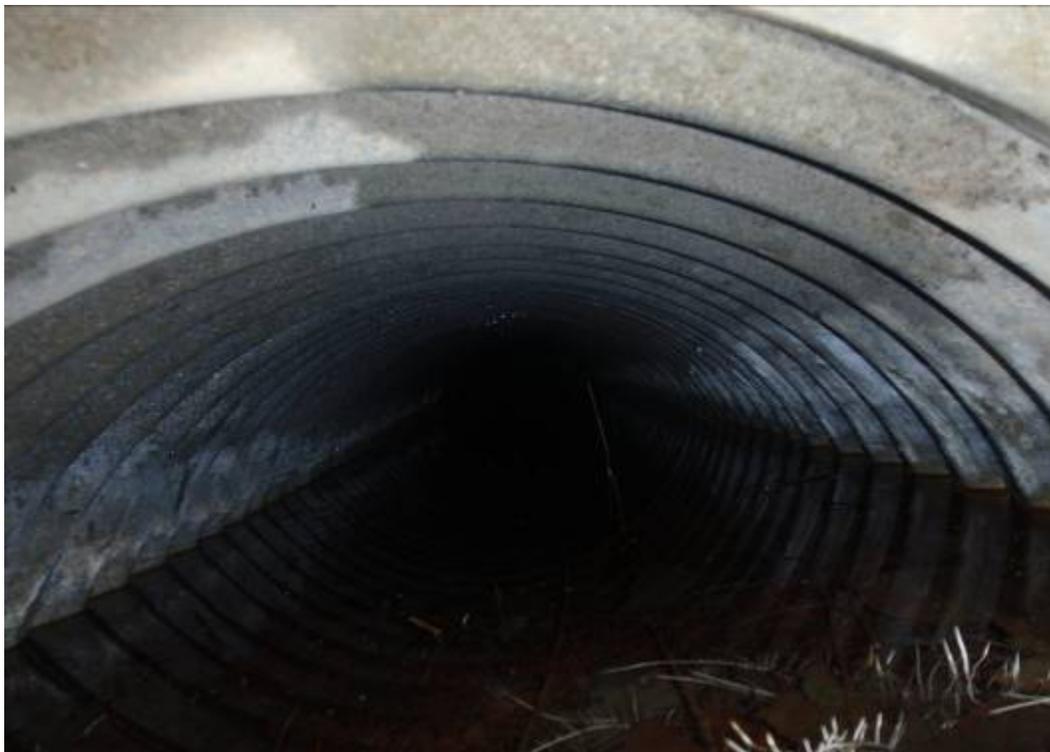
Photo 20: Interior of Old 36-Inch Diameter CMP Drain Located at the Toe of the Downstream Slope.
