RE: Comments of Minnkota Power Cooperative, Inc. on the Draft Specific Site Assessment for Coal Combustion Waste Impoundments at Minnkota Power Cooperative Milton R. Young Station, Center, North Dakota (GEI Consultants, Inc., December 2010)

Comments of Minnkota Power Cooperative, Inc. on the Draft Specific Site Assessment for Coal Combustion Waste Impoundments at Minnkota Power Cooperative Milton R. Young Station, Center, North Dakota (GEI Consultants, Inc., December 2010).

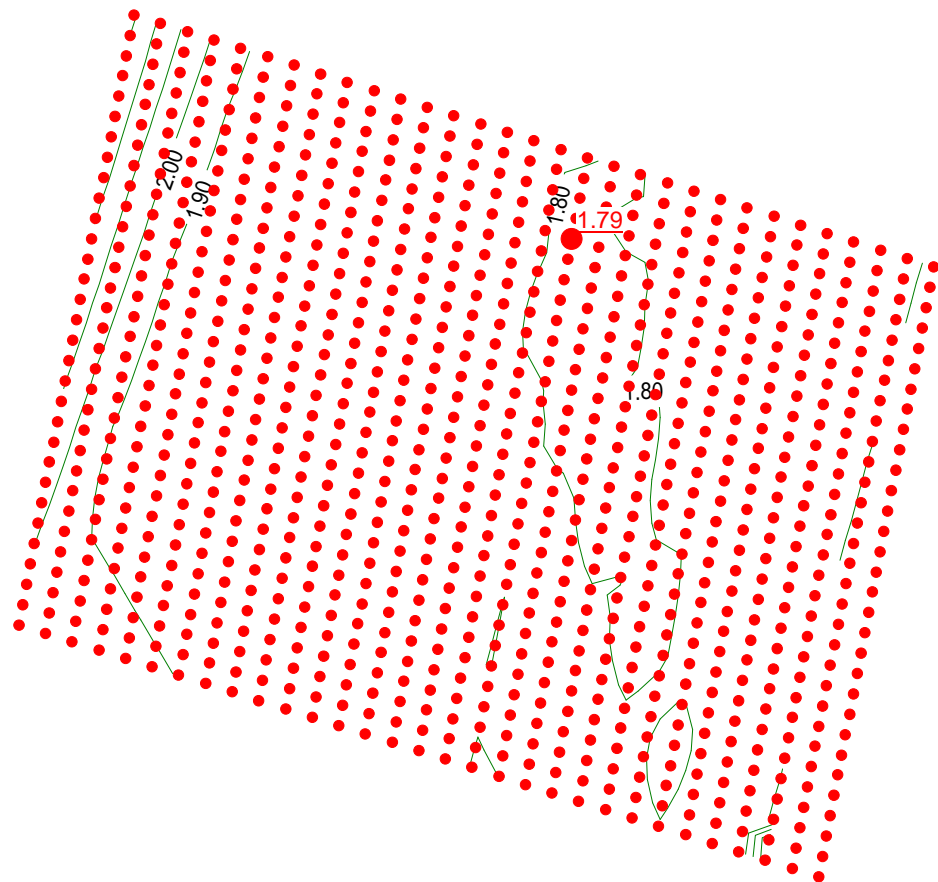
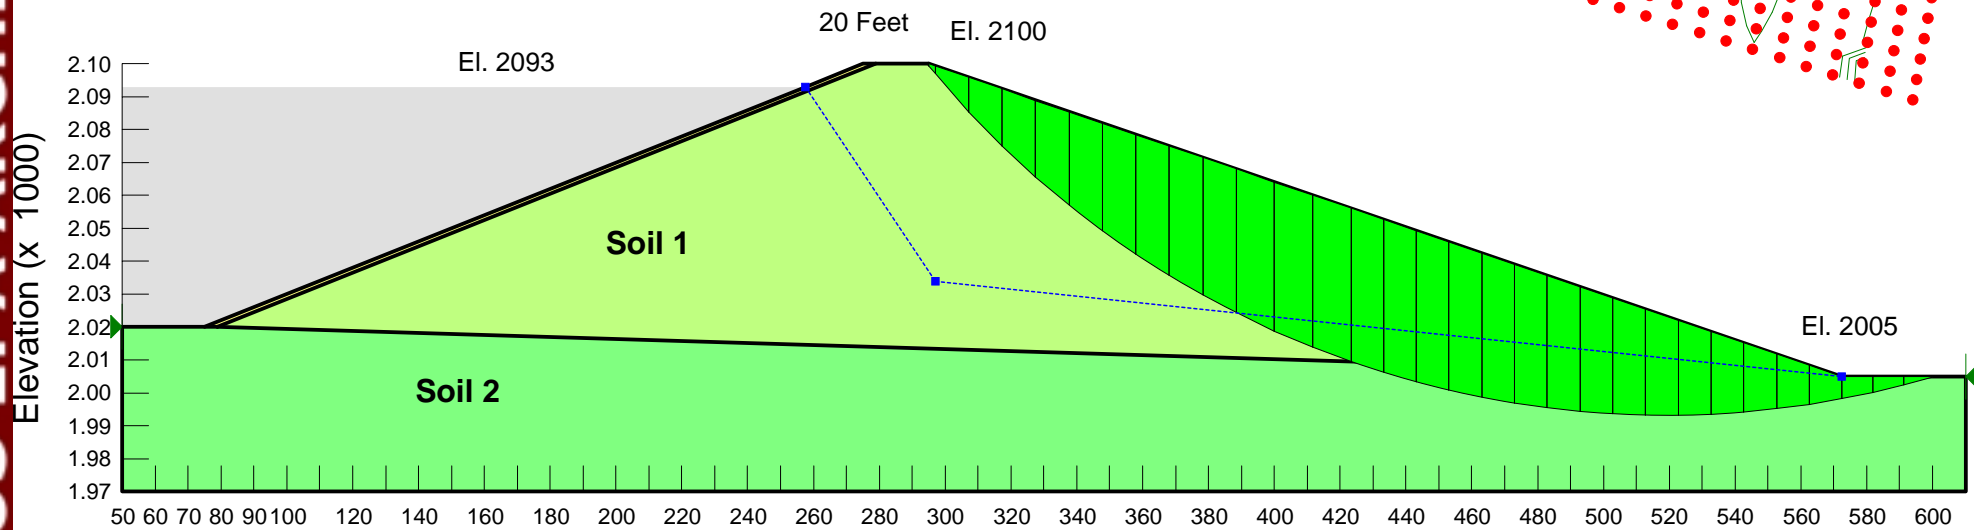
FOS: 1.79

Name: Minnkota
 Description: Exterior Slope Analysis - 3:1 Slope
 Method: Spencer
 File Name: Cell3 - slope_analysis_3-1-95 ft-ave.gsz
 Date: 2/2/2011
 Slip Surface Option: Grid and Radius
 Average Properties

Distance		
Name: Liner	Unit Weight: 130 pcf	Cohesion: 0 psf	Phi: 25 °	Piezometric Line: 1
Name: Soil 1	Unit Weight: 127 pcf	Cohesion: 0 psf	Phi: 31.6 °	Piezometric Line: 1
Name: Soil 2	Unit Weight: 127 pcf	Cohesion: 0 psf	Phi: 31.6 °	Piezometric Line: 1
Name: Water	Piezometric Line: 1

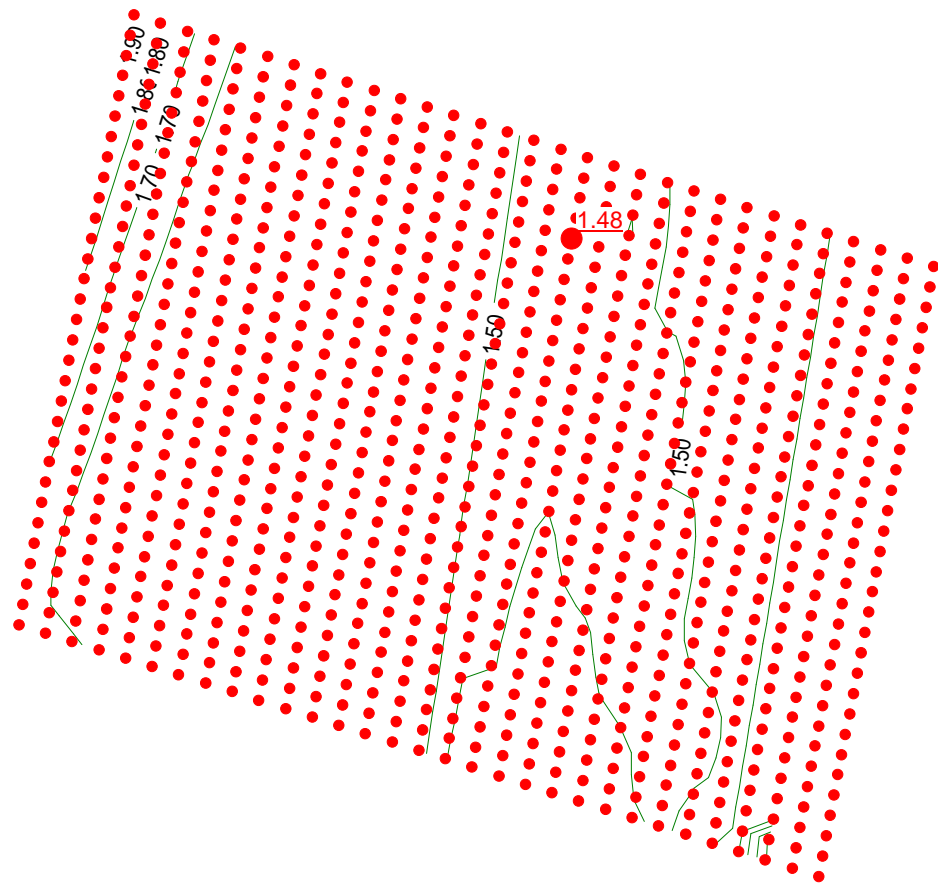
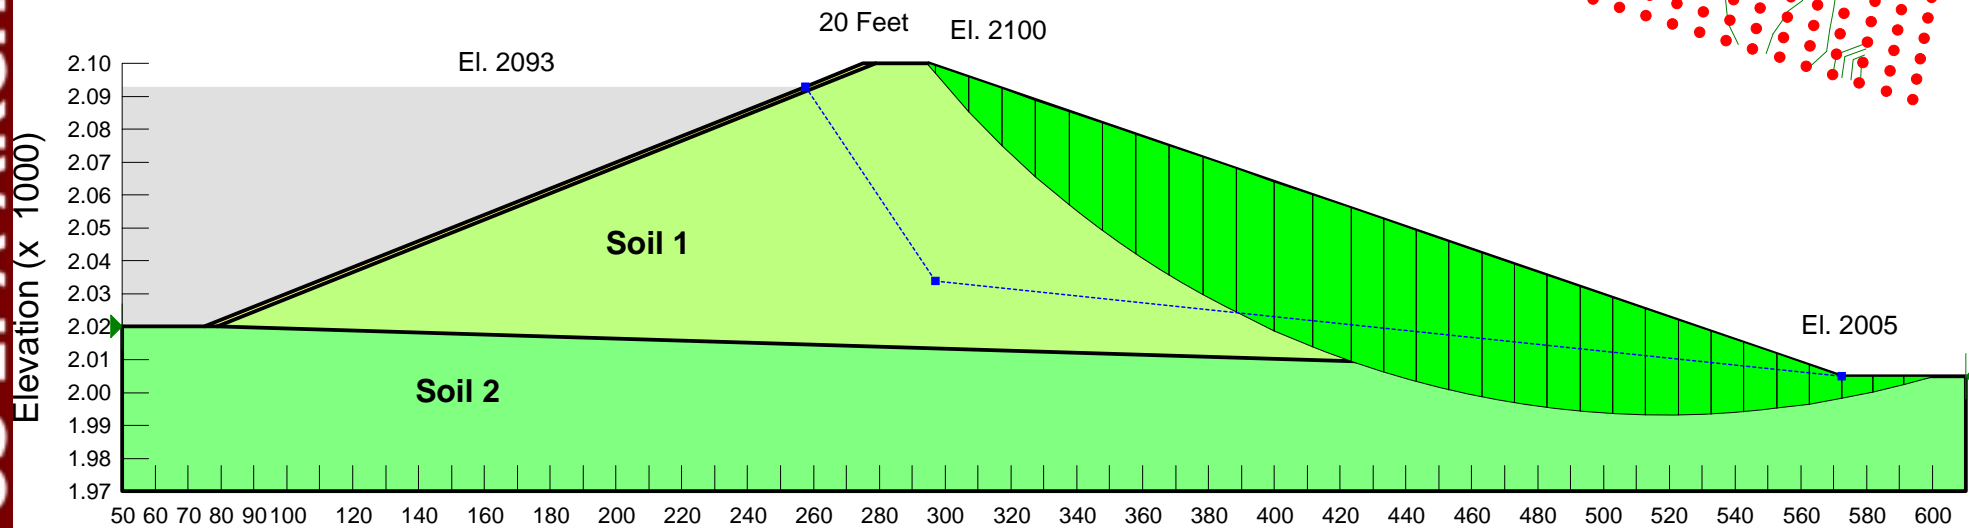
FOS: 1.48

Name: Minnkota
 Description: Exterior Slope Analysis - 3:1 Slope
 Method: Spencer
 File Name: Cell3 - slope_analysis_3-1-95 ft-min.gsz
 Date: 2/2/2011
 Slip Surface Option: Grid and Radius
 Minimum Properties

Name: Liner	Unit Weight: 130 pcf	Cohesion: 0 psf	Phi: 25 °	Piezometric Line: 1
Name: Soil 1	Unit Weight: 127 pcf	Cohesion: 0 psf	Phi: 27 °	Piezometric Line: 1
Name: Soil 2	Unit Weight: 127 pcf	Cohesion: 0 psf	Phi: 27 °	Piezometric Line: 1
Name: Water	Piezometric Line: 1

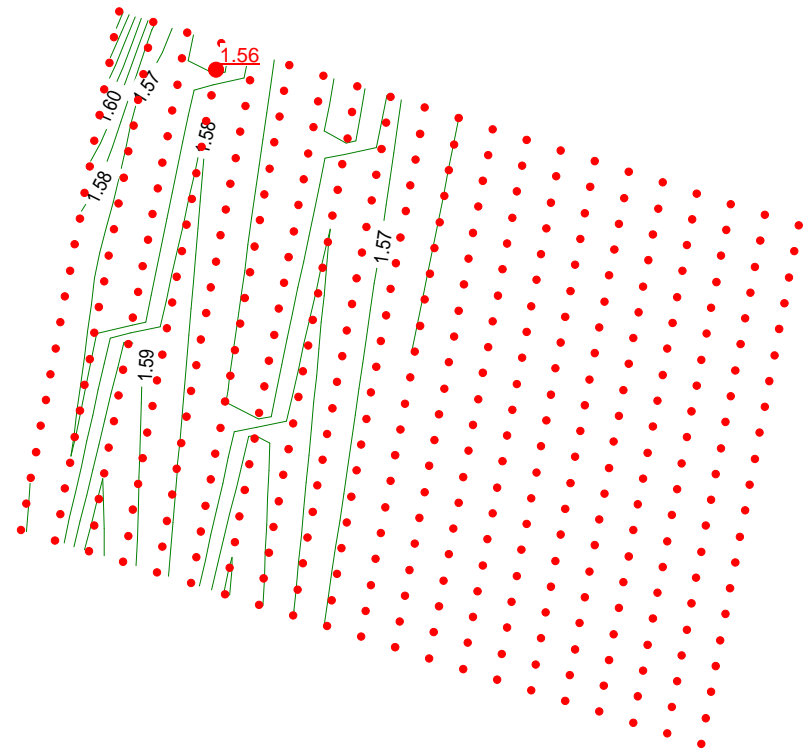
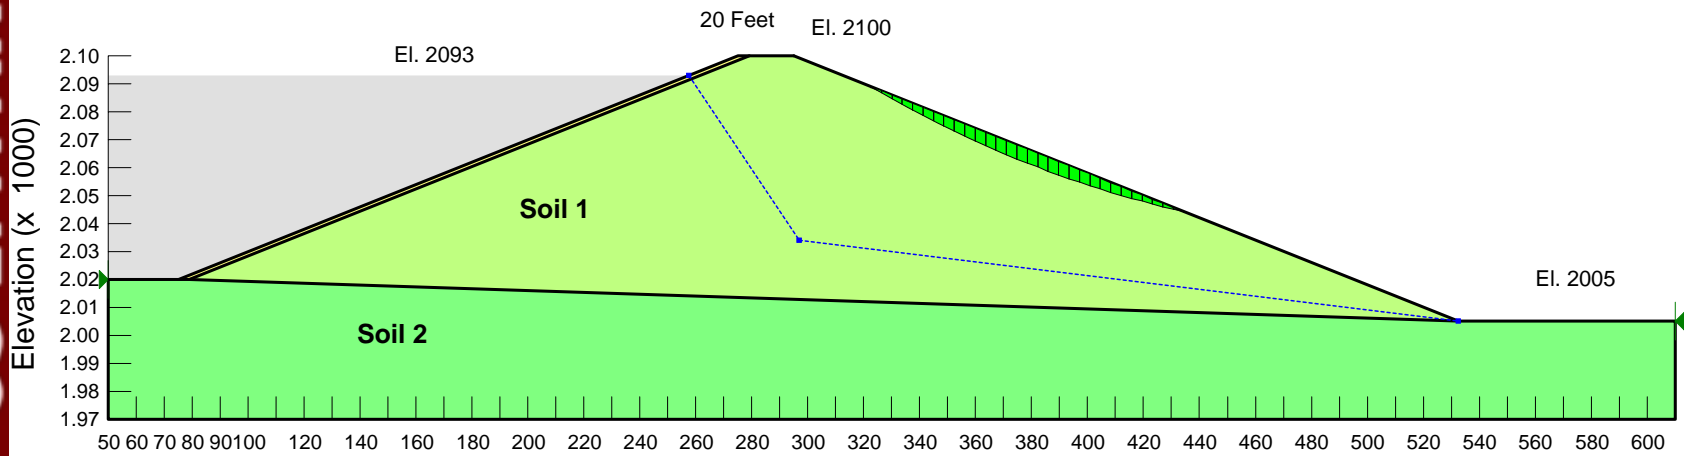
FOS: 1.56

Name: Minnkota
 Description: Exterior Slope Analysis - 2.5:1 Slope
 Method: Spencer
 File Name: Cell3 - slope_analysis_2-5-1-95 ft-ave.gsz
 Date: 2/2/2011
 Slip Surface Option: Grid and Radius
 Average Properties

Name: Liner	Unit Weight: 130 pcf	Cohesion: 0 psf	Phi: 25 °	Piezometric Line: 1
Name: Soil 1	Unit Weight: 127 pcf	Cohesion: 0 psf	Phi: 31.6 °	Piezometric Line: 1
Name: Soil 2	Unit Weight: 127 pcf	Cohesion: 0 psf	Phi: 31.6 °	Piezometric Line: 1
Name: Water	Piezometric Line: 1

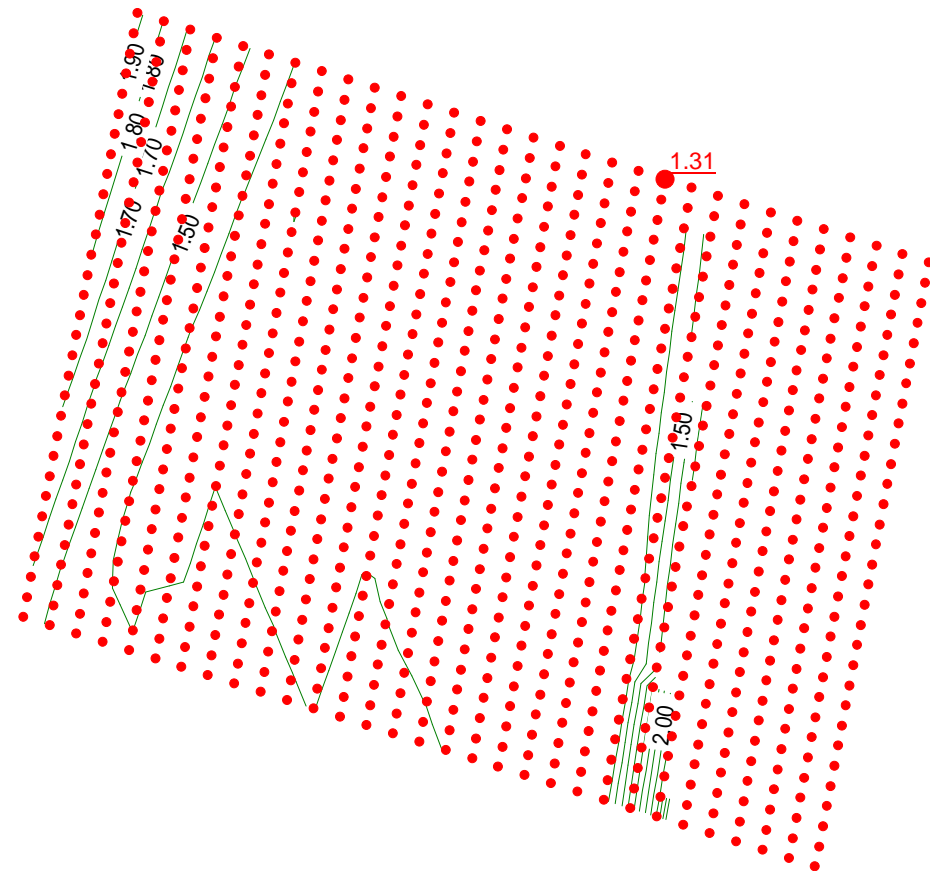
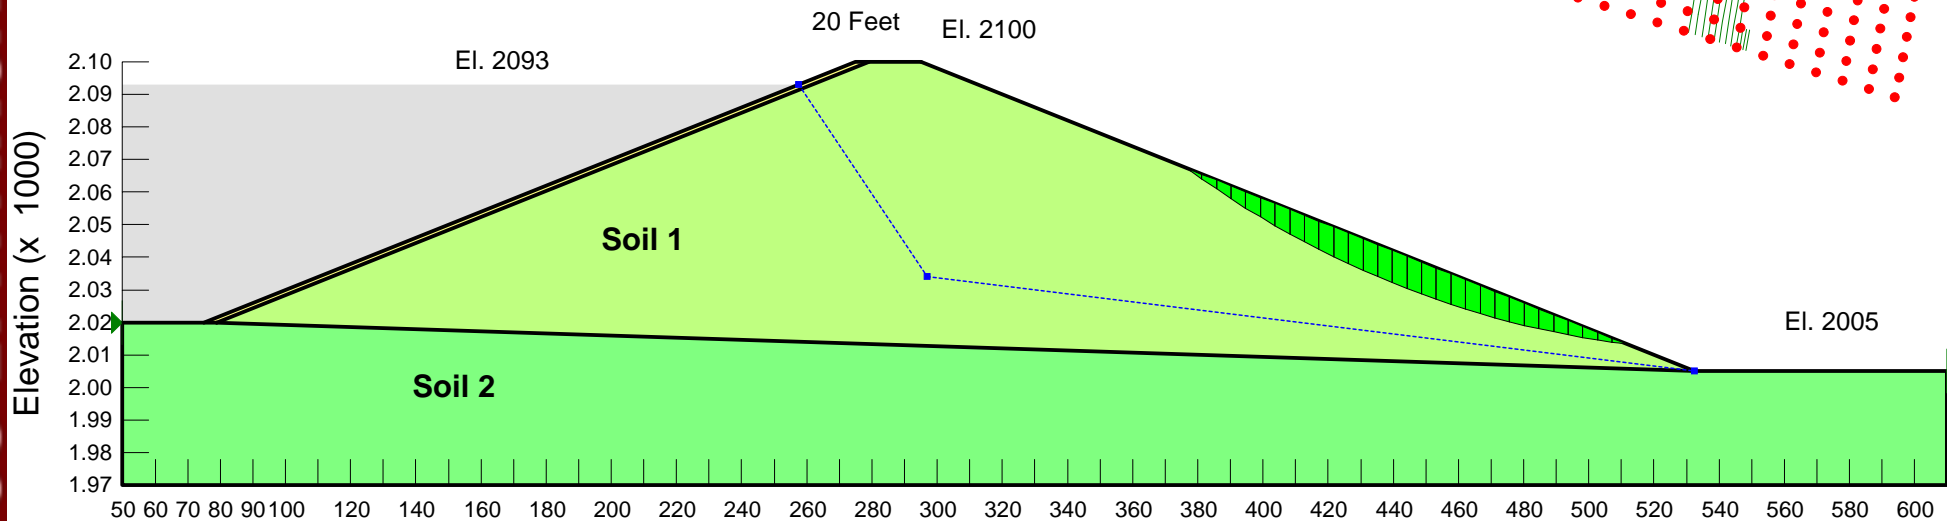
FOS: 1.31

Name: Minnkota
 Description: Exterior Slope Analysis - 2.5:1 Slope
 Method: Spencer
 File Name: Cell3 - slope_analysis_2-5-1-95 ft-min.gsz
 Date: 2/2/2011
 Slip Surface Option: Grid and Radius
 Minimum Properties

Name: Liner	Unit Weight: 130 pcf	Cohesion: 0 psf	Phi: 25 °	Piezometric Line: 1
Name: Soil 1	Unit Weight: 127 pcf	Cohesion: 0 psf	Phi: 27 °	Piezometric Line: 1
Name: Soil 2	Unit Weight: 127 pcf	Cohesion: 0 psf	Phi: 27 °	Piezometric Line: 1
Name: Water	Piezometric Line: 1

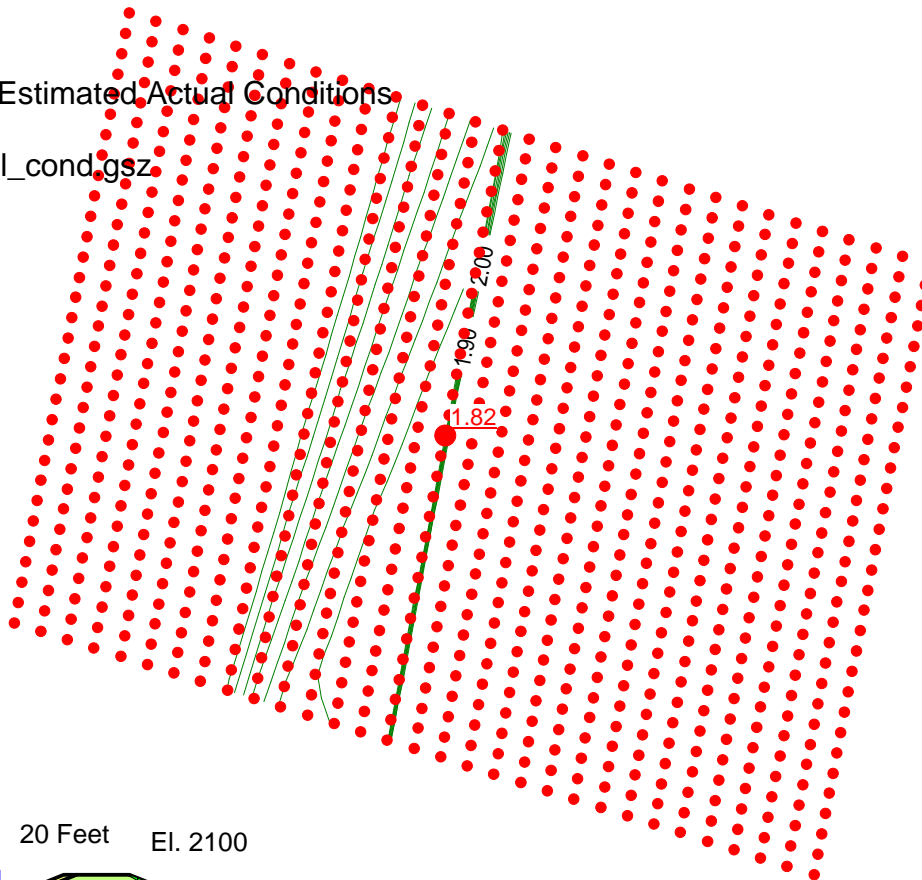
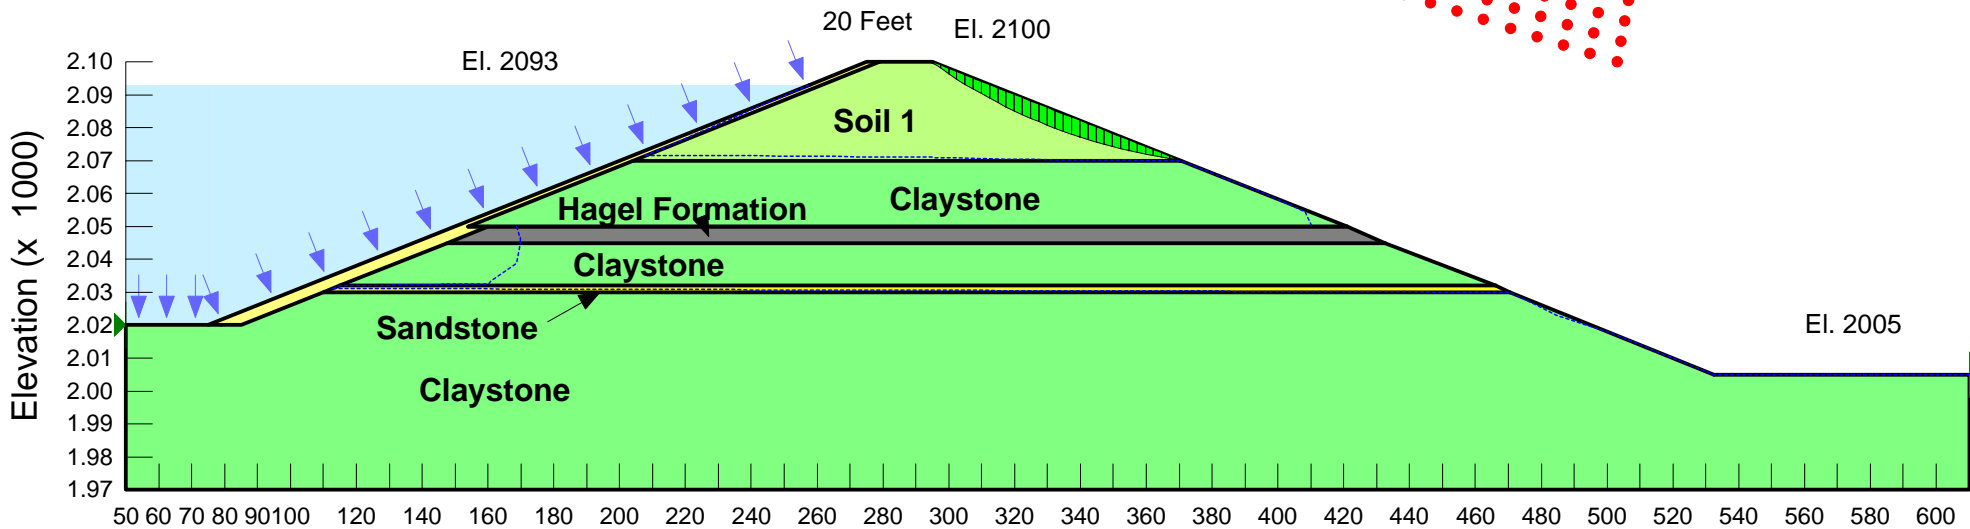
FOS: 1.82

Name: Minnkota
 Description: Exterior Slope Analysis - 2.5:1 Slope - Estimated Actual Conditions
 Method: Spencer
 File Name: Cell3 - slope_analysis_2-1-1-95 ft-actual_cond.gsz
 Date: 2/4/2011
 Slip Surface Option: Grid and Radius
 Minimum Properties

Name: Liner	Unit Weight: 130 pcf	Cohesion: 0 psf	Phi: 25 °
Name: Soil 1	Unit Weight: 127 pcf	Cohesion: 0 psf	Phi: 35 °
Name: Claystone	Unit Weight: 127 pcf	Cohesion: 6200 psf	Phi: 27 °
Name: Water			
Name: Hagel Unit	Unit Weight: 127 pcf	Cohesion: 10000 psf	Phi: 29.8 °
Name: Sandstone	Unit Weight: 127 pcf	Cohesion: 10000 psf	Phi: 38 °

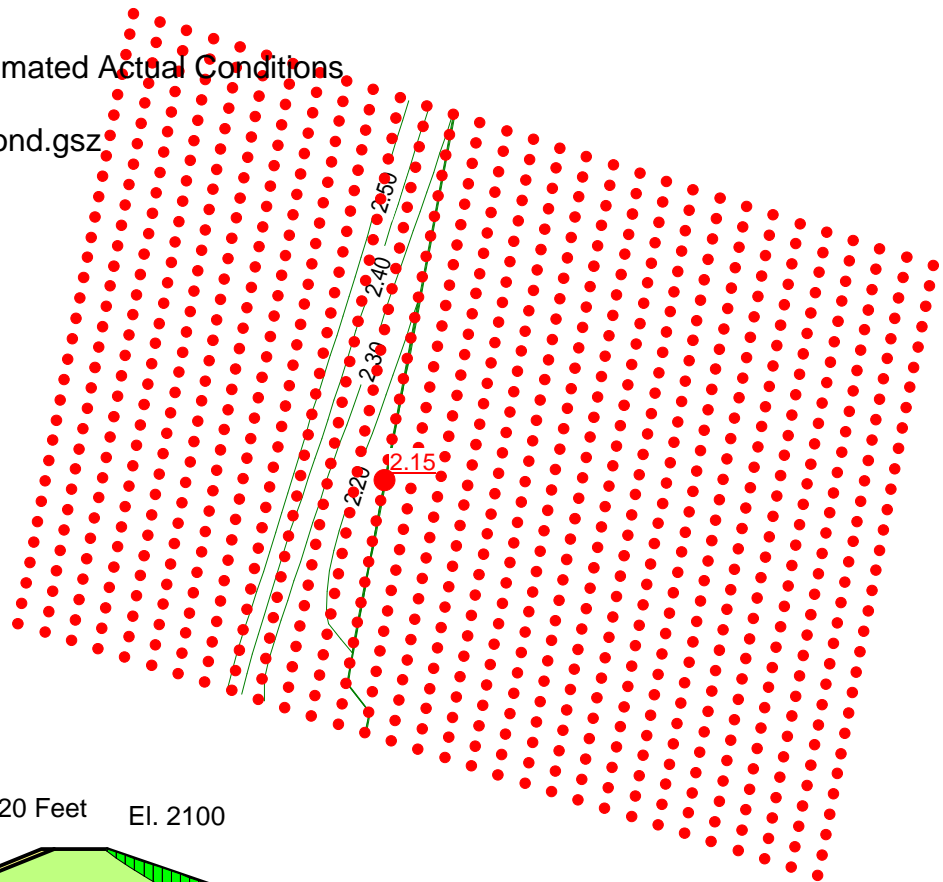
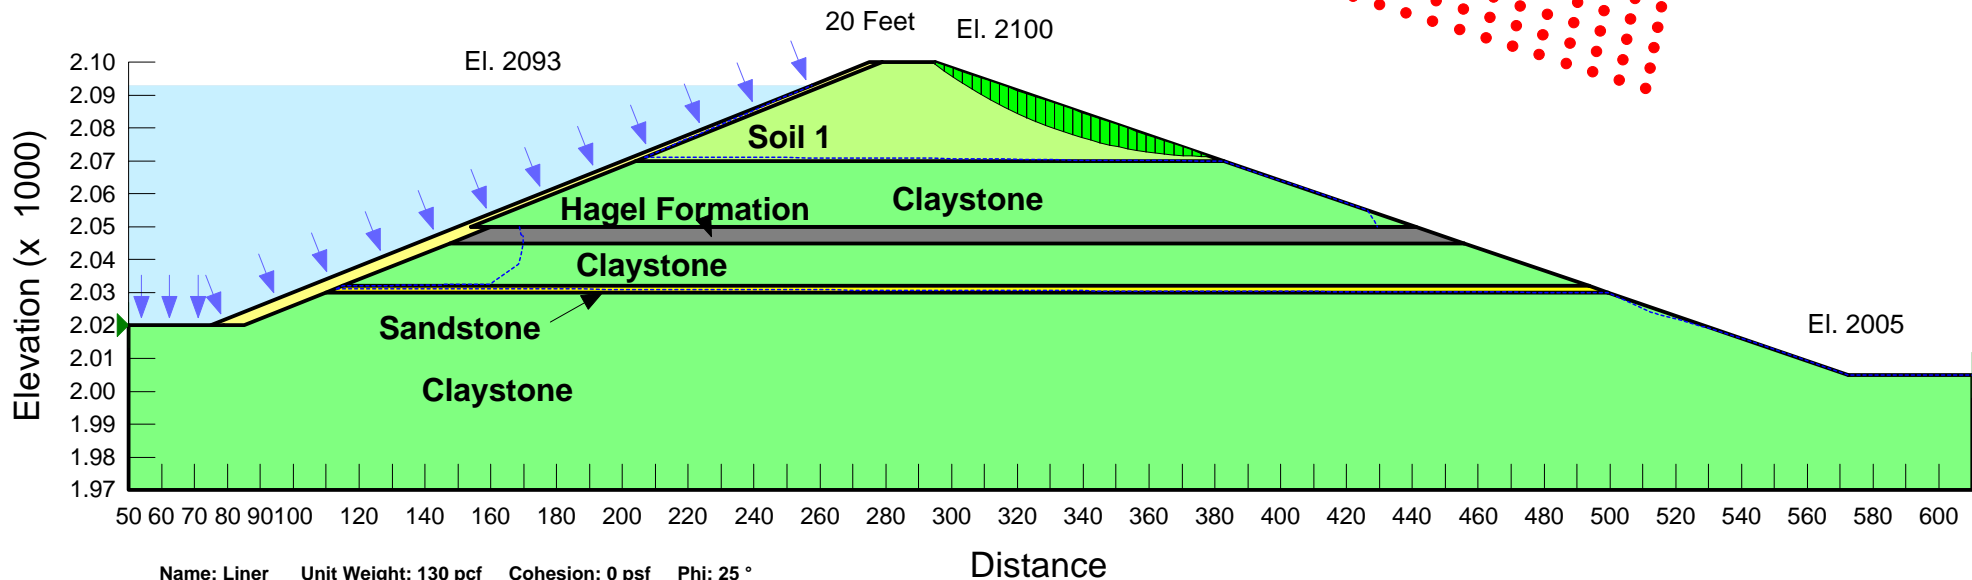
FOS: 2.15

Name: Minnkota
 Description: Exterior Slope Analysis - 3:1 Slope - Estimated Actual Conditions
 Method: Spencer
 File Name: Cell3 - slope_analysis_3-1-95 ft-actual_cond.gsz
 Date: 2/4/2011
 Slip Surface Option: Grid and Radius
 Minimum Properties

Name: Liner	Unit Weight: 130 pcf	Cohesion: 0 psf	Phi: 25 °
Name: Soil 1	Unit Weight: 127 pcf	Cohesion: 0 psf	Phi: 35 °
Name: Claystone	Unit Weight: 127 pcf	Cohesion: 6200 psf	Phi: 27 °
Name: Water			
Name: Hagel Unit	Unit Weight: 127 pcf	Cohesion: 10000 psf	Phi: 29.8 °
Name: Sandstone	Unit Weight: 127 pcf	Cohesion: 10000 psf	Phi: 38 °
