# **Dam Safety Assessment of CCW Impoundments**

## **NRG ELRAMA POWER STATION**

**United States Environmental Protection Agency  
Washington, DC**

February 2014

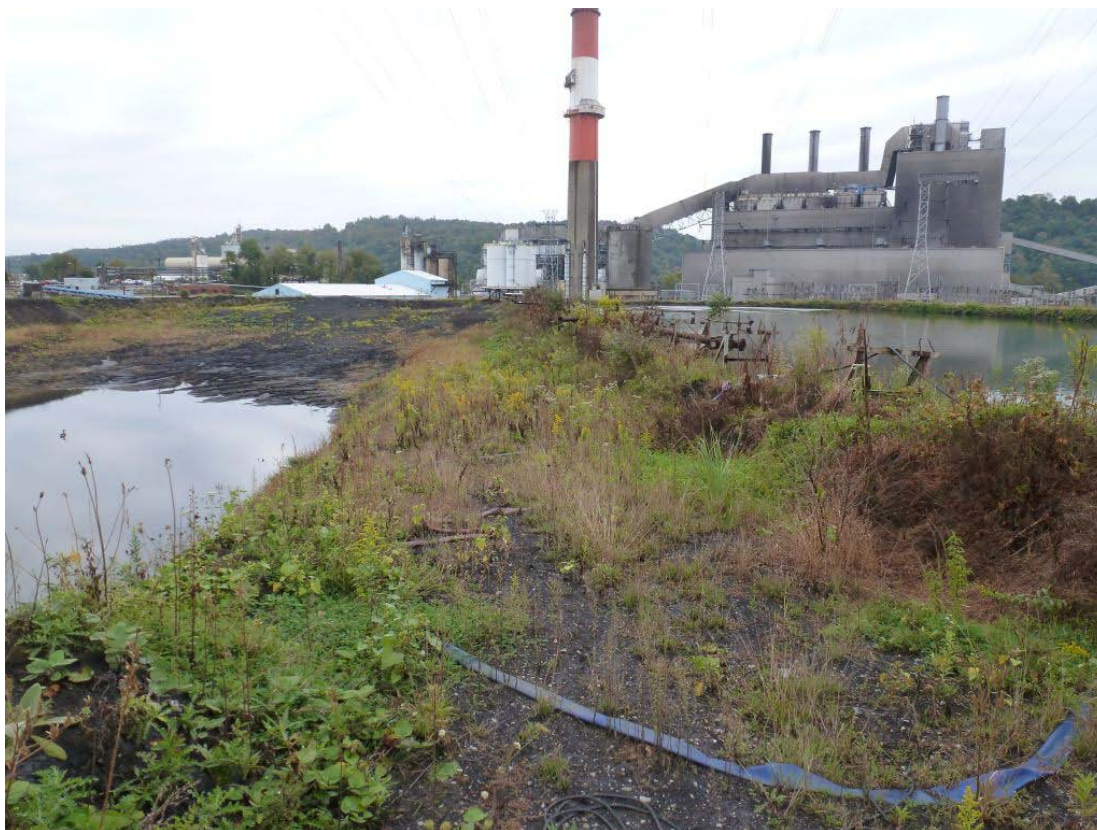
Photo Number:  
1

Description:  
Ash Settling  
Ponds SPD-1  
(right) and  
SPD-2 (left).  
SPD-1 in  
operation, SPD-  
2 drained. SPD-  
2 dividing dike  
slope (center).

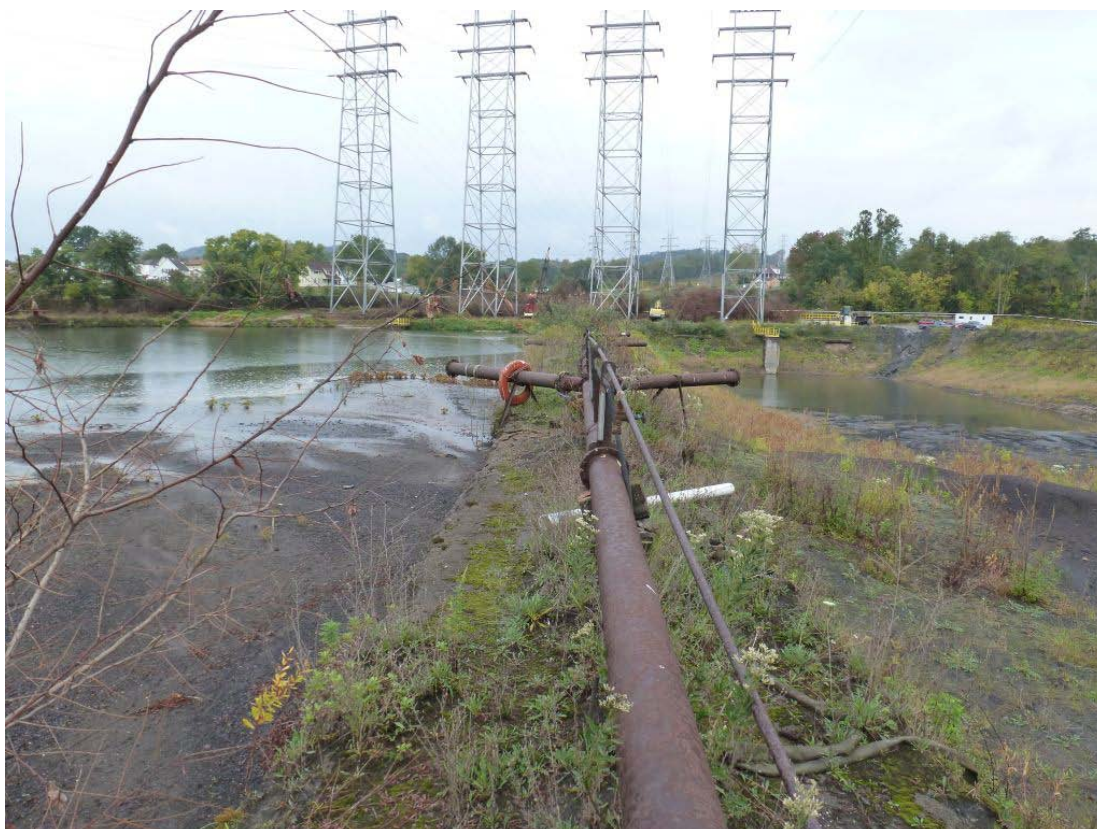
Photo Number:  
2

Description:  
Ash Settling  
Ponds SPD-1  
(left) in  
operation and  
SPD-2 (right)  
drained.  
Dividing dike  
crest (center).

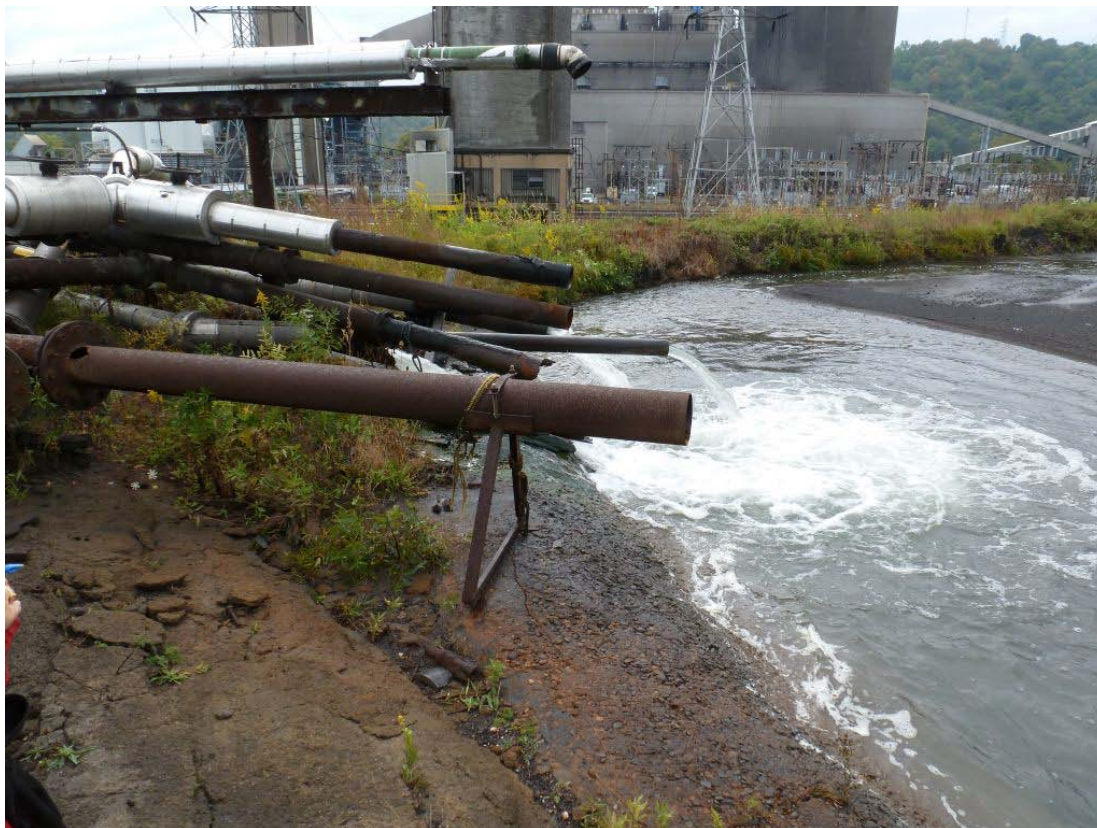
Photo Number:  
3

Description:  
Ash Settling  
Pond SPD-1  
inflow pipes.

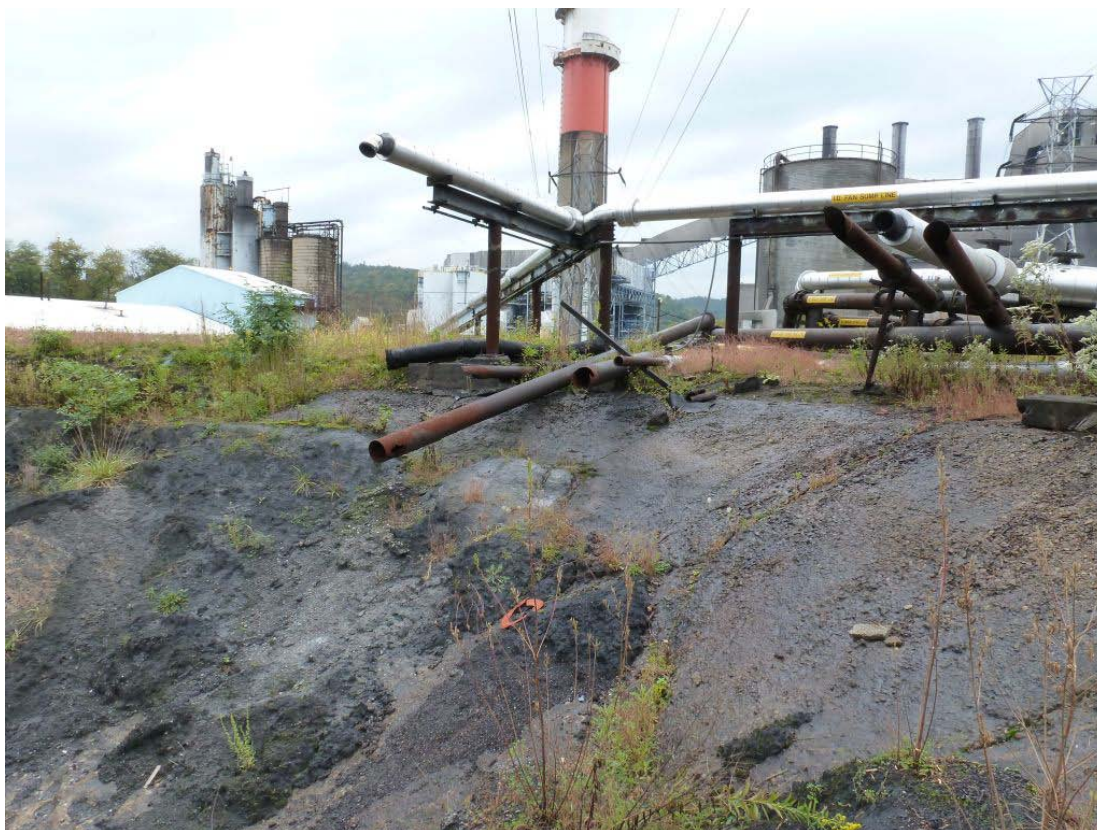
Photo Number:  
4

Description:  
Ash Settling  
Pond SPD-2  
inflow pipes  
(not in use  
while pond  
drained).

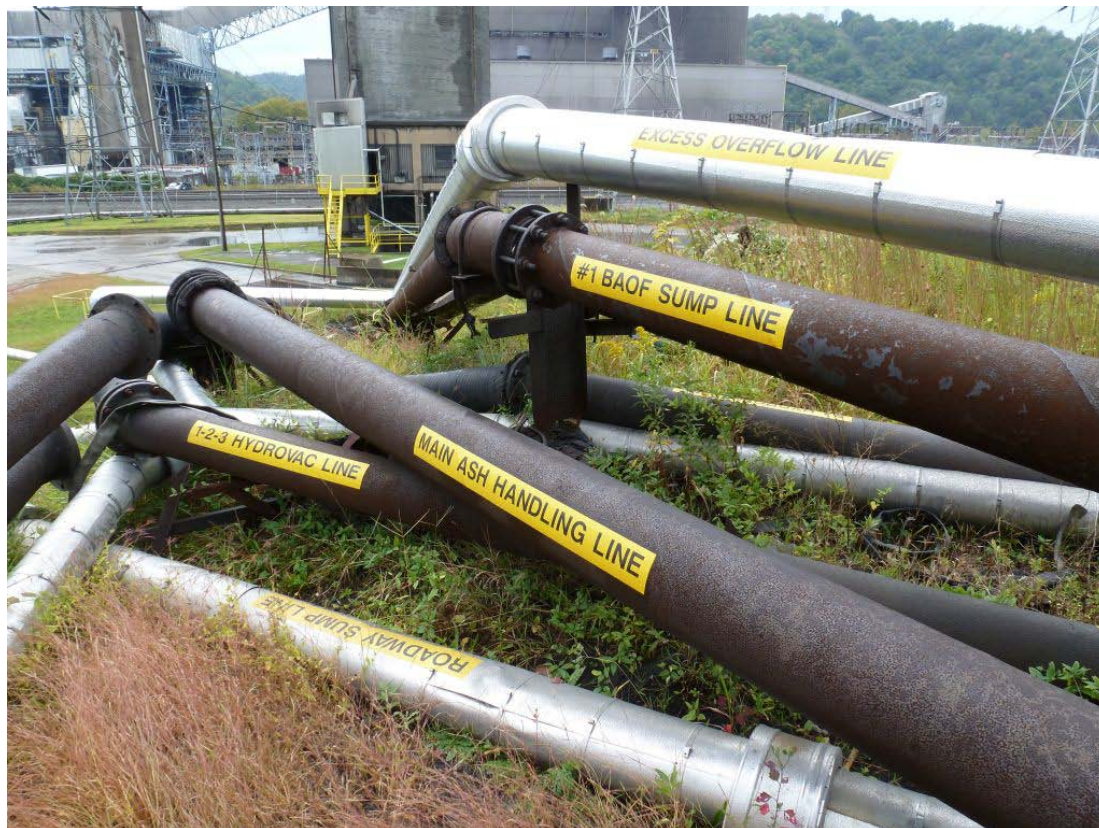
Photo Number:  
5

Description:  
Ash Settling  
Ponds SPD-1  
and SPD-2  
pipes.

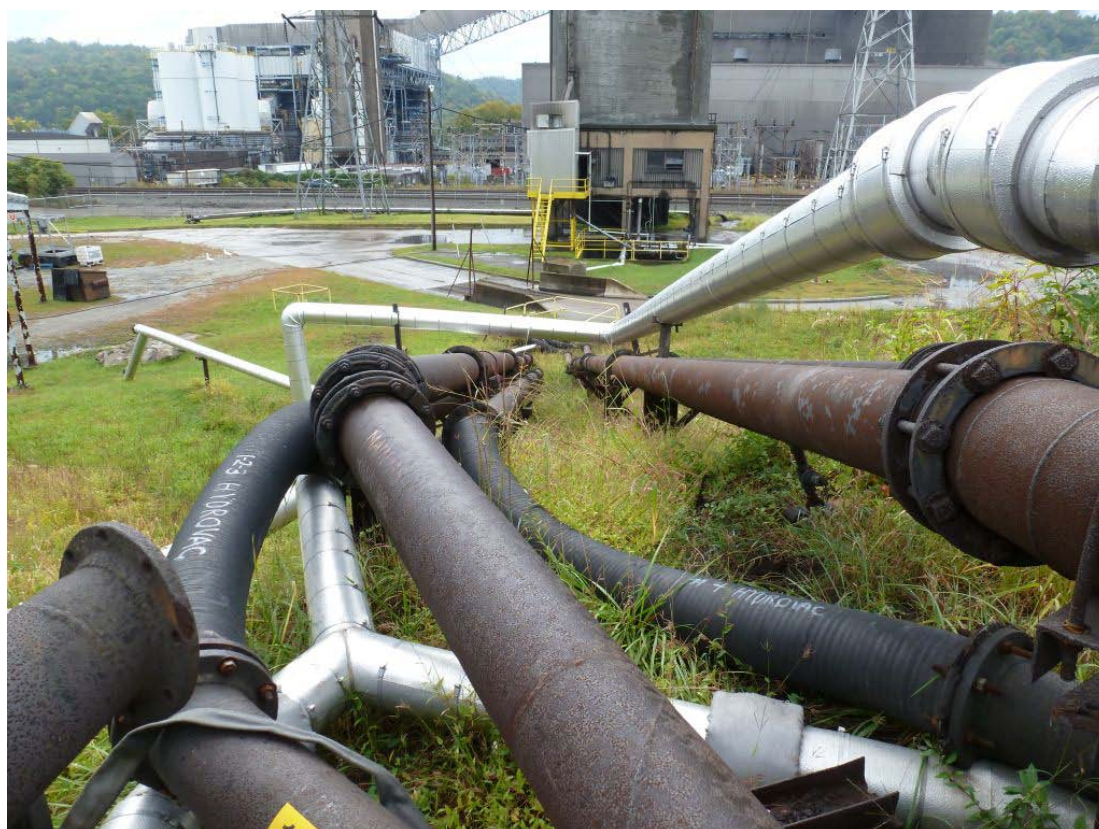
Photo Number:  
6

Description:  
Ash Settling  
Ponds SPD-1  
and SPD-2  
pipes  
along eastern  
embankment of  
ponds.

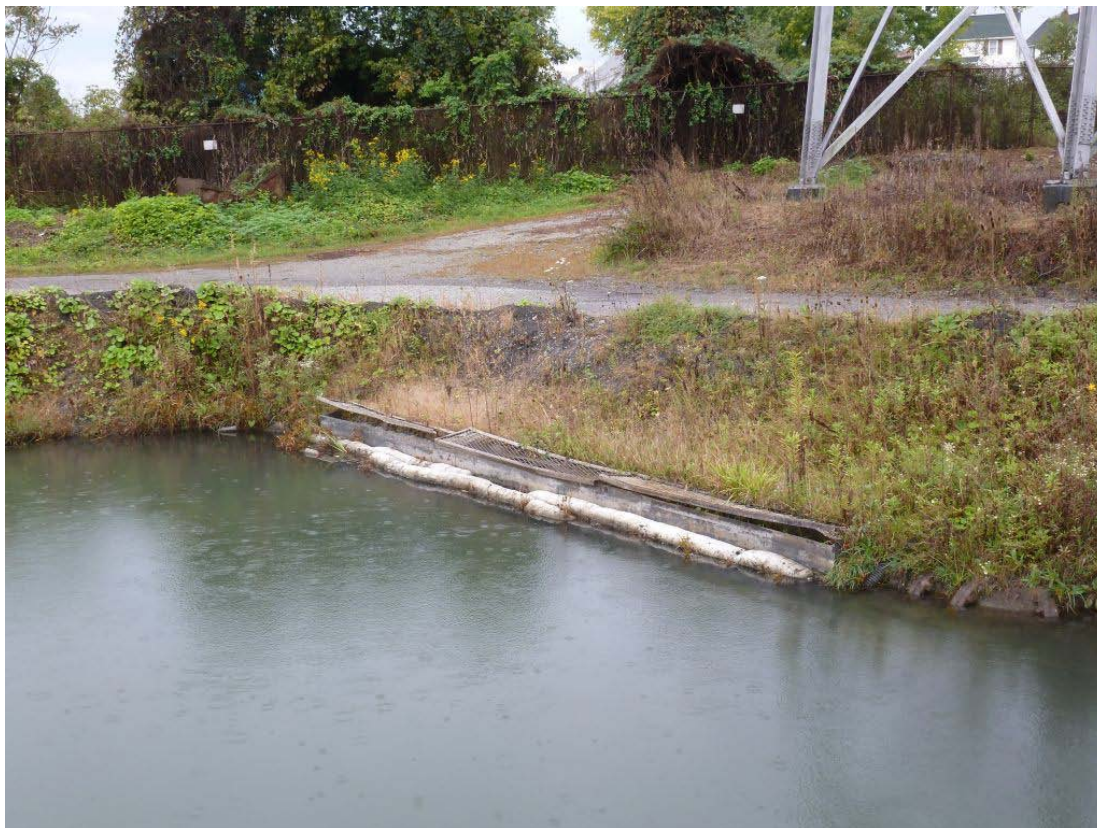
Orientation:  
SWDescription:  
Ash Settling  
Pond SPD-1  
outflow  
structure and  
western  
embankment  
inboard slope  
(in operating  
pond).

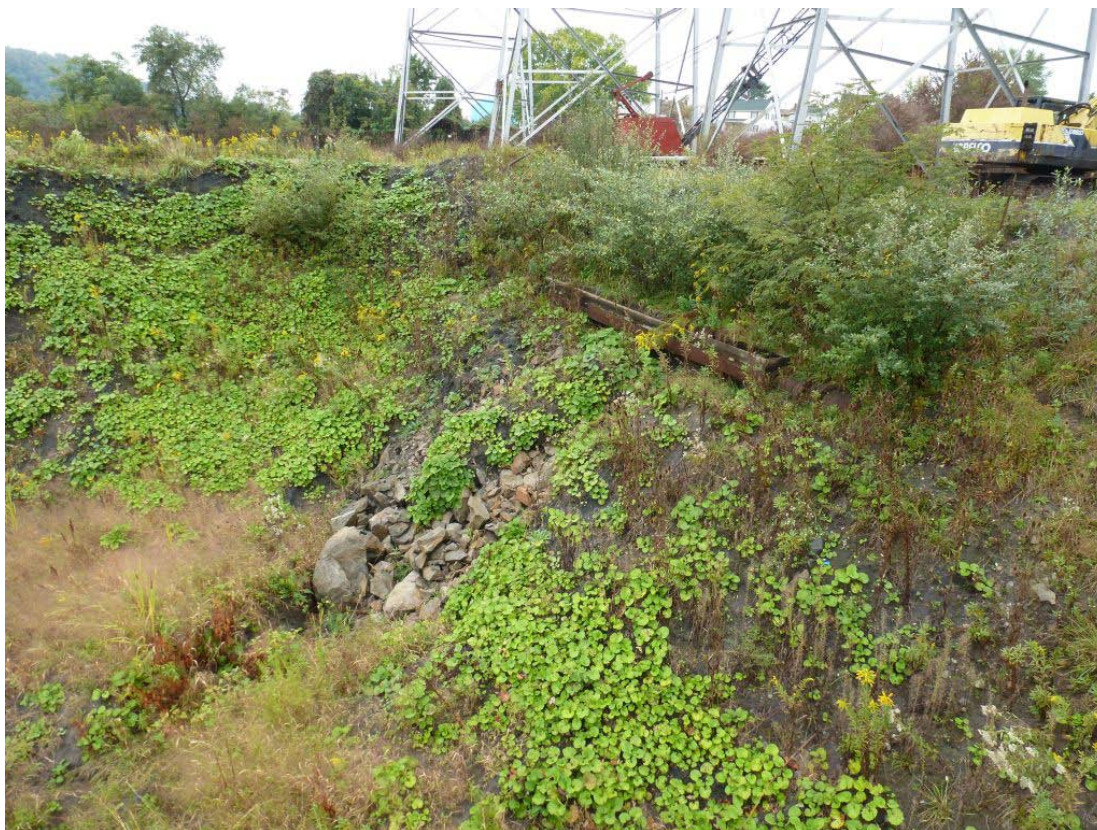
Date:  
9/26/12Photo Number:  
8Photographer:  
DDW

Date:  
9/26/12Photo Number:  
7Photographer:  
DDWOrientation:  
SWDescription:  
Ash Settling  
Pond SPDs  
outflow  
structure and  
western  
embankment  
inboard slope  
(in drained  
pond).

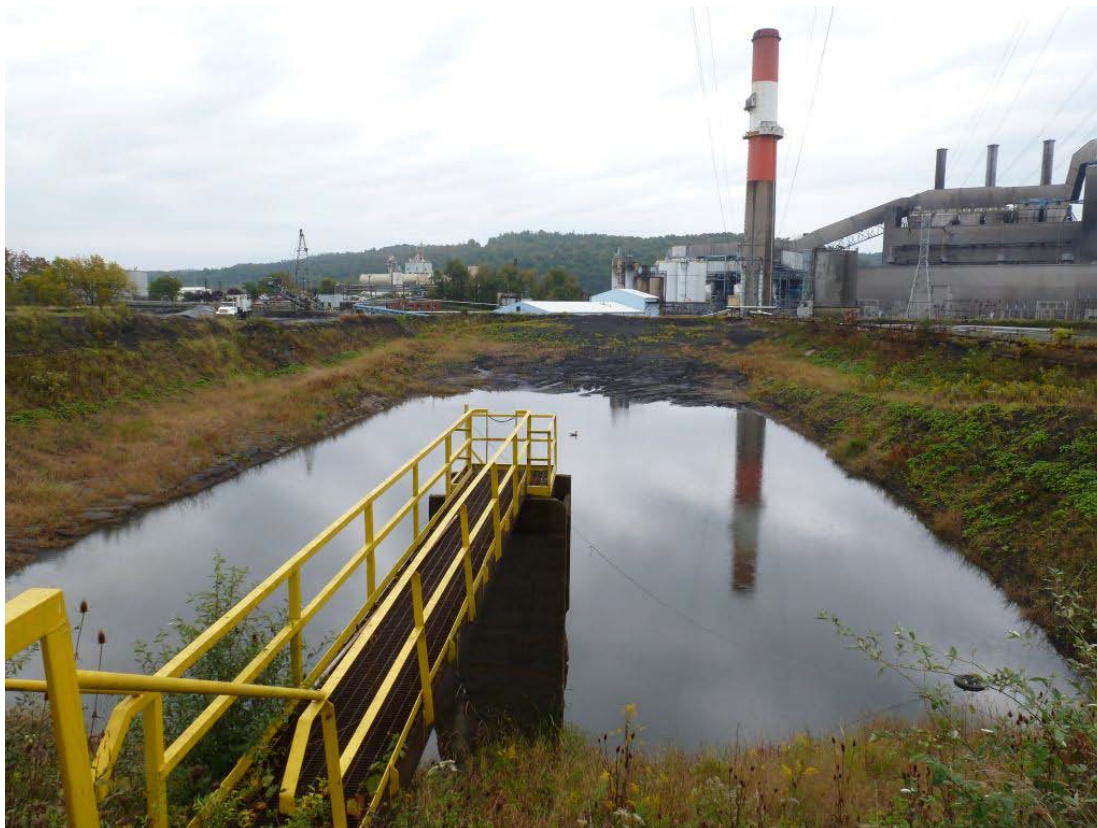
Photo Number:  
9

Description:  
Ash Settling  
Pond SPD-2 (out  
of operation)  
outlet tower  
and inboard  
slopes.

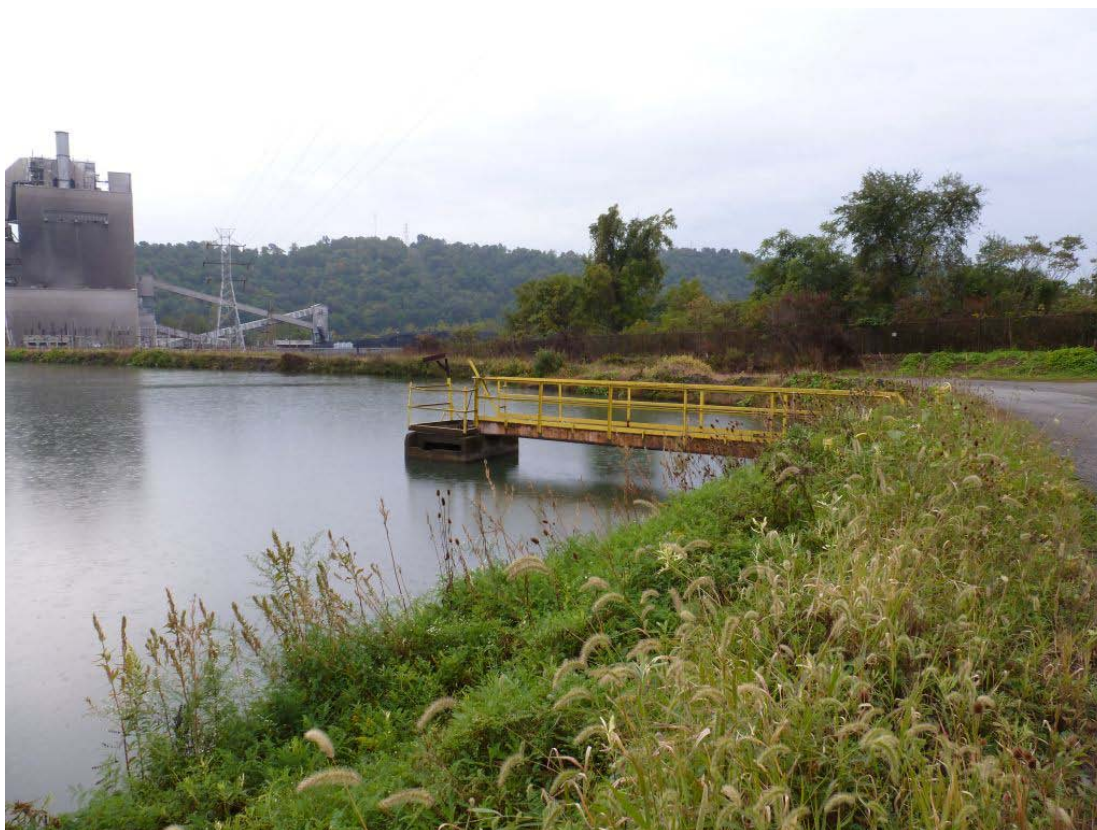
Photo Number:  
10

Description:  
Ash Settling  
Pond SPD-1 (in  
operation)  
outlet tower  
and western  
embankment  
inboard slope.

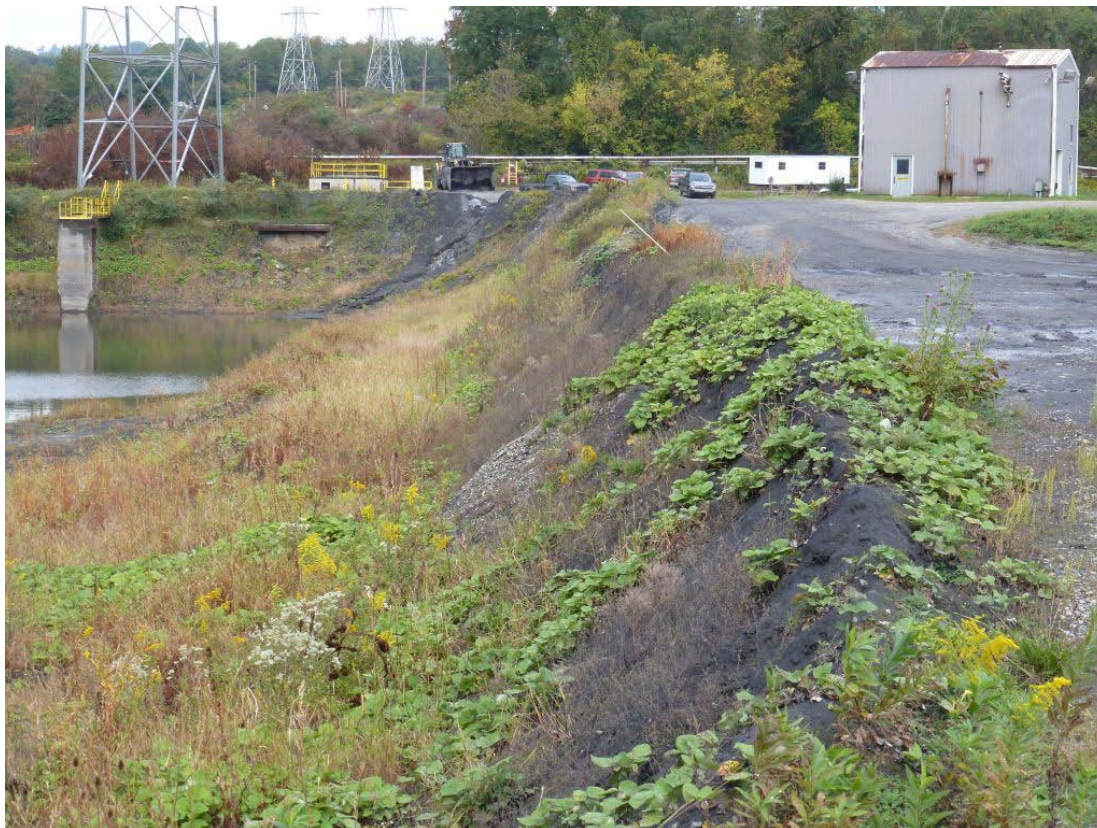
Photo Number:  
11

Description:  
Ash Settling  
Pond SPD-2  
northern  
embankment  
inboard slope.

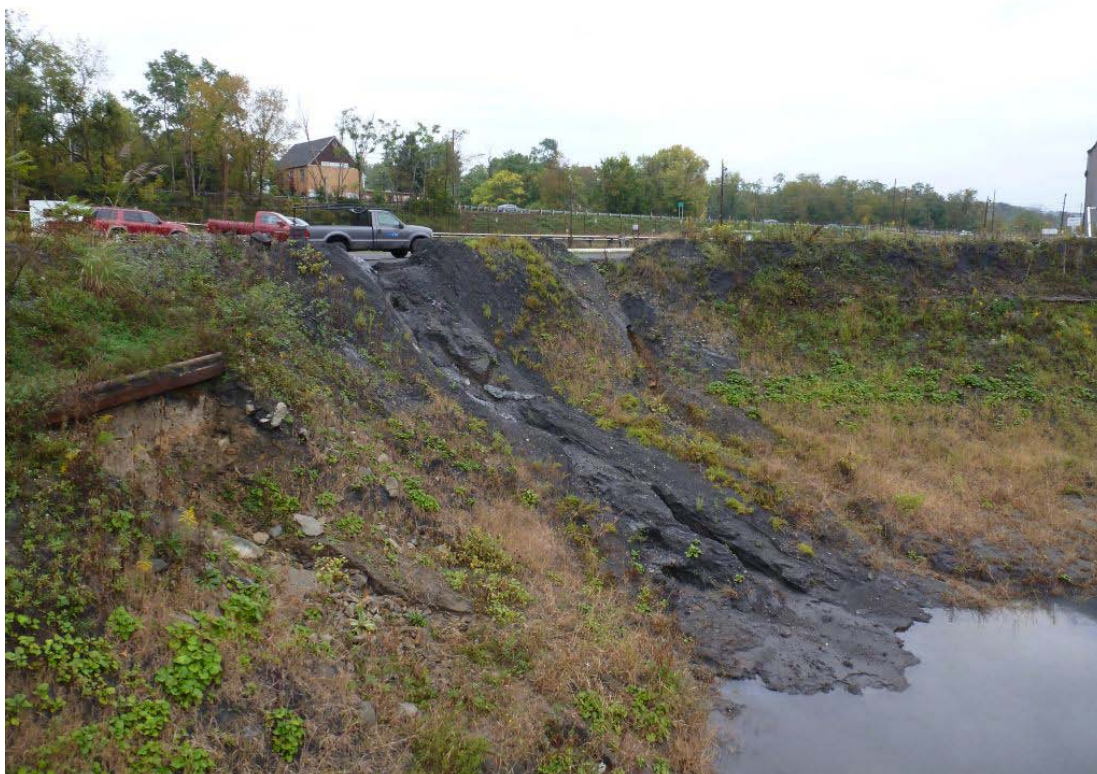
Photo Number:  
12

Description:  
Ash Settling  
Pond SPD-2  
western  
embankment  
inboard slope,  
erosion at  
northwest  
corner and  
outflow  
structure.

- Inspect and maintain operable low level outlet structures to maintain a drained condition in the ponds.
- Repair severely eroded areas on the inboard and outboard slopes.
- Fill low areas along the outboard toe of slope and maintain cut vegetation along outboard slopes so they can be inspected for seepage.
- Establish better surface drainage along the outboard toe to eliminate or reduce stormwater ponding.
- A geotechnical investigation and slope stability analysis should be performed, potentially in conjunction with a decommissioning study and closure plan if embankments remain impounding CCW. The analysis should include static and seismic loading conditions along with liquefaction potential analysis.

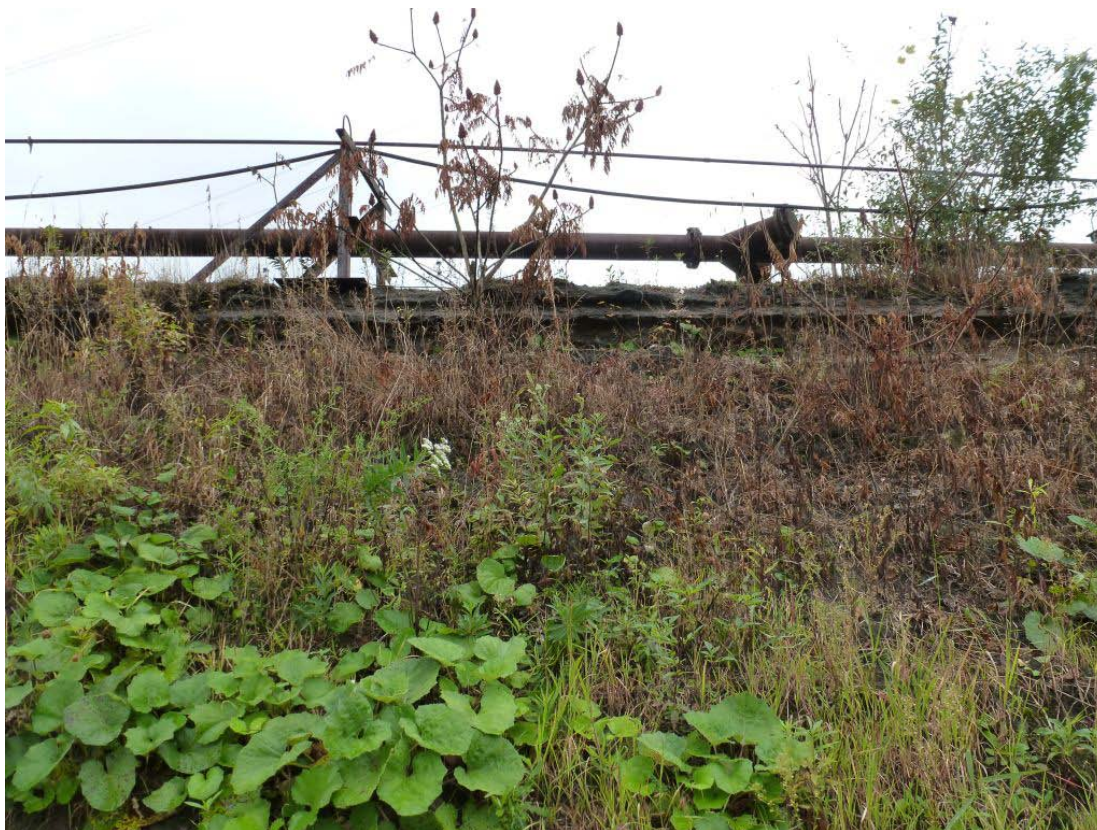
Ash Settling  
Pond dividing  
dike and SPD-2  
inboard slope,  
erosion at  
dividing dike  
crest.

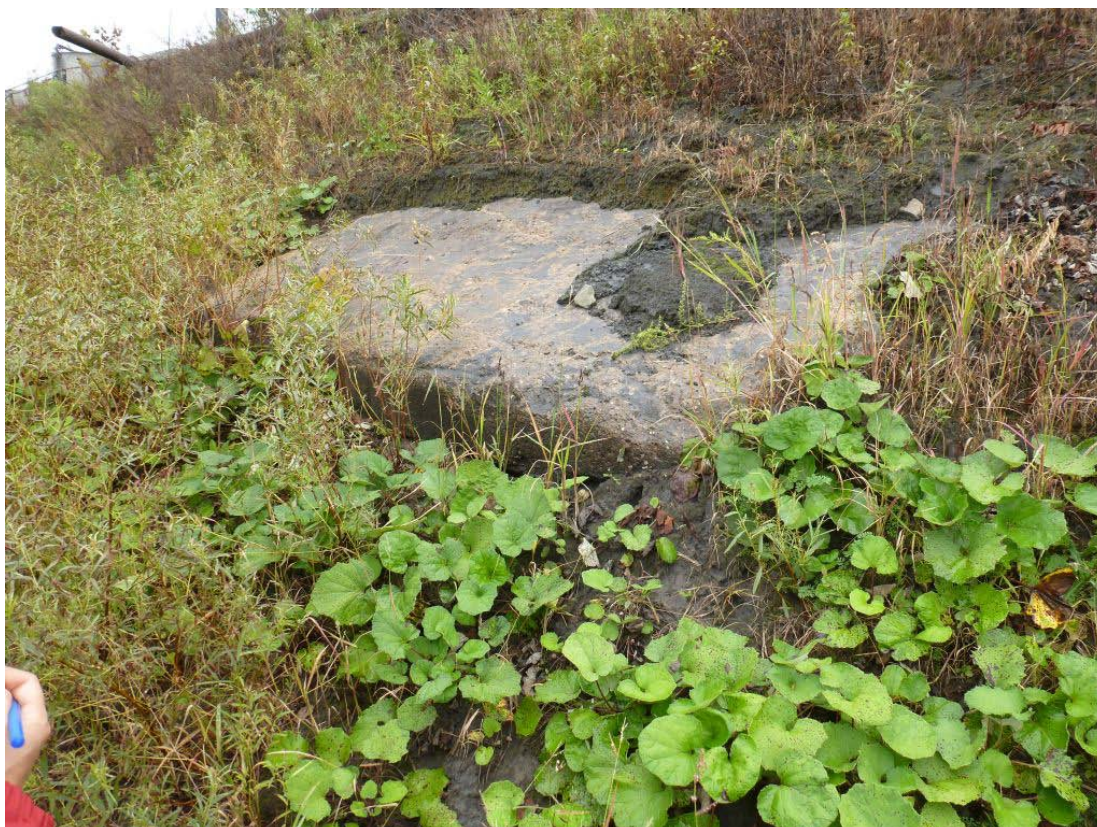
Ash Settling  
Pond dividing  
dike and SPD-2  
inboard slope,  
sediment from  
erosion evident  
on large stone.

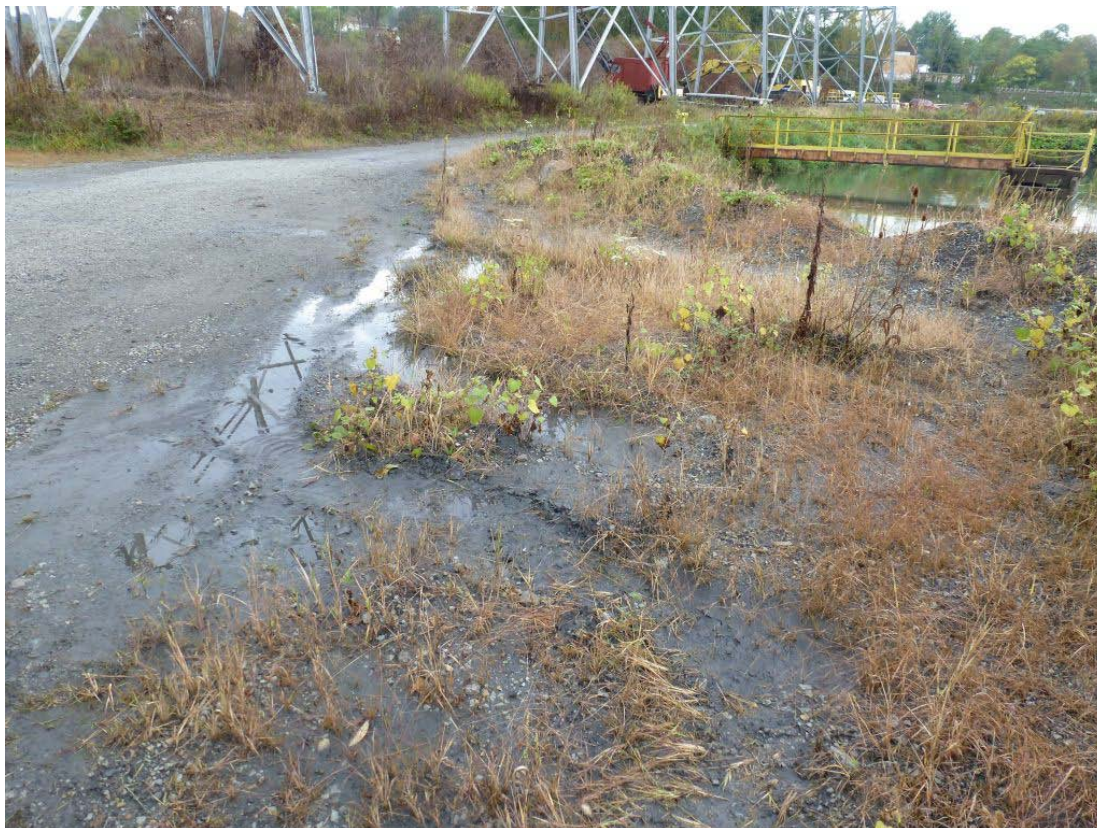
Ash Settling  
Pond SPD-1  
southwest  
corner, ponding  
at crest near  
inboard slope.

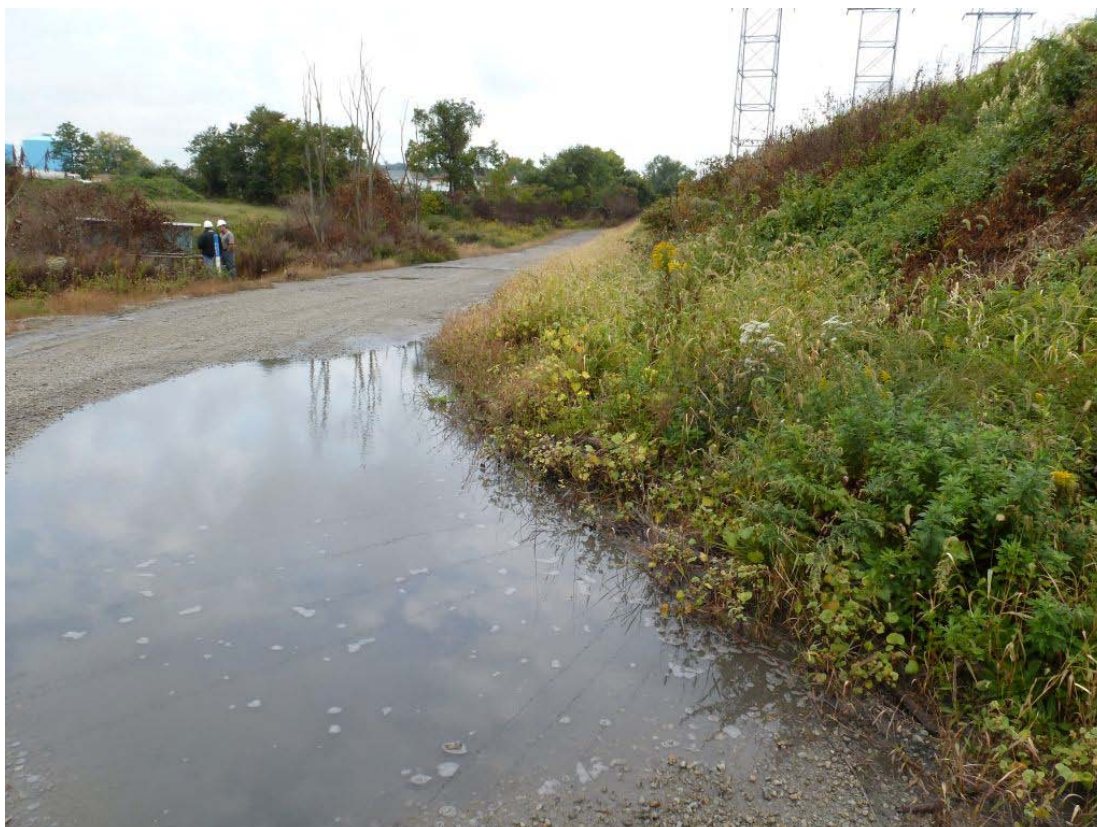
Ash Settling  
Pond SPD-1  
southeast  
corner, ponding  
at toe of slope  
along access  
road.

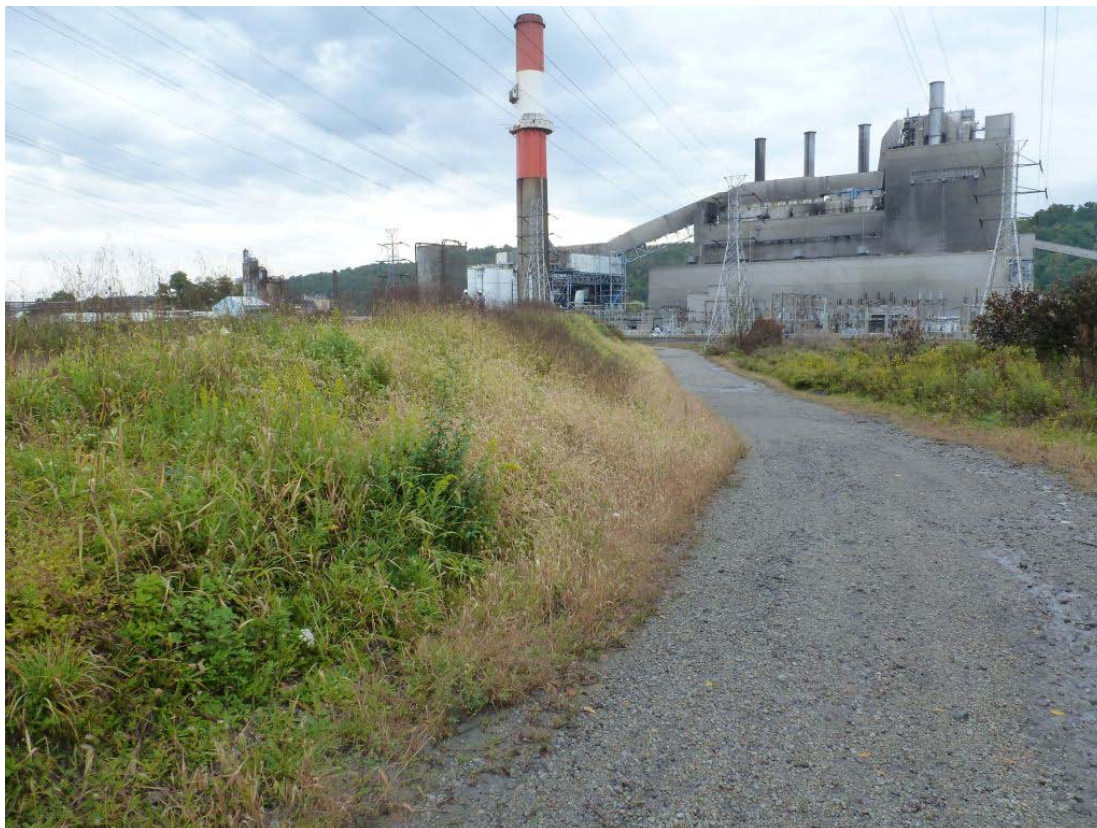
Photo Number:  
17

Description:  
Ash Settling  
Pond SPD-1  
southern  
embankment  
outboard slope  
and access  
road.

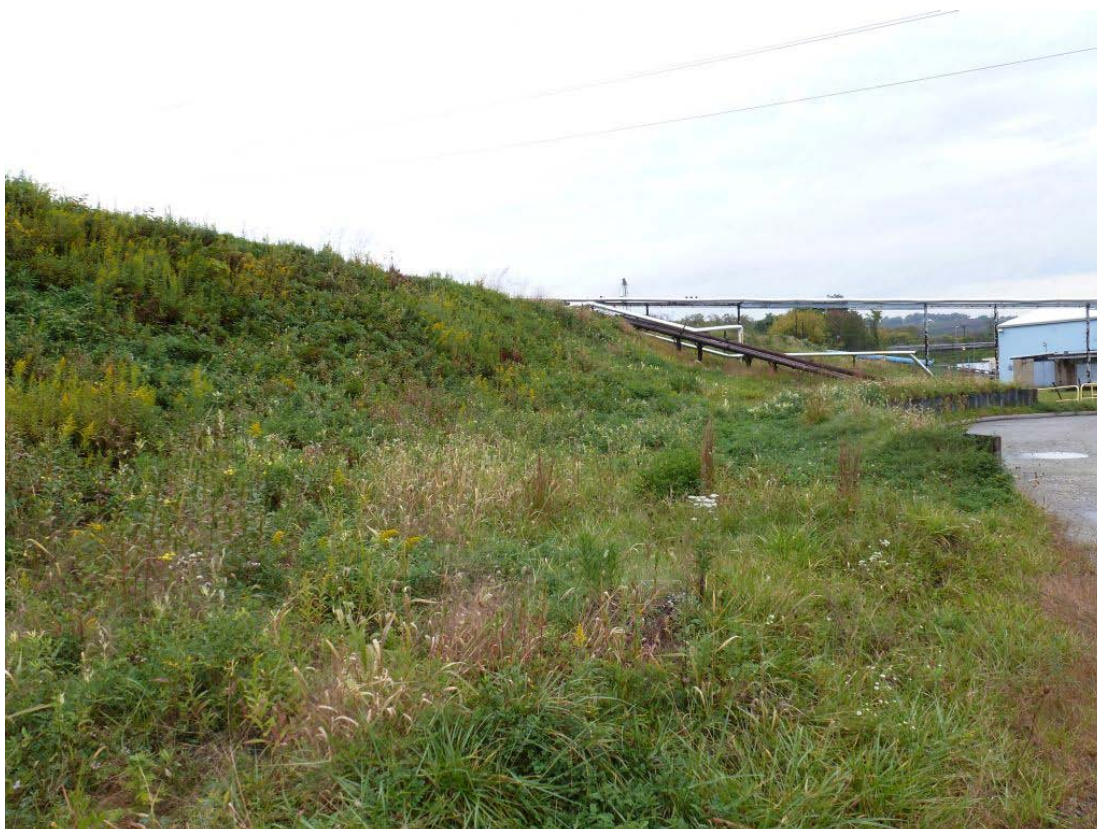
Photo Number:  
18

Description:  
Ash Settling  
Pond SPD-1  
eastern  
embankment  
outboard slope.

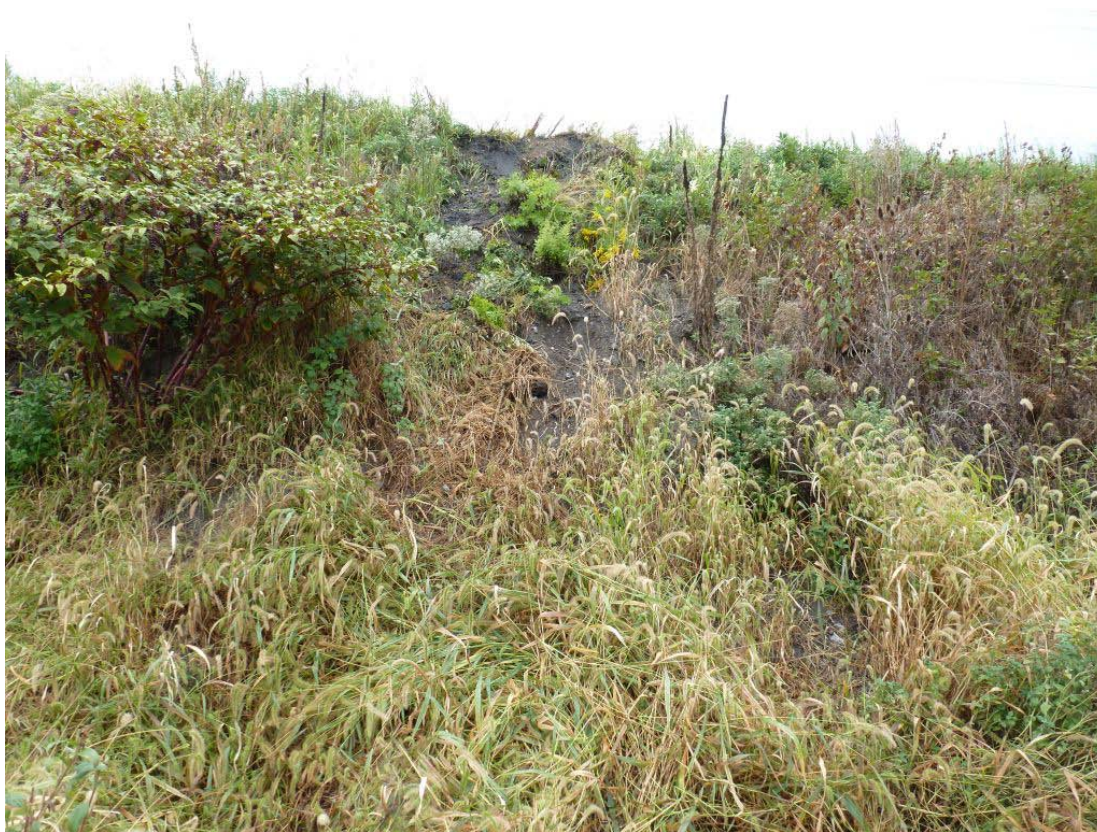
Orientation:  
NDescription:  
Ash Settling  
Pond SPD-1  
erosion near  
top of southern  
embankment  
outboard slope  
and shrub  
vegetation.

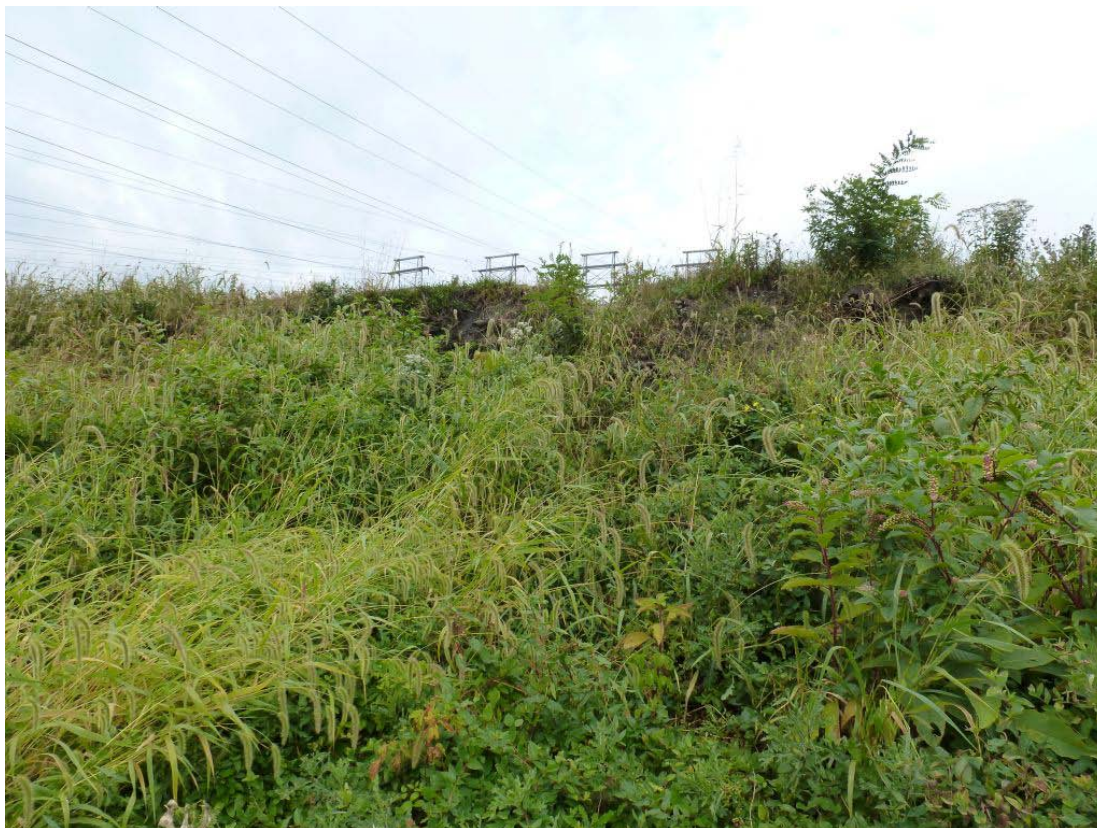
Date:  
9/26/12Photo Number:  
20Photographer:  
DDW

Date:  
9/26/12Photo Number:  
19Photographer:  
DDWOrientation:  
NDescription:  
Ash Settling  
Pond SPD-1  
erosion near  
top of southern  
embankment  
outboard slope  
and heavy  
vegetation.

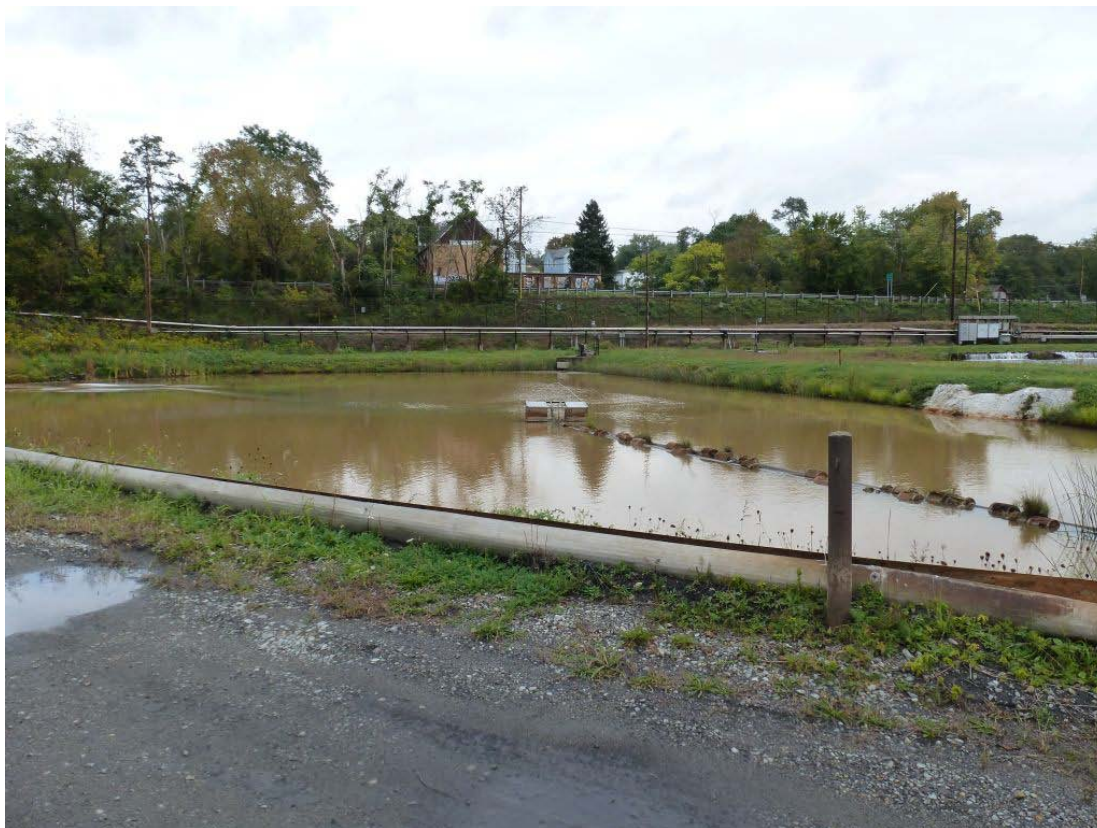
Orientation:  
NWDescription:  
Coal Runoff  
Pond SPD-3  
(incised).

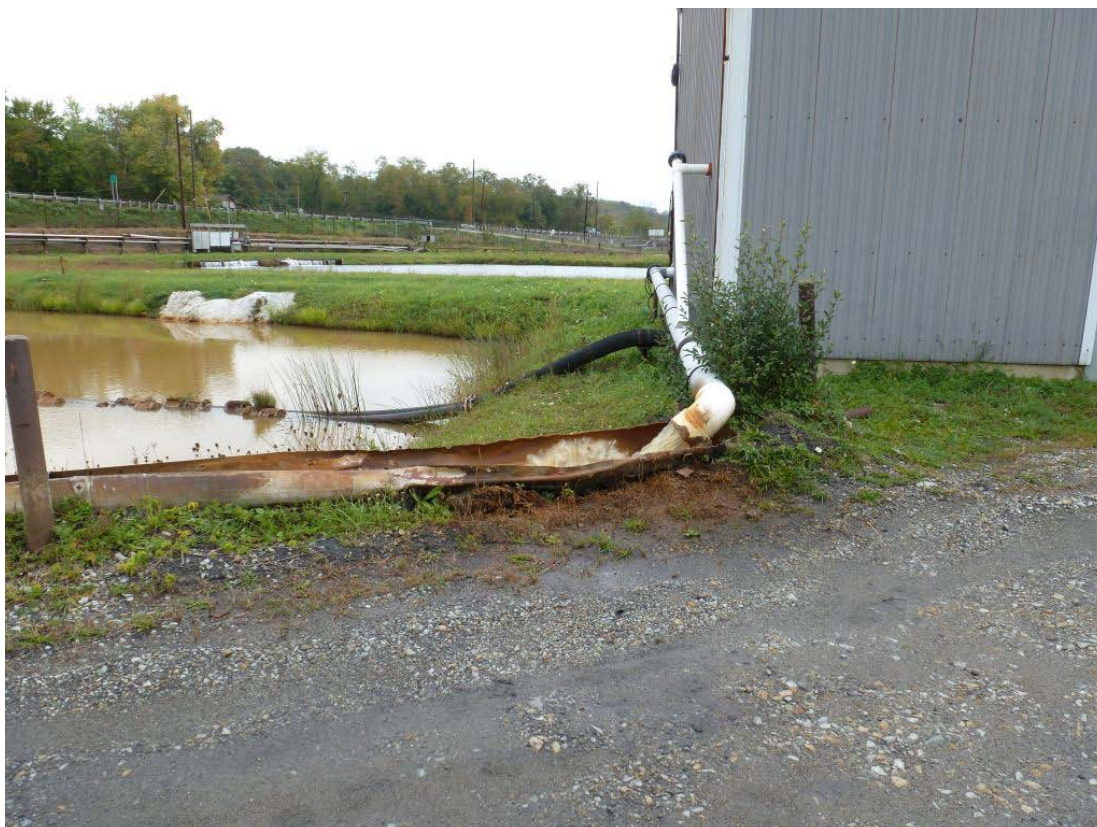
Date:  
9/26/12Photo Number:  
22Photographer:  
DDW

Date:  
9/26/12Photo Number:  
21Photographer:  
DDWOrientation:  
NDescription:  
Coal Runoff  
Pond SPD-3  
inflow.

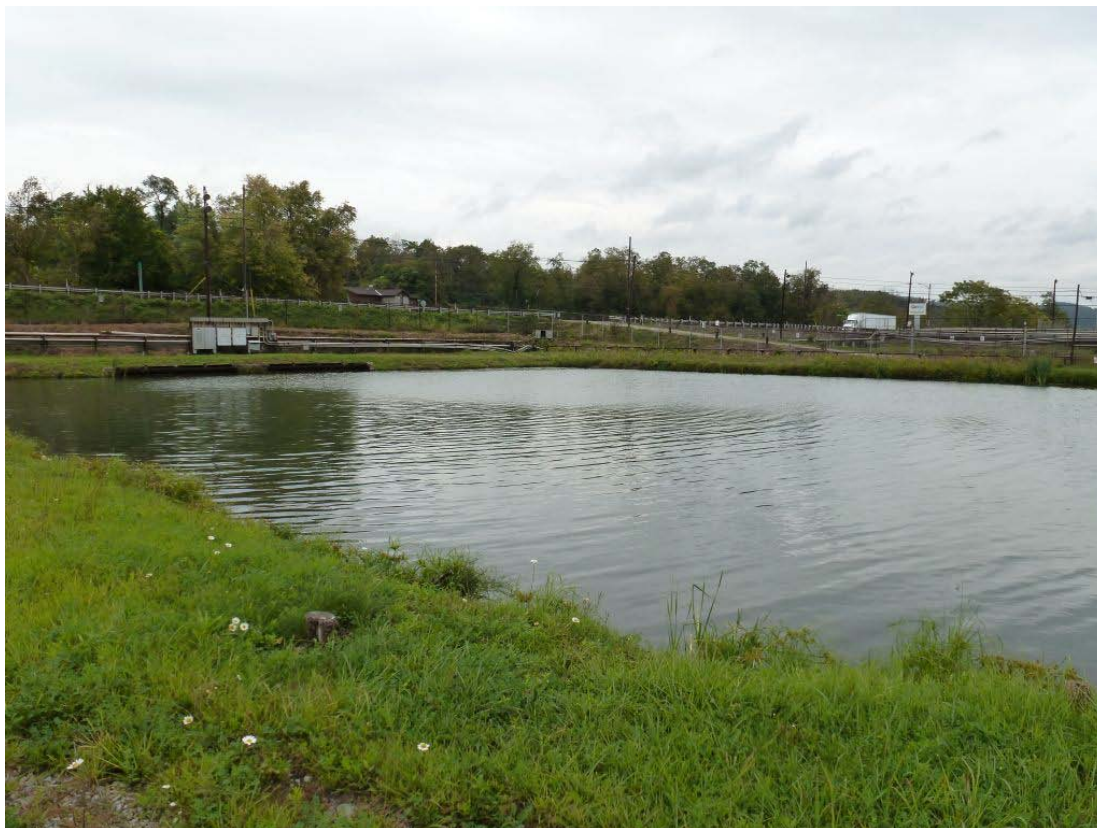
Polishing Pond  
SPD-4 (incised).

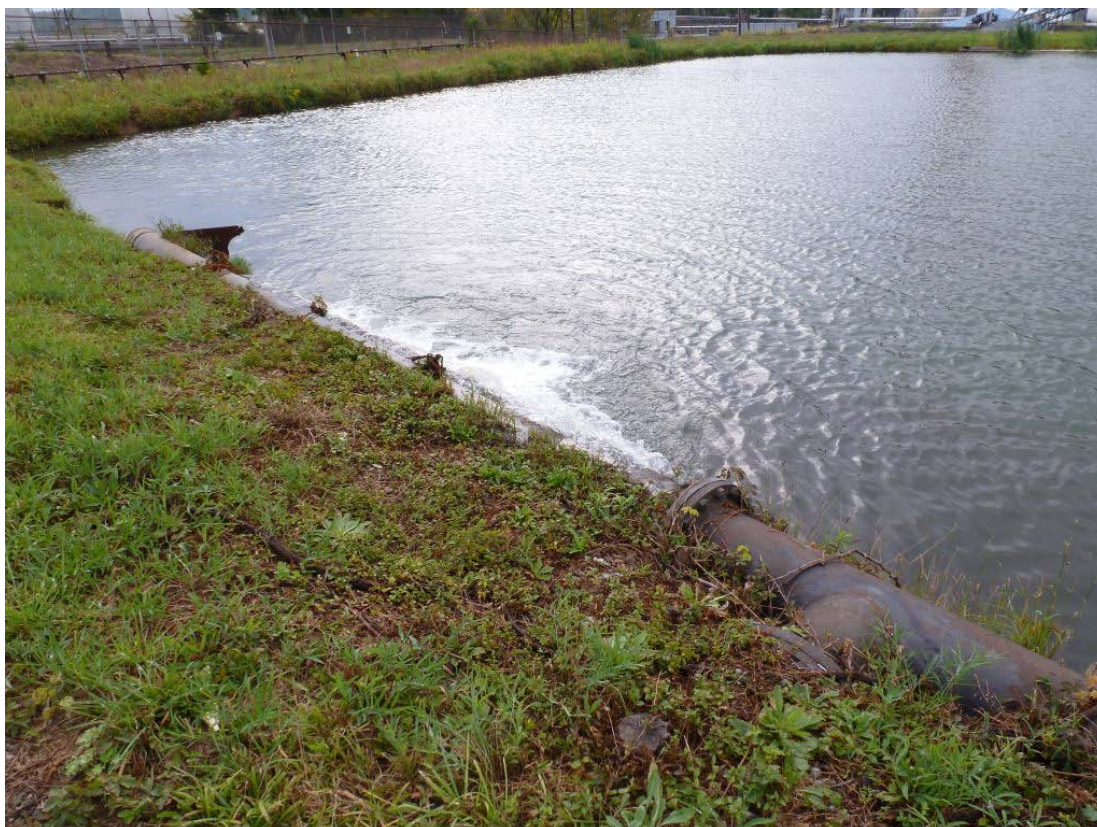
Polishing Pond  
SPD-4 inflow  
structure.
