# **Dam Safety Assessment of CCW Impoundments**

## **NRG ELRAMA POWER STATION**

**United States Environmental Protection Agency  
Washington, DC**

February 2014

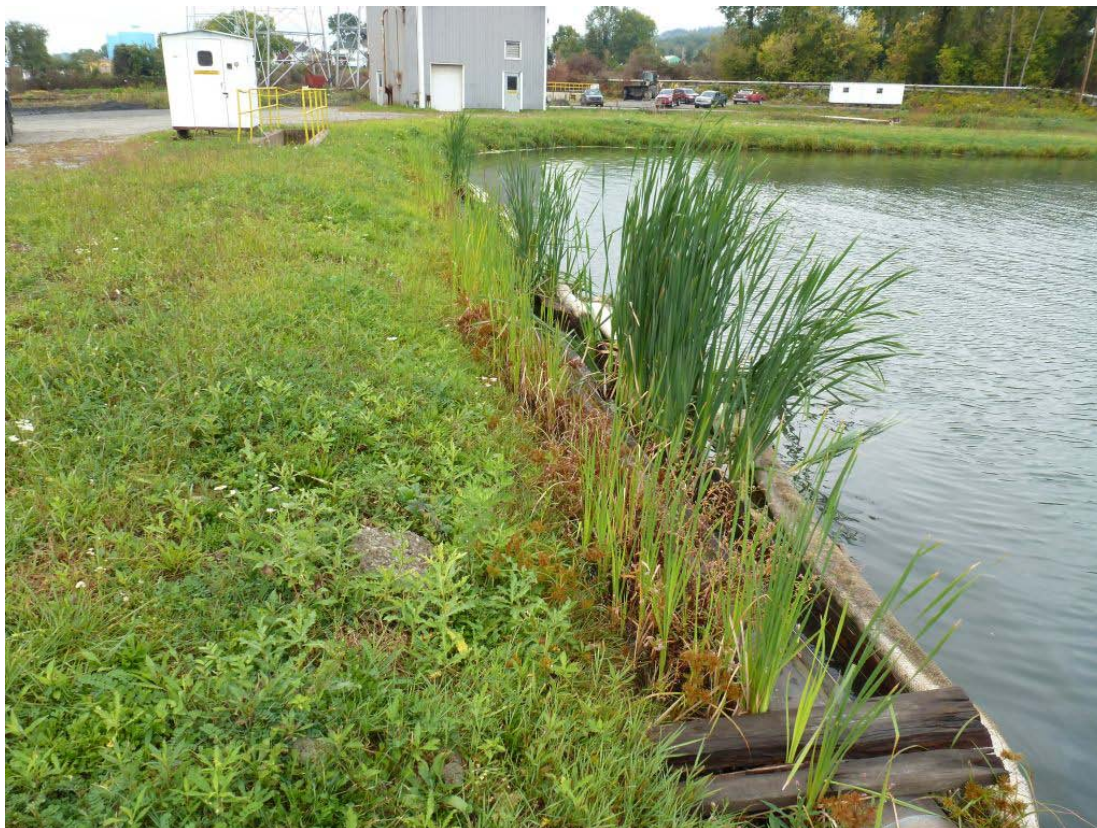
Photo Number:  
25

Description:  
Polishing Pond  
SPD-4 in pond  
outflow  
structure with  
tall grass  
growing in and  
around it.

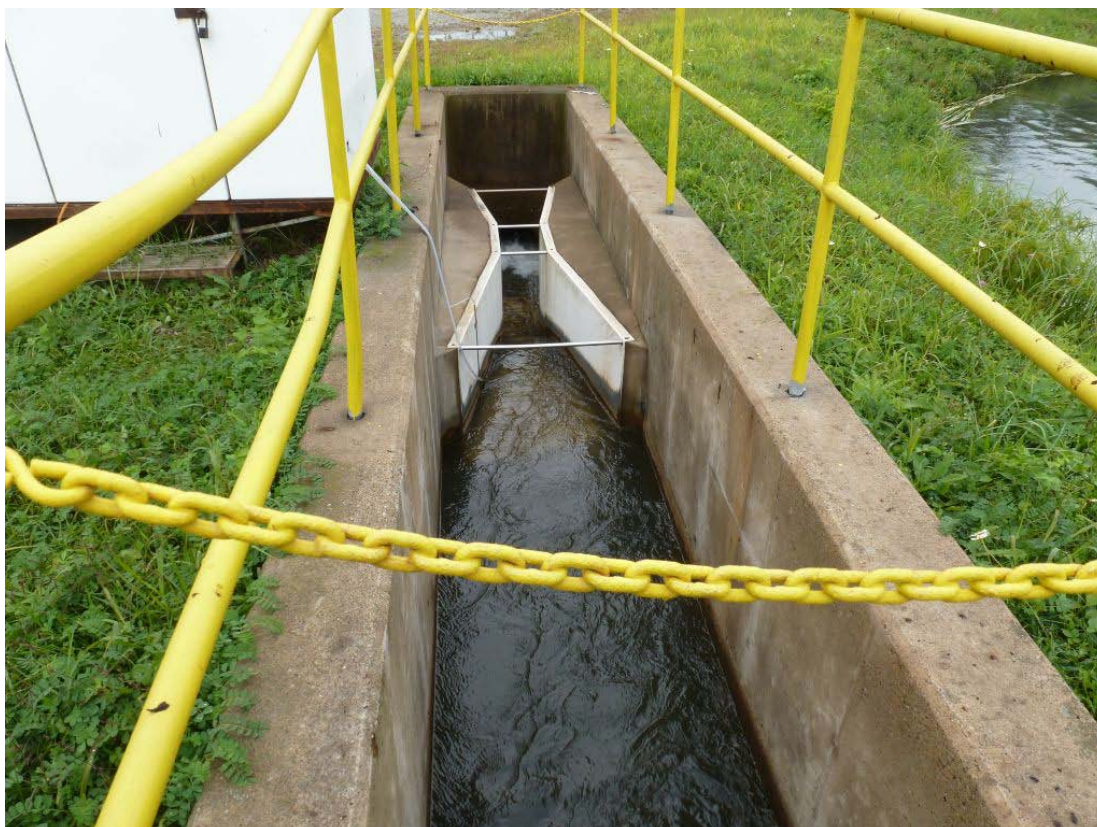
Photo Number:  
26

Description:  
Polishing Pond  
SPD-4 Parshall  
Flume outflow  
structure  
adjacent to  
pond.

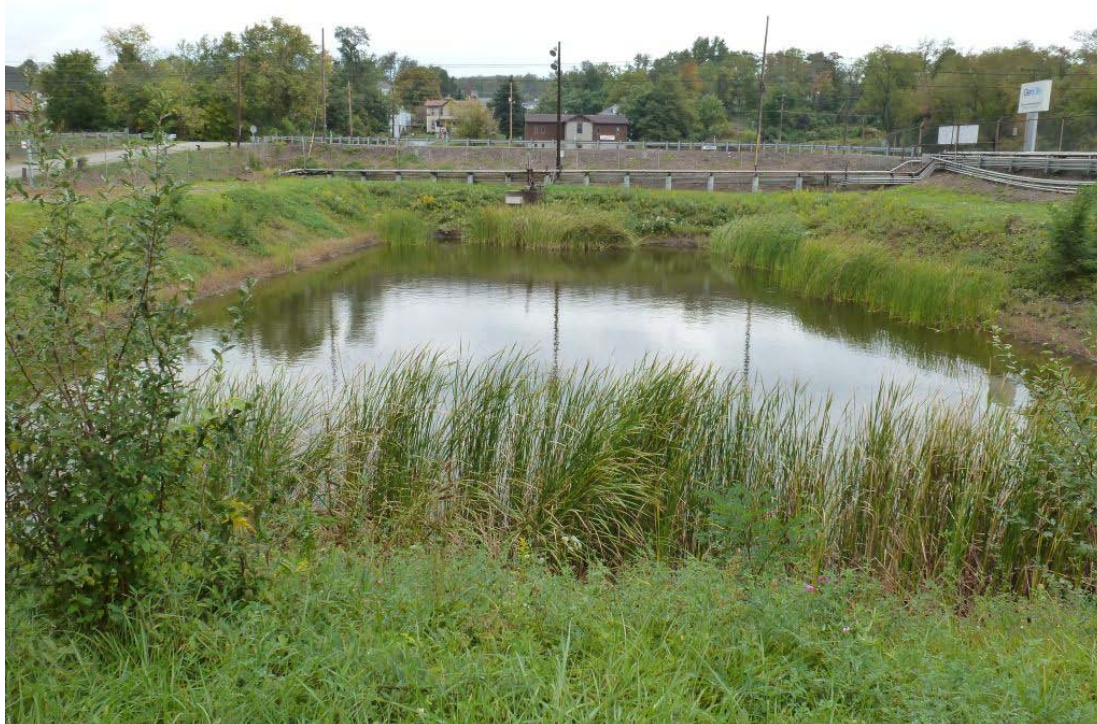
Photo Number:  
27

Description:  
Emergency  
Pond SPD-5 and  
inboard slopes.

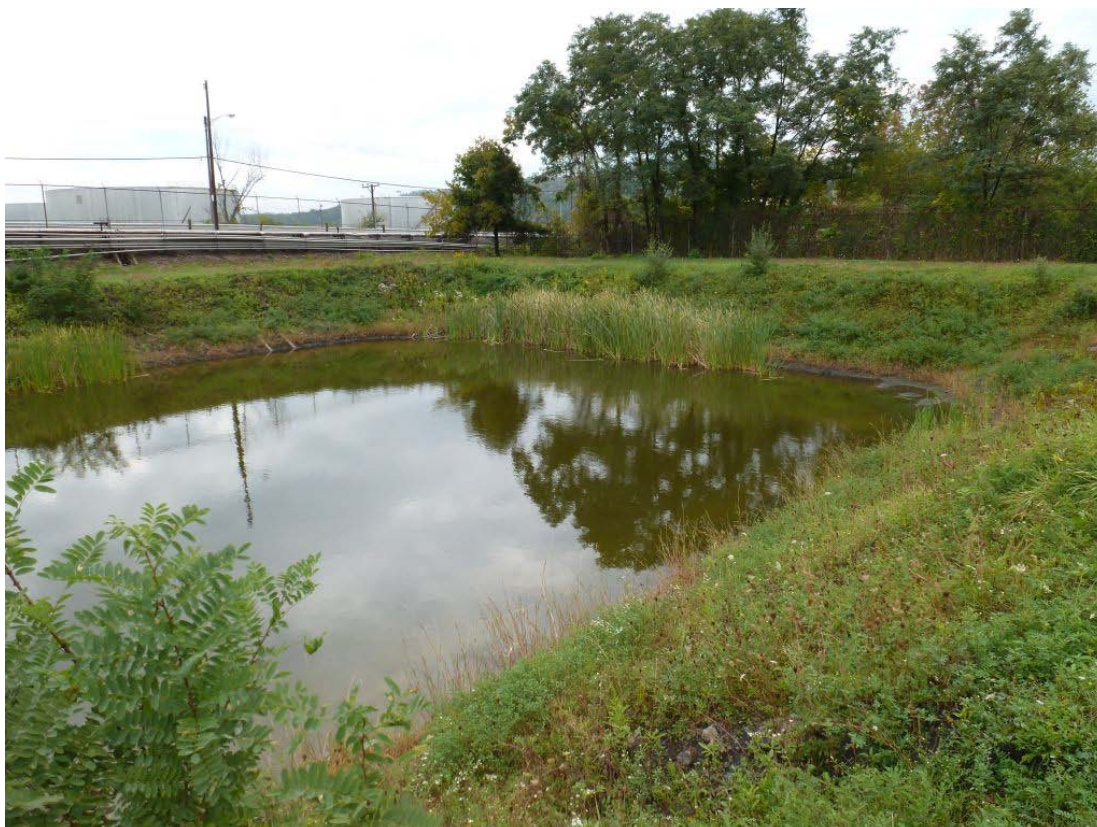
Photo Number:  
28

Description:  
Emergency  
Pond SPD-5 and  
inboard slopes.

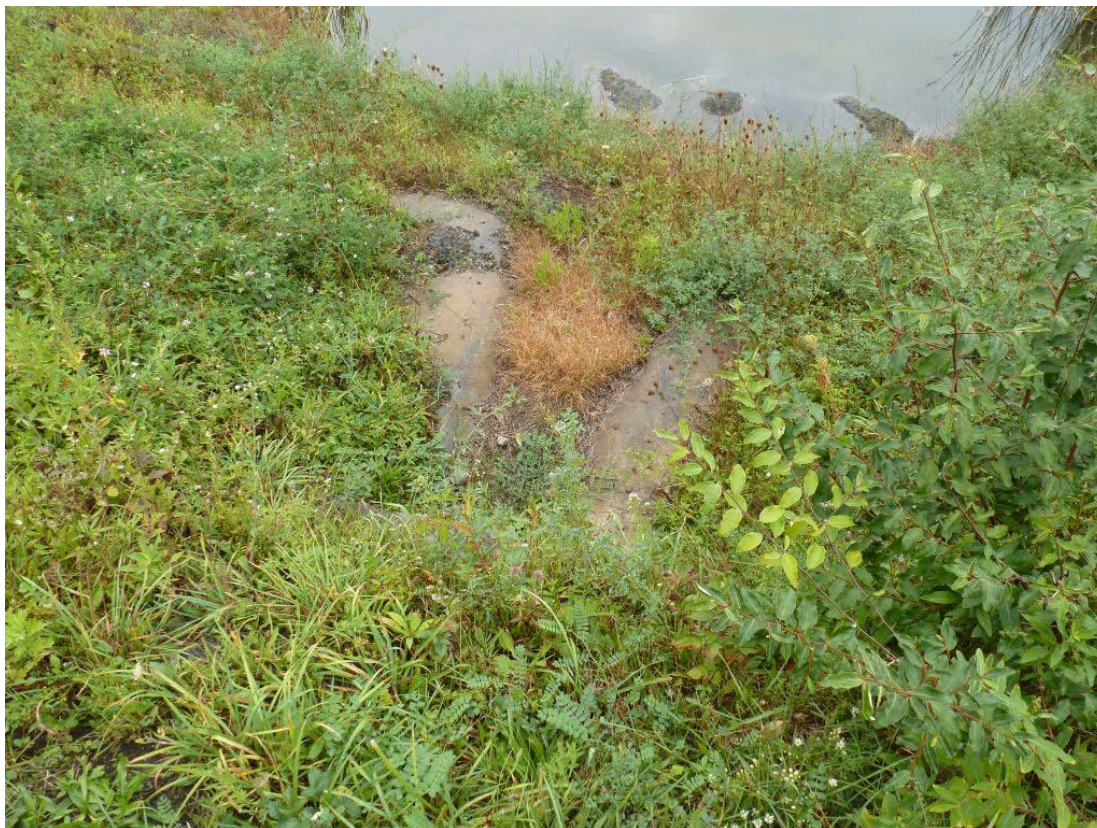
Photo Number:  
29

Description:  
Emergency  
Pond SPD-5  
south corner  
inboard slope.

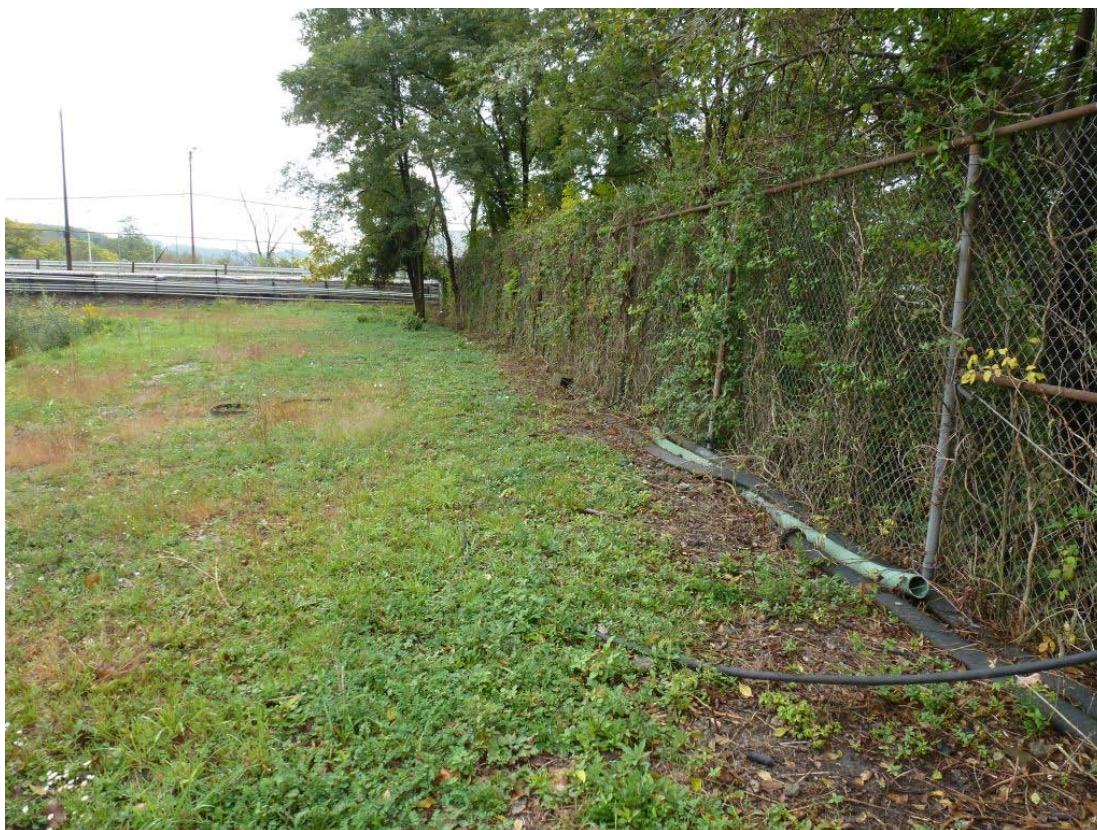
Photo Number:  
30

Description:  
Emergency  
Pond SPD-5  
southeastern  
embankment  
crest bordered  
by fence and  
woody  
vegetation on  
downstream  
slope.
