Report of Dam Safety Assessment of Coal
Combustion Surface Impoundments
NRG Energy
Huntley Generating Station
Tonawanda, NY

AMEC Project No. 3-2106-0194

March 2013

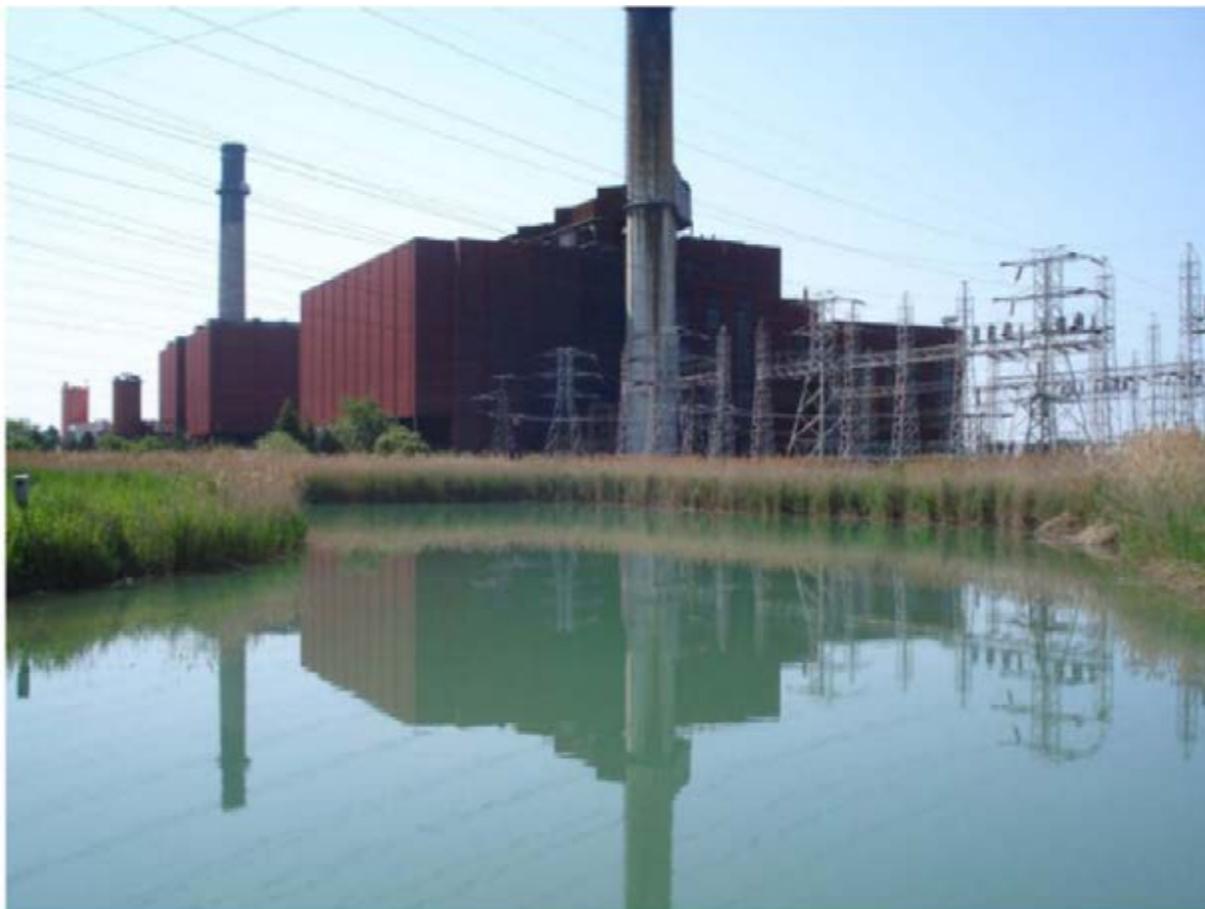
Pond 2 is located in the ash management area at the north end of the plant (North Ponds). The pond is situated in the northwest portion of this area. Pond 2 is bordered by Pond 3 to the east, a ditch to the north, a substation to the west and Pond 1 to the south. An inlet pipe from Pond 1 enters Pond 2 at the southeast corner. Plans show the width of the top of the common dike of Pond 2 with Pond 1 as 20 feet. Dense, tall grass prevented a good view of the area. See the following photo presented as 2-1 in Appendix B.

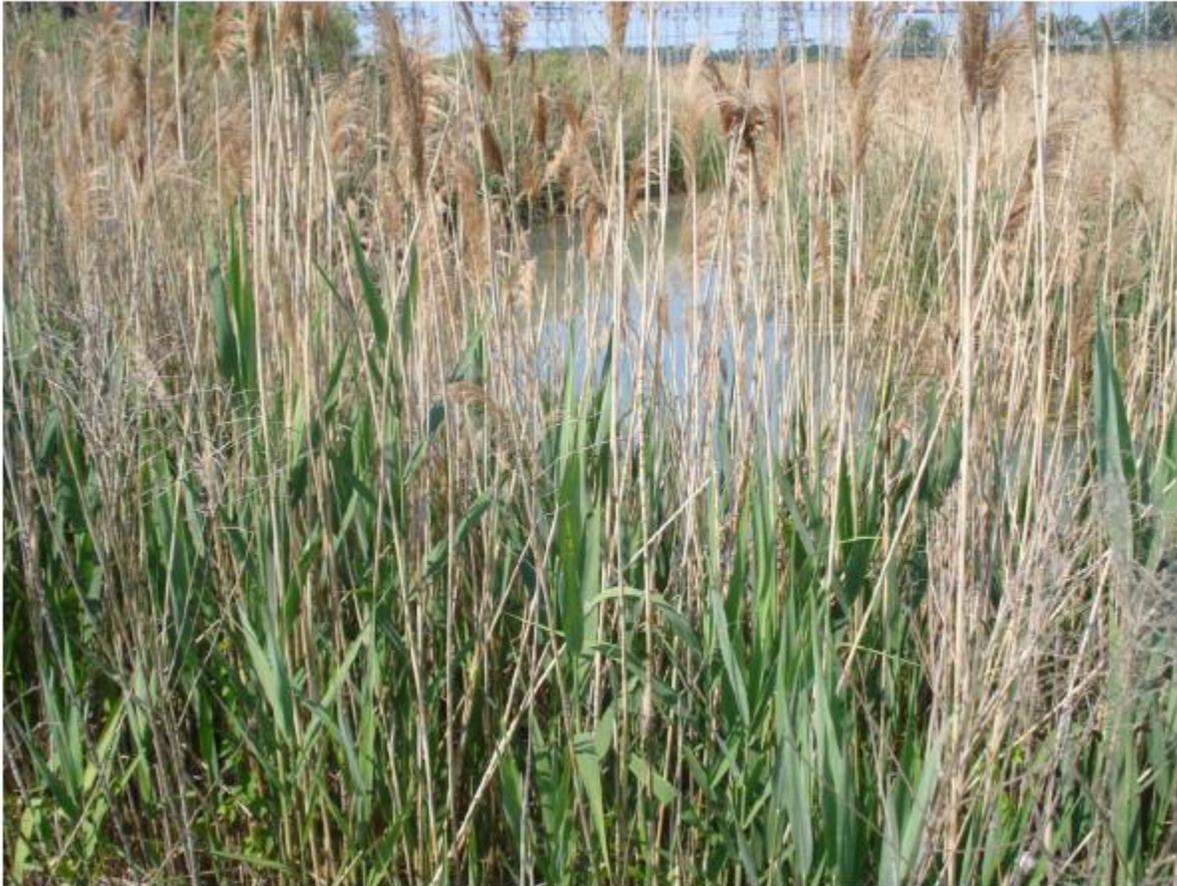
prevented a good view of the interior and exterior slopes (Photos 3-2 through 3-8). See the following photo presented as 3-2 in Appendix B.

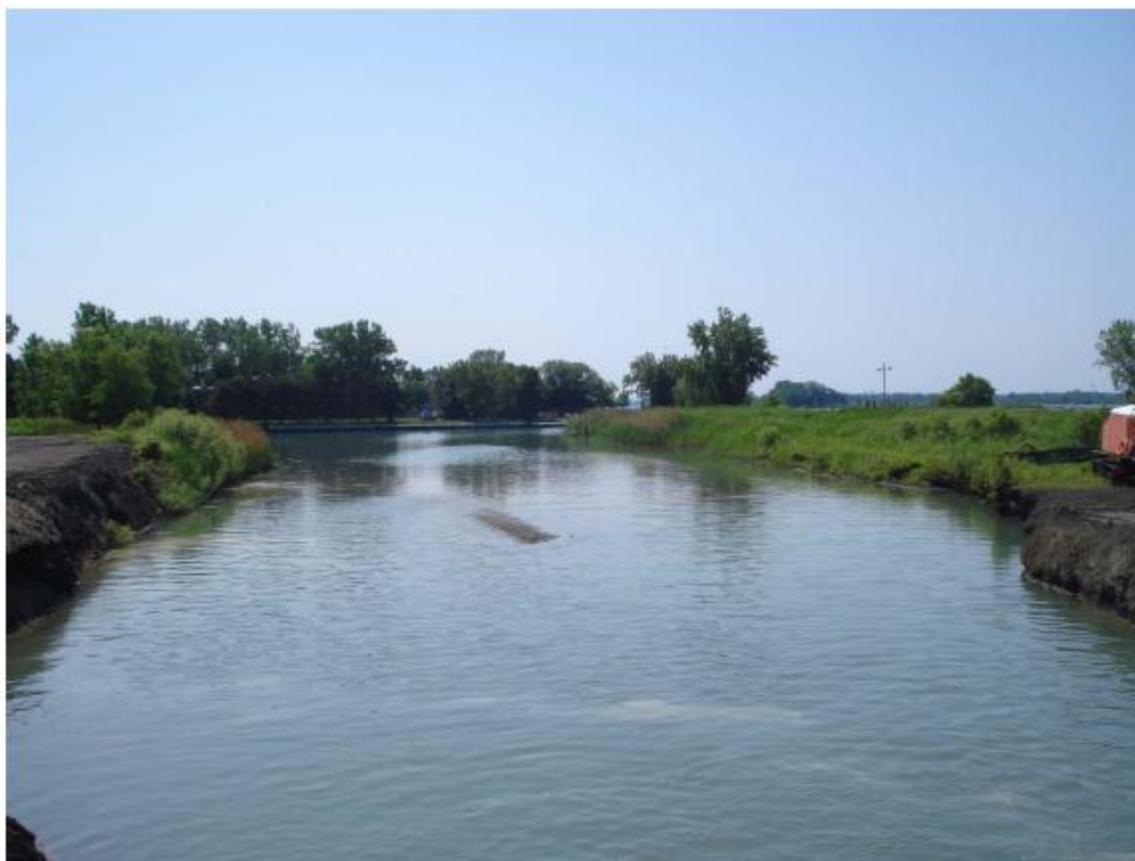
At the time of the field assessment, the upstream slopes at the north end of the South Pond were steep and void of vegetation (Photo S-2 and S-8). Generally, all other upstream slopes, crests and downstream slopes were covered with high grass preventing a good view of the slopes (Photos S-2, S-3, S-5, S-9 and S-10). Steep slopes appeared to be present on the inside of the curve on the west embankment and at the southeast end of the pond (Photos S-2 and S-10). See the following photo presented as S-2 in Appendix B.

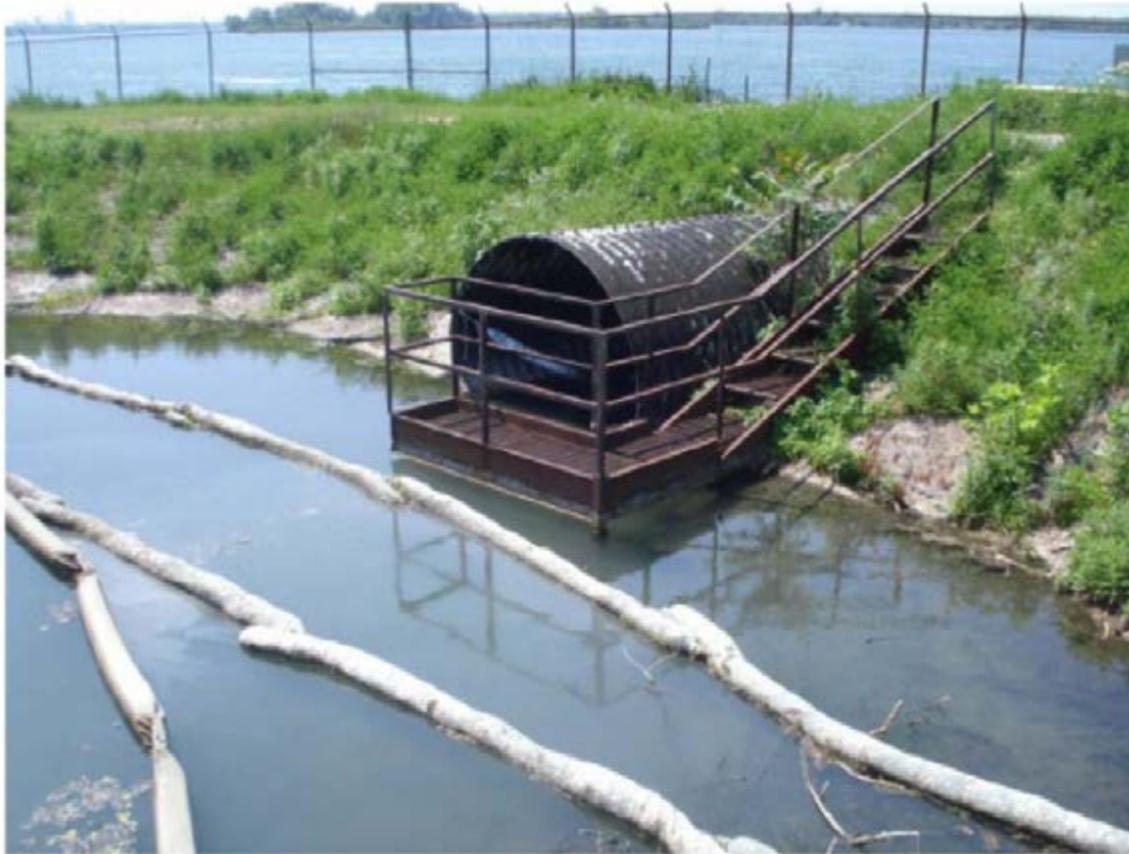
The South Pond was modified in 1984. This modification included the southwest end of the pond and the outlet structure. The South Pond discharges flow by gravity through a 92-inch by 65-inch arched CMP located on the southwest dike (Photos S-3, S-4, S-6 and S-7). Skimmer booms are located upstream of the outlet pipe and the upstream slope is armored with rip-rap (Photo S-4 and S-7). The flow discharges to the Niagara River with grouted rip-rap slopes upstream and downstream of the outlet pipe (Photo S-6). The inlet and outlet elevations of the 92-inch by 65-inch arched CMP are 568.8 and 565.0 feet, respectively. See the following photo presented as S-4 in Appendix B showing the inlet of the outlet pipe.

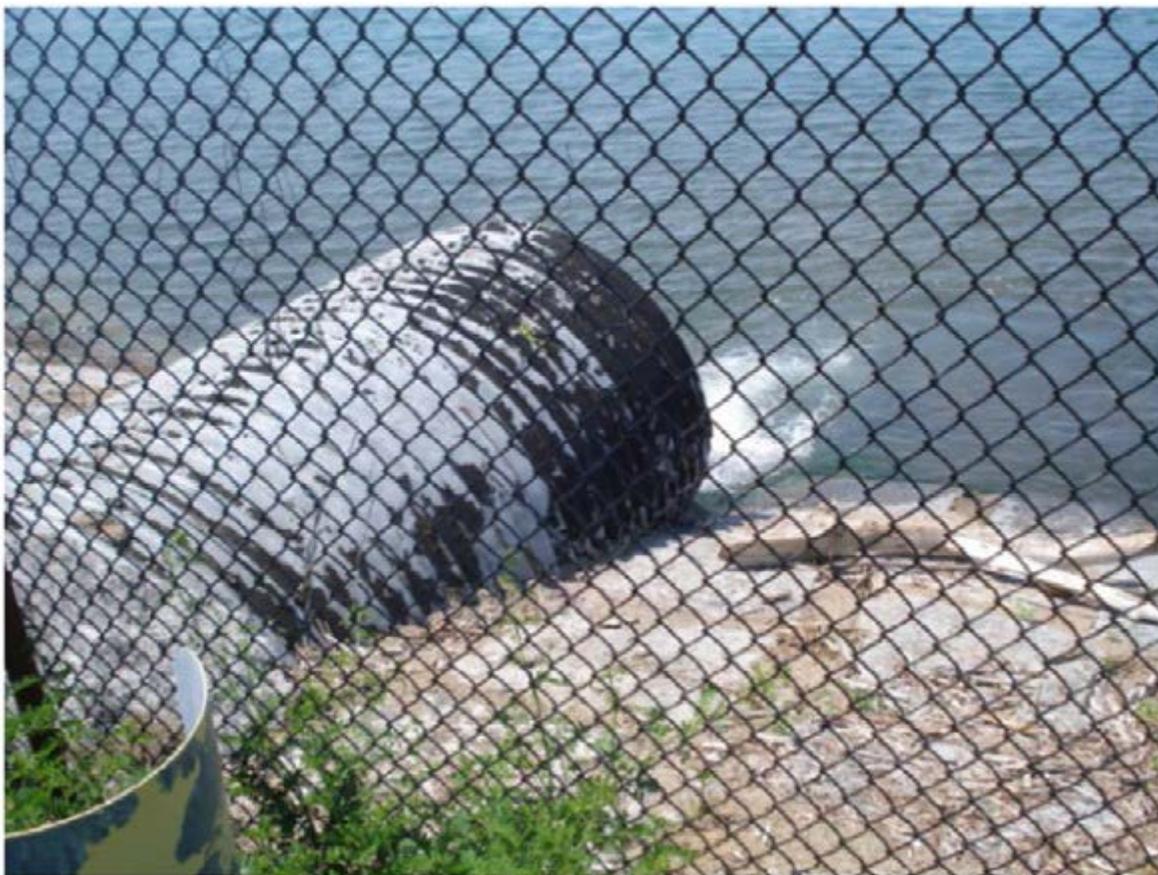
See the following photo presented as S-6 in Appendix B showing the outlet pipe area to the Niagara River.

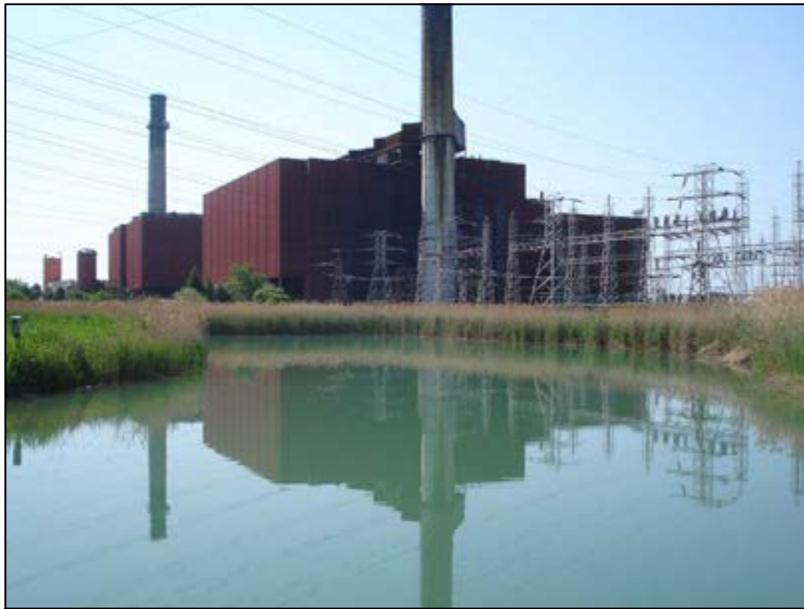
2-1
 LOOKING SOUTH AT INTERIOR OF
 POND 2, HIGH VEGETATION

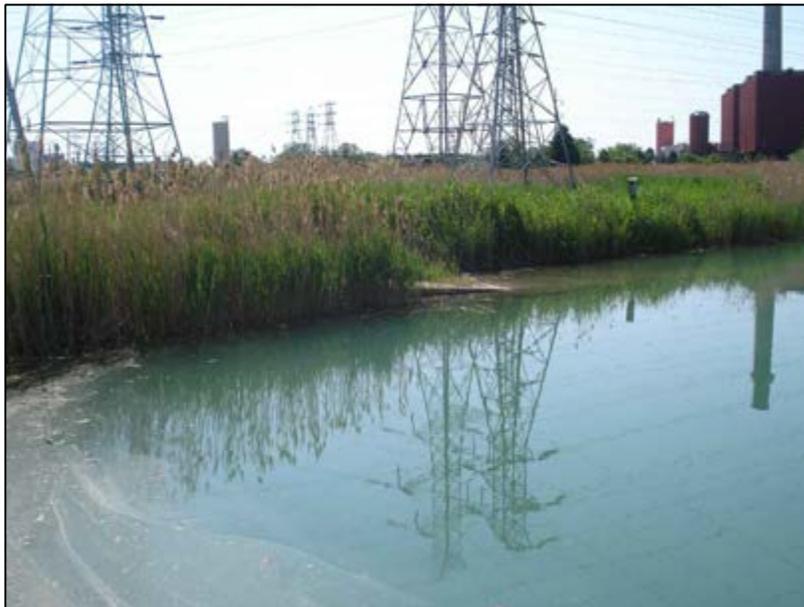
2-2
 LOOKING SOUTHEAST AT INTERIOR OF POND 2,
 HIGH VEGETATION, RAMP INTO POND

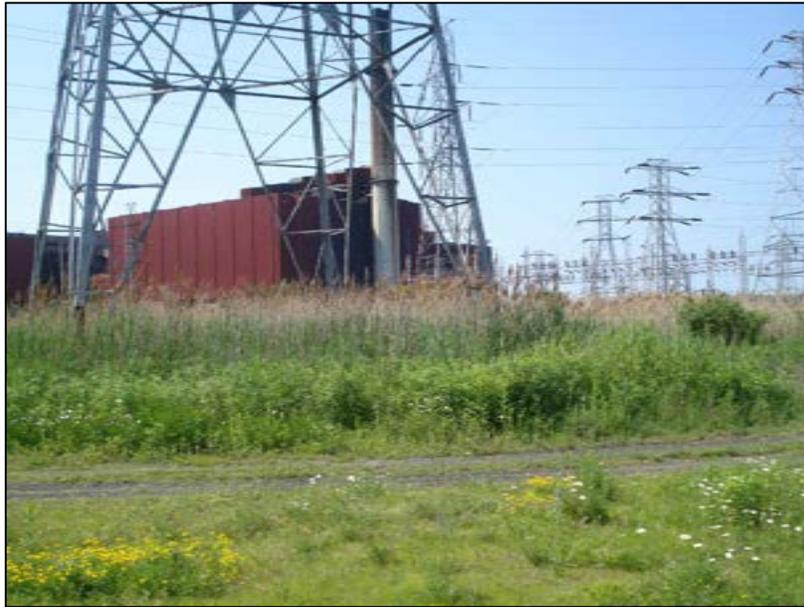
3-7

LOOKING SOUTHWEST AT POND 3, HIGH VEGETATION

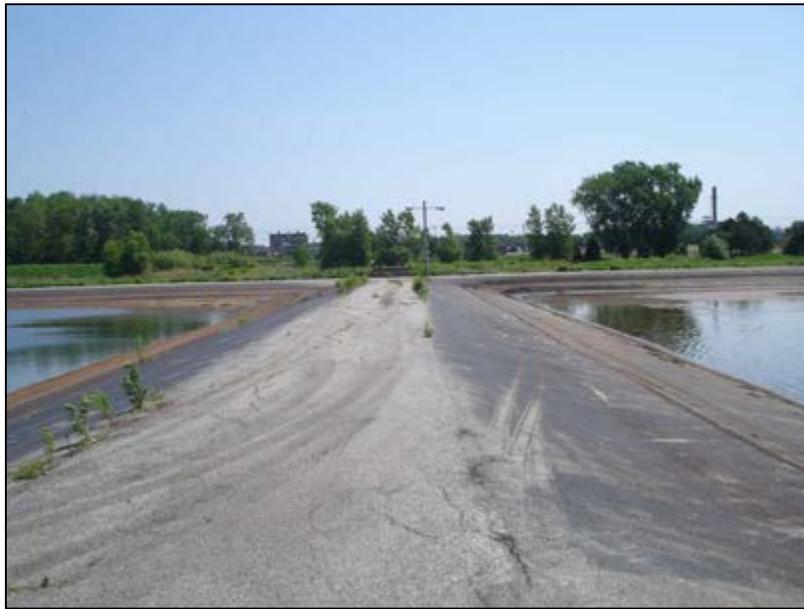
SEQ-1
 BETWEEN EQUALIZATION BASINS LOOKING EAST AT COMMON DIKE

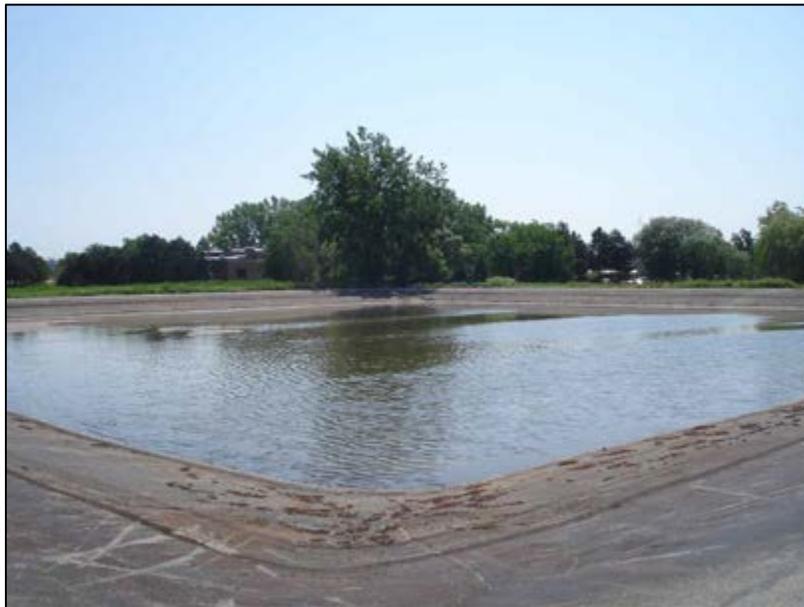
SEQ-2
 NORTHWEST CORNER OF SOUTH EQUALIZATION
 BASIN LOOKING SOUTHEAST ACROSS BASIN.

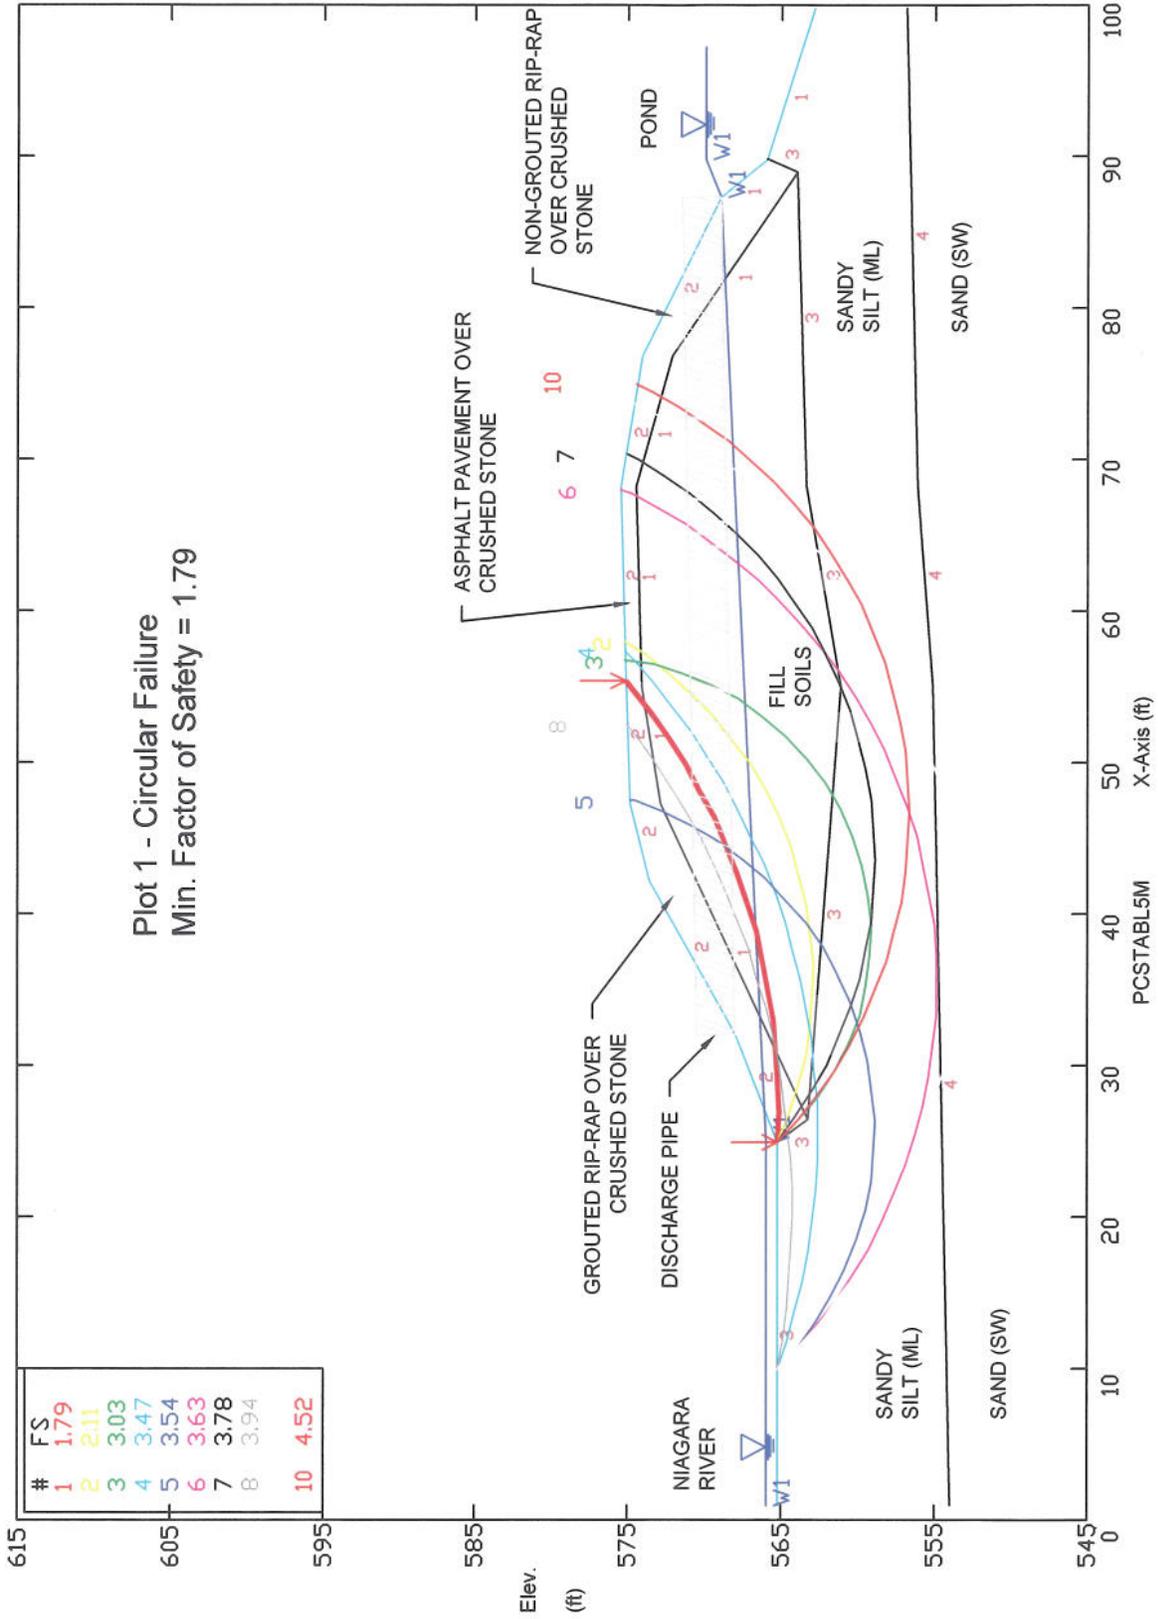
Plot 1 - Circular Failure
Min. Factor of Safety = 1.79

The results of GZA's stability analyses indicated minimum factors of safety of 1.79 and 1.78 for circular failure surfaces and minimum factors of safety of 3.53 and 2.20 for block failure surfaces on the exterior face of the outlet dike. The two sets of factors of safety for each case are based on the sandy silt (1) and sandy silt (2) parameters, respectively (as discussed above and shown in Table 7).
