# Assessment of Dam Safety

## Coal Combustion Surface Impoundments (Task 3)

Northern States  
Power Company –  
Minnesota

Sherburne County  
Power Station

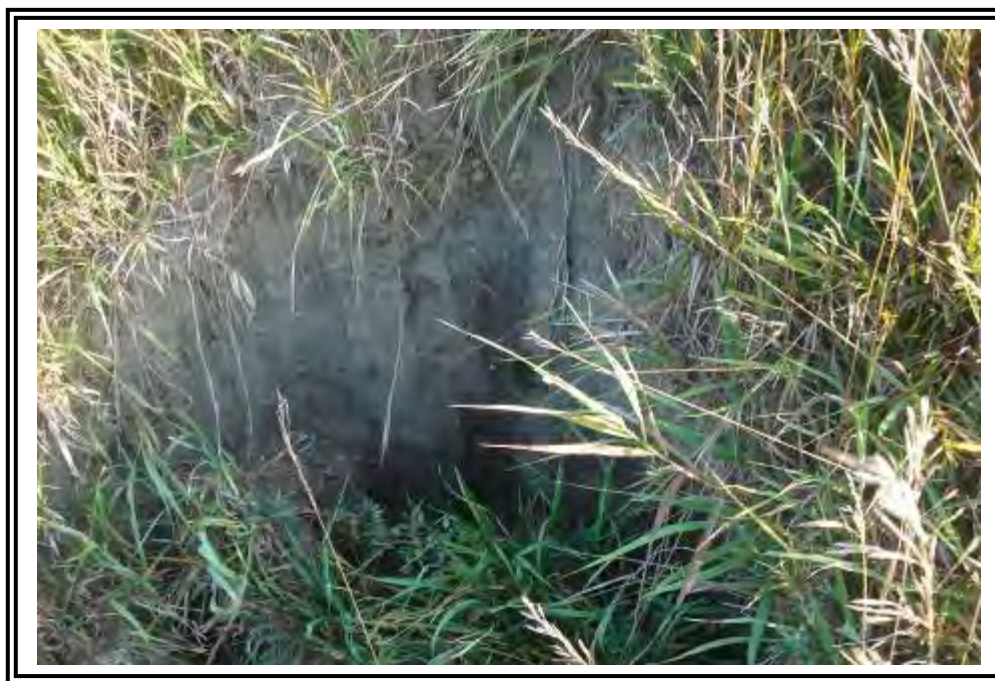
22

On the South Dam a 48-inch wide, 3-foot deep sinkhole was observed near the crest at the storm line (Photo 22). On the dam, erosion/rills were noted approximately 30 feet and 50 feet west due to crest road runoff (Photo 23). Approximately 30 feet east of southwest corner of the dam, an erosion/sinkhole was observed near the crest. Numerous tree stumps greater than 4 inches in diameter were observed indicating that the trees had been recently cut.

48-inch diameter, 3-foot deep sink hole near crest of South Dam.

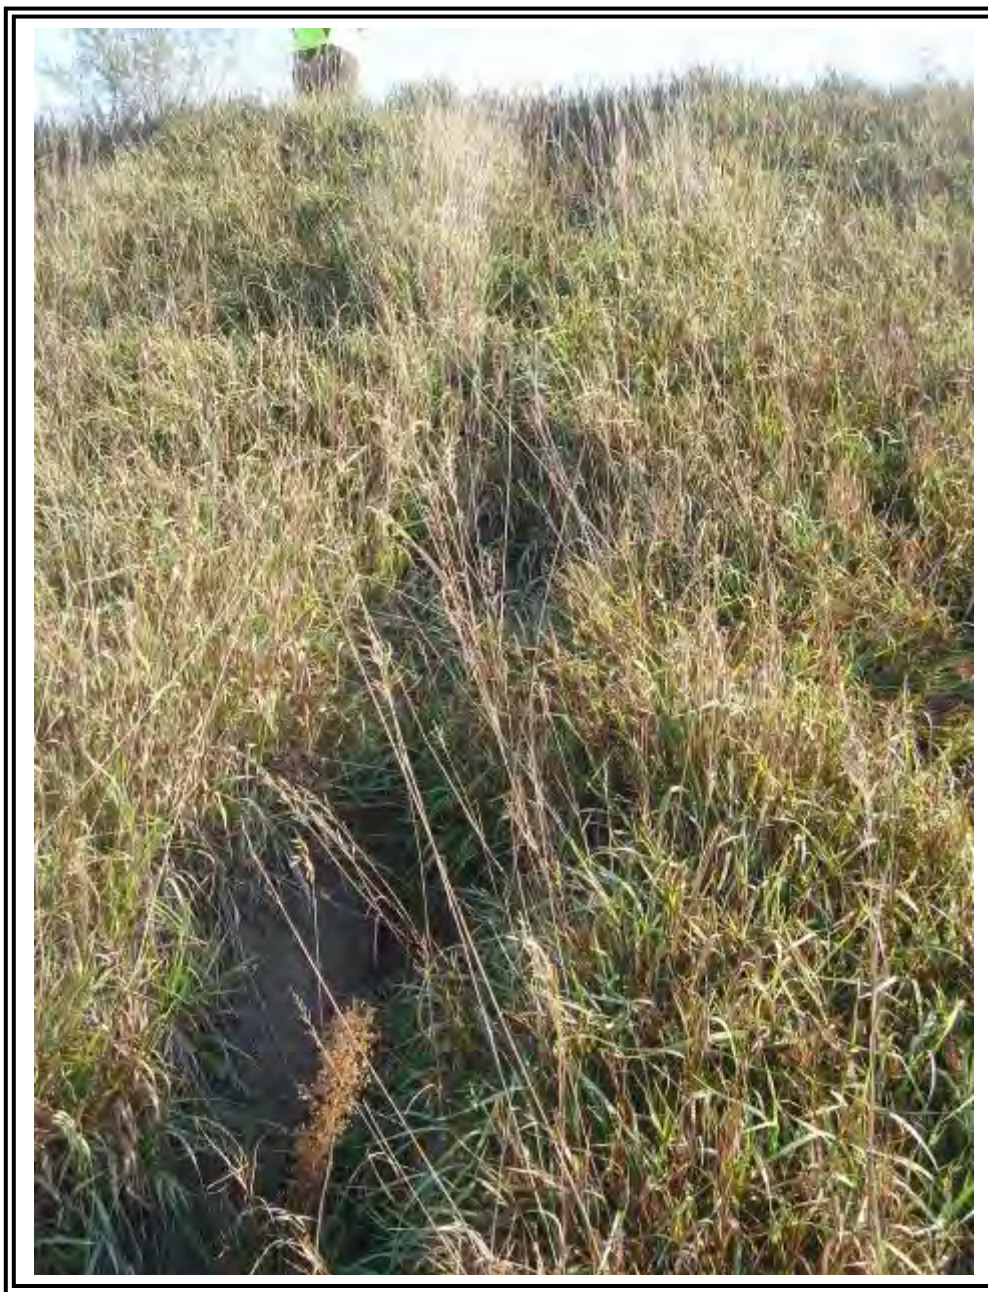
23

Erosion observed on downstream embankment slope of South Dam.

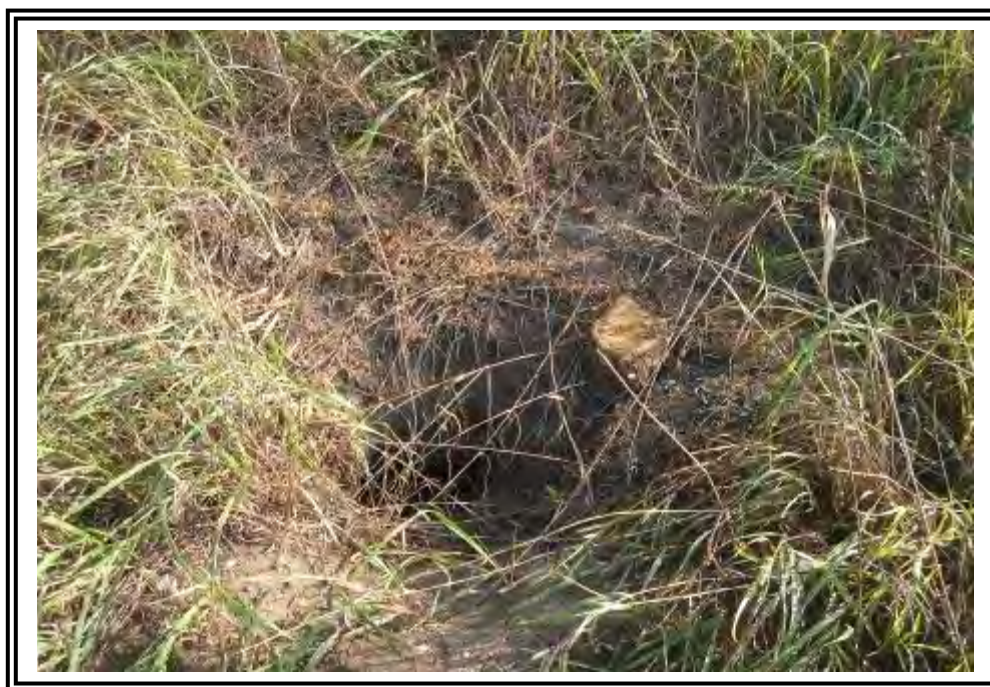
24

Animal burrows were observed on the downstream slope of the West and South Dams. On the South Dam slope approximately two-thirds the distance along the dam, a 4.5-foot deep animal burrow was observed (Photo 24). In the West Dam slope surface, undulations were observed possibly caused by animal burrow initiated creep.

Animal burrow on embankment slope of South Dam.

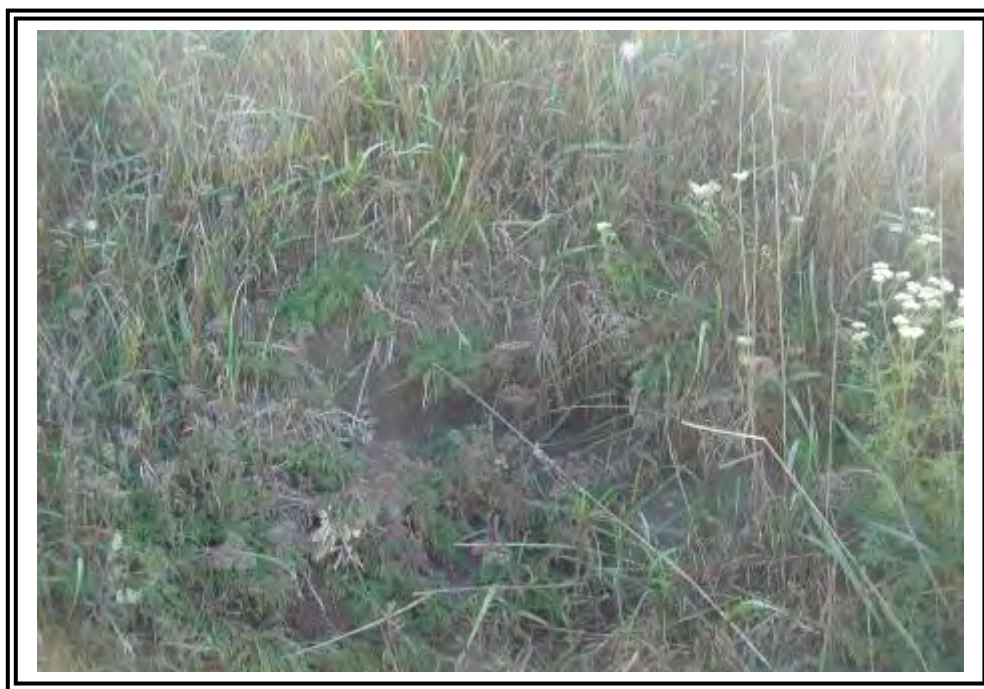
34

On the West Dam, an area of minor erosion/toe scarp was observed in the ditch adjacent to the rock lined outfall ditch. Erosion was also observed at the mid-slope of the embankment and is

likely due to runoff from the access road above (Photo 34). At approximately three-quarter distance from southwest corner of the dam a 6-foot, 2-foot deep wide gulley formed in surface of slope in area of surface undulation (Photos 35 and 36). This surficial slope deformation/creep is again likely due to substantial animal (i.e. pocket gophers, foxes, etc.) activity noted on the West Dam.

Erosion observed at mid-height on downstream embankment slope of the West Dam.

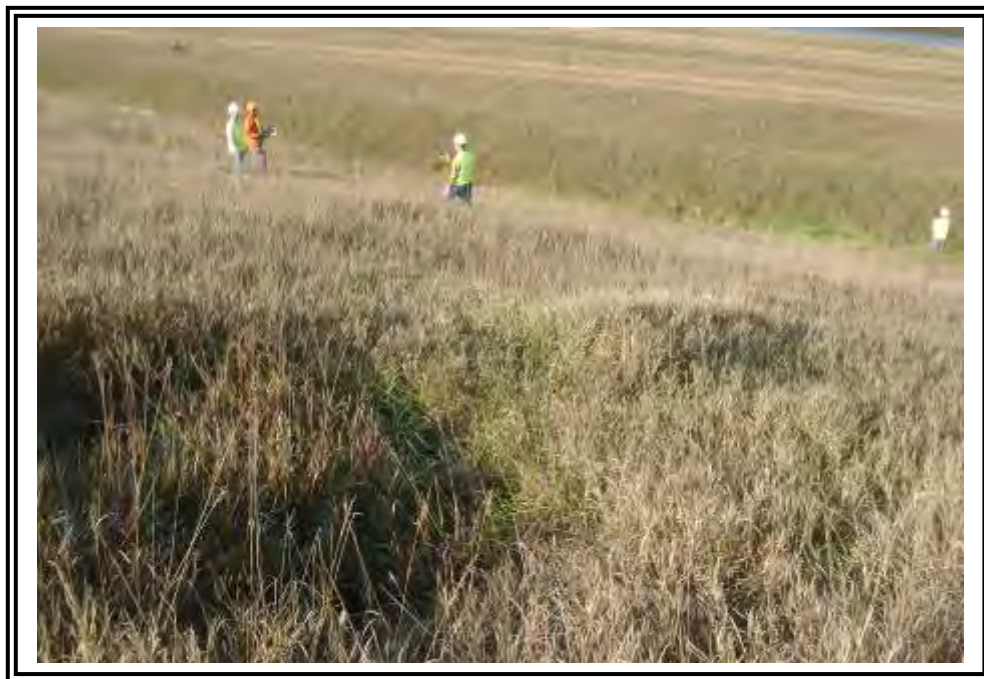
35

Downstream embankment slope of West Dam, facing west. Note surface undulations observed.

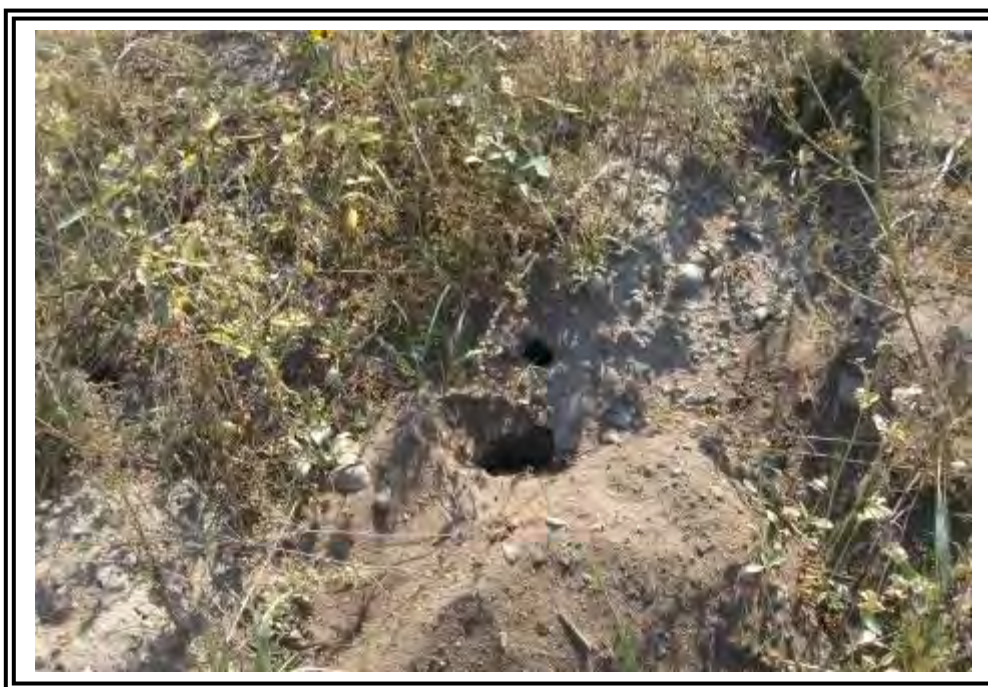
Animal burrows were noted near the crest of the North Dam and on the East Dam. The burrows were measured to be approximately 4 to 6 inches deep (Photos 41 and 42) near the crest of the North Dam.

Animal burrows on downstream embankment of North Dam.
