DRAFT
Specific Site Assessment for
Coal Combustion Waste
Impoundments at Reid
Gardner Generating Station

NV Energy
Moapa, Nevada

April 2011
Project 092885

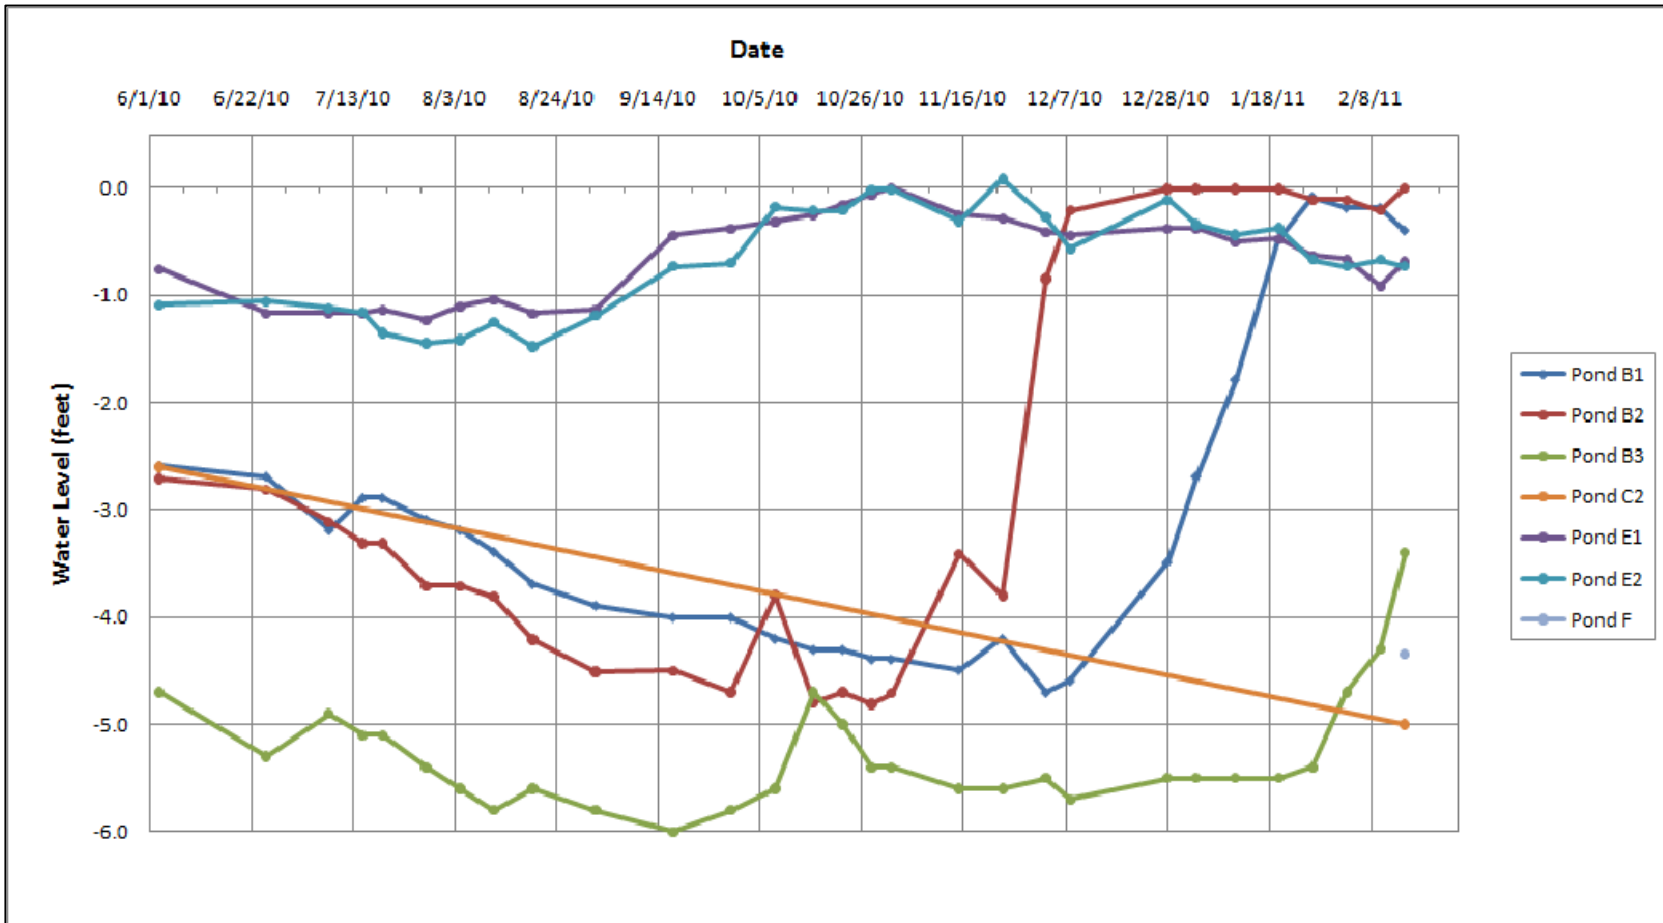
<p>IMPOUNDMENT WATER LEVEL MEASUREMENTS</p>
<p>Environmental Protection Agency Washington, D.C.</p>	<p>Project 092885</p>	<p>April 2011 Figure 3</p>

To observe temporal fluctuations in the water level recordings, data recorded from January 2010 to February 2011 was compared by date and by pond. Data collected prior to January 2010 consists of data collected by numerous individuals, and also includes many events in which ponds were out of service for repairs. Current water levels appear to be consistent and maintained. Ponds E1 and E2 follow similar trends, fluctuating together near the 2-foot freeboard level. Ponds B1, B2, and B3 also follow similar trends in fluctuating water levels but not rising to the 2-foot freeboard level.

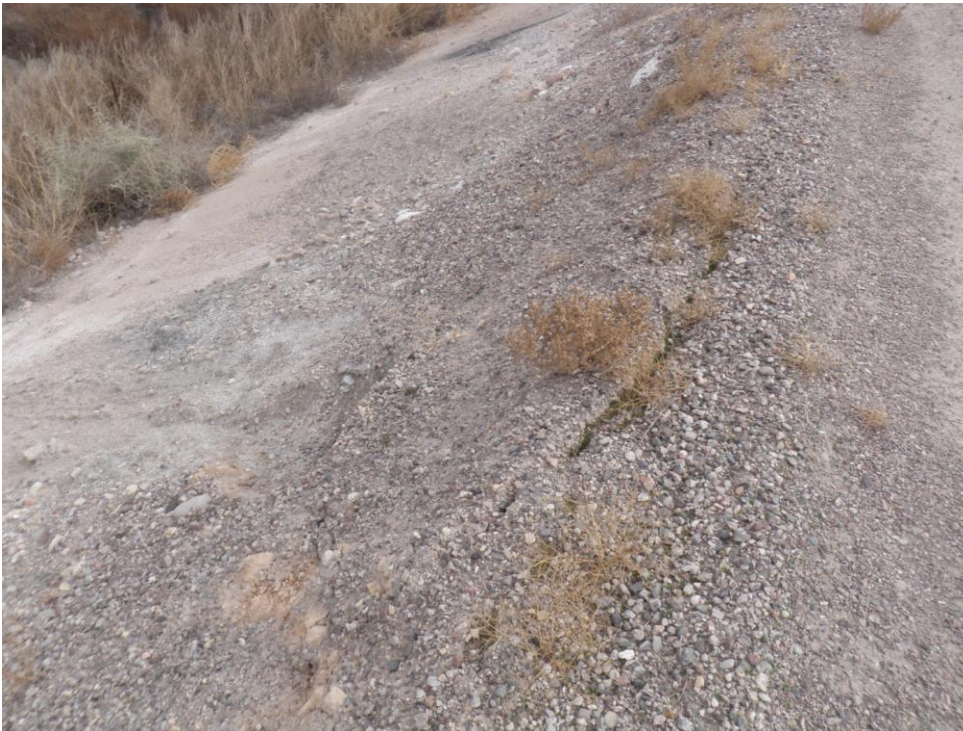
Photo 14: Pond F. Typical cracking and vegetation located along edge of crest and slope.

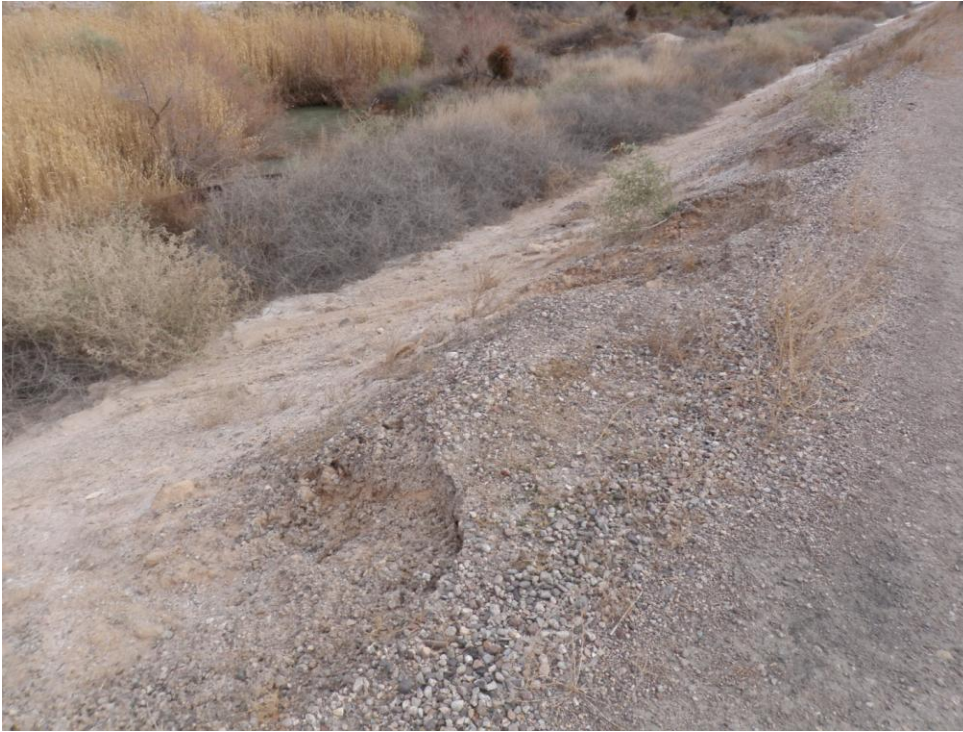
Photo 15: Pond F. Typical erosion of aggregate road base overbuild on top of soil cement slope protection.

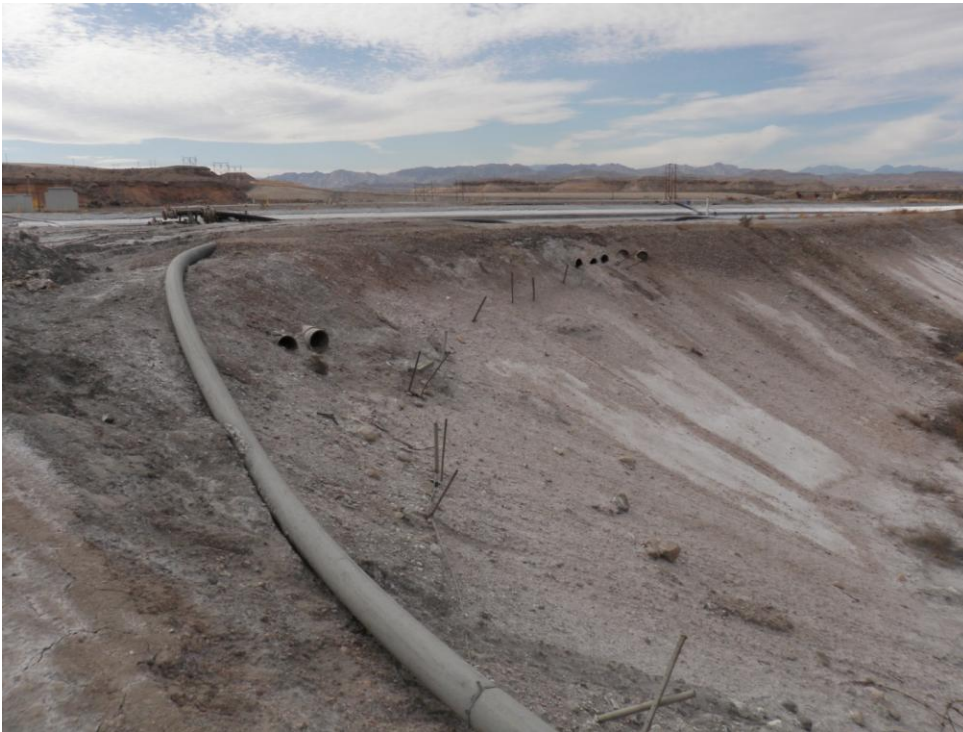
Photo 17: Looking southwest. Abandoned pipe penetrations through north dike of Pond F, near the northeast corner of the Pond.

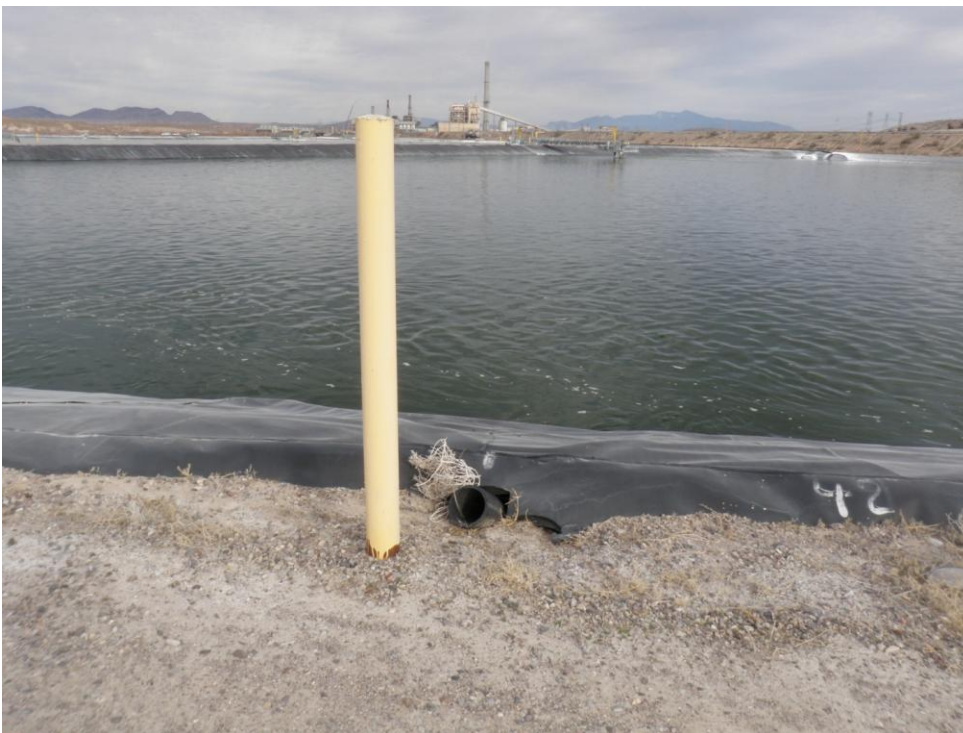
impoundments. Some minor damage was observed on the HDPE liner at Ponds B1, B3, C1, and E1 including unsealed penetrations, a tear at the crest at B3, and a bulge midslope at C1. Slightly oversteepened downstream slopes were observed on the north berm of Pond C1 and on the north end of the west berm of C2.

Photo 34: Looking east. Pond B3 west dike. Interstitial drain with HDPE liner in need of repair.

- Perform repairs to the HDPE lining to seal the interstitial liner drainage system.

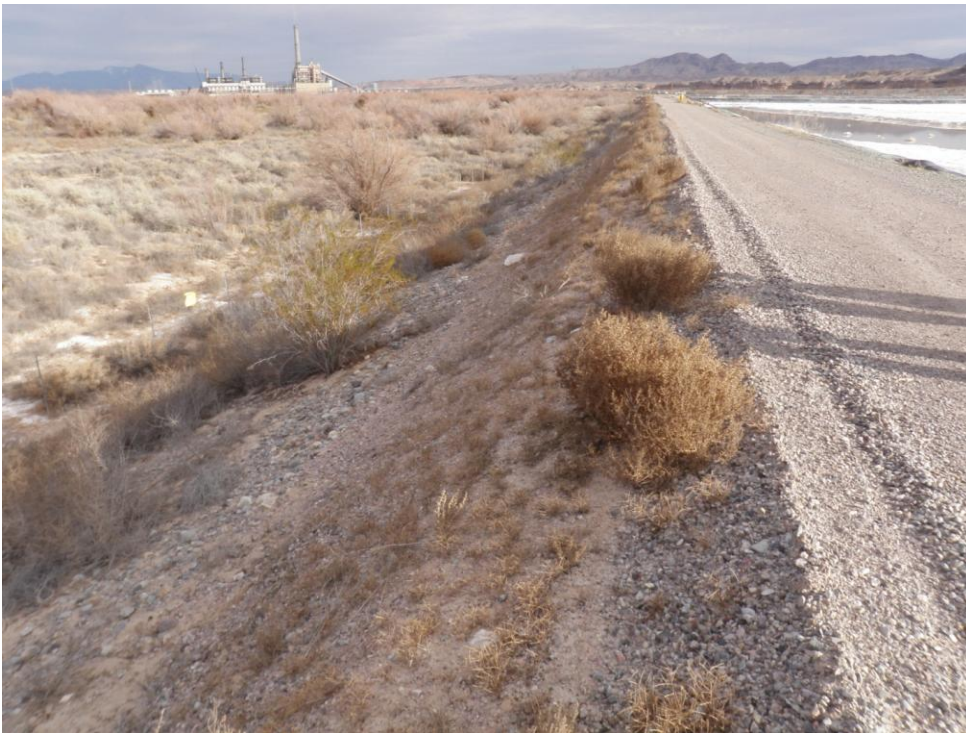
Photo 38: Looking southeast. Pond C2 north dike. Shrub growing on slope near toe.

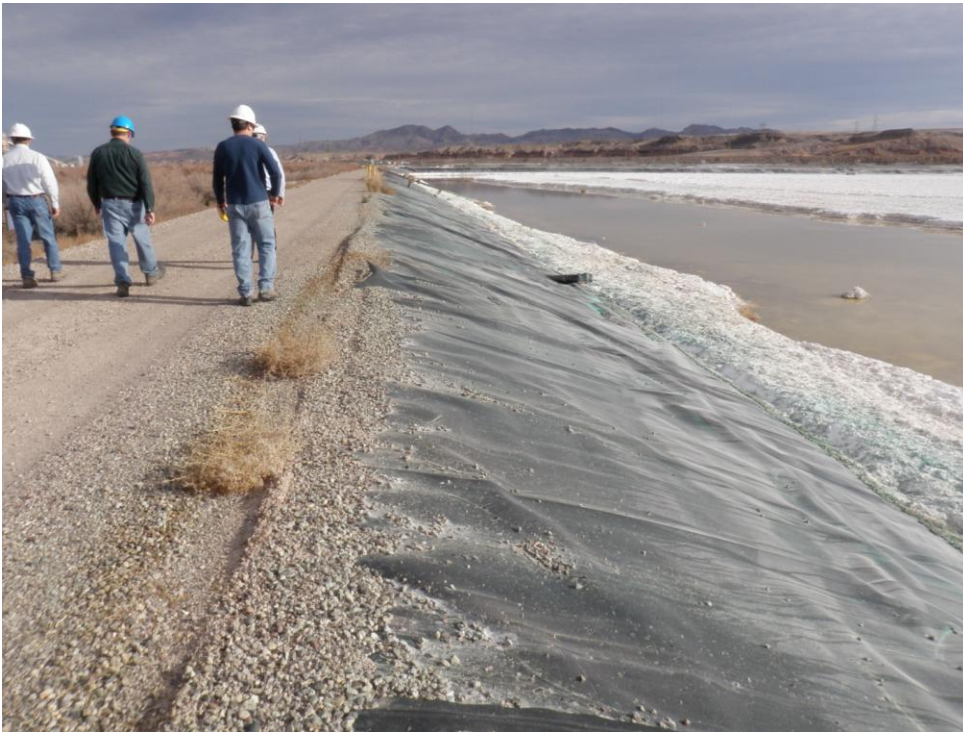
Photo 39: Looking southeast. Pond C2 north dike. HDPE with abandoned penetration.

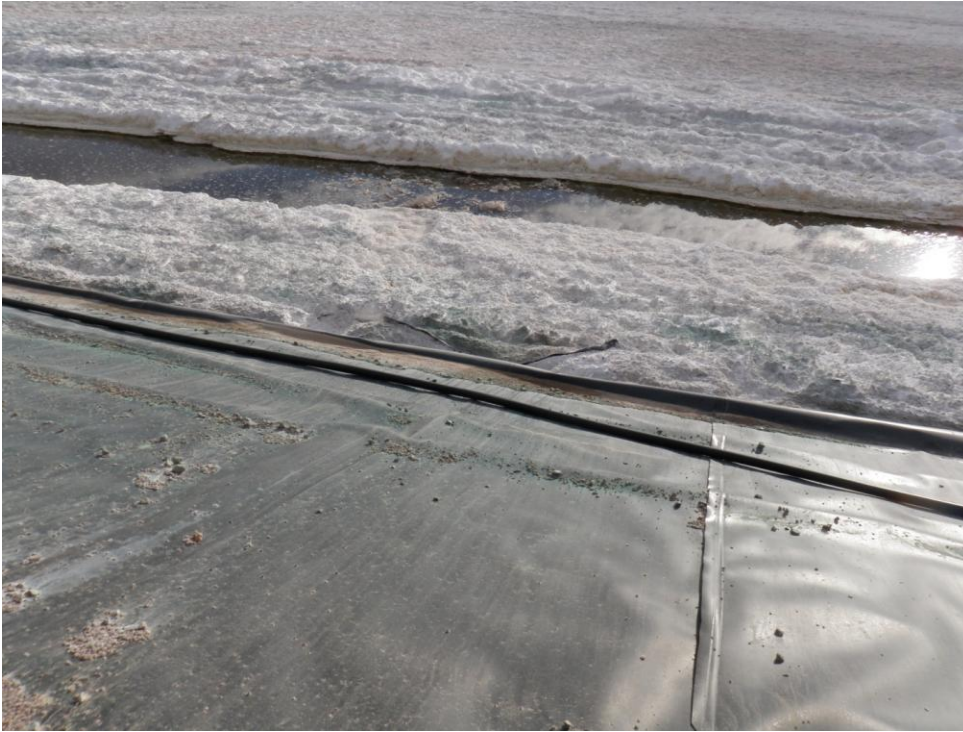
Photo 41: Bulge in HDPE liner on Pond C1 north dike.
