Specific Site Assessment for Coal Combustion Waste Impoundments at Reid Gardner Generating Station

**NV Energy
Moapa, Nevada**

September 2011
Project 092885

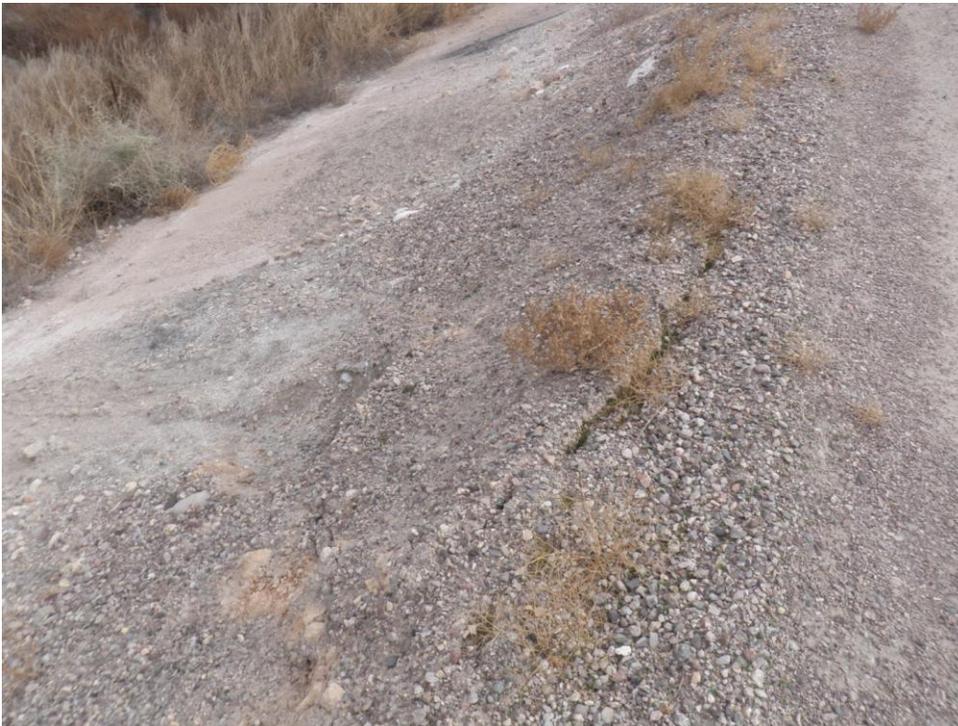
Photo 14: Pond F. Typical cracking and vegetation located along edge of crest and slope.

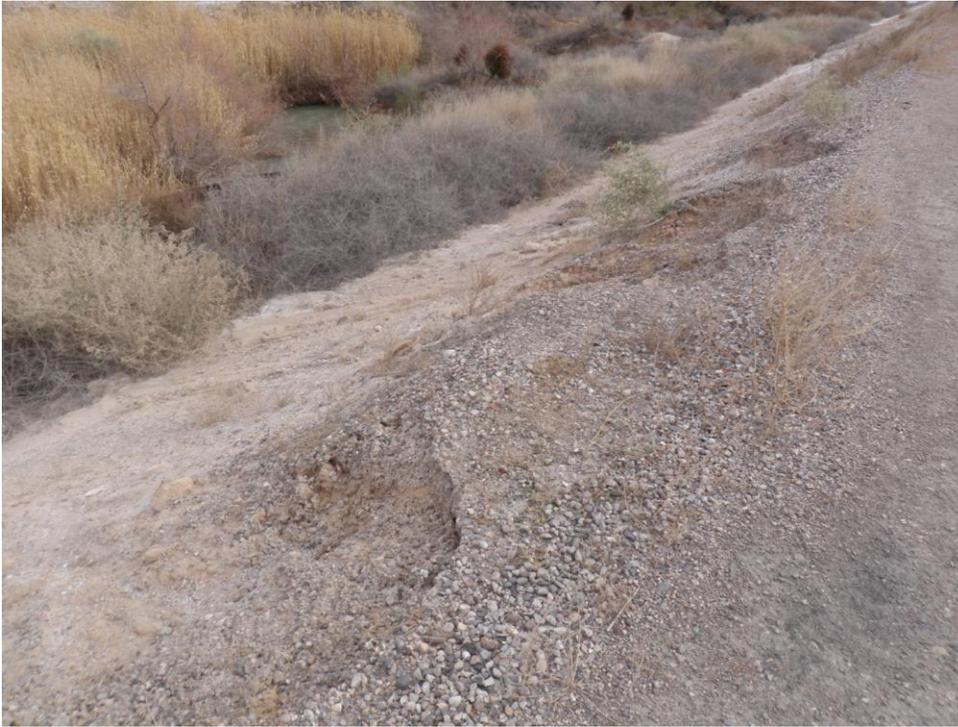
Photo 15: Pond F. Typical erosion of aggregate road base overbuild on top of soil cement slope protection.

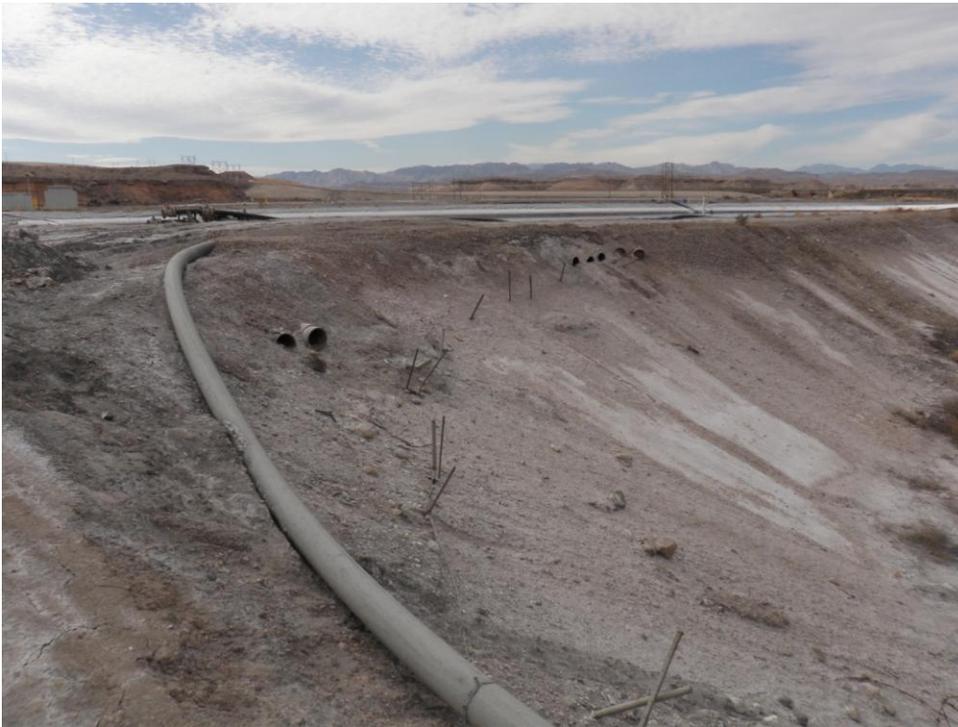
Photo 17: Looking southwest. Abandoned pipe penetrations through north dike of Pond F, near the northeast corner of the Pond.

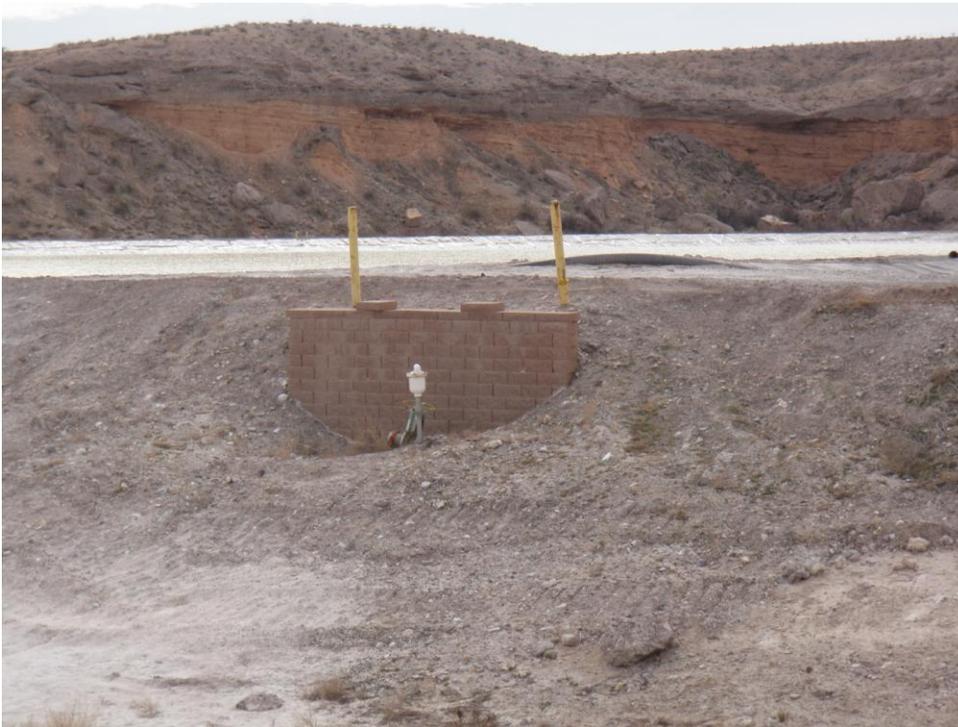
Photo 19: Typical retaining wall to protect air release valve. Looking west at east dike of Pond E2.

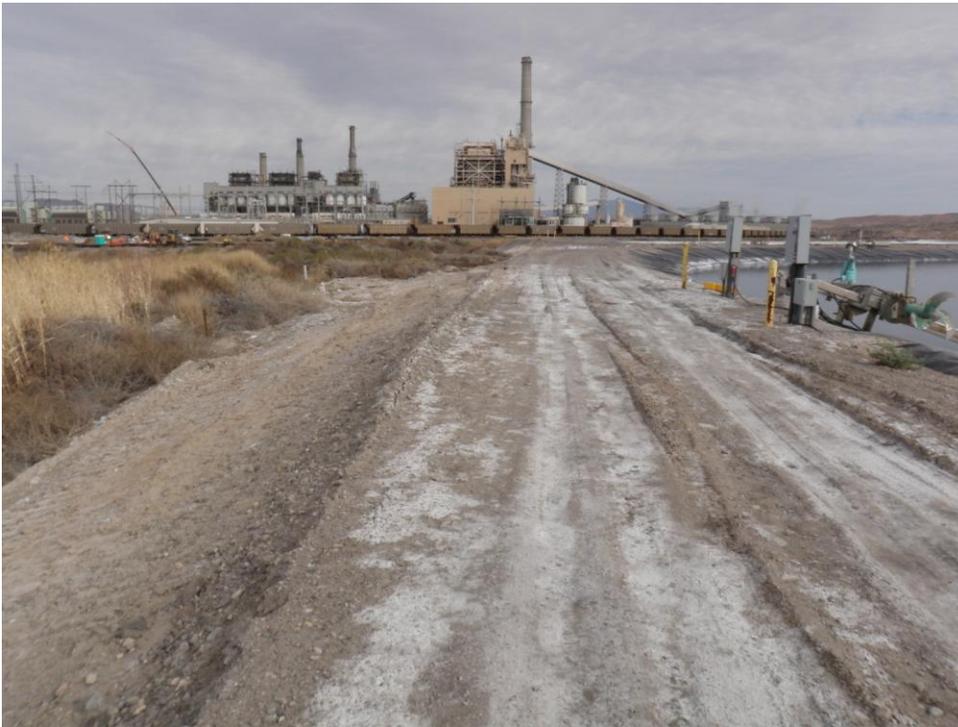
Photo 25: Looking east. Pond E2 north dike near northeast corner. Muddy River on right.

NVE: This photo shows the Muddy River on the left (the caption notes it being on the right).

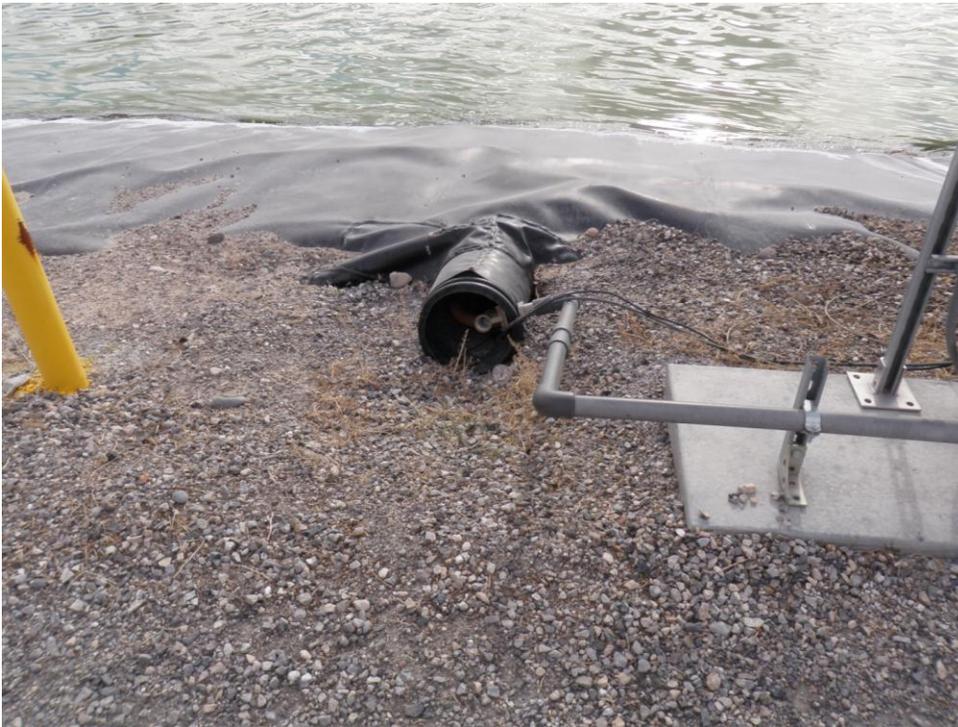
Photo 31: Typical interstitial drain.

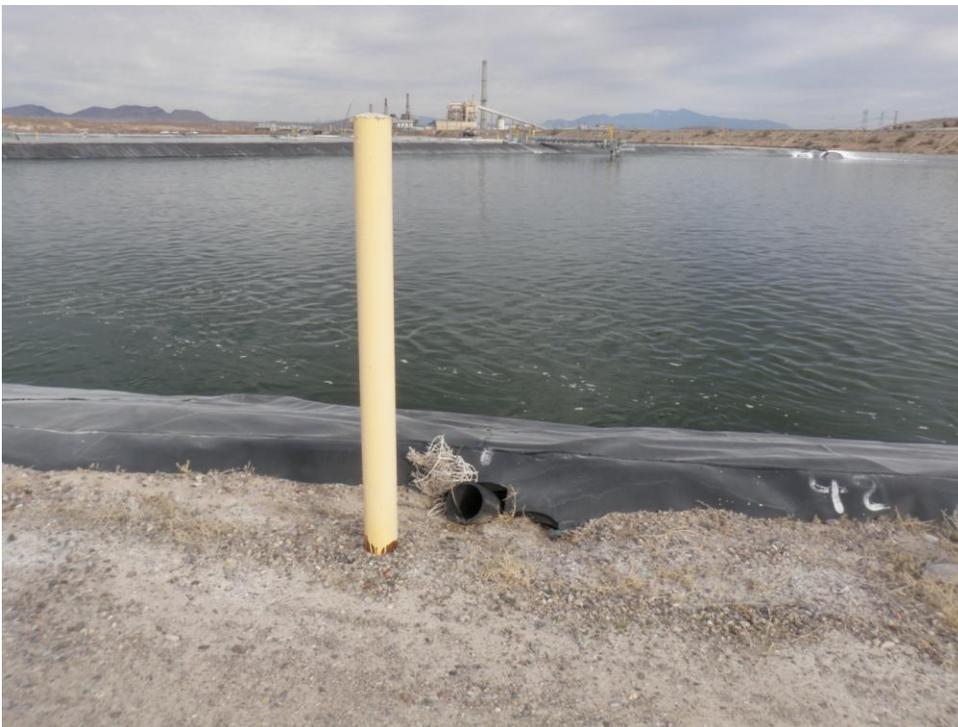
Photo 34: Looking east. Pond B3 west dike. Interstitial drain with HDPE liner in need of repair.

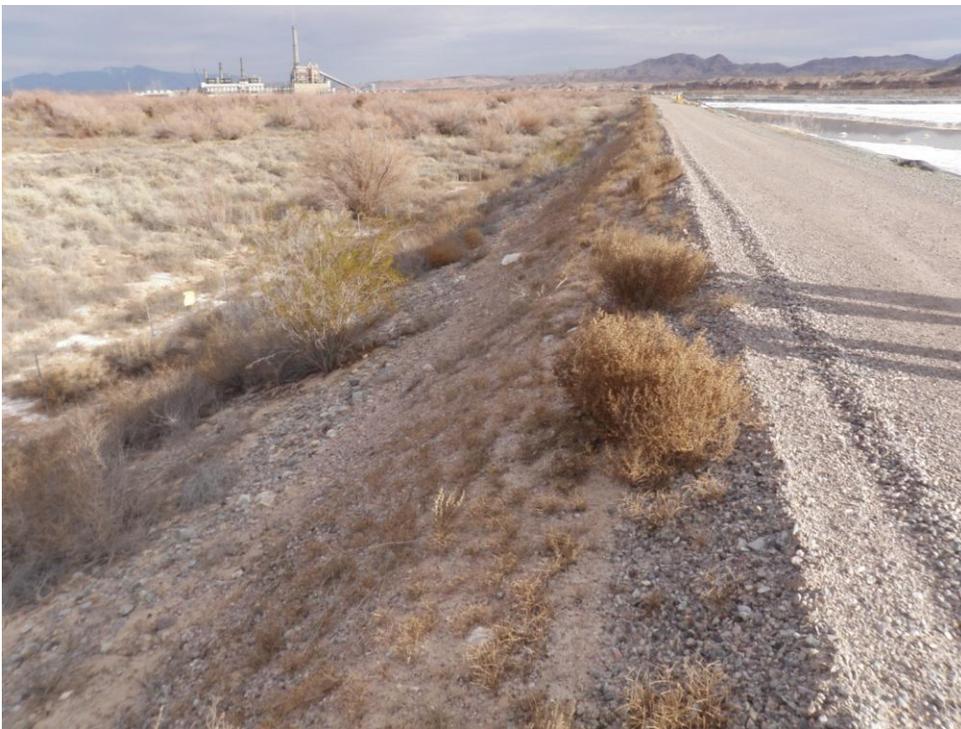
Photo 38: Looking southeast. Pond C2 north dike. Shrub growing on slope near toe.

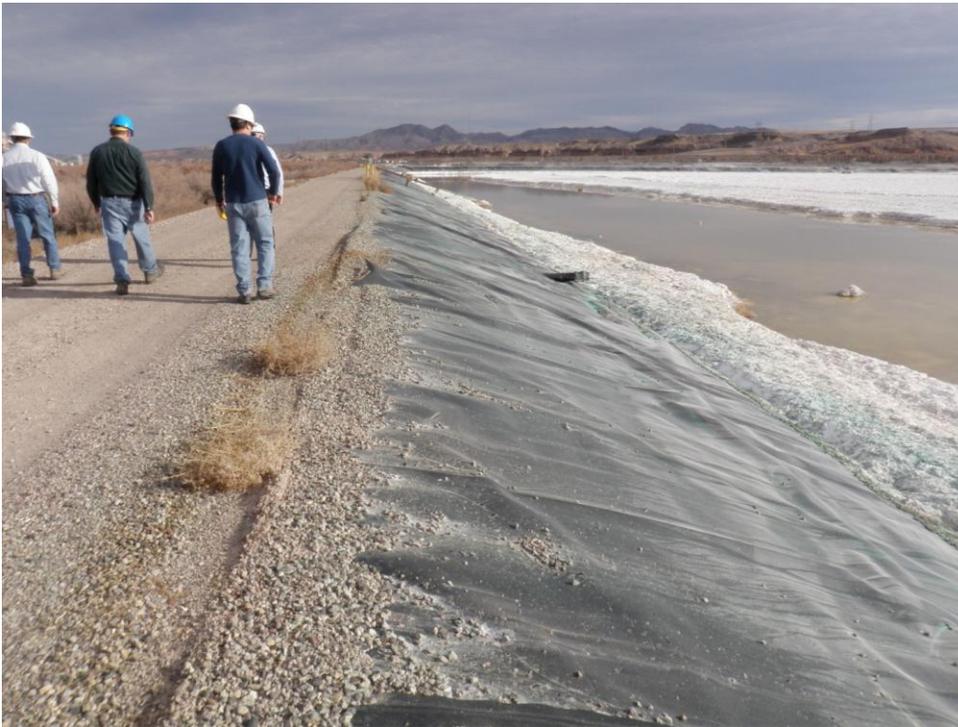
Photo 39: Looking southeast. Pond C2 north dike. HDPE with abandoned penetration.

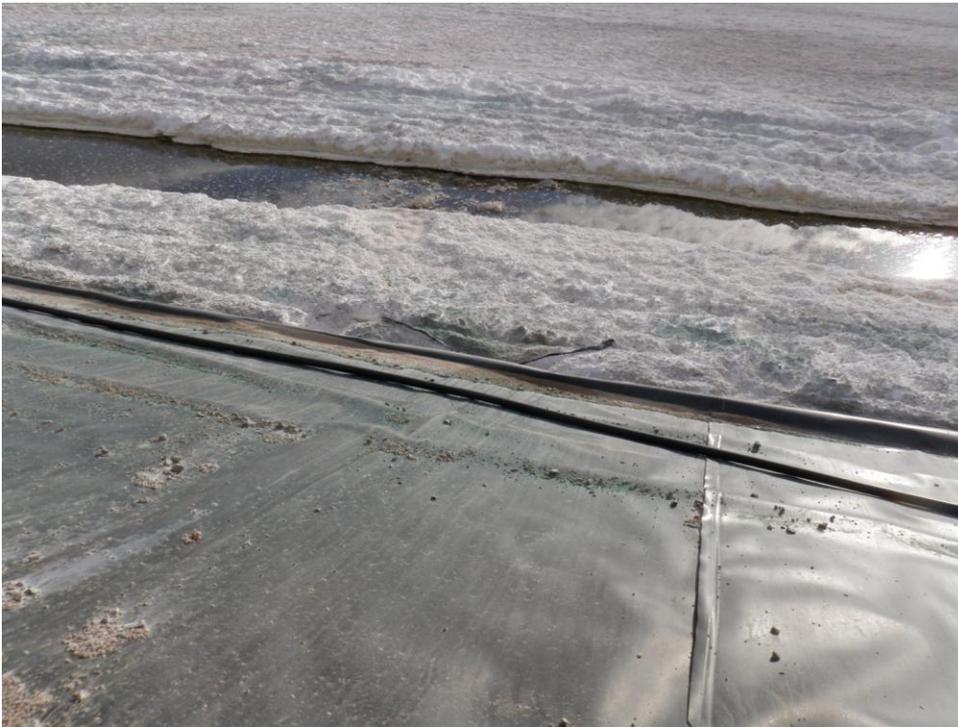
Photo 41: Bulge in HDPE liner on Pond C1 north dike.
