COAL ASH IMPOUNDMENT  
SITE ASSESSMENT DRAFT REPORT

Coy Station  
Ottawa Oil Power Company  
Beulah, North Dakota

KLEINFELDER PROJECT NUMBER 118953-3

June 26, 2011

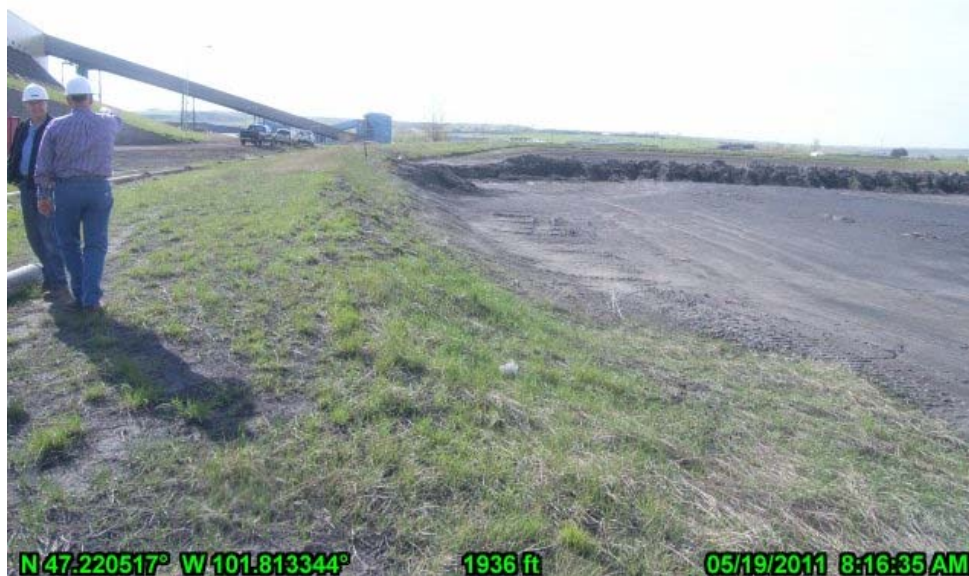
Overall, the upstream slope of the impoundment was in Satisfactory condition. Photos 1, 3, 7, 15, 21, and 22 show the conditions of the upstream slope. Specific observations include:

1-Nelson Pond Northeast Waterside Embankment (looking SE)

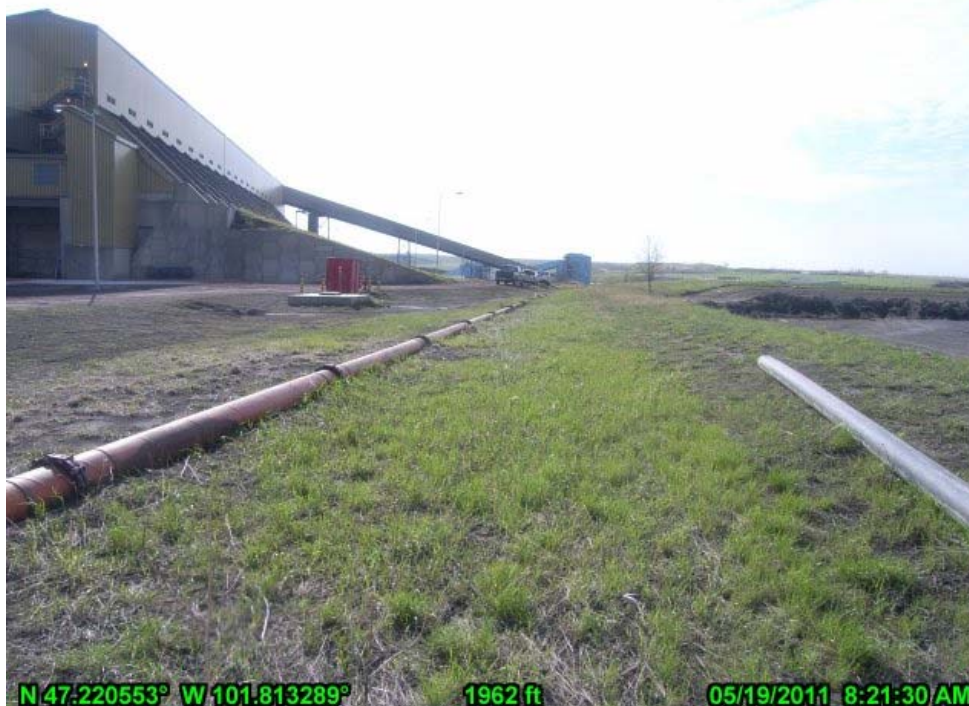
Overall, the crest of the impoundment was in Satisfactory condition. Photos 1, 2, 7, 15, 19, 21, and 22 show the condition of the crest. Specific observations include:

2-Nelson Pond Northeast Landside Embankment and Sluice Pipe (looking SE)

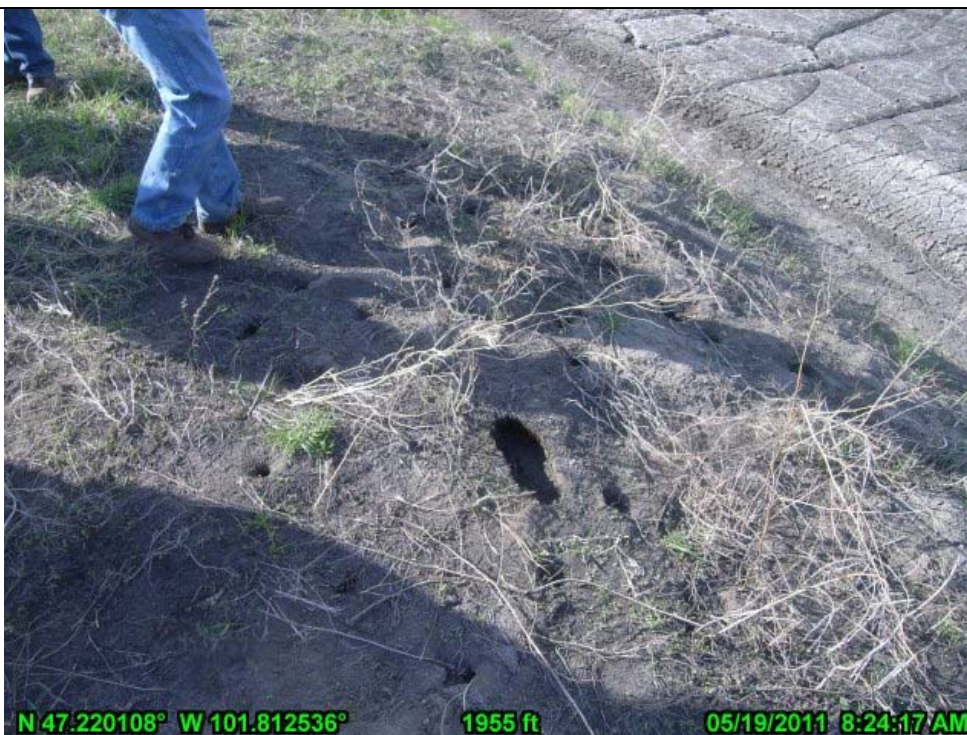
- No major depressions, erosion, or rutting was noted on the impoundment crest.
- The crest was generally well vegetated with native grasses.
- Numerous small animal burrows are present on the crest.

4-Nelson Pond Animal Burrows

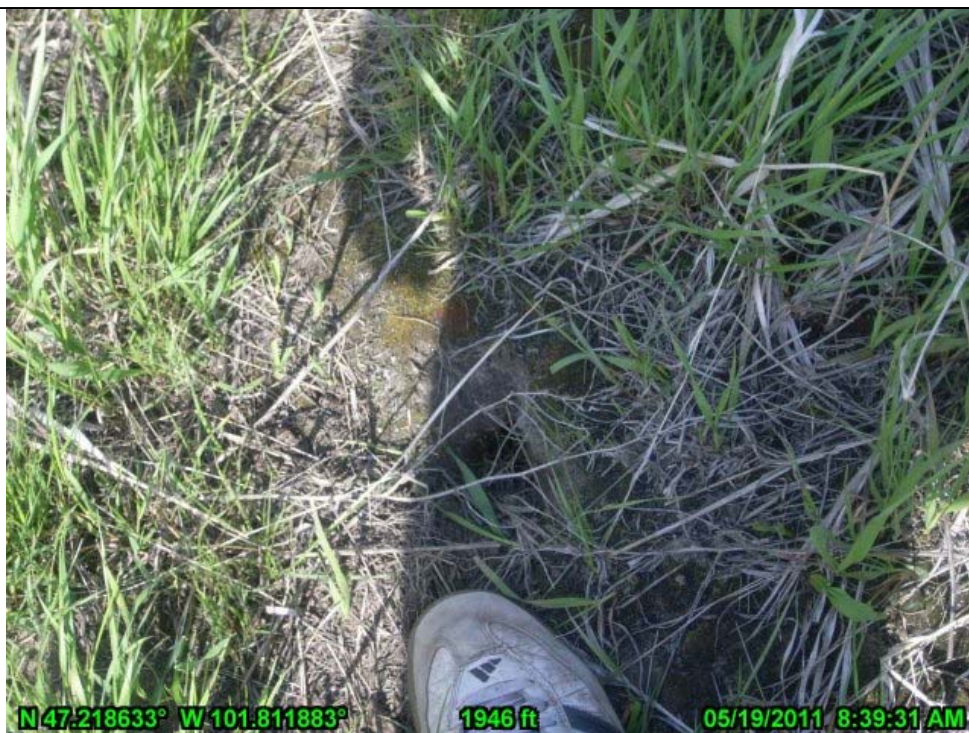
- A few small animal burrows were noted.

20-Nelson Pond Animal Burrow

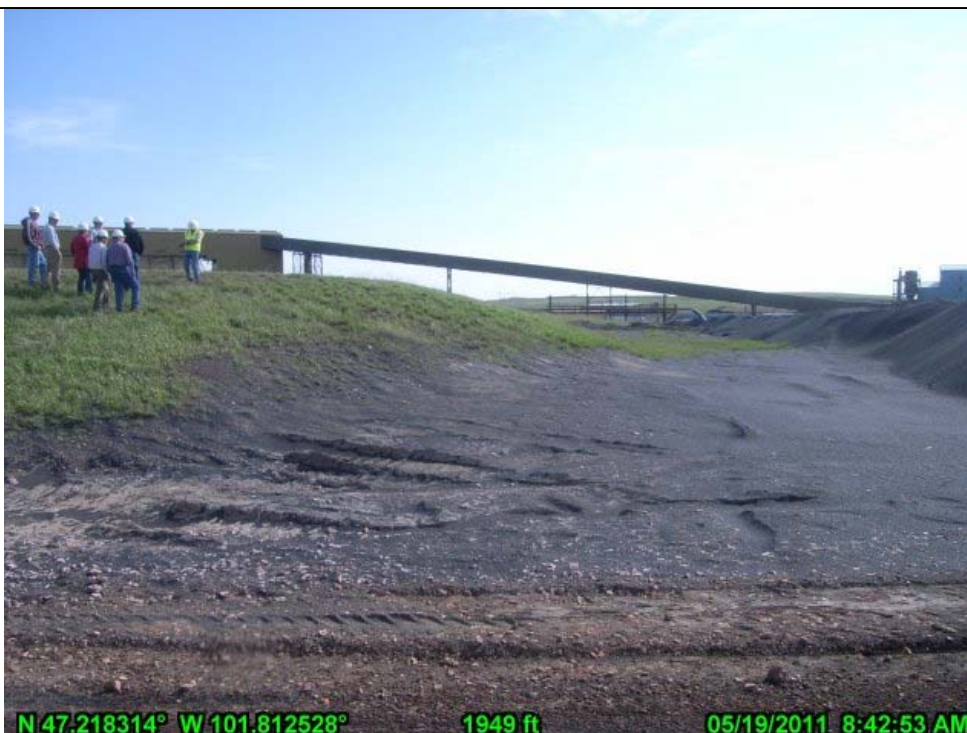
24-Nelson Pond Steepening of Southern Landside Embankment Corner (looking E)

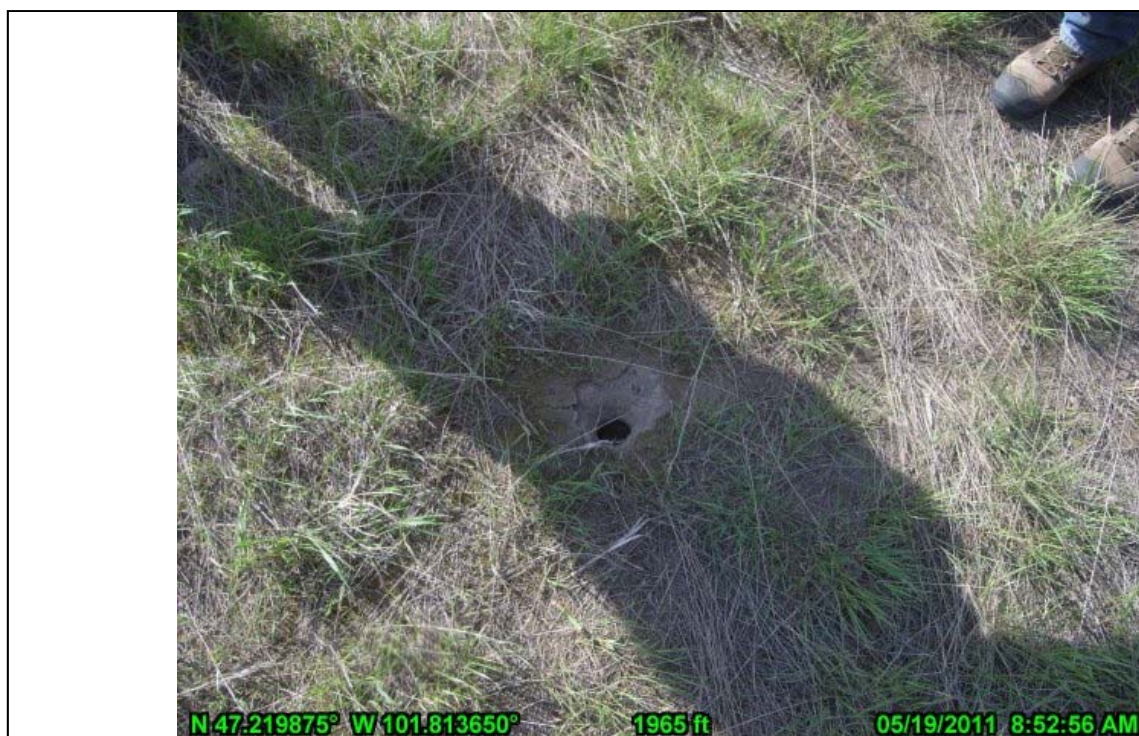
26-Nelson Pond West Embankment Animal Burrow

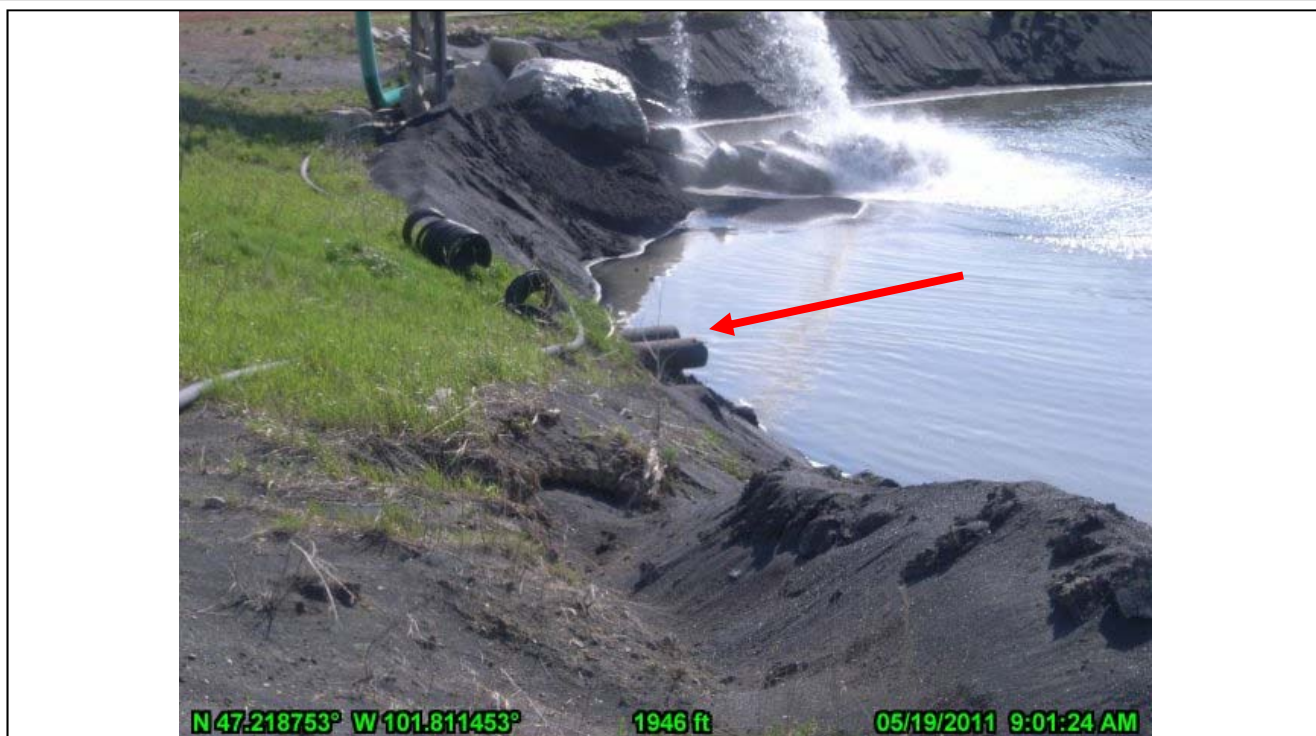
- The outlet piping was buried and thus unable to be observed at the time of the assessment.
- The intake structure grate was clean and appeared that it would function effectively if needed.
- No video monitoring of the pipe was available at the time of assessment.
- Overall, the outlet works and overflow system piping system appears to be functioning as intended at this time, and as confirmed by plant staff during the assessment.

29-Outlet Pipes from Nelson Pond (Steel Drain Pipe and Overflow Pipe)

1. Perform video assessments of Nelson Pond outlet piping by October 31, 2012.
2. Repair scarp on embankment between the Sluice Pond and Ash Pond by October 31, 2012.
3. Install trashrack on Sluice Pond outlet drop structure by October 31, 2012.
4. Maintain a log of maintenance and other activities at the impoundments and supporting facilities by October 31, 2012.
5. Update the Operation and Maintenance (O&M) Manual for the impoundments and the facility by October 31, 2012.

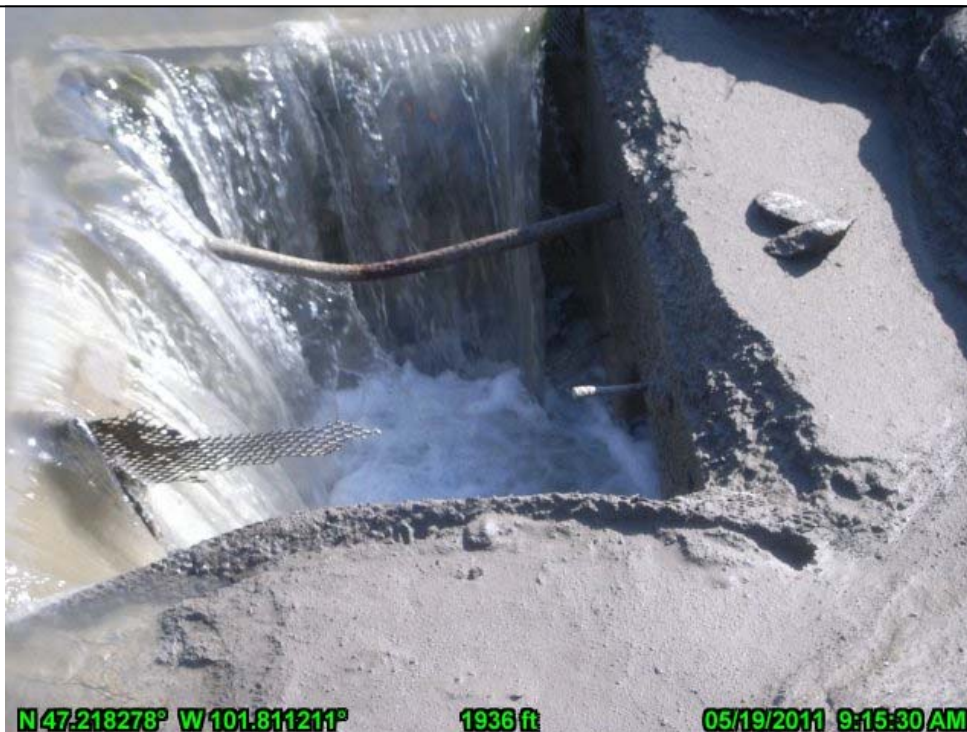
- The intake portion of the outlet pipe was not able to be observed because it was inundated at the time of the assessment.
- The concrete drop inlet is approximately 3 feet by 4 feet, is uncontrolled and does not have a trashrack.
- The discharge location of the outlet pipe into the Ash Pond appeared to be functioning normally, as shown on photo 38.
- No video monitoring of the pipe was available at the time of assessment.
- Overall, the outlet works system appeared to be functioning as intended during the site assessment.
- The drop inlet has no trashrack and exposed rebar, and presents a possible fall hazard.

35-Sluice Pond 3'x4' Concrete Outlet Intake Structure to the Ash Pond without Trashrack

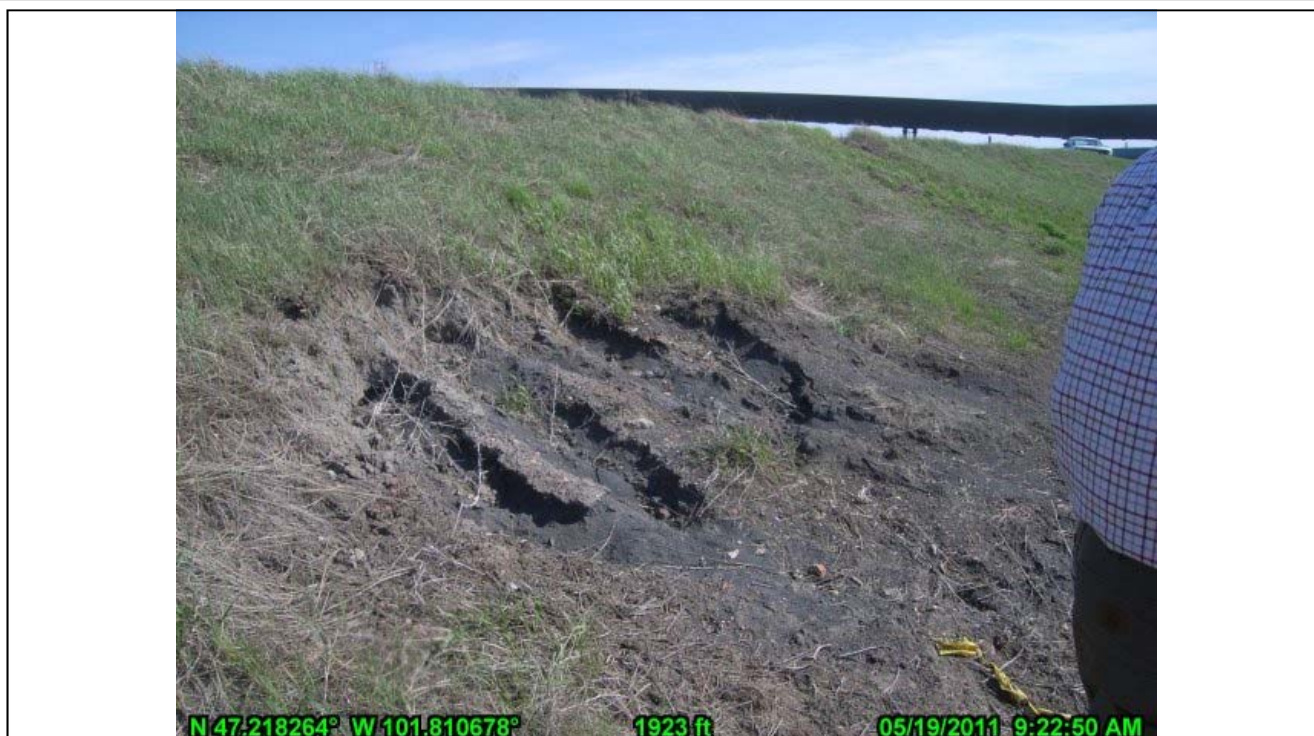
- The slope is well vegetated and appeared stable.
- The east slope between the Sluice Pond and the Ash Pond has small scarp feature, as shown on photos 39 and 42. While that condition does not appear to present an imminent threat to the slope stability, the embankment should be repaired with vegetation re-established.

39-Ash Pond Northwest Waterside Embankment Scarping (looking NE)

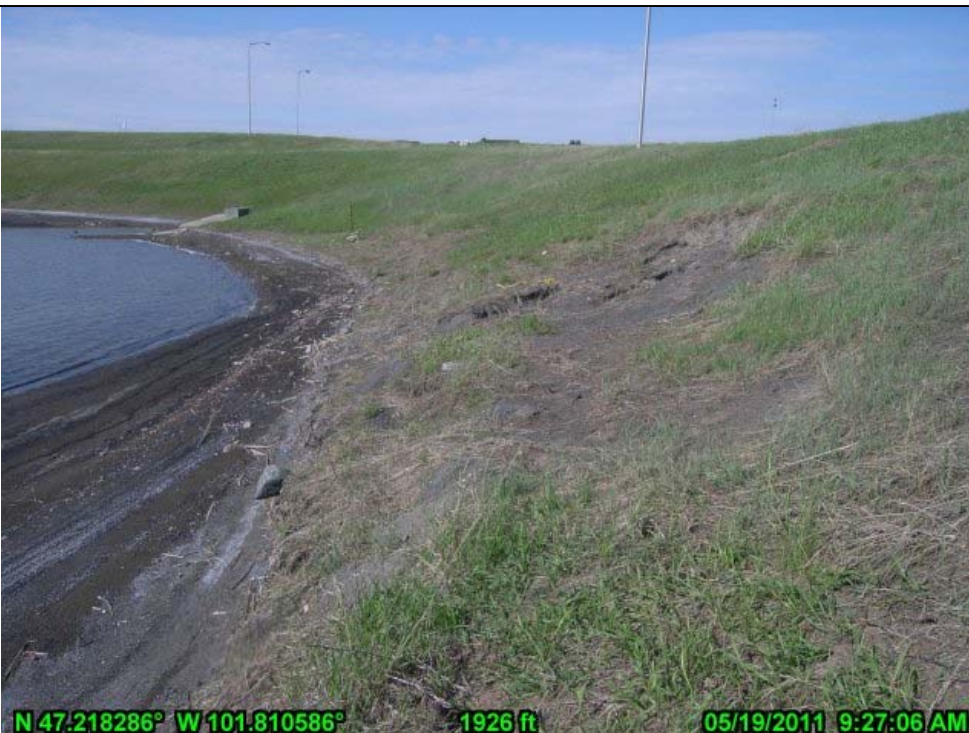
42-Ash Pond Northwest Waterside Embankment Scarping (looking SW)
