**COAL ASH IMPOUNDMENT
SITE ASSESSMENT FINAL REPORT**

**Coyote Station
Otter Tail Power Company, Montana-
Dakota Utilities, Co., Northern
Municipal Power Agency, and
NorthWestern Energy**

KLEINFELDER PROJECT NUMBER 118953-3

February 28, 2013

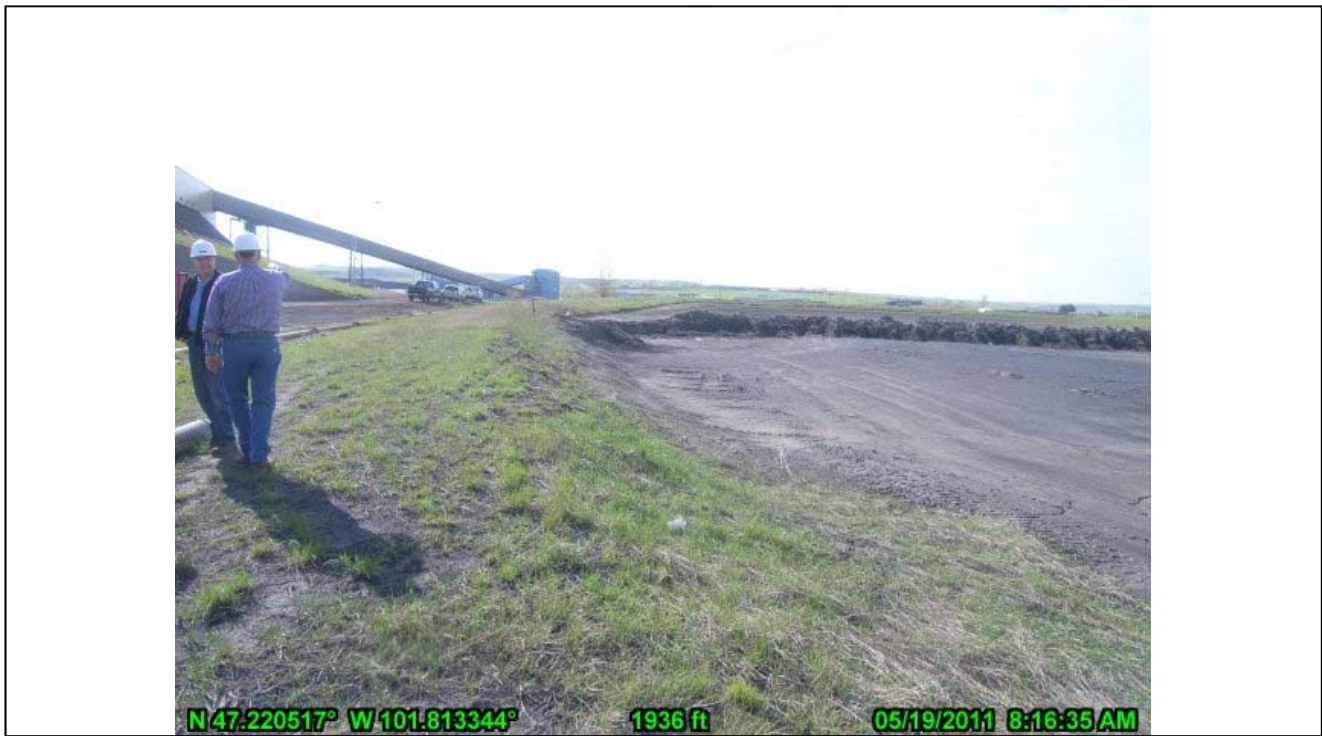
1-Nelsen Pond Northeast Waterside Embankment (looking SE)

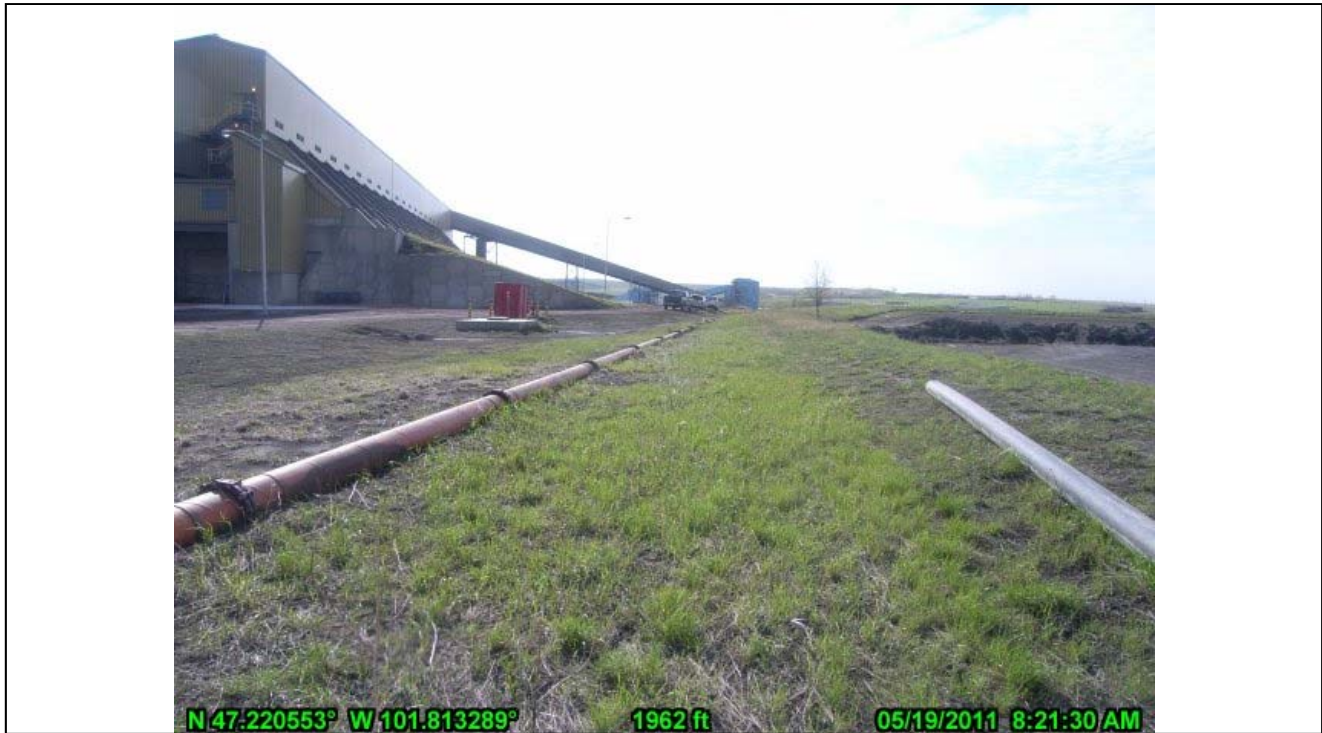
2-Nelsen Pond Northeast Landside Embankment and Sluice Pipe (looking SE)

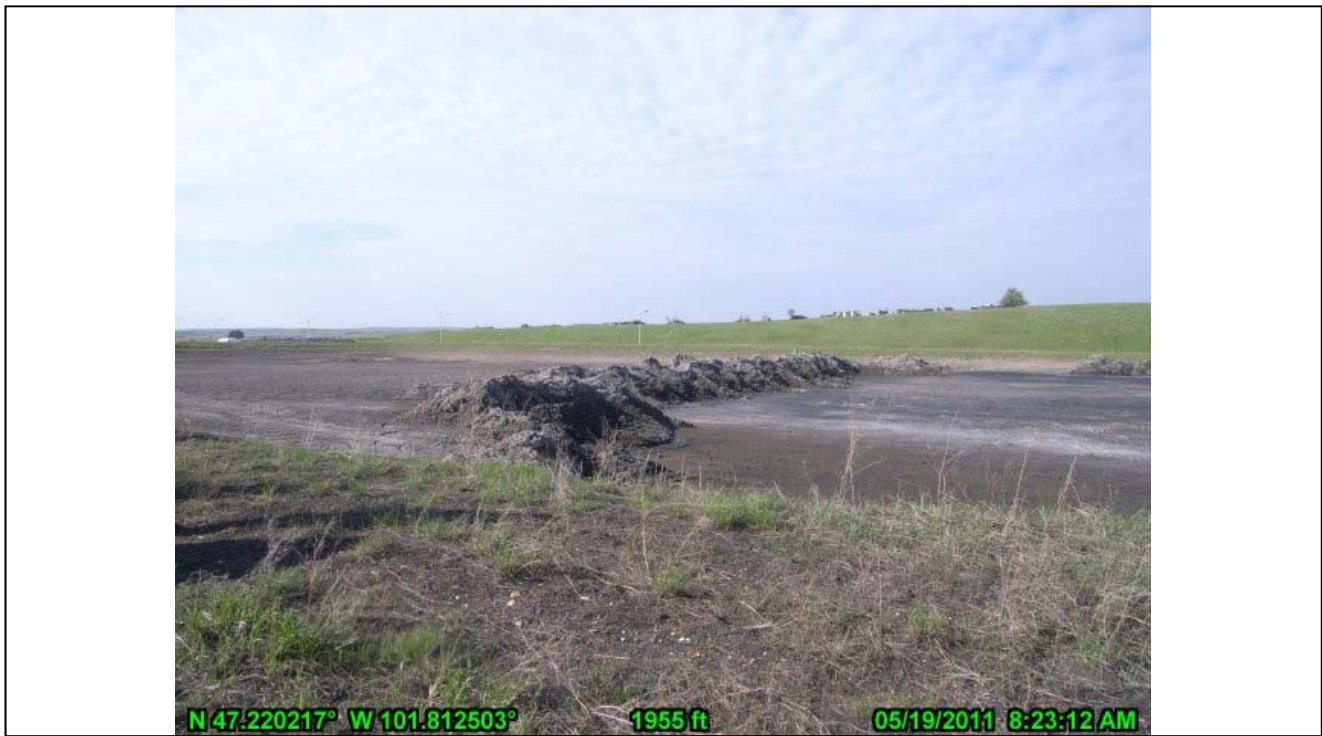
3-Nelsen Pond Dredging Activity (looking SW)

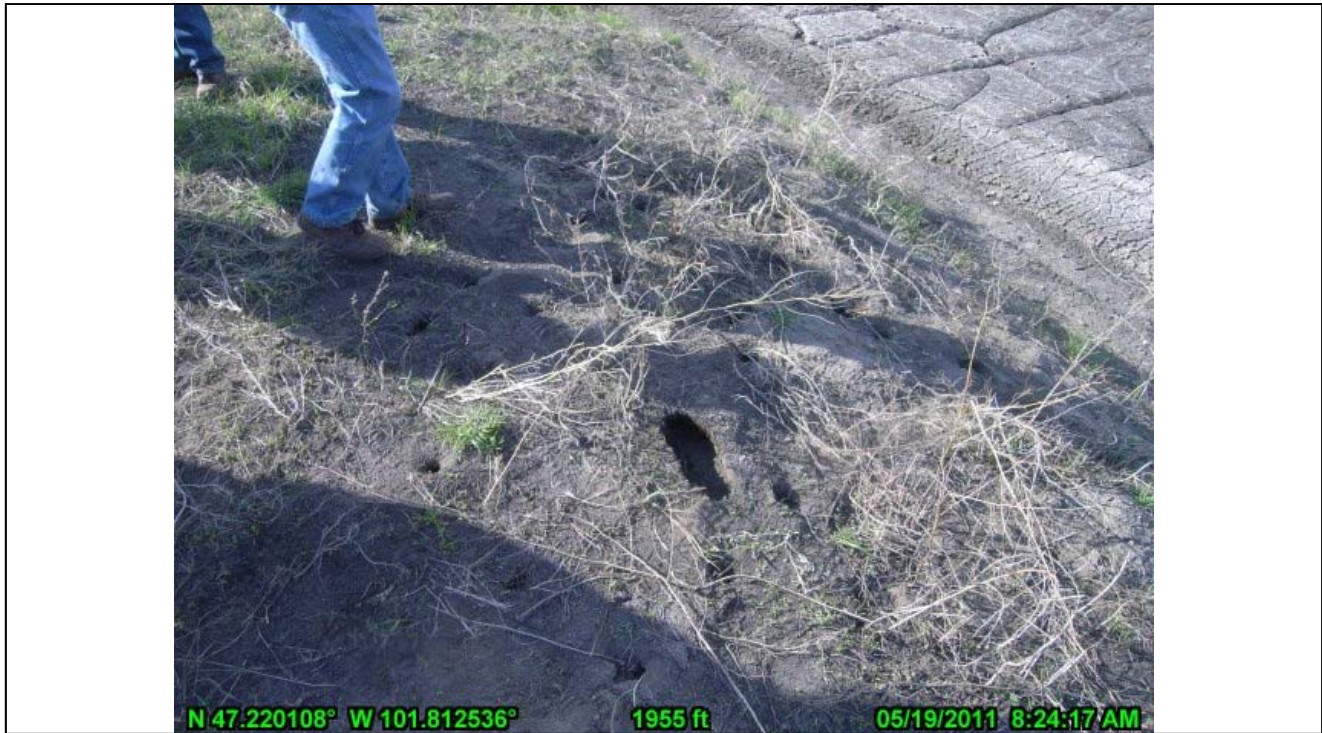
- The slopes were well vegetated and appeared stable.
- No slope scarps or depressions were noted.
- A few small animal burrows were noted.

4-Nelsen Pond Animal Burrows

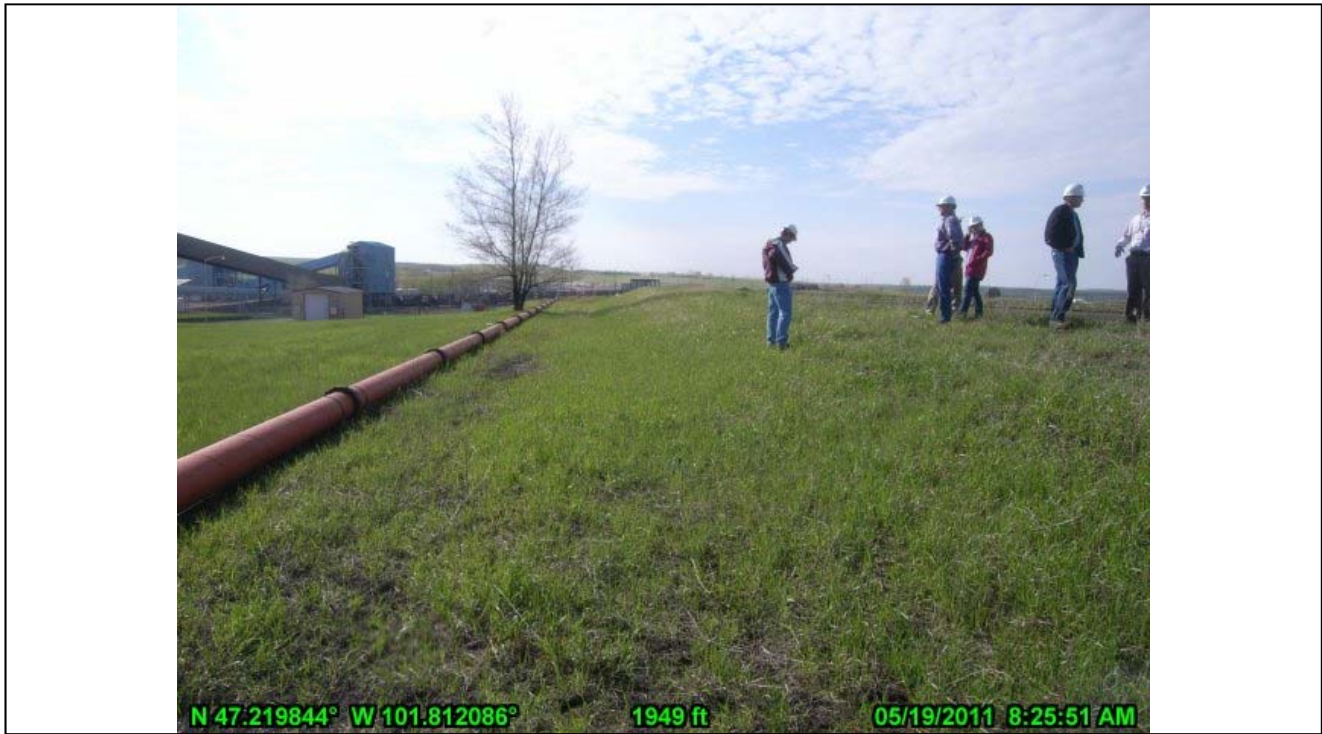
5-Nelsen Pond Northeast Landside Embankment and Sluice Pipe (looking SE)

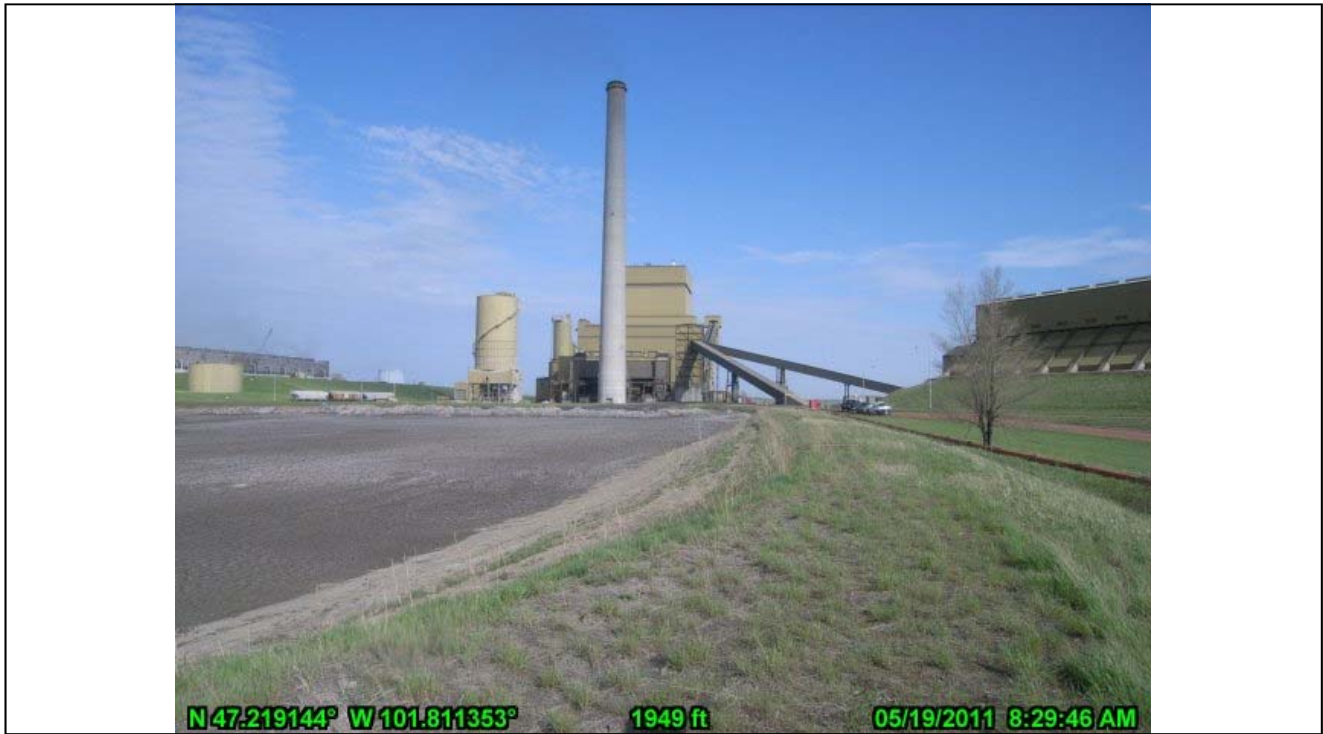
7-Nelsen Pond Northeast Waterside Embankment (looking NW)

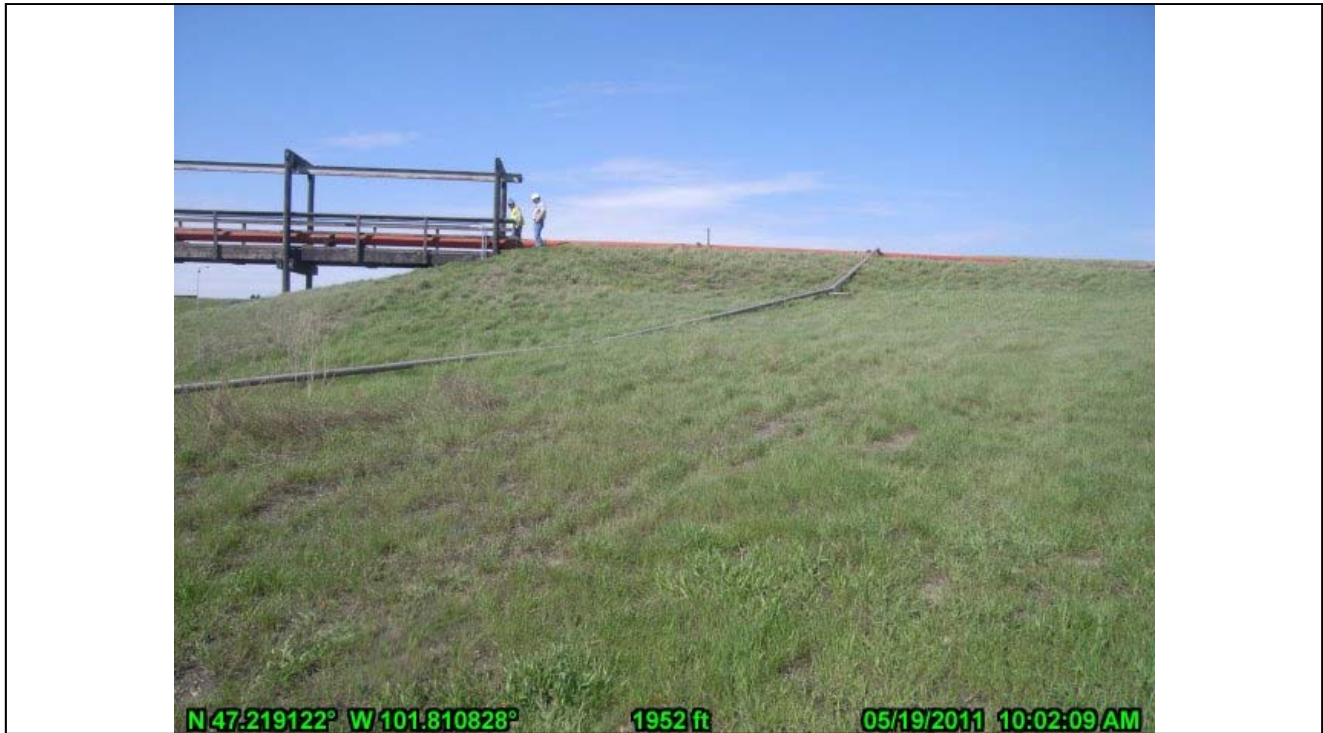
8-Nelsen Pond East Corner Landside Embankment with Sluice Pipe (looking W)

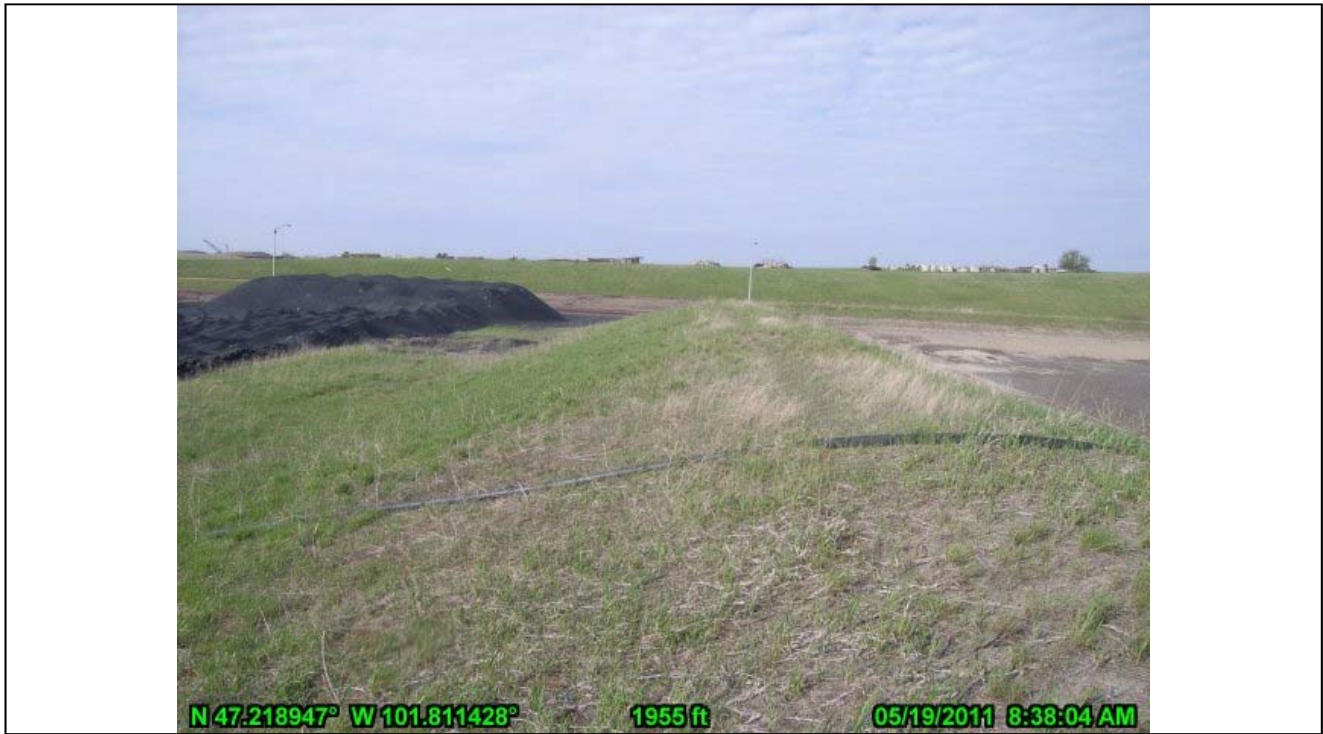
19-Nelsen Pond Southeast Landside Embankment (looking SW)

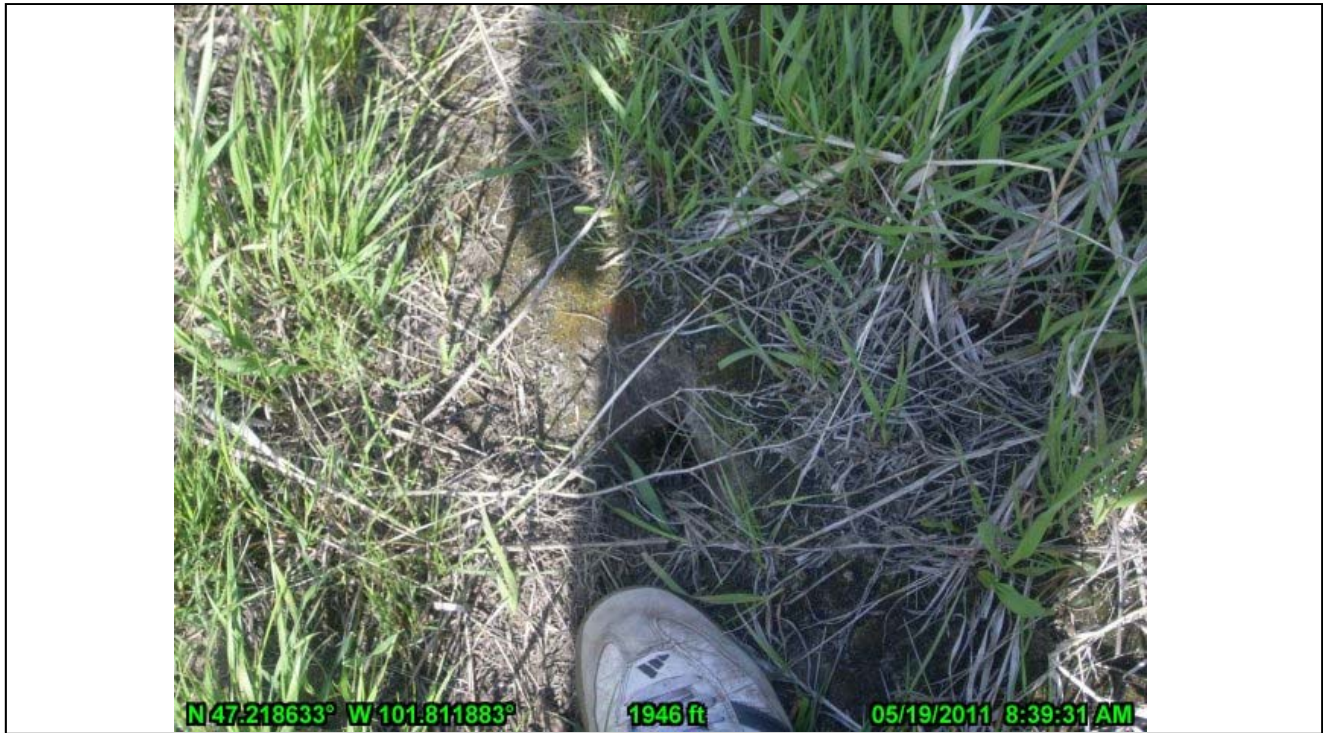
20-Nelsen Pond Animal Burrow

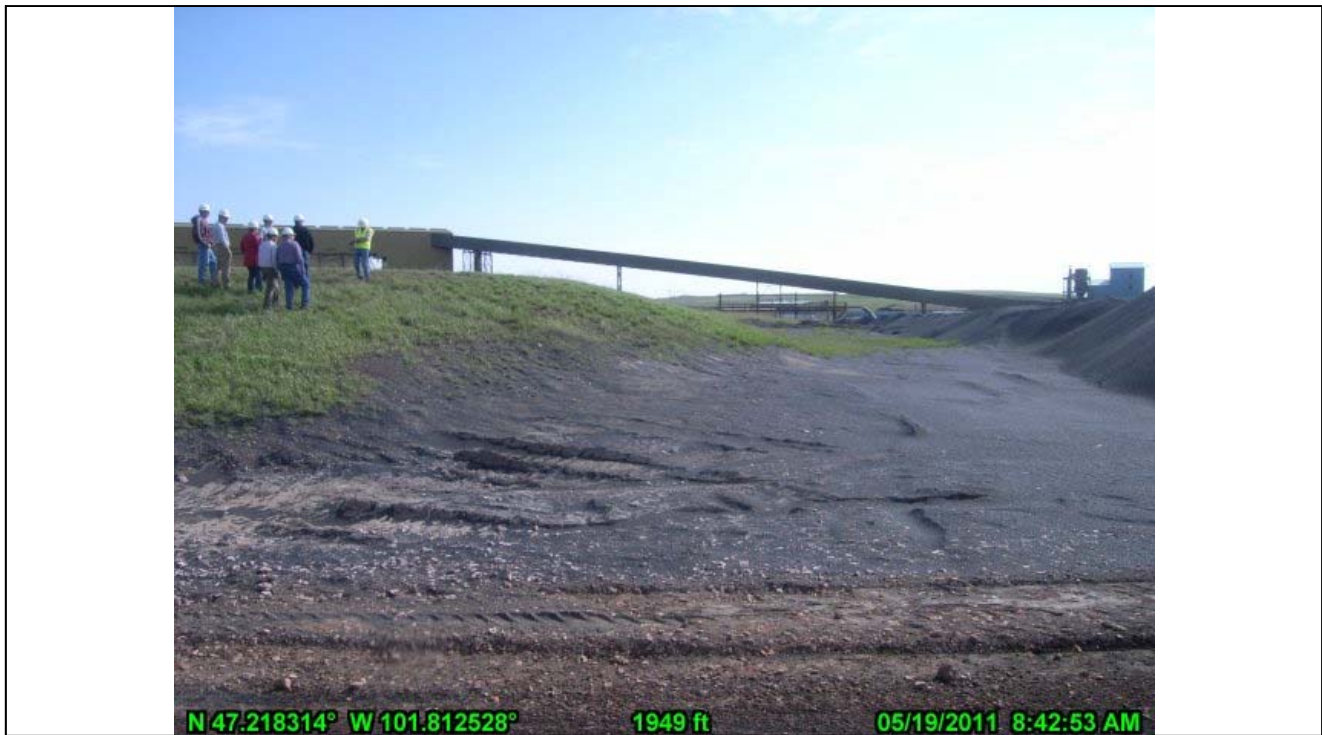
24-Nelsen Pond Steepening of Southern Landside Embankment Corner (looking E)

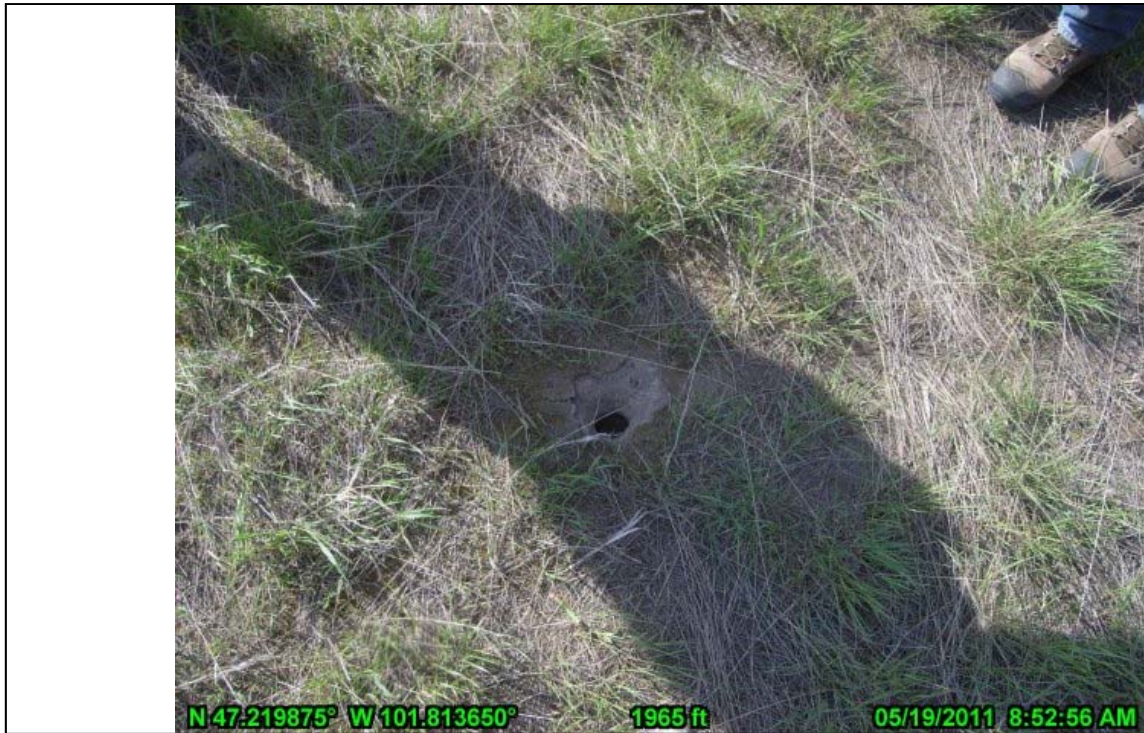
26-Nelsen Pond West Embankment Animal Burrow

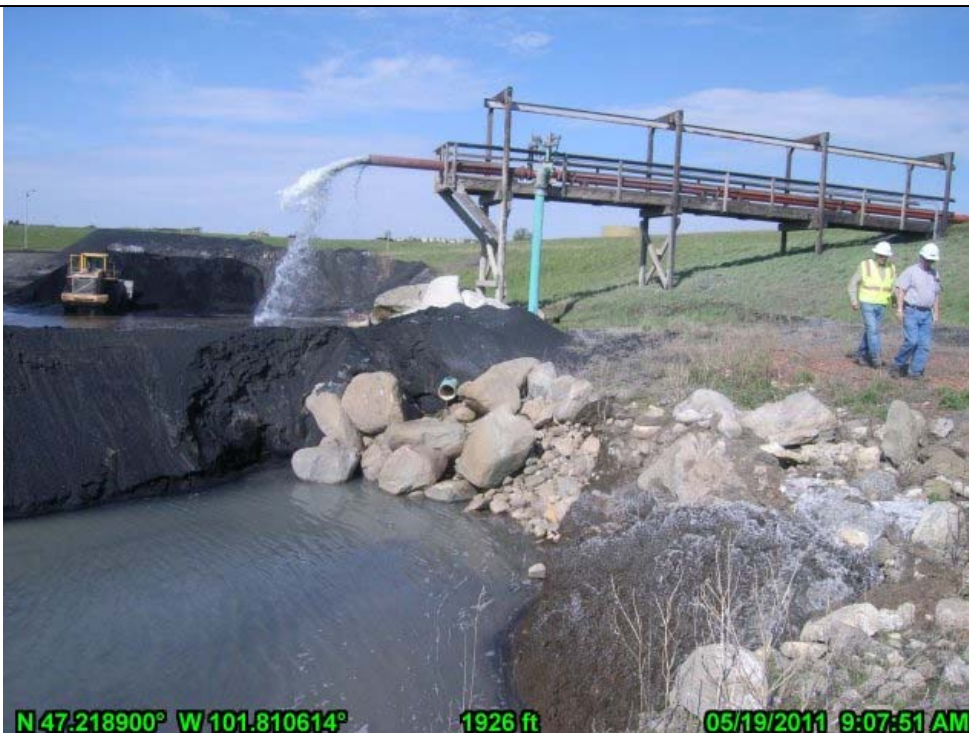
Pond, as shown on Photo 32. The inlet pipe was operating during the site assessment and appeared to be in functional condition.

32-Sluice Pond Slag Inlet (red pipe) and Economizer Inlet (green pipe)

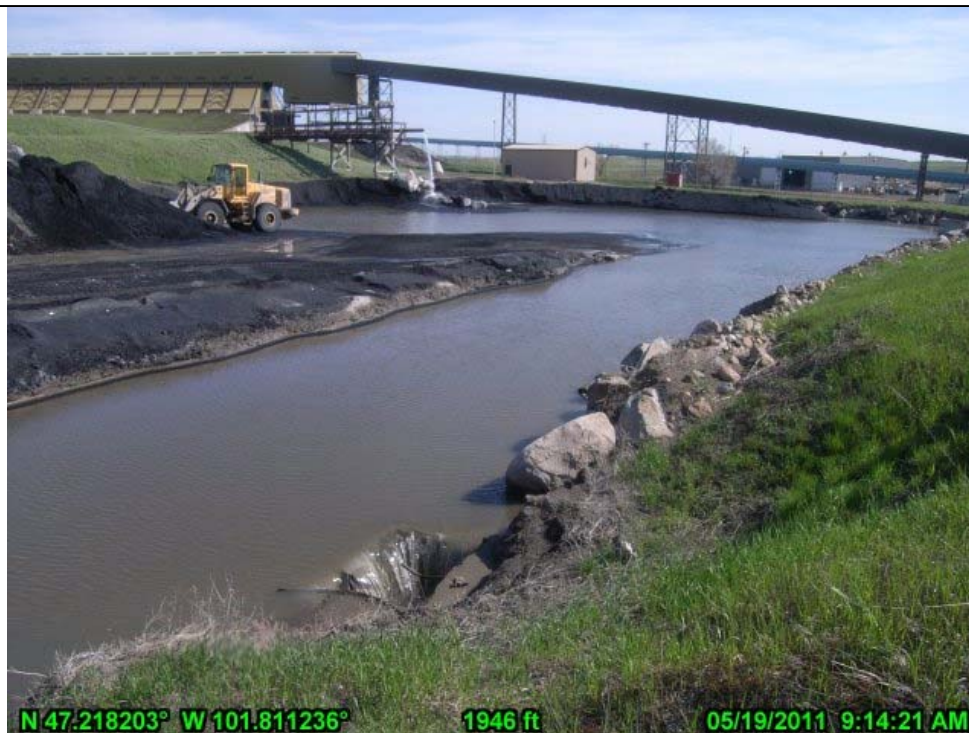
- The intake portion of the outlet pipe was not able to be observed because it was inundated at the time of the assessment.
- The concrete drop inlet is approximately 3 feet by 4 feet, is uncontrolled and does not have a trashrack.
- The discharge location of the outlet pipe into the Ash Pond appeared to be functioning normally, as shown on Photo 38.
- No video monitoring of the pipe was available at the time of assessment.
- Overall, the outlet works system appeared to be functioning as intended during the site assessment.
- The drop inlet has no trashrack and exposed rebar, and presents a possible fall hazard.

34-Sluice Pond 3'x4' Outlet Intake to Ash Pond without Trashrack (looking NE)

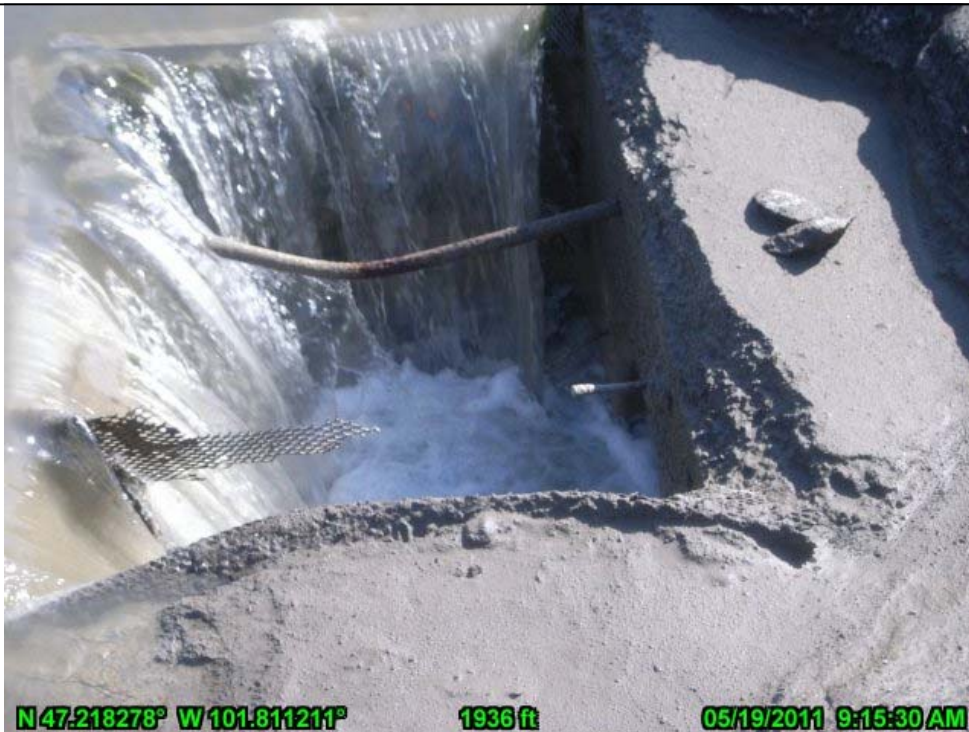
35-Sluice Pond 3'x4' Concrete Outlet Intake Structure to the Ash Pond without Trashrack

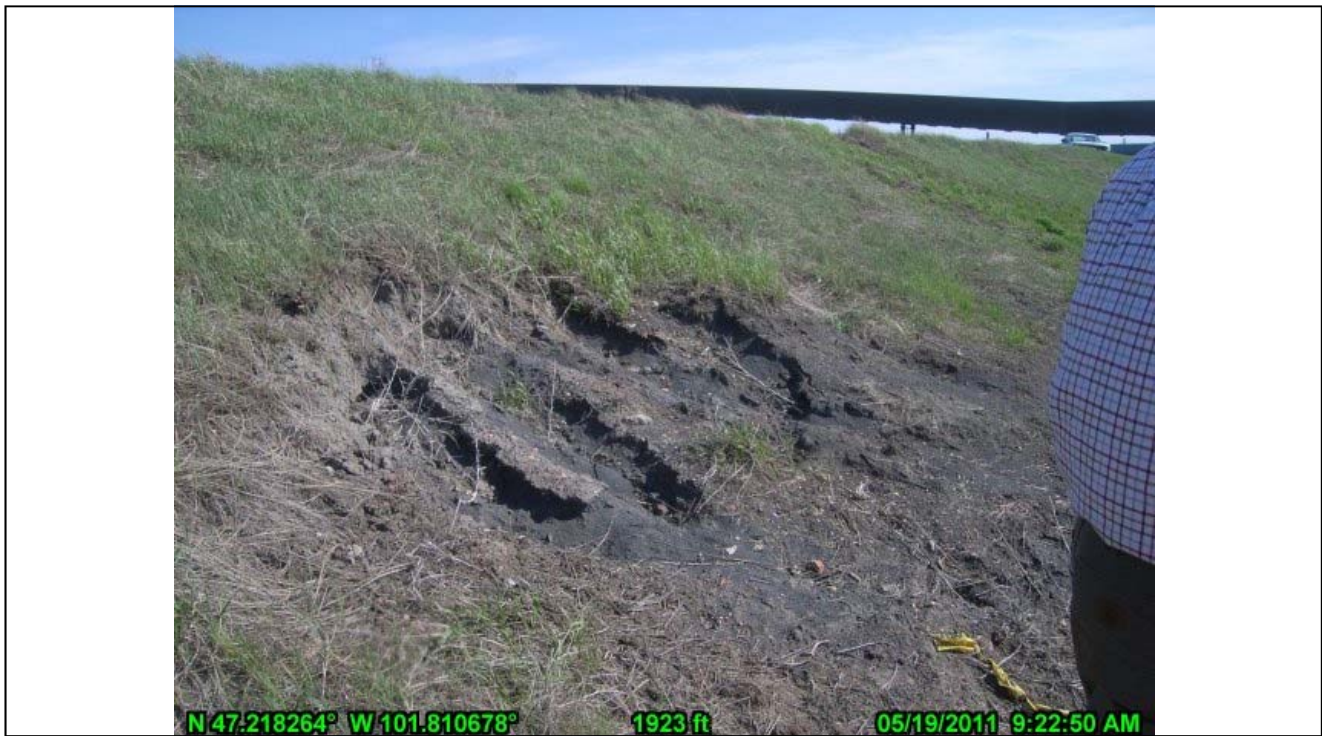
- The slope was well vegetated and appeared stable.
- The east slope between the Sluice Pond and the Ash Pond had a small scarp feature, as shown on Photos 39 and 42. While that condition did not appear to present an imminent threat to the slope stability, the embankment should be repaired with vegetation re-established.

39-Ash Pond Northwest Waterside Embankment Scarping (looking NE)

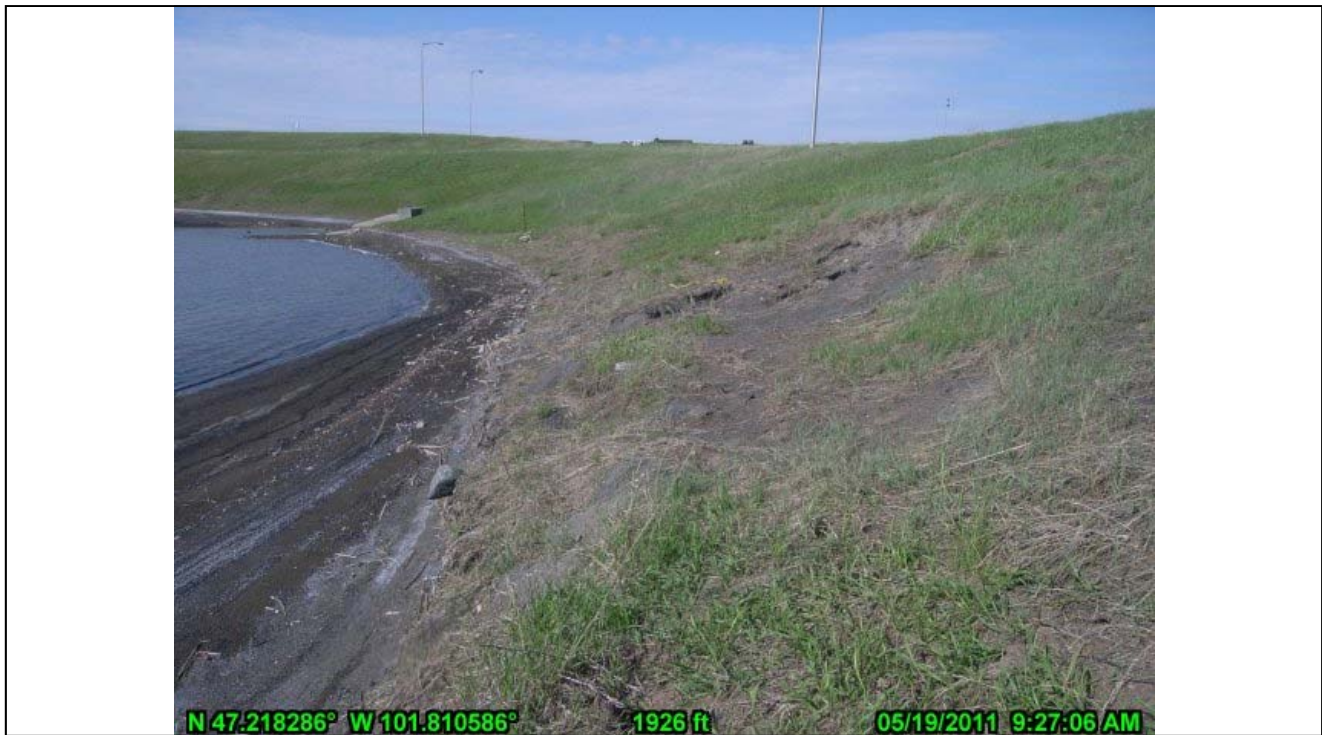
42-Ash Pond Northwest Waterside Embankment Scarping (looking SW)
