Assessment of Dam Safety of Coal Combustion Surface Impoundments (Task 3) Draft Report

Ohio Valley
Electric Corporation

Kyger Creek Power Station

December 9, 2009

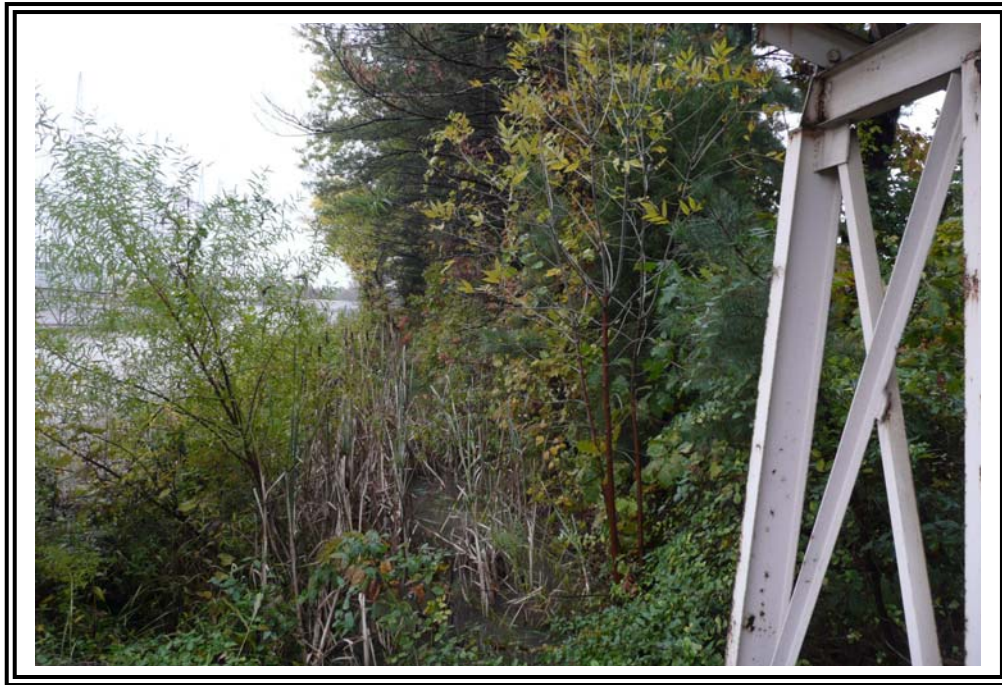
3

Exterior slope of north dike, looking east. Trees and heavy vegetation was observed.

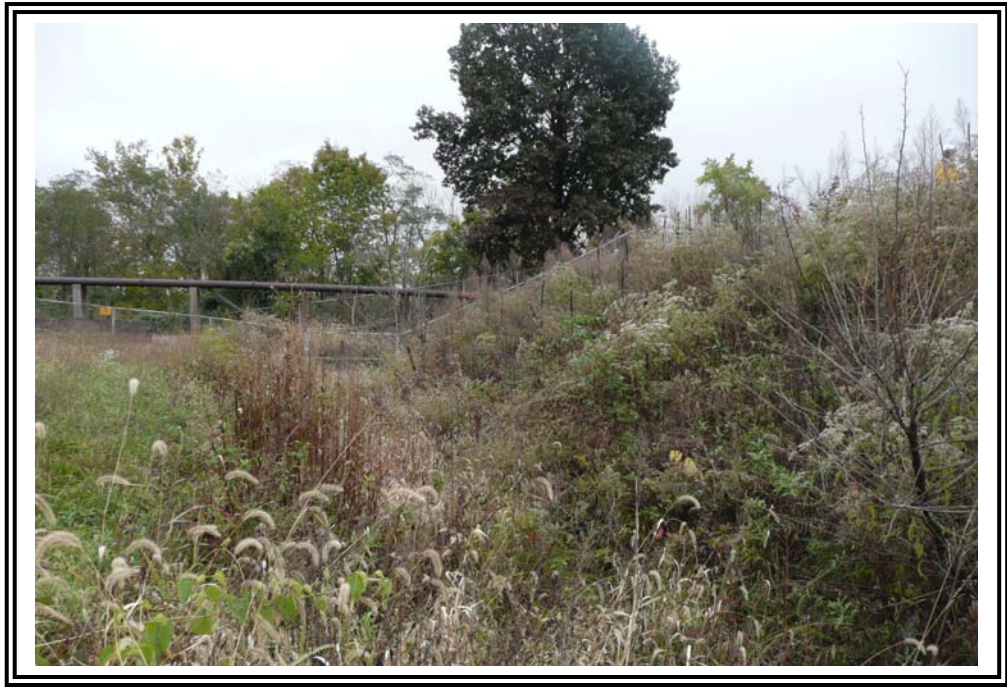
5

Exterior slope of north dike where sluice pipes enter the pond, looking east.
Moderate to heavy woody vegetation was observed.

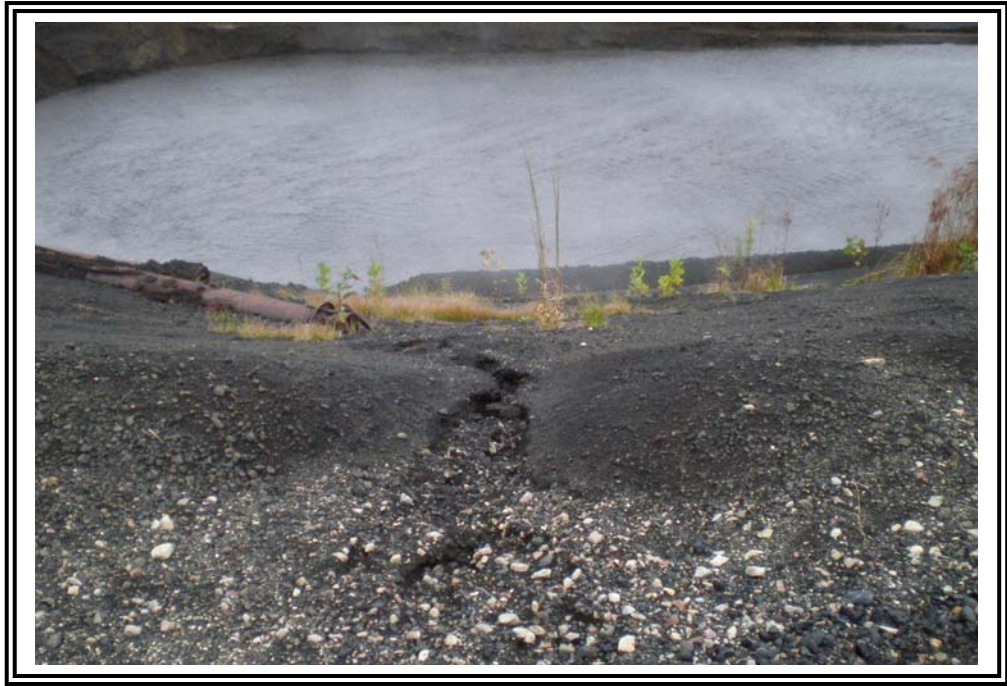
11

Erosion rills on interior slope of north dike.

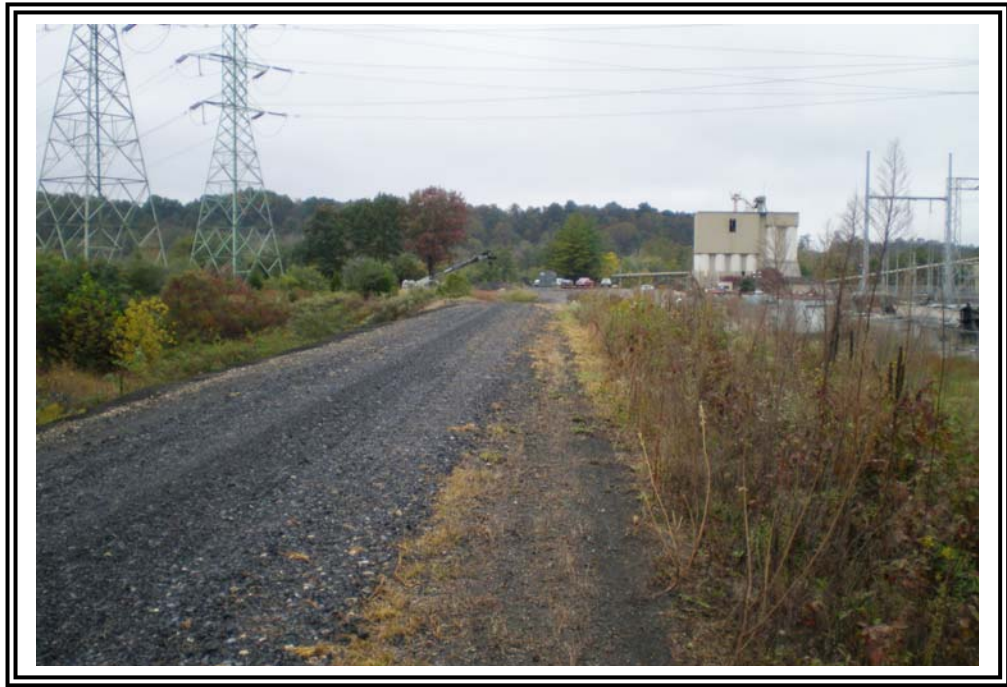
12

At the time of the site visit, the north dike was not actively impounding water. An access road runs the length of the crest of the north dike (Photo No. 12), which runs parallel to the plant. The interior embankment slope is generally covered by granular material and sparsely vegetated, with occasional erosion features observed (Photo Nos. 6, 9, 10, and 11). Heavier vegetation was noted near the transmission towers on the interior embankment slope (Photo Nos. 7 and 8). The exterior slope of the north dike was observed to be moderately to heavily vegetated (Photo Nos. 2, 3, 5). The dike is only 5 to 8 feet in height as the north end where it is predominately incised (Photo No. 1). No slumps or bulges were observed in the interior or exterior embankment slopes.

Crest of north dike, facing northwest.

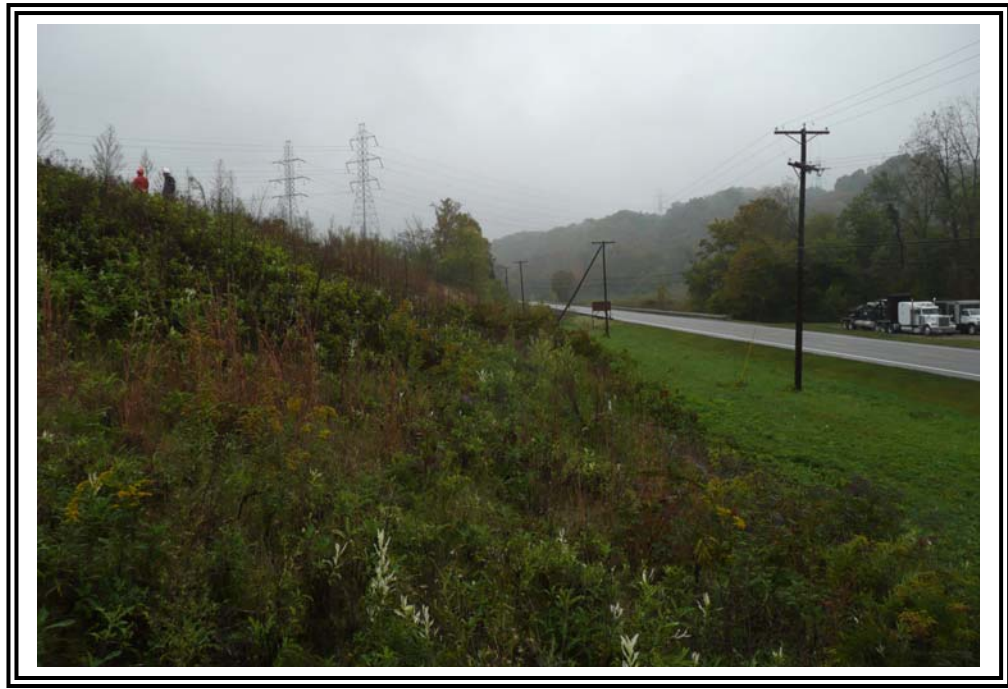
14

The crest and interior embankment slope of the west dike was observed to be gravel and bottom ash covered (Photo No. 15 and 16). The exterior embankment slope was noted to be moderately to heavily vegetated (Photo Nos. 13 and 14). Occasional erosion rills were observed in the interior embankment slope surface from concentrated stormwater runoff from the crest. The exterior embankment slope toe terminated at the State Route 7 right-of-way where a change in vegetation from field grasses, leafy weeds, and brush to maintained grass occurs (Photo No. 14). Probing in these areas revealed relatively firm conditions. Heavy vegetation, including isolated woody vegetation, present on the embankment slope at the time of the site assessment hindered

Exterior slope of west dike, looking south. Note moderate to heavy vegetation.

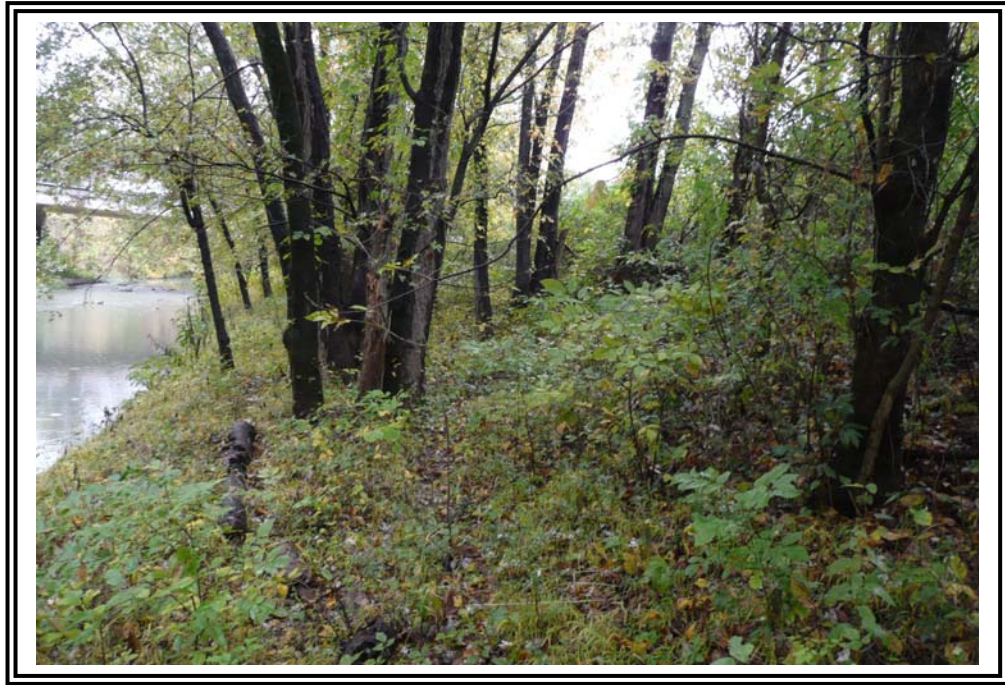
18

Toe of the exterior slope of south dike, looking west. Note trees and heavy vegetation and Kyger Creek adjacent to the slope toe. There is approximately 12 feet to the creek from the toe.

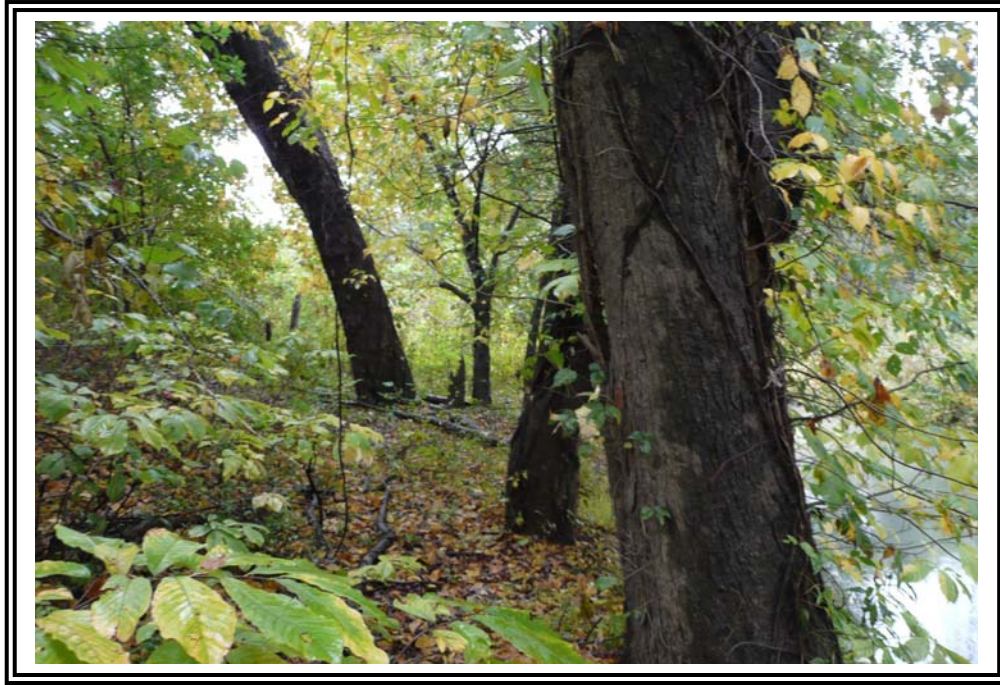
19

Toe of exterior slope of south dike, facing east. Note curvature of trees towards the dike.

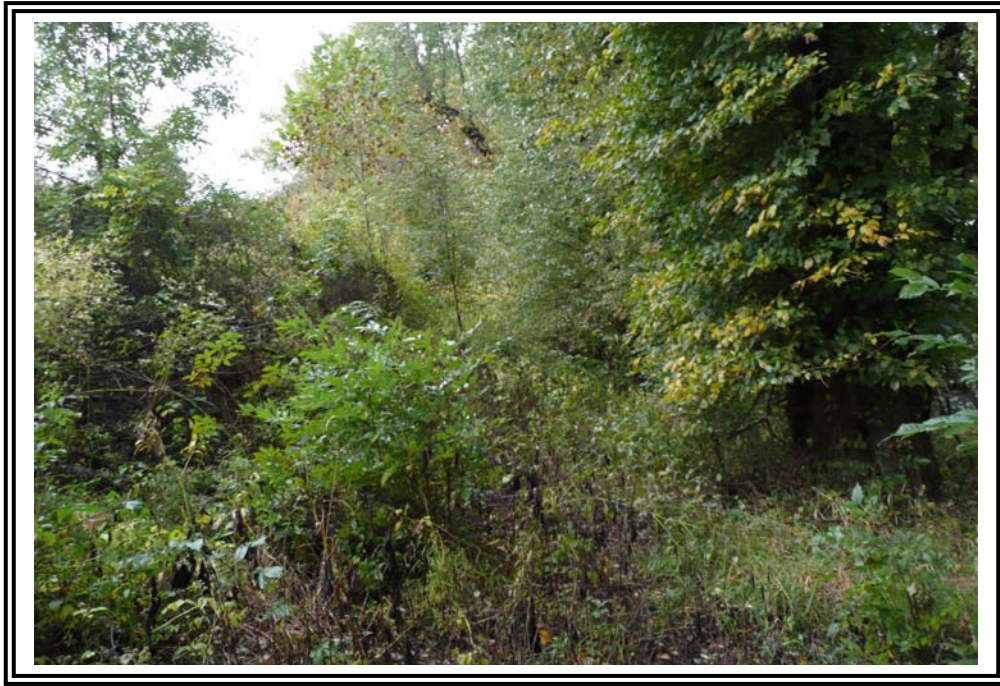
20

Exterior slope of south dike, looking east. Note heavy brush and vegetation.

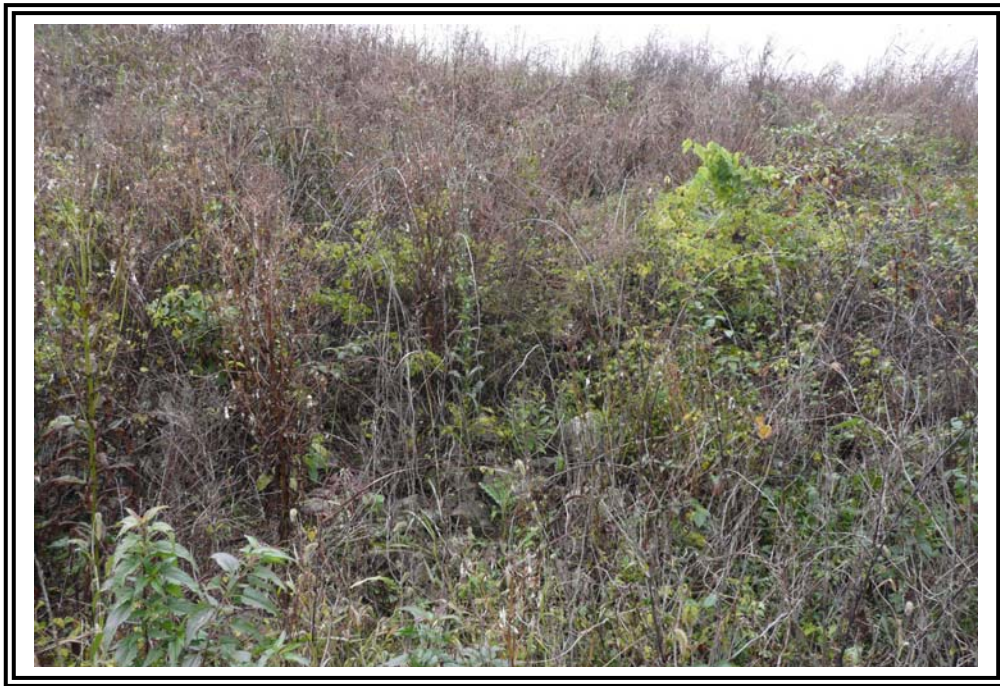
36

Area of rock slope protection/drain on exterior slope of east dike. Slope protection placed where slope steepened in area of transmission tower.

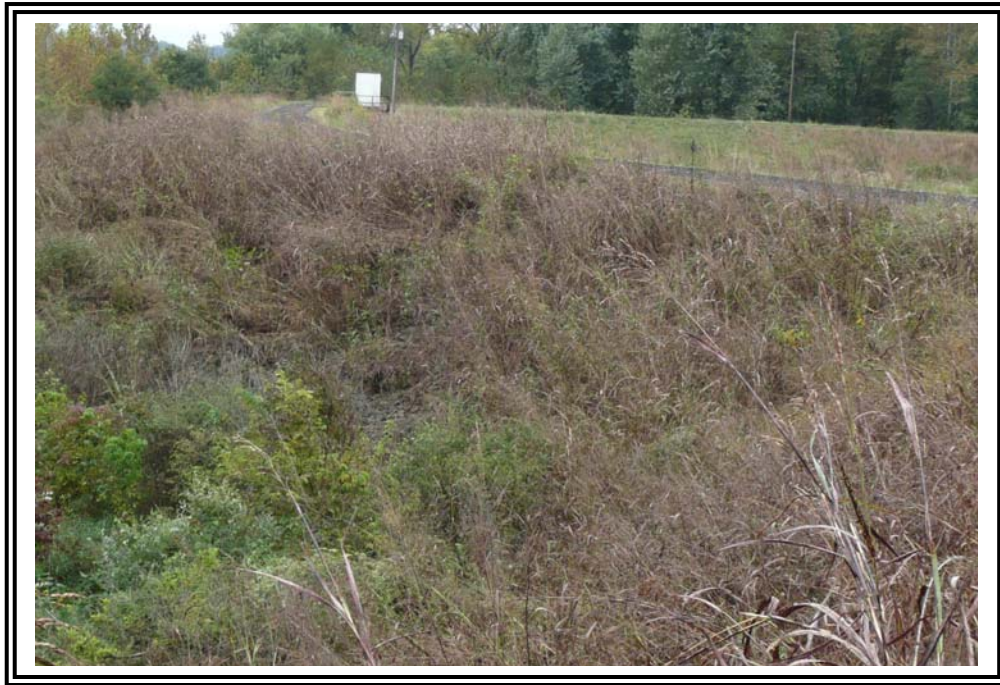
37

East dike exterior slope, looking south. Note rock slope protection/drain in this area is generally obscured by vegetation.

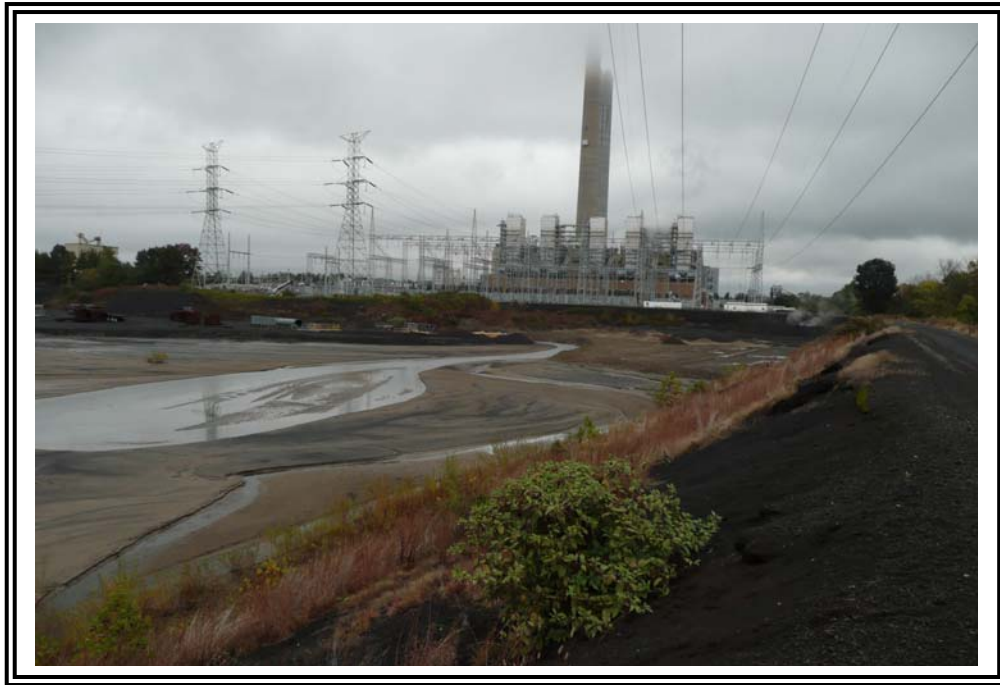
39

The east dike runs parallel to the Ohio River (Photo No. 38). The interior embankment slope is generally covered with granular material and sparsely vegetated with occasional erosion features (Photo No. 35, 39, and 41). Areas were observed where erosion and undercutting of bottom ash material at the crest has occurred where it appears to have been over built due to grading activities (Photo No. 40). The exterior embankment slope was observed to be moderately vegetated along the top $\frac{1}{4}$ to $\frac{1}{3}$ portion of the slope and more heavily vegetated, with brush, bushes, briars and trees, nearer to the toe (Photo No. 34, 36, and 37). Mature trees, approximately 24 to 30 inches in diameter, were observed near the toe along the Ohio River. There was an area of exposed slope where there has been a loss of vegetation cover and erosion rills have developed (Photo Nos. 41 and 42).

East dike interior slope, looking north. Note isolated woody vegetation on slope.

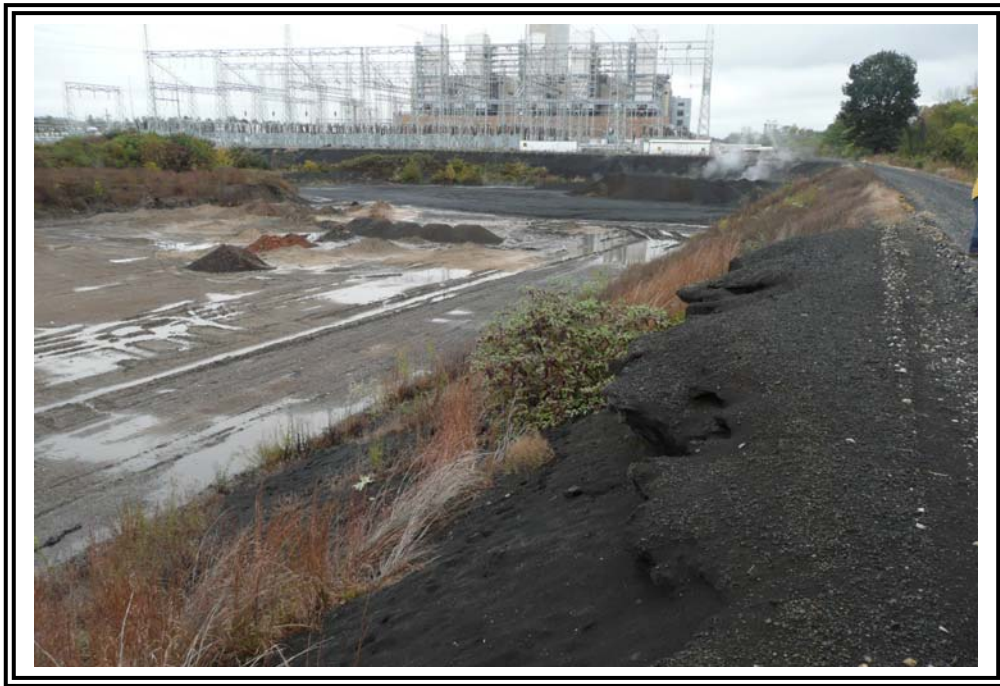
40

East dike and interior slope, looking north. Note erosion and undercutting of bottom ash material at the crest. Brush vegetation was also evident.

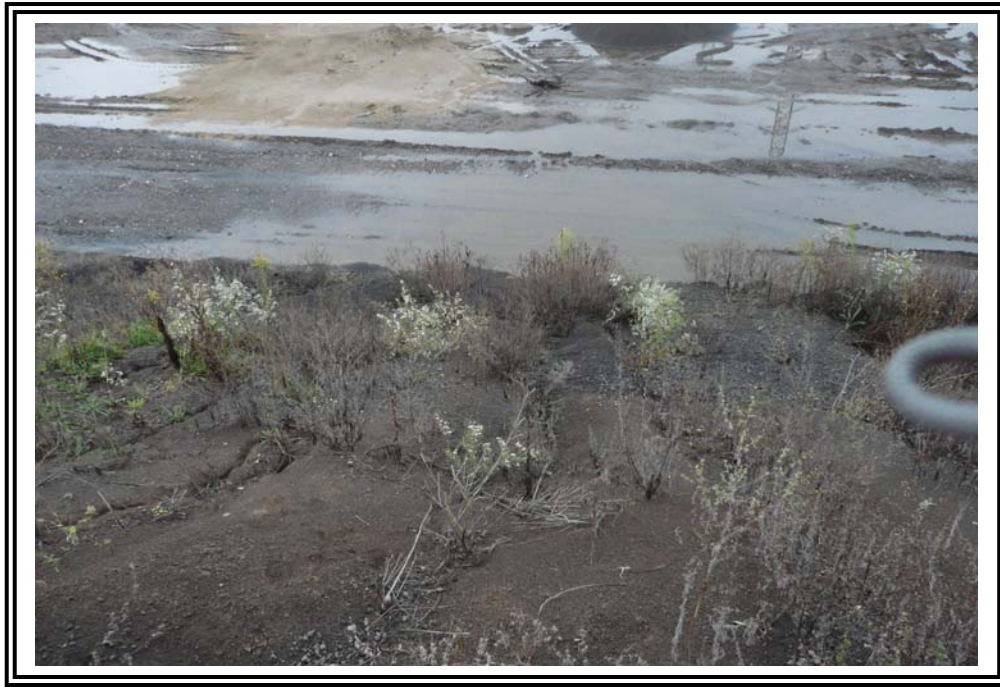
41

Erosion rills and isolated vegetation cover on interior slope of east dike.

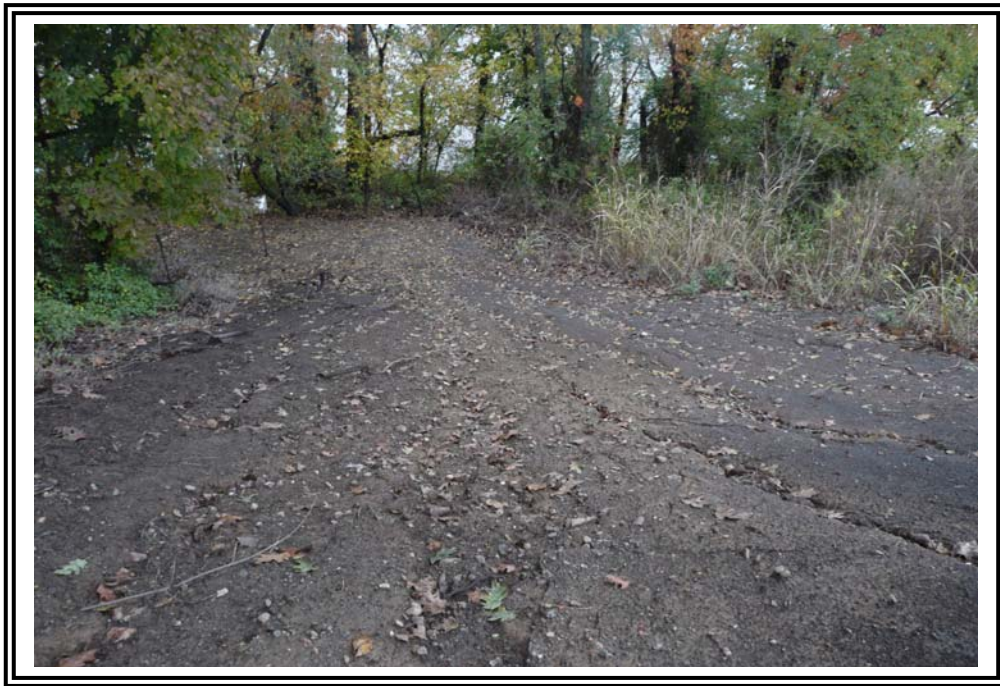
42

Loss of vegetation cover and erosion rills on exterior slope of the east dike.

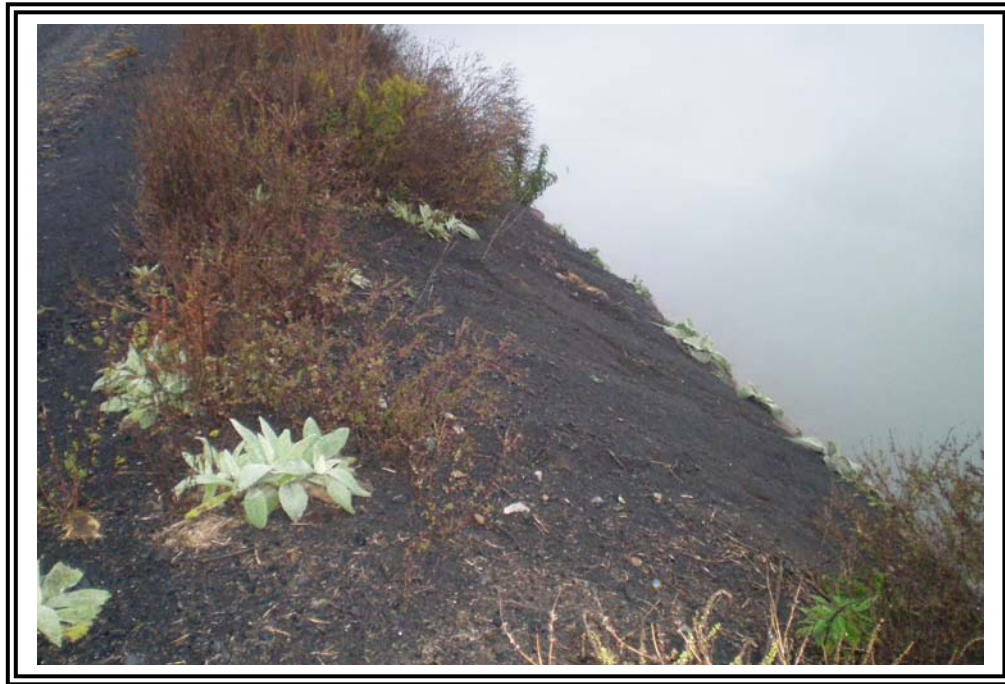
45

Loss of ground cover and erosion observed on interior slope of west dike.

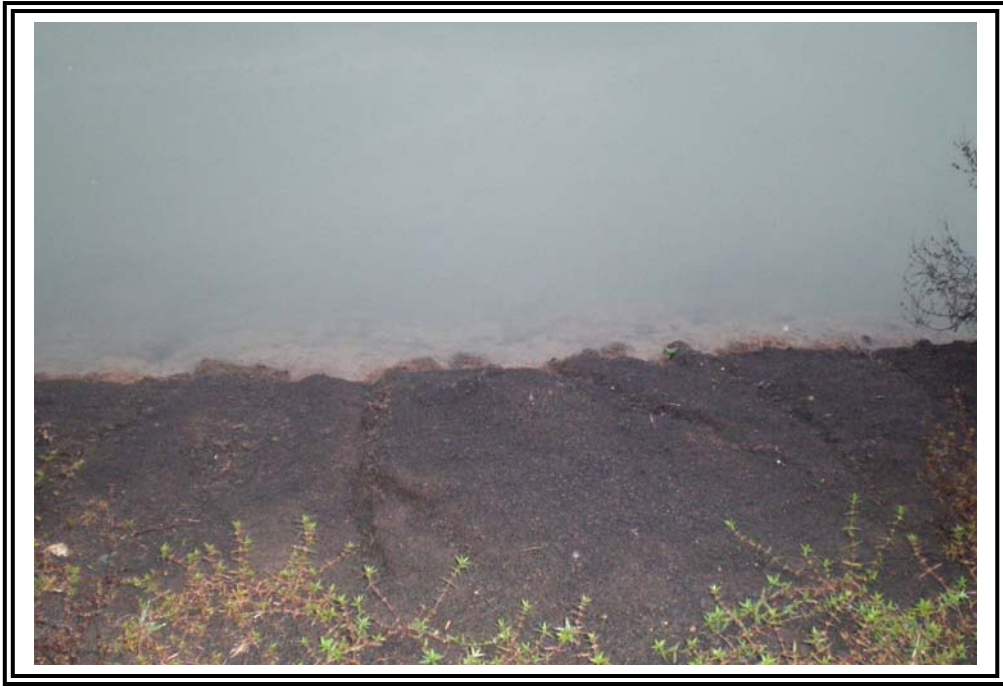
46

Erosion rills and loss of ground cover on interior slope of west dike.

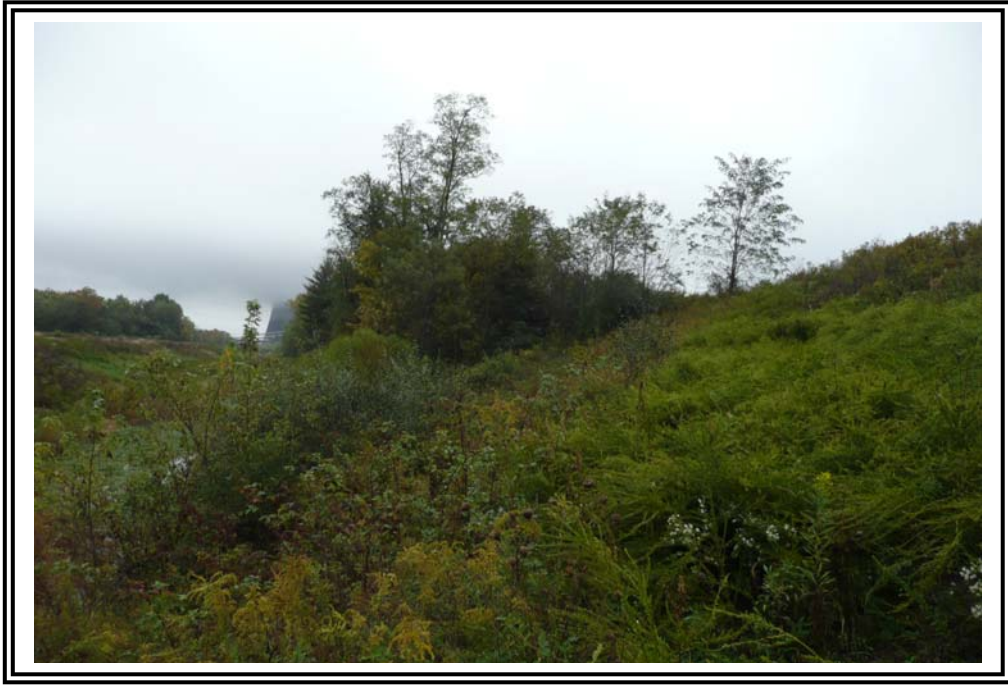
49

An access road runs the length of the crest of the west dike (Photo No. 44). The interior and exterior embankment slope surfaces of the west dike are predominantly covered with granular materials with numerous cobble sized rock fragments. The interior slope had sparse to moderate vegetation (Photo No. 45). Erosion rills were observed on both the interior and exterior embankment slopes (Photo No. 46). The exterior embankment slope was observed to have moderate to heavy vegetation (Photo No. 49) with an isolated small slump, an isolated grassed

West dike exterior slope, looking north. Note moderate to heavy vegetation.

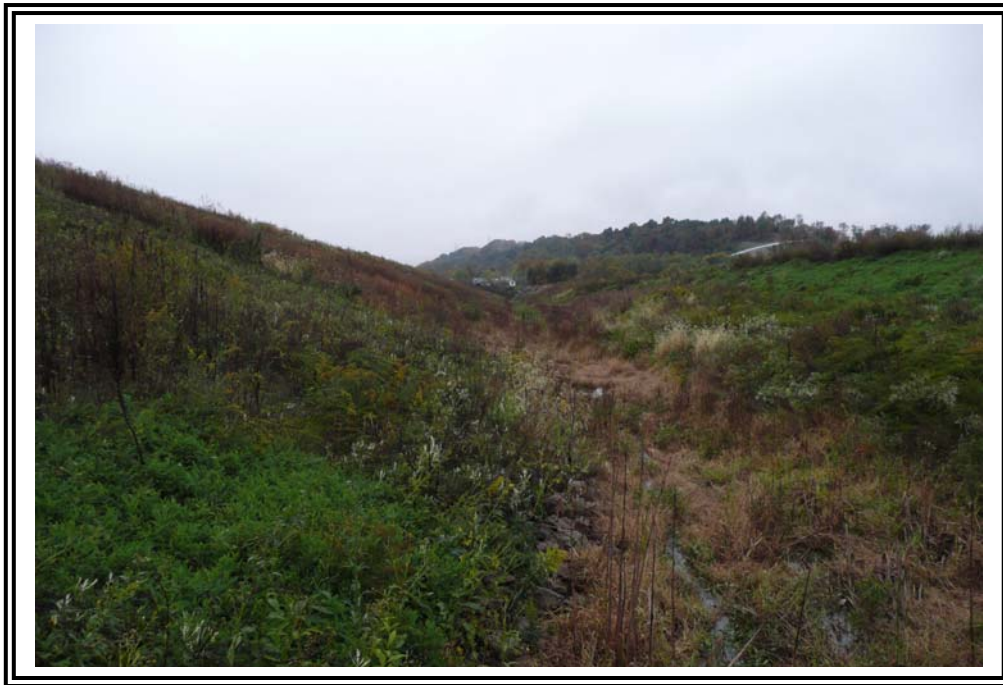
50

West dike exterior slope, looking south. Standing water observed in rock lined ditch at toe.

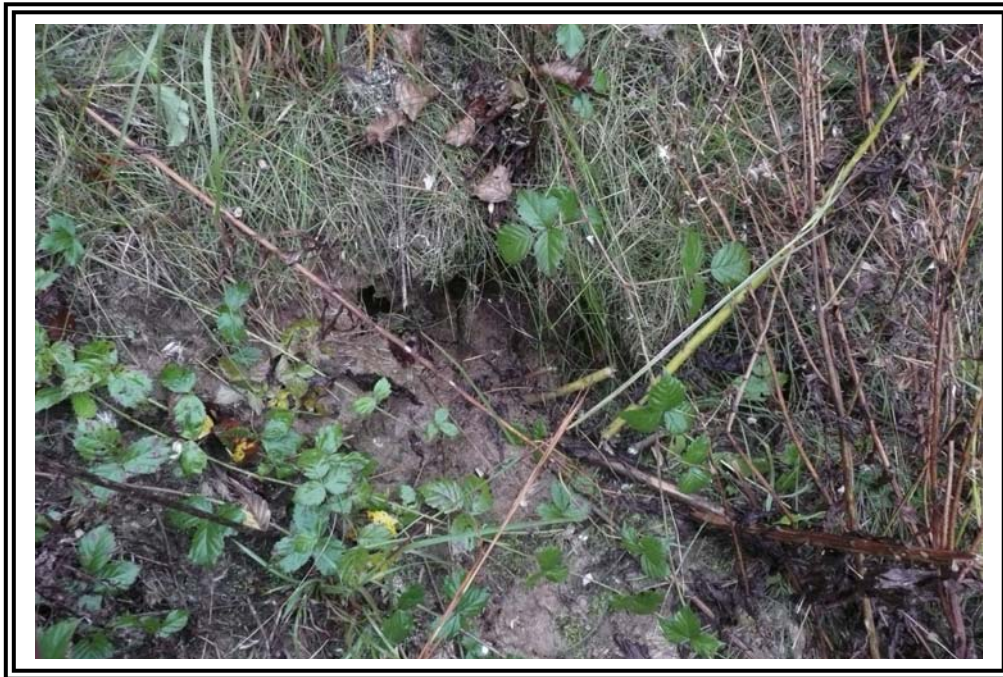
51

Possible animal burrow in west dike exterior slope.

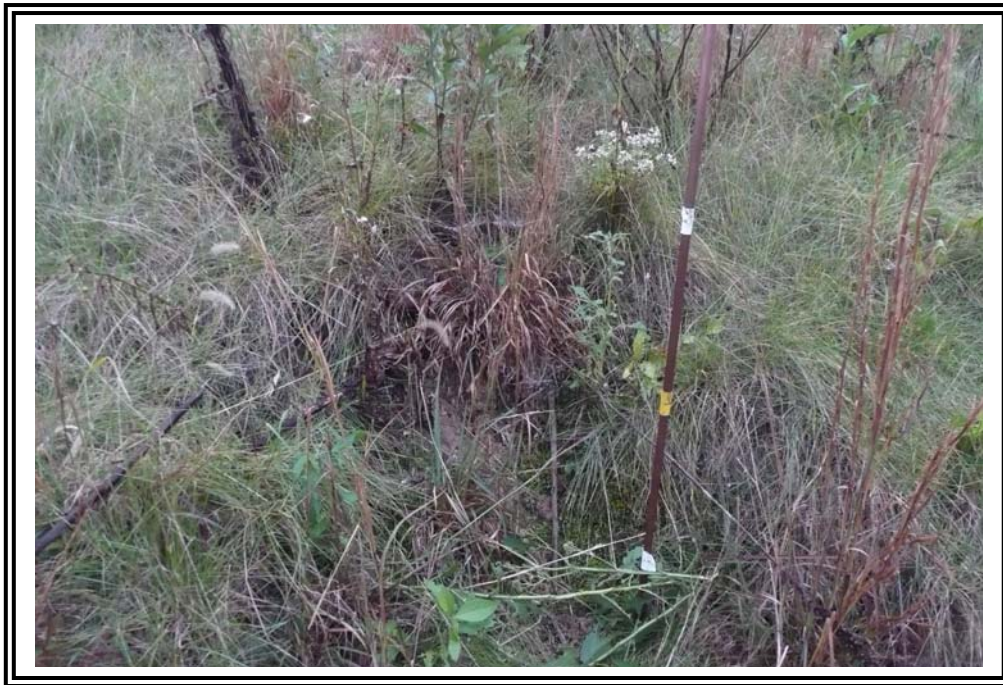
52

Small scarp/slough in west dike exterior slope.

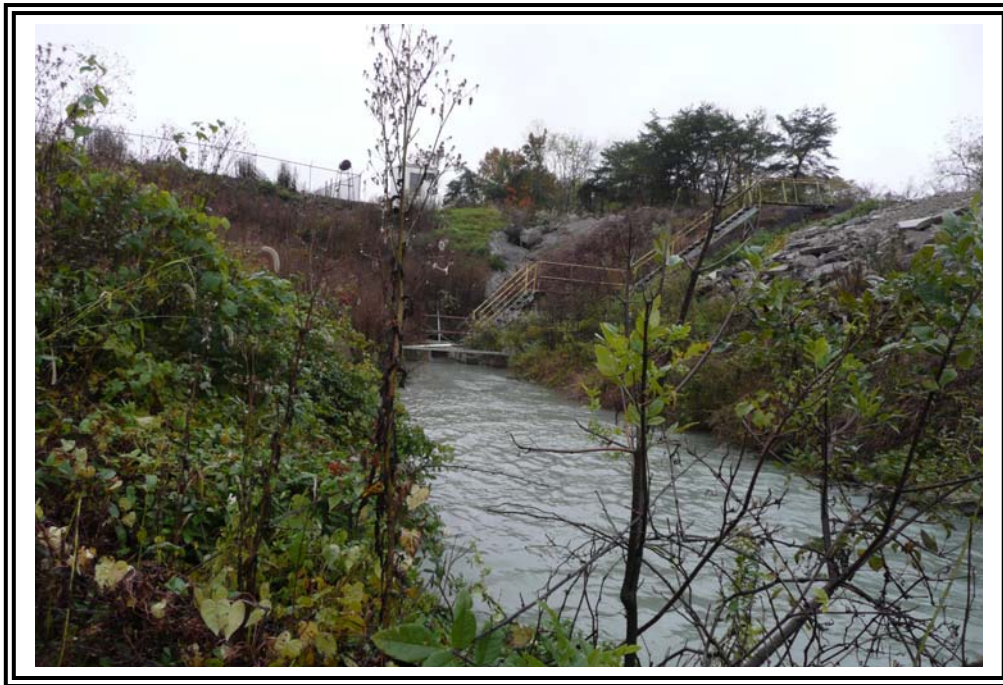
54

Drainage ditch near South Fly Ash Pond outlet. Note pooling water and heavy vegetation.

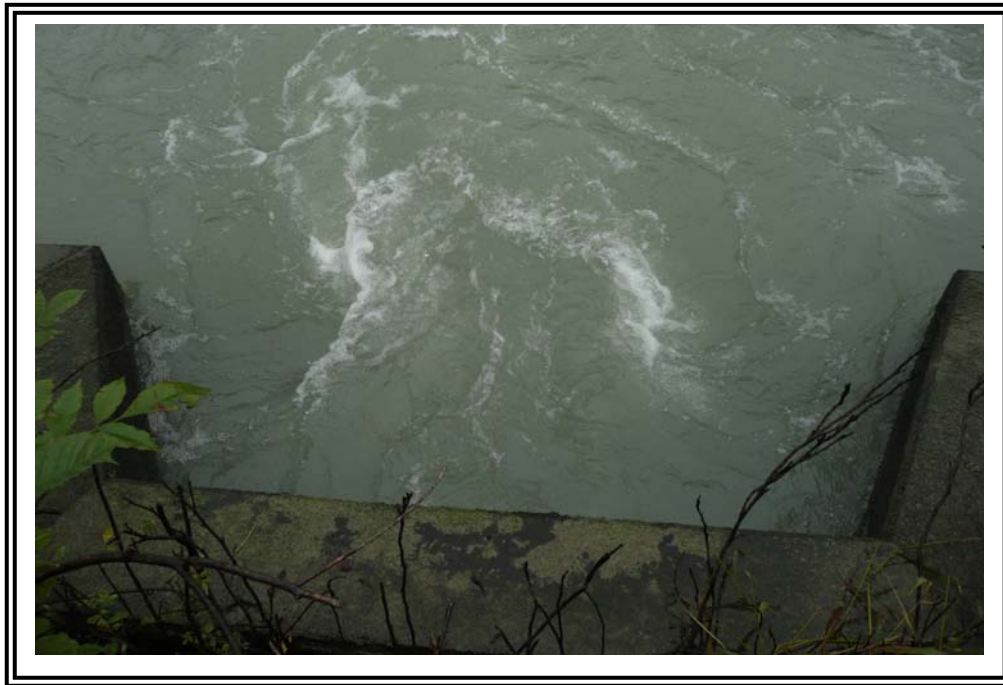
55

South Fly Ash Pond outlet headwall. Outlet partially submerged during site visit.

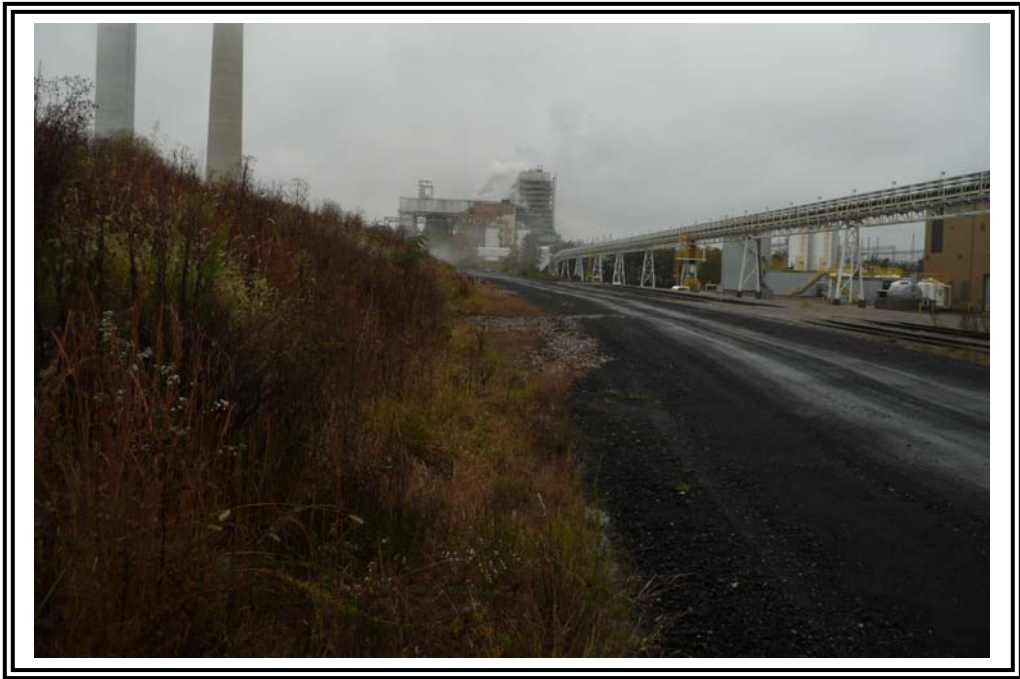
57

Exterior slope of south dike. Note vegetation on slope and ditch line between the slope toe and access drive.

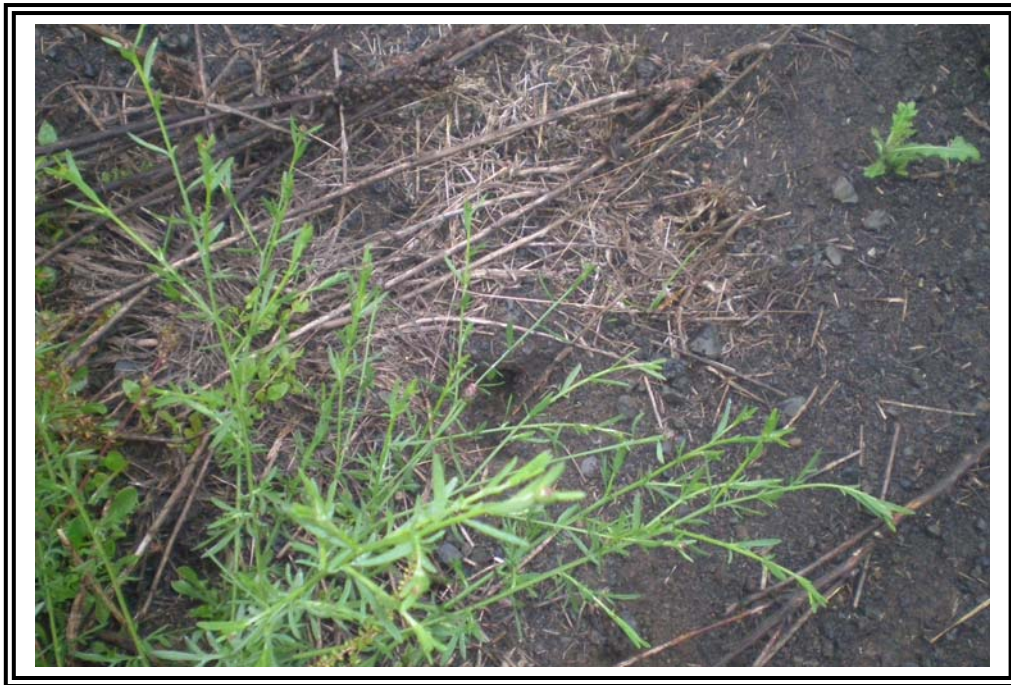
58

Small, isolated animal burrow on interior slope of the south dike.

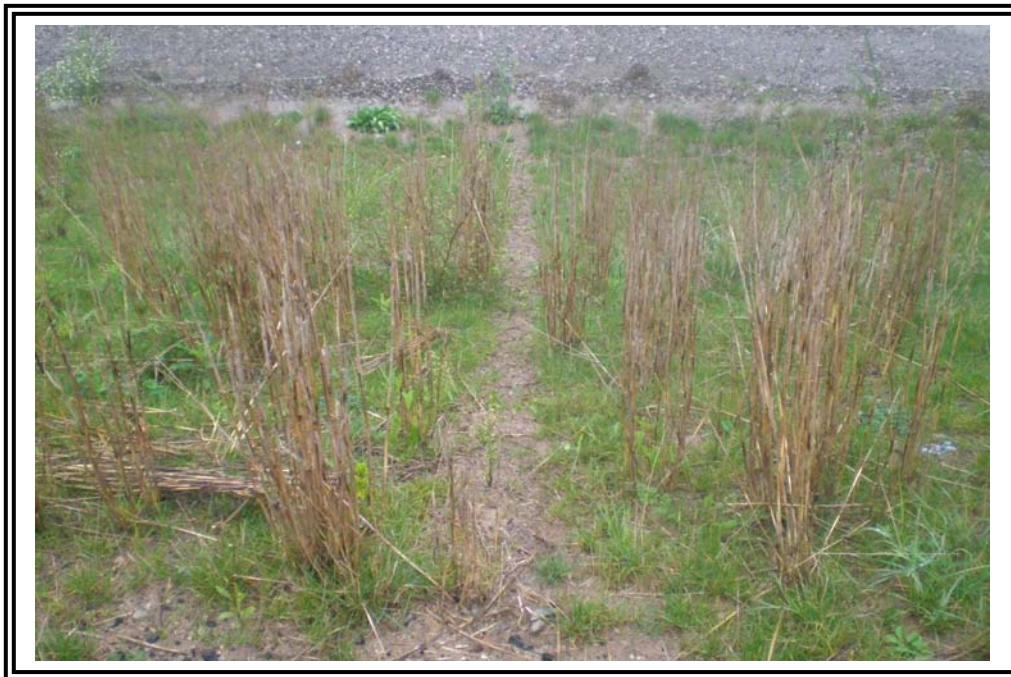
59

Rill in exterior slope of south dike created by concentrated run-off from the maintenance road along the crest of dike.

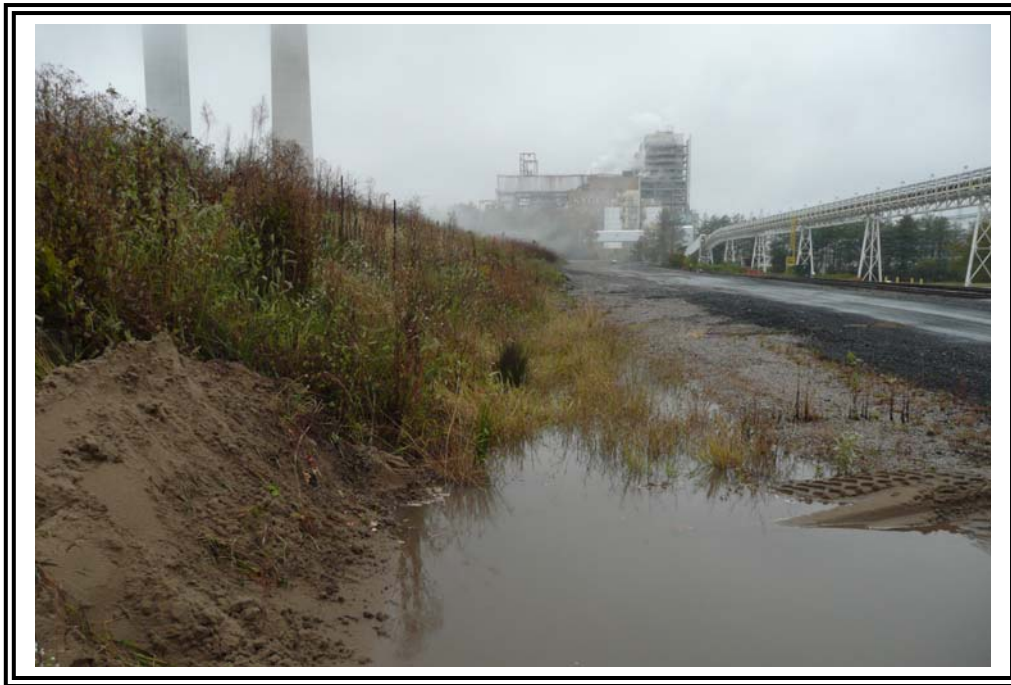
60

An access road runs the length of the south dike crest (Photo No. 56). The interior embankment slope is generally covered with granular material and is sparsely to moderately vegetated. Occasional erosion features were noted. The exterior embankment slope was noted to be moderate to heavy vegetation (Photo No. 57). An animal burrow and erosion rills were noted on the slope (Photo Nos. 58 and 59). The drainage ditch at the toe of the embankment slope was blocked with soil and gravel material and appeared rutted probably from maintenance activities (Photo No. 60).

Water pooling in ditch line at toe of south dike. Water is due to recent heavy rainfall and poor drainage.

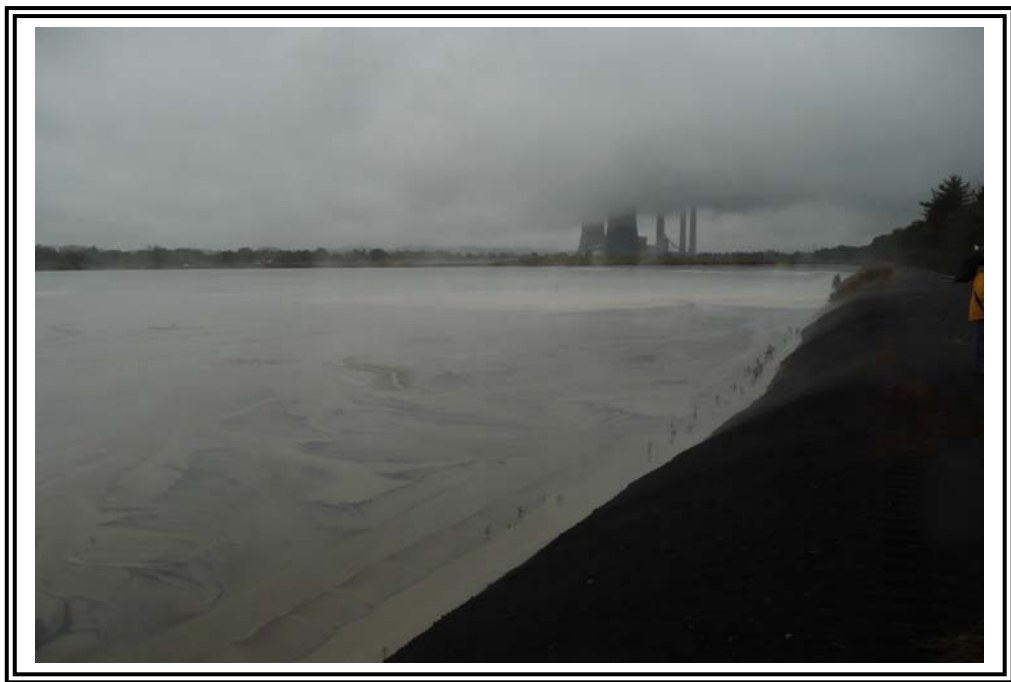
An access road also runs the length of the south dike crest (Photo No. 64). Little to no vegetation cover was observed on the interior embankment slope of the east dike (Photo Nos. 61 and 66). Heavy vegetation and mature trees cover the downstream slope (Photo Nos. 62 and 63). Minor erosion features resulting from concentrated run-off was observed on both the interior and exterior embankment slopes. Sluice lines run along the exterior side of the crest (Photo No. 64).

Interior slope of east dike, looking north. Slope is covered predominately with ash with little vegetation.

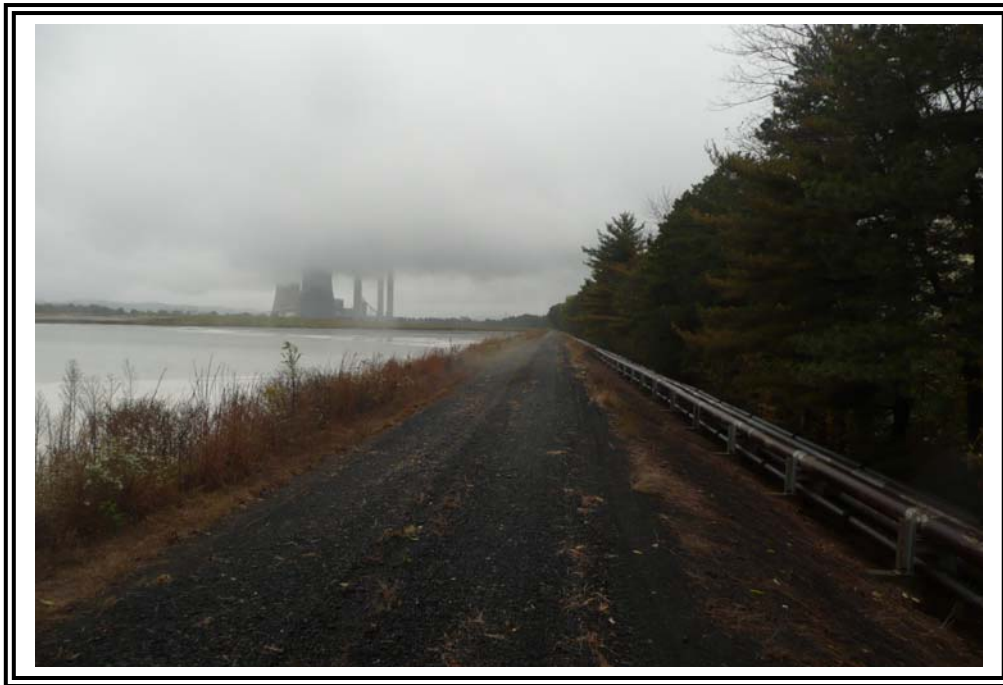
64

Crest of east dike, facing north. Note pipeline trace and trees on lower portion of the slope.

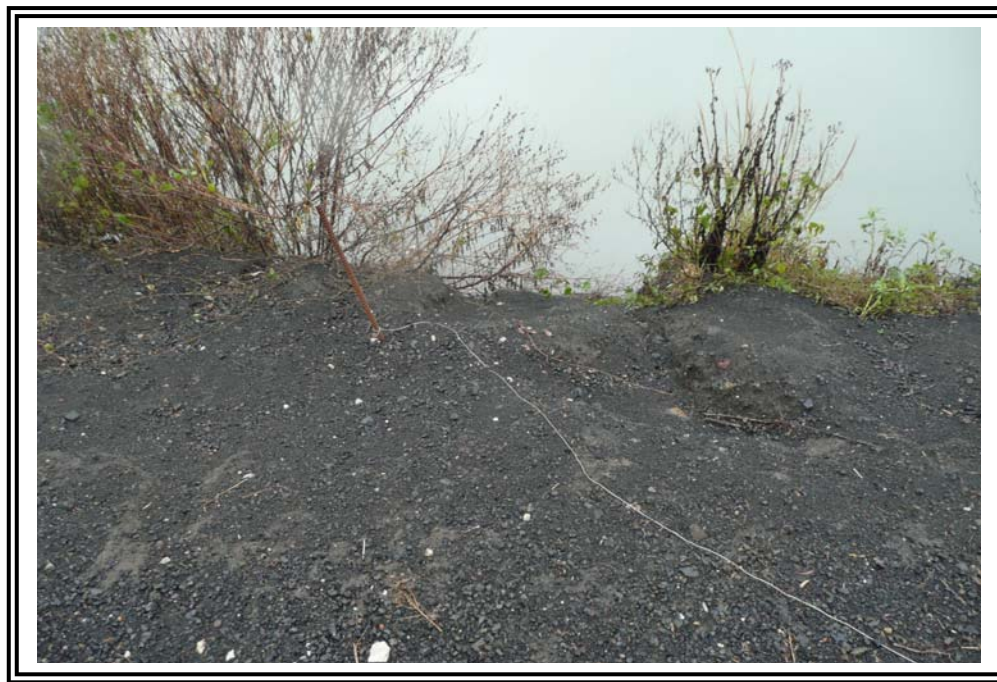
69

Bottom ash and erosion rills observed in the ash covering the interior slope of the north dike.
