Assessment of Dam Safety Coal Combustion Surface Impoundments (Task 3) Final Report

Progress Energy
Carolinas
Cape Fear Plant

Moncure, North Carolina

September 14, 2009

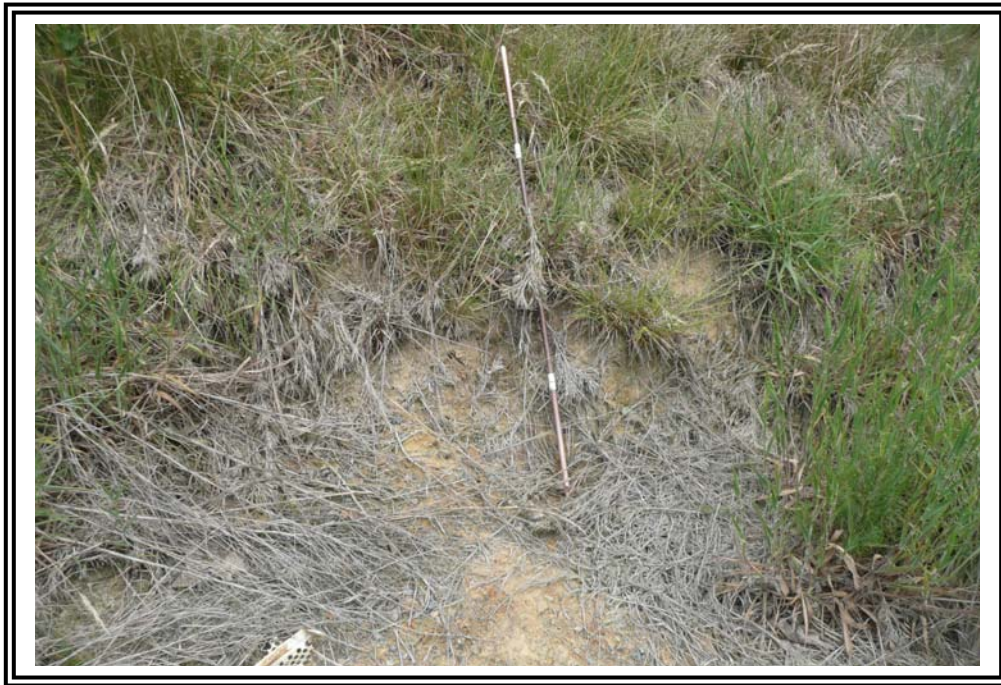
3

Erosion at the toe of the 1985 Ash Pond West Dike in an area of poor drainage.

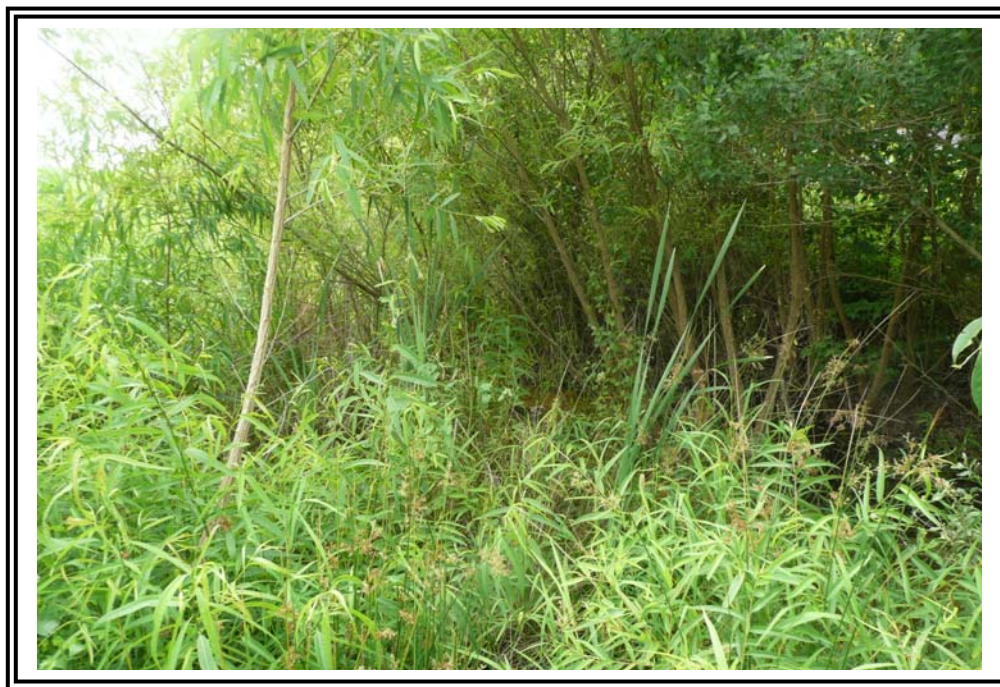
5

Woody growth along the West Dike of the 1985 Ash Pond.

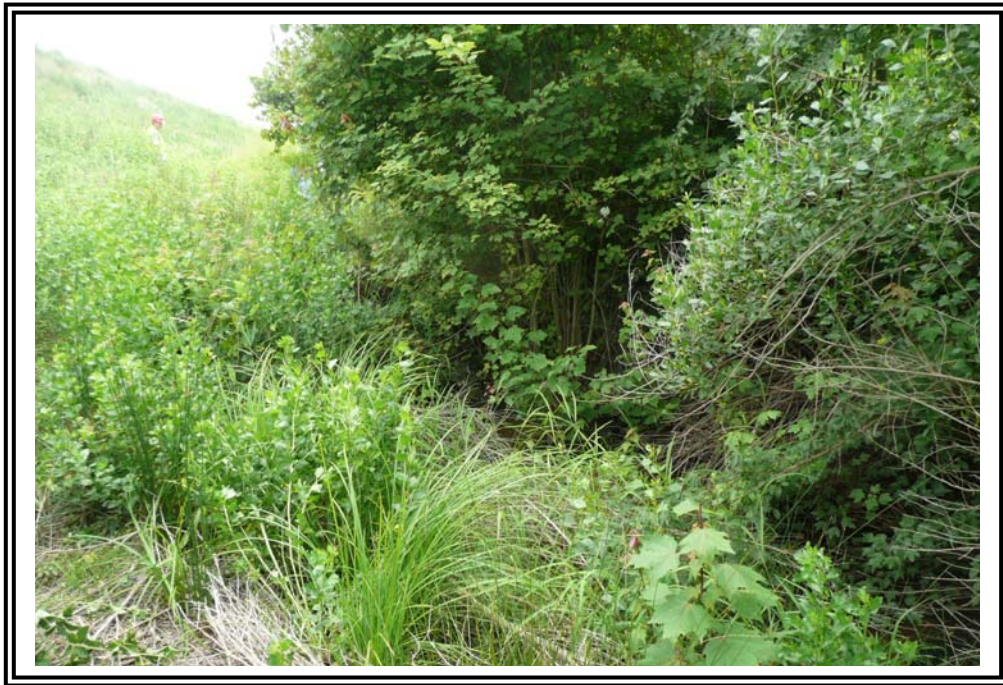
7

Tree growth at the toe of the 1985 Ash Pond West Dike.

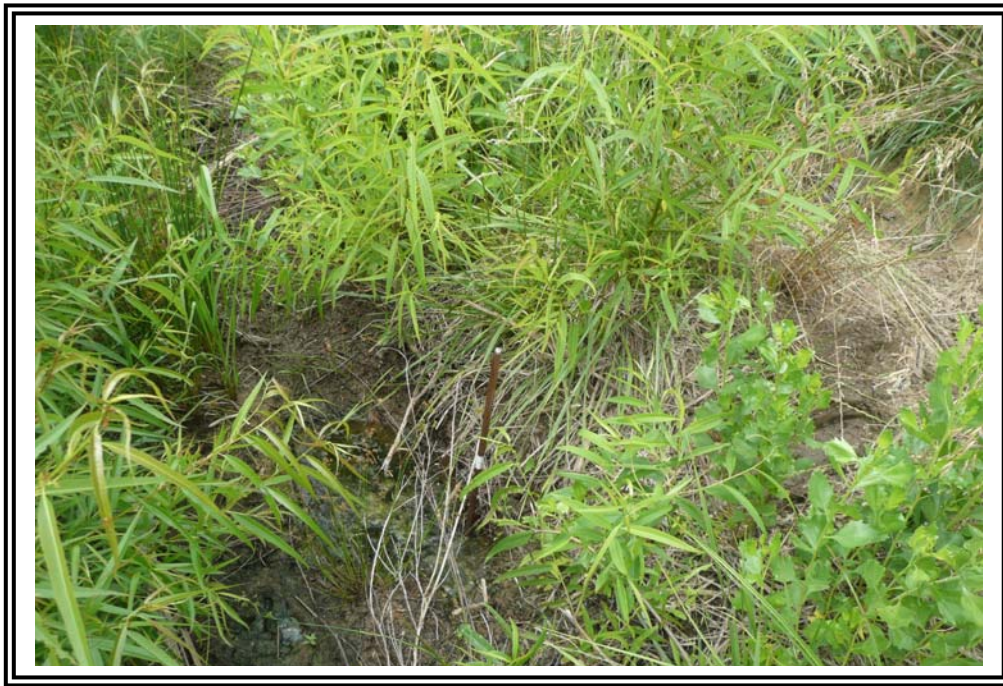
8

Soft soil at the toe of the 1985 Ash Pond West Dike. Probe pushed into the ground about 2 feet.

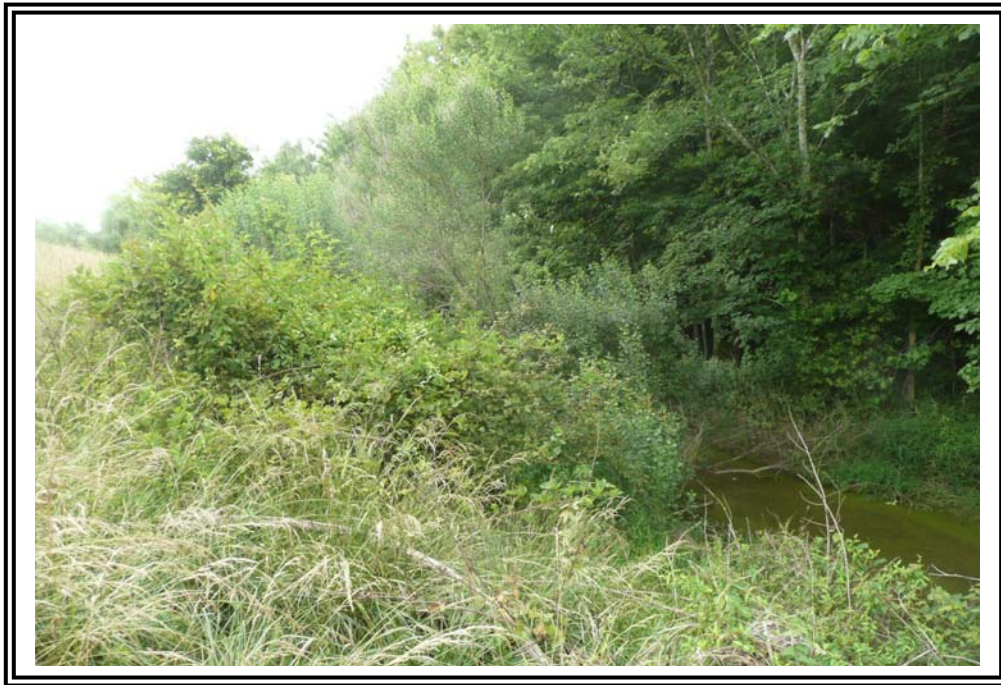
15

Drainage swale/channel adjacent to toe of 1985 Ash Pond.

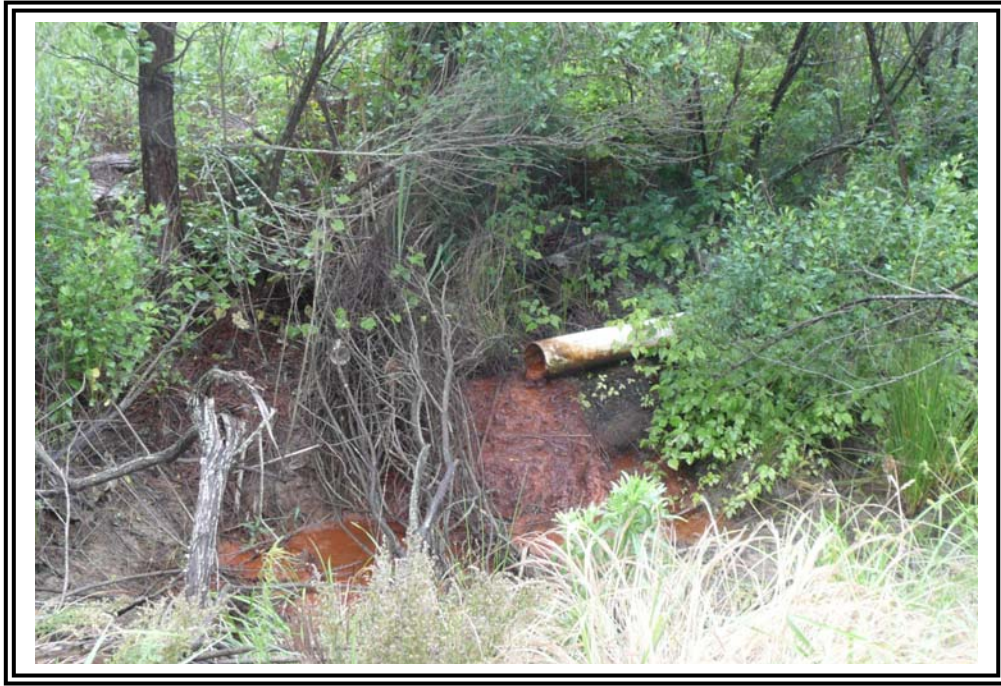
43

The 1978 Ash Pond has had an issue with shallow groundwater at the north dike toe in the area of the plant cooling towers. According to available documentation, this area was originally observed during pond construction as the subgrade was being stripped for the dike fill and noted after the pond was completed since 1986. In 1990, plant personnel installed a trench drain in this location to capture groundwater and convey it to a point beyond the dike toe adjacent to the cooling towers. Details regarding this construction are not available but a historical site observation of the open trench suggests that it is approximately 15 feet beyond the dike toe and 5 feet deep, excavated in what appeared to be alluvium. A 6-inch diameter pipe functions as the

trench drain outlet. Periodic inspections have noted clear seepage from the pipe since it was installed and the facility's independent engineering consultant is of the opinion that the seepage does not pose a stability problem for the dike.

Apparent trench/field drain outlet at north dike toe on 1978 pond adjacent to cooling towers.

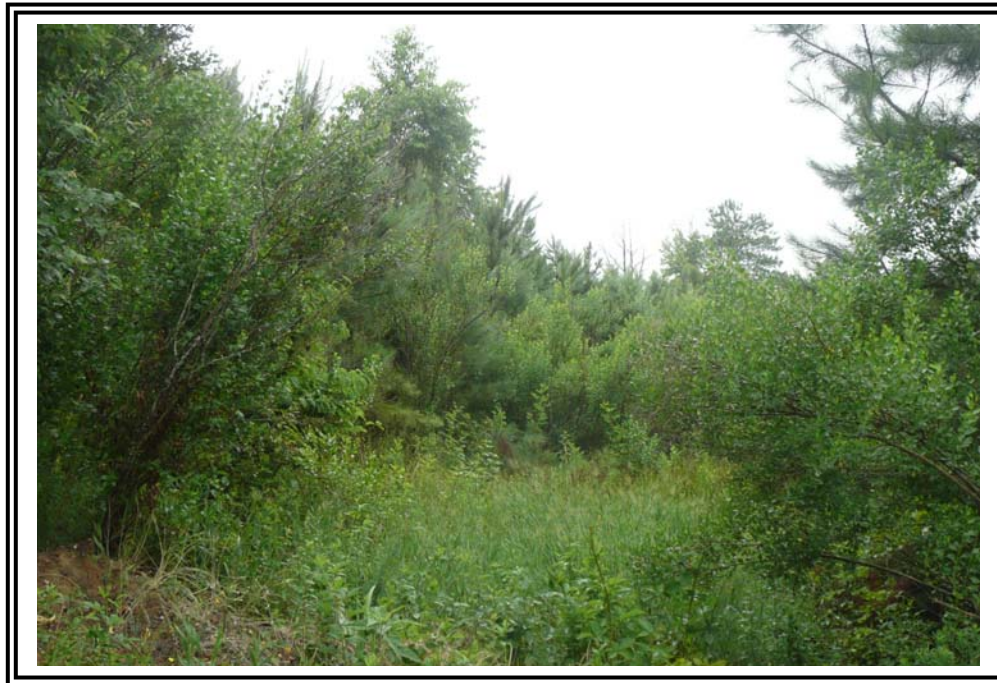
45

General vegetation conditions on the north end of the 1978 Ash Pond Dike downstream slope.

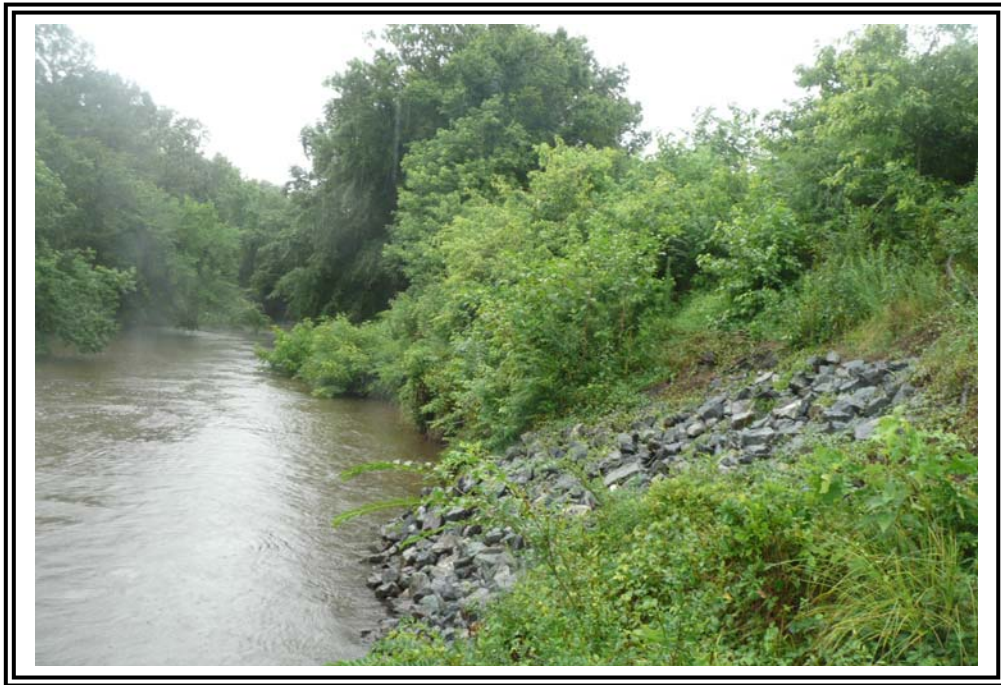
47

The discharge canal adjacent to the toe of the ash pond had a large tree fall and rupture the soil in late 2006 – early 2007. This required placing a geotextile with rip-rap armoring in the area of the fall to stabilize the bank and protect against continued erosion. Though the dike toe is very close to discharge canal in this area, the tree fall and resulting soil rupture was not believed to be a detriment to the dike stability. Other large trees adjacent to the canal in this area were subsequently removed as a precautionary measure.

Rip rap fill at the toe of the 1978 Ash Pond Dike along the discharge canal.

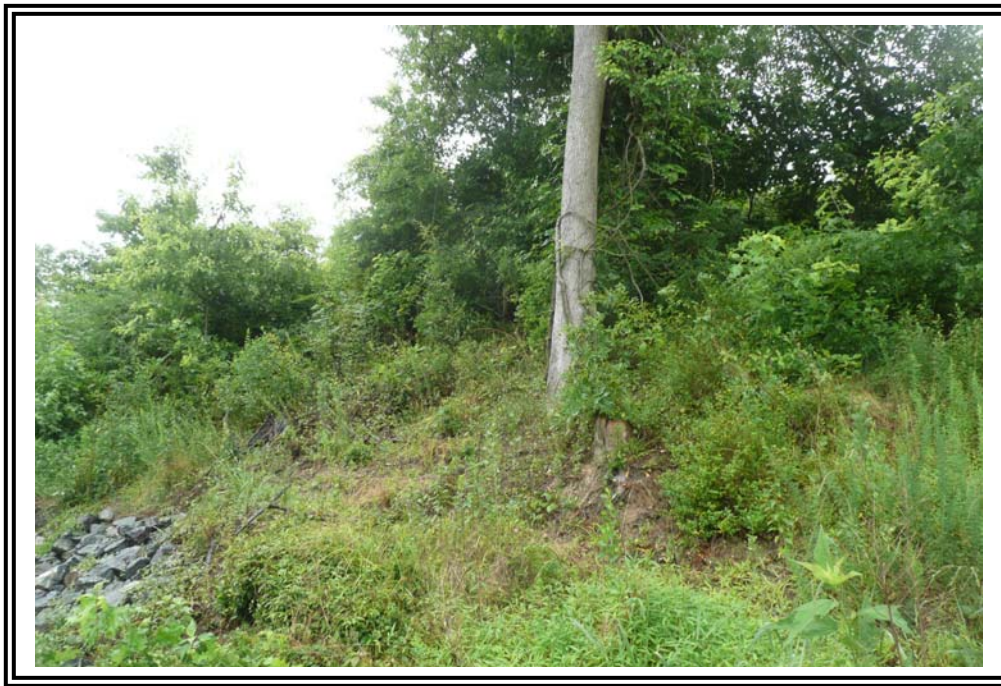
Along the easternmost portion of the dike where it parallels the Discharge Canal, undercutting of the dike toe from flows in the Discharge Channel in combination with fallen (uprooted) trees has resulted in sloughing of the slope. An area where a tree reportedly had uprooted was repaired in late 2006 or early 2007 with rip rap as shown in Photo 47. Photo 48 shows sloughing in this area and Photo 49 shows the undercutting of the toe from the Discharge Channel flows.

Erosion/surface sloughing around the tree stump on the 1978 Ash Pond Dike.

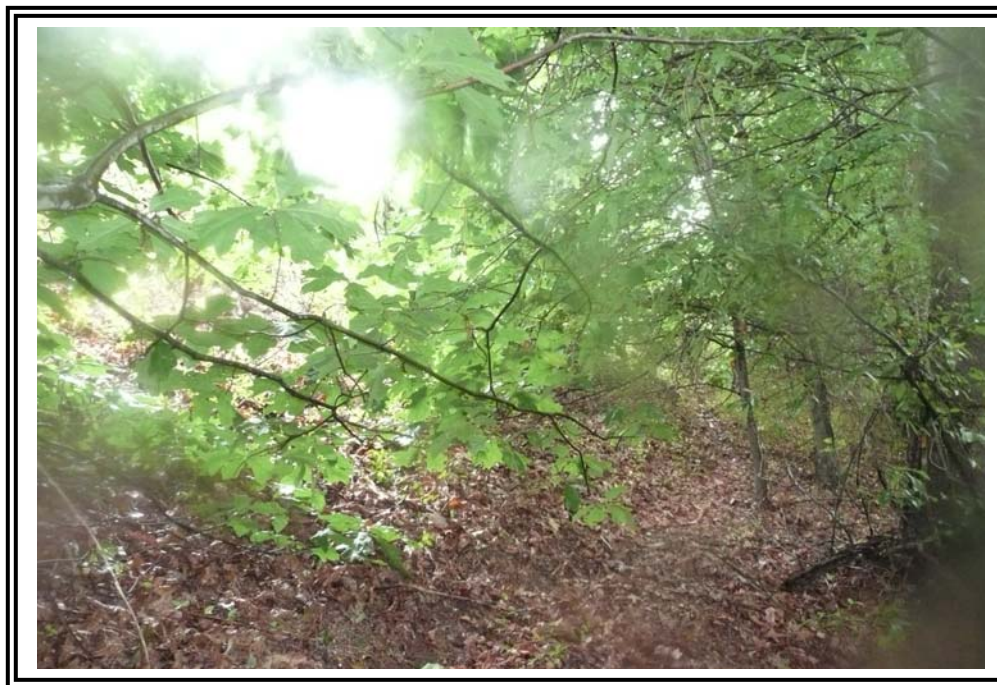
54

Slough on the downstream slope, east side of the 1978 Ash Pond Dike.

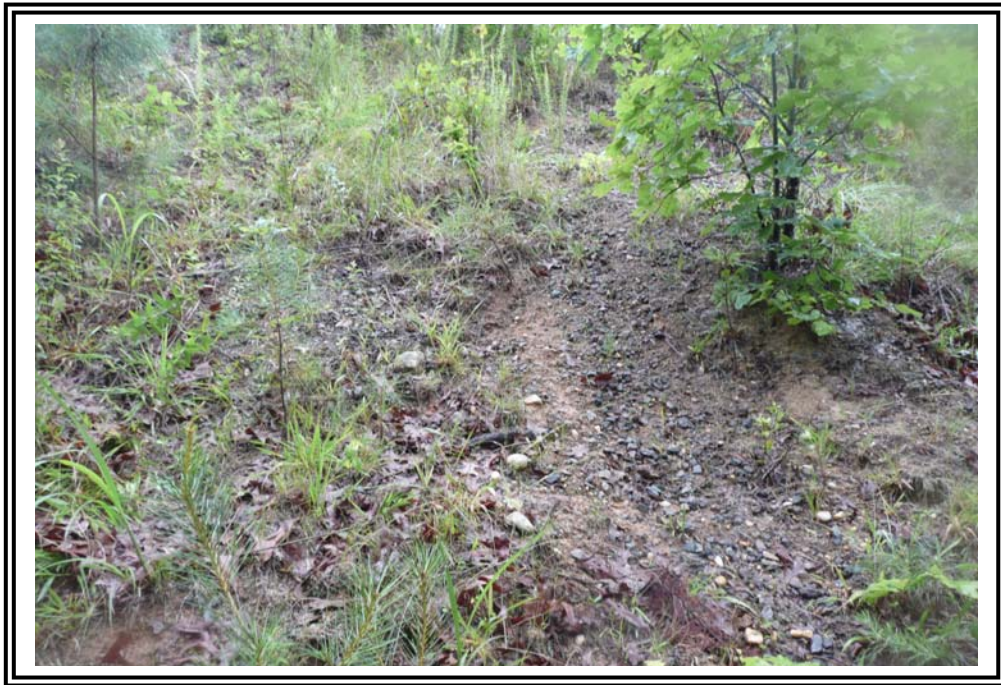
59

Surface erosion southeast of the downstream slope of the 1978 Ash Pond Dike.

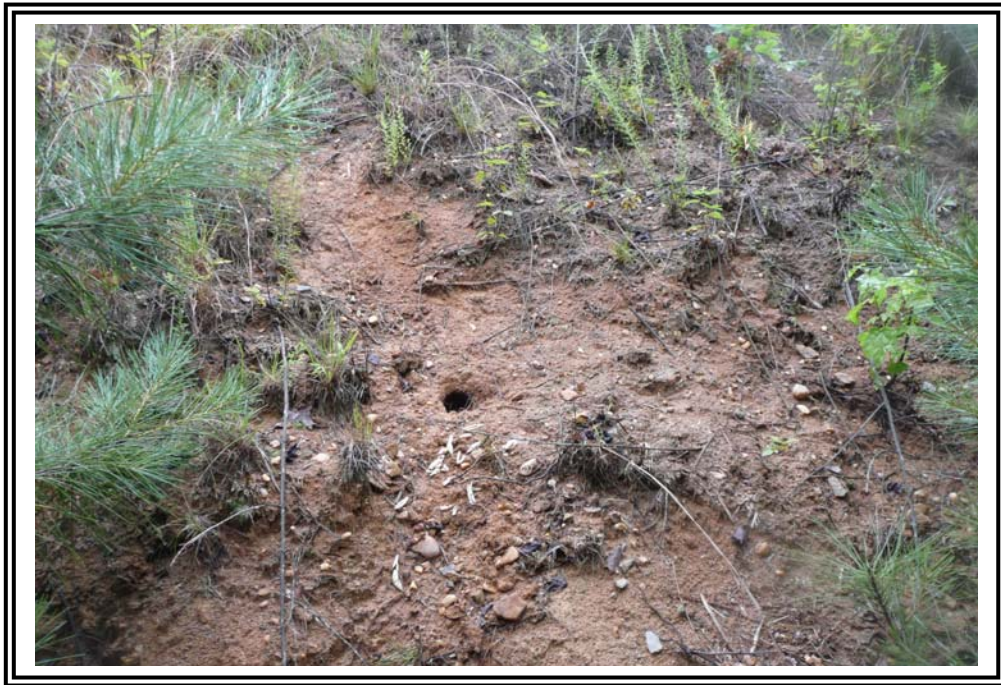
Evidence of soil disturbance from animal activity was observed in a few locations. Photo 52 shows a slide likely resulting from beaver or muskrat activity, and Photo 63 shows an animal burrow.

Evidence of animal burrow at the south end of the 1978 Ash Pond Dike.

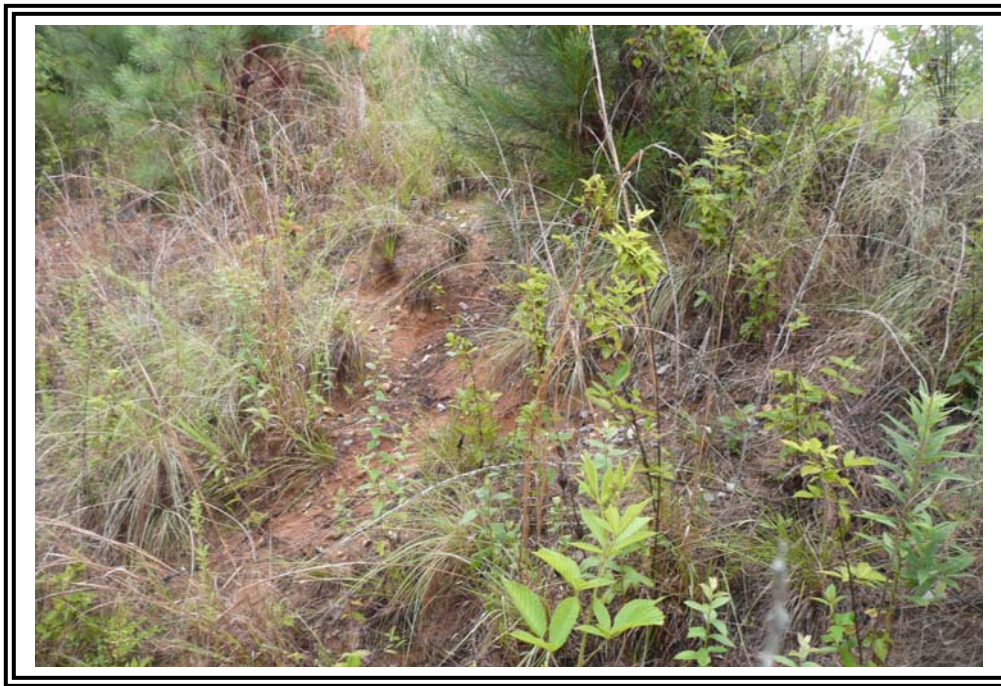
64

Example of erosion around sparse surface vegetation at the south end of the 1978 Pond.

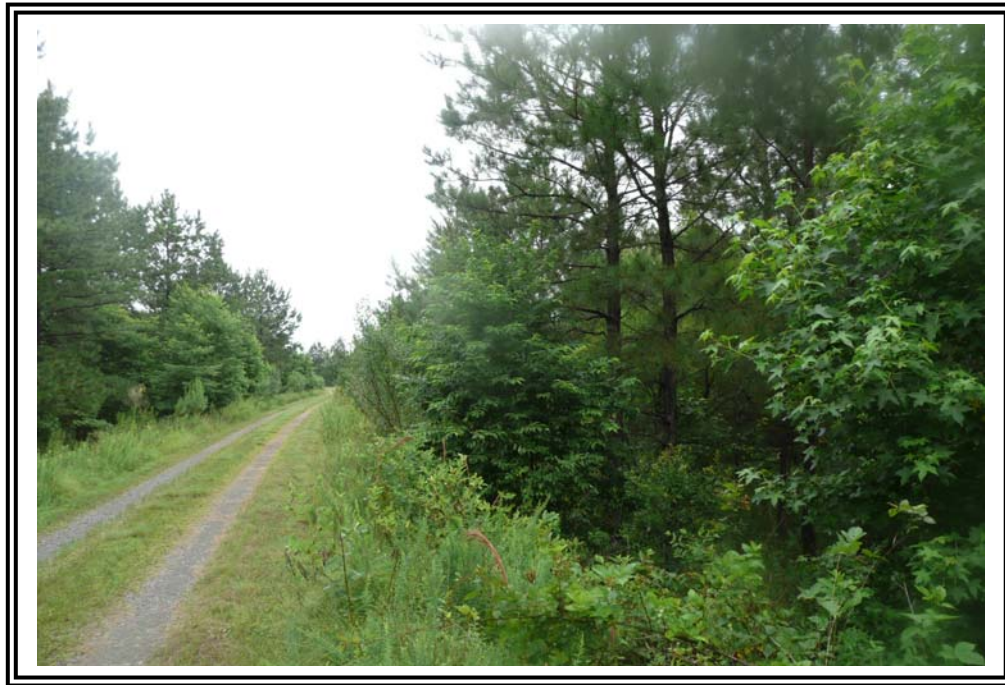
65

West Dike of 1978 Ash Pond shared with 1963/1970 Ash Ponds. Looking north, trees on either side are growing in deposited ash within the 1970 (left) and 1978 (right) ponds.

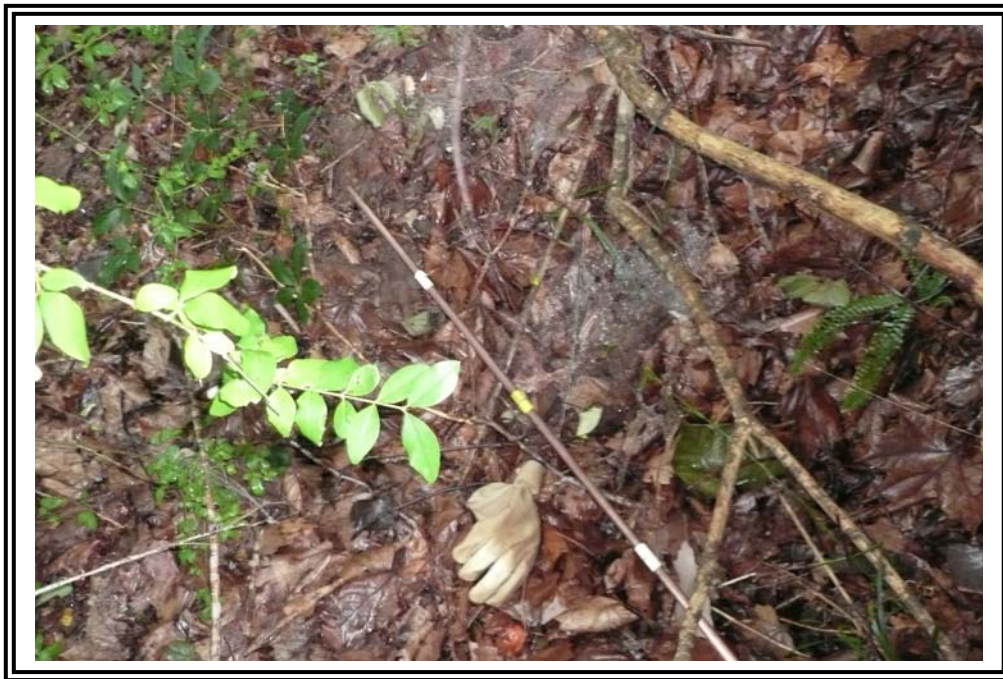
82

Erosion feature along 1970 Ash Pond west dike toe. Work glove placed below 4' probing rod supported at edge of feature for scale purposes.

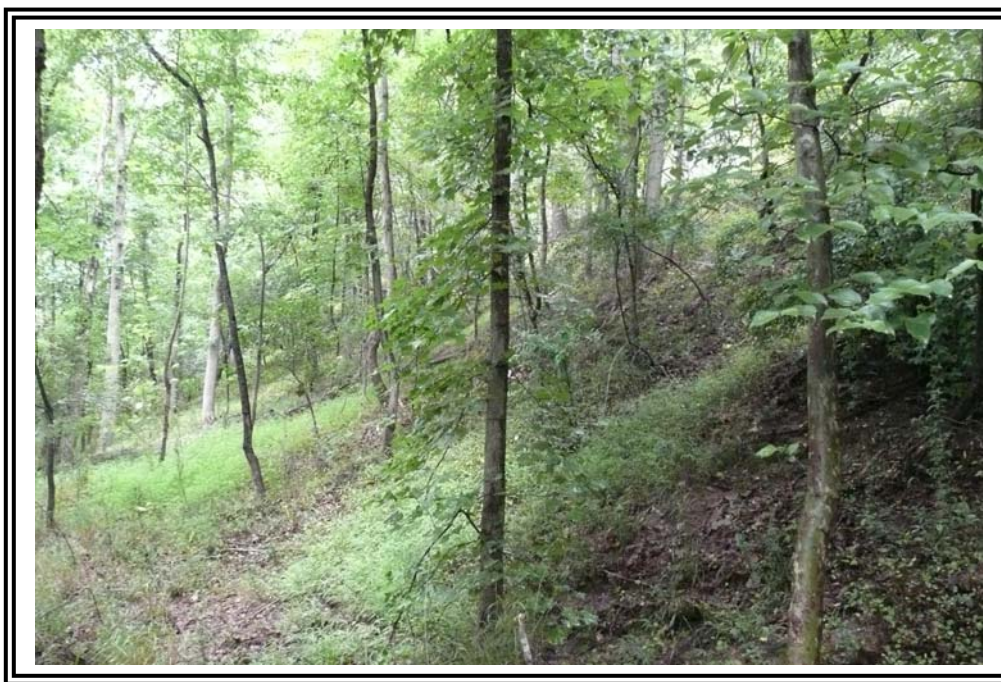
86

Steepened conditions on 1963 Ash Pond west dike from surface erosion and sloughing.

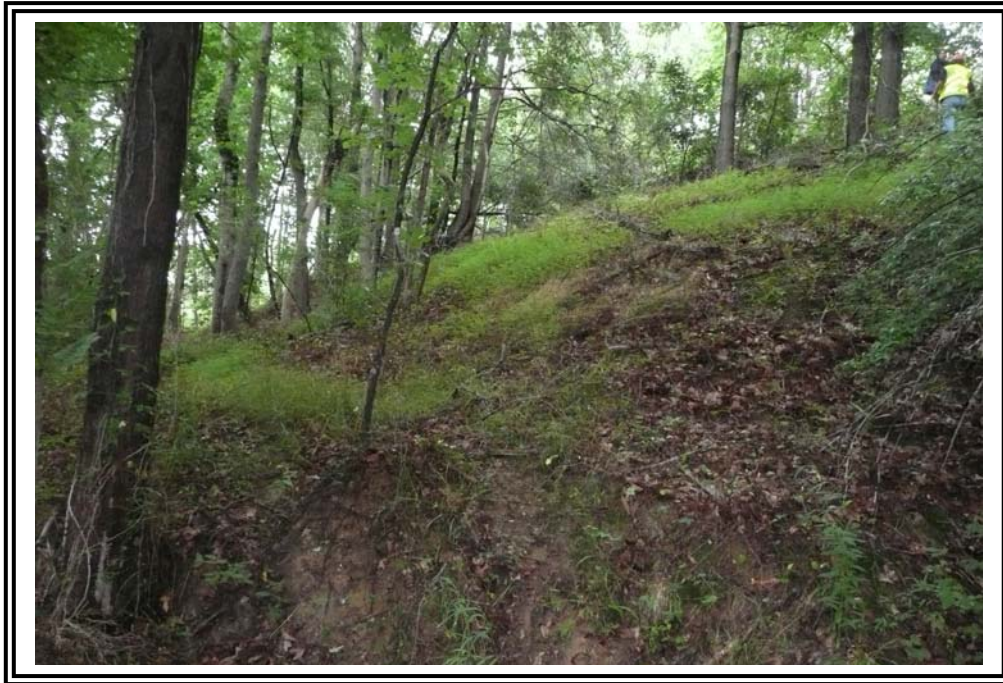
87

Steepened conditions on 1963 Ash Pond west dike from surface erosion and sloughing.

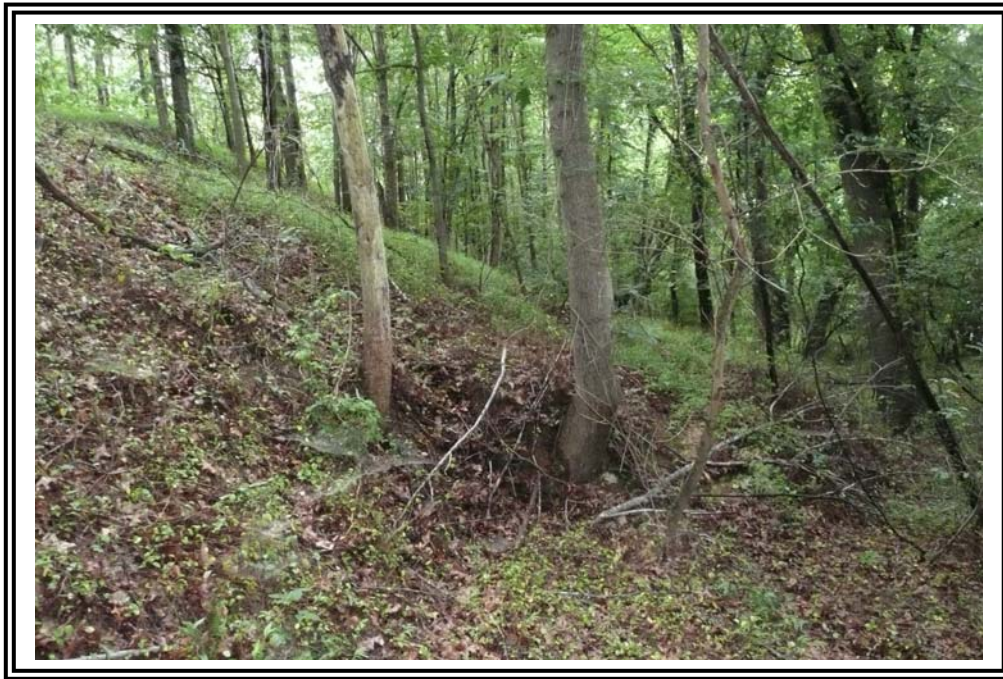
88

In 1982, a slope failure occurred on the north end of the west dike in the 1963/1970 ash pond adjacent to the Cape Fear River. According Progress Energy Carolinas' engineering consultant (MACTEC), at that time it was proposed to repair the failure with a rip-rap berm placed at the dike toe on the banks of the river channel. As the repair was being implemented, construction activity initiated additional instability and deformation (possibly localized vibratory induced liquefaction) and the work was halted with only a portion of the proposed rip-rap being placed at the river's edge and base of the dike. An independent engineering review and analysis of the failure was completed after the partial repair construction was halted and concluded that the dike was acceptable because the pond had been inactive since 1970 and the dike was impounding mostly sedimented ash.

Steepened conditions on 1963 Ash Pond west dike from surface erosion and sloughing from the partially repaired 1982 slide.

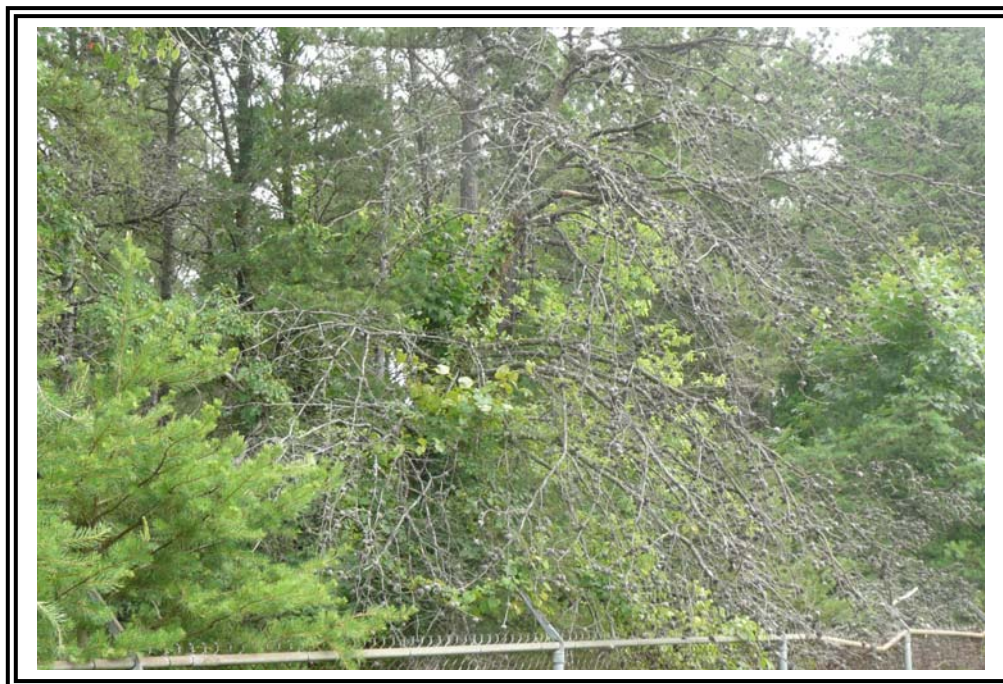
94

1956 Ash Pond from the south Dike, looking north.
Note: This pond does not contain free water and is overgrown with trees.

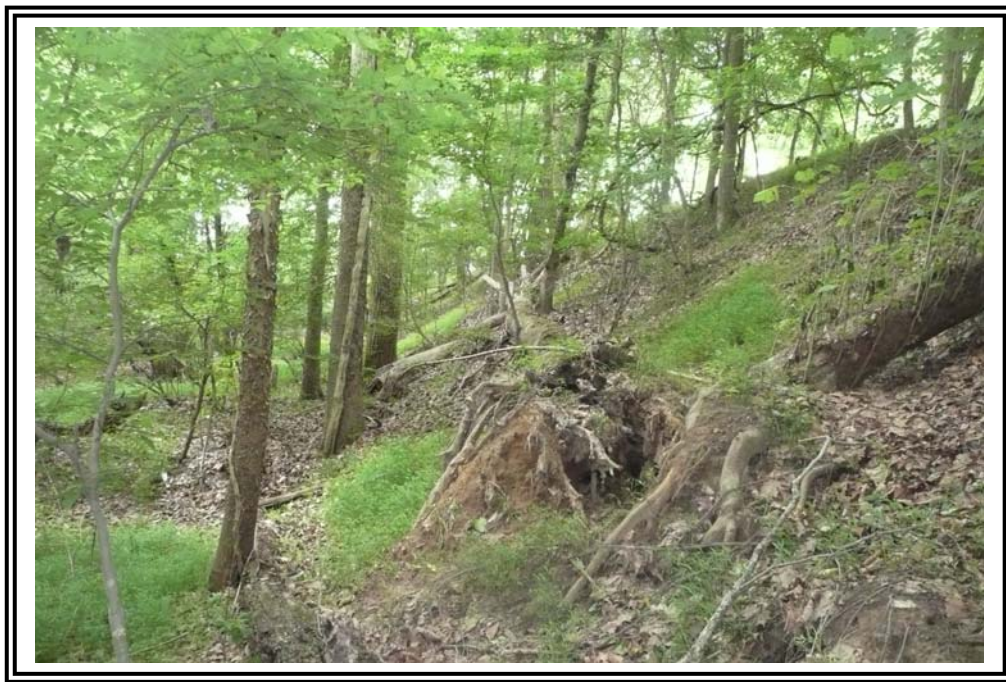
101

Along the northwest to east sides of the 1956 Ash Pond there is 3 to 8 feet of freeboard between the top of the deposited ash and the crest of the dikes. The downstream slopes are severely eroded, have experienced fallen (uprooted) trees, and sloughing. Examples of these conditions and the resulting steepening of the downstream slopes are shown in Photos 98 through 101, and 103.

Uprooted tree on the 1956 Ash Pond Dike.
