**CAROLINA POWER & LIGHT
MAYO ELECTRIC GENERATING PLANT**

**MAYO CREEK DAM
ASH POND DAM
PERSON COUNTY, NORTH CAROLINA**

**FIVE-YEAR INDEPENDENT CONSULTANT INSPECTION
AS REQUIRED BY
NORTH CAROLINA UTILITIES COMMISSION**

December 22, 1999

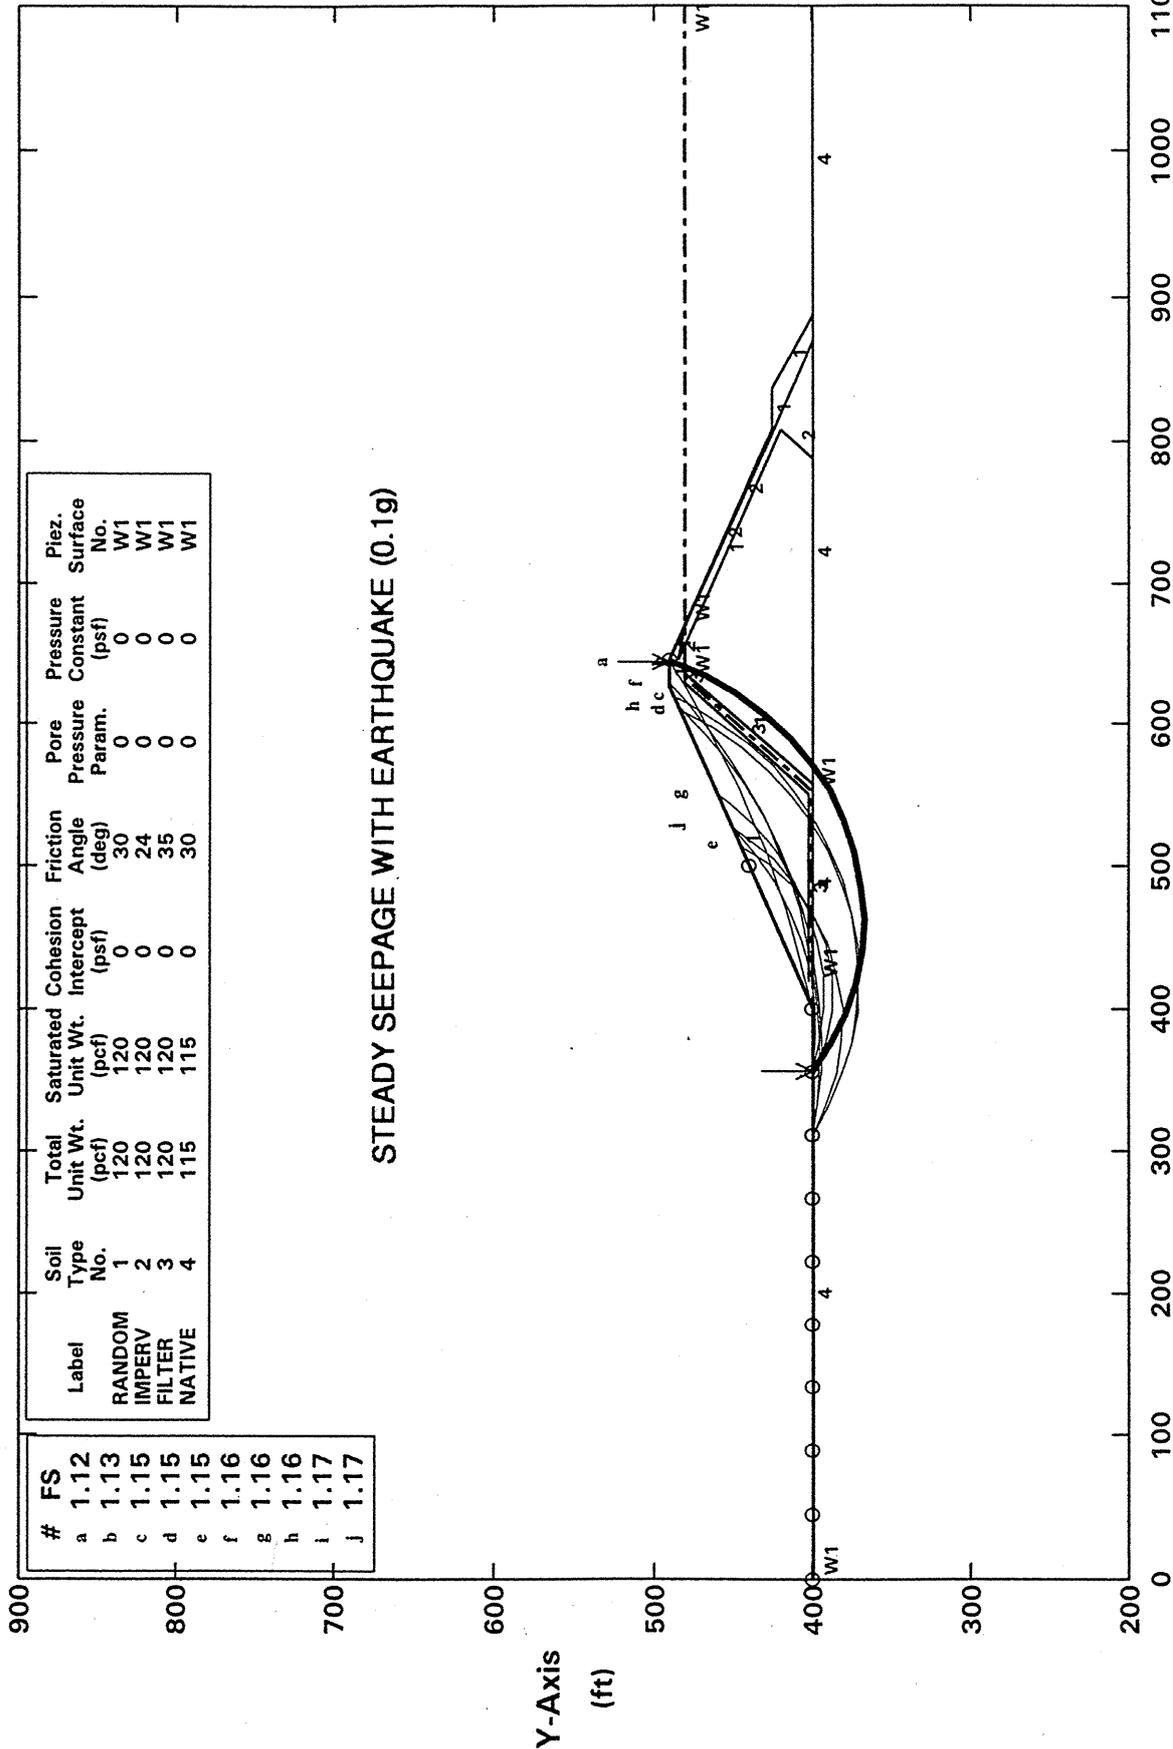
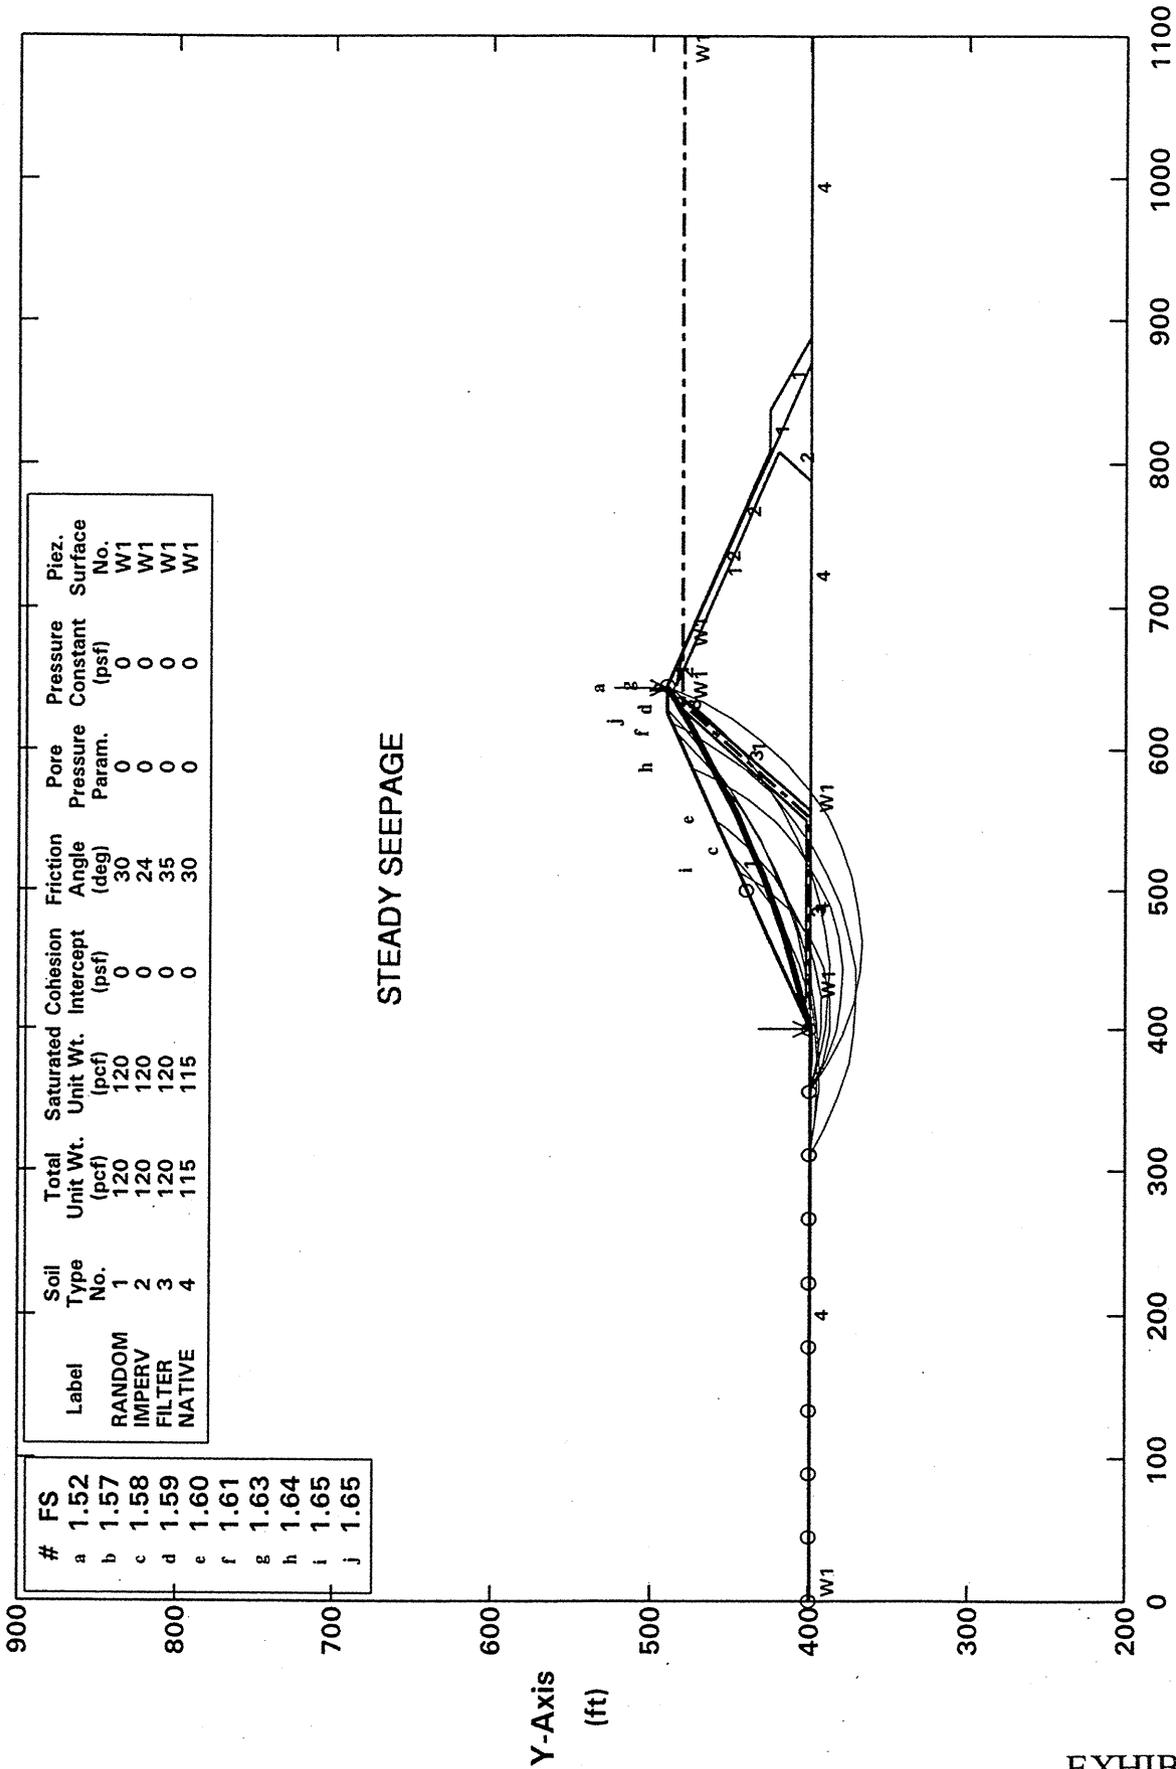
Each of the computed failure surfaces indicated a shallow, slumping-type failure.

Exhibit 29 shows the ten most critical failure surfaces for both cases.

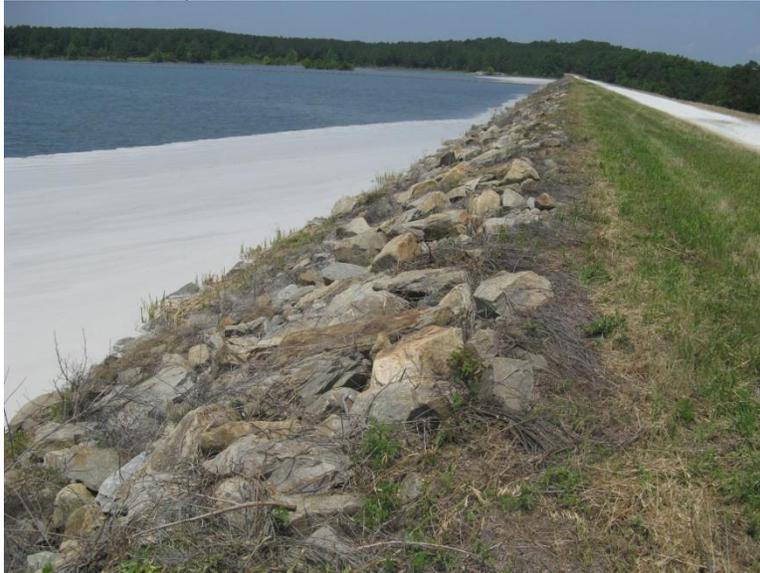
Photo 1: Upstream Embankment, Crest, Photo: 042, 6/3/09

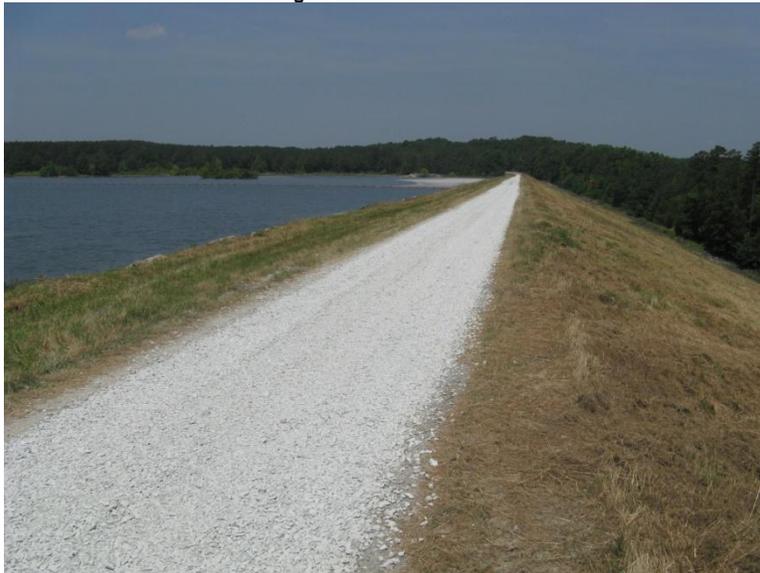
Photo 2: Crest Looking Northwest, Crest, Photo: 041, 6/3/09

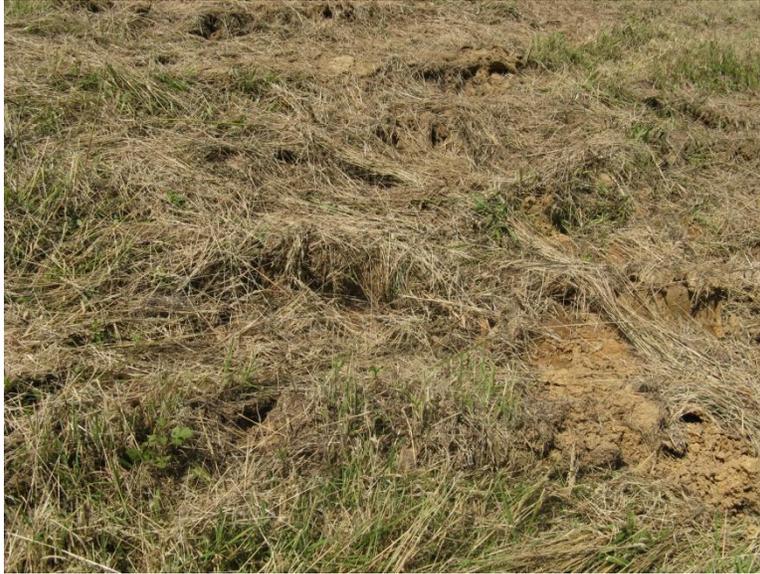
Photo 3: Bare Areas and Straw Build Up, Downstream Embankment, Photo: 004, 6/3/09

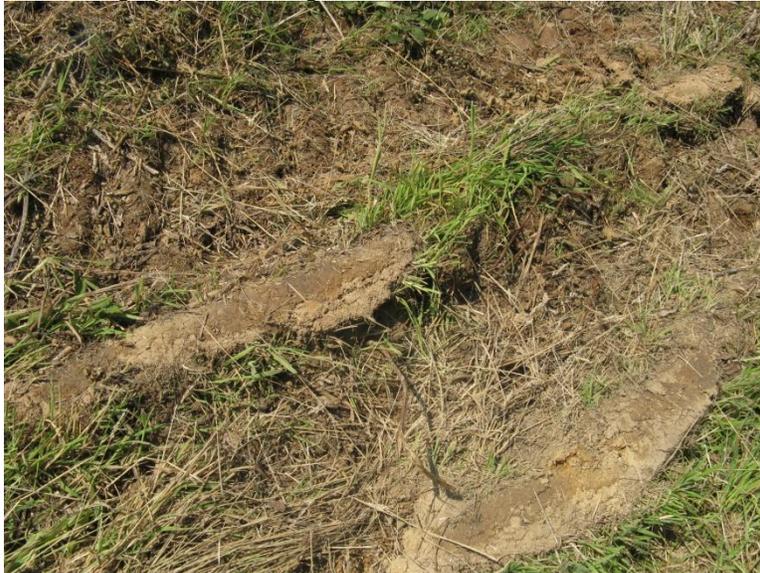
Photo 4: Mowing Equipment Rutting, Downstream Embankment, Photo: 007, 6/3/09

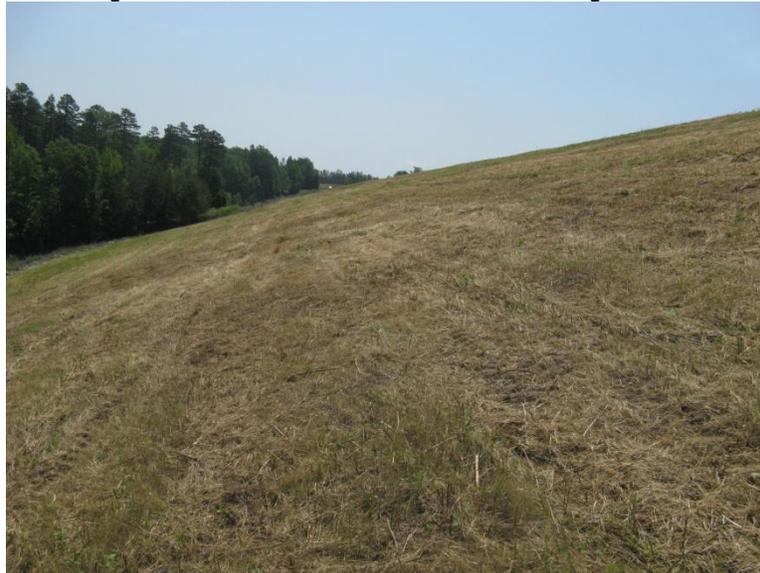
Photo 5: Embankment Looking to Right Abutment, Downstream Embankment, Photo: 036, 6/3/09
(Note right and left are referenced from observer facing downstream)

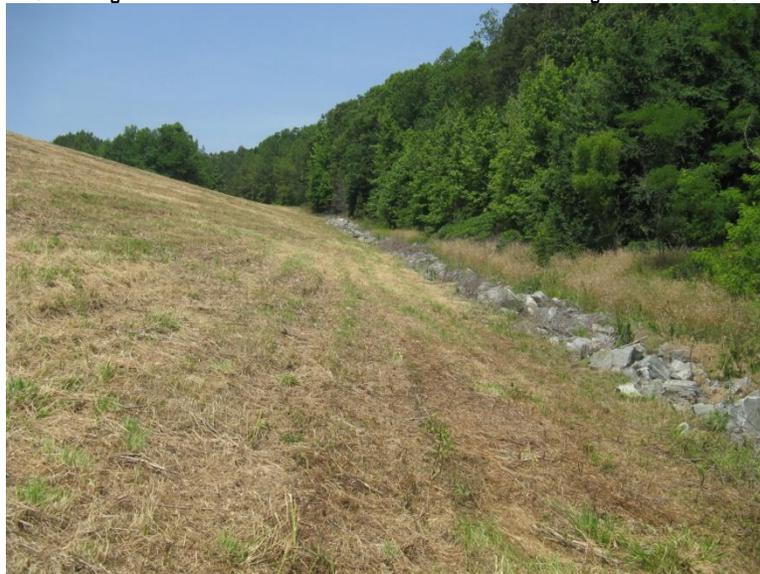
Photo 6: View of Left Groin and Embankment, Left Groin, Photo: 032, 6/3/09
(Note right and left are referenced from observer facing downstream)

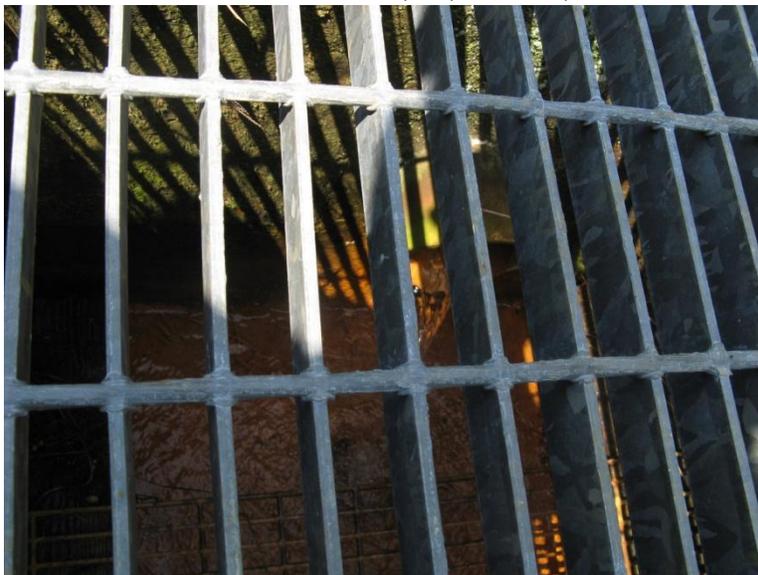
Photo 7: Internal Drain Outlet, Toe, Photo: 019, 6/3/09

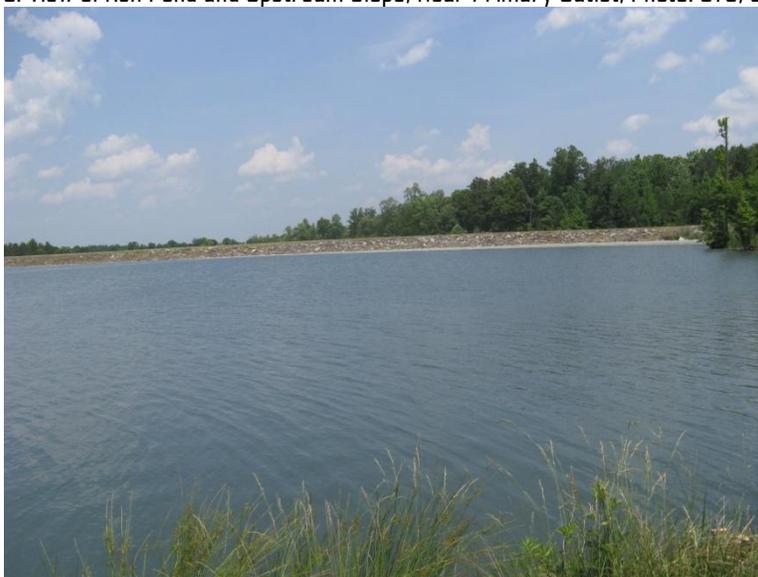
Photo 8: View of Ash Pond and Upstream Slope, Near Primary Outlet, Photo: 075, 6/3/09

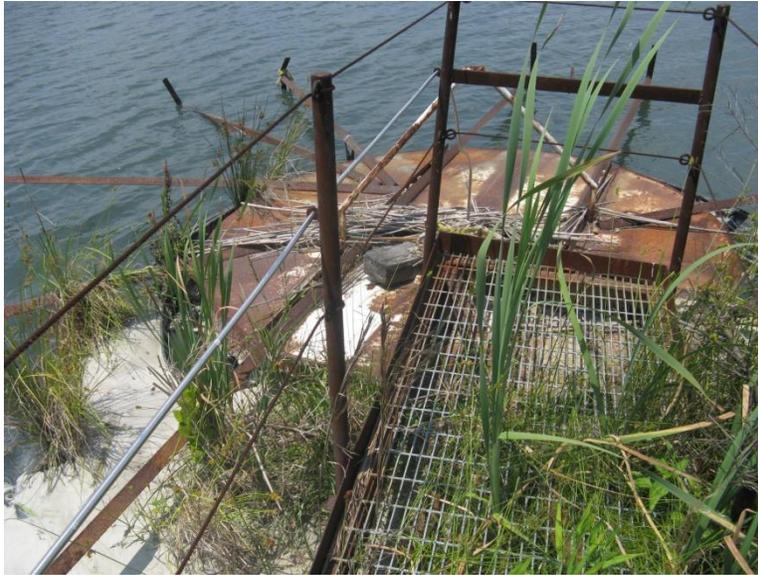
Photo 9: riser and skimmer at stilling pool, Photo: 079, 6/3/09

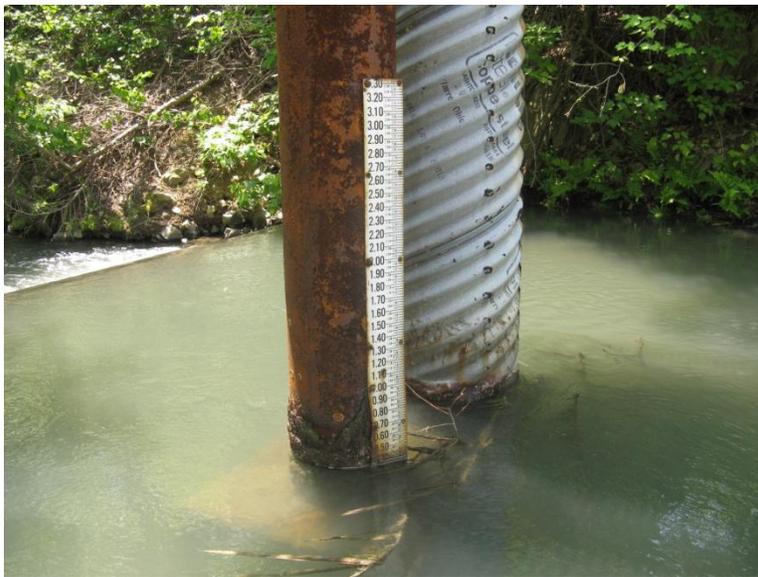
Photo 10: stilling pool staff gauge near spillway, Photo: 072, 6/3/09

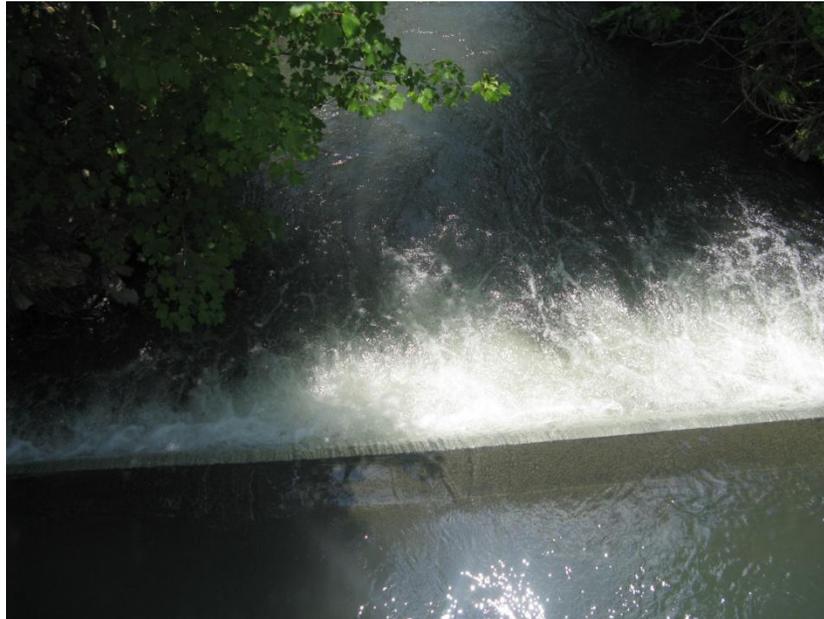
Photo 11 concrete overflow weir spillway, Photo: 068, 6/3/09

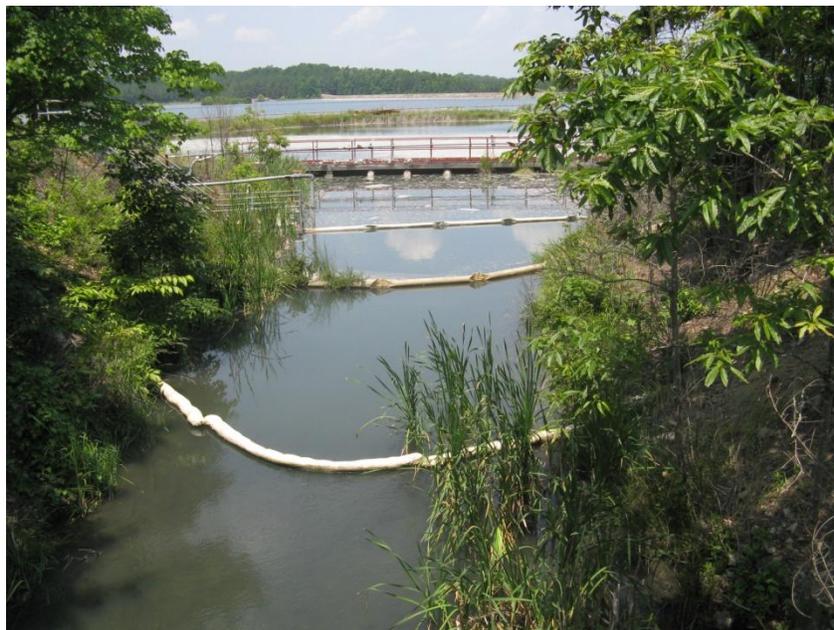
Photo 12: Downstream channel looking upstream at stilling pool with embankment dam in background, Photo: 069, 6/3/09
