### **CCW IMPOUNDMENTS INSPECTION REPORT**

#### **ROXBORO STEAM ELECTRIC PLANT PERSON COUNTY, NORTH CAROLINA**

**PROJECT NO. 09-4157  
OCTOBER, 2009**

**TRANSMITTAL  
DRAFT INSPECTION REPORT  
ASSESSMENT OF DAM SAFETY COAL COMBUSTION SURFACE IMPOUNDMENTS  
ROXBORO STEAM ELECTRIC PLANT  
PERSON COUNTY, NORTH CAROLINA**

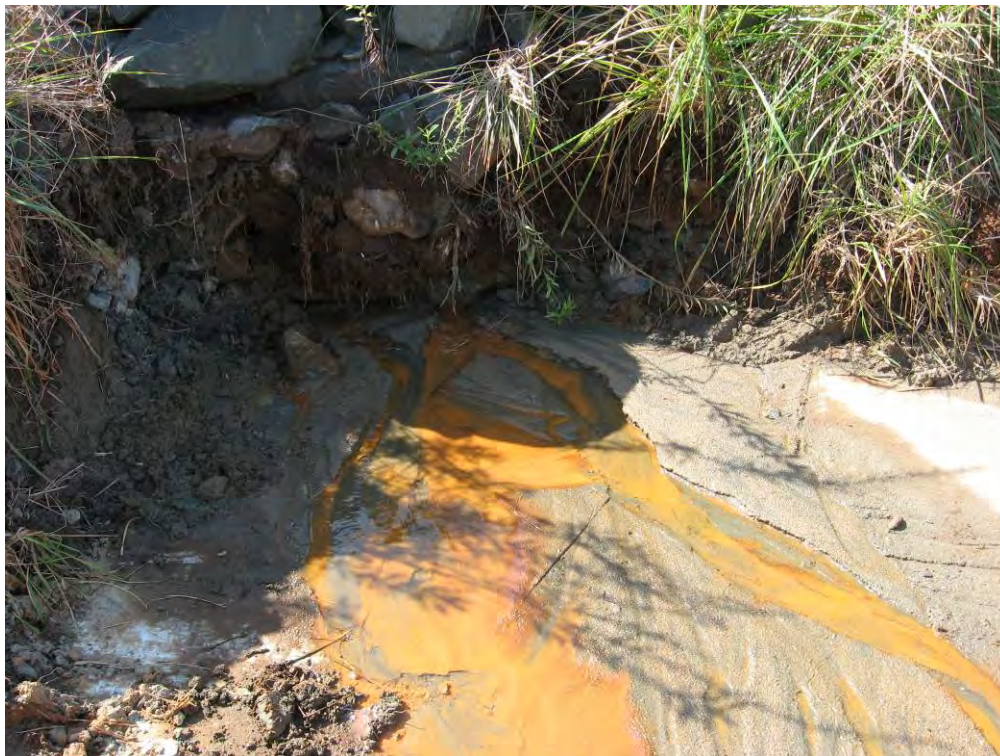
**PHOTO 3: CHIMNEY DRAIN AT TOE OF WEST ASH POND DAM**

Seepage water was clear with orange stain typical of flow from dam drainage systems in the Piedmont region. Two drains that were seeping had developed deltas of sand size materials possibly indicative of transport of fine filter material. The deltas could also be from local erosion due to the clean-out operation. The drains should be observed during the weekly inspections to determine if material is being transported from within the dam. A method to quantify the amount of seepage from each outlet is recommended.

A method to quantify the amount of seepage from the West Ash Pond Dam internal drain outlets is recommended

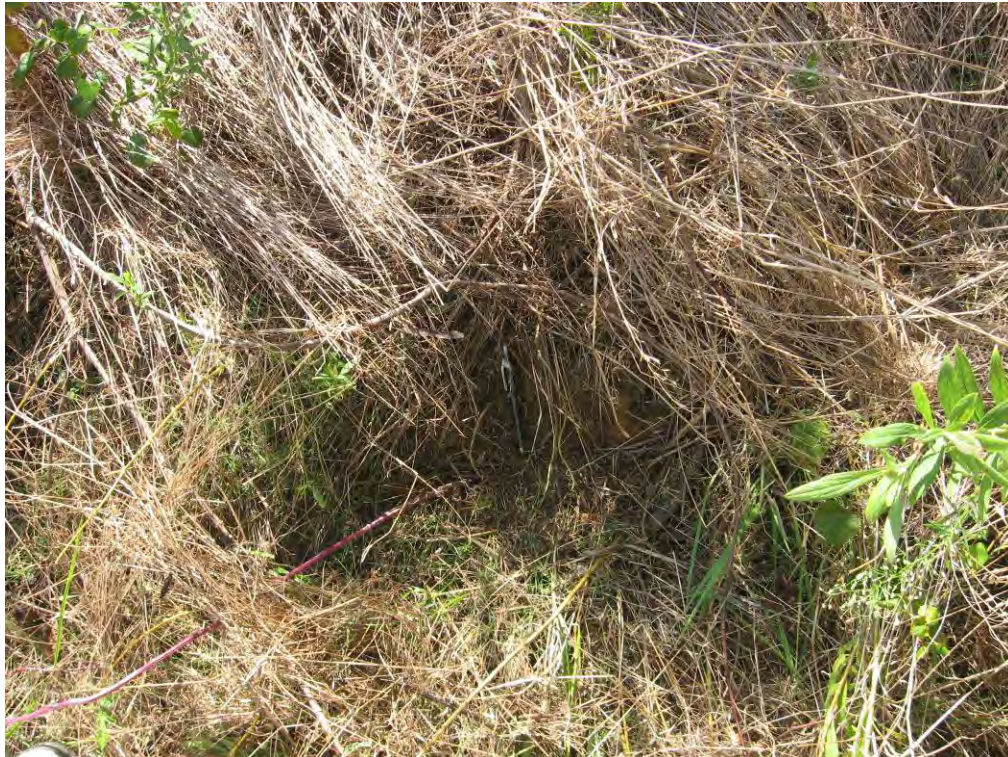
**PHOTO 5: SMALL SCARP LOCATED BETWEEN SECOND AND THIRD  
DRAIN OUTLETS OF WEST ASH POND DAM**

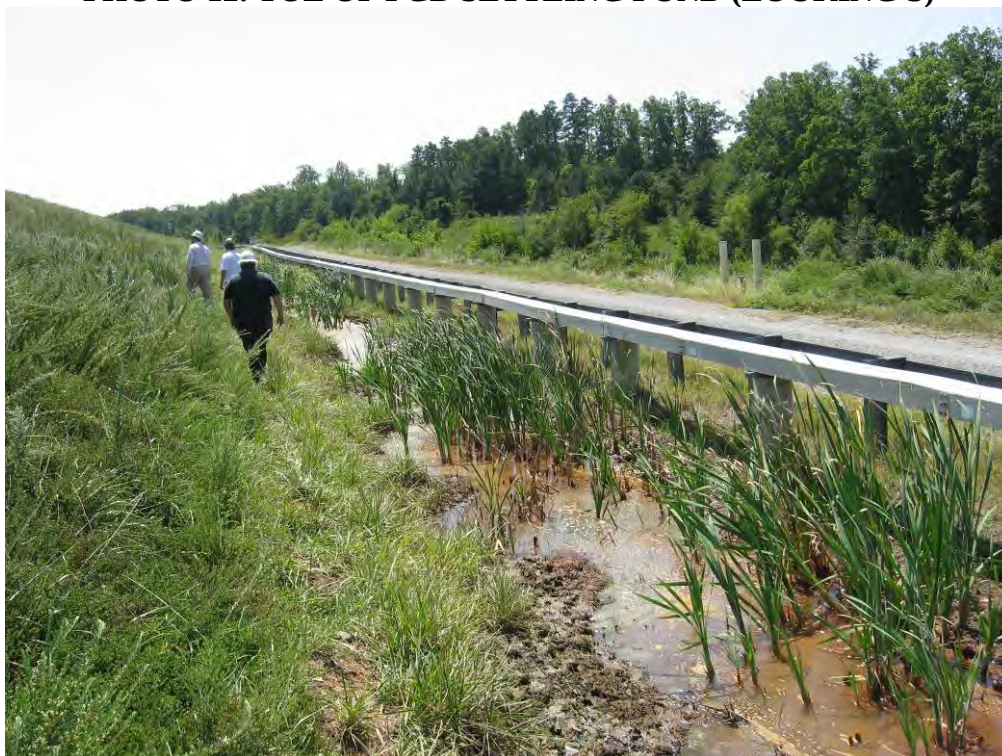
**PHOTO 12: TOE OF FGD SETTLING POND (LOOKING S)**

Seepage is present along the toe of the exterior slope. See **Photo 12, Appendix A**. This seepage is carried in a toe ditch to a sump where it is pumped back into the pond. Seepage is generally clear; however small boils and deposits of fines indicate that piping of materials is occurring. (**Photo 14, Appendix A**). Monitoring of the seepage should be continued until the repairs are initiated.

Continue to monitor the seepage at the toe of the Settling Pond Dike until the pond is taken out of service for repairs.

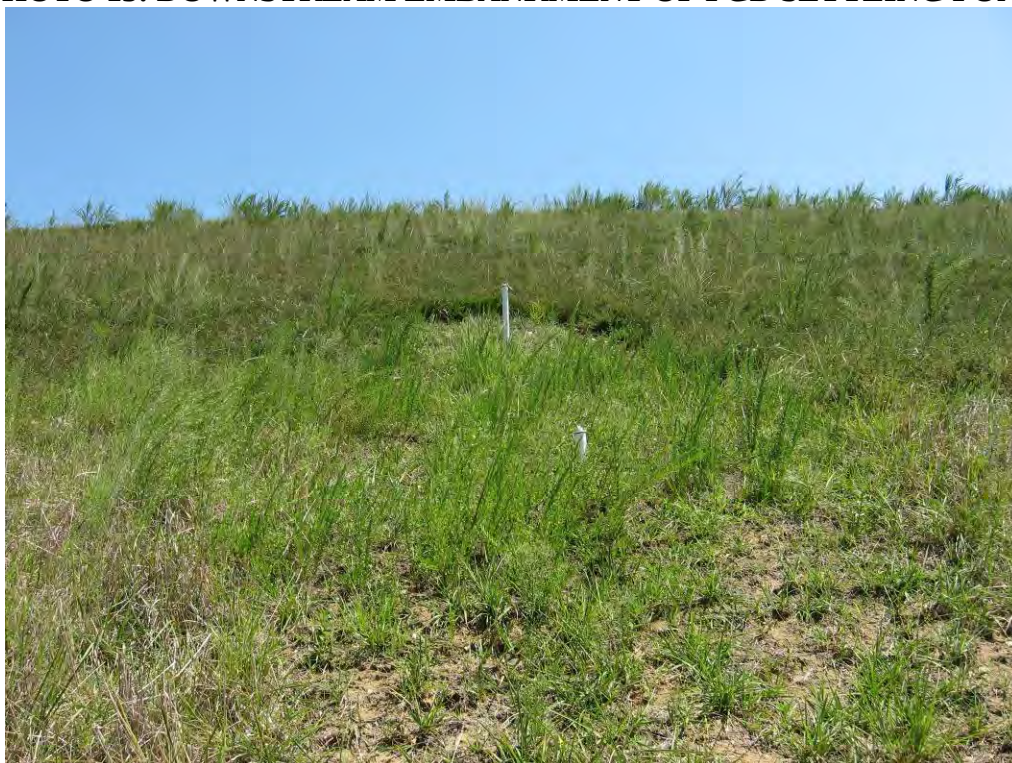
**PHOTO 13: DOWNSTREAM EMBANKMENT OF FGD SETTLING POND**

The crest of the structure has a hard surface that is relatively new and showed no signs of cracking, settlement or rutting. The interior slope is covered by riprap and appeared to be uniform with no sloughing, bulging, or scarps. The exterior slope is generally uniform and well grassed with the exception of isolated sloughs that had been patched following the seepage event. See *Photo 13, Appendix A*.

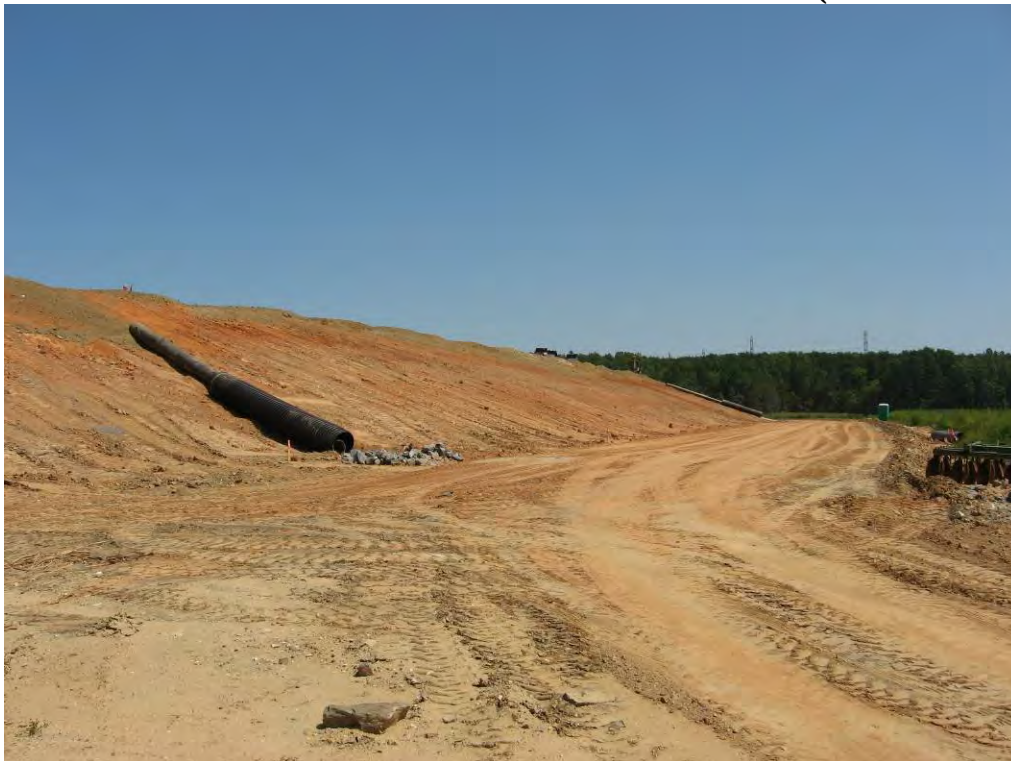
**PHOTO 16: DOWNSTREAM TOE OF FGD FLUSH POND (LOOKING NE)**

The Flush Pond is currently under construction. It was taken out of service in February 2008 when a piping failure occurred that resulted in the development of a slough in both the inside and outside slopes.

- Construction of a permanent east settling pond to hold water removed from the West Settling Pond and from plant discharge while the west pond is being repaired;
- Reconstruction of the embankment of the Flush Pond to include both a clay and synthetic liner; and
- Reconstruction of the embankment of the Settling Pond to include both a clay and synthetic liner.

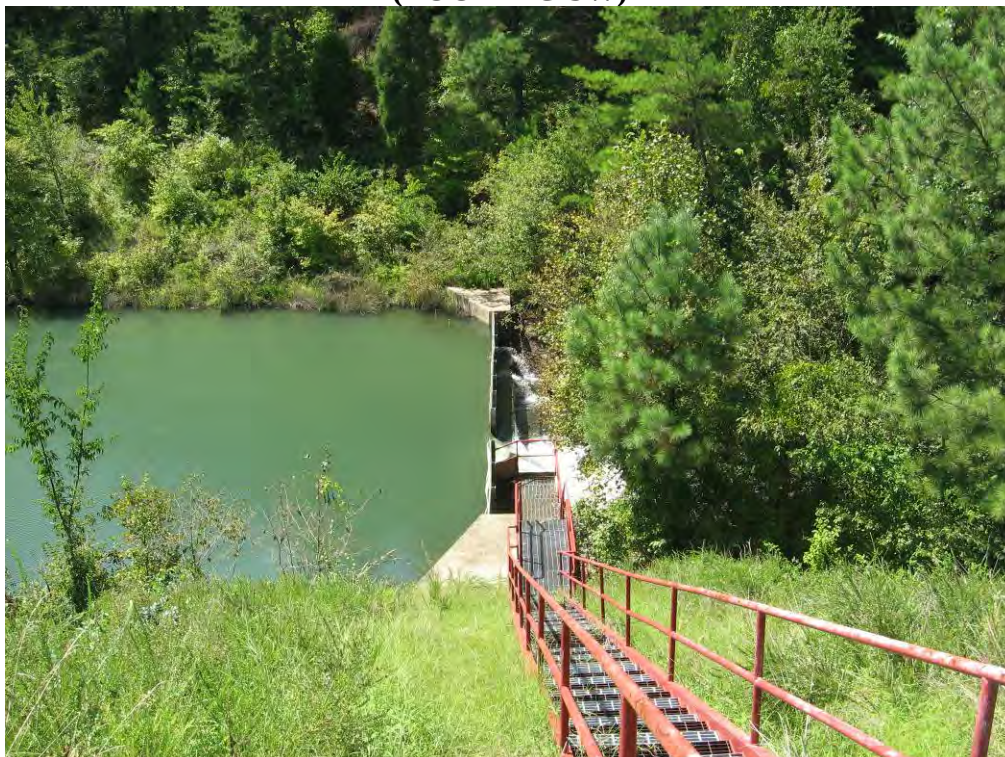
**PHOTO 26: WEST ASH POND DAM DISCHARGE WEIR STRUCTURE (LOOKING SW)**

The discharge weir structure is the NPDES Permit NC-0003425 discharge point. (See **Photo 27, Appendix A**). At the time of inspection clear water was freely flowing from the canal to Hyco Lake. Significant seepage was noted flowing from beneath the concrete abutment on the right (East) side of the structure. The flow appears to be coming through the rock foundation. The *2007 Report of Limited Field Inspection* by MACTEC noted this concern and offered assistance in developing and implementing a repair plan for the condition. RIZZO recommends that this action be taken along with monitoring the flow on a monthly basis concurrent with existing scheduled inspections.

Follow-up to developing and implementing a repair plan for the seepage at the NPDES Discharge Point.
