**Coal Combustion Residue Impoundment
Round 9 - Dam Assessment Report**

Weatherspoon Steam Electric Plant

Ash Pond Embankment

Progress Energy Carolinas, Inc.

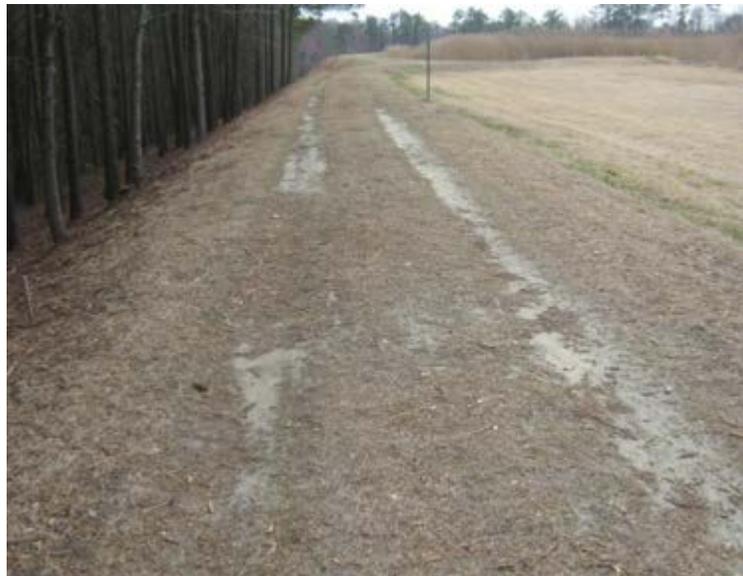
The crest had no signs of depressions, tension cracking, or other indications of settlement or shear failure and appeared to be in satisfactory condition; however, there were signs of minor rutting most likely from vehicular traffic.

Crest showing minor rutting – Northern Ash Area

- Installed animal guards at toe drains
- Began monitoring seepage along downstream toe along southern, eastern and western dikes
- Repaired rutting along crest
- Addressed standing water within roadside ditches downstream of toe

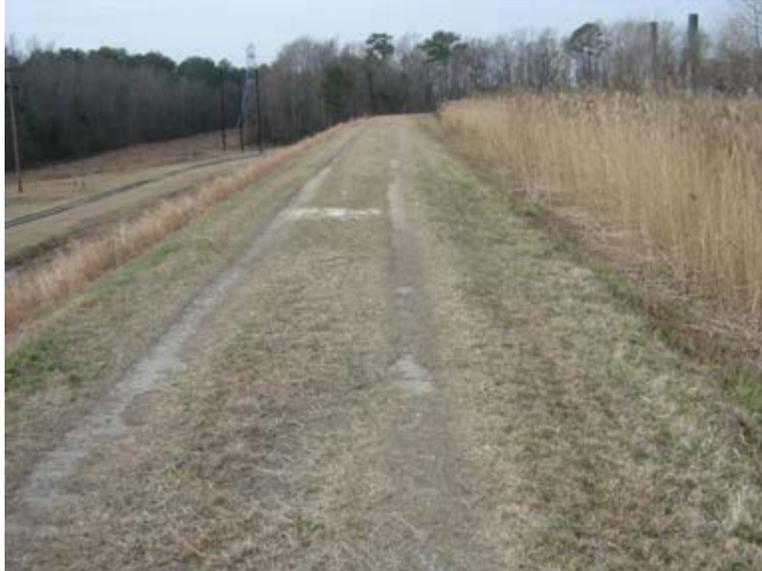
The crest had no signs of depressions, tension cracking, or other indications of settlement or shear failure and appeared to be in satisfactory condition; however, there were signs of minor rutting most likely from vehicular traffic.

Crest - Southern Ash Area

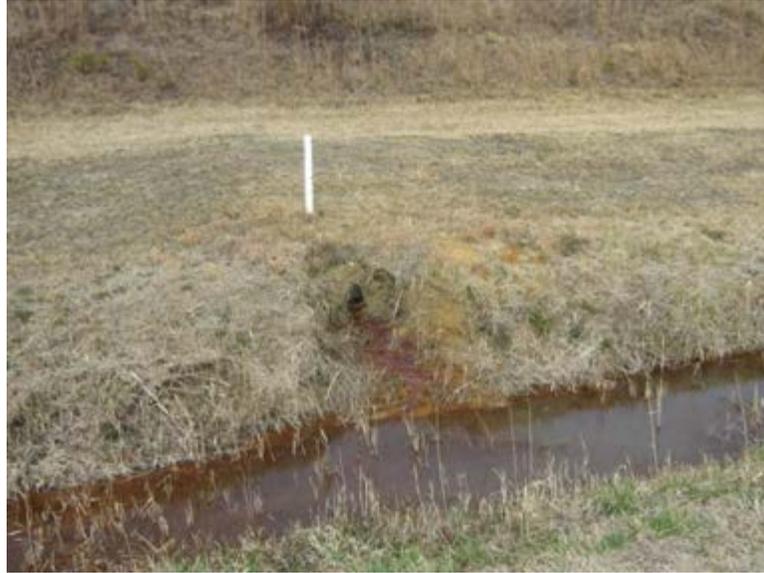
No scarps, sloughs, depressions, bulging or other indications of slope instability or signs of erosion were observed. It is recommend the power plant install animal guards for the toe drains. Seepage was observed at a few locations and this needs to be monitored.

Toe drains – Southern Ash Area

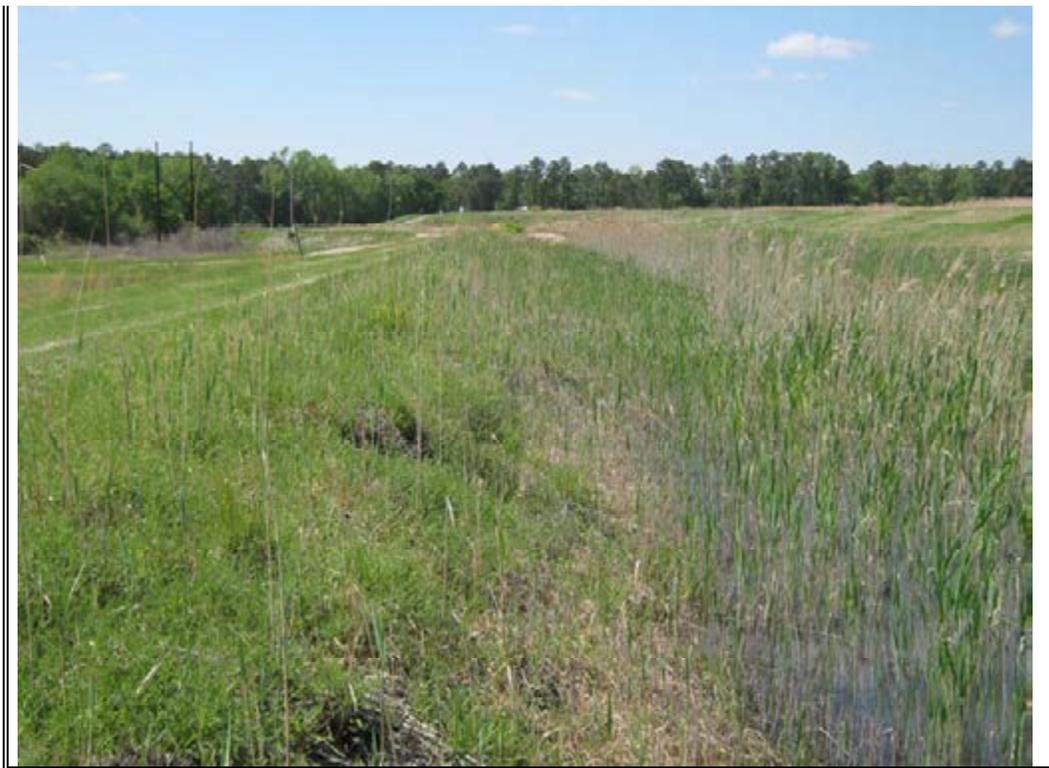
Photograph 16: Interior slope – Southern Ash Area, west dike.

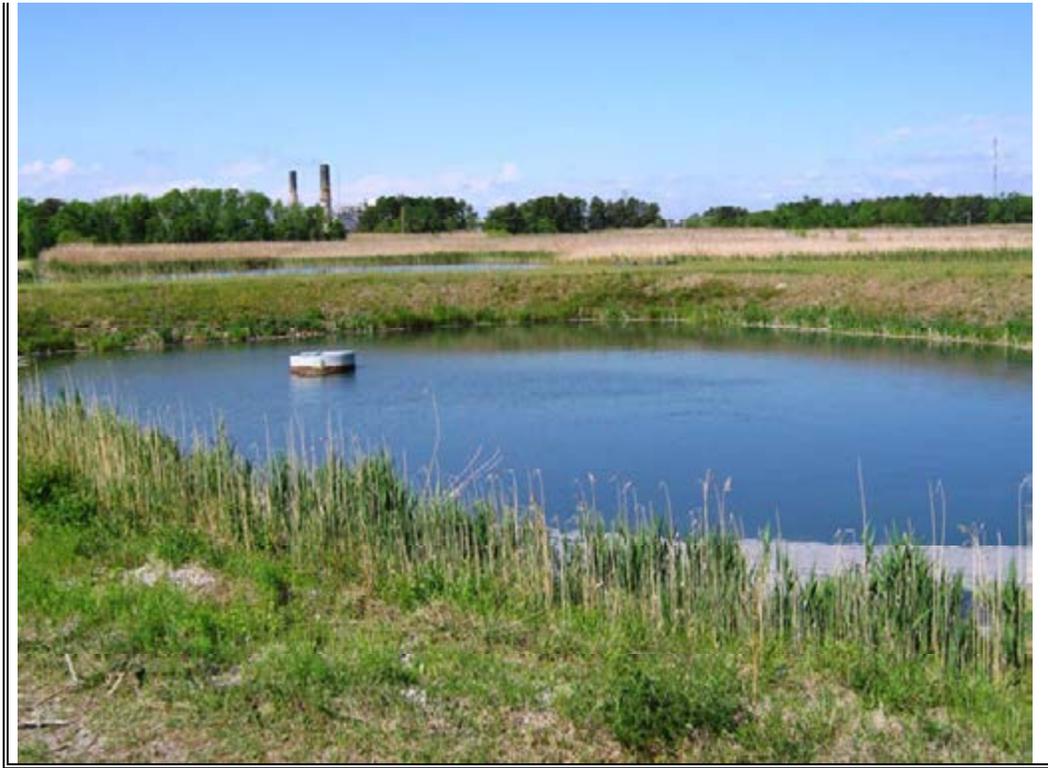
Photograph 17: Interior slopes and skimmer, settling basin – Southern Ash Area.

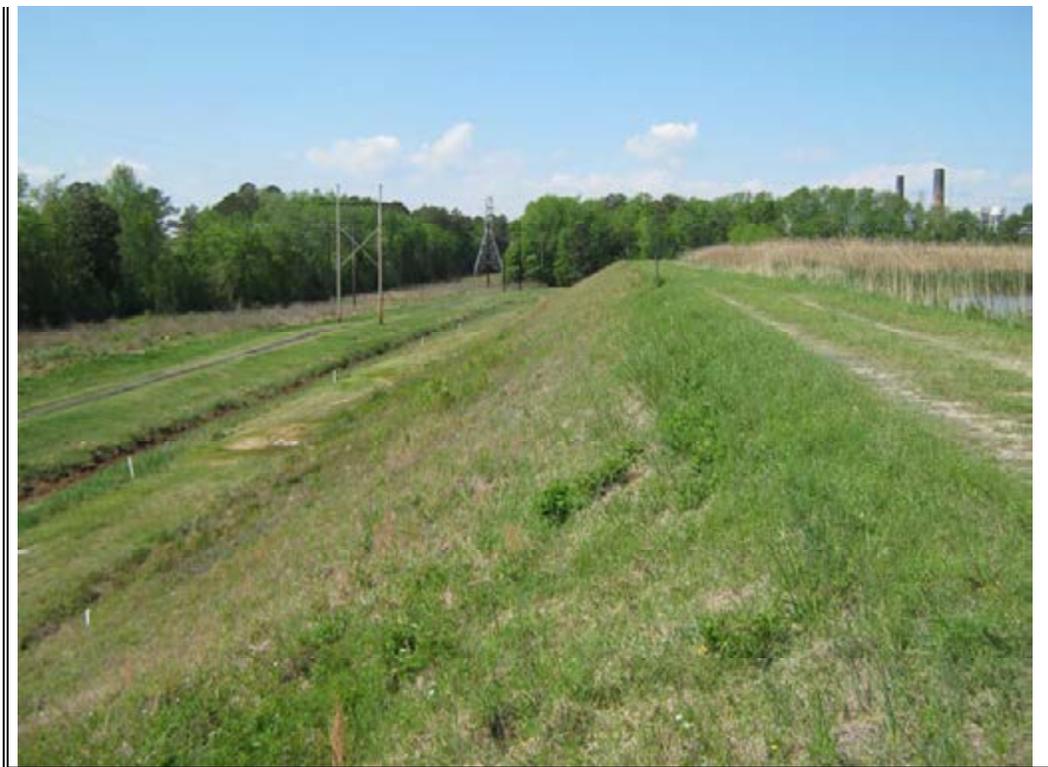
Photograph 20: Exterior slope and toe road – Southern Ash Area, south dike.

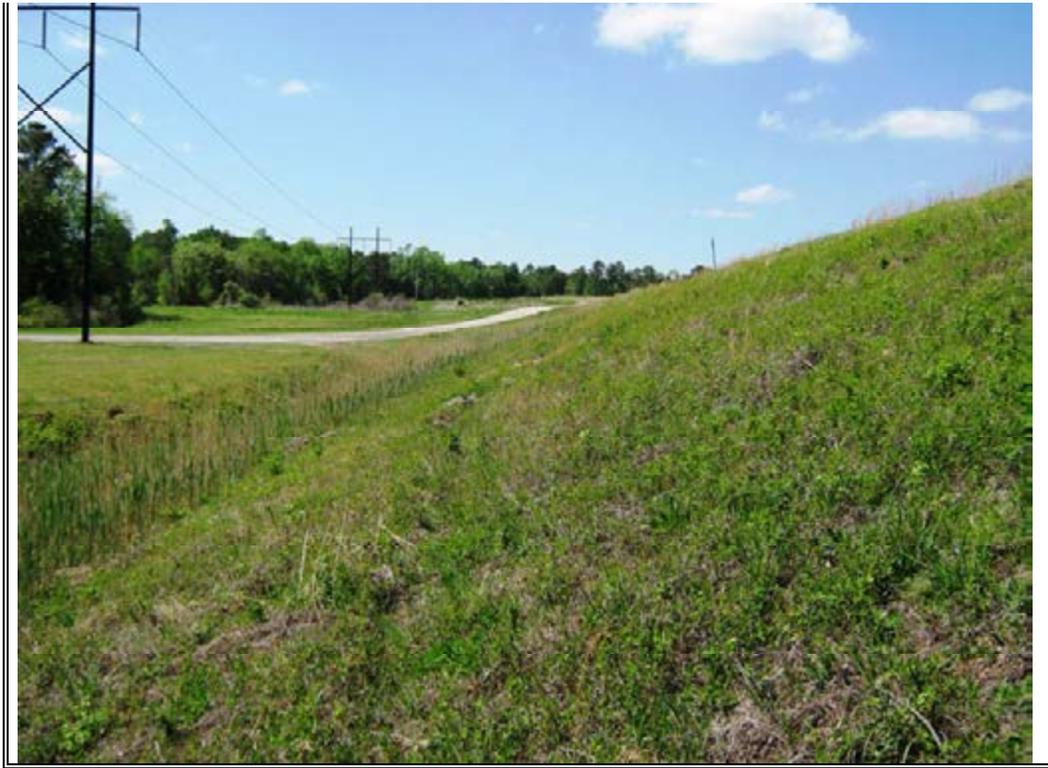
Photograph 21: Exterior slope – Southern Ash Area, west dike.
