Coal Combustion Residue Impoundment

Round 9 - Dam Assessment Report

Cross Generation Station

Santee Cooper

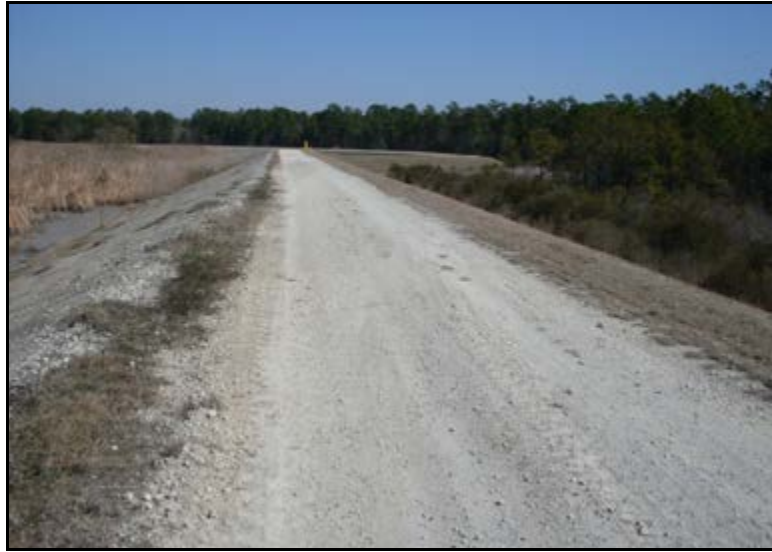
A typical view of the perimeter dike embankment crest of Bottom Ash Pond 1 is shown in Photograph 5.1. The limerock-surfaced crest appeared to be in satisfactory condition with no major sags, depressions, or other signs of significant settlement. No tension cracks which might suggest soil shear failure were observed in the crest or along the edge of the crest. The crest of the dike on the northeast side of Bottom Ash Pond 1 is shown in Photograph 5.2, as viewed from the southeast end toward the location of the notch spillway through this dike. A sparse grass cover has become established on this part of the crest, apparently due to low traffic on this dead-end section. The grass appeared to be maintained.

Photograph 5.1. View of crest and inside slope, southeast side looking northeast.

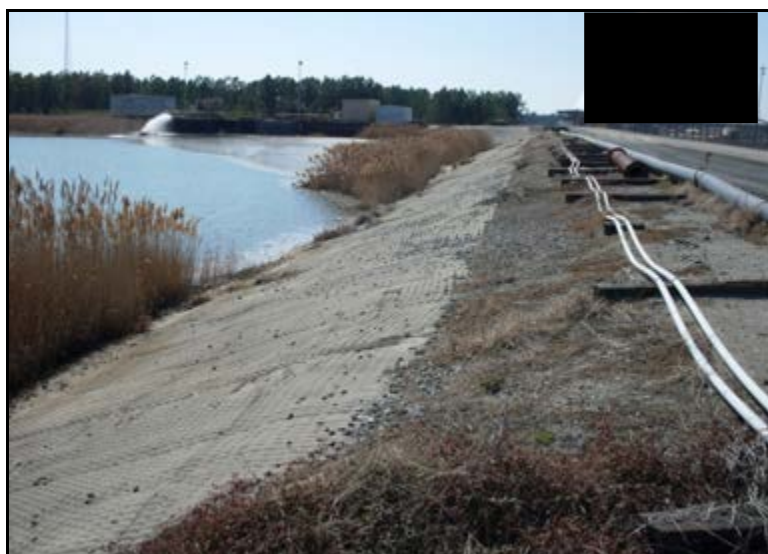
A typical view of the upstream slope of Bottom Ash Pond 1 is shown in Photograph 5.3. (Note the wider crest with pipelines on the northwest side of Bottom Ash Pond 1.) The Fabriform revetment that overlies the original riprap on the upstream slope was observed to have slight unevenness in its surface, but it appeared to be sound and generally free of

deterioration. Patches of vegetation (primarily the reed, Phragmites) were observed on the upstream slopes, generally along and just above the water line or ash sediment line. No slumps, slides, or other signs of shear failure were observed in the visible parts of the slopes above the water surface or ash surface.

Photograph 5.3. Typical view of inside slope, northwest side looking southwest.

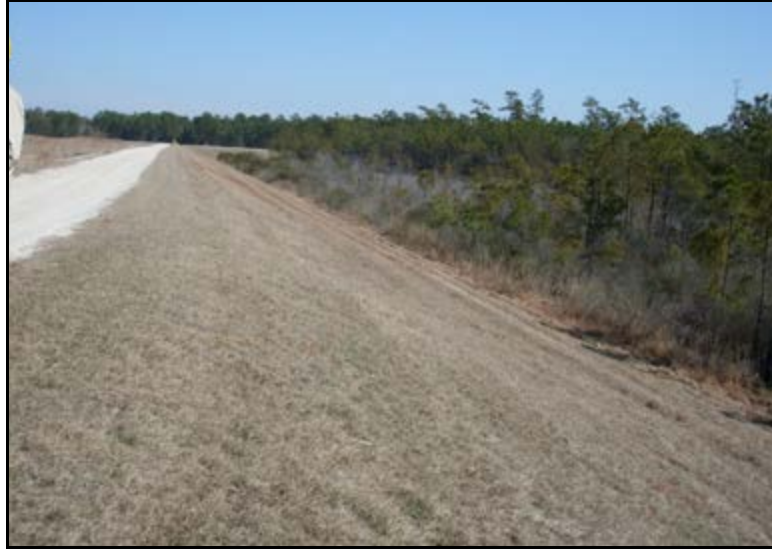
Photograph 5.4. Typical view of outside slope, southeast side looking northeast.

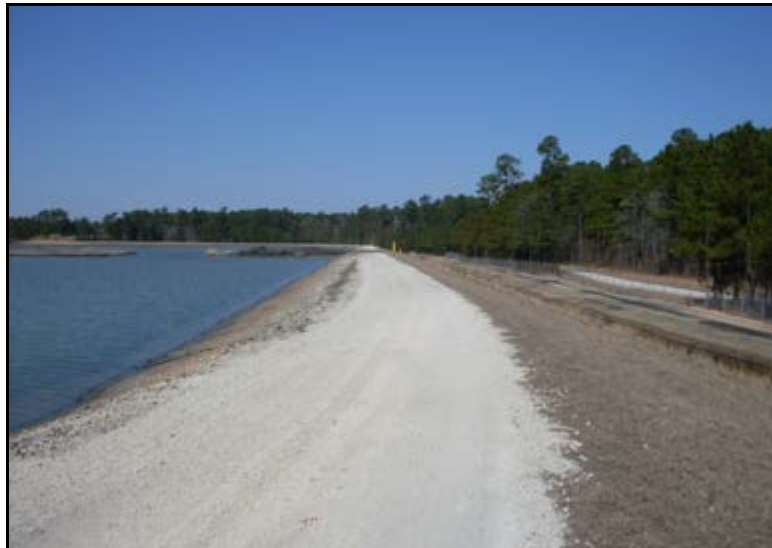
Typical views of the perimeter dike embankment crest of Bottom Ash Pond 2 are shown in Photographs 5.6a and 5.6b. The ash finger dike in the pond is visible in Photographs 5.6a. The limerock-surfaced crest was observed to be in satisfactory condition. No major sags, depressions, or other signs of significant settlement were observed in the crest. No tension cracks or other signs of insipient mass soil movement were observed in the crest or along the edge of the crest.

Photograph 5.6a. Typical view of crest and inside slope, northeast side looking northwest.

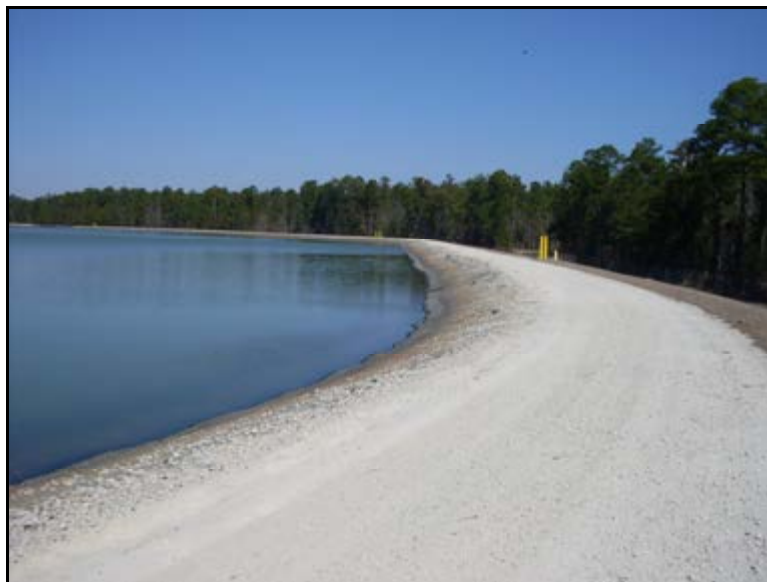
Photograph 5.6b. Typical view of inside slope and crest, east side looking north.

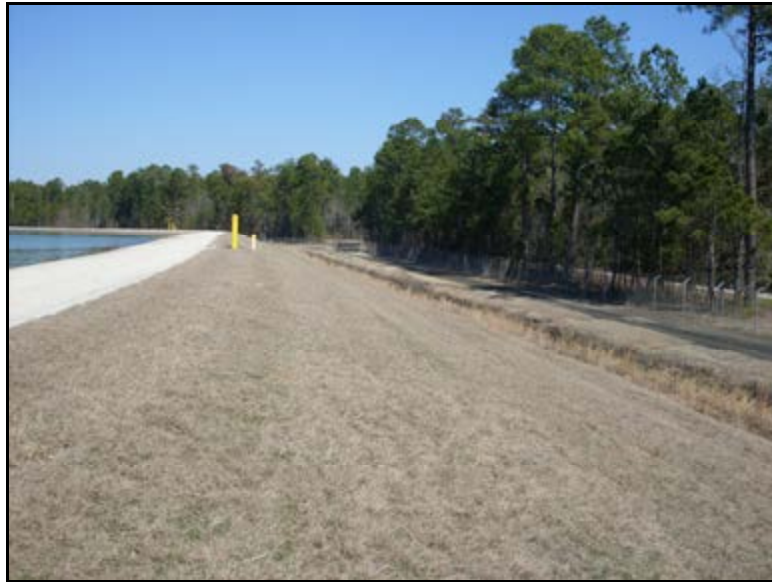
Photograph 5.7a. Typical view of outside slope and toe, east side looking north.

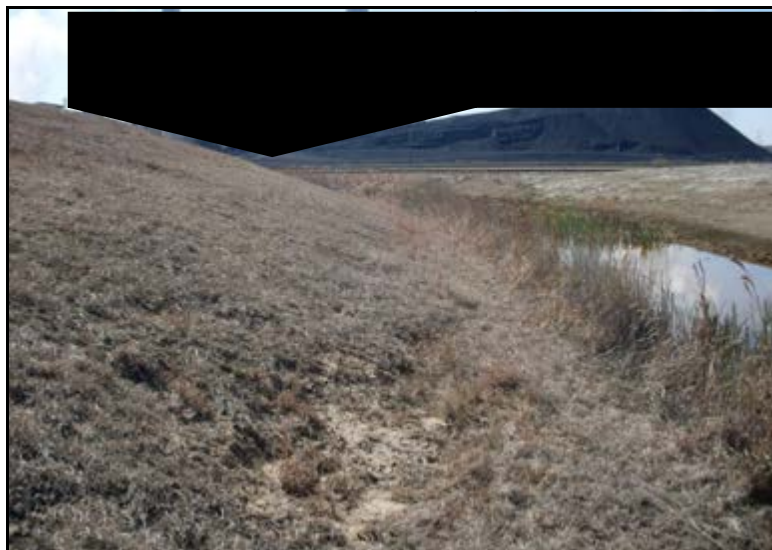
surface runoff or disturbance of mowing equipment was observed at a number of locations, typically along the toe, as shown by a typical view in Photograph 5.7b. Santee Cooper personnel indicated that topsoil was not used on the outside slope for vegetation establishment. No areas of major erosion were observed. No obvious signs of slumps, slides, bulges, tension cracks, seepage, or animal holes were observed on the outside slope.

Photograph 5.7b. View of outside slope and toe, northwest side looking southwest.

A water-filled perimeter ditch is located along the outside toe, which restricts access of mowers. Therefore, tall grass was observed to typically occur along the toe (see Photograph 5.7b). There were no obvious signs of seepage from the toe.

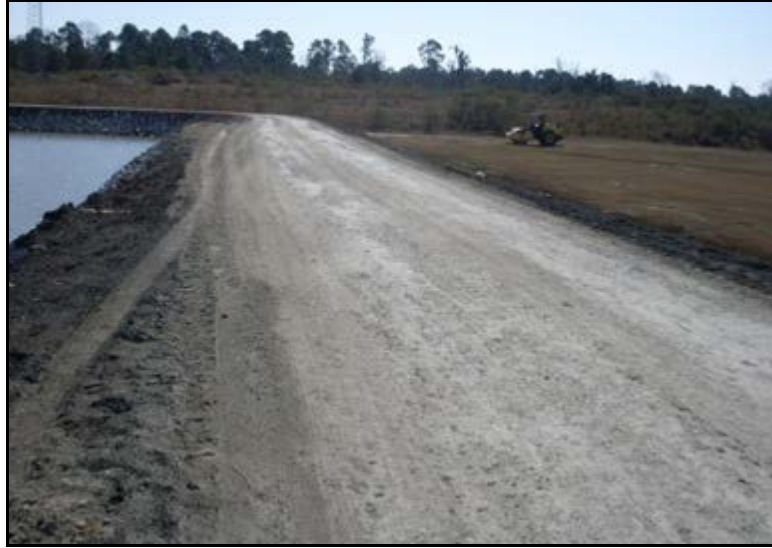
Photograph 5.8. Typical view of crest, southwest side looking southeast.

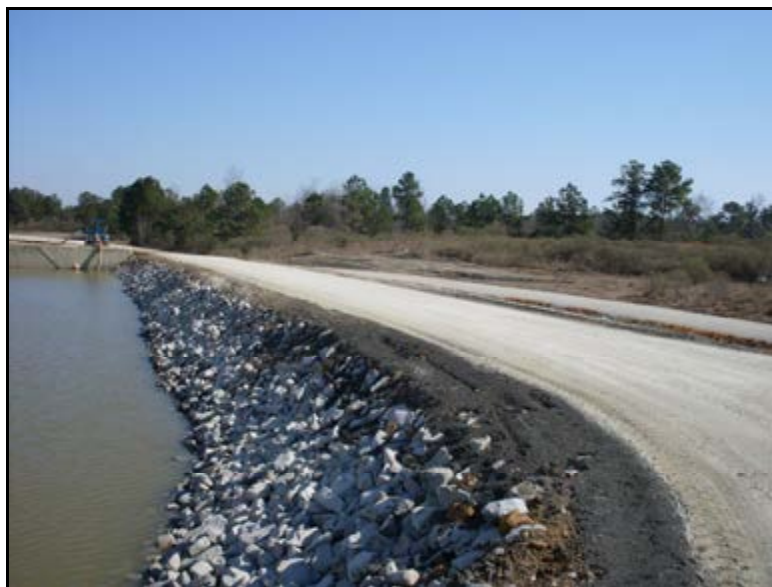
The slope of the riprap above the water level appeared steeper than the 3H to 1V design slope of the embankment. The slopes of the finger dike within the pond were observed to be bare earth. No slumps, slides, or other signs of shear failure were observed in the visible parts of the slopes above the water surface.

Photograph 5.9b. Typical view of inside slope, southeast side looking northeast.

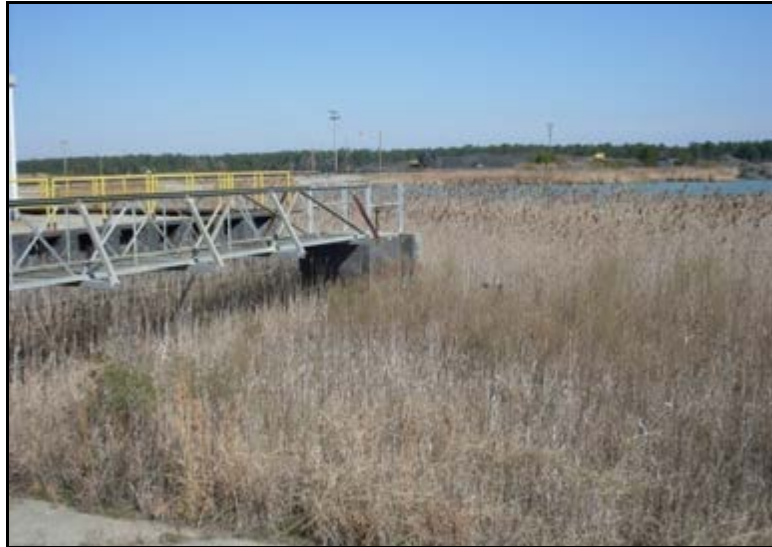
Photograph 5.11a. Emergency overflow structure.

The emergency overflow structure has bottom discharge into an 18-inch diameter conduit through the dike. The discharge end of the emergency outlet conduit, shown in Photograph 5.12, appeared to be steel pipe with a smooth PVC liner. The visible part of the emergency outlet conduit appeared to be sound. It appeared that discharges from the pipe would flow into a wetland area and ultimately into the Diversion Canal.

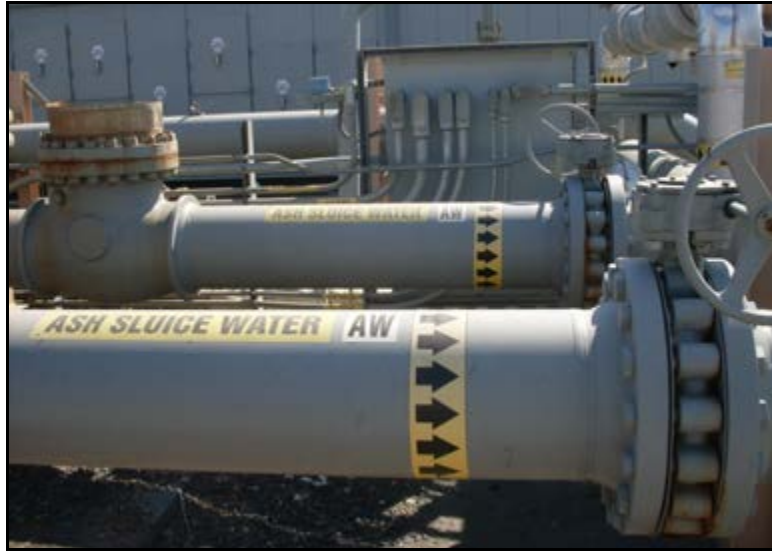
Photograph 5.13. Ash sluice lines to plant.

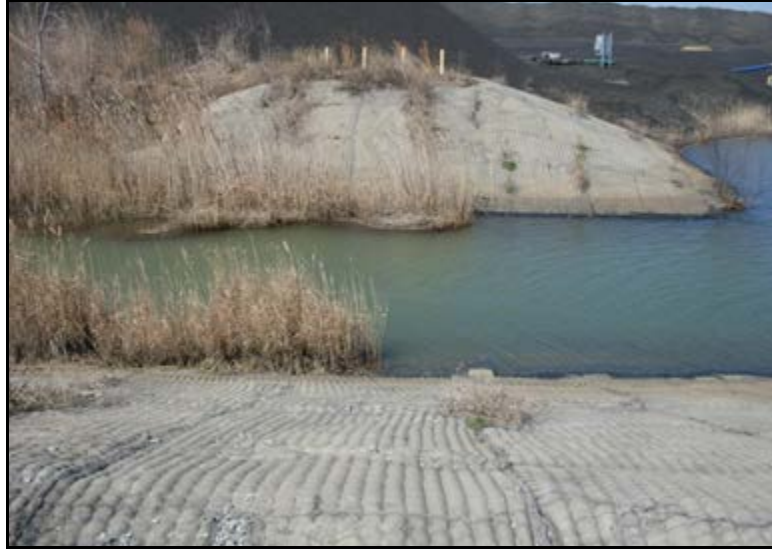
Photograph 5.14. Trapezoidal notch weir.

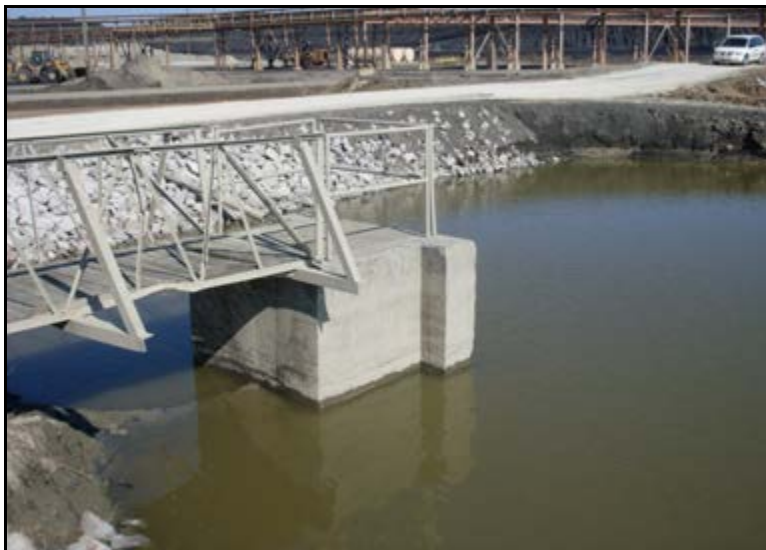
The emergency outfall structure and the access footbridge (in part) is shown in Photograph 5.15; it is of the same design as the emergency outfall for the ash ponds. The galvanized steel-frame footbridge appeared to be in sound condition with no significant rust. The reinforced concrete box with overflow weir appeared to be in satisfactory condition with no major cracks, spalls, or other deterioration.

Photograph 5.15. Emergency overflow structure.

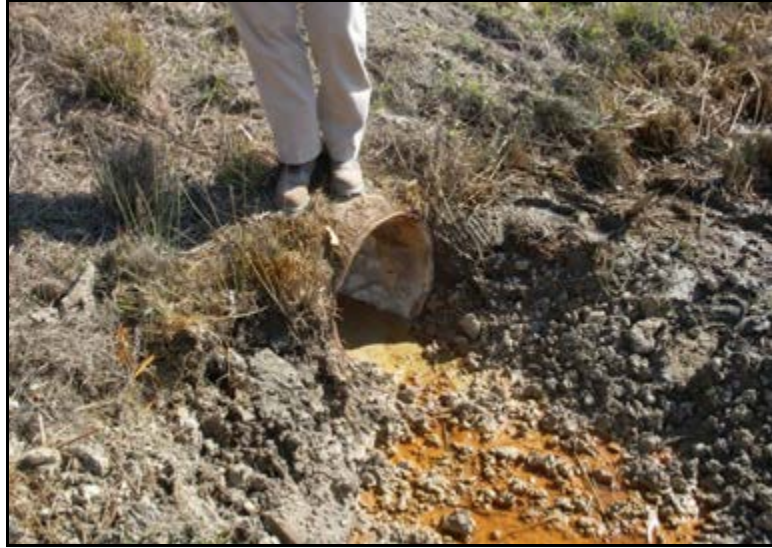
Photograph 5.16. Emergency outlet conduit.

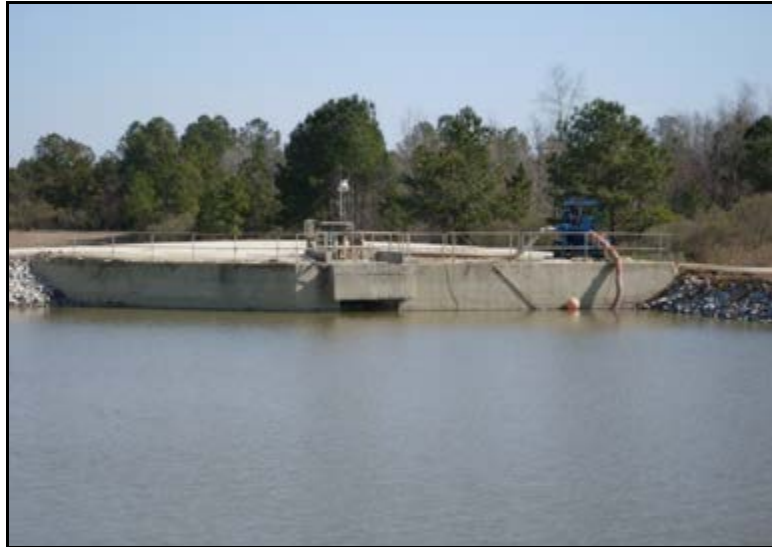
Photograph 5.17. View of discharge pump structure and auxiliary pump, looking northeast.
