**Specific Site Assessment for
Coal Combustion Waste
Impoundments at Santee
Cooper Grainger Generating
Station**

Conway, South Carolina

July 2010
Project 092881

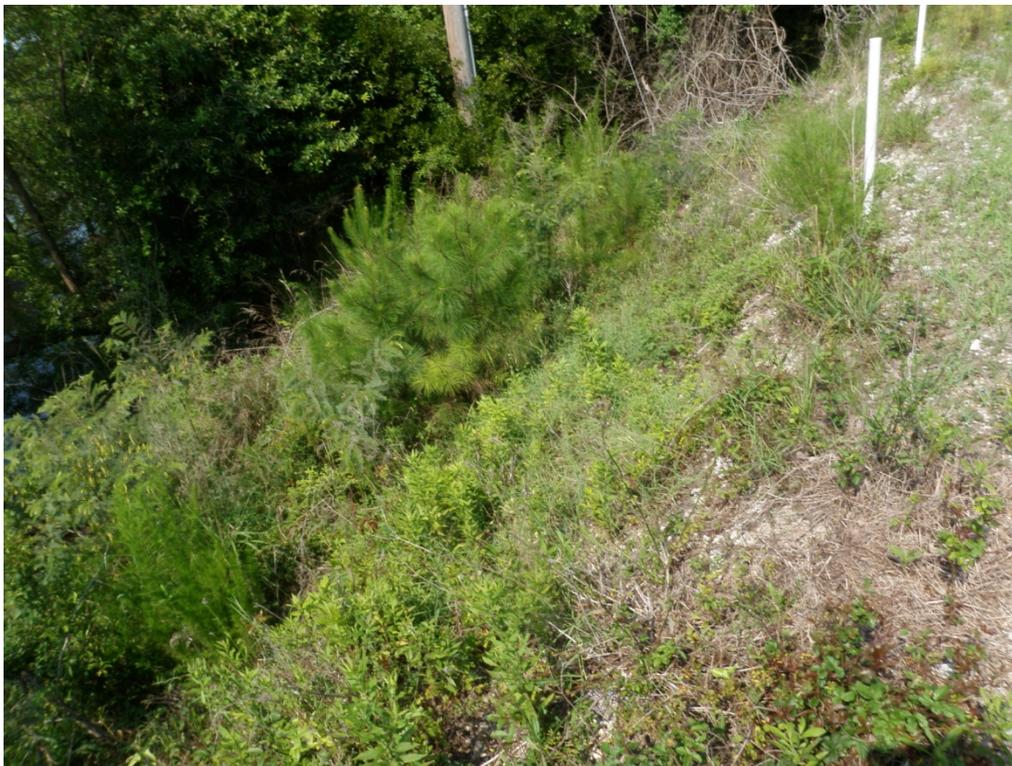
Ash Pond #1 was converted to a dry storage area in 1977, though the dike surrounding the storage area is still in place. We observed the existing dike to generally be in good condition, with no signs of movement, cracking, settling, erosion or deterioration. Trees have been allowed to grow on the downstream slope of the dike since it does not impound wet CCW.

Photo 1 – Ash Pond #1 (dry handling, continually dewatered): Downstream slope.

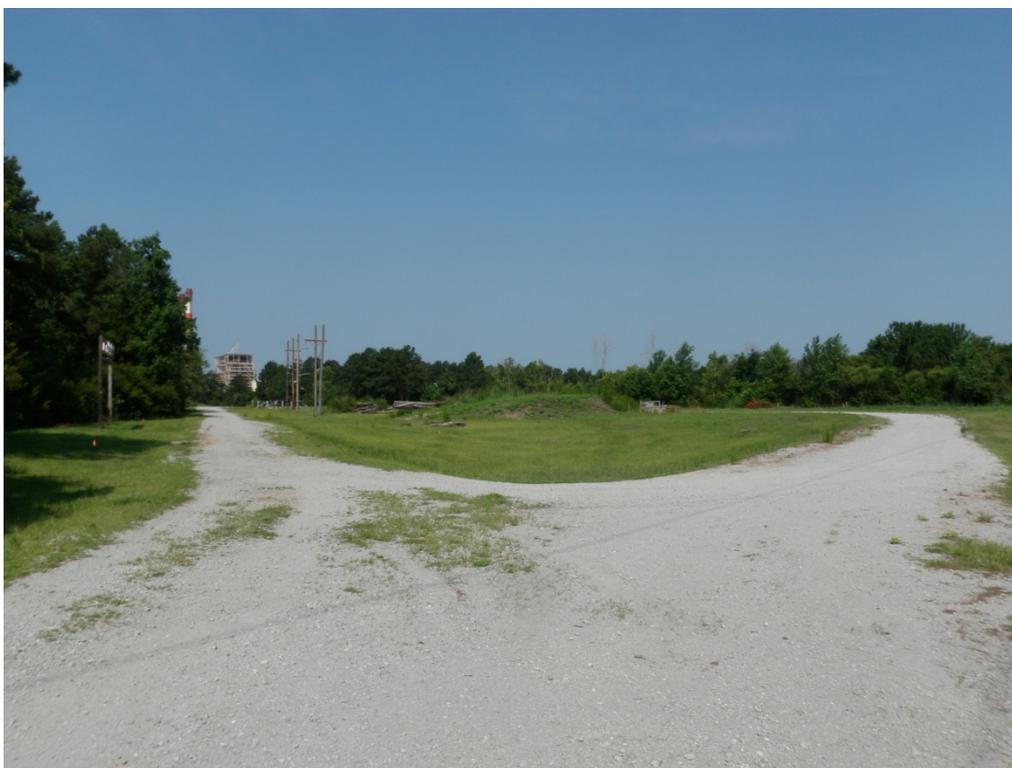
Photo 2 – Ash Pond #1: Overview.

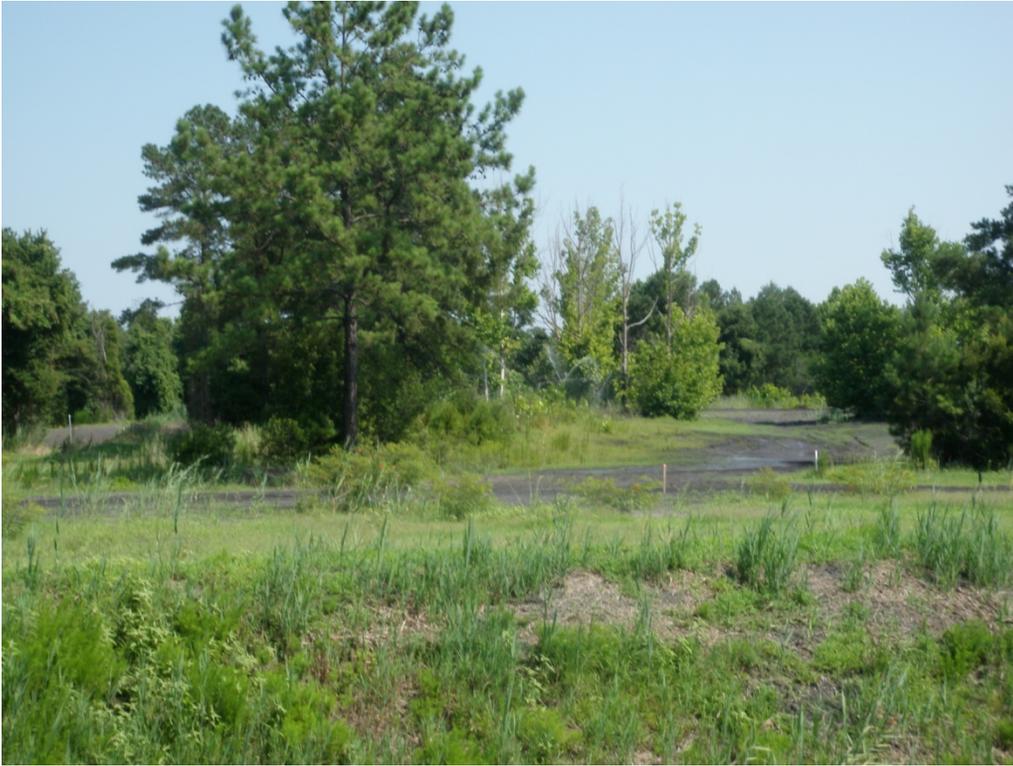
The ground surface within Ash Pond #1 was dry at the time of our visit, and trees are growing in the area. We observed the piles of dry CCW that have been placed in the impoundment. The CCW is sprayed with water to reduce dust. A network of drainage ditches has been constructed within the impoundment to drain stormwater and excess water from the dry CCW. The water collected in the impoundment is pumped to Ash Pond #2. We observed water flowing in the drainage ditches, and the system appeared to be functioning properly.

Photo 3 – Ash Pond #1: Dry ash handling area – note sprinklers to reduce dust.

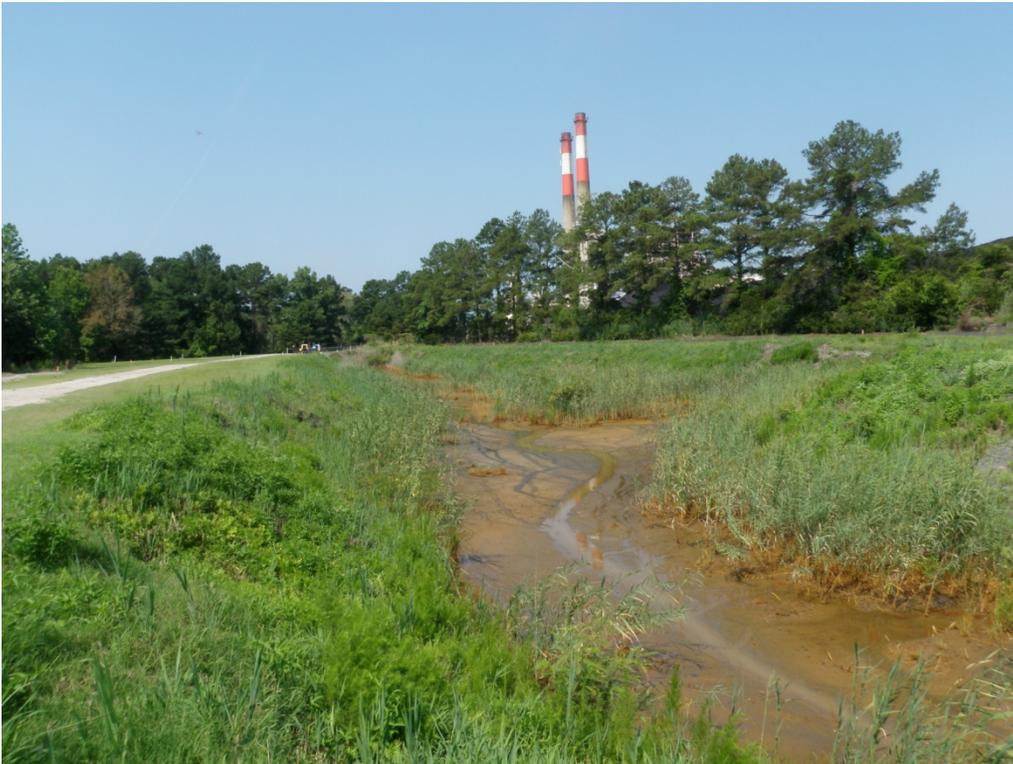
Photo 4 – Ash Pond #1: Dewatering channel.

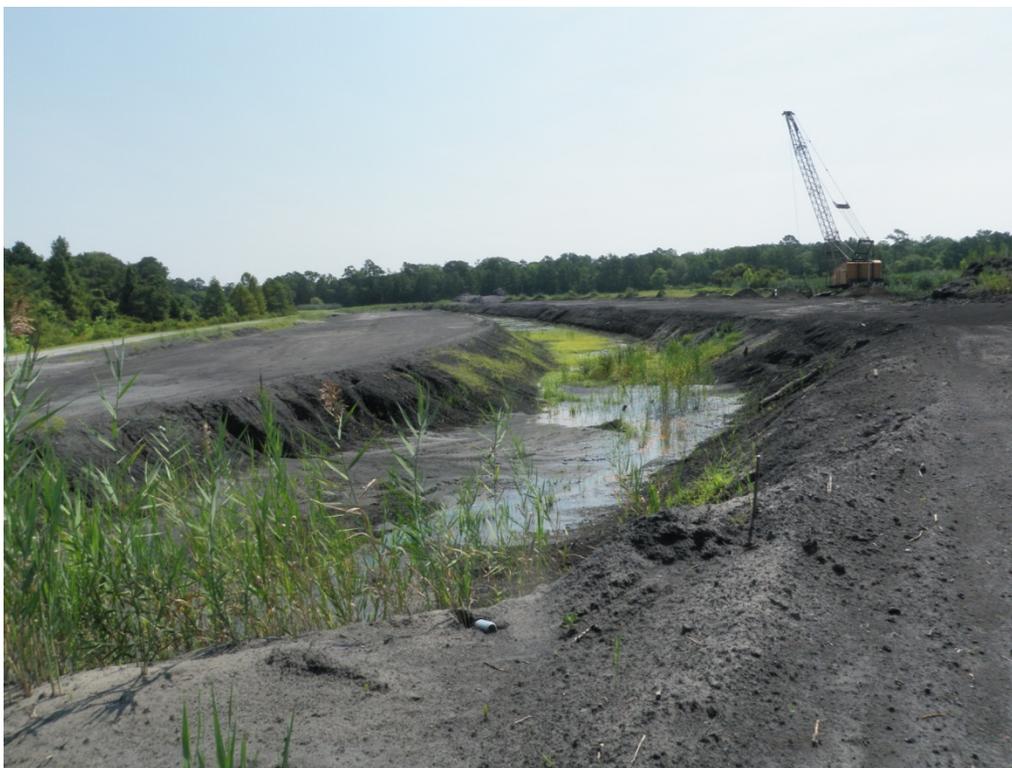
Photo 5 – Ash Pond #2: Primary ash slurry channel – dewatered and not in use during site visit.

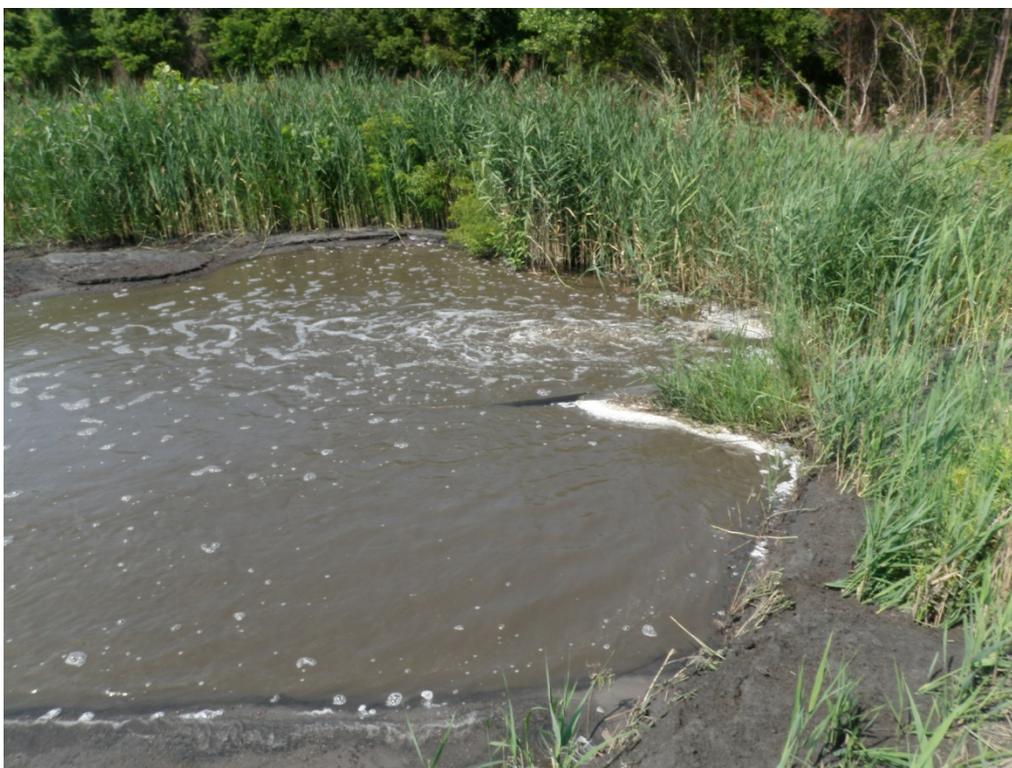
Photo 6 – Ash Pond #2: Ash slurry inflow.

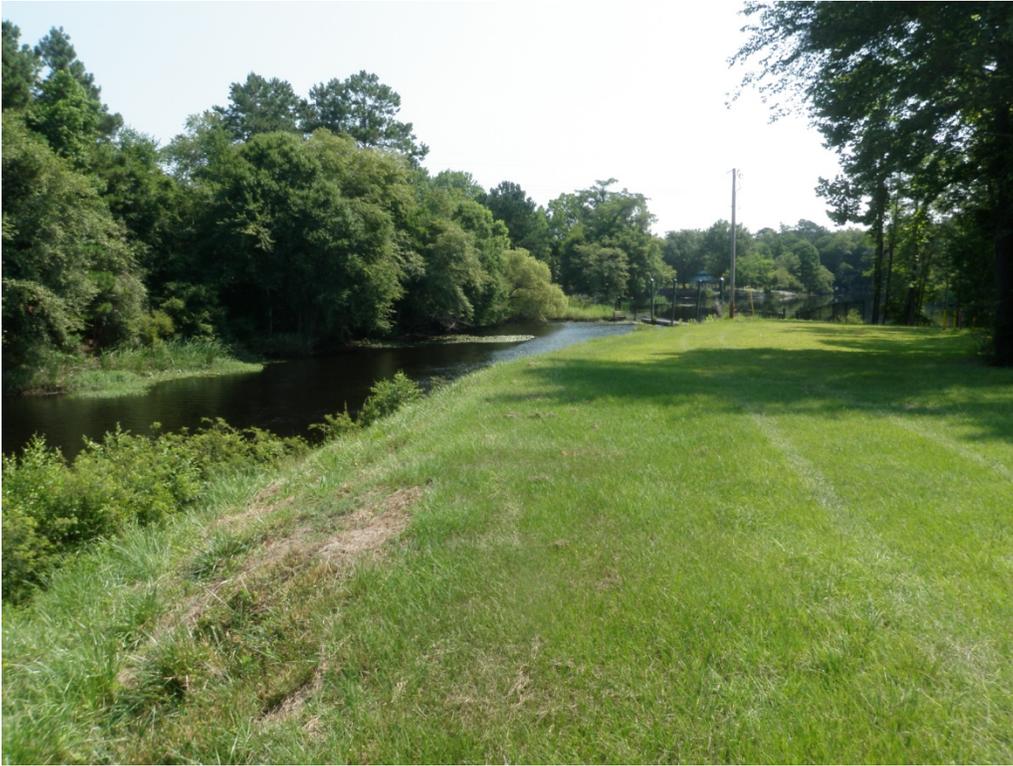
The downstream slopes of the dike at Ash Pond #2 have well-established grass growth, which provides some erosion protection. Large trees are present immediately downstream of the toe. These should be monitored to ensure that they do not encroach upon the dike slope, but in our opinion they are not currently a threat to the stability of the dike. No scarps, sloughs, depressions or other indications of slope instability or signs of erosion were observed during the inspection of the CCW impoundment.

Photo 7 – Ash Pond #2: Downstream slope, intake channel on left.

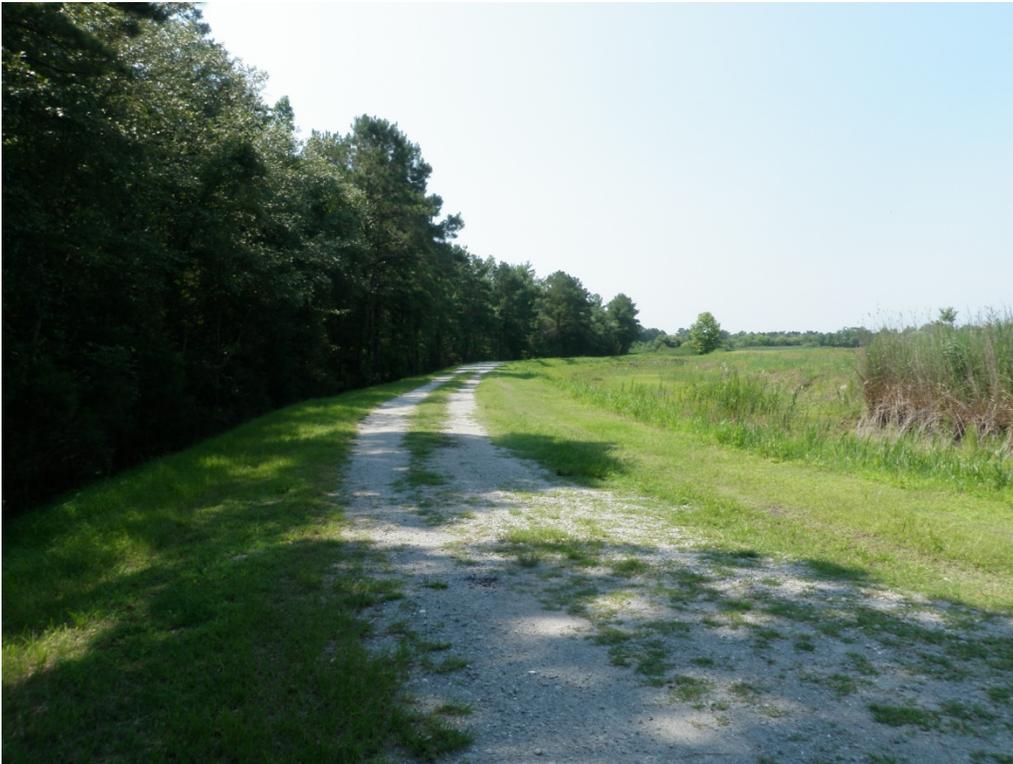
The crest of the dike at Ash Pond #2 appeared to be in good condition. No signs of cracking, settlement, movement, erosion or deterioration were observed during the assessment. The crest appears to be well-drained and no standing water was observed. The dike crest surface is generally composed of gravel road base material that traverses the length of the dike for vehicle access.

Photo 8 – Ash Pond #2: Crest near intake channel.

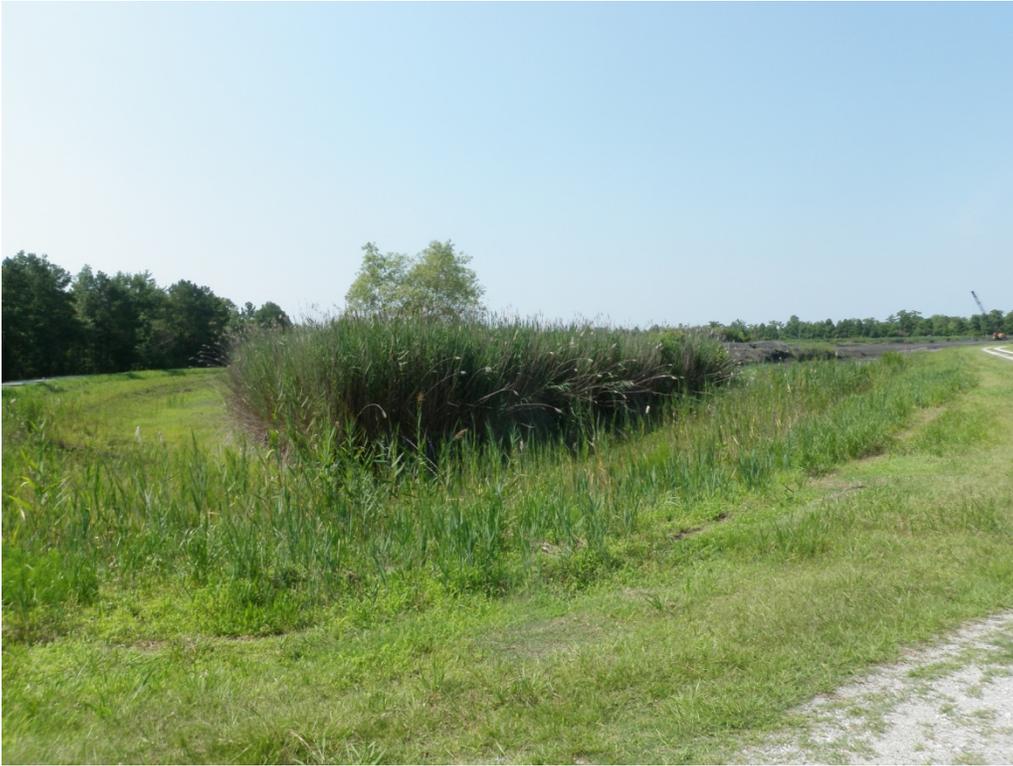
Photo 9 – Ash Pond #2: Overview.

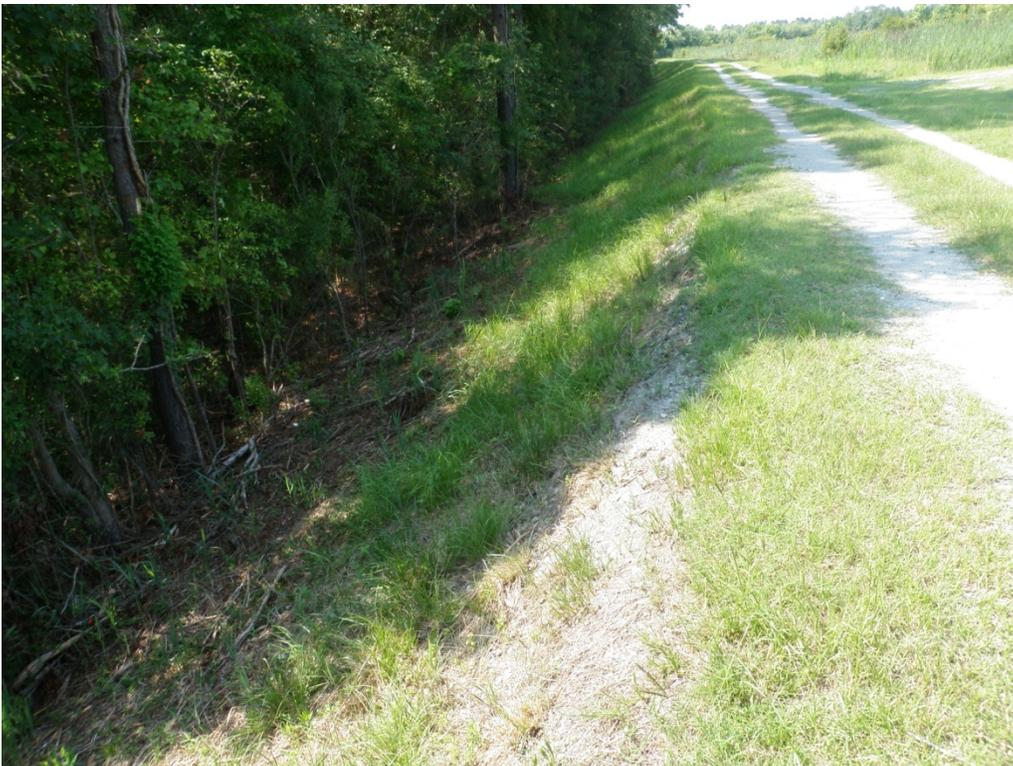
Photo 10 – Ash Pond #2: Downstream slope.

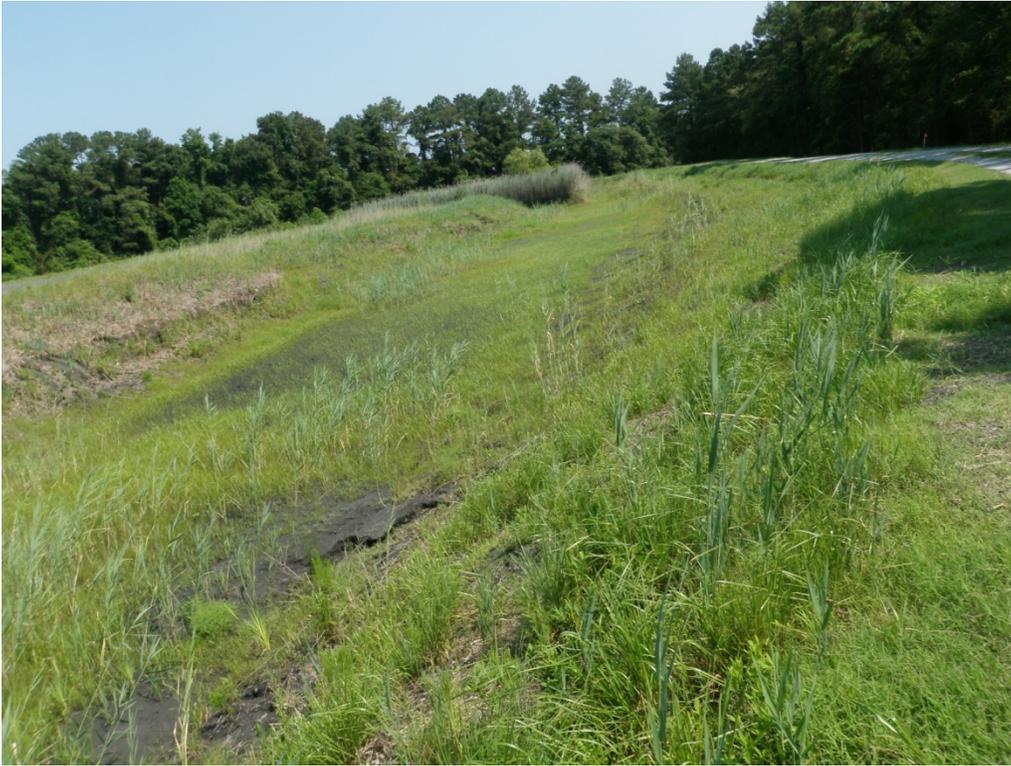
The upstream slopes of the dike at Ash Pond #2 have well-established grass growth. Riprap is present along the upstream slope where it is necessary for wave protection. The upstream slope protection appeared to be in good condition. No scarps, sloughs, depressions or other indications of slope instability or signs of erosion were observed during the inspection of the CCW impoundment.

Photo 11 – Ash Pond #2: Upstream slope.

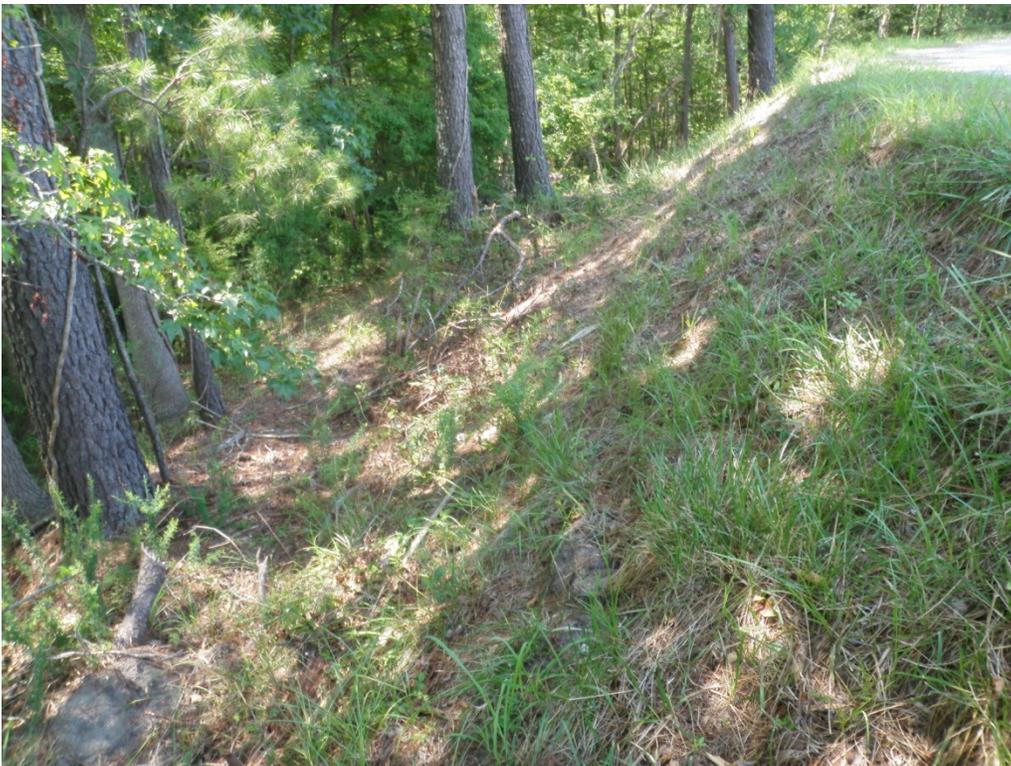
Photo 12 –Ash Pond #2: Downstream slope.

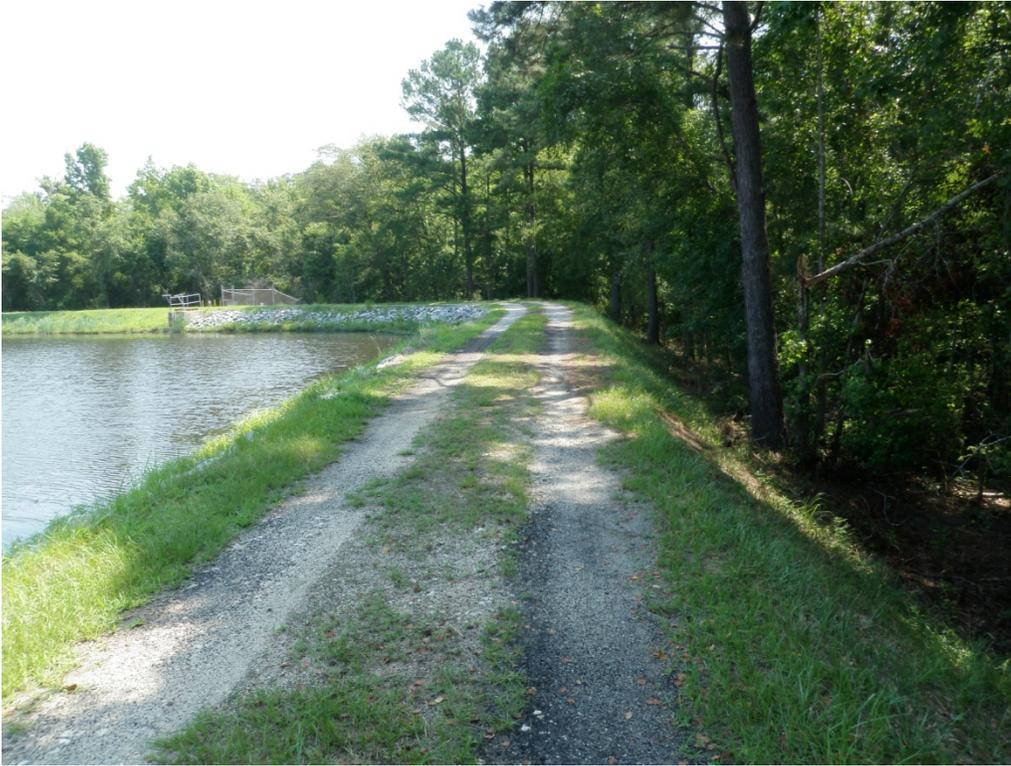
Photo 13 –Ash Pond #2: Crest.

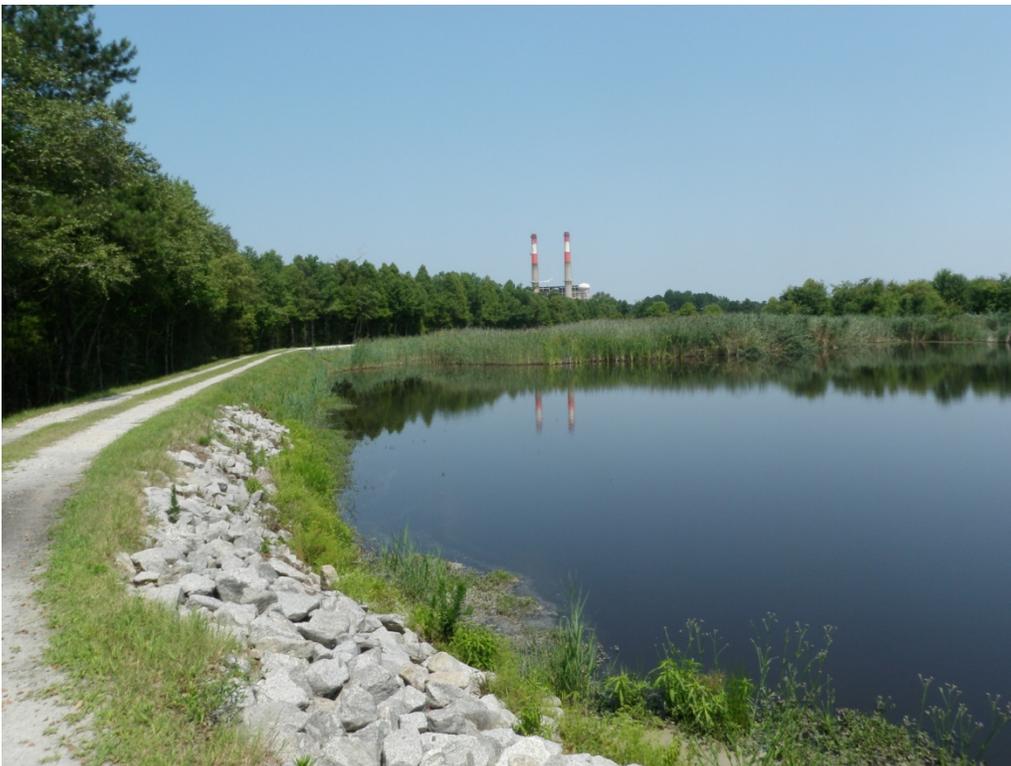
Photo 14 – Ash Pond #2: Upstream slope. Note riprap slope protection.

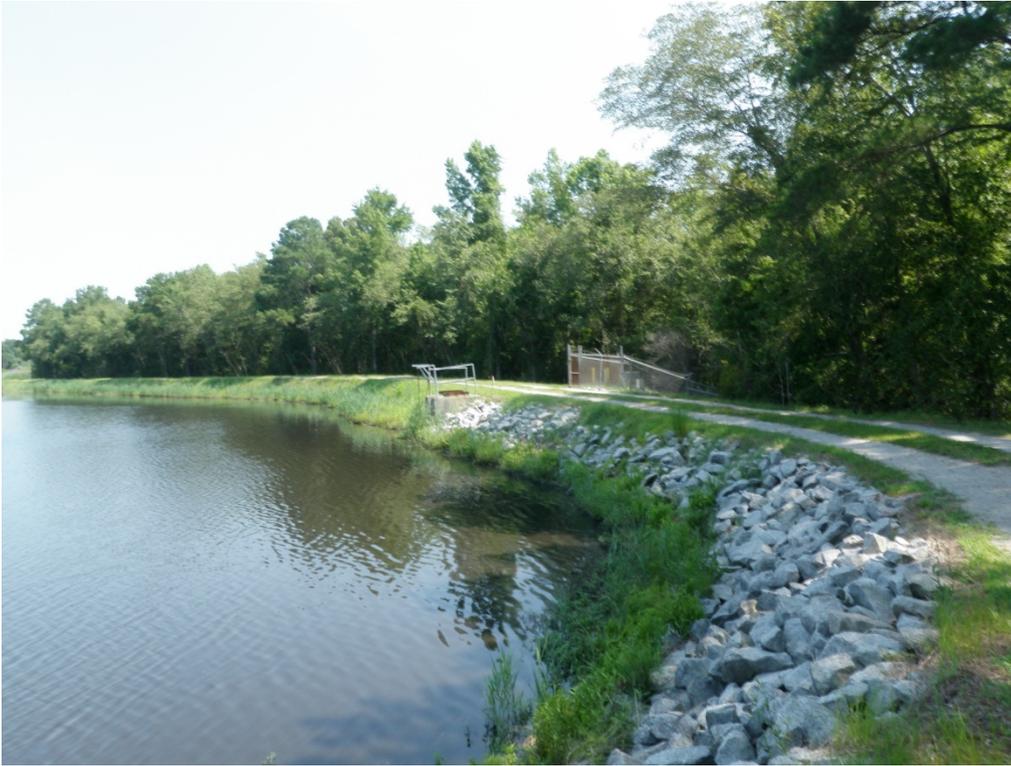
The outlet structure located in Ash Pond #2 appeared to be in good condition. The structure was observed to be working properly, discharging decant water downstream. Stop logs used to control the flow appeared to be functional, and a trashrack was in place. The outlet conduit consists of 12-inch reinforced concrete pipe (RCP) and appears to be in good condition. The Parshall Flume used to monitor flow appeared to be functional and readable. Riprap in the outlet channel was also in good condition.

Photo 15: Ash Pond #2: Outlet works and upstream slope.

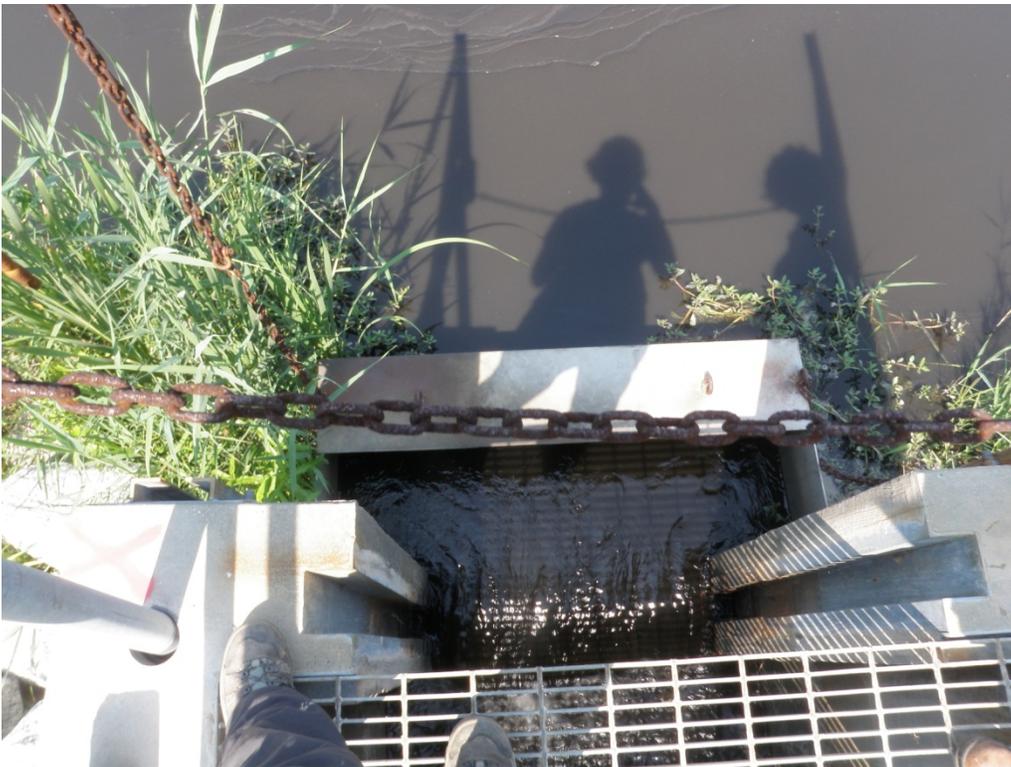
Photo 16 – Ash Pond #2: Decant inlet.

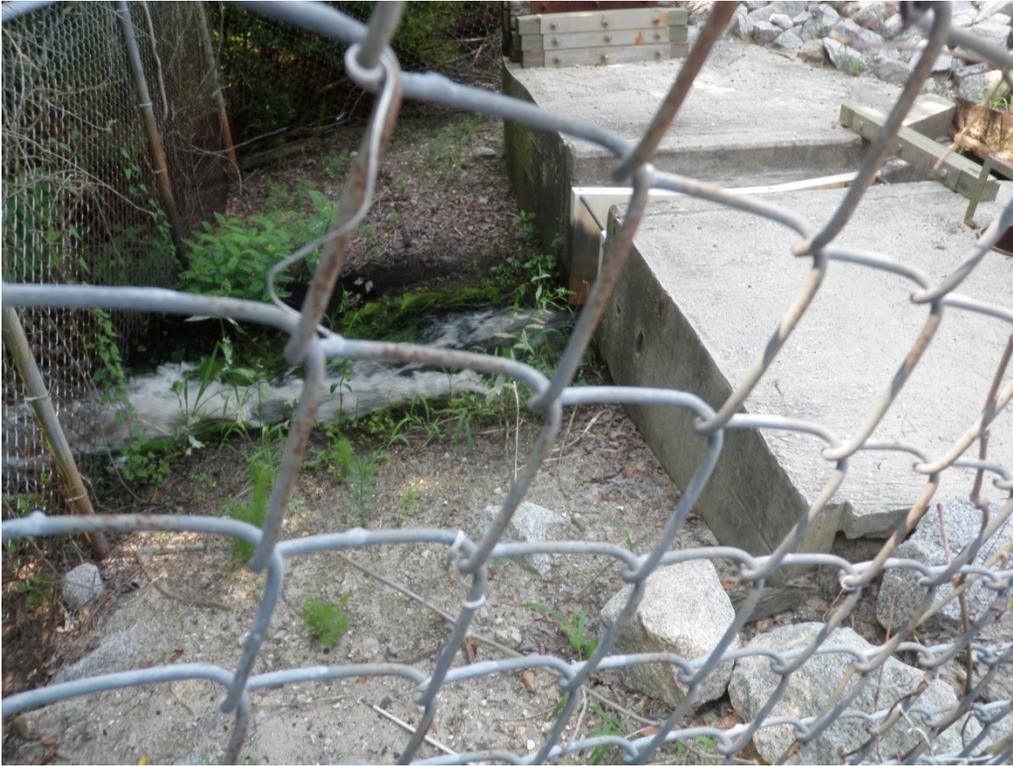
Photo 17: Ash Pond #2: Outlet structure with Parshall Flume.

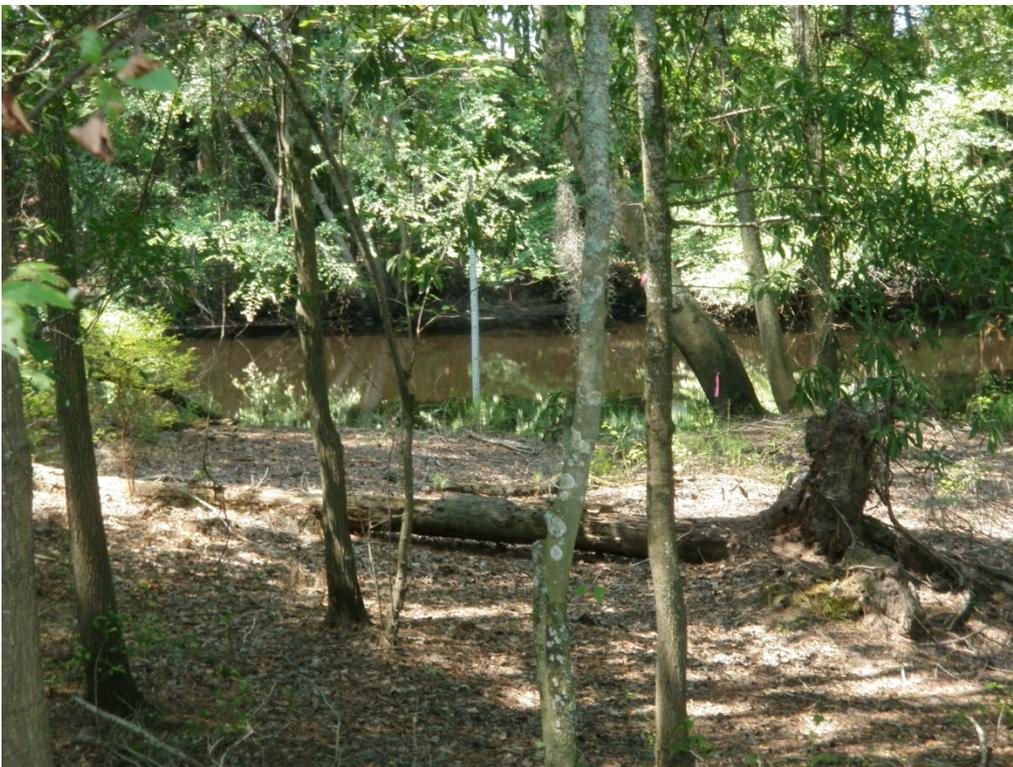
Photo 18: Ash Pond #2: Staff gauge at highway drainage ditch west of pond.

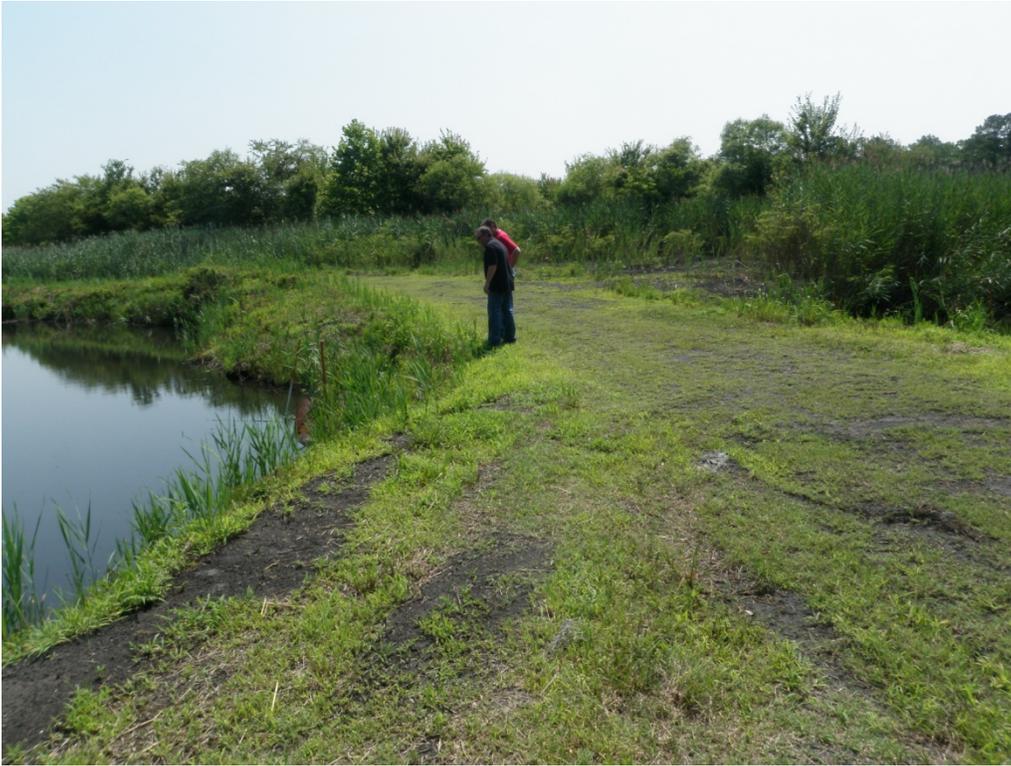
Photo 19 – Ash Pond #2: Divider fill between east and west cells.

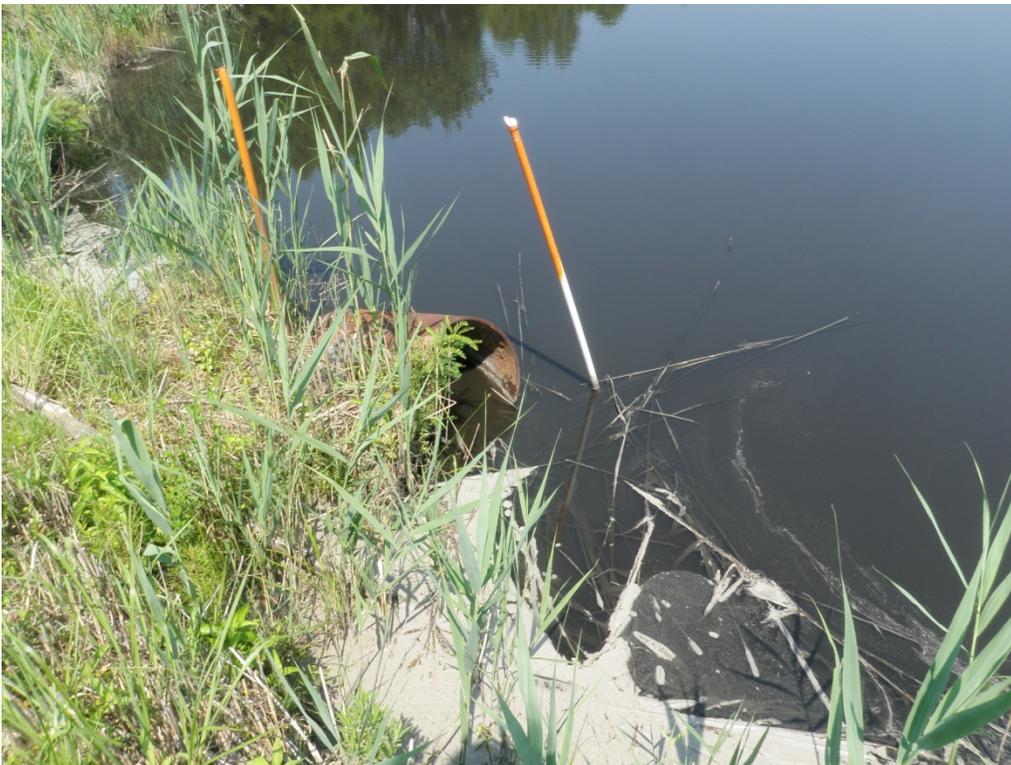
Photo 20 – Ash Pond #2: Decant pipe between cells – west cell inlet.

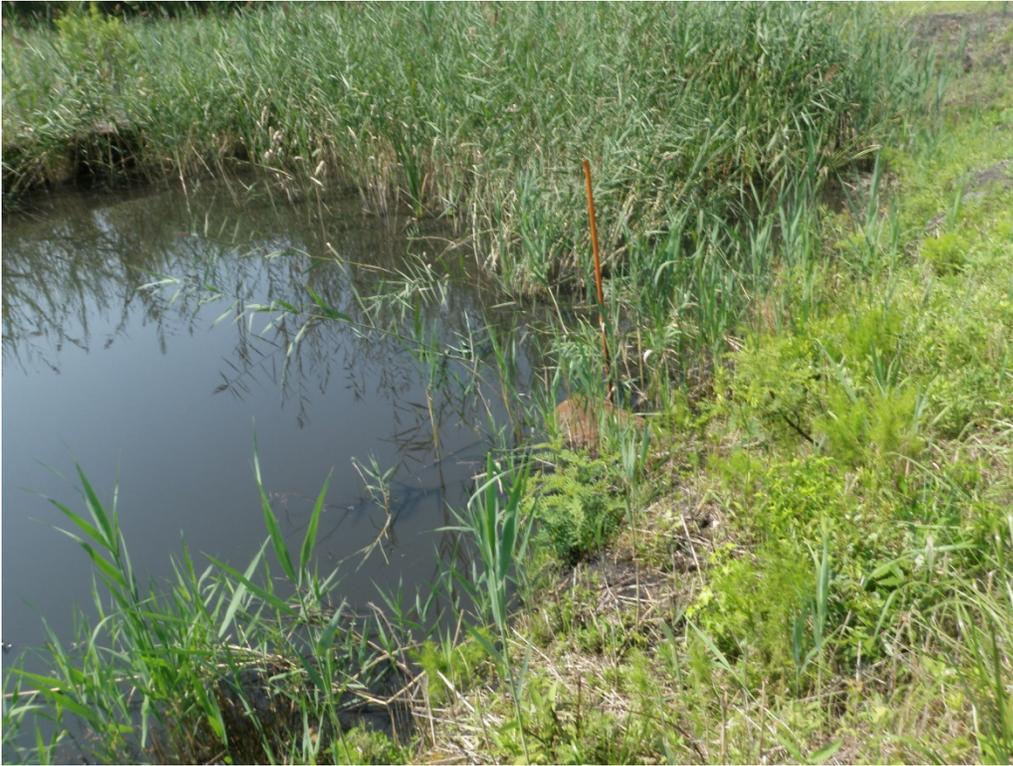
Photo 21 – Ash Pond #2: Decant pipe between cells – east cell outlet.

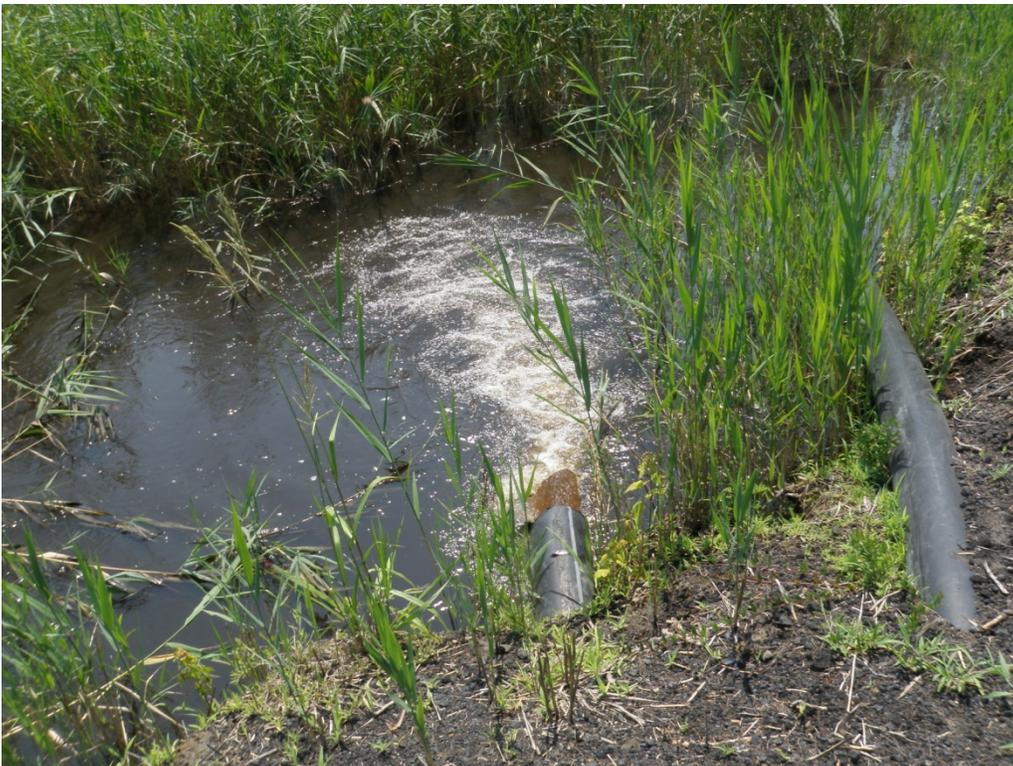
Photo 22 – Ash Pond #2: Wastewater discharge into east cell.
