Specific Site Assessment for Coal Combustion Waste Impoundments at Santee Cooper Grainger Generating Station

Conway, South Carolina

December 2010
Project 092881

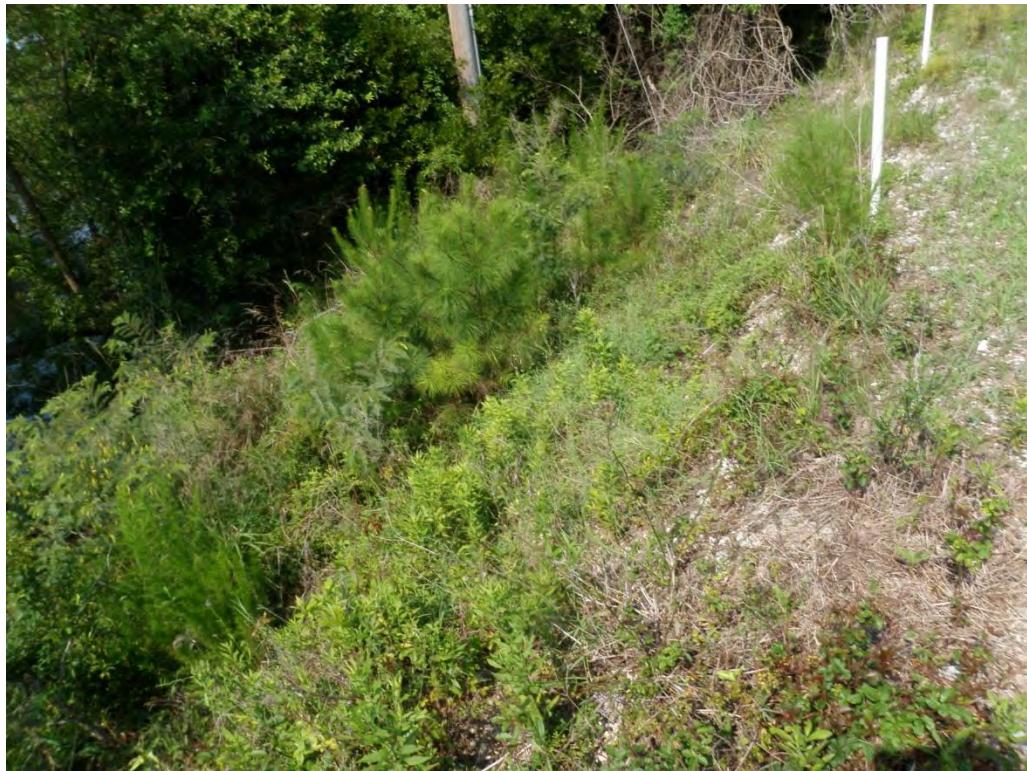
Ash Pond #1 was converted to a dry storage area in 1977, at which time its NPDES outfall was eliminated. Ash Pond #2 was constructed in 1977, and all wet sluiced CCW from Grainger Generating Station has since been sent to Ash Pond #2. The dike surrounding Ash Pond #1 is still in place. We observed the existing dike to generally be in good condition, with no signs of movement, cracking, settling, erosion or deterioration. Trees have been allowed to grow on the downstream slope of the dike since it does not impound wet CCW.

Photo 1: Ash Pond #1 (dry handling, continually dewatered): Downstream slope.

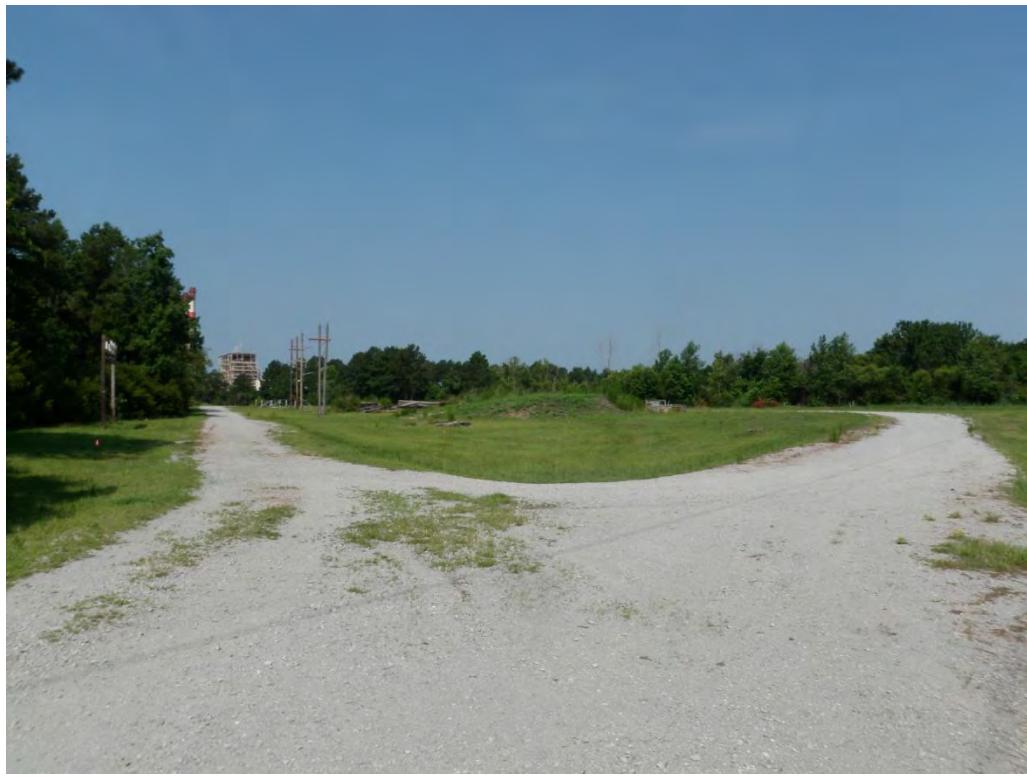
Photo 2: Ash Pond #1: Overview.

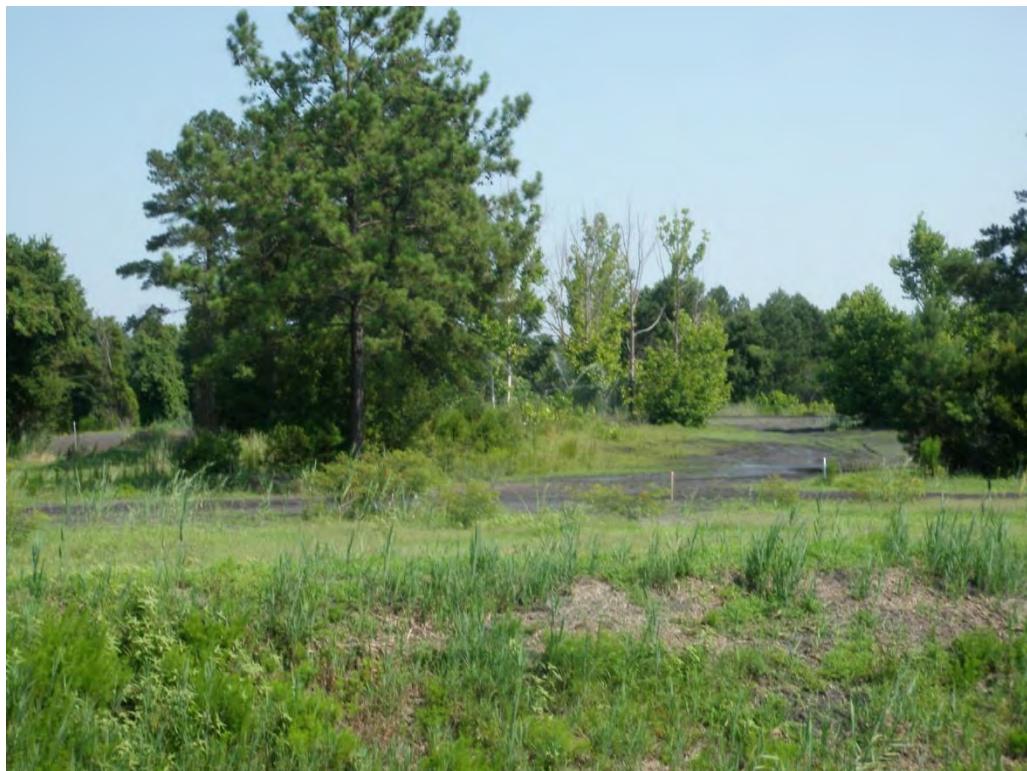
The ground surface within Ash Pond #1 was dry at the time of our visit, and trees are growing in the area. We observed the piles of dry CCW that have been placed in the impoundment. The CCW is sprayed with water to reduce dust. A network of drainage ditches has been constructed within the impoundment to drain stormwater and excess water from the dry CCW. The water collected in the impoundment is pumped to Ash Pond #2. We observed water flowing in the drainage ditches, and the system appeared to be functioning properly.

Photo 3: Ash Pond #1: Dry ash handling area – note sprinklers to reduce dust.

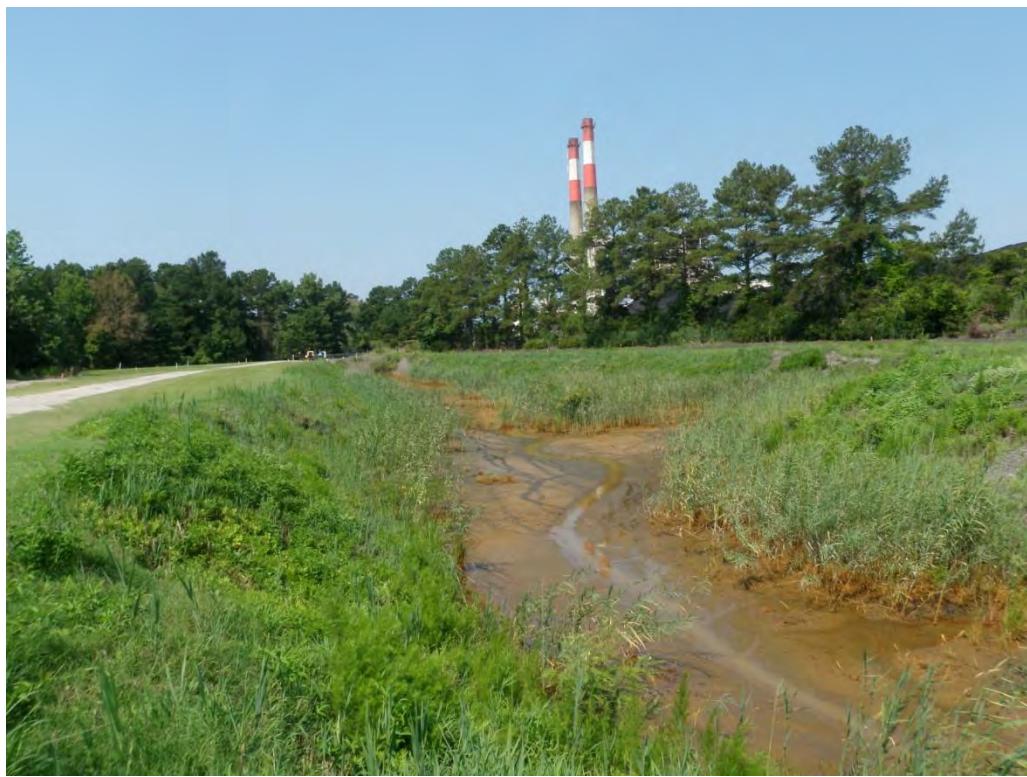
Photo 4: Ash Pond #1: Dewatering channel.

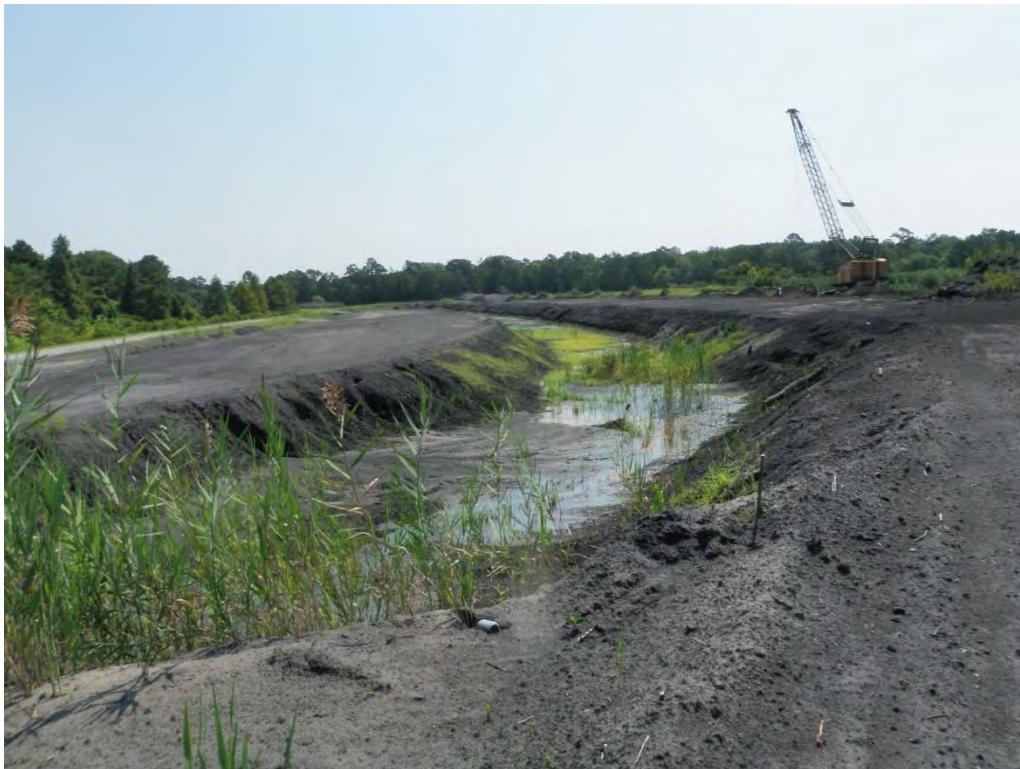
Photo 5: Ash Pond #2: Primary ash slurry channel – dewatered and not in use during site visit.

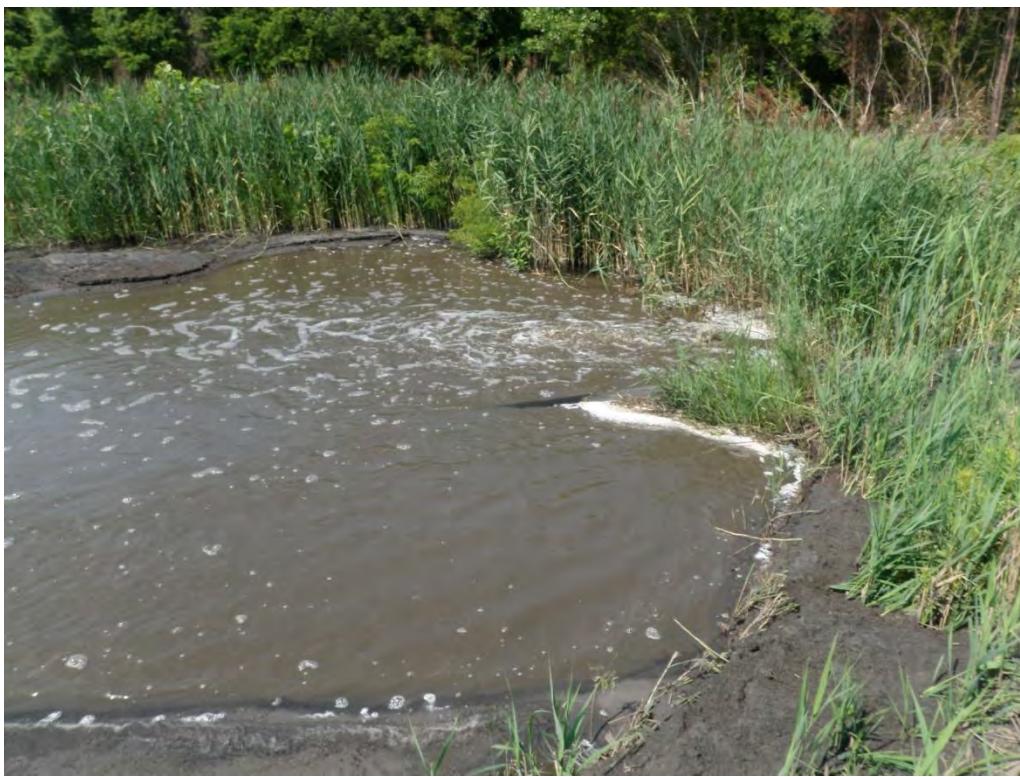
Photo 6: Ash Pond #2: Ash slurry inflow.

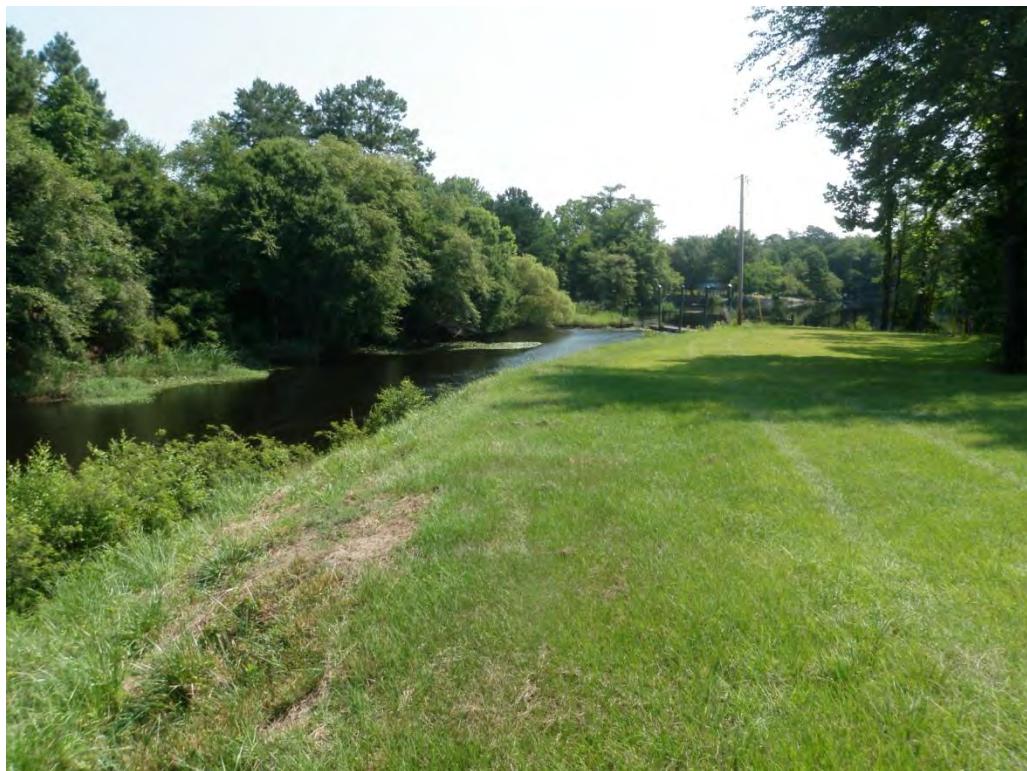
Photo 7: Ash Pond #2: Downstream slope, intake channel on left.

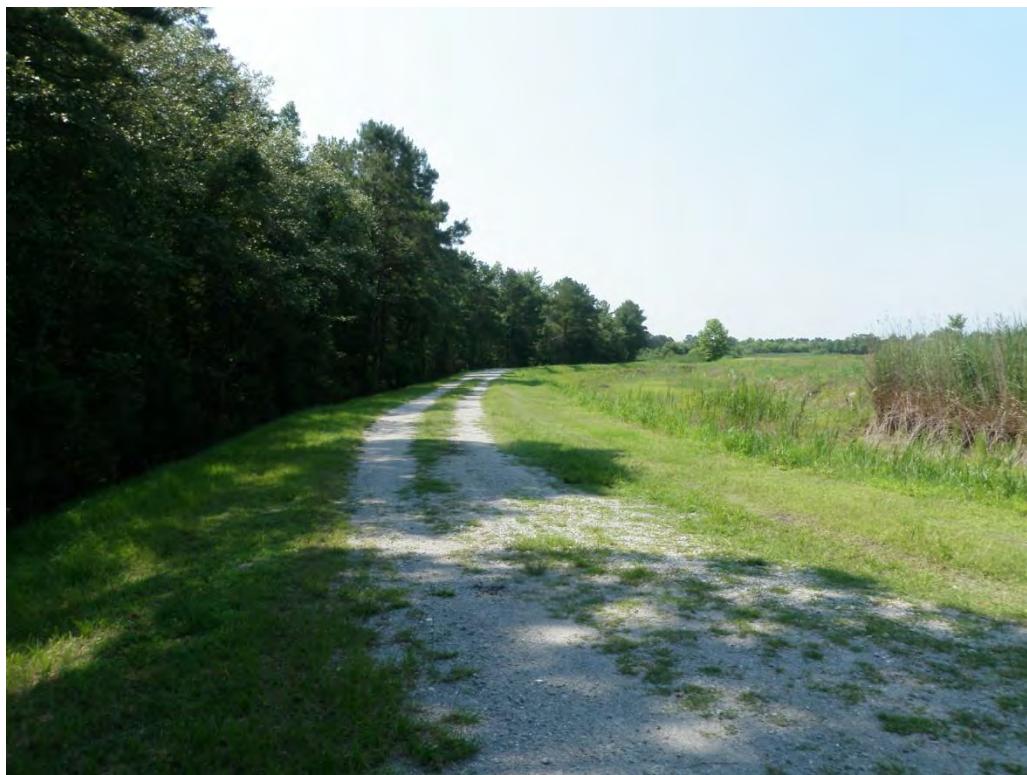
The crest of the dike at Ash Pond #2 appeared to be in good condition. No signs of cracking, settlement, movement, erosion or deterioration were observed during the assessment. The crest appears to be well-drained and no standing water was observed. The dike crest surface is generally composed of gravel road base material that traverses the length of the dike for vehicle access.

Photo 8: Ash Pond #2: Crest near intake channel.

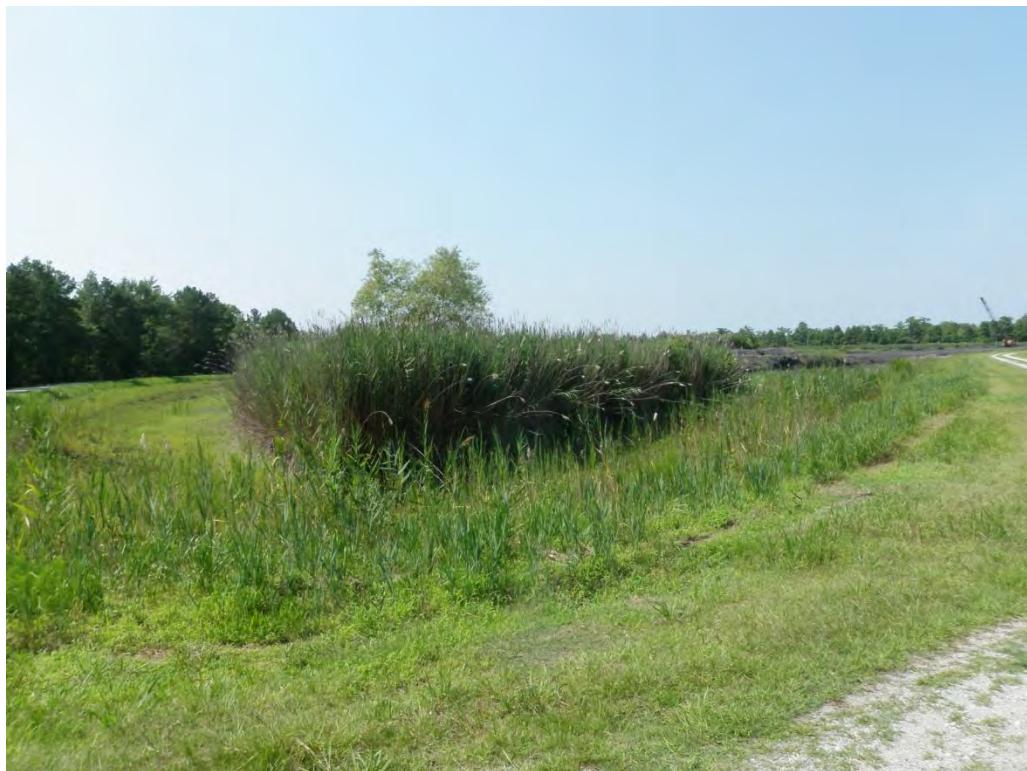
Photo 9: Ash Pond #2: Overview.

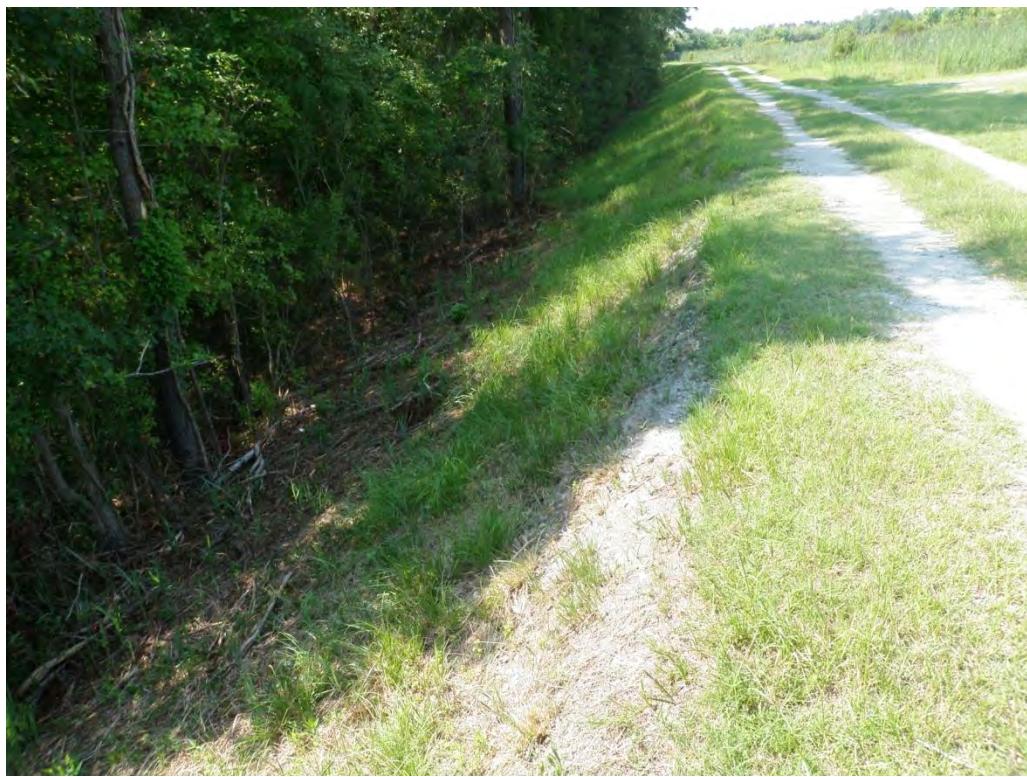
The downstream slopes of the dike at Ash Pond #2 have well-established grass growth, which provides some erosion protection. Large trees are present immediately downstream of the toe. These should be monitored to ensure that they do not encroach upon the dike slope, but in our opinion they are not currently a threat to the stability of the dike. No scarps, sloughs, depressions or other indications of slope instability or signs of erosion were observed during the inspection of the CCW impoundment.

Photo 10: Ash Pond #2: Downstream slope.

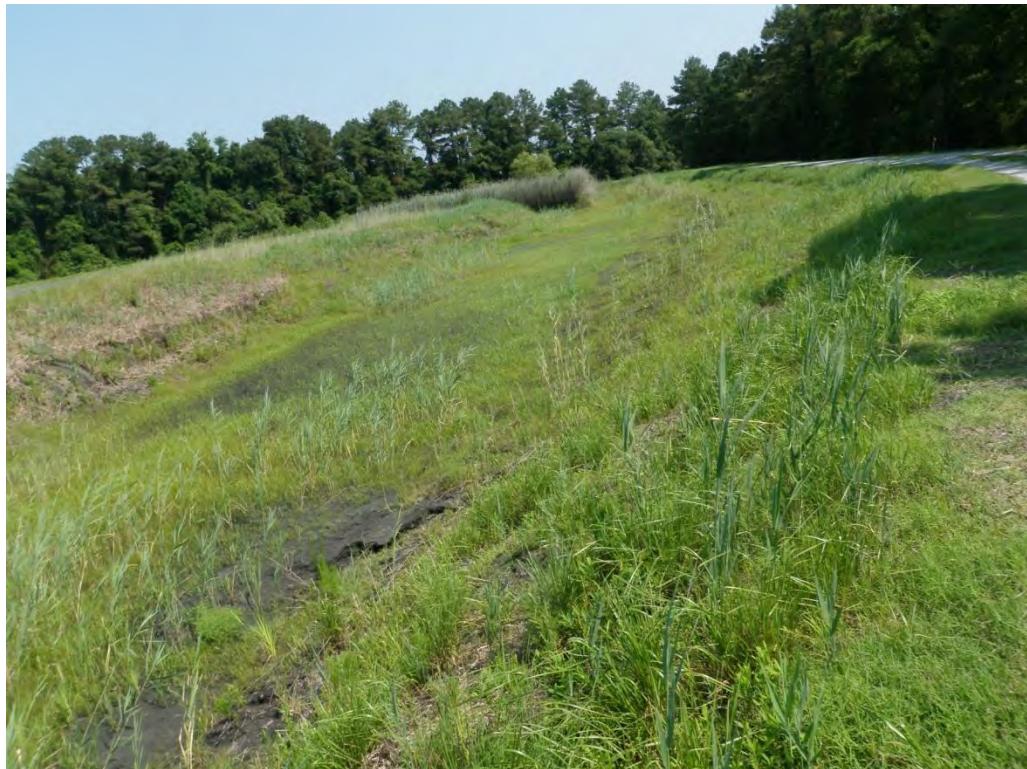
The upstream slopes of the dike at Ash Pond #2 have well-established grass growth. Riprap is present along the upstream slope where it is necessary for wave protection. The upstream slope protection appeared to be in good condition. No scarps, sloughs, depressions or other indications of slope instability or signs of erosion were observed during the inspection of the CCW impoundment.

Photo 11: Ash Pond #2: Upstream slope.

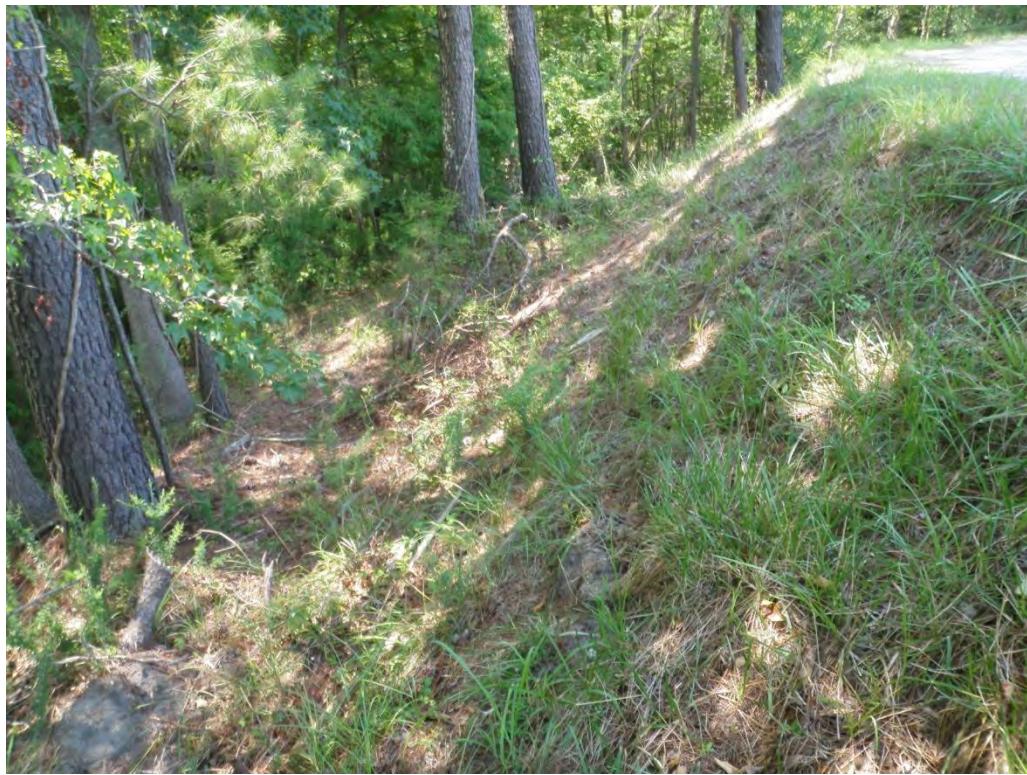
Photo 12: Ash Pond #2: Downstream slope.

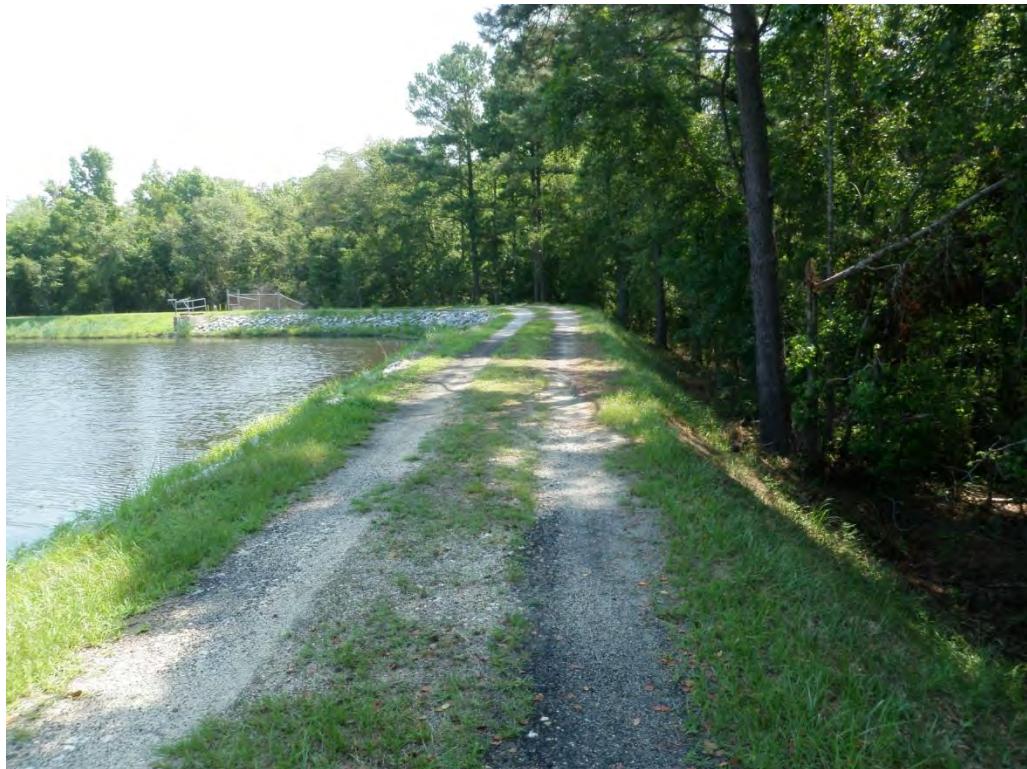
Photo 13: Ash Pond #2: Crest.

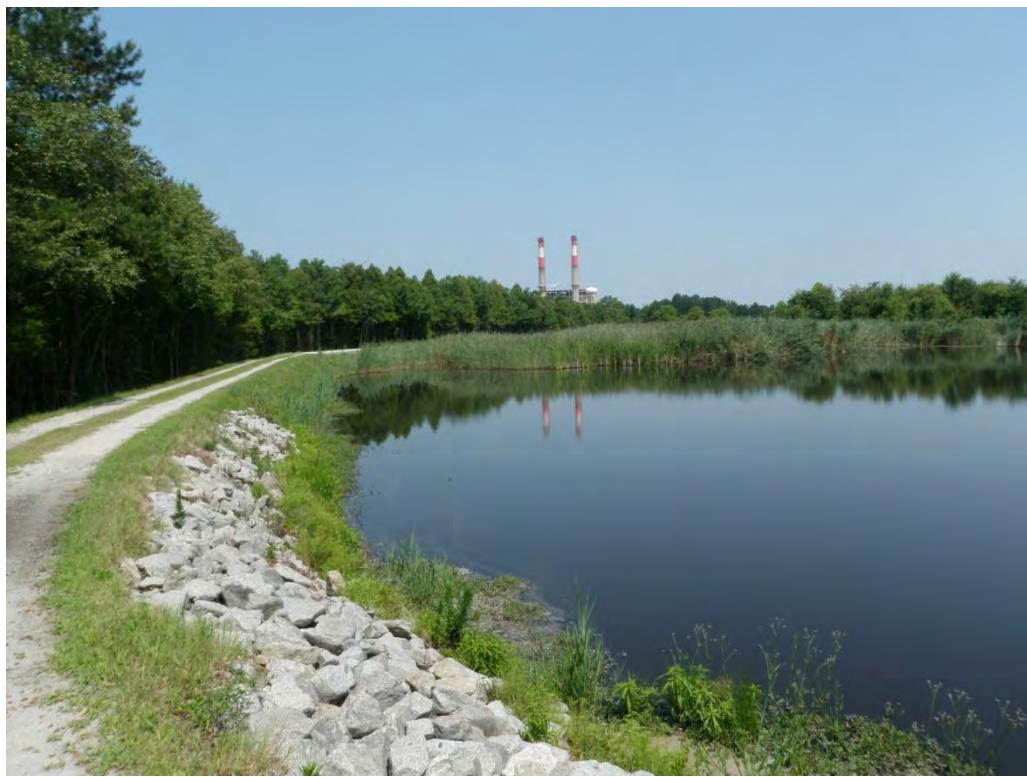
Photo 14: Ash Pond #2: Upstream slope. Note riprap slope protection.

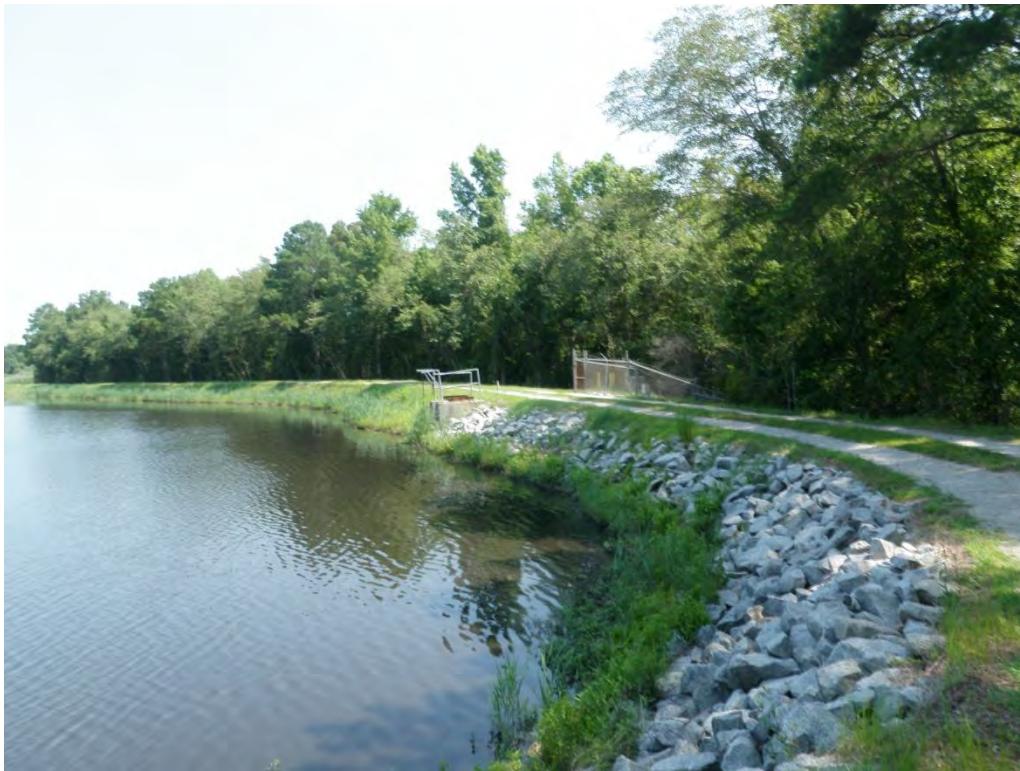
The outlet structure located in Ash Pond #2 appeared to be in good condition. The structure was observed to be working properly, discharging decant water downstream. Stop logs used to control the flow appeared to be functional, and a trashrack was in place. The outlet conduit consists of 12-inch reinforced concrete pipe (RCP) and appears to be in good condition. The Parshall flume used to monitor flow appeared to be functional and readable. Riprap in the outlet channel was also in good condition.

Photo 15: Ash Pond #2: Outlet works and upstream slope.

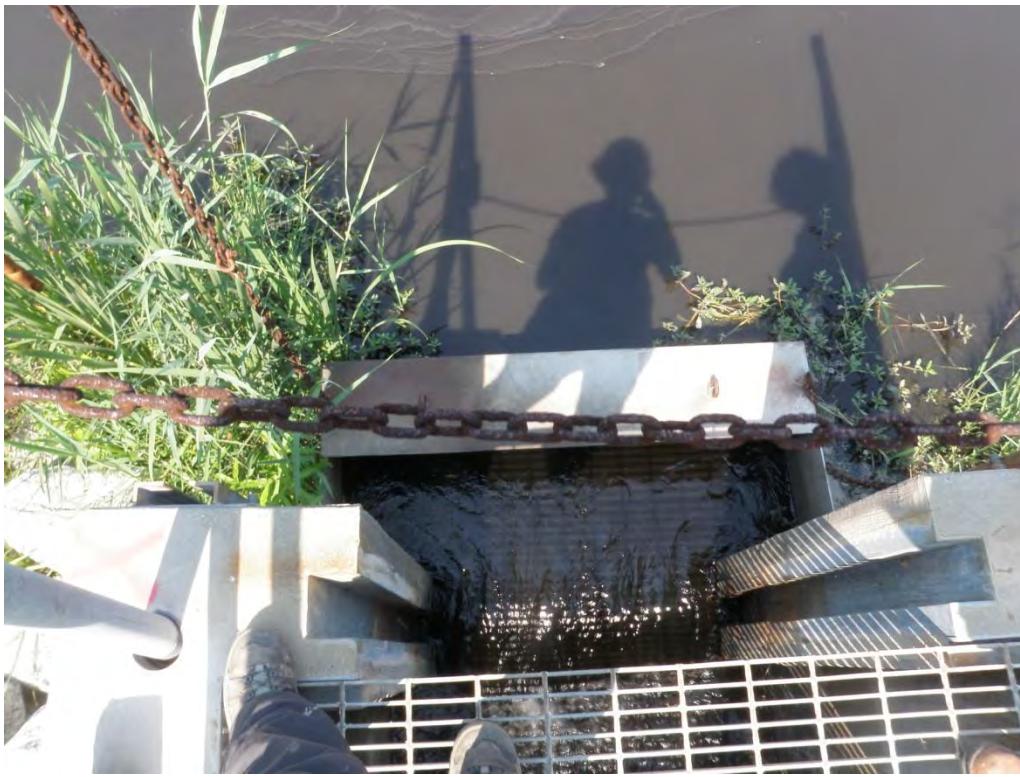
Photo 16: Ash Pond #2: Decant inlet.

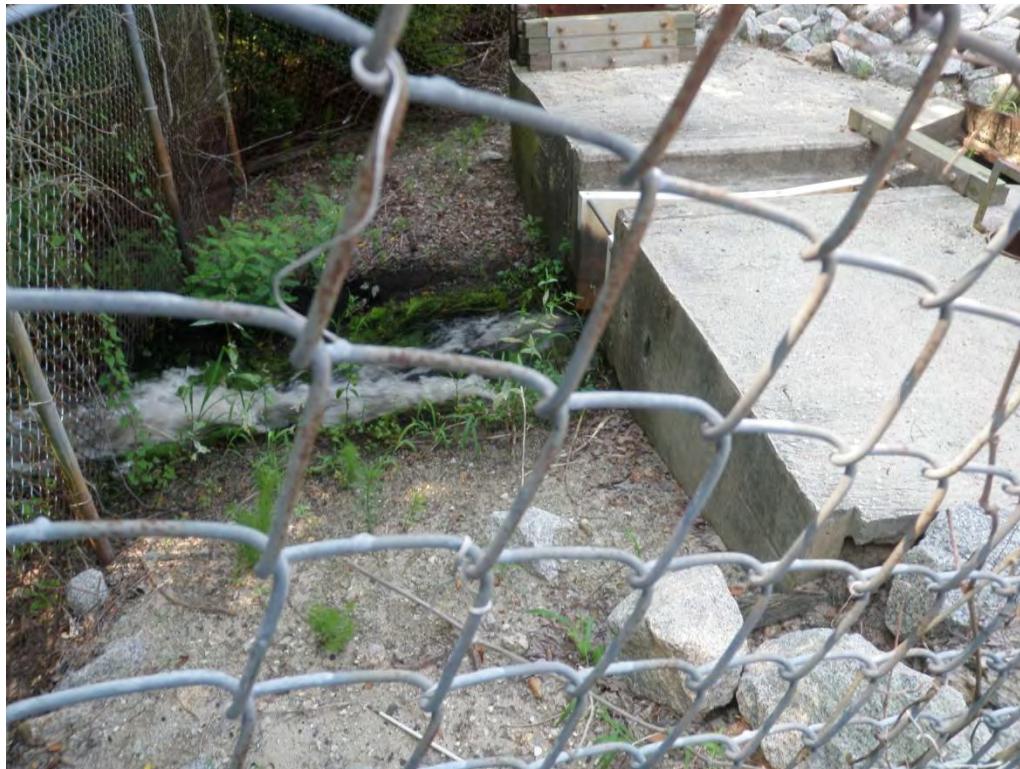
Photo 17: Ash Pond #2: Outlet structure with Parshall Flume.

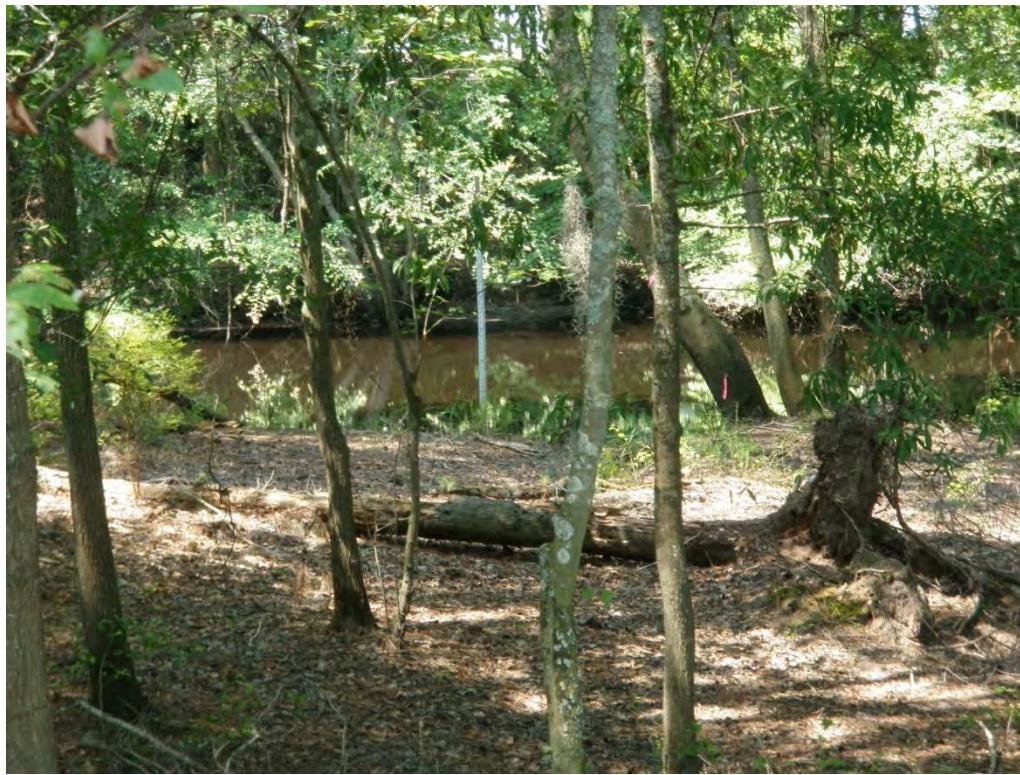
Photo 18: Ash Pond #2: Staff gauge at highway drainage ditch west of pond.

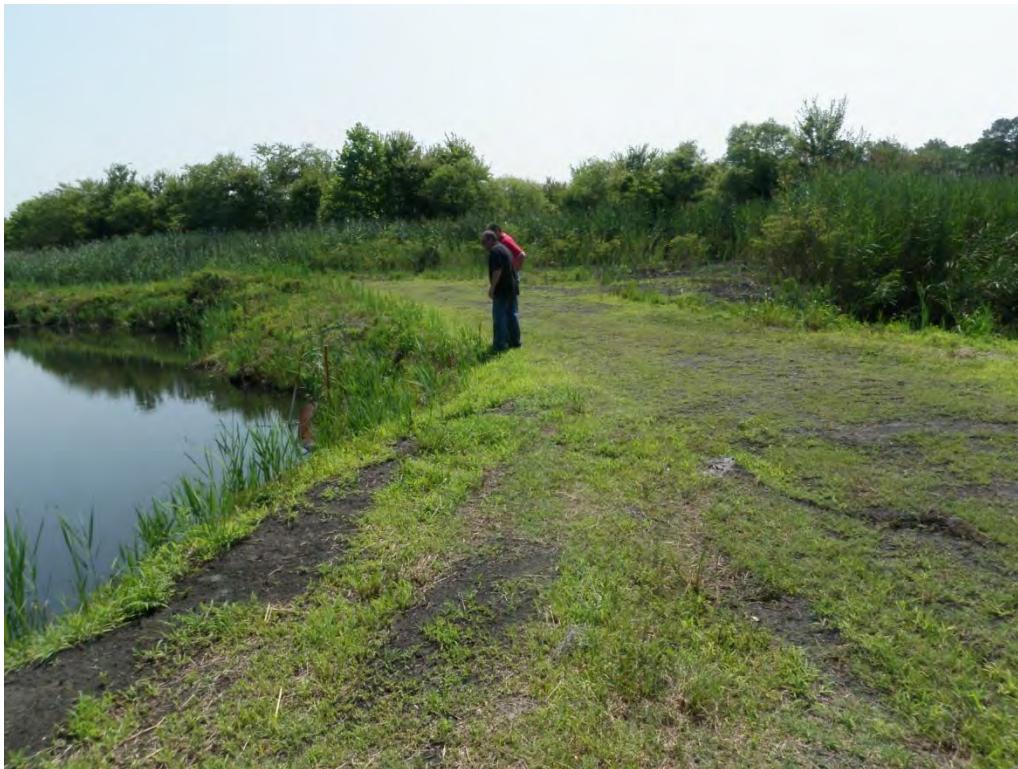
Photo 19: Ash Pond #2: Divider fill between east and west cells.

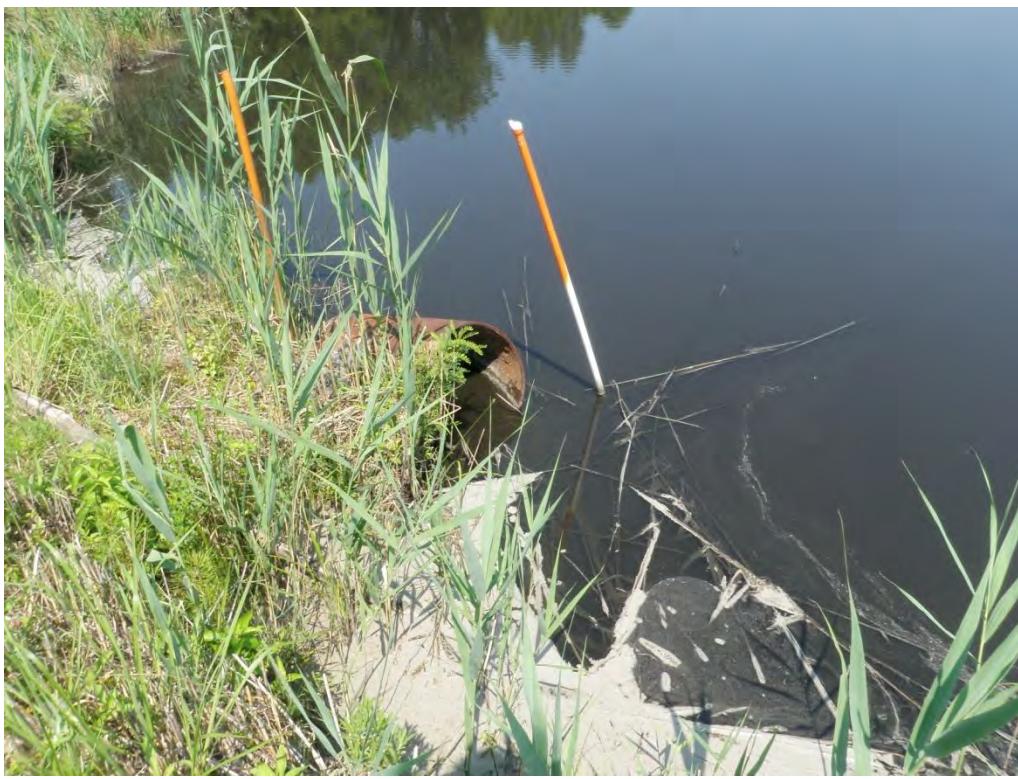
Photo 20: Ash Pond #2: Decant pipe between cells – west cell inlet.

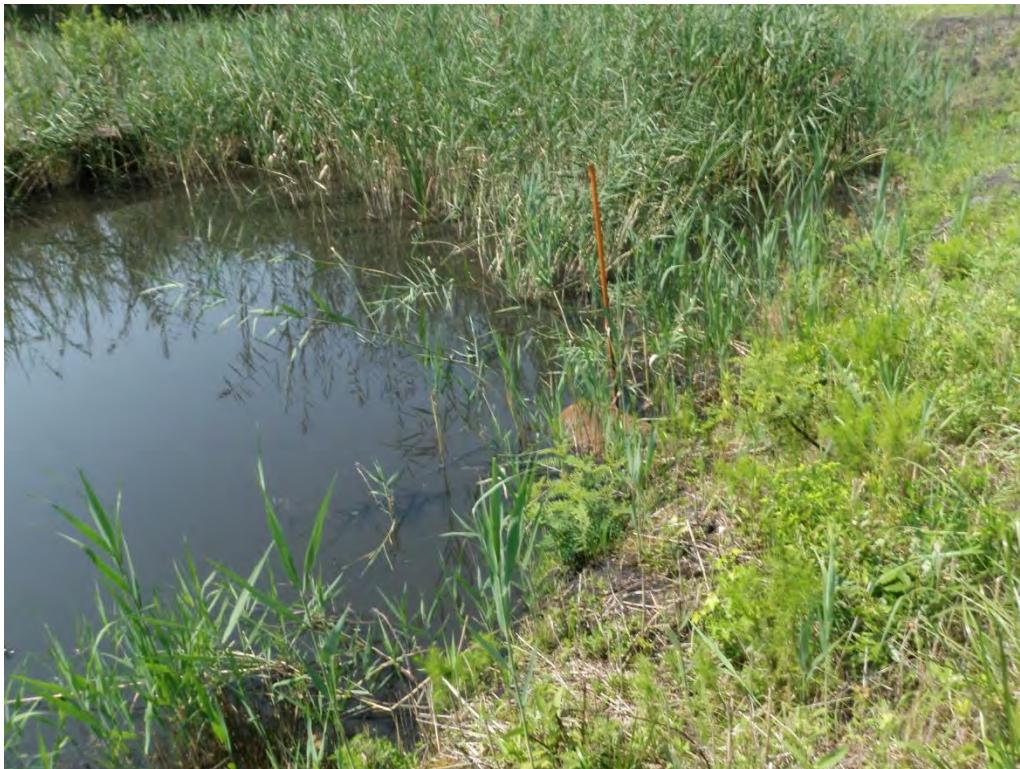
Photo 21: Ash Pond #2: Decant pipe between cells – east cell outlet.

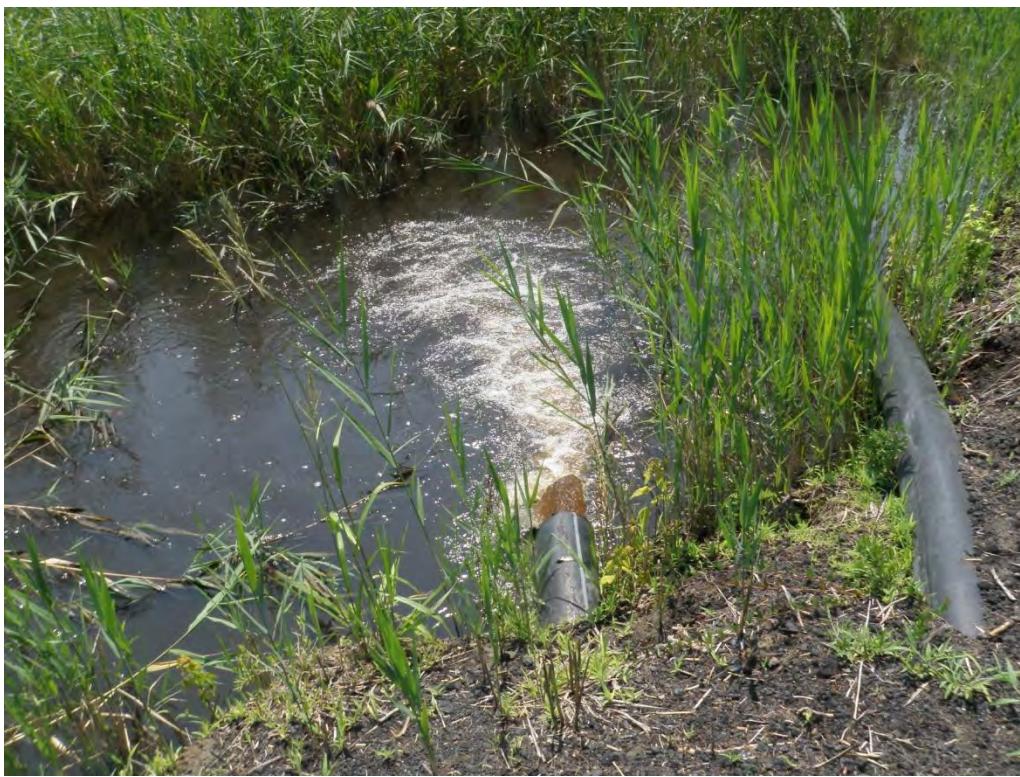
Photo 22: Ash Pond #2: Wastewater discharge into east cell.
