**DRAFT**  
**SPECIFIC SITE ASSESSMENT**  
**REPORT**  
**TRI-STATE GENERATION AND**  
**TRANSMISSION ASSOCIATION**

Escalante Generating Station

July 2009

Project 091330

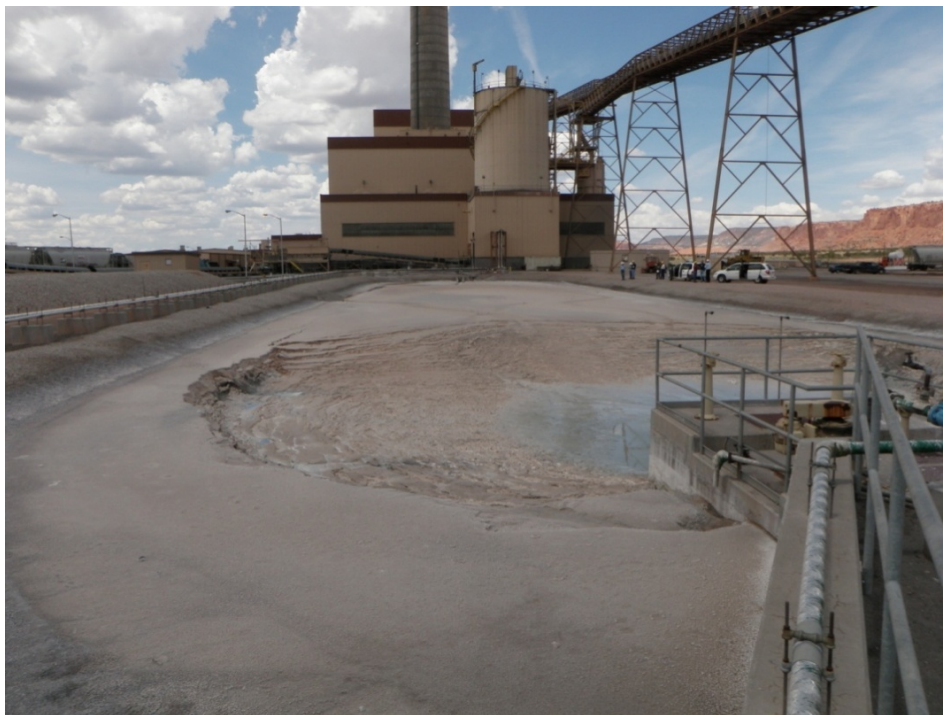
Photo 1: Emergency Scrubber Pond Looking West

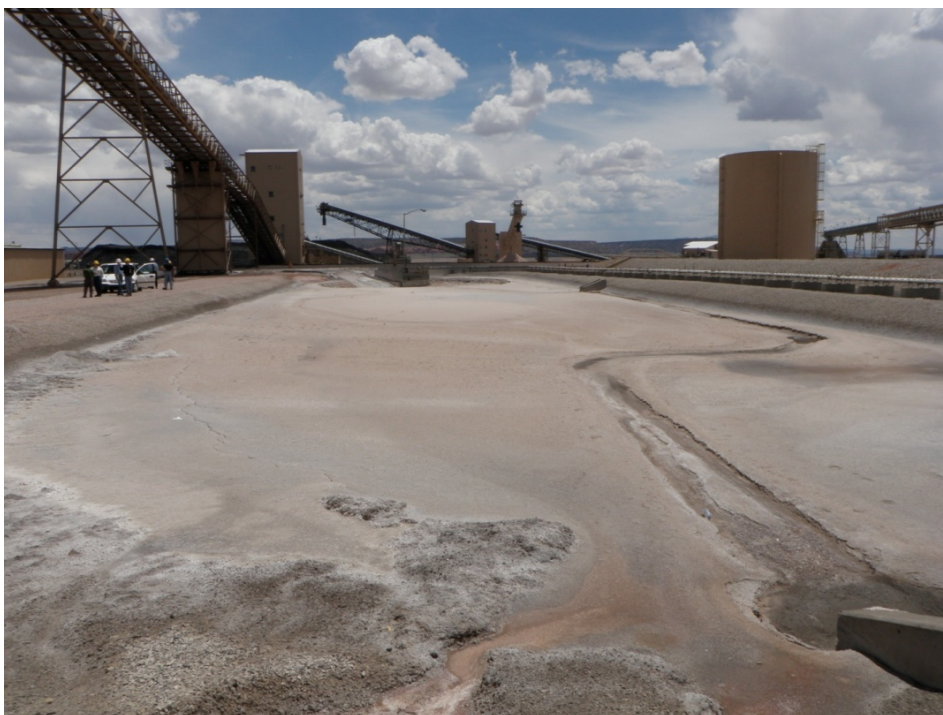
Photo 2: Emergency Scrubber Pond Looking East

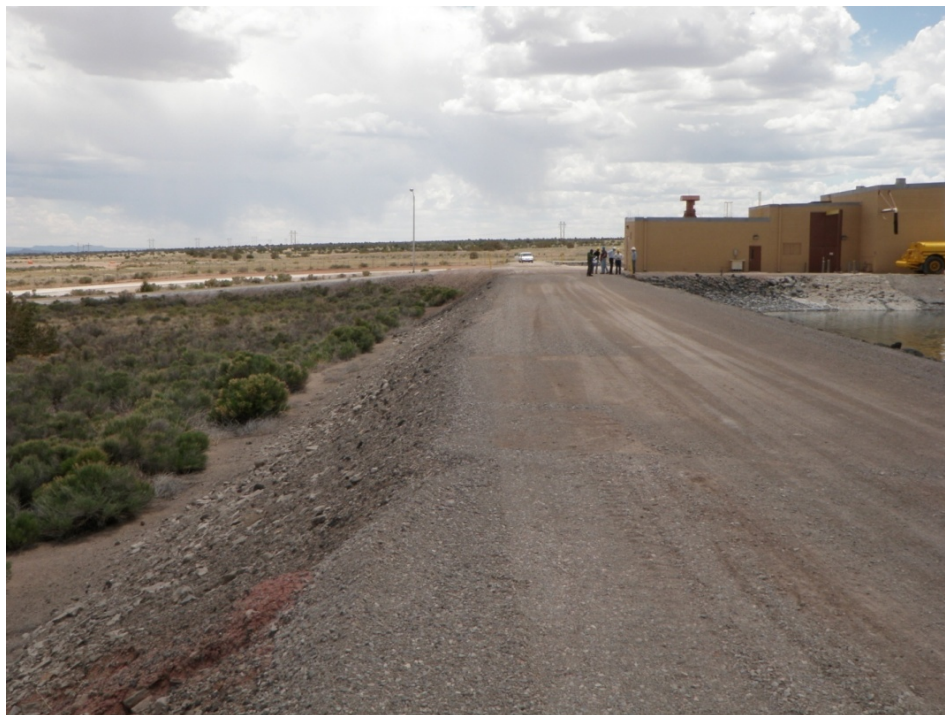
Photo 7: Bottom Ash Pond – North : Crest: Looking South along East Dike

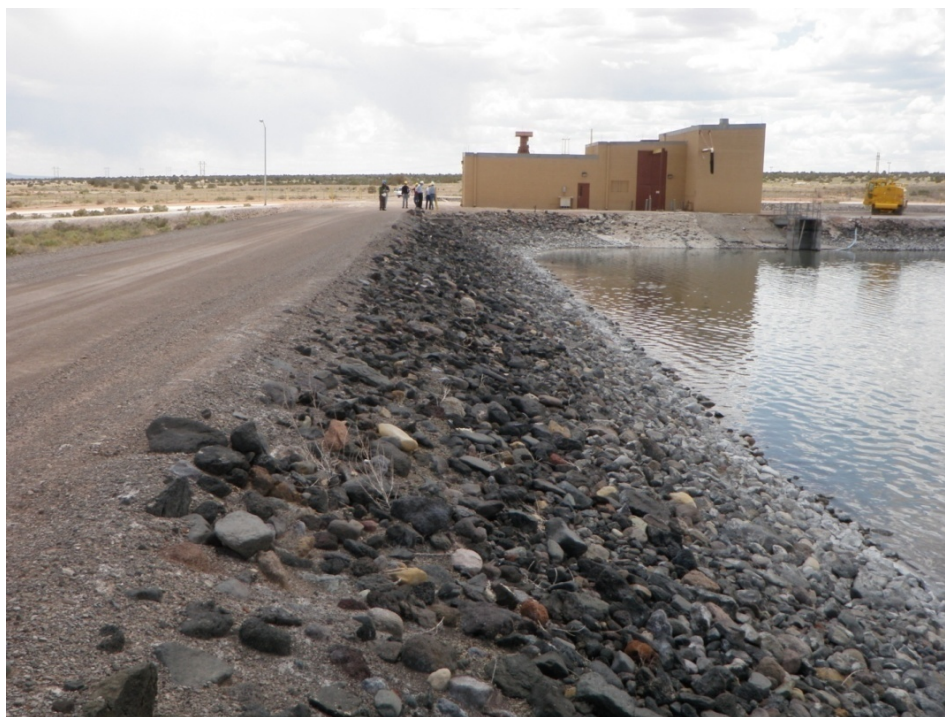
Photo 8: Bottom Ash Pond – North : Upstream Toe : Looking South along East Dike

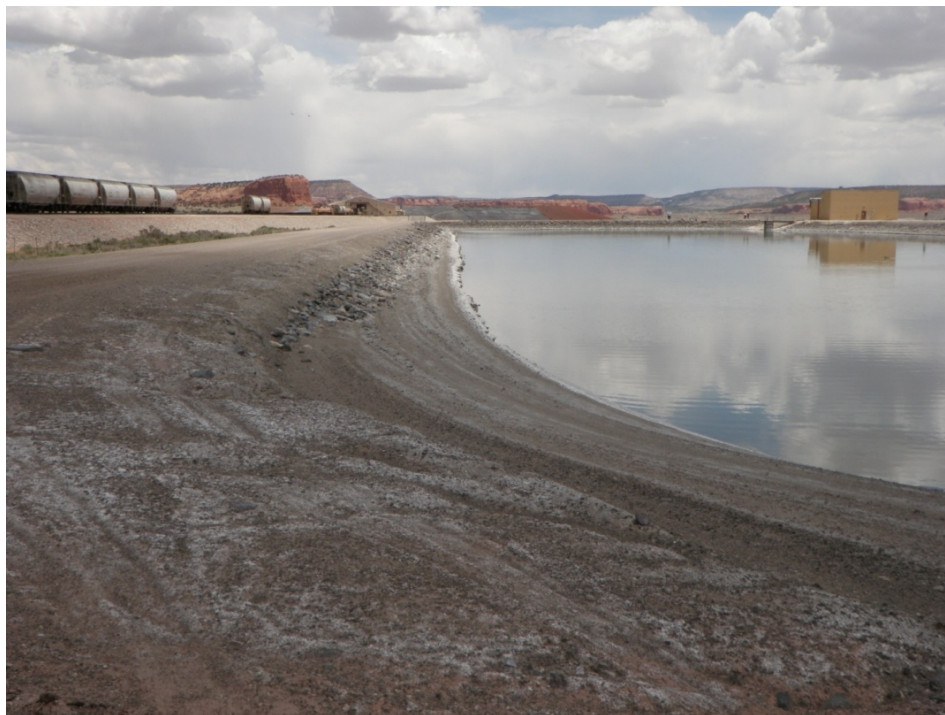
Photo 11: Bottom Ash Pond – North : Upstream Toe : Looking East along North Dike

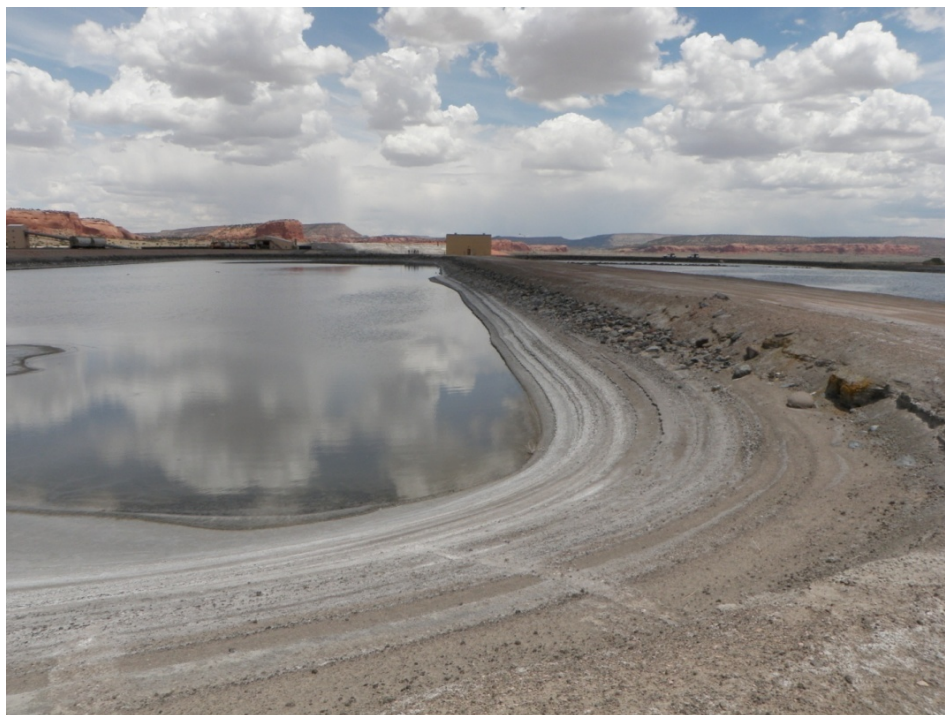
Photo 12: Bottom Ash Pond – North : Upstream Toe : Looking East along South Dike

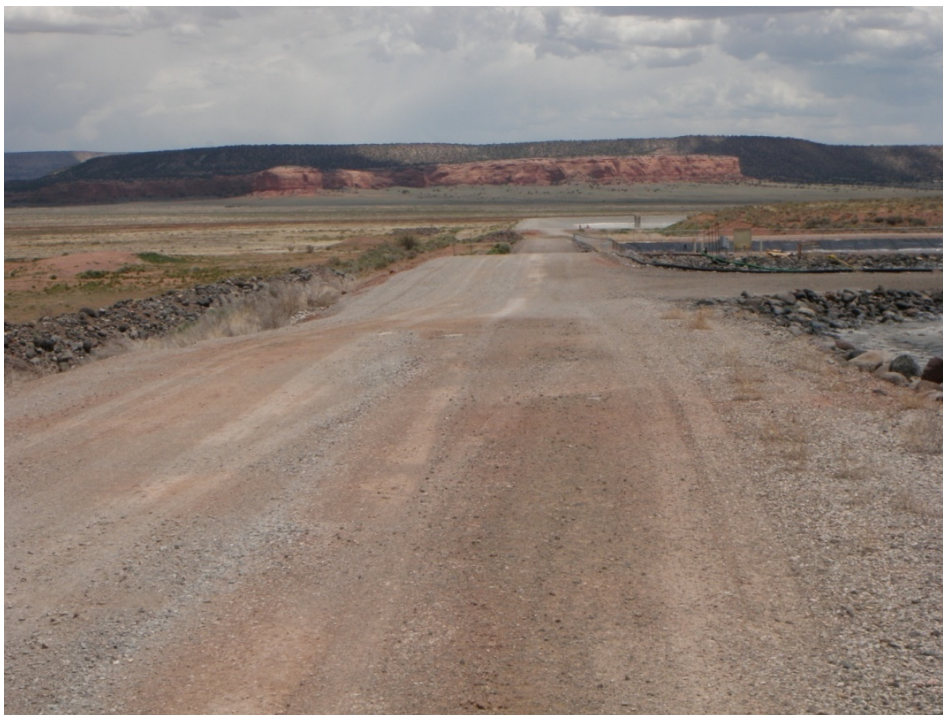
Photo 17: Evaporation Pond 2 : Crest : Looking East along North dike

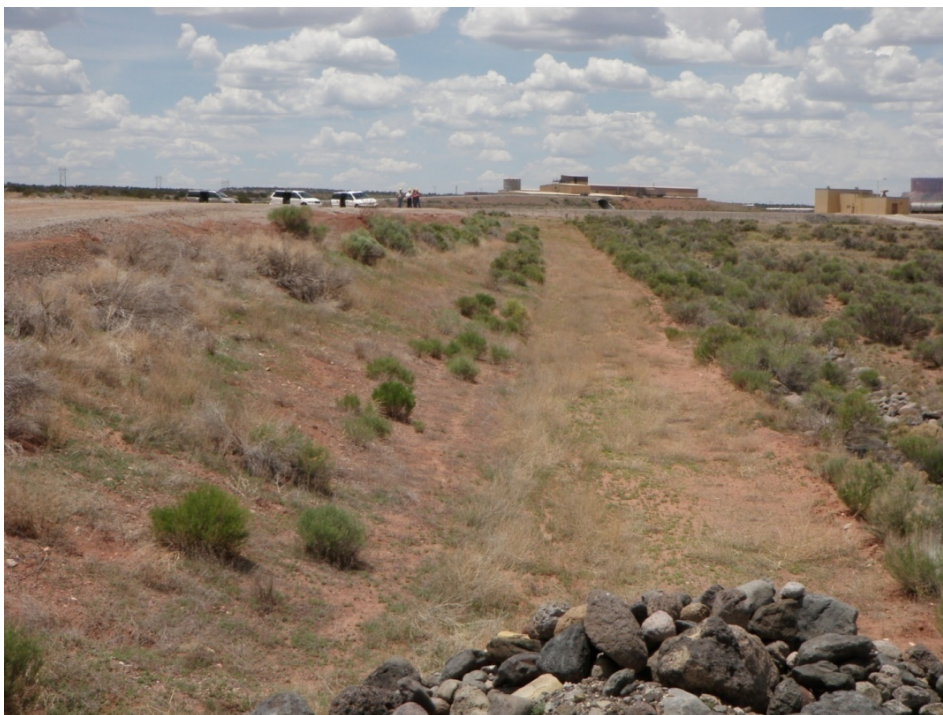
Photo 18: Evaporation Pond 2 : Downstream Toe : Looking West along north dike

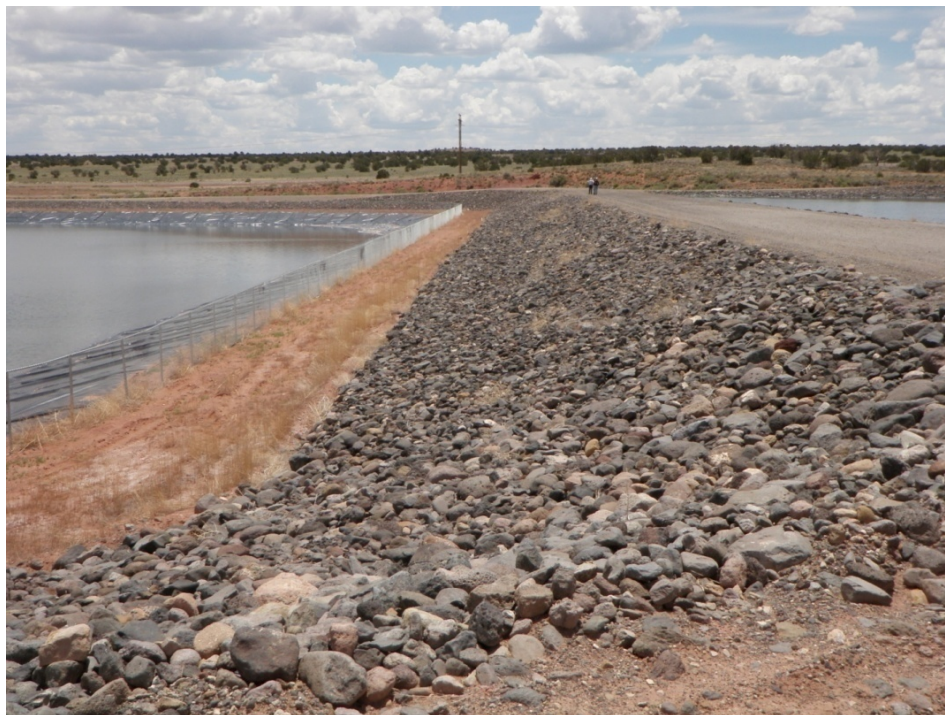
Photo 19: Evaporation Pond 4 : Upstream Toe : Looking South along West dike

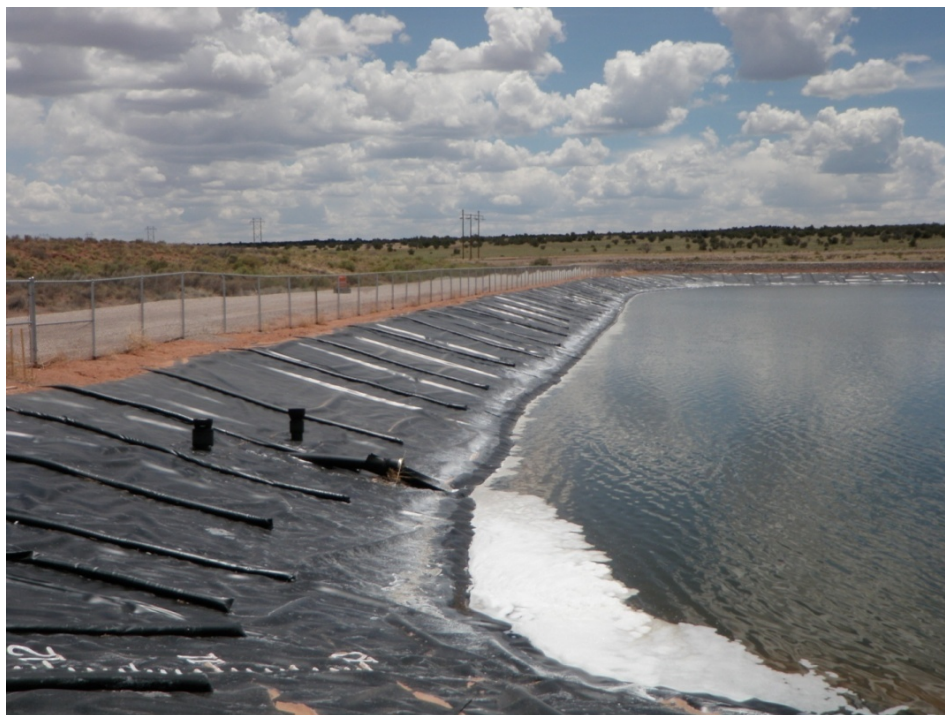
Photo 20: Evaporation Pond 4 : Upstream Toe : Looking South along east dike

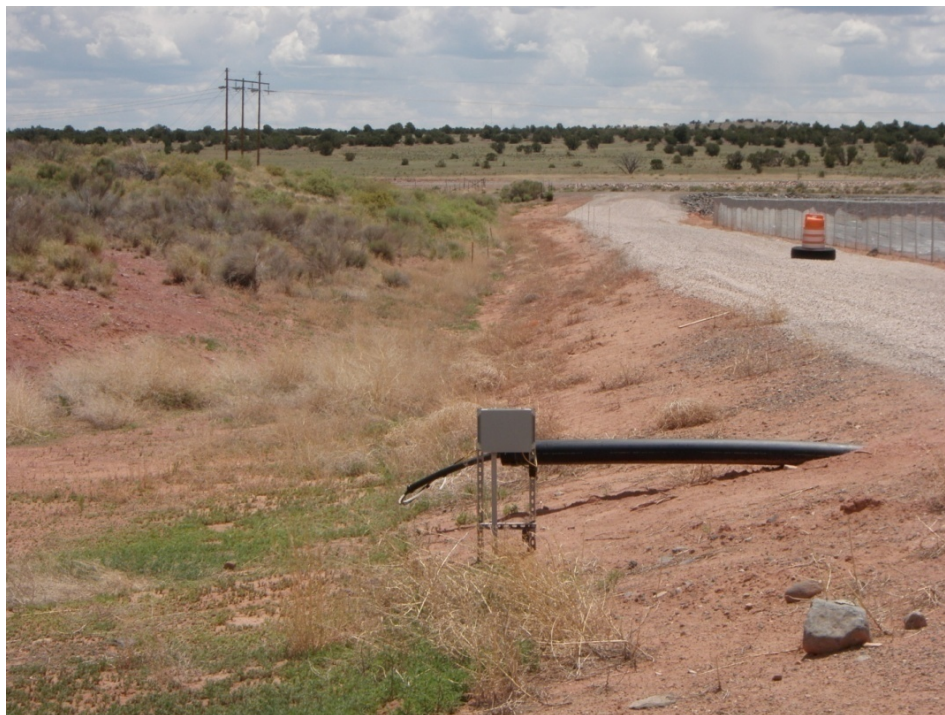
Photo 21: Evaporation Pond 4 : Downstream Toe : Looking South along east dike

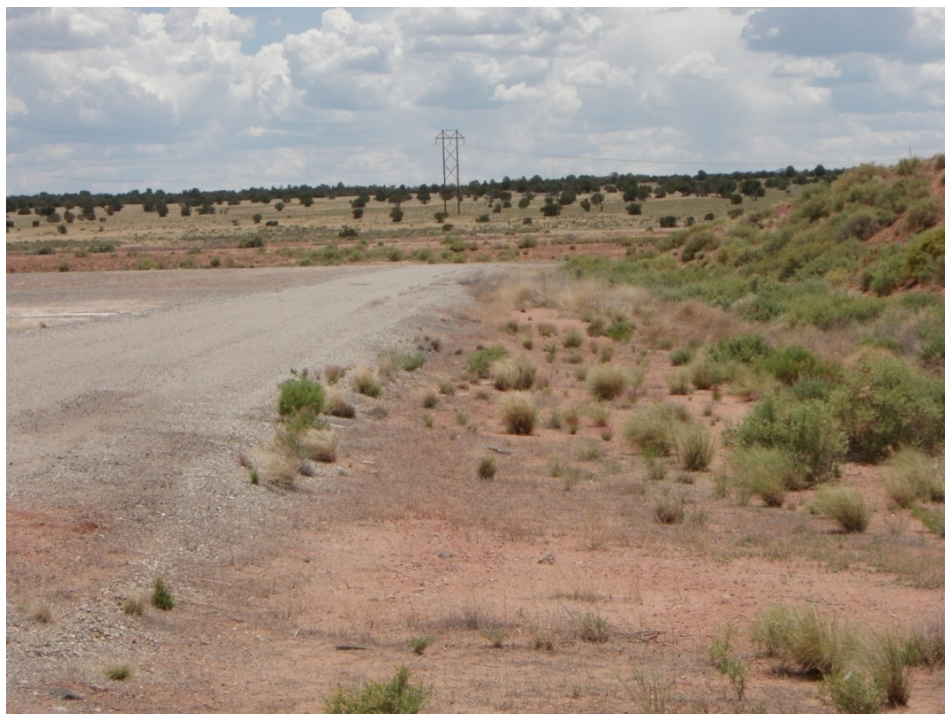
Photo 22: Evaporation Pond 5: Downstream Toe : Looking South along west dike

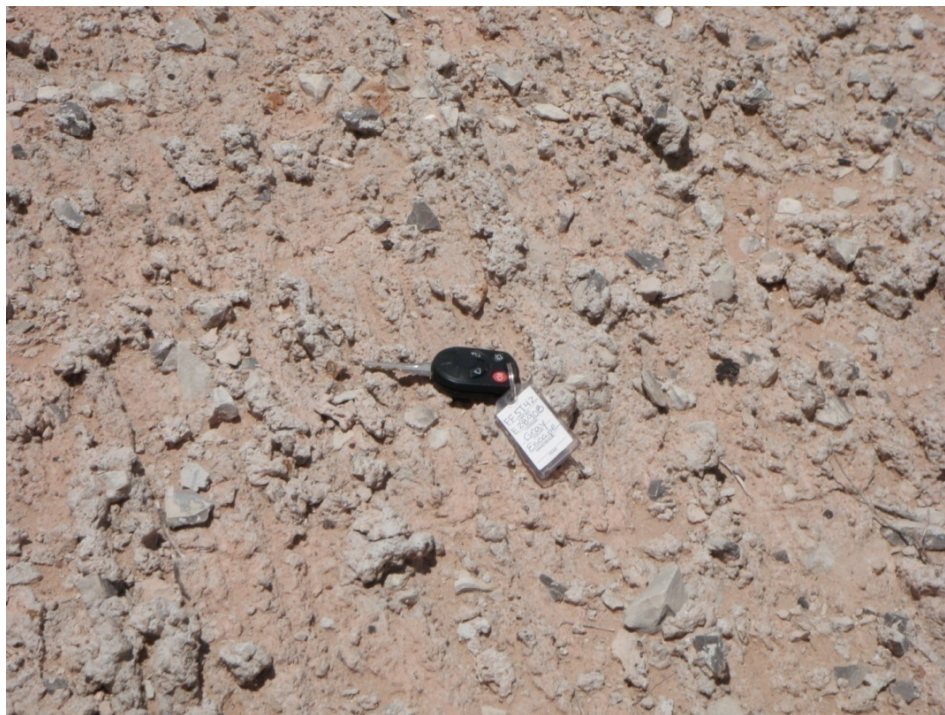
Photo 23: Evaporation Pond 5 : Raked liner finish

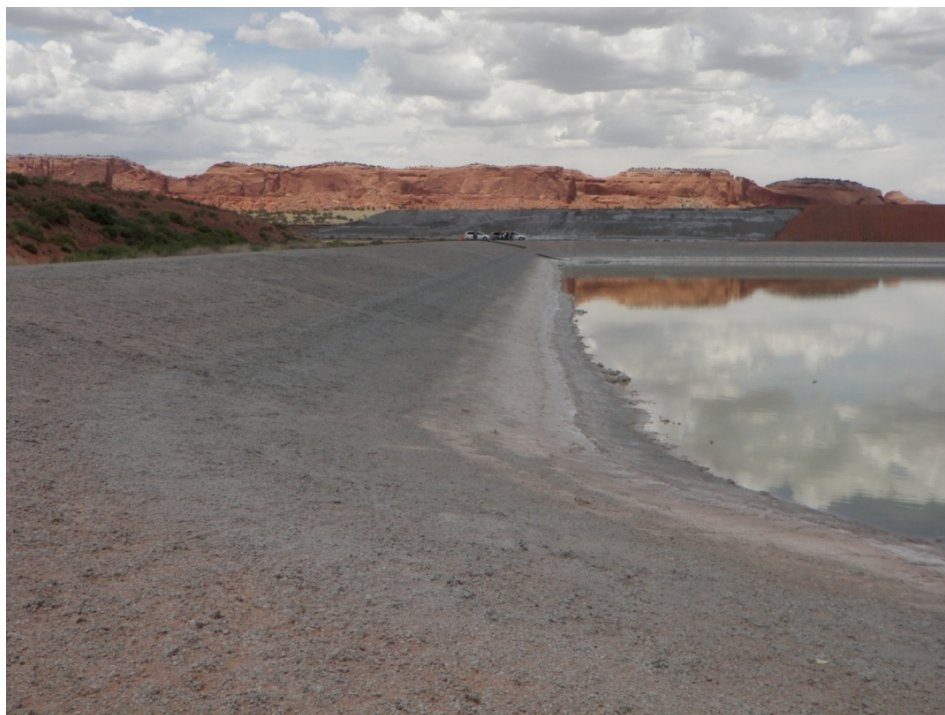
Photo 24: Evaporation Pond 5 : Upstream Toe : Looking North along west dike

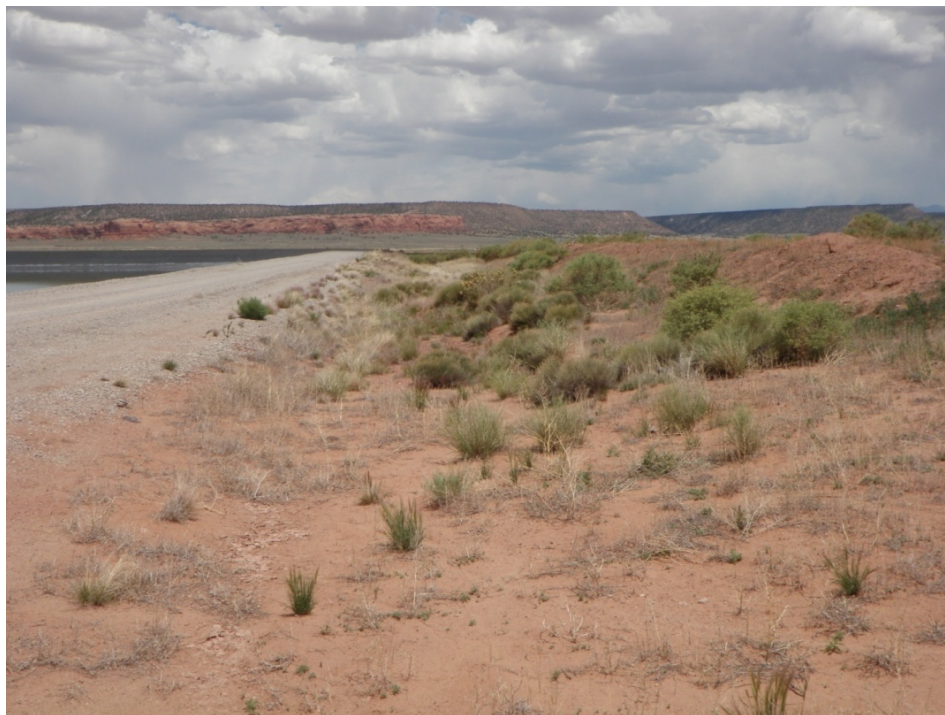
Photo 25: Evaporation Pond 5 : Downstream Toe : Looking East along south dike

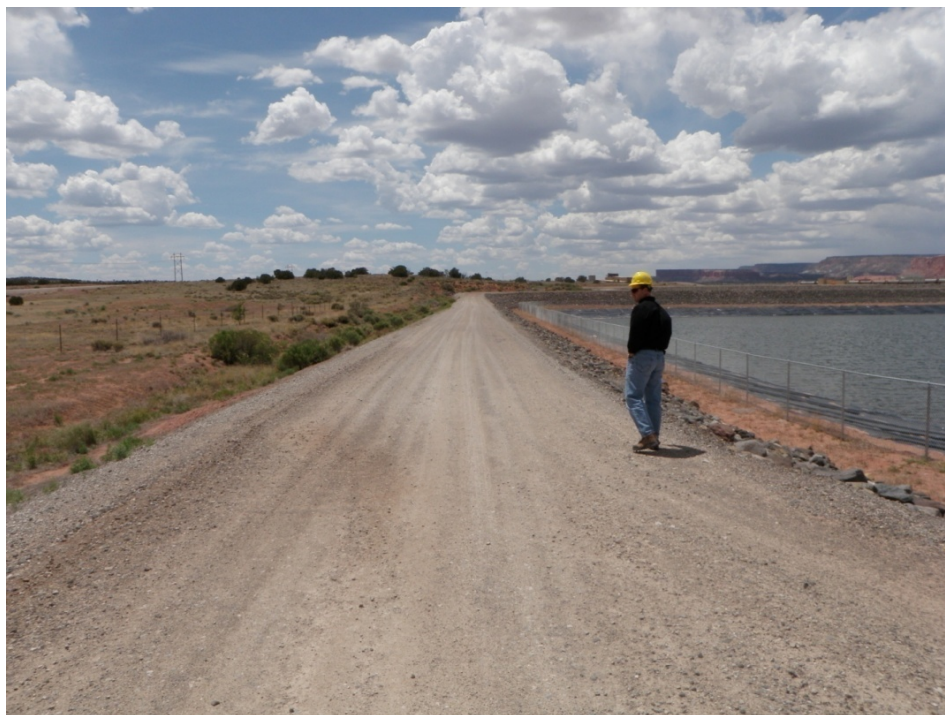
Photo 26: Evaporation Pond 4 : Crest : Looking East along south dike

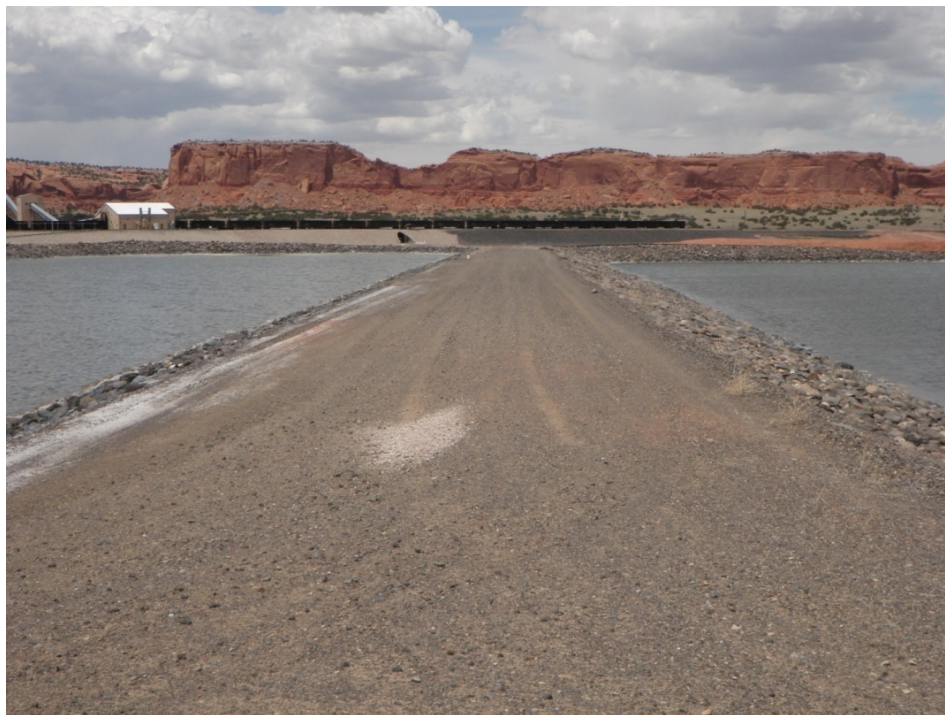
Photo 29: Evaporation Pond 2 (left) & Pond 3 (right) : Crest : Looking North

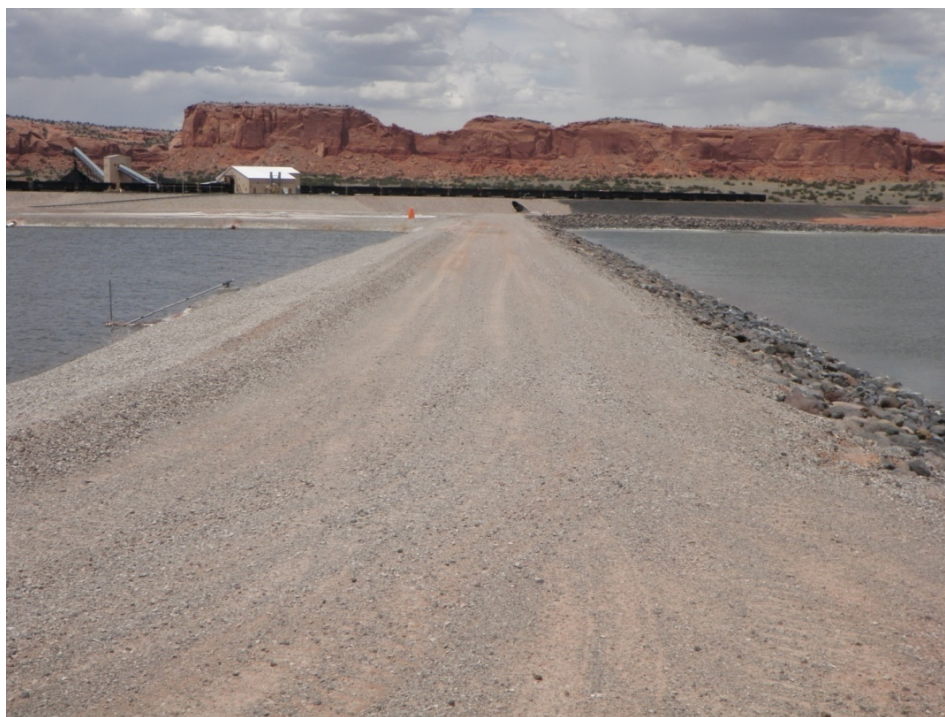
Photo 30: Evaporation Pond 2 (right) & 1b (left) : Crest : Looking North

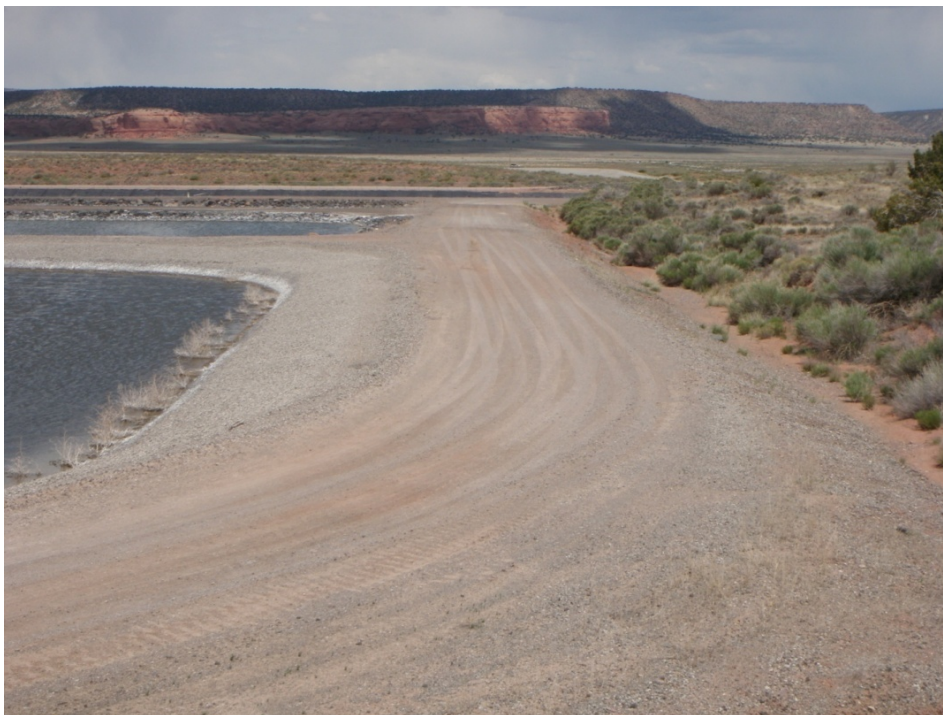
Photo 31: Evaporation Pond 1b : Crest : Looking East along south dike

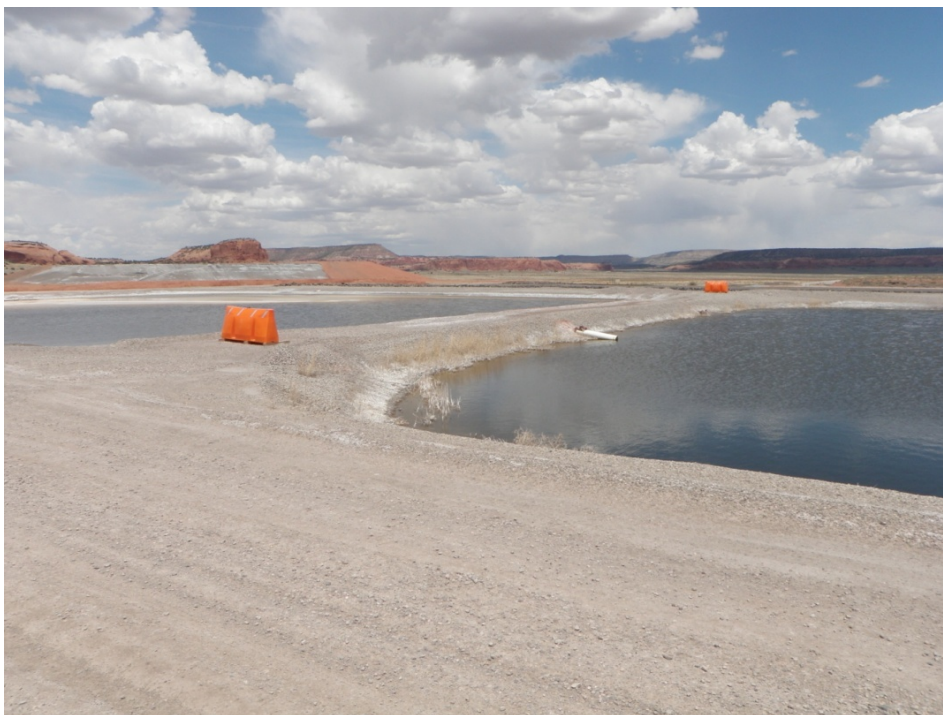
Photo 32: Evaporation Pond 1a (left) & 1b (right) : Looking Northeast from the west dike of Pond 1b at dike dividing 1b from 1a
