**Coal Combustion Residue Impoundment
Round 11 - Dam Assessment Report**

Cumberland Fossil Plant
Dry Ash Storage / Ash Pond
TVA
Cumberland City, Tennessee

Dewberry Consultants LLC
Fairfax, Virginia

April 2013

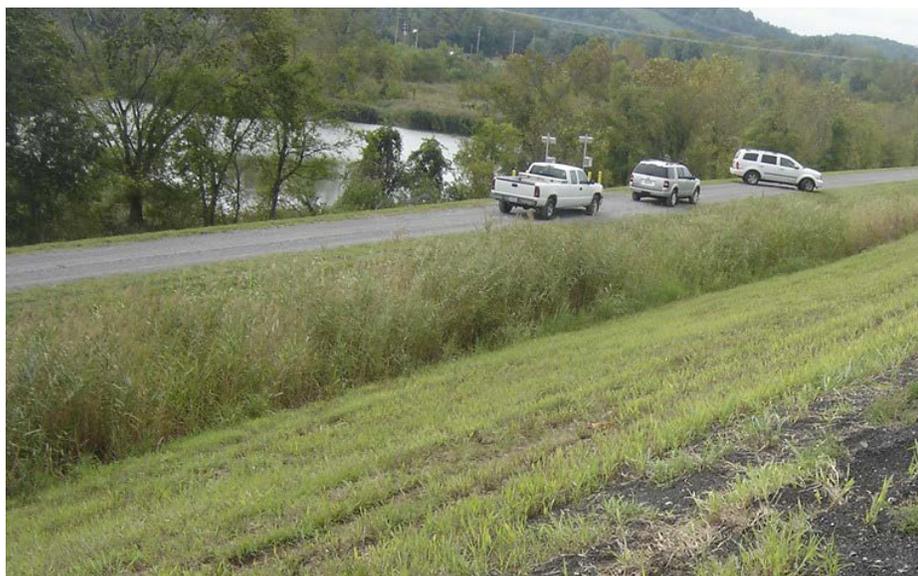
Figure 5.2.1-1 Photo showing Crest, East Dike

The dike divides the gypsum disposal area and Wells Creek. The crest had no signs of depressions, tension cracks, or other indications of settlement or shear failure, and appeared to be in satisfactory condition.

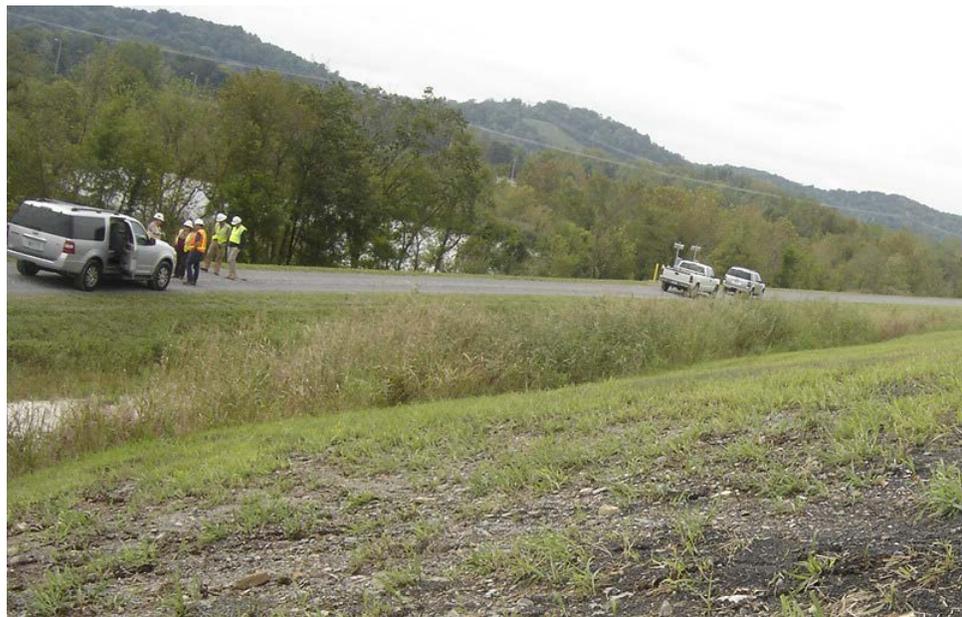
Figure 5.2.2-1 Photo showing inside slope, East Dike

There were no observed scarps, sloughs, bulging, cracks, or depressions or other indications of slope instabilities or signs of erosion. Figures 5.2.2-1 and 5.2.2-2 show the general condition of the inside slope. Vegetation should be installed to help minimize erosion in bare areas and maintained to allow for inspection of the slopes.

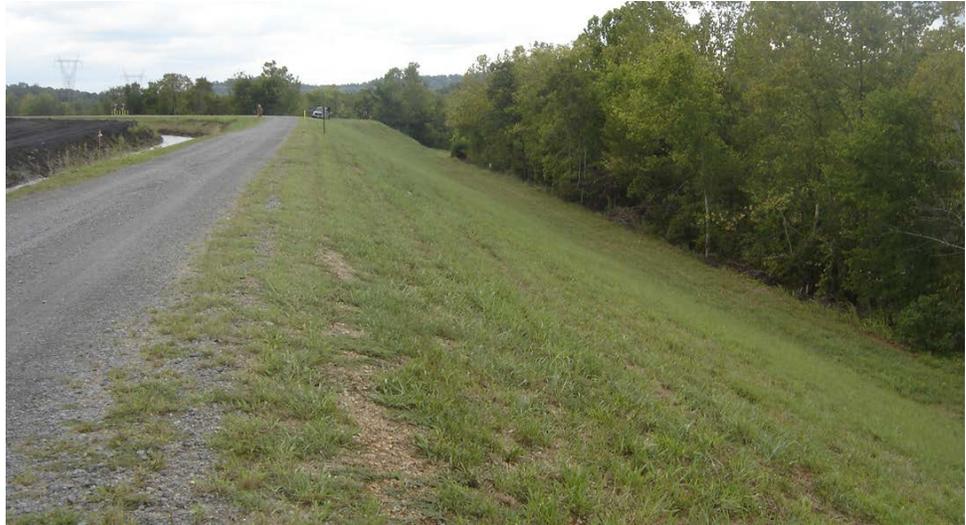
Figure 5.3.1-1 Photo showing crest, West Dike

The dike divides the ash storage area and Wells Creek. The crest had no signs of depressions, tension cracks, or other indications of settlement or shear failure, and appeared to be in satisfactory condition.

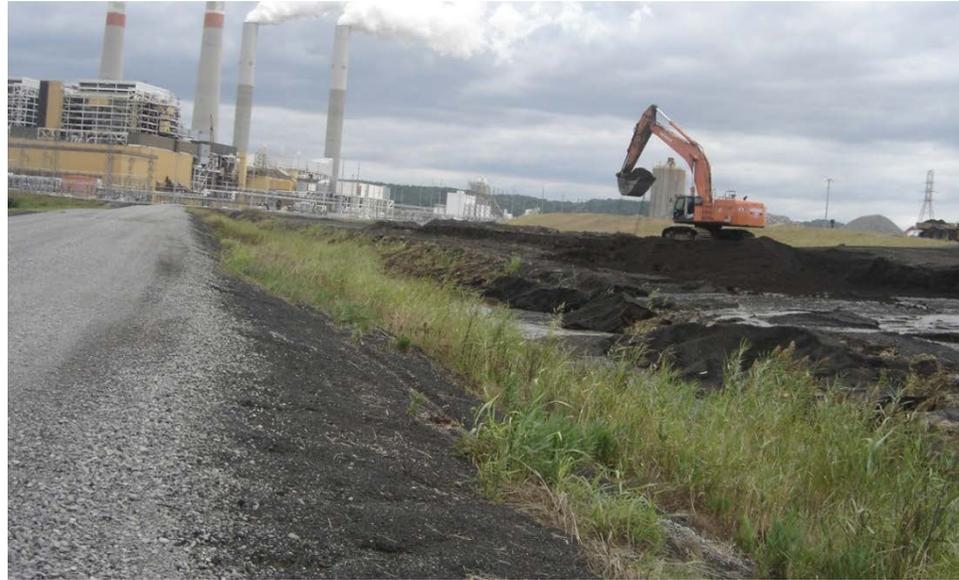
Figure 5.3.2-1 Photo showing inside slope, North Dike

There were no observed scarps, sloughs, bulging, cracks, or depressions or other indications of slope instabilities or signs of erosion. The three pictures below show the general condition of the inside slope. Vegetation should be installed to help minimize erosion in bare areas and maintained to allow for inspection of the slopes.

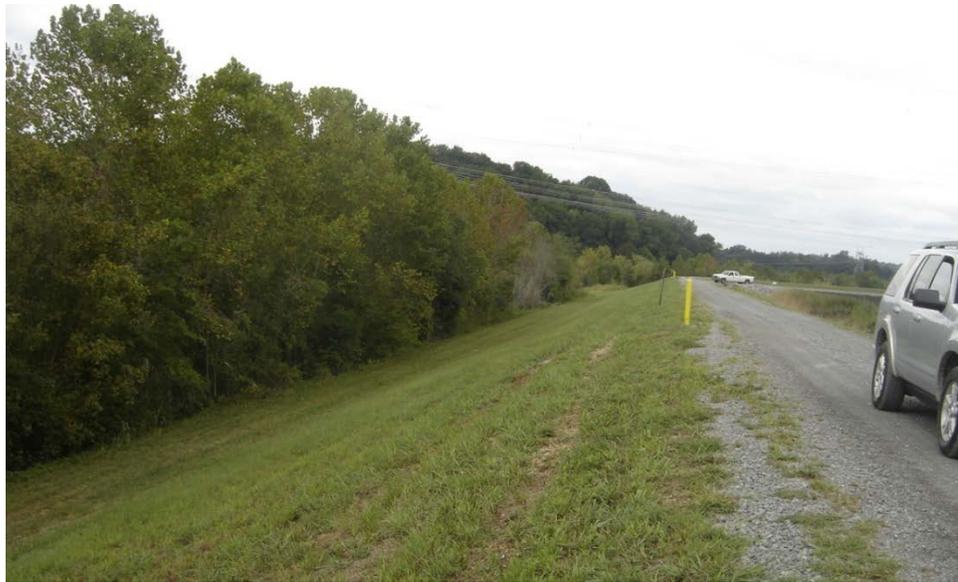
Figure 5.3.3-1 Photo showing outside slope, West Dike

There were no observed scarps, sloughs, bulging, cracks, or depressions or other indications of slope instabilities or signs of erosion. Figures 5.3.3-1 and 5.3.3-2 show the general condition of outside slope. Vegetation should be installed to help minimize erosion in bare areas and maintained to allow for inspection of the slopes.

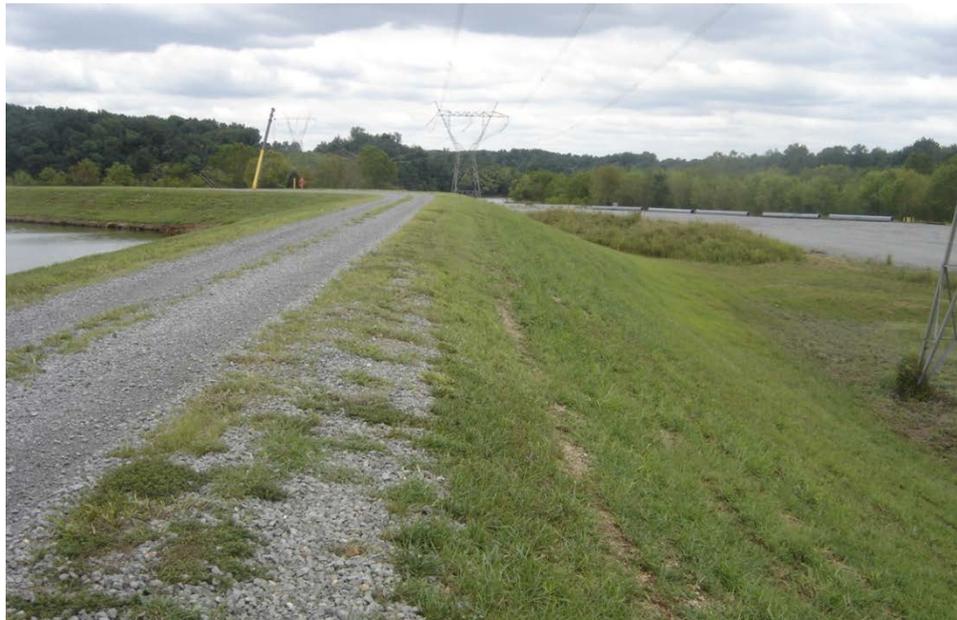
Figure 5.4.1-1 Photo showing crest, North Dike

The dike divides the Ash Pond and Wells Creek on the south and Lake Barkley to the north. The crest had no signs of depressions, tension cracks, or other indications of settlement or shear failure, and appeared to be in satisfactory condition.

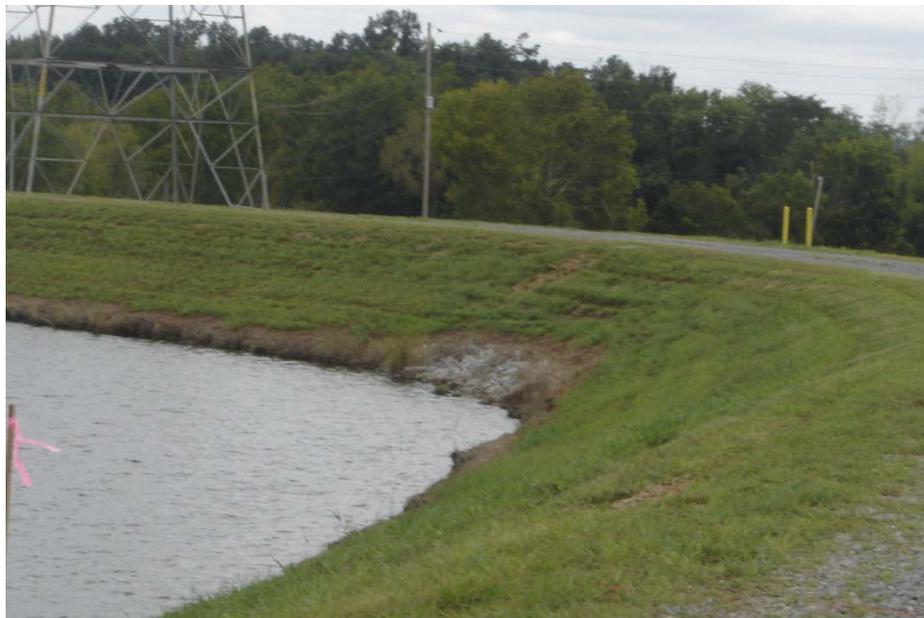
Figure 5.4.2-1 Photo showing inside slope, North Dike

There were no observed scarps, sloughs, bulging, cracks, or depressions or other indications of slope instabilities or signs of erosion. The photo below shows the general condition of the inside slope. Vegetation should be installed to help minimize erosion in bare areas and maintained to allow for inspection of the slopes.

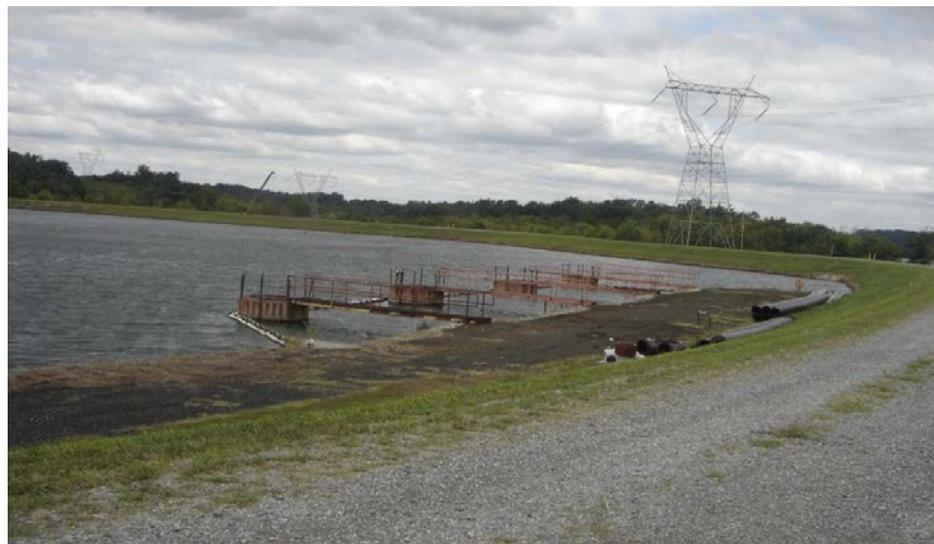
Figure 5.5.1-1 Photo showing Outlet Structures

The primary overflow structures were observed to be working properly, discharging flow from the ash pond. The outlet structure visually appeared to be in satisfactory condition. There were no signs of clogging.

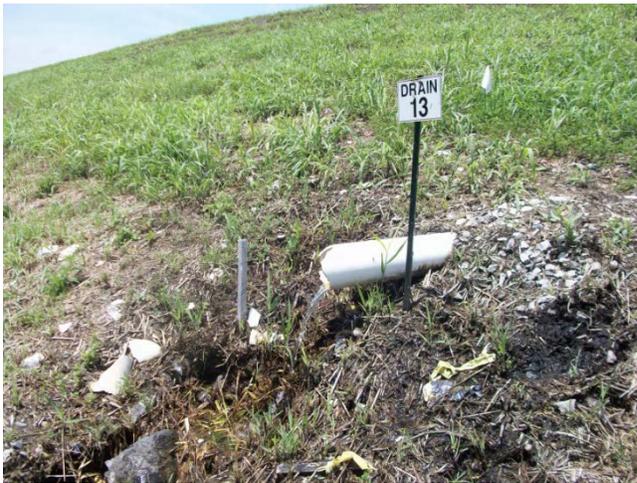
Photo 7
Erosion noted below subdrain 13.

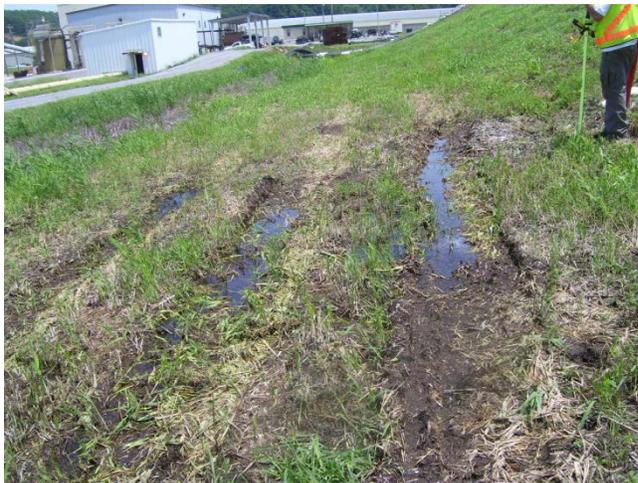
Photo 9
Ponding/Rutting below subdrain #21.

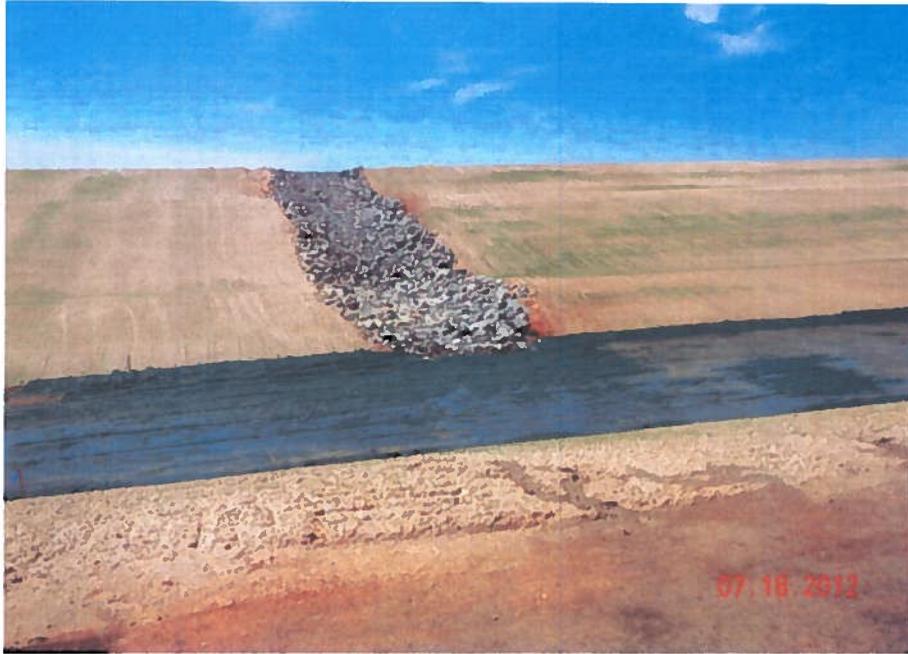
Erosion Repair and Perimeter Ditch Improvements from CUF Work Plan 11

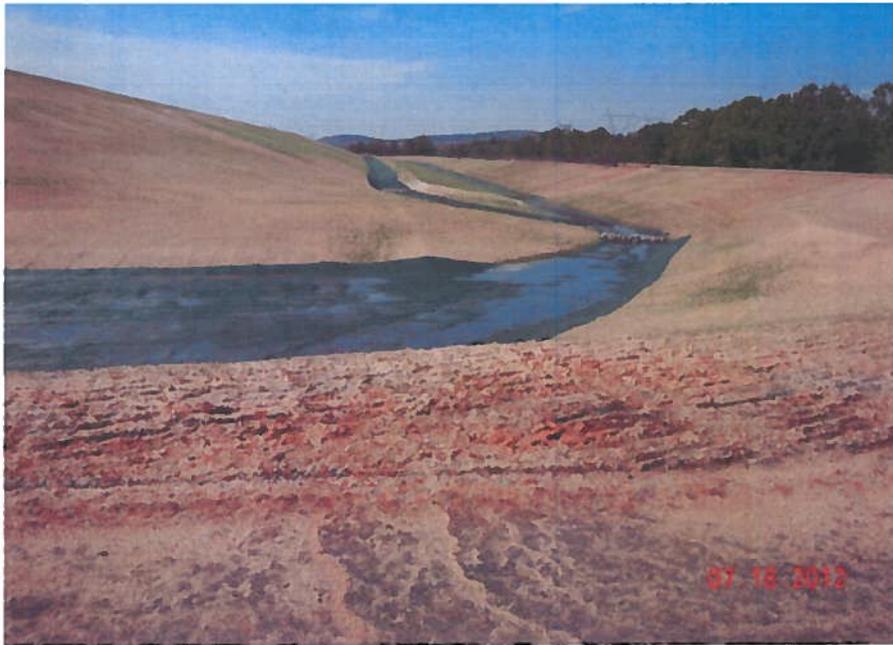
Perimeter Ditch Improvements from CUF Work Plan 11
