**Lower Ash Pond Dam
– A.B. Brown Station Assessment
Report**

Lockheed Martin

July 2009

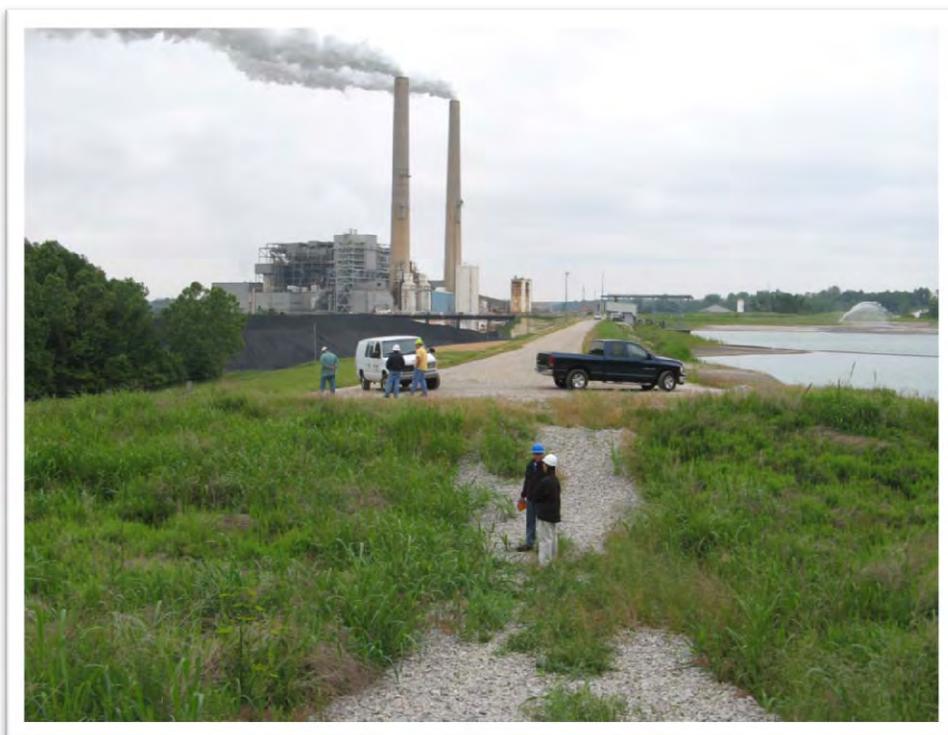
Photo 1- Lower Ash Pond Dam Crest Looking North

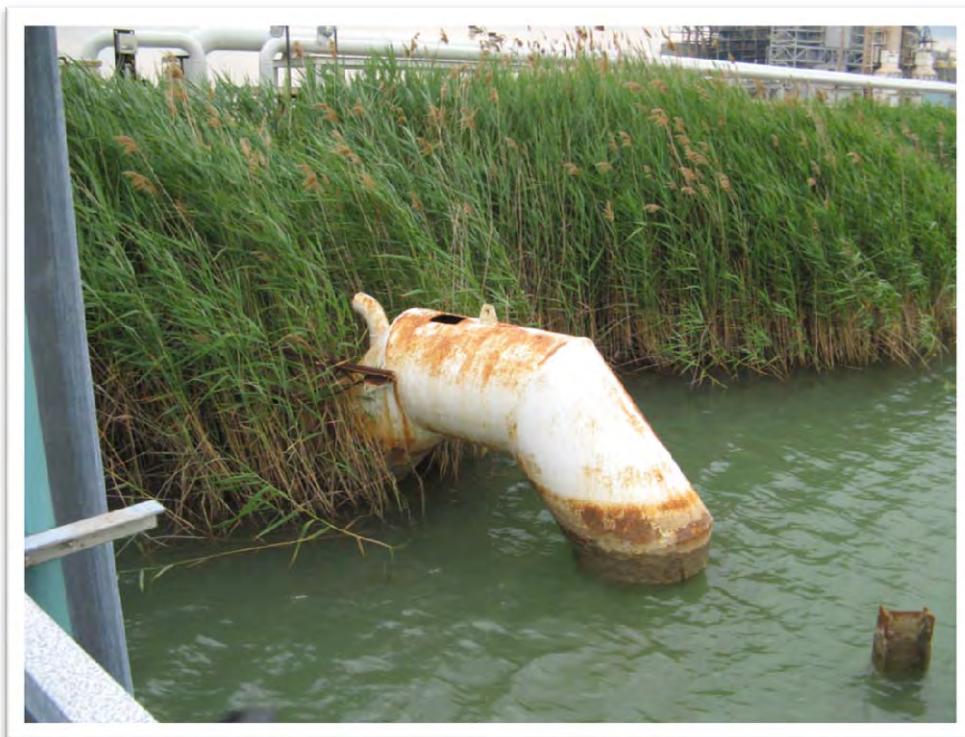
- The phragmites vegetation growing from the upstream slope in the vicinity of the normal pool elevation obscures the slope and inhibits thorough inspection of the embankment in this area.

Photo 2- Principal Spillway Goose Neck Inlet. Note Vegetation on Embankment

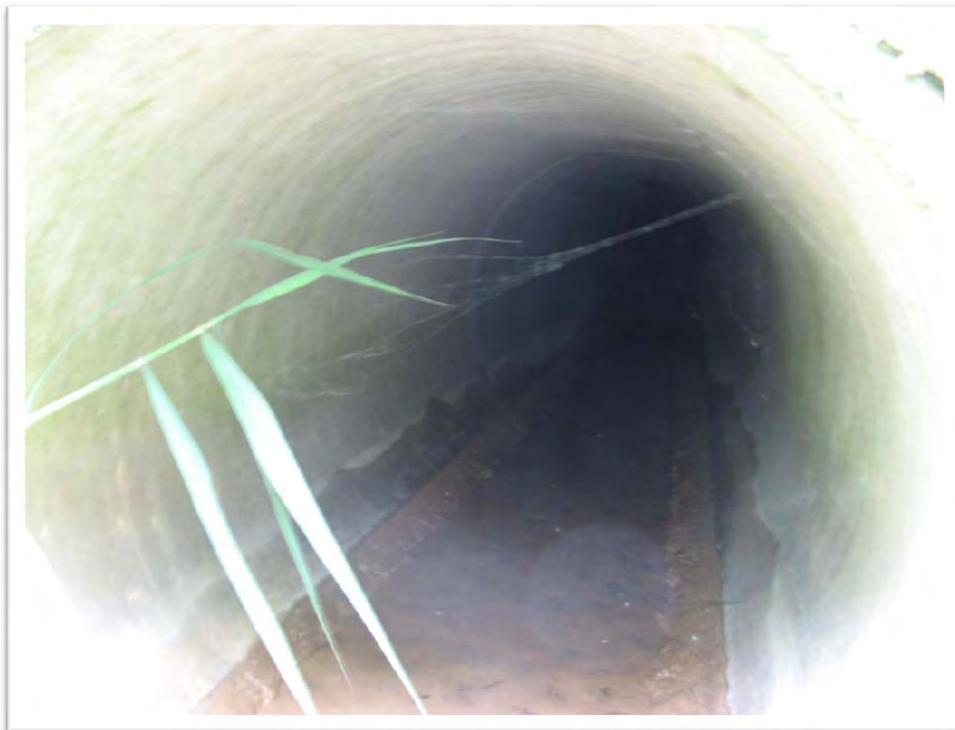
2. Principal Spillway – The principal spillway consists of a 36” reinforced concrete riser and outlet pipe with a metal gooseneck drop inlet that appears to be in good condition. The Vectren staff maintains the pond level about one foot below the overflow elevation of the drop inlet, therefore, the principal spillway was not flowing on the dates of the inspections. Some minor leakage was evident at the outlet end of the pipe; however, the source of this leakage could not be ascertained and this condition may have been a result of ponded water at the toe of the dam infiltrating the pipe and subsequently receding.

Photo 3- Principal Spillway Outlet

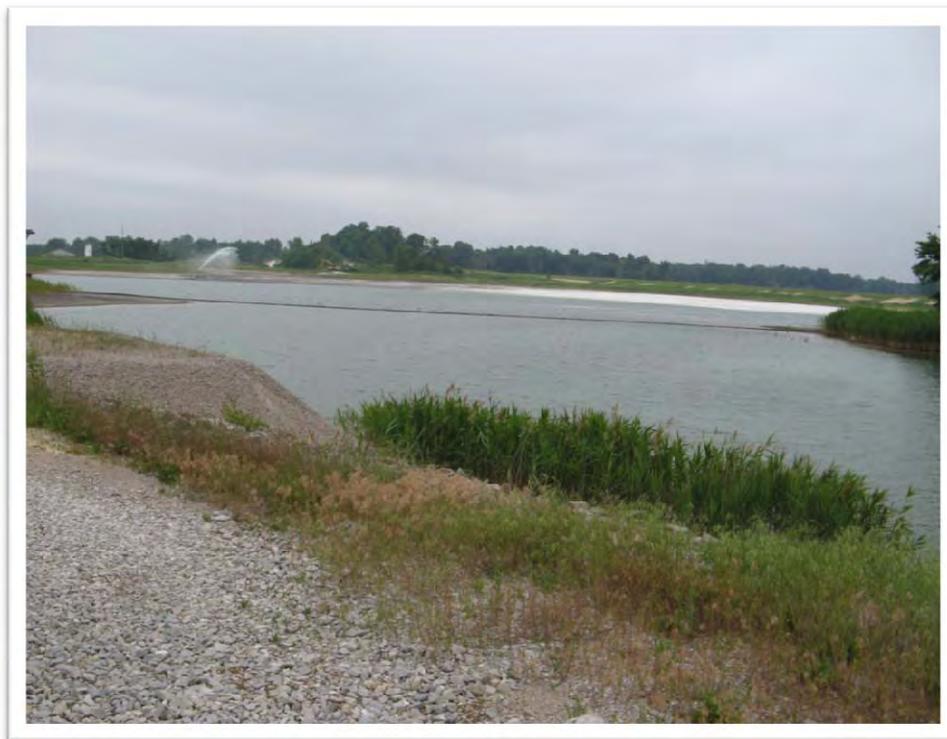
Photo 4- Lower Ash Pond Looking Northeast. Note White Residue from Scrubber Blowdown

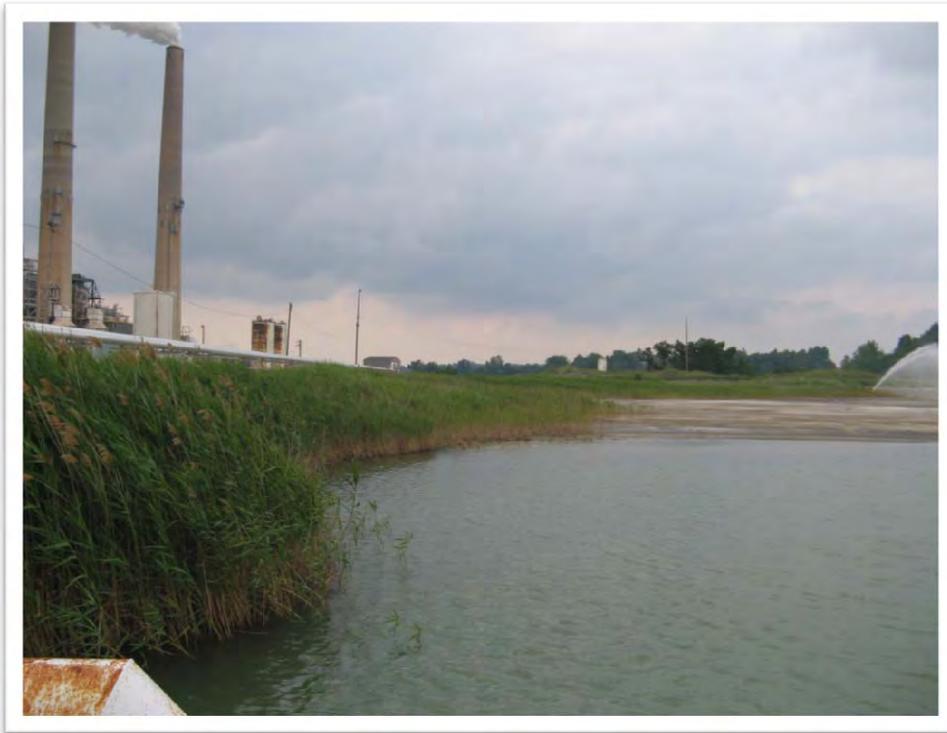
Photo 5- Upstream Embankment Looking North. Note Vegetation on Embankment

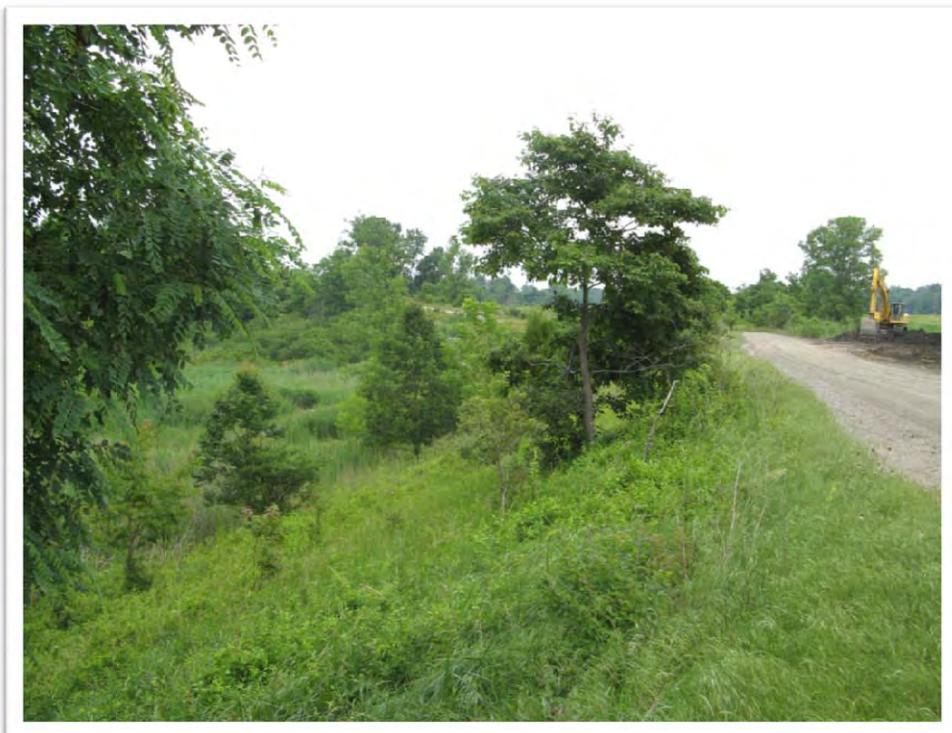
Photo 6- Northwest Area of Downstream Embankment

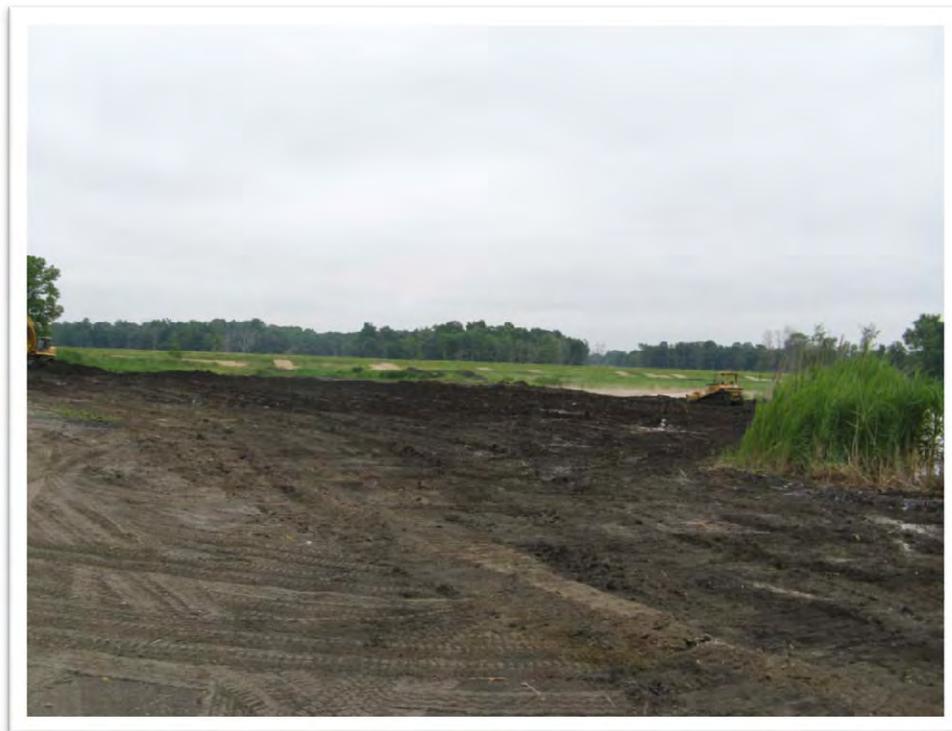
Photo 7- Northern Area of Ash Pond with Solidified Material

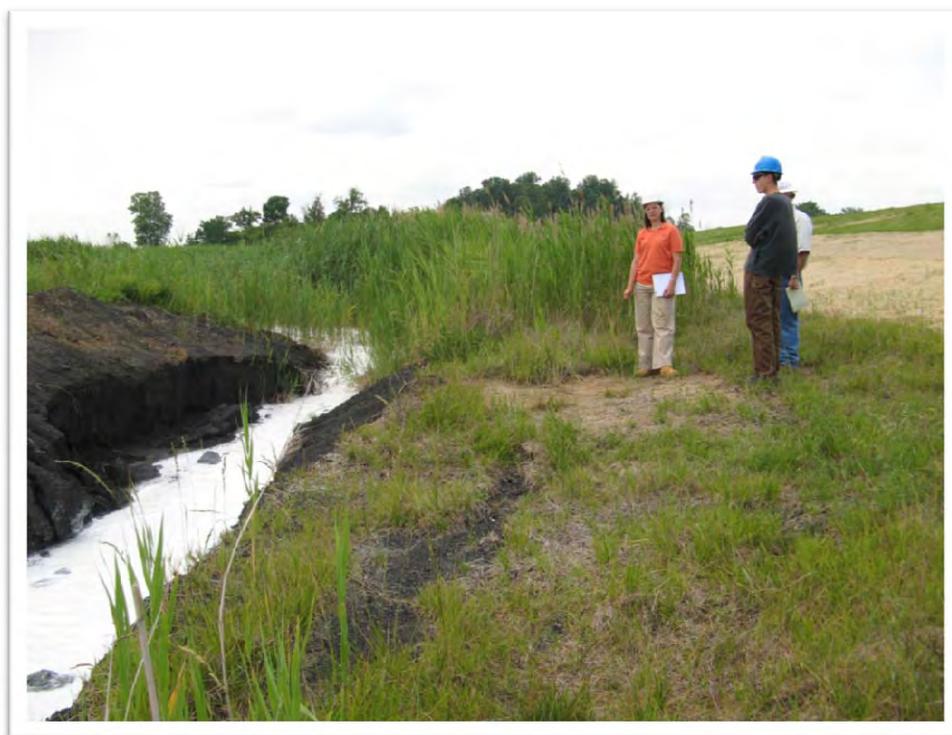
Photo 8- Northern Area of Ash Pond with Channel for White-ish Scrubber Blowdown

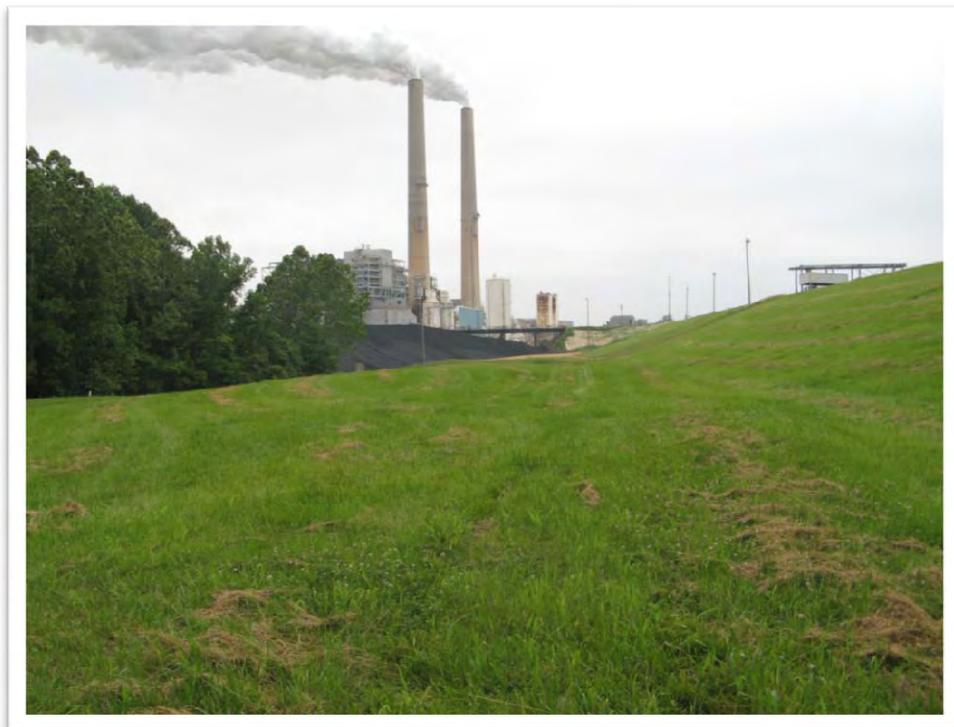
Photo 9- Lower Embankment Berm Area Looking North

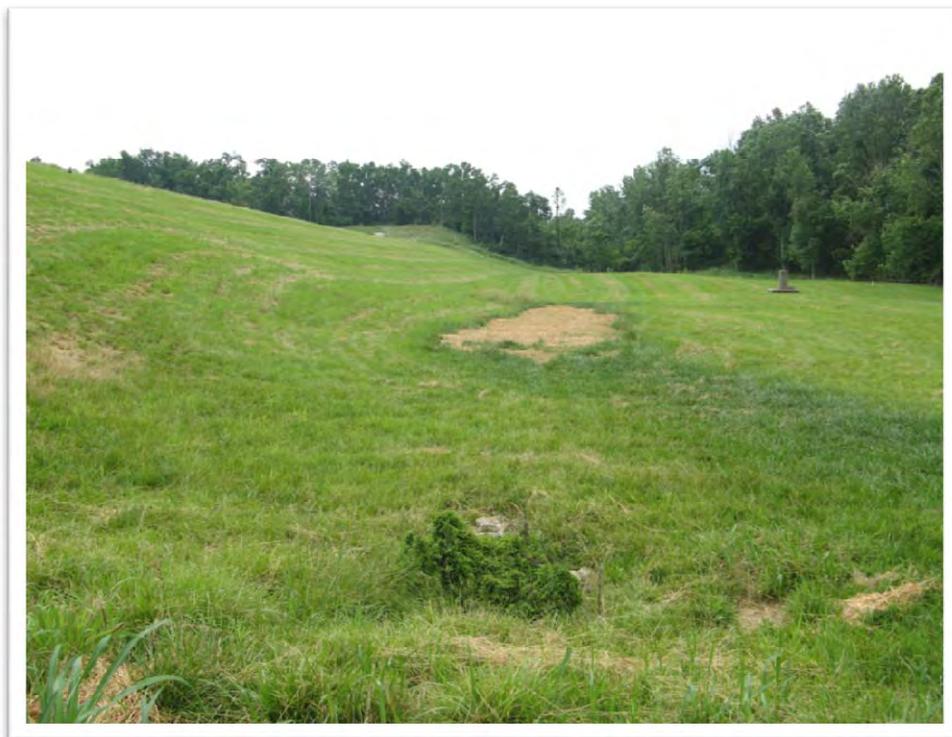
Photo 10- Lower Embankment Berm Area Looking South. Note Repaired Area

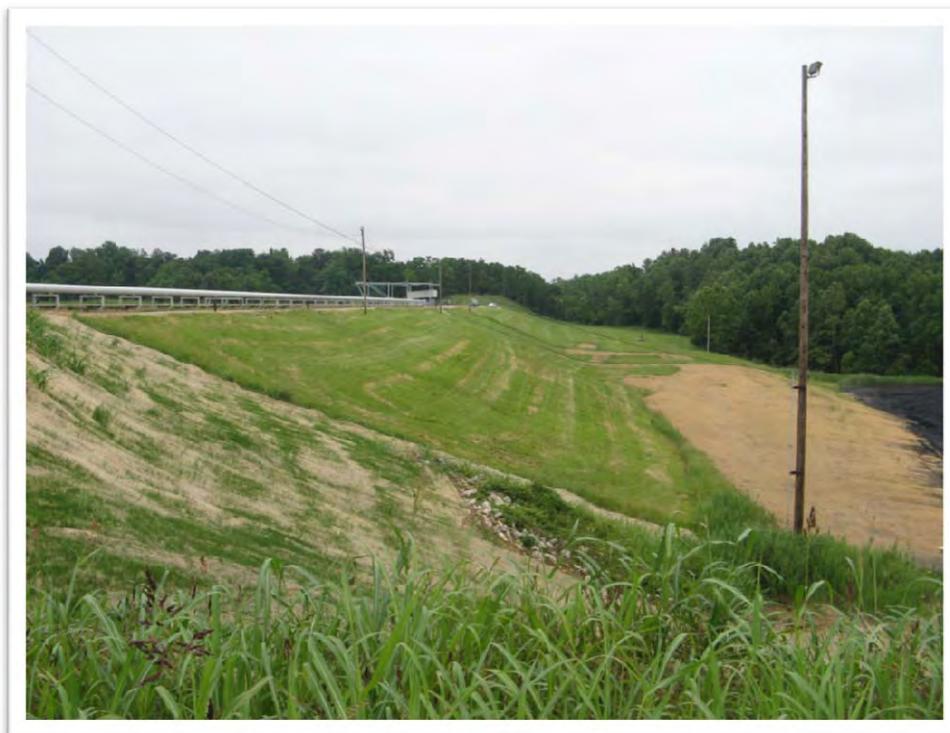
Photo 11- Upper Area of Downstream Embankment Looking South. Note Repaired Area Adjacent to Coal Pile and Random Rip Rap and Vegetation near Utility Pole

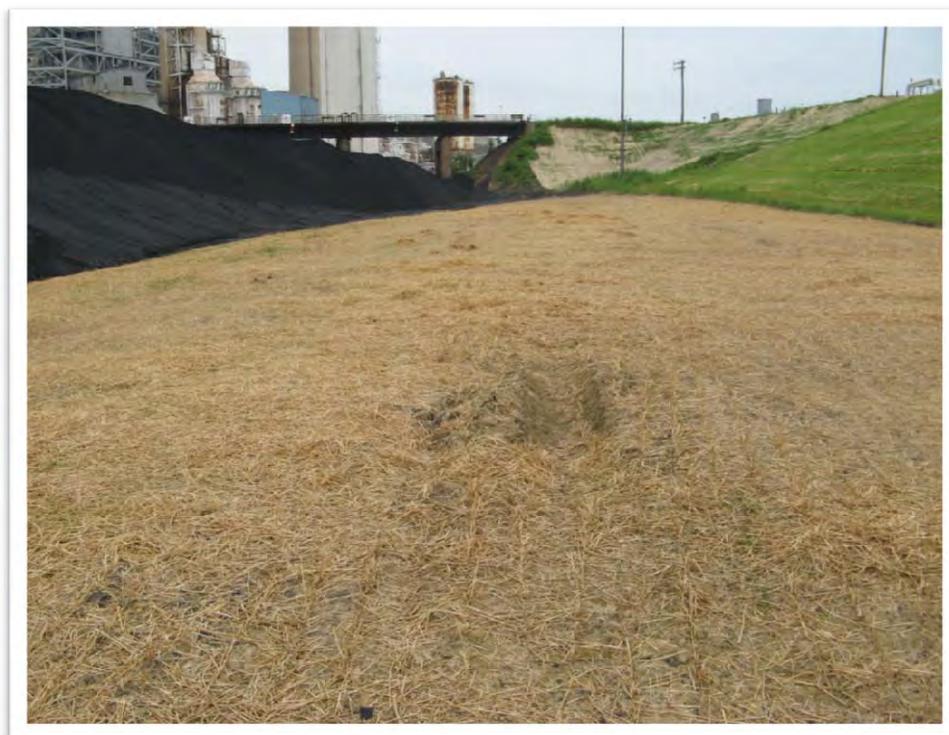
Photo 12- Repaired Area on Berm Looking North. Note Tire Rut in Repaired Area

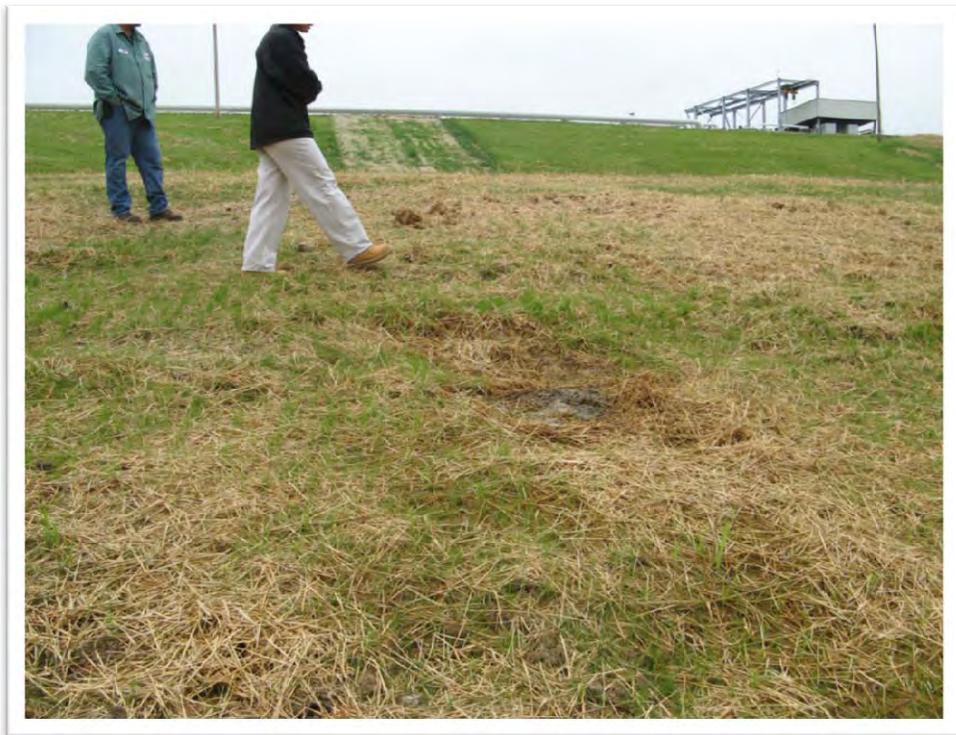
- Ponding of water on the berm surface indicates that the berm does not have sufficient slope for adequate drainage.
 - Trees growing from the lower portion of the downstream slope (to the south of the outlet channel) could threaten the integrity of the embankment, since they could be uprooted during storm conditions with significant displacement of the earth around the roots.

Photo 13- Wet Area on Berm Looking North

2. Depending on the results of the seepage investigation described above, a drain outlet system should be designed to allow free drainage from the Seepage Collection Zone and collection/conveyance of the seepage flow. The berm surface should also be regraded as necessary to promote drainage of rainfall runoff and to minimize infiltration of surface water into the Seepage Collection Zone.

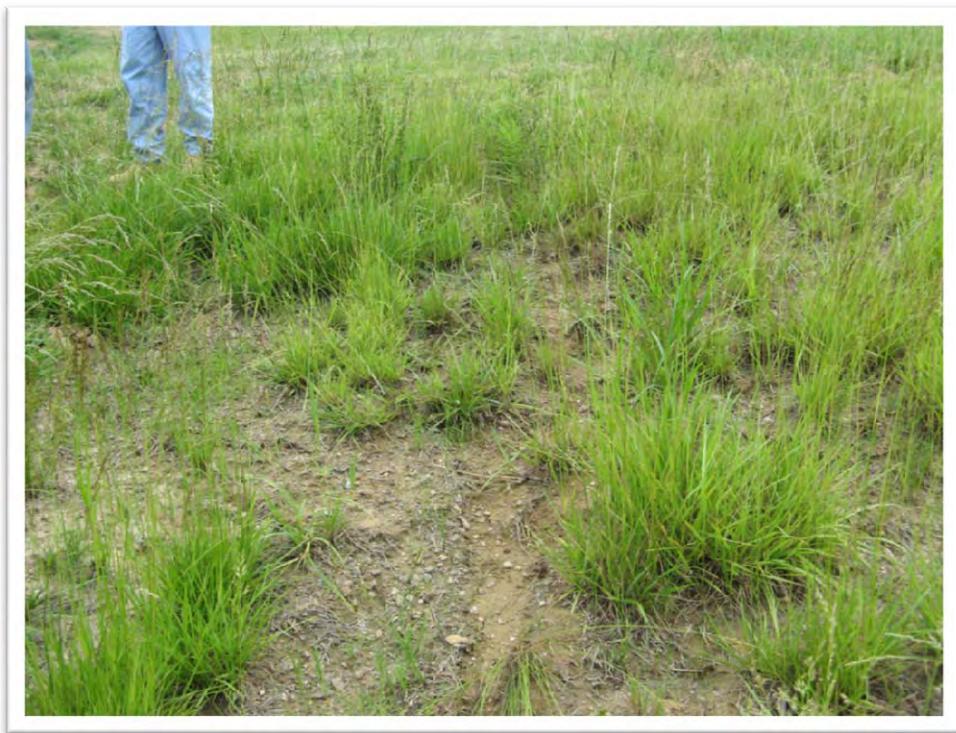
- The saturated areas on the lower portion of the downstream slope appear to be a result of drainage from the Seepage Collection Zone; however, it is not clear as to whether the flow from this drainage system is due to seepage through the embankment or from rain water seeping through the ground surface and into the Seepage Collection Zone. This saturation can reduce the stability of the lower slope and create maintenance difficulties which; therefore, further investigation of this situation should be conducted.

Photo 14- Wet and Eroded Area on Lower Slope Below Berm Looking East

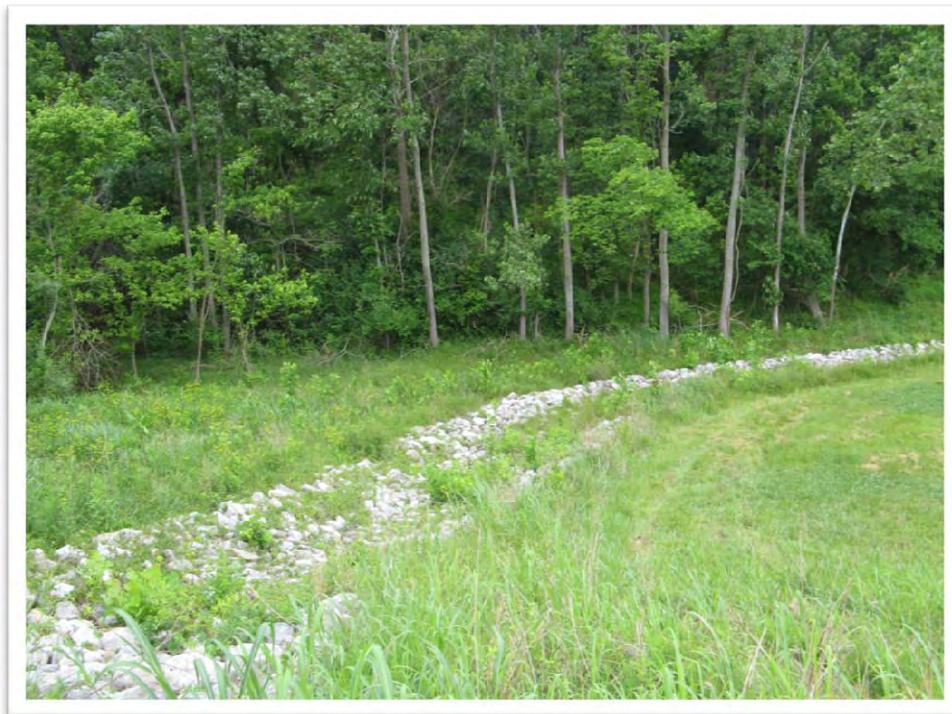
3. Emergency Spillway – The emergency spillway appears to be in satisfactory condition; however, reed-like vegetation growing in the outlet channel could impede flow in the event of a major storm. According to Vectren representatives, the emergency spillway has not been activated since its construction in 2003, which is consistent with the hydrologic/hydraulic analyses that indicate that the peak SDF (50% of 6-hour PMF) pond elevation would be below the emergency spillway crest.

Photo 15- Emergency Spillway Looking South. Note Vegetation Growth in Spillway

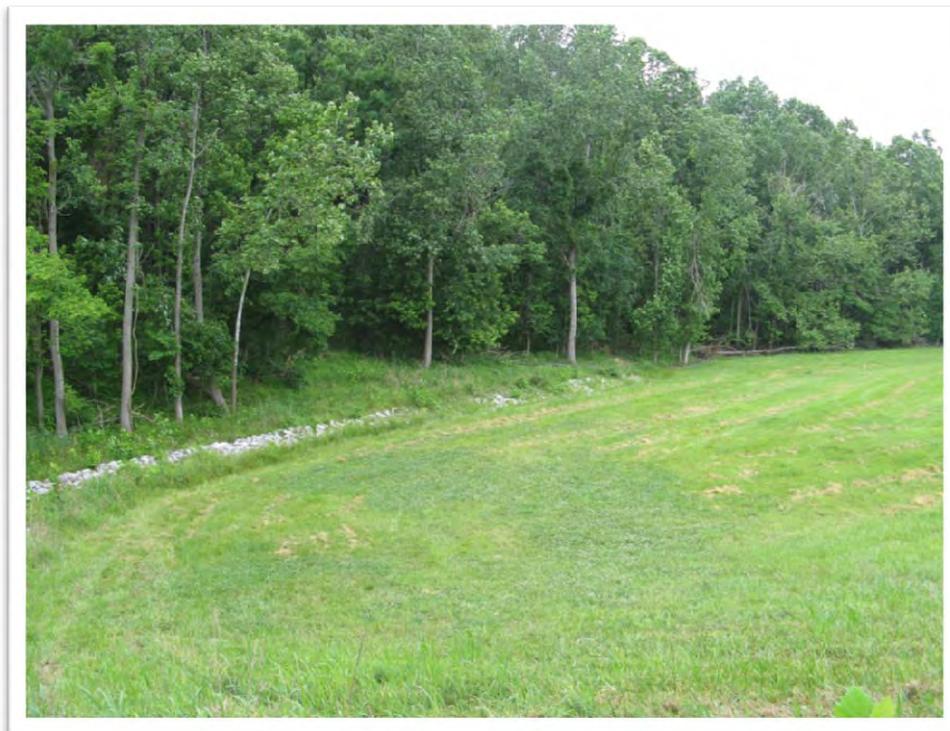
Photo 16- Emergency Spillway Looking South. Note Tree Growth on Lower Embankment Area Adjacent to Spillway
