**Upper Ash Pond Dam
– A.B. Brown Station
Assessment Report**

Lockheed Martin

July 2009

This report addresses the above issues for the Upper Ash Pond Management Unit at the A.B. Brown Generating Station in Evansville, Indiana . This Southern Indiana Gas & Electric power generation facility is owned and operated by Vectren Power Supply.

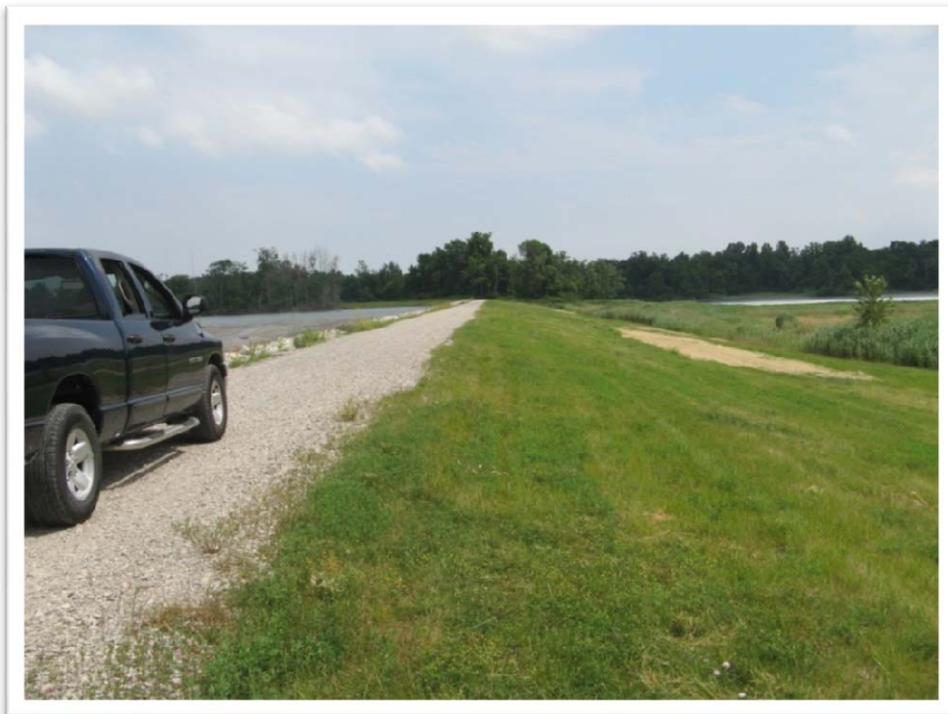
Photo 1- Upper Ash Pond Dam Crest Looking South

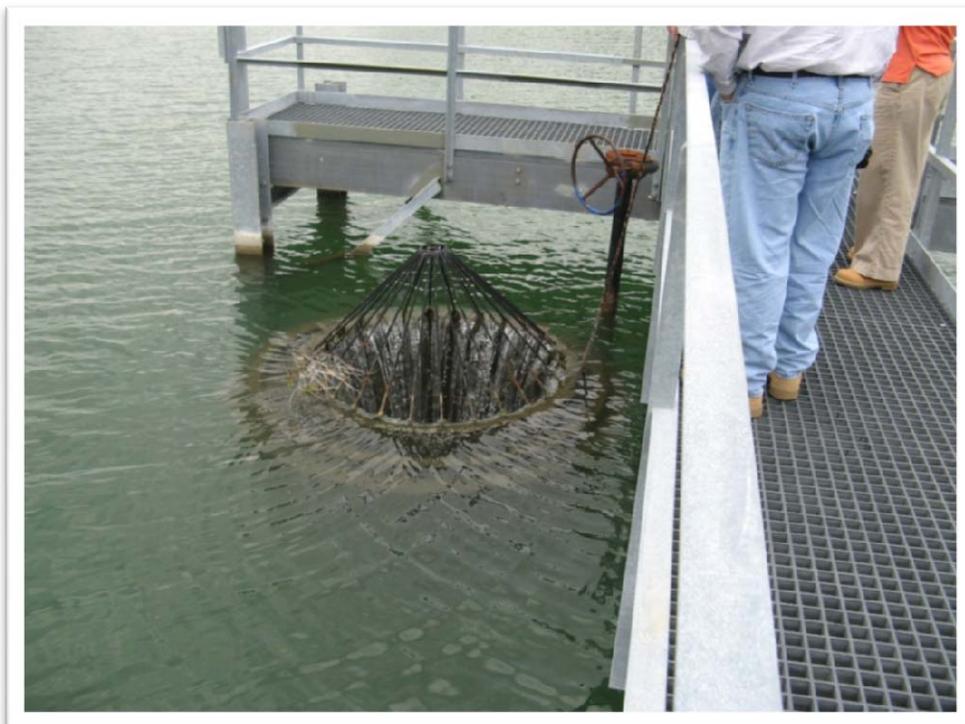
2. Spillway System – The drop inlet principal spillway appears to be in good condition and functioning as designed. The trash rack for the drop inlet opening is somewhat smaller than typical spillway racks, but should be adequate for the limited amount of runoff experienced by the Upper Pond. The emergency spillway also appears to be in good condition, with a riprap cover that should adequately protect the outlet channel against erosion during heavy flows. Some overgrowth of vegetation is evident in the outlet channel, but should not significantly inhibit flow through the spillway.

Photo 2- Principal Spillway Drop Inlet

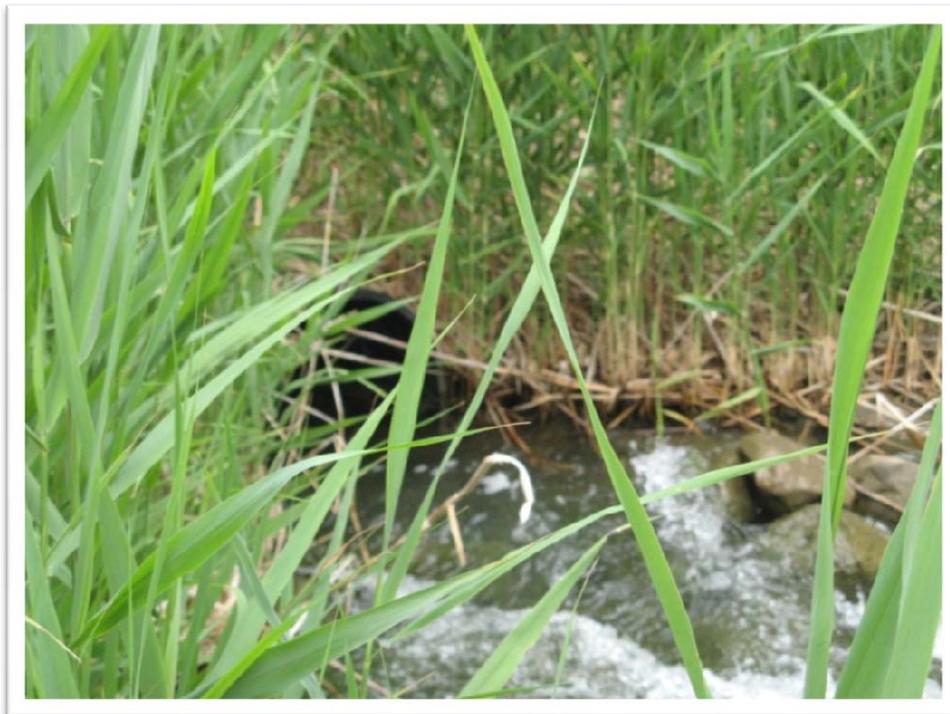
Photo 3- Principal Spillway Outlet

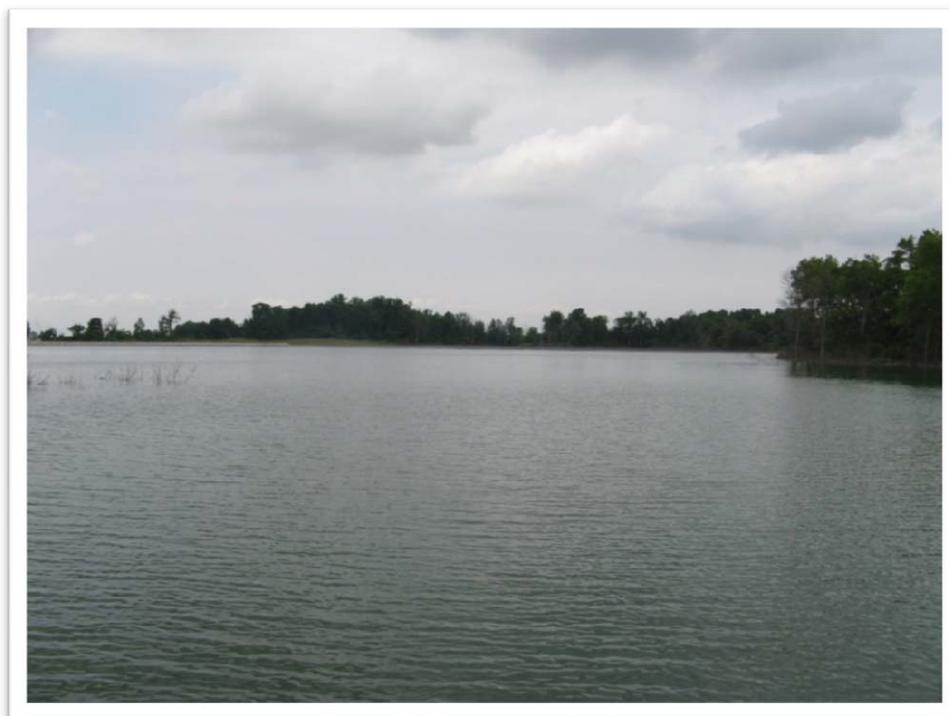
Upper Pond – The dam crest is lined with crushed stone and appeared to be in good condition. Fly ash from the generating station was discharging as a black-ish stream from a pipe on the embankment into the southwestern part of the pond. The bottom ash pipe adjacent to the fly ash discharge pipe was not flowing. The surface of the pond in the vicinity of the ash discharge pipes had a solidified black residue from the ash material. Influent from the fly ash line flows over the solidified material towards the principal spillway outlet in the southeast corner area of the pond.

Photo 4- Upper Ash Pond Looking Northwest

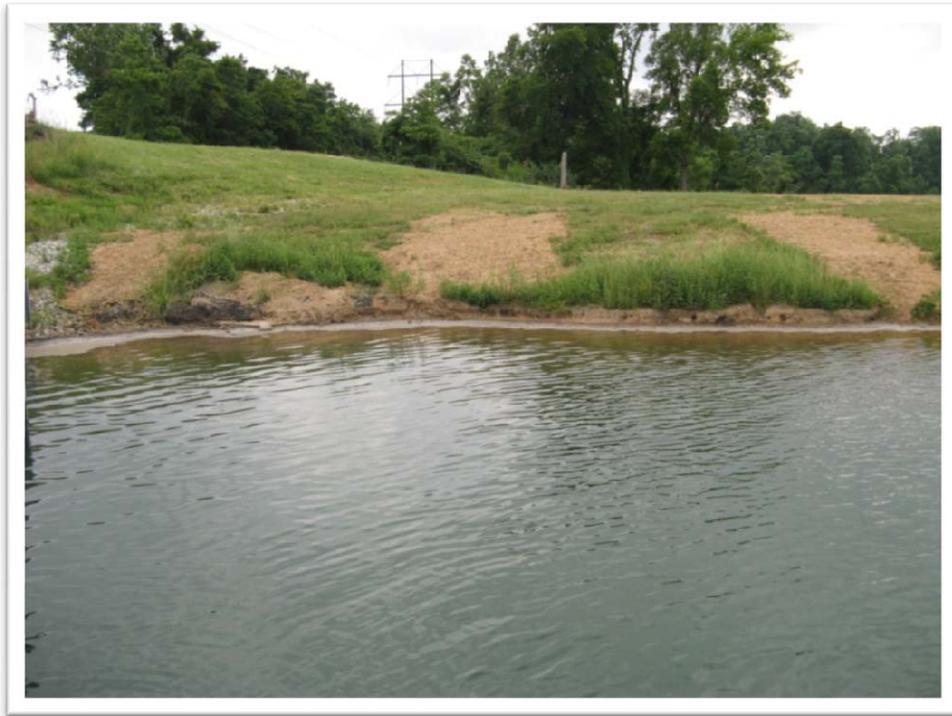
Earth Embankment - The crest and upstream embankment slope appear to be in generally good condition, with some repairs related to the ATC report recommendations noticeable. The upper portion of the slope is lined with riprap, which appears to be providing adequate erosion protection.

Photo 5- Upstream Embankment Looking West Near Principal Spillway. Note Repairs on Embankment

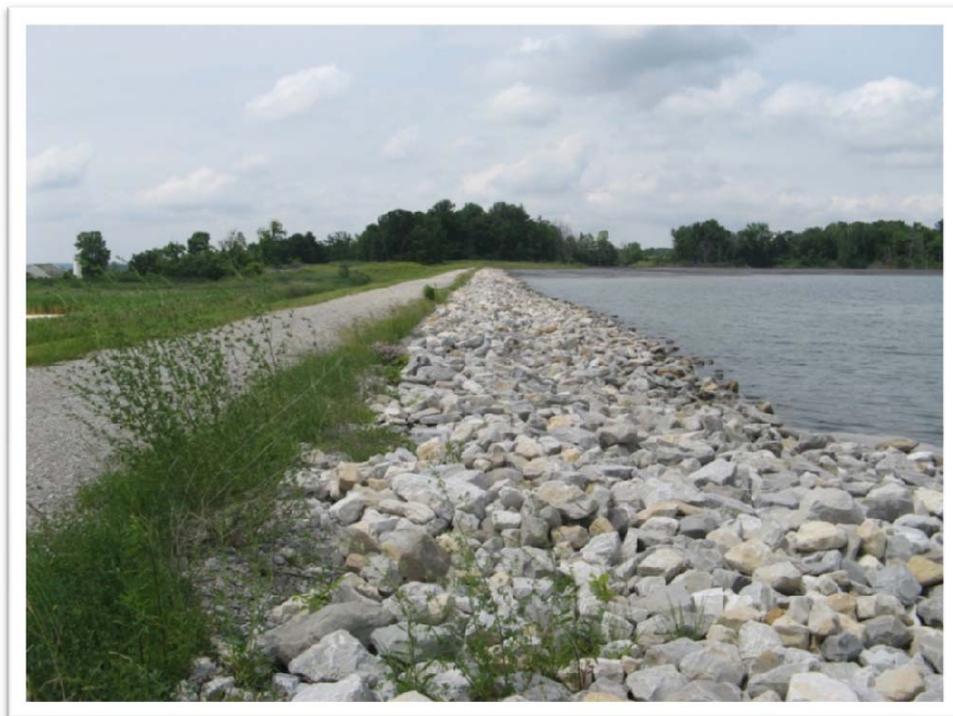
Photo 6- Dam Crest and Upstream Rip-Rapped Embankment Looking Northwest

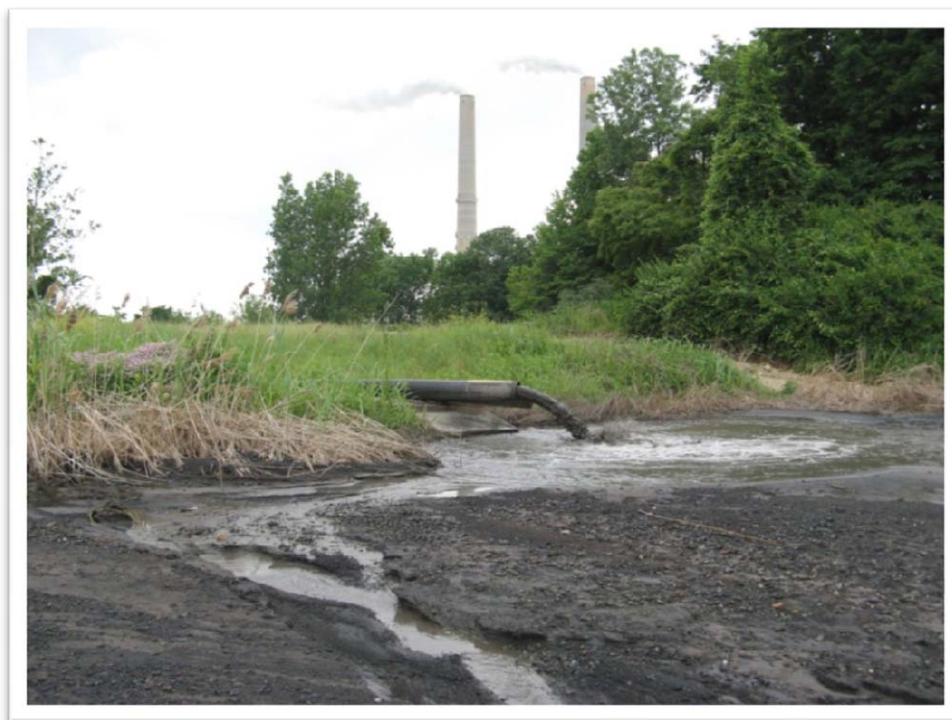
Photo 7- Southwest Area of Ash Pond with Fly Ash Discharge and Solidified Waste Material

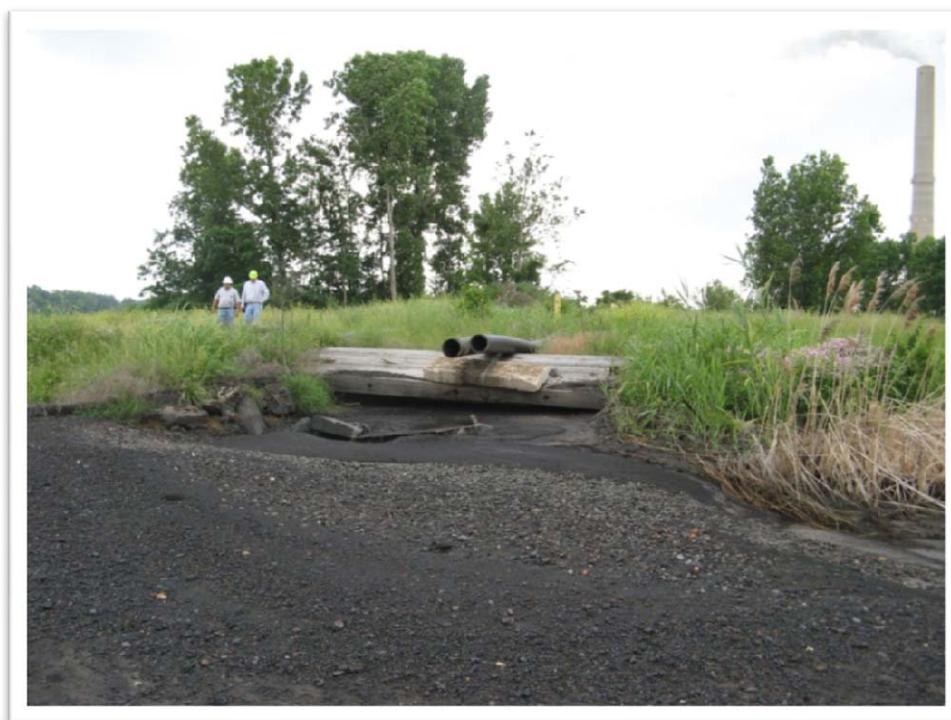
Photo 8- Southwest Area of Ash Pond with Bottom Ash Discharge Pipes and Solidified Waste Material

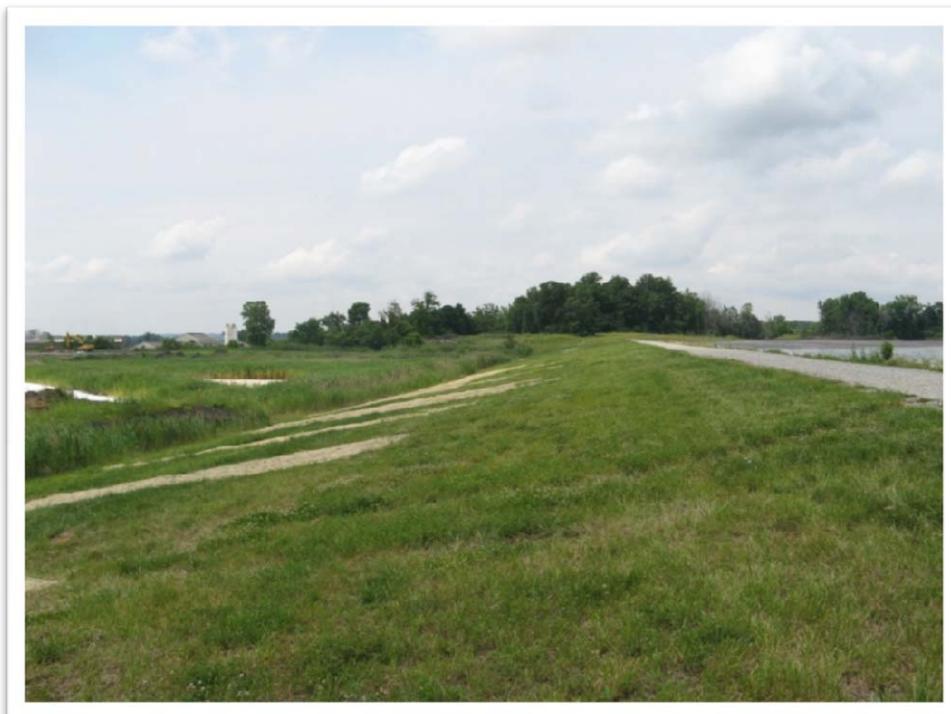
Downstream Slope - The downstream embankment slope appears to be in satisfactory condition, also with repairs related to the ATC report recommendations noticeable. Erosion gullies that had developed from storm runoff had been filled with earth, seeded and mulched; however, additional gullies were forming at the base of the straw mat component of the repair work. The downstream toe of the Upper Dam terminates at the edge of the Lower Pond, such that the toe is slightly submerged. The principal spillway outlet from the Upper Pond discharges into the eastern end of the Lower Pond and, at the time of inspection, flow was entering the Lower Pond from the Upper Pond. At one location, the scrubber blowdown outlet channel along the edge of the Lower Pond has caused some erosion of the channel edge in the general vicinity of the downstream toe of the Upper Dam.

Photo 9- Downstream Embankment Area Looking Northwest. Note Repaired Areas

1. The effectiveness of the erosion repairs along the downstream slope of the dam should be evaluated once the grass vegetation has become adequately established in these areas. If the erosion persists, consideration should be given to use of better topsoil, placement of more erosion-resistant vegetation, regrading of the crest to promote more uniform runoff, use of turf reinforcement matting and/or placement of stone/rock along the lower portion of the slope.

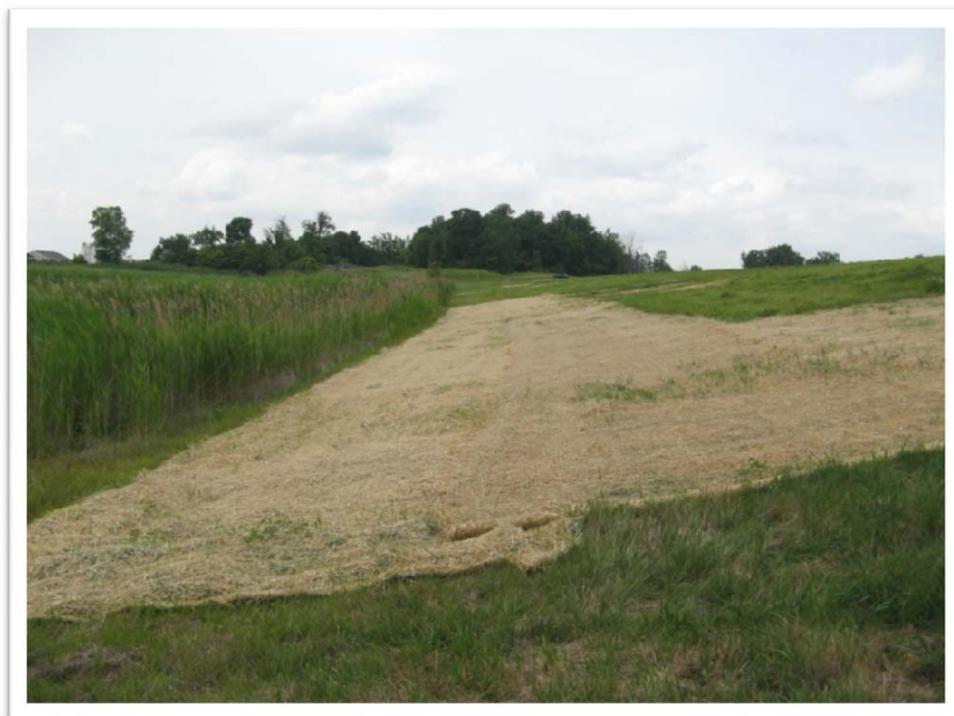
Photo 10- Downstream Embankment Area Looking Northwest. Note Repaired Areas

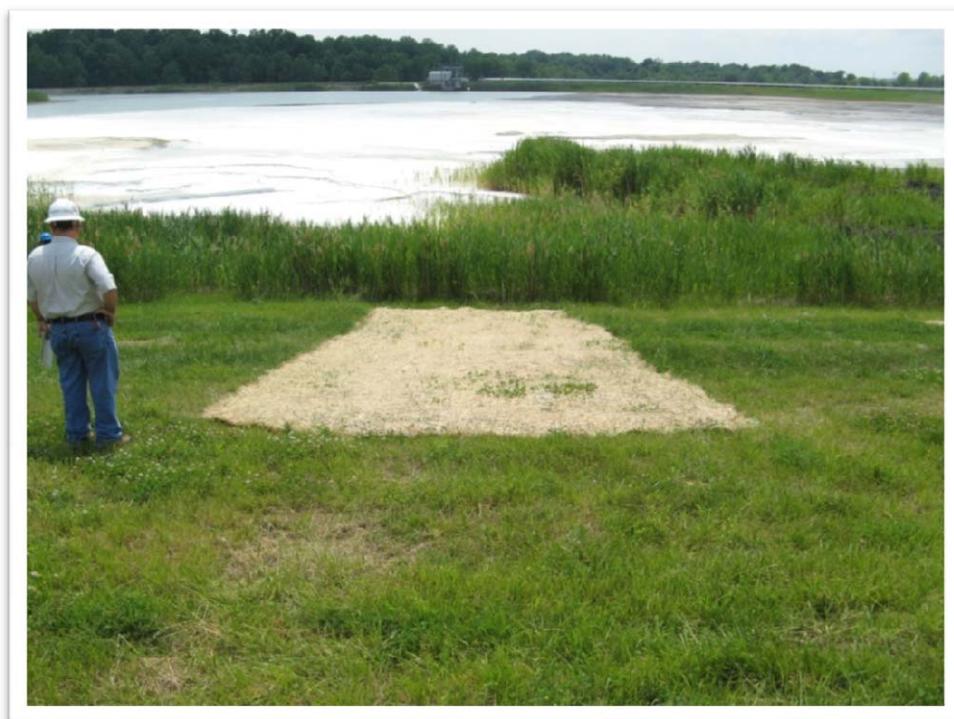
Photo 11- Downstream Embankment Area Looking South. Note Repaired Area and Lower Pond

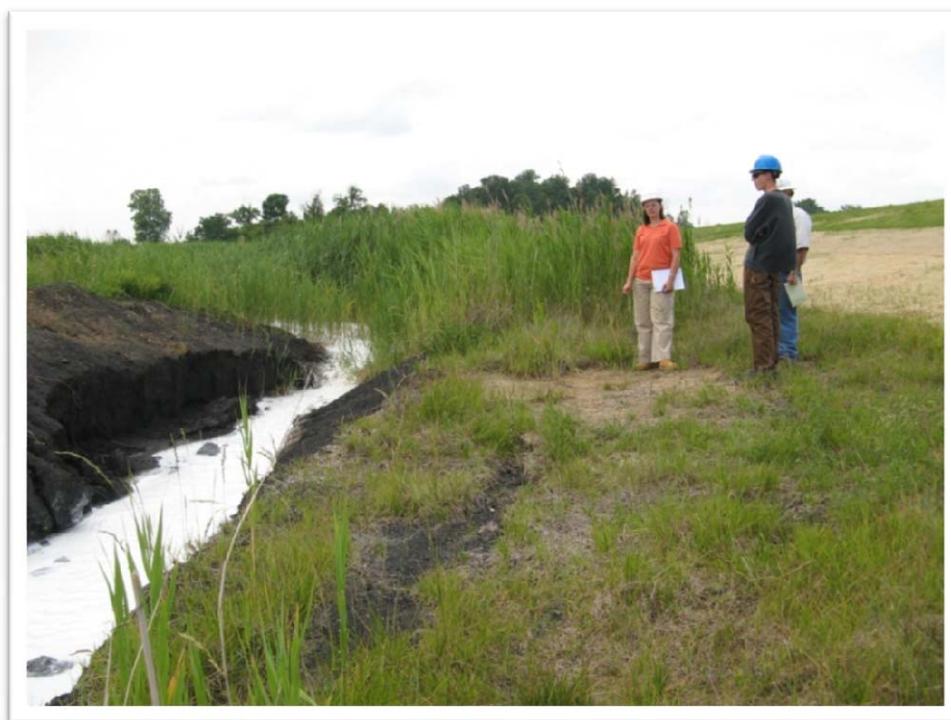
- Erosion of the scrubber blowdown outlet channel could eventually encroach on the downstream toe of the Upper Dam; this condition should be monitored.

Photo 12- Downstream Embankment Area Looking Northwest. Note repaired Area and Lower Pond with Channel for White-ish Scrubber Blowdown at Toe of Upper Dam Embankment

The erosion along the edge of the scrubber blowdown outlet channel should be monitored during future inspections to verify that the erosion does not impact the downstream toe of the Upper Dam.

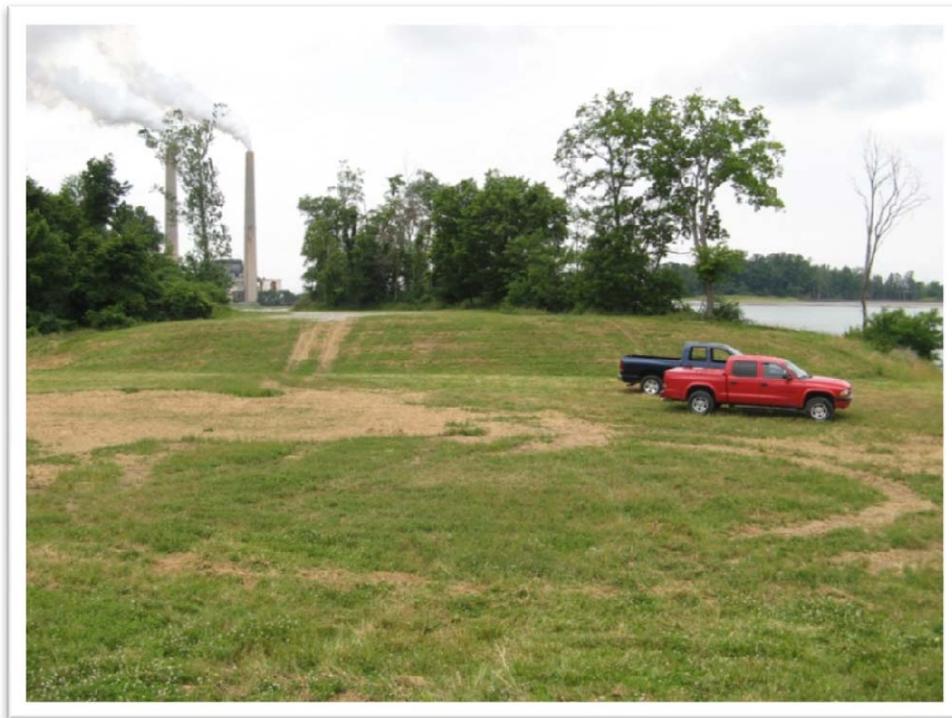
Photo 13- Crest of Upper Ash Pond Dam at Emergency Spillway Looking Northwest

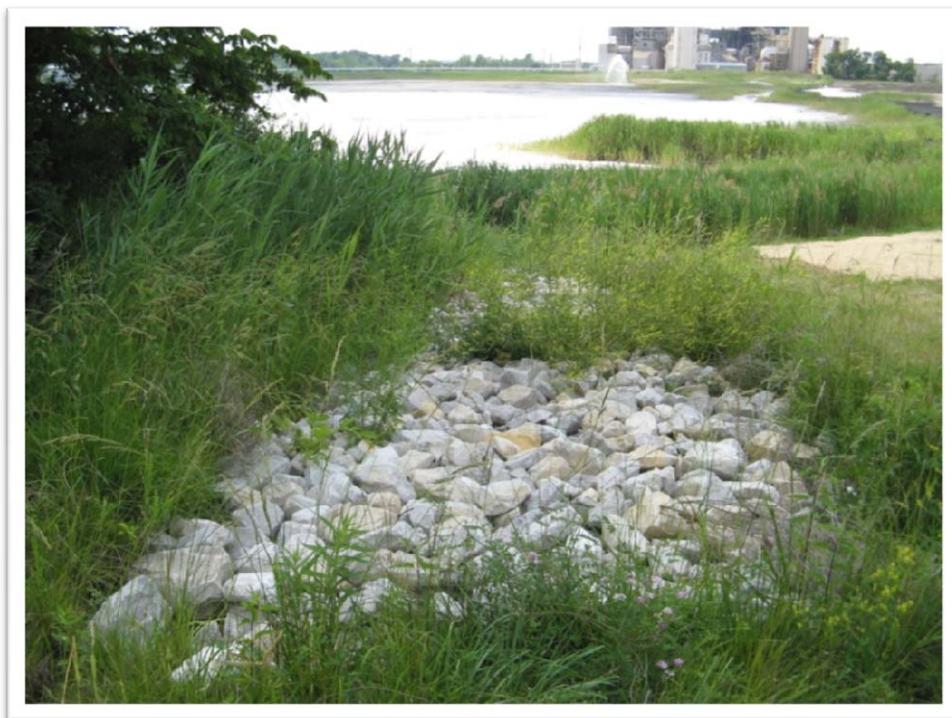
Spillway System - The principal spillway, which consists of a 60-inch diameter RCP drop inlet at El. 460 with a 24-inch diameter outlet pipe, was discharging at the time of inspection. The outlet pipe discharges into a rock-lined channel which leads to the Lower Pond. The emergency spillway is a 30-foot wide trapezoidal earth channel with 5H:1V side slopes and a crest elevation of 461.5. Both portions of the spillway system appeared to be in good condition; however, some overgrowth of vegetation was observed in the emergency spillway outlet channel.

Photo 14- Emergency Spillway Looking West. Note Vegetation Growth in Spillway

3. The vegetation in the emergency spillway outlet channel should be removed to prevent further overgrowth and possible future blockage of the outflow path.
