**Coal Combustion Waste Impoundment
Round 7- Dike Assessment Report (Site #007)**

Lawrence Energy Center

Ash Impoundment Dike

Westar Energy

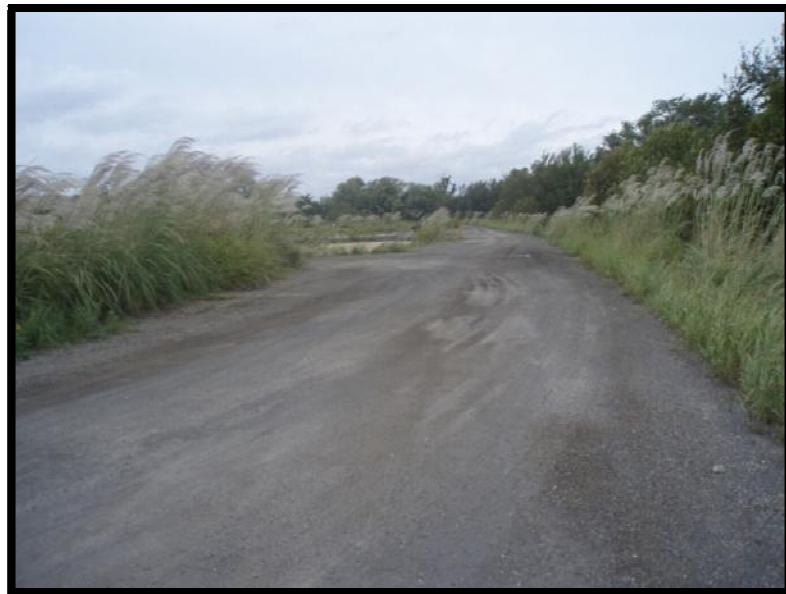
The crest of the north dike had no signs of depressions, tension cracks, or other indications of settlement or shear failure, and appeared to be in satisfactory conditions. Figure 5.2.1-1 shows the conditions of the crest of the north dike.

Figure 5.2.1-1: Crest of North Dike.

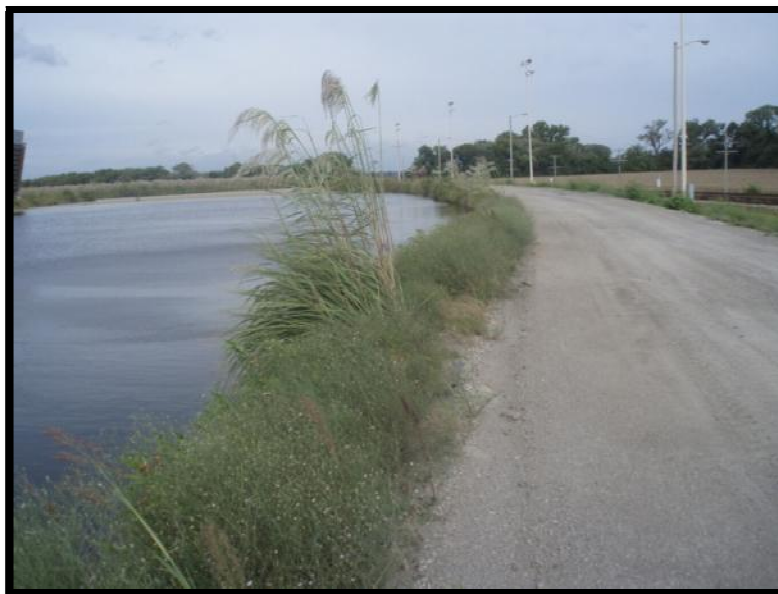
The inside dike embankments are basically unprotected. Much of the interior embankment was substantially vegetated. Figure 5.2.2-1 shows the general condition of the inside slope of the north dike (Area 1).

Figure 5.2.2-1: Inside Slope of the North Dike.

There were no observed scarps, sloughs or other indications of slope instability.

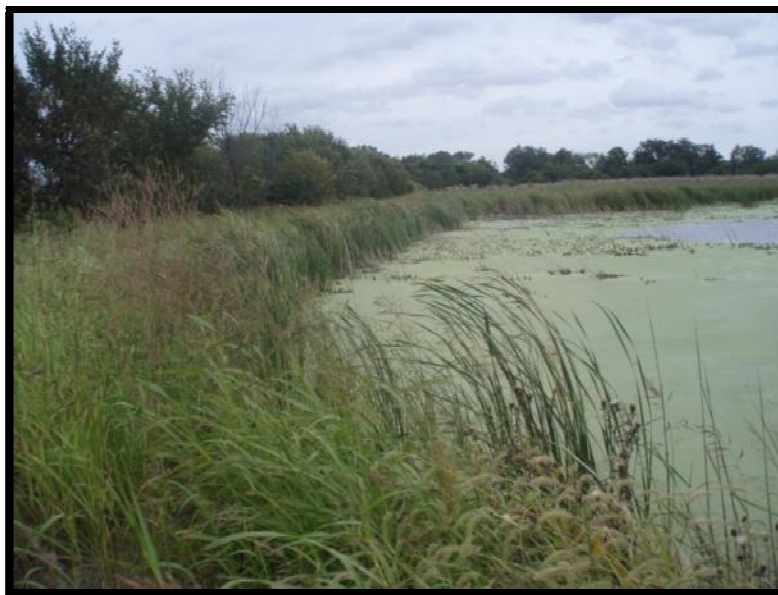
The inside slope of the west dike reveals varying amounts of exposed earth embankment depending on the amount of sediment or plant wash contained in them. Similar to most areas, substantial vegetation was observed on the interior of the dike in Area 4, see Figure 5.3.2-1.

Figure 5.3.2-1: Inside Slope of Northwest Dike (Area 4).

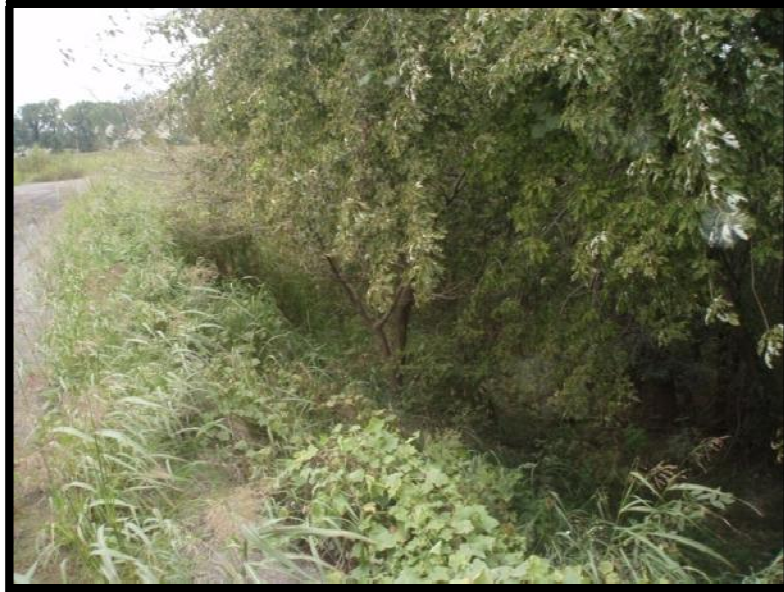
The outside slope is heavily vegetated, including some large trees in the lower portion and toe areas, see Figure 5.3.3-2. The northwestern half of the dike is bordered by Baldwin Creek and a dirt road, which appeared to be seldom used based upon the vegetation growing in the roadway, see Figure 5.3.3-3. There were no observed scarps, sloughs, bulging, cracks, or depressions or other indications of slope instability or signs of erosion. Figure 5.3.3-1 shows the general condition of the outside slope.

Figure 5.3.3-1: Typical Condition of Outside Slope of West Dike.

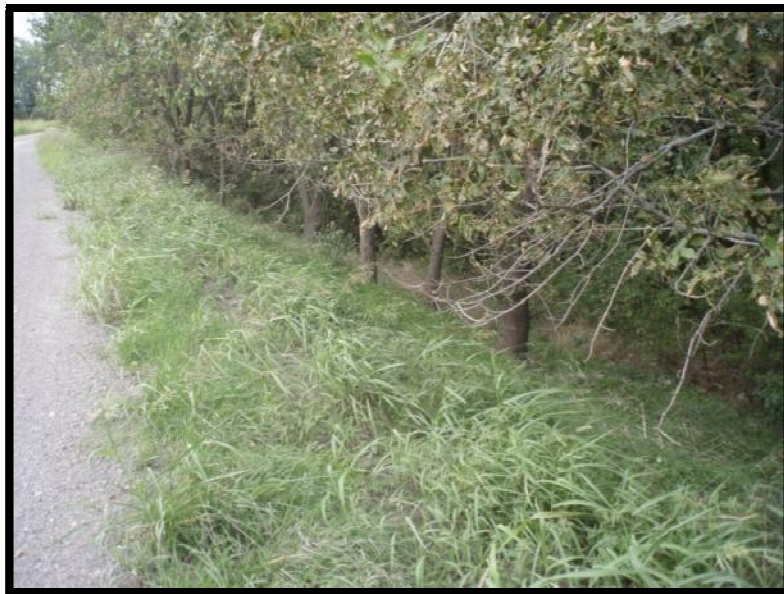
Figure 5.3.3-2: Trees on Outside of West Dike.

The large trees along the lower section of the western embankment should be removed. A vegetation control program should be instituted to control the type, amount, and height of vegetation on the outer embankment slopes. Implementation of this recommendation will prevent the creation of potential seepage paths in the embankment and allow for easier inspection of the outer slopes and toes of the embankment.

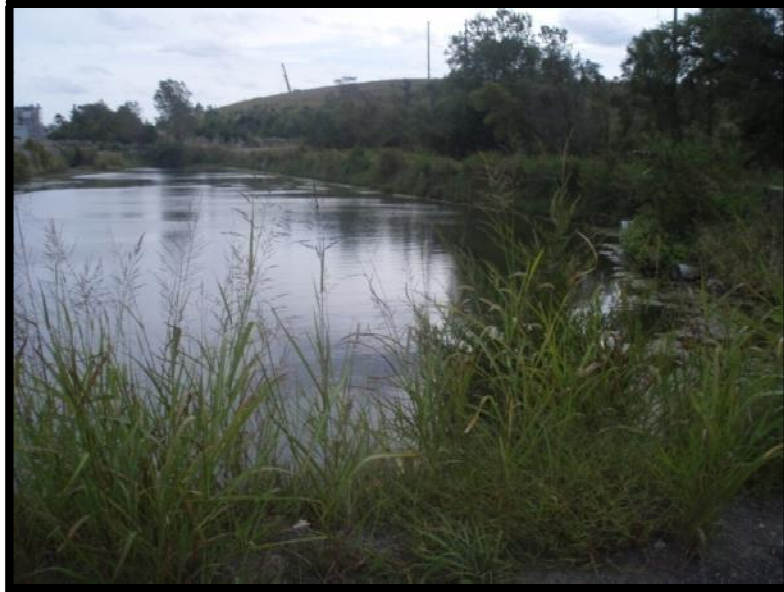
The crest of the south dike had no signs of depressions, tension cracks, or other indications of settlement or shear failure, and appeared to be in satisfactory condition. This is the section of the impoundment that merges into natural terrain. It currently is bordered by a laydown yard, storm water pond, and solid waste disposal area to the south.

Figure 5.4.1-1: Looking East Across Storm Water Pond on South Side of Ash Pond Area (Adjacent to Area 3). Closed landfill is seen in background.

There were no observed scarps, sloughs, bulging, cracks, or depressions or other indications of slope instability or signs of erosion. Figure 5.4.1-1 above shows the general condition of the inside slope of the south dike.

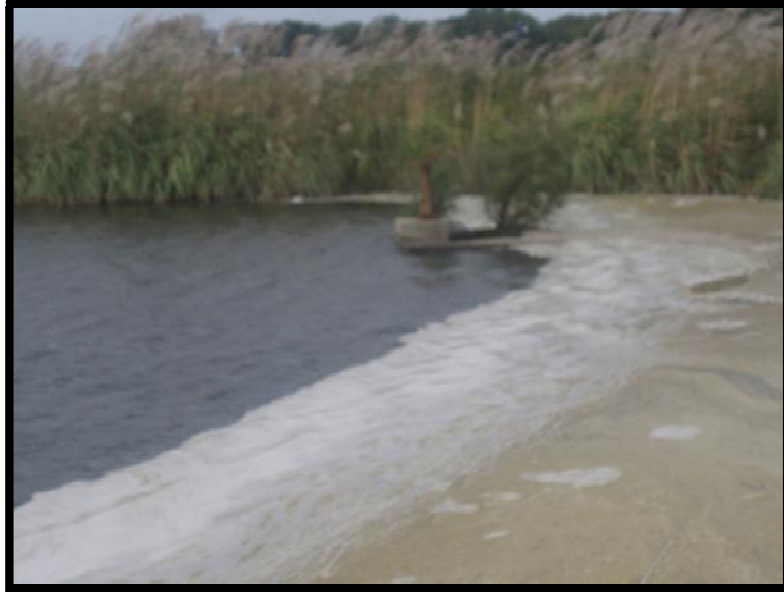
The plant personnel believe the overflow structure has never been used. It visibly appears to be in working condition; however, we were not able to access the discharge outlet, see Figure 5.5.1-1

Figure 5.5.1-1: Overflow Outlet Structure.

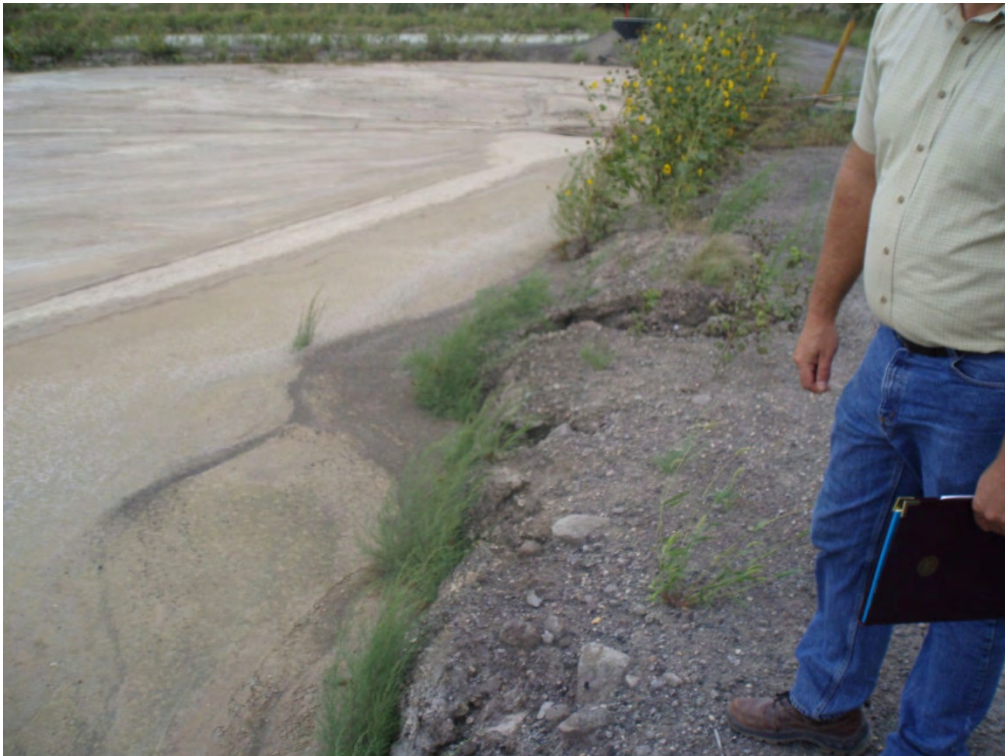
10. Interior of northern dike in Area 2 – Some minor washout/erosion observed.

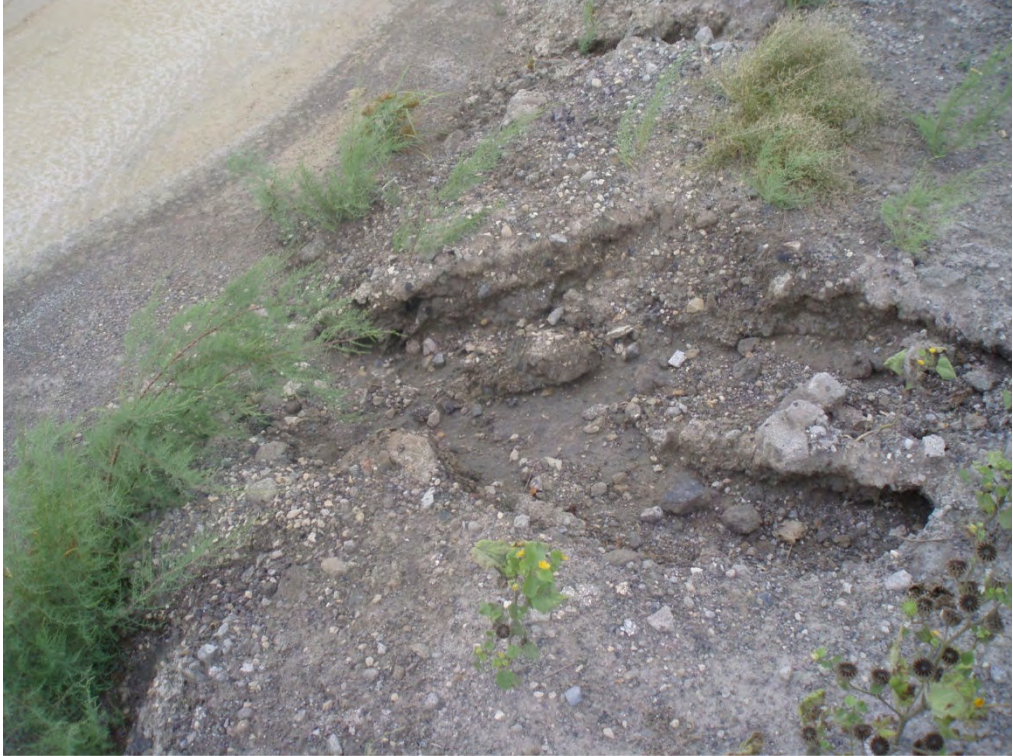
11. Close-up of 10.

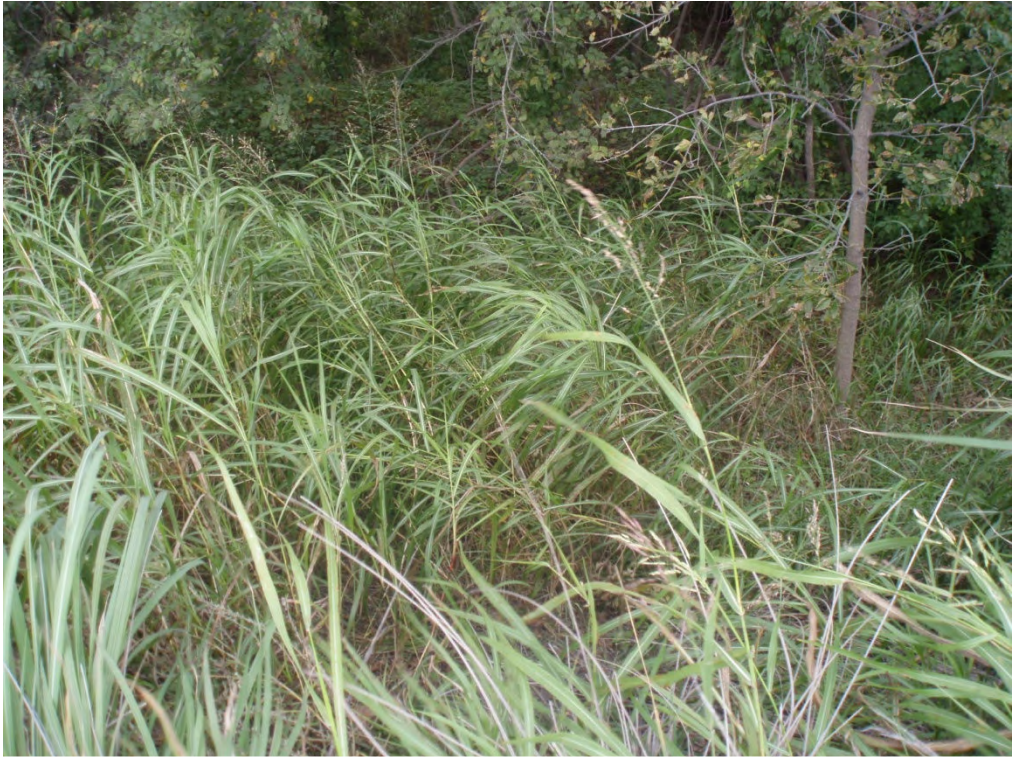
12. Exterior of northern dike (Area 4) – heavy vegetation observed.

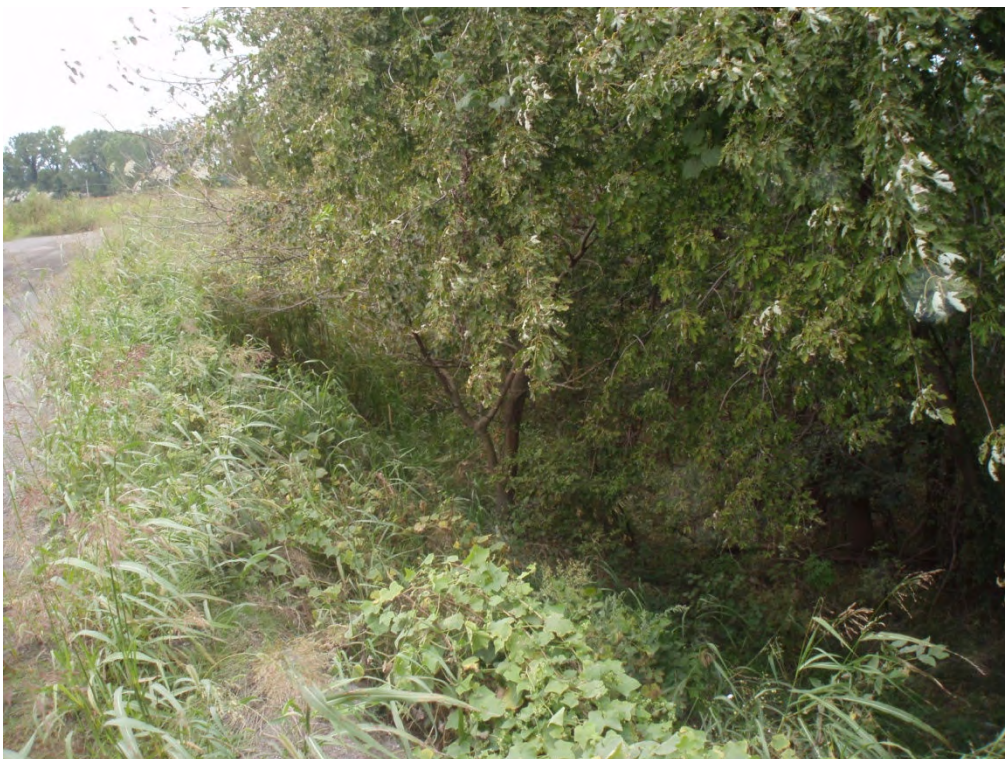
13. Exterior of northwestern dike (Area 4) – heavy vegetation and trees observed.

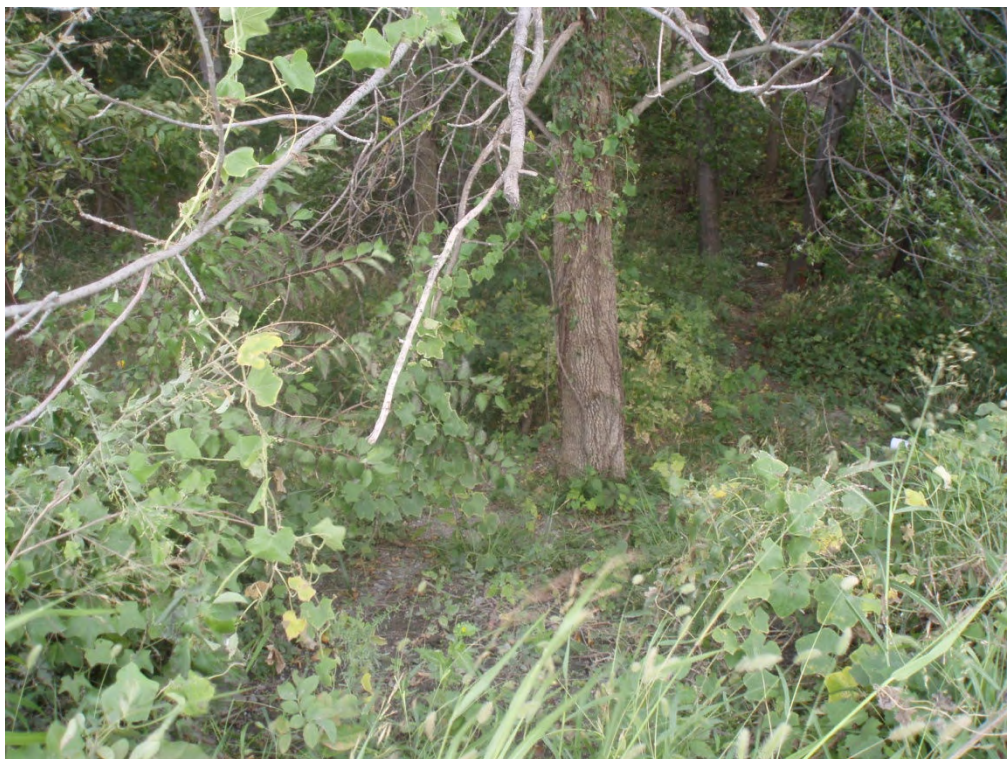
15. Exterior of northwestern dike (Area 4) – 10” tree observed at toe of embankment.

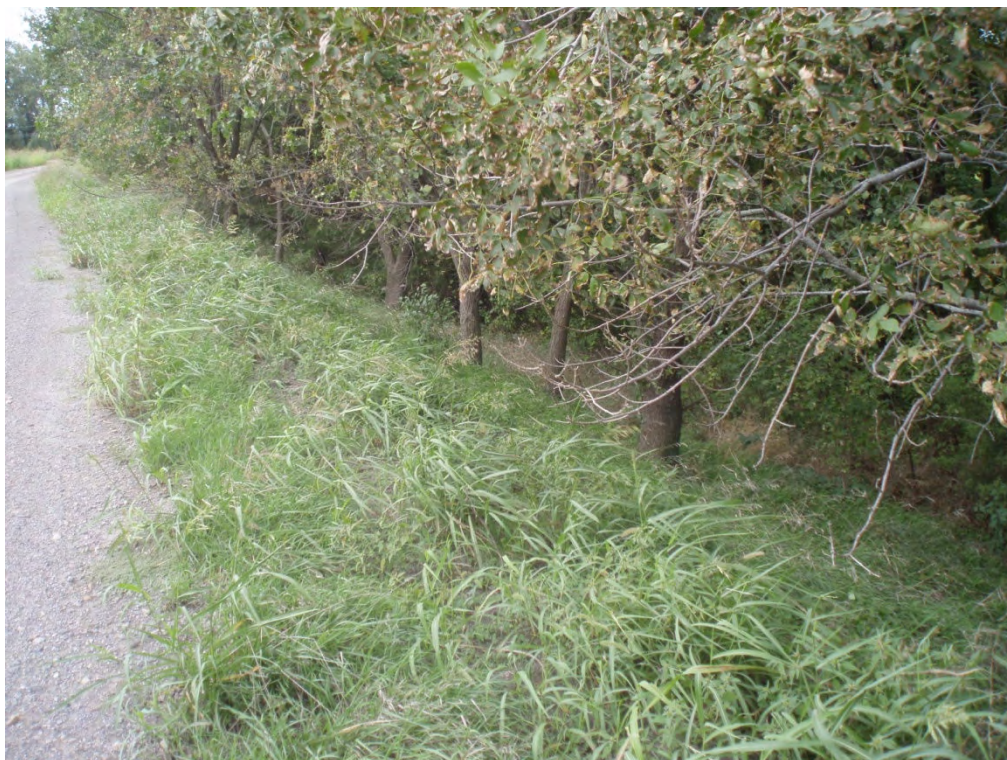
16. Exterior of northwestern dike (Area 4) – multiple trees observed on embankment.

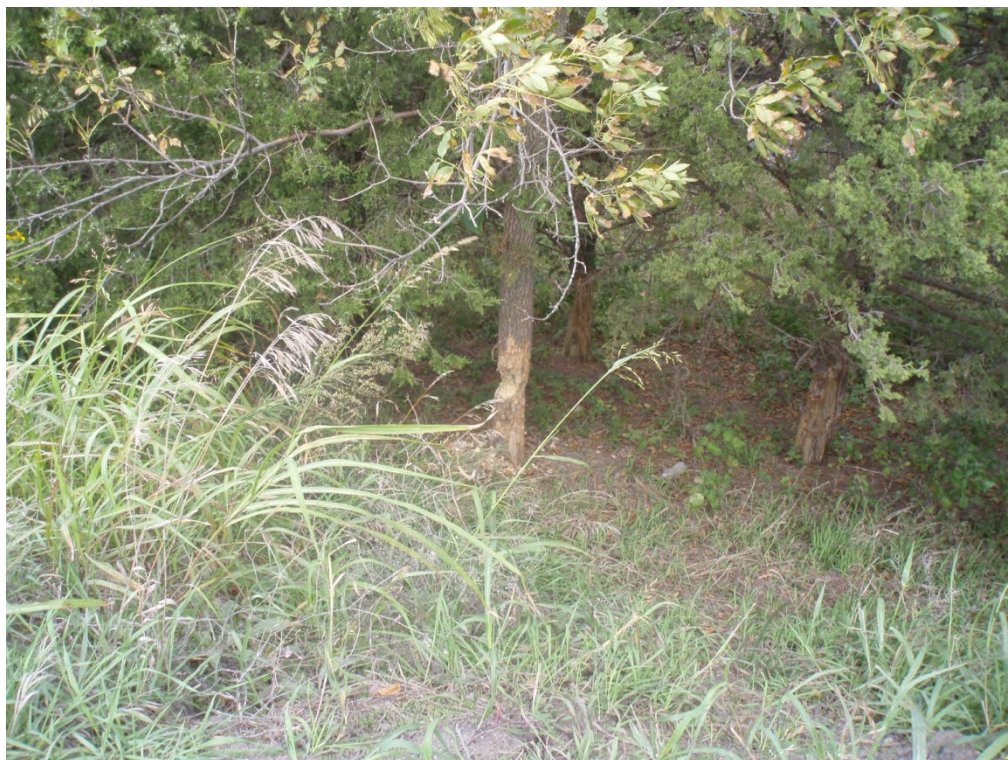
18. Exterior of northwestern dike (Area 4) – 10" tree observed at toe of embankment.
