## Assessment of Dam Safety of Coal Combustion Surface Impoundments

### Hugo Power Plant

Western Farmers Electric Cooperative  
U.S. Highway 70  
Fort Towson, Oklahoma

March 23, 2011

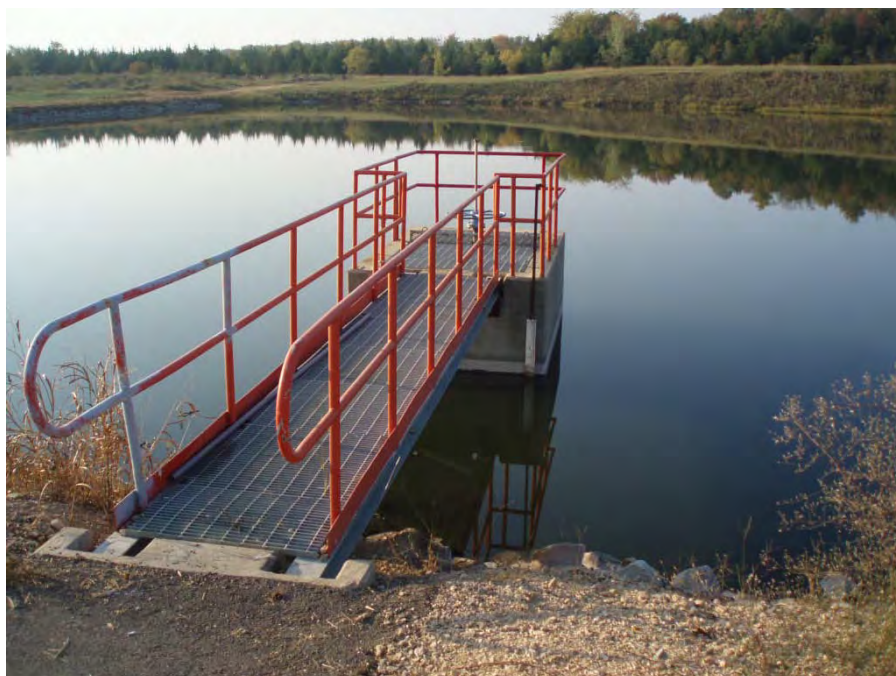
1. South Bottom Ash Pond -Outlet Structure, looking south

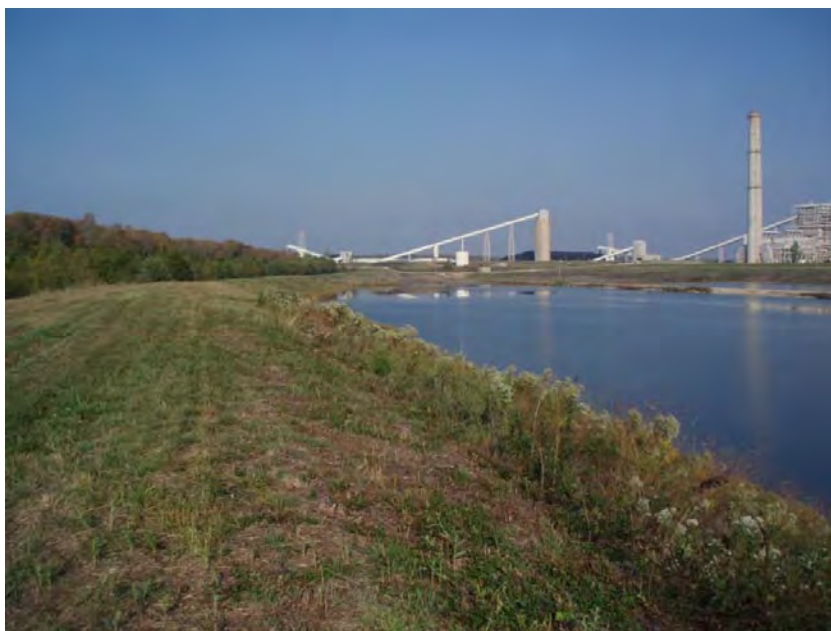
The interior slopes were approximately 2H: 1V. Riprap armoring of the interior slope is present on the east embankment (Photographs 4 and 6). Some small desiccation cracks were observed near the southeast corner of the interior slope. There were also some small sloughs observed well above the crest elevation on the excavated portion of the south embankment interior slope. On the south embankment, it appeared that the water level was below the natural ground surface elevation. The interior slopes appeared to be in generally good condition (Photographs 6, 9 and 10).

10. South Bottom Ash Pond – South embankment crest, looking west

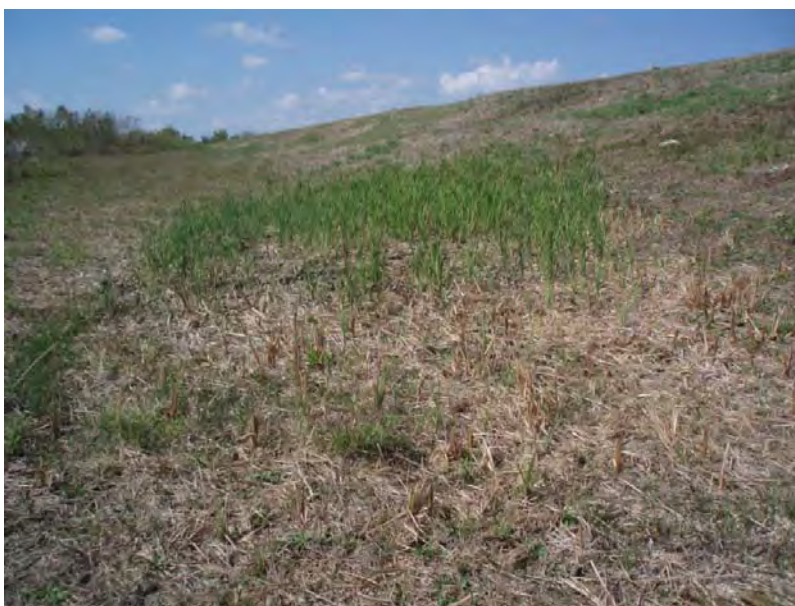
30. South Fly Ash Pond – Cattails growing on south embankment exterior face, looking west
