DOCUMENTATION OF ENVIRONMENTAL INDICATOR DETERMINATION
Interim Final 2/5/99
RCRA Corrective Action
Environmental Indicator (EI) RCRIS code (CA750)
Migration of Contaminated Groundwater Under Control

Facility Name: Molycorp, Inc.
Facility Address: 300 Caldwell Avenue, Washington, PA 15301
Facility EPA ID #: PAD030068282

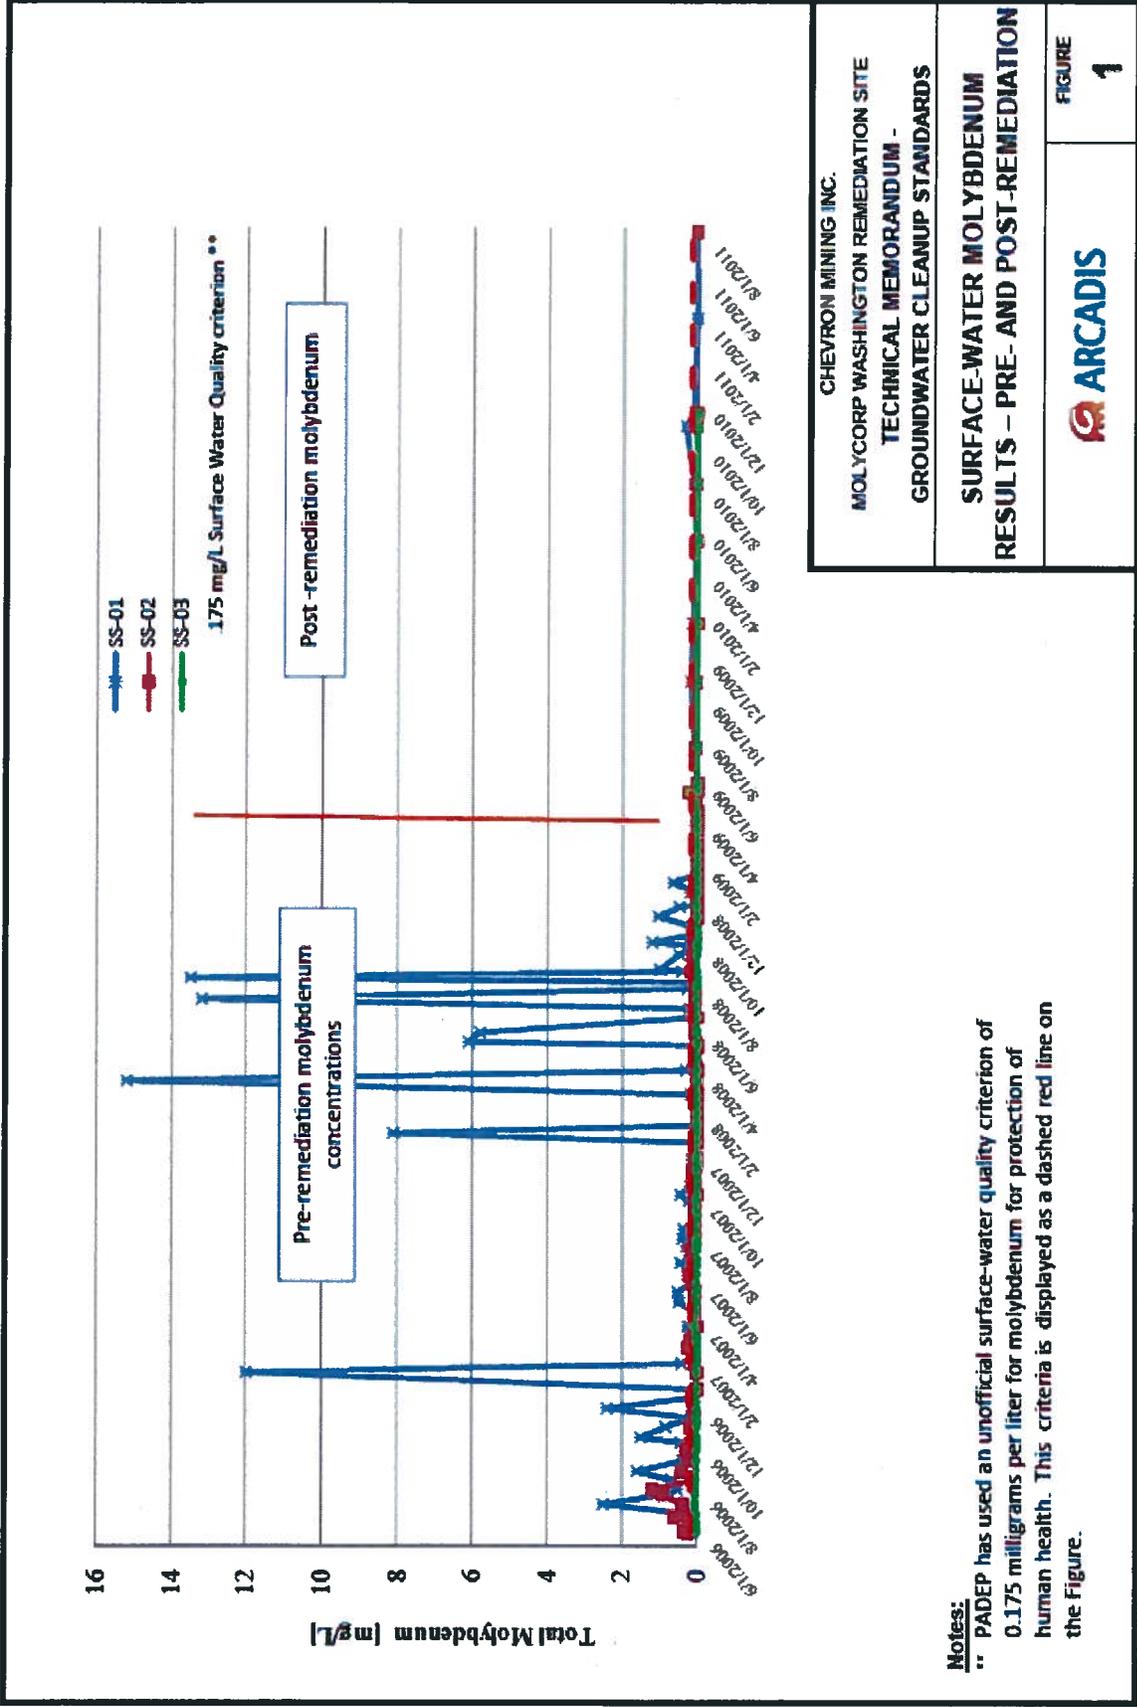
CHEVRON MINING INC. MOLYCORP WASHINGTON REMEDIATION SITE TECHNICAL MEMORANDUM - GROUNDWATER CLEANUP STANDARDS	
SURFACE-WATER MOLYBDENUM RESULTS - PRE- AND POST-REMEDIATION	
	FIGURE 1

The success of the above efforts have been documented in the eight rounds of post remedial surface water sampling for the Act 2 Final Report. Samples were collected from five locations along Chartiers Creek from June 2009 to December 2010. As illustrated in the attached Figure 1, molybdenum concentrations in the surface water have decreased dramatically since the remediation efforts have been completed. Comparing the sample results to the agreed upon surface water quality standard of 175 µg/l indicates compliance with that standard. The concentration of molybdenum in surface water exceeded the standard on only one occasion at one sample location. Surface water sample SS-01 contained 317 µg/l of molybdenum in a sample collected on November 16, 2010. A sample collected from the same location three weeks later (12/6/10) exhibited a molybdenum concentration of 104 µg/l. The detected molybdenum on November 16, 2010 is speculated to be associated with surface water discharge from Outfall 001.

Notes:
 ** PADEP has used an unofficial surface-water quality criterion of 0.175 milligrams per liter for molybdenum for protection of human health. This criteria is displayed as a dashed red line on the Figure.
