PROPERTY TRANSFER ASSESSMENT:
OLIVER PROPERTY
NORWEGIAN TOWNSHIP
SCHUYLKILL COUNTY, PENNSYLVANIA

PHASE I REPORT

Versar Job No. 6115.36

February 24, 1988

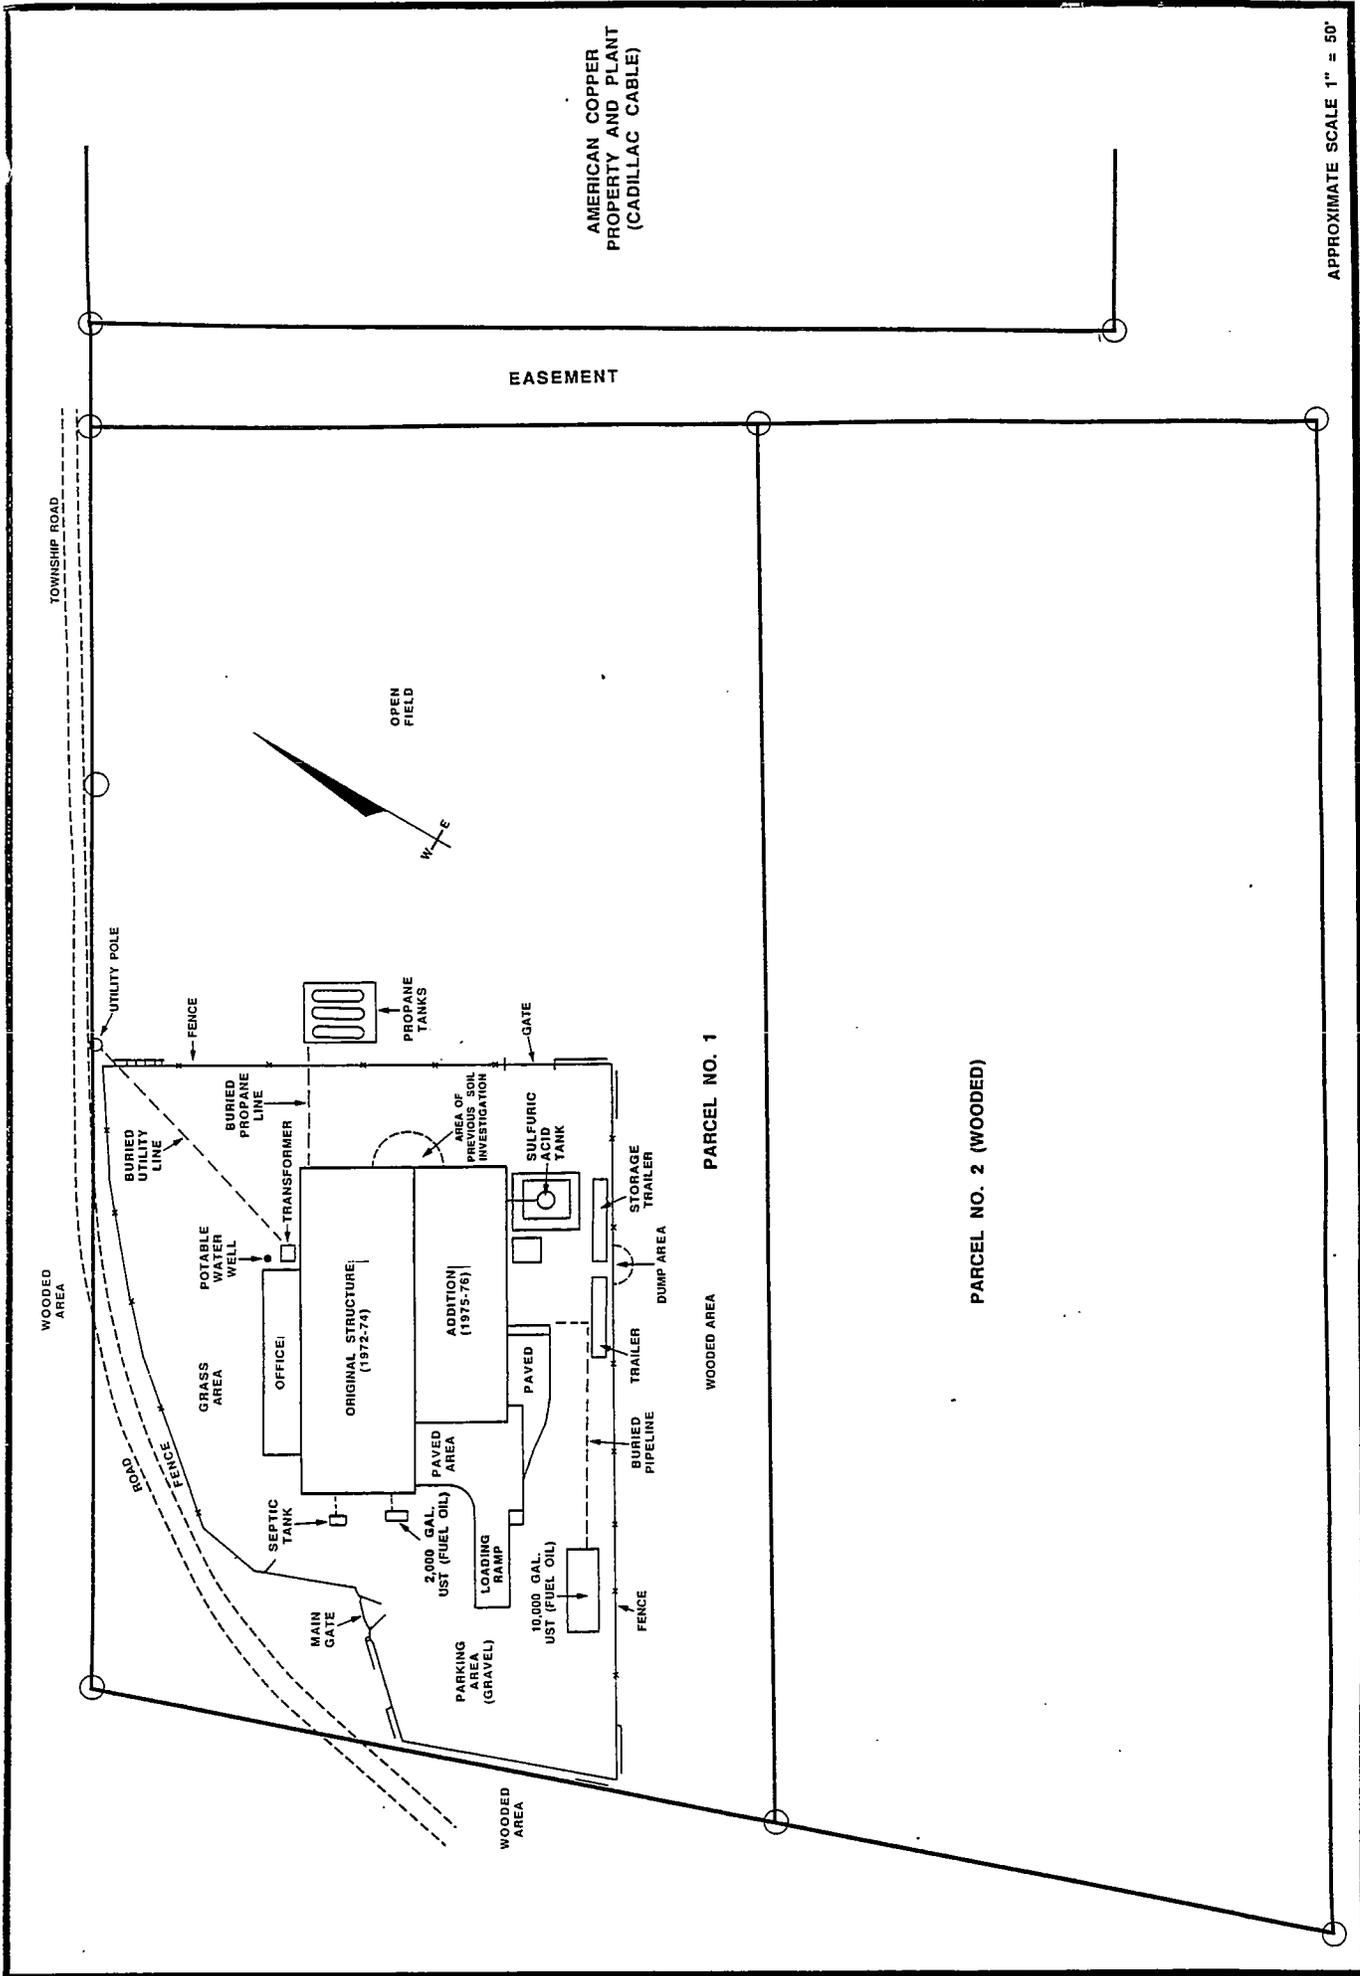
FIGURE 1. LAYOUT OF WORLD RESOURCES AND ADJOINING PROPERTIES

The extent of the buried debris was located via visual inspection of samples from each of the nine exploratory holes. The area sampled was described as a half circle along the east side of the buildings, having a radius of approximately ten feet and centered on a point approximately 55 feet from the northeast corner of the original building (see

Figure 1). (No determination of the extent of the debris under the concrete floor of the original building was attempted. As previously noted, this building was expanded in 1975.

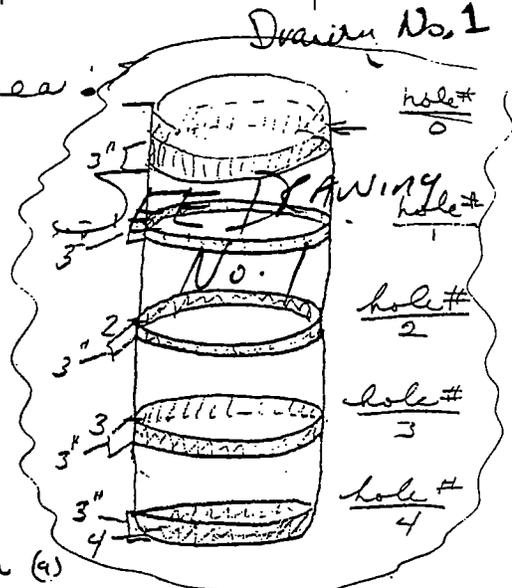
eight (8) and nine (9). SAND 9 were drilled only ^{two (2)} feet deep and only composite samples were taken. SEE Drawing No 1.

← Description of hole placement.

Number one (1) was drilled 44 feet from the front of the building and 3 feet away from the building, ~~to~~ a depth of 4 ^{feet.} feet. All holes used this method of measurement. A 3 digit coordinate system will describe the placement of each hole, eg hole

See attached ~~picture~~ ^{drawing} showing ~~the~~ placement

of ^{the} holes. The grid is scaled 1/2' per
division. The drawing is not to scale
between the front of the building

and the 39' mark.

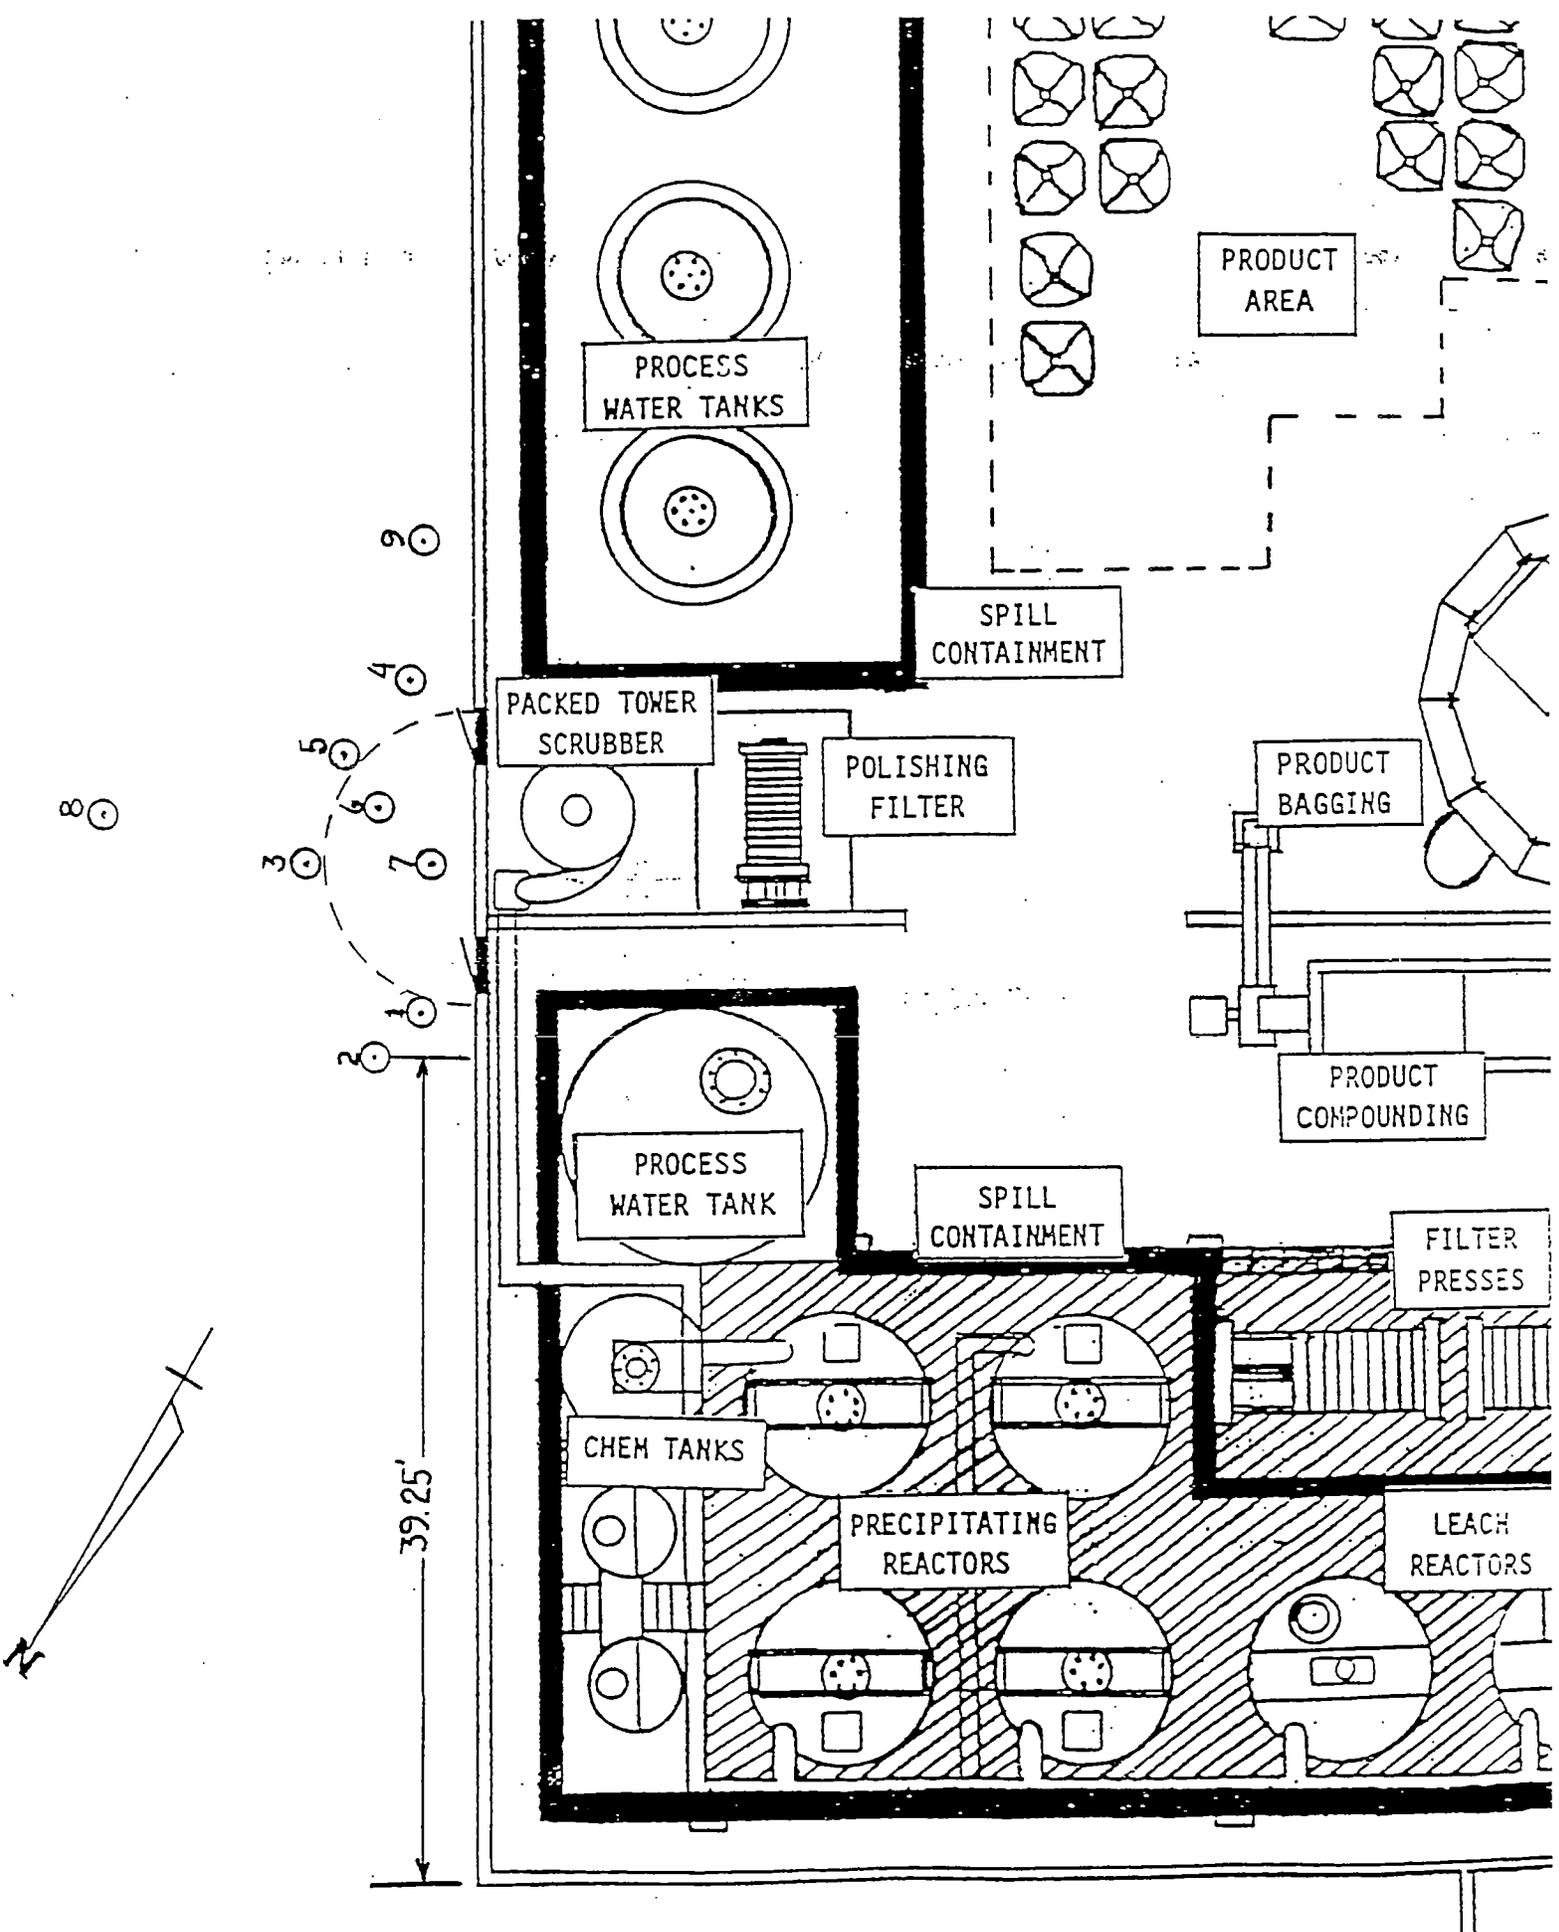
Conclusion - composite samples from 1, 3, 4 and 5 should be analyzed to prove that this is the perimeter of the contamination and 6 & 7 should be analyzed for the maximum concentration of contamination. The total area of contamination ^{outside the building} (not under the building) is estimated to have a radius of 10 feet from the point 53.5 feet from the front of the building at a depth of

approximately 6' feet and totaling
35 cubic yards of material ~~not~~
including contaminated soil, ^{if any,} under
the building ^{for} which no data was
collected. Attached is a map of
the sampling ^{area} with the contaminated
area highlighted in blue. Once the
sample results are received, this
conclusion should be reviewed.
