DOCUMENTATION OF ENVIRONMENTAL INDICATOR DETERMINATION

RCRA Corrective Action Environmental Indicator (EI) RCRAInfo code (CA750) Migration of Contaminated Groundwater Under Control

Facility Name: General Motors Corporation – Linden Assembly Plant
Facility Address: 1016 West Edgar Road, Linden, New Jersey
Facility EPA ID #: NJD 002 186 690

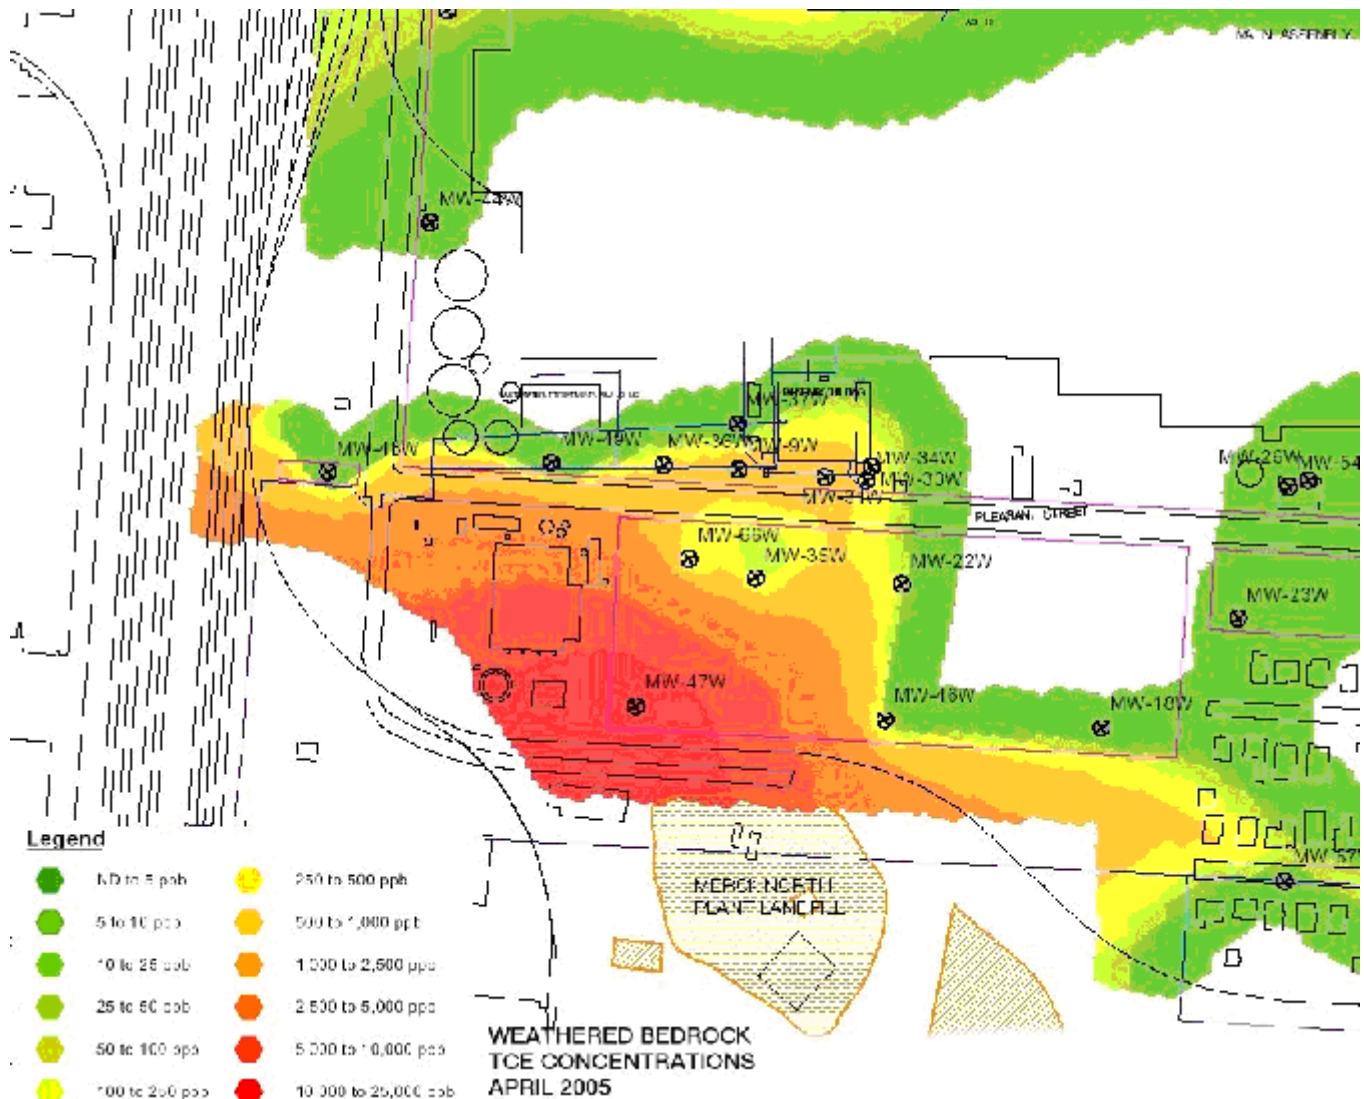
As discussed in Section 2.4, Merck reported that its North Plant Landfill is unlined and received liquid solvent and laboratory waste from the 1940s to 1970s. This landfill is located immediately west of MW-47W. Non-aqueous flow from the landfill following relic bedding plane fractures to the northeast[PN] and a sloping top of weathered bedrock to the east[PN] and southeast[PN] could facilitate a distribution of contaminants, which would be independent of the current predominant weathered bedrock flow direction to the southwest[PN]. Based on the proximity of MW-47W to the Merck landfill and the constituent mix, it appears that this second source area is unrelated to Facility activities.

Like MW-47W, monitoring well MW-46W is believed to be predominantly affected by the Merck landfill based on its similar proximity. The historic mechanisms that resulted in the contamination of groundwater at MW-47W would likely have also caused the groundwater contamination at MW-46W. In addition, MW-46W is currently downgradient of MW-47W, rather than the Paint Mix Building.,

See contour diagram focusing on Group 1 below.

[The contour diagram is for illustrative purpose and is based on available datapoints. This is an excerpt of Figure 37. (Note that MW-47 is at the edge of the corner of GM property.) As additional data is gathered the contours will be re-evaluated and refined. However, from the diagram the possibility of an off-site source is apparent. This scenario is expected to be verified
