FORMER WOLFF ALPORT CHEMICAL COMPANY
Site Visit Report

Site Name: Wolff Alport Chemical Company Site
1127-29 Irving Avenue Brooklyn, New York
DEC Region 2

Date of Visit(s): May 5 and 6, 2007

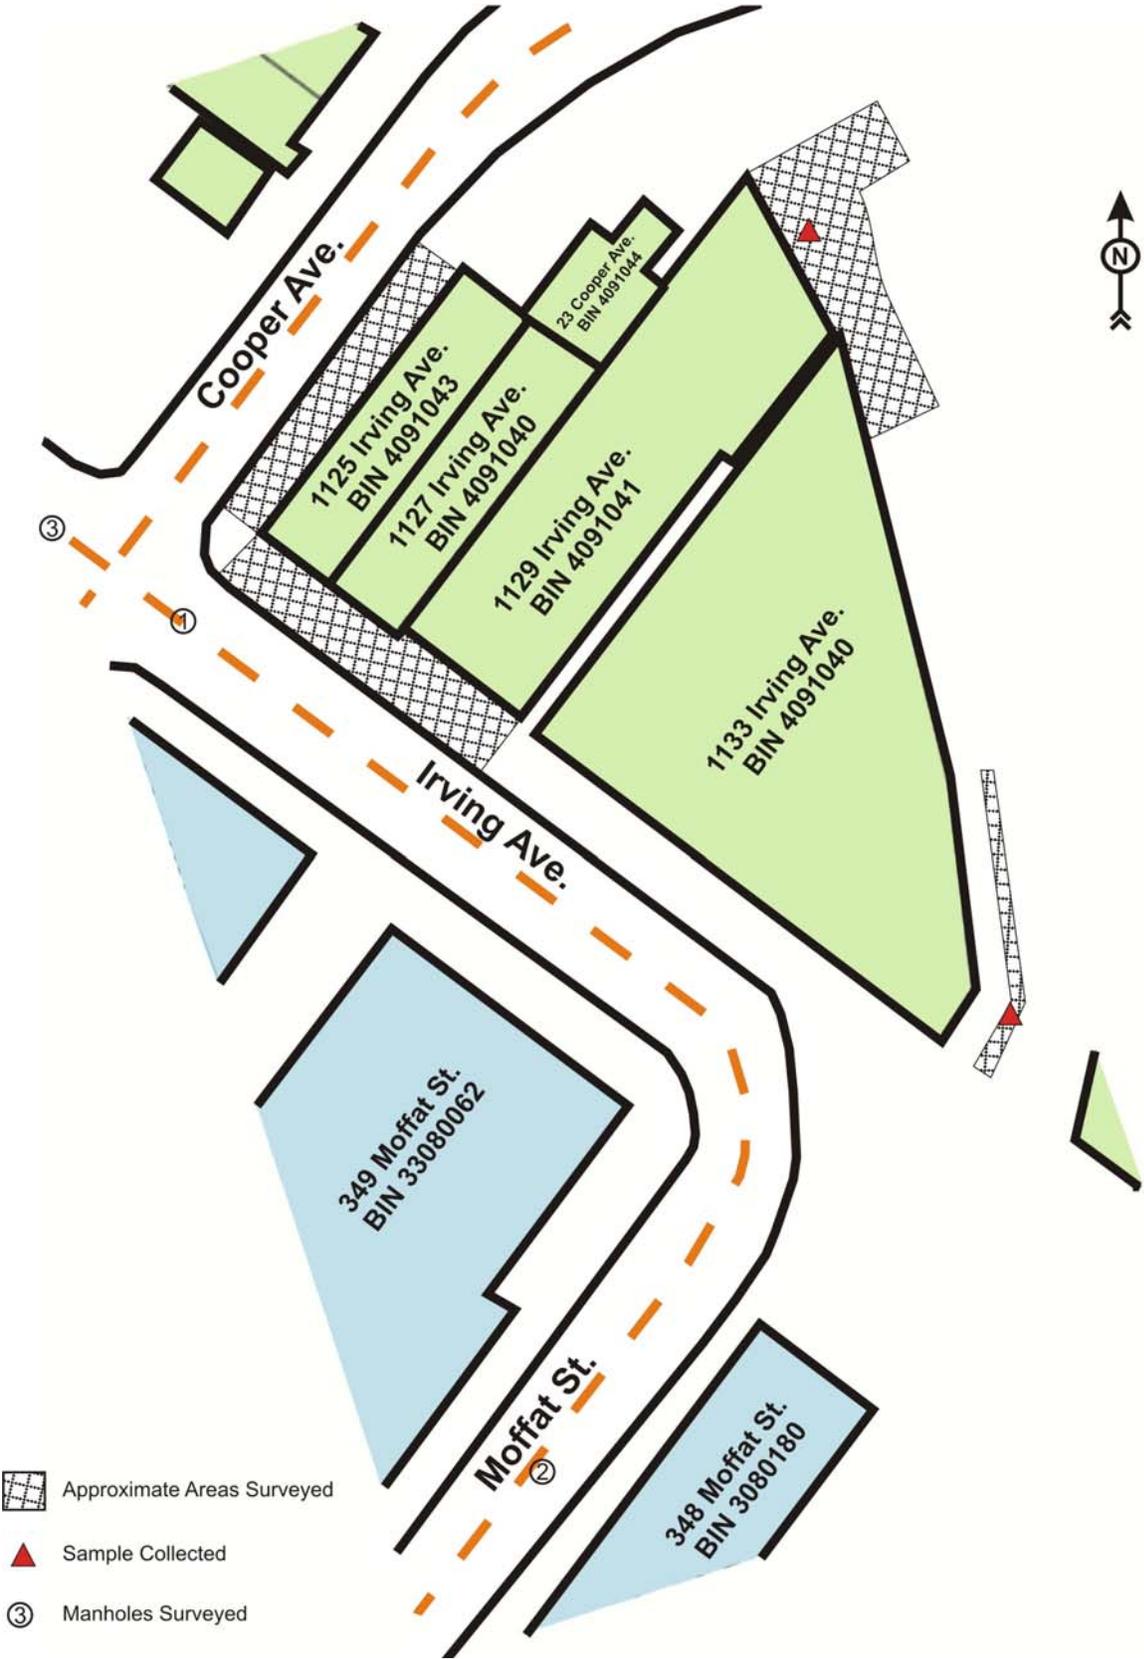
On May 5, 2007, radiological walkover surveys were conducted on the sidewalks along both Irving and Cooper Avenues. The areas surveyed are shown in the figure on page 9.

A NaI 2 X 2 attached to a scaler was used for the survey. The detector was held about three inches from the surface of the ground during the surveys. Selected locations behind 1125 through 1133 Irving Avenue were surveyed, within the areas marked on the figure on page 9 (these were not 100% walkover surveys).

As the back door of 1129 Irving Avenue was approached, count rates steadily increased, from about 24,000 cpm just off the rail spur bed, to 390,000 cpm, two feet from the building. A surface soil sample was collected at that location (see figure on page 9). The area to the south of the doorway was surveyed. Count rates within 10 feet of the building were in the range of 200,000 to 350,000 cpm, with the higher count rates closer to the building and the door.

Manhole 1 was a few yards southeast of the intersection of Irving Avenue and Cooper Avenue, in front of 1125 Irving (see figure on page 9). The inside surface was crusted with a granular material, all the way down to the bottom. Sewage was flowing about 9 feet below the street level. This was the only manhole in which measurements exceeded 0.2 mR/hr. The maximum measurement was 4 mR/hr, seven feet below street level in area less than six inches by six inches, on the southwest side of the manhole.

Manhole 2 was on Moffat Street, in front of 338 Moffat (see figure on page 9). This manhole was dry, and the inside was clean brick, with no granular deposits. All readings were 0.2 mR/hr or less.

Manhole 3 was on Irving Avenue, north of the intersection with Cooper Avenue (see figure on page 9). Sewage was flowing at 11 feet below street level. There was some granular material clinging to the sides, but it was not thick or extensive. All readings were 0.1 mR/hr or less.
