Program Audit Report
Las Vegas Valley Storm Water Management Program:
Clark County Regional Flood Control District; Clark County; City of Las
Vegas; City of North Las Vegas; and City of Henderson
(NPDES Permit No. NV0021911)

September 19-23, 2005

Prepared for:
EPA Region 9
75 Hawthorne Street
San Francisco, CA 94105

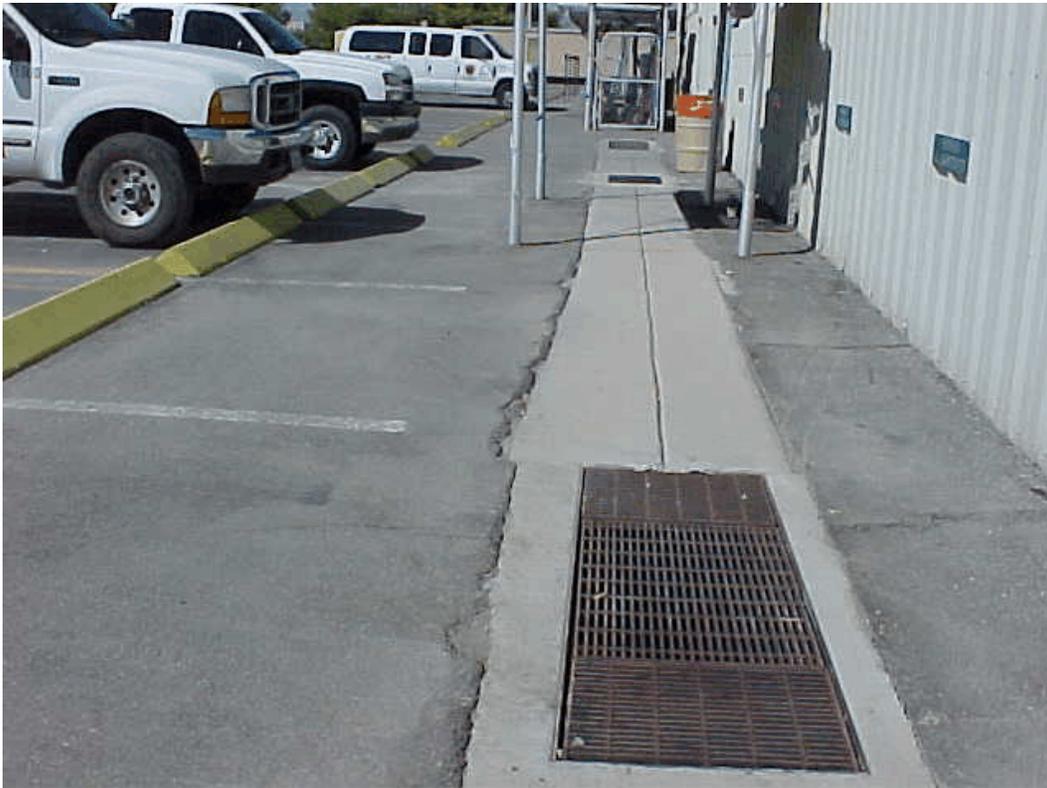
Photo 1. Fleet (primary) facility: Unprotected storm water inlets at north edge of parking area.

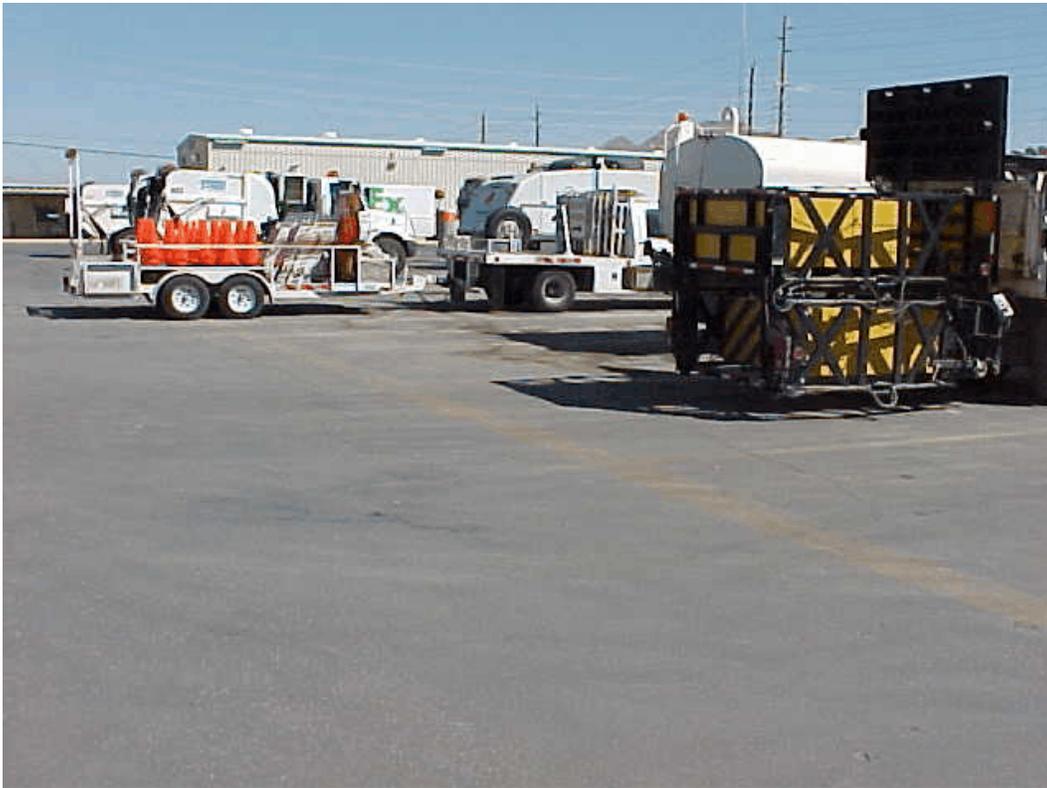
5. The secondary Fleet facility parking lot petroleum product pavement staining was upslope from offsite locations at the southern property boundary. The petroleum product would be carried in storm water runoff from the pavement.
6. The spilled residue biological larvicide was in a uncontained, uncovered area of pavement at the Vector Control facility. Storm water runoff would potentially carry the larvicide off site.
7. The Traffic facility had chemical containers that were uncontained and exposed to rain and rupture from vehicle accident. Storm water would carry any spillage that might occur.

Photo 7. Fleet (primary) facility: Truck parking area with spills/leakage staining on pavement.

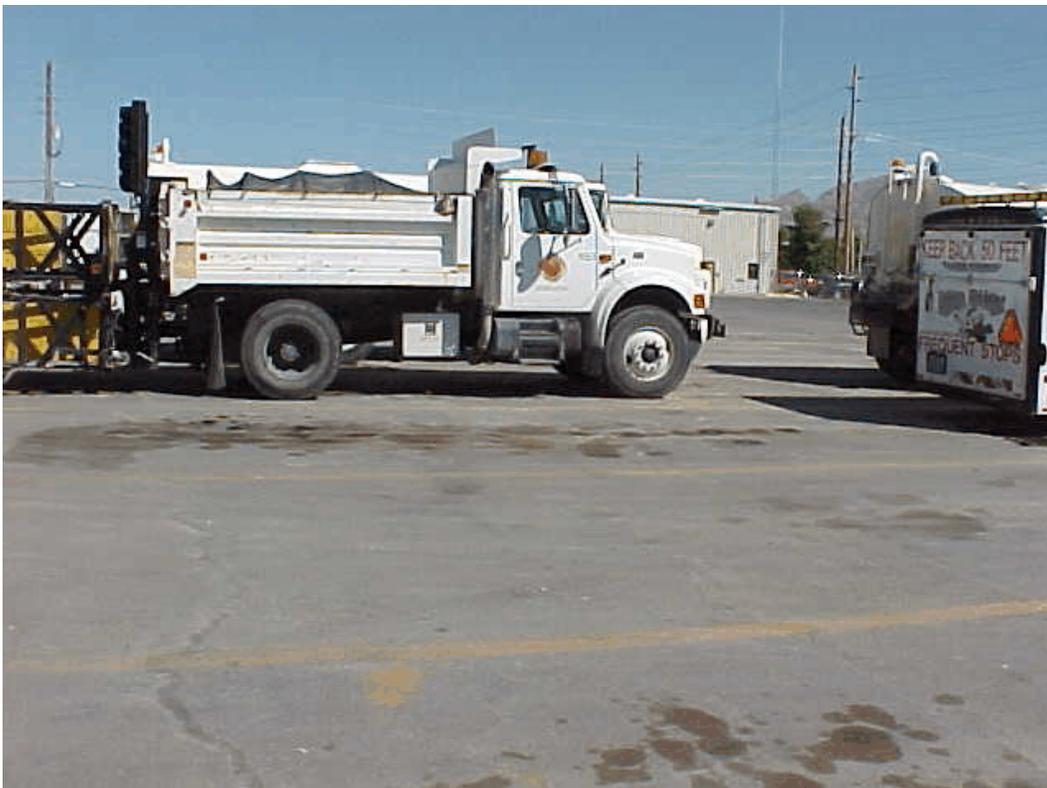
Photo 8. Fleet (primary) facility: Truck parking area with spills/leakage staining on pavement.

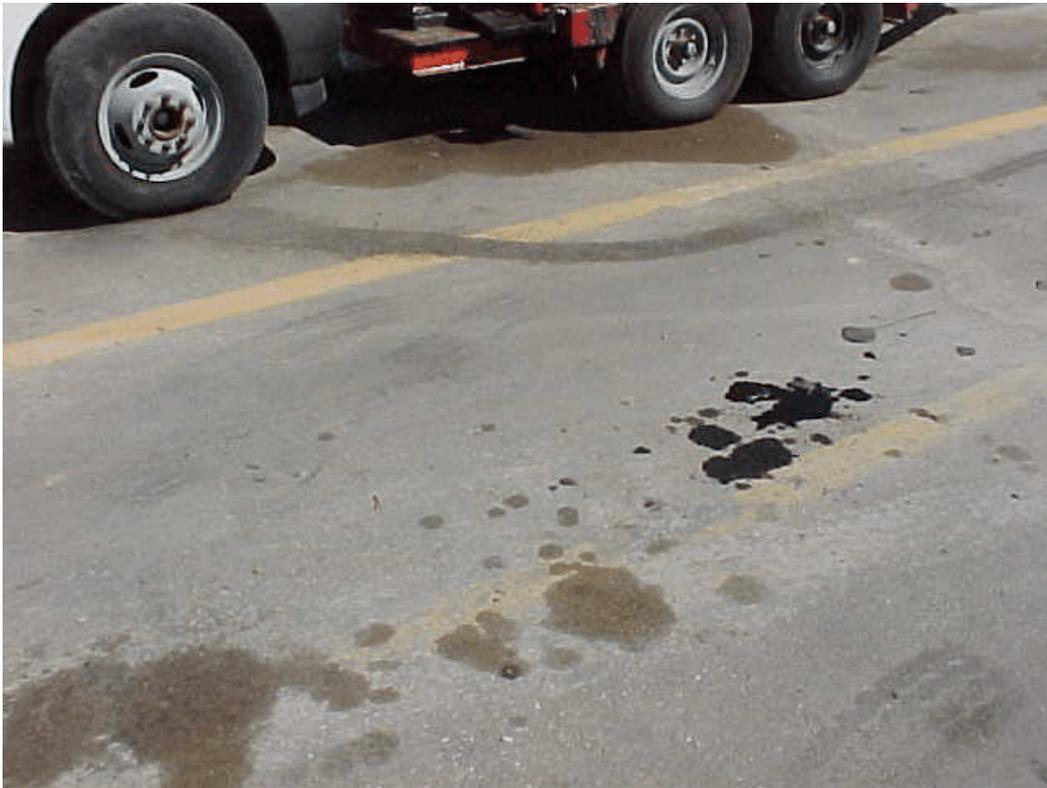
Photo 9. Fleet (primary) facility: Truck parking area with spills/leakage staining on pavement.

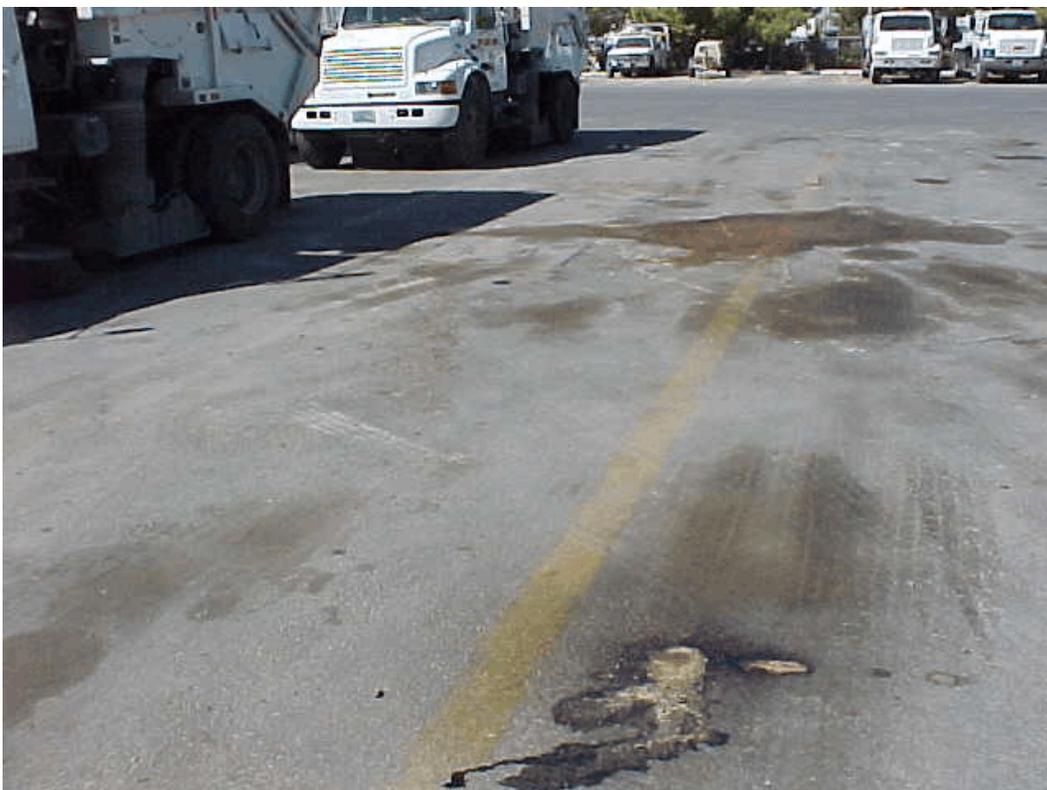
Photo 10. Fleet (primary) facility: Truck parking area with spills/leakage staining on pavement.

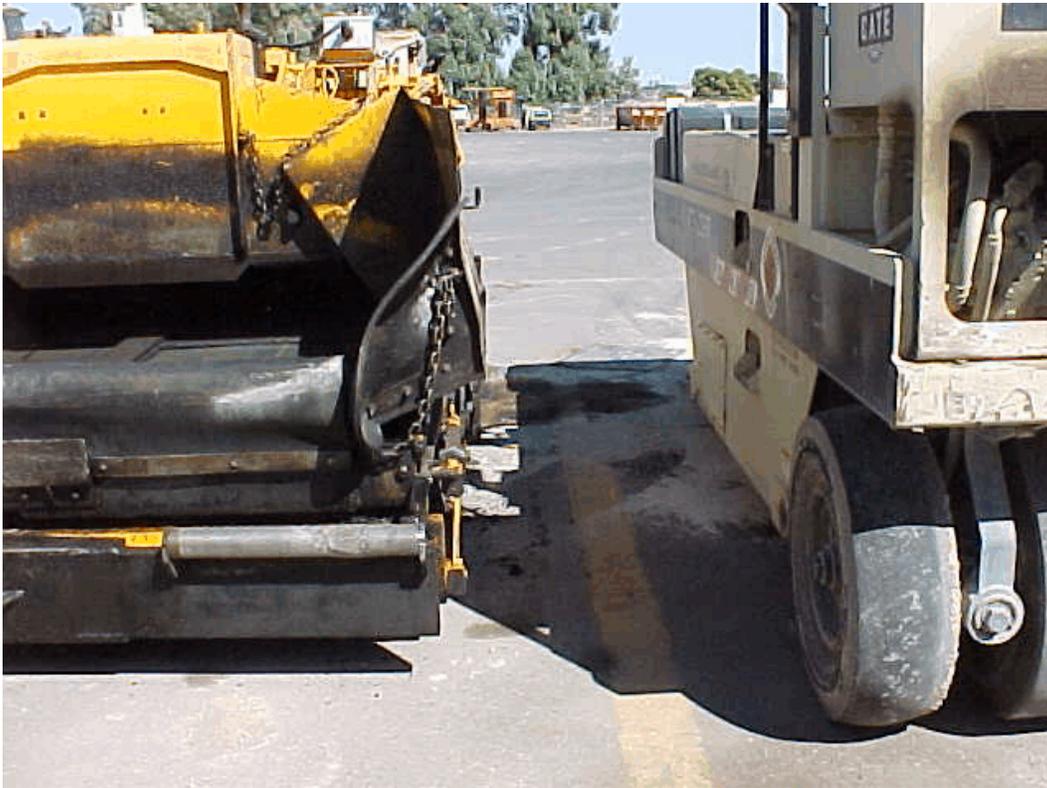
Photo 11. Fleet (secondary) facility: Truck and paving equipment parking area with spills/leakage staining on pavement.

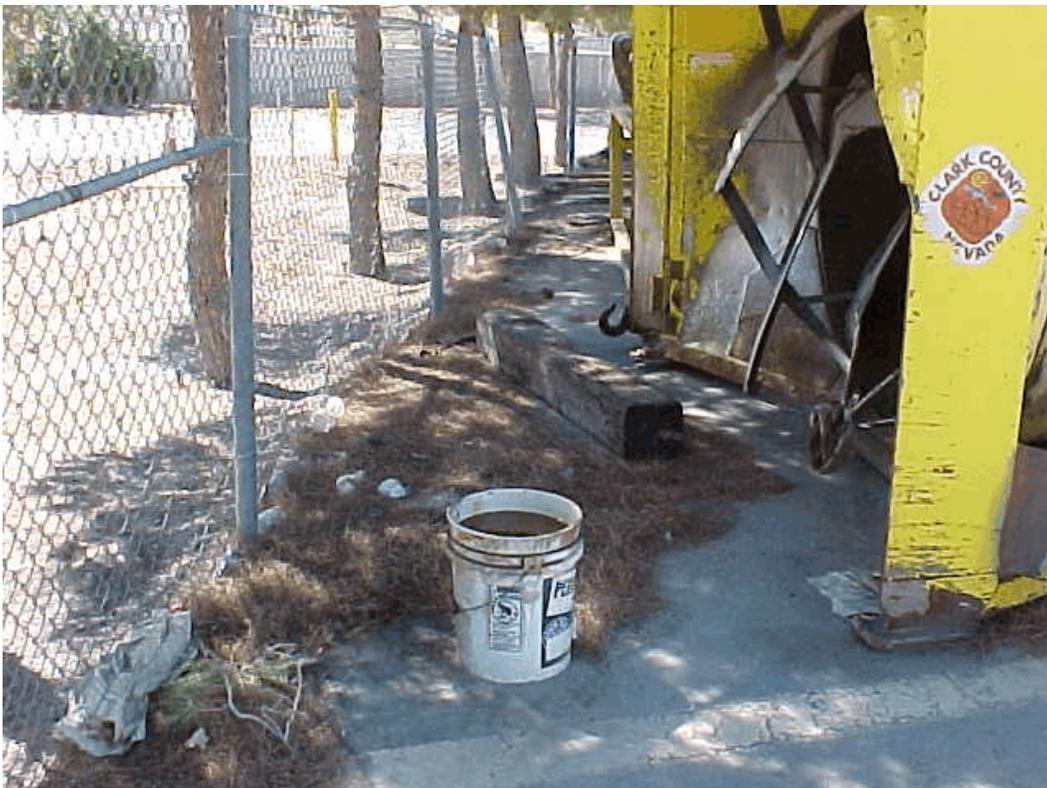
Photo 12. Fleet (secondary) facility: Open 5-gallon pail of oily water in truck and paving equipment parking area.

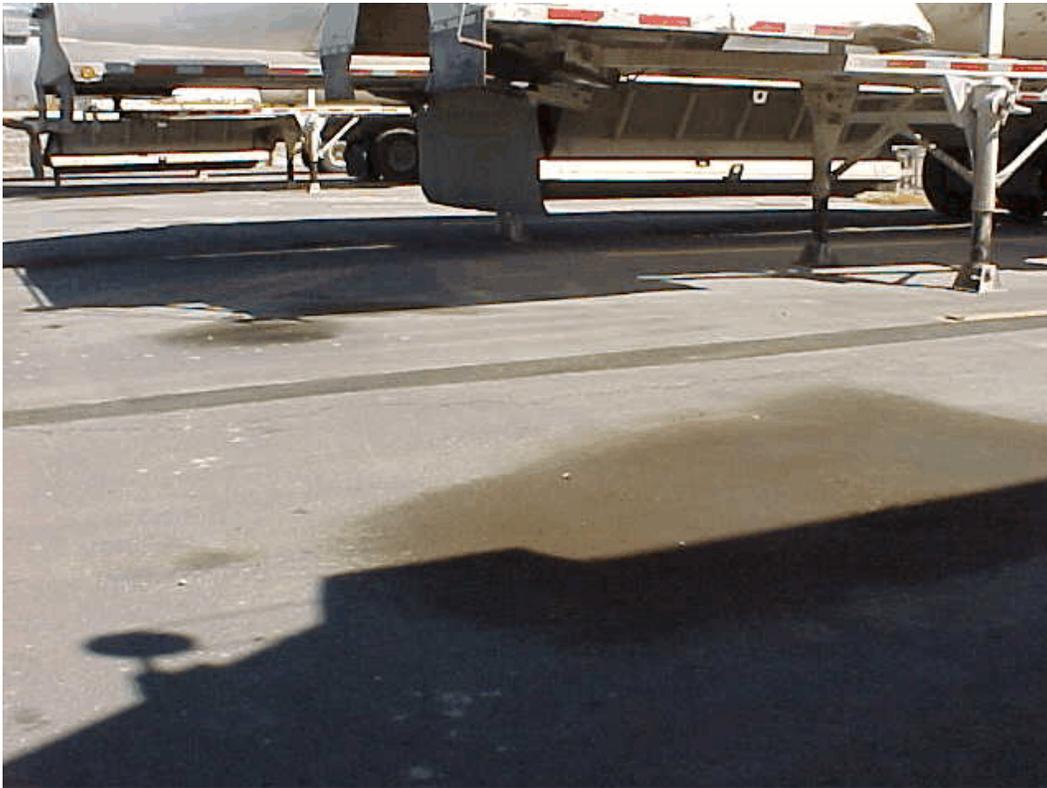
Photo 13. Fleet (secondary) facility: Truck and paving equipment parking area with spills/leakage staining on pavement.

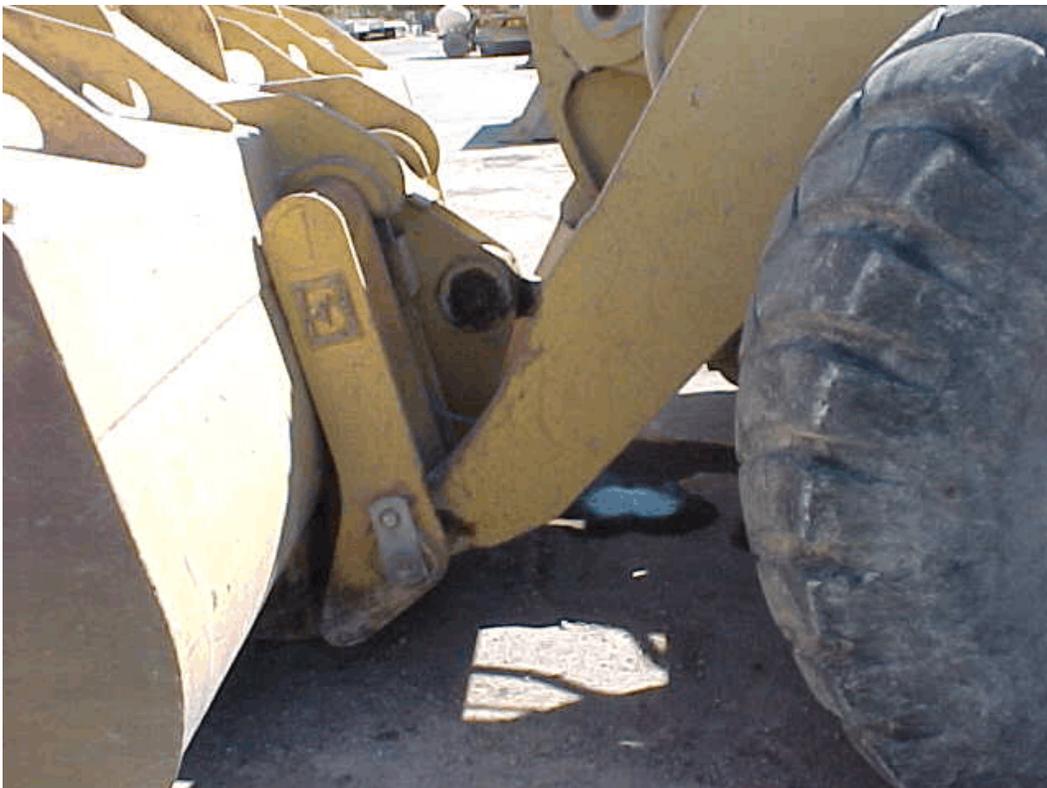
Photo 14. Fleet (secondary) facility: Front loader with an active leak.

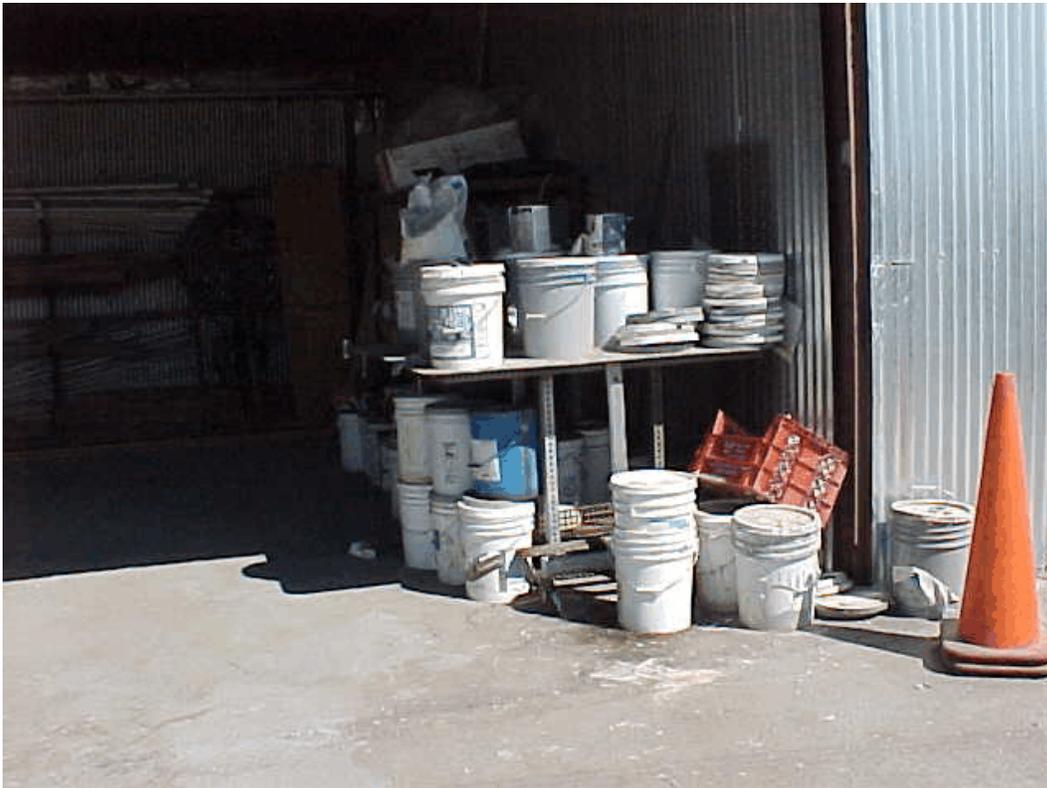
Photo 15. Fleet (secondary) facility: Full and partially full 5-gallon pails of stucco and form oil.

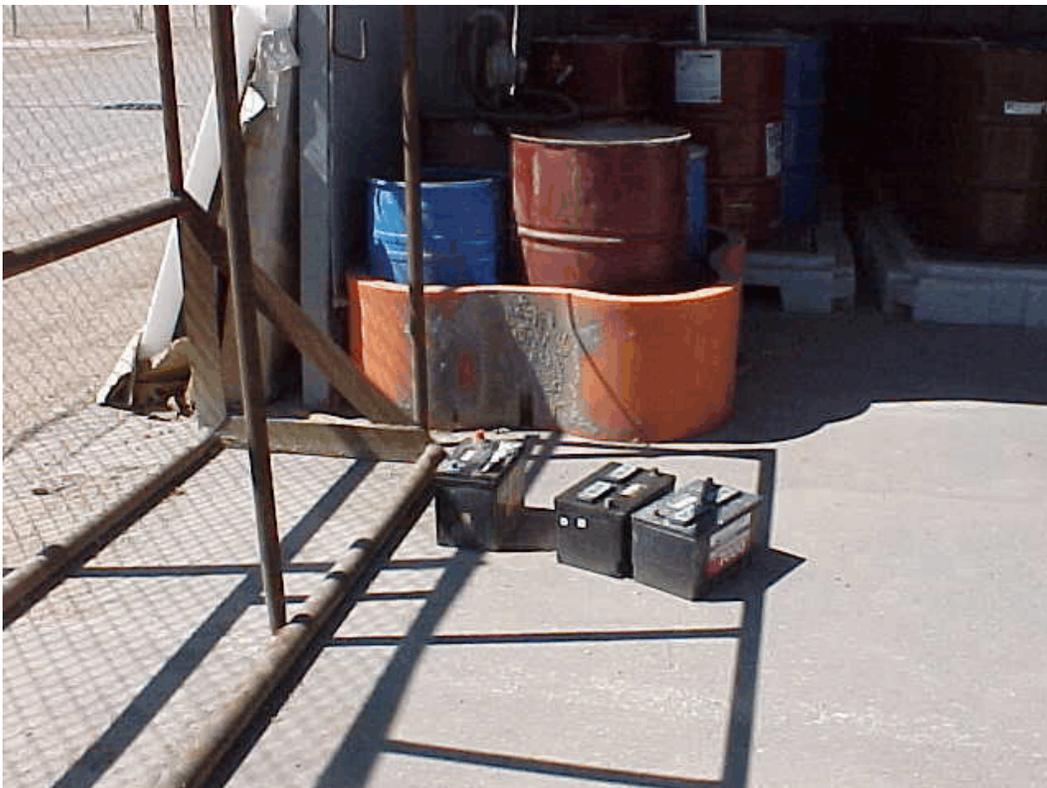
1. Exposed and uncontained used batteries at the Automotive Repair facility had the potential to lose acid to storm water runoff.
2. The spillage at the Fuel Point area was under the canopy, but had the potential to be tracked out of the canopy area and be carried to the adjacent street by storm water.

Photo 2. Three used exposed and uncontained batteries located outside the Automotive Repair facility.

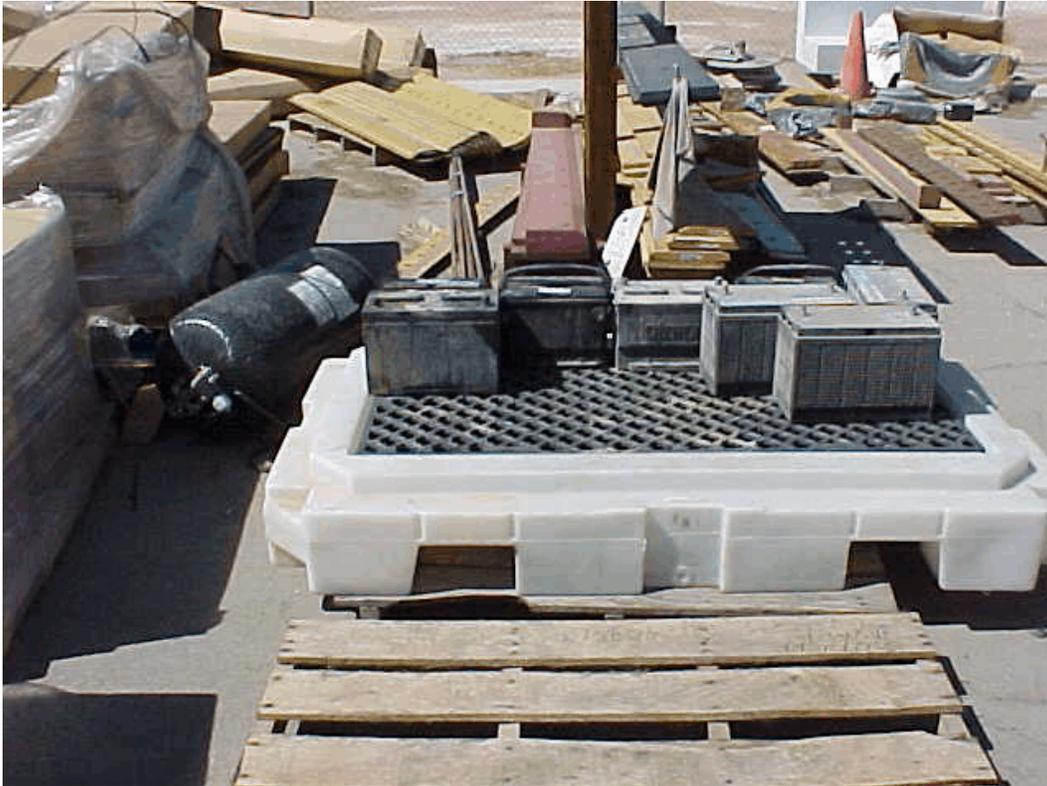
Photo 3. Exposed, but contained used batteries located outside the Automotive Repair facility.

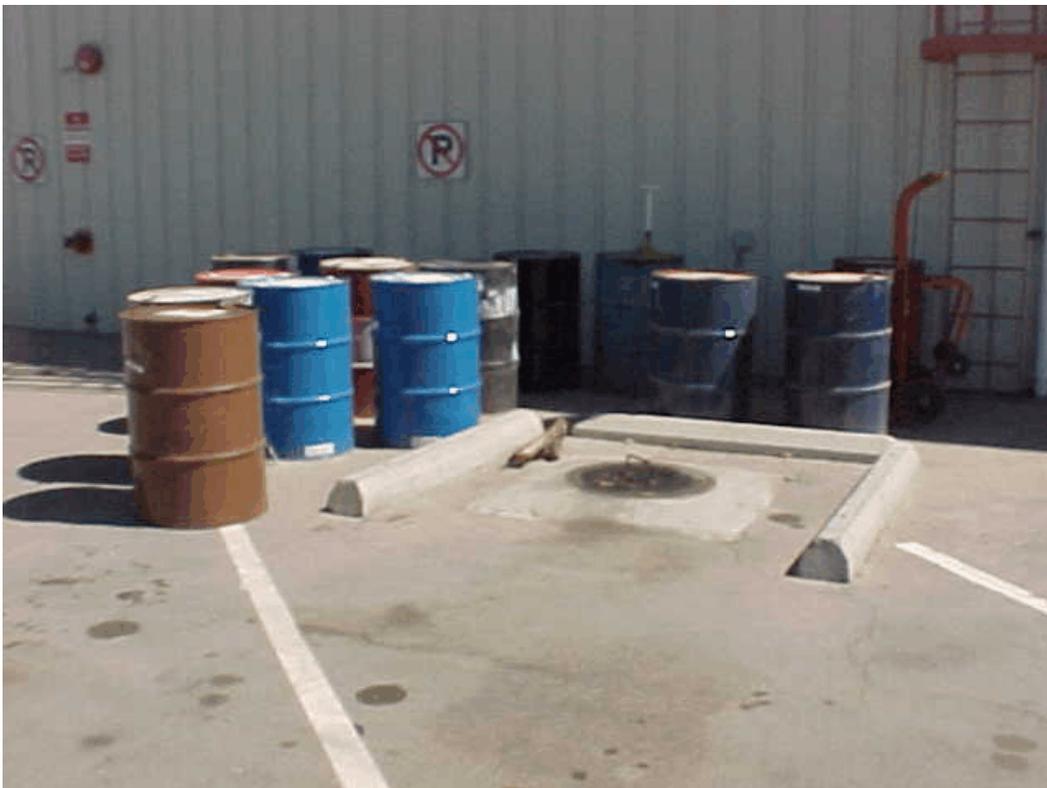
Photo 4. Waste oil pit and multiple 55-gallon drums that are full, partially full, and empty at the Automotive Repair facility.

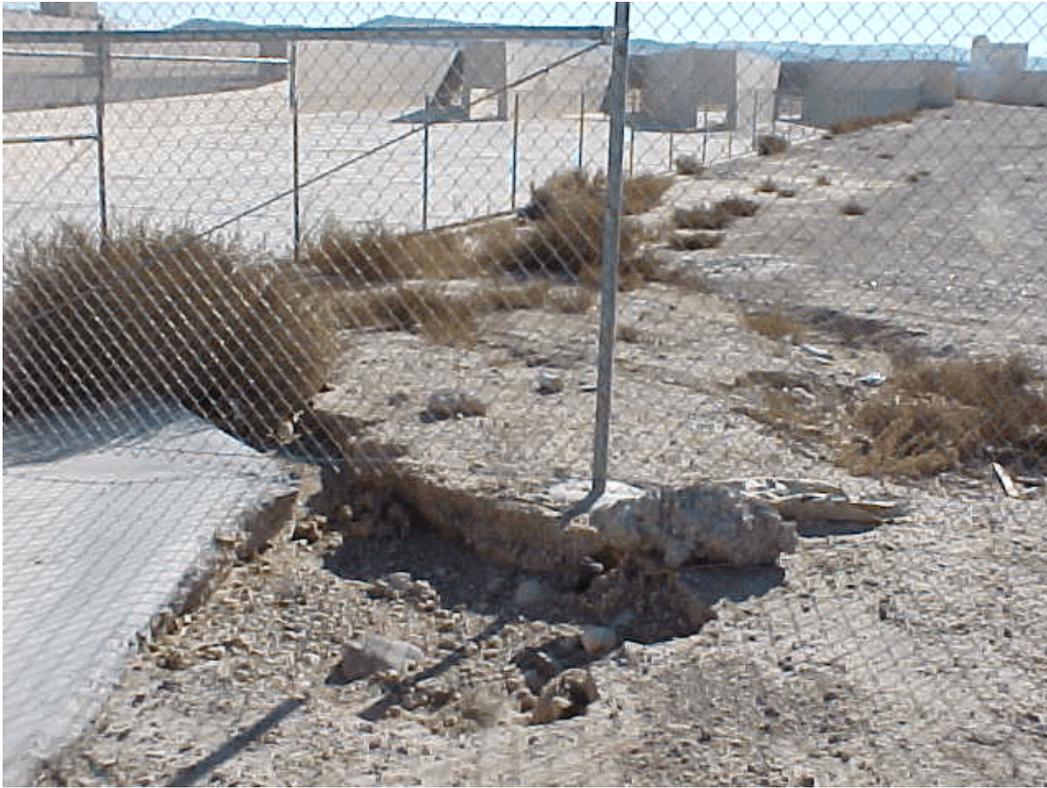
- Installation of discharge pipes to the detention basin may result in erosion where the pipe enters the basin and may cause scouring of the basin floor at the discharge point. Loose soils will potentially be carried by storm water to Duck Creek Channel when a rain event occurs.

Photo 1. Erosion to the detention basin at the northeast corner.

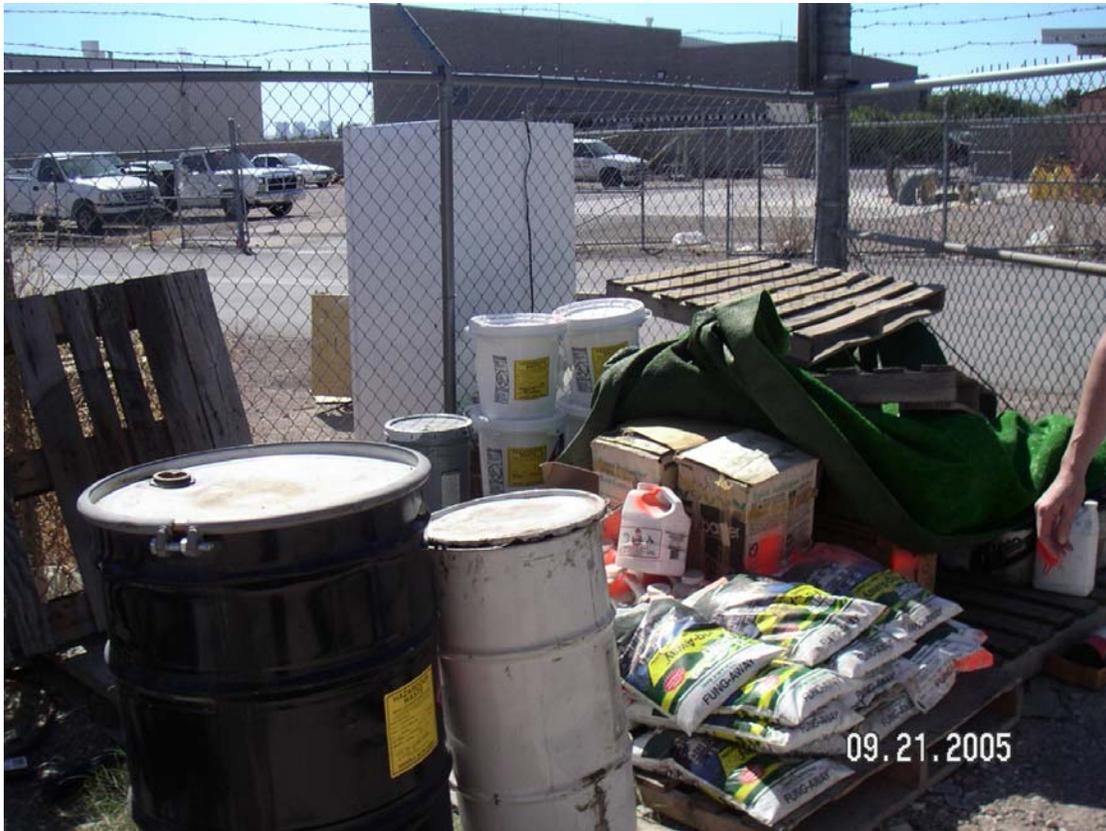
Photo 3. Waste materials abandoned by Parks Department.

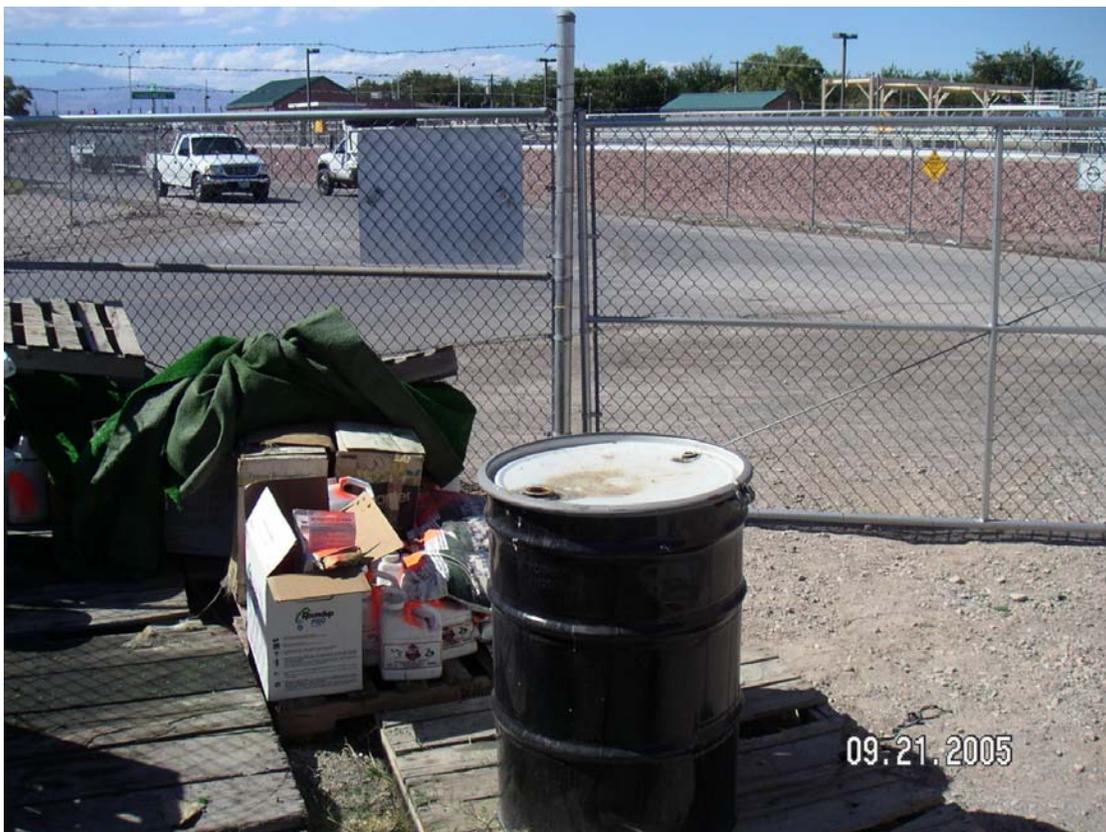
Photo 4. Waste materials abandoned by Parks Department.

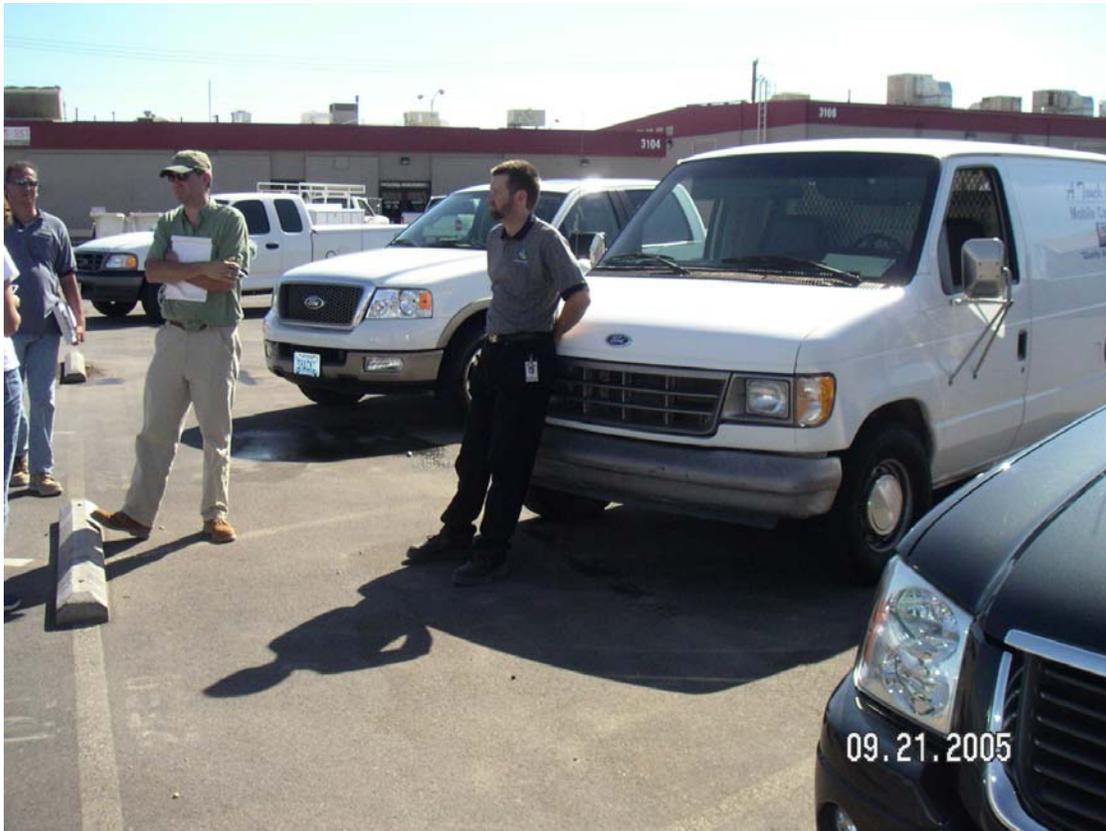
Photo 9. Mobile car wash in parking lot of East Yard.

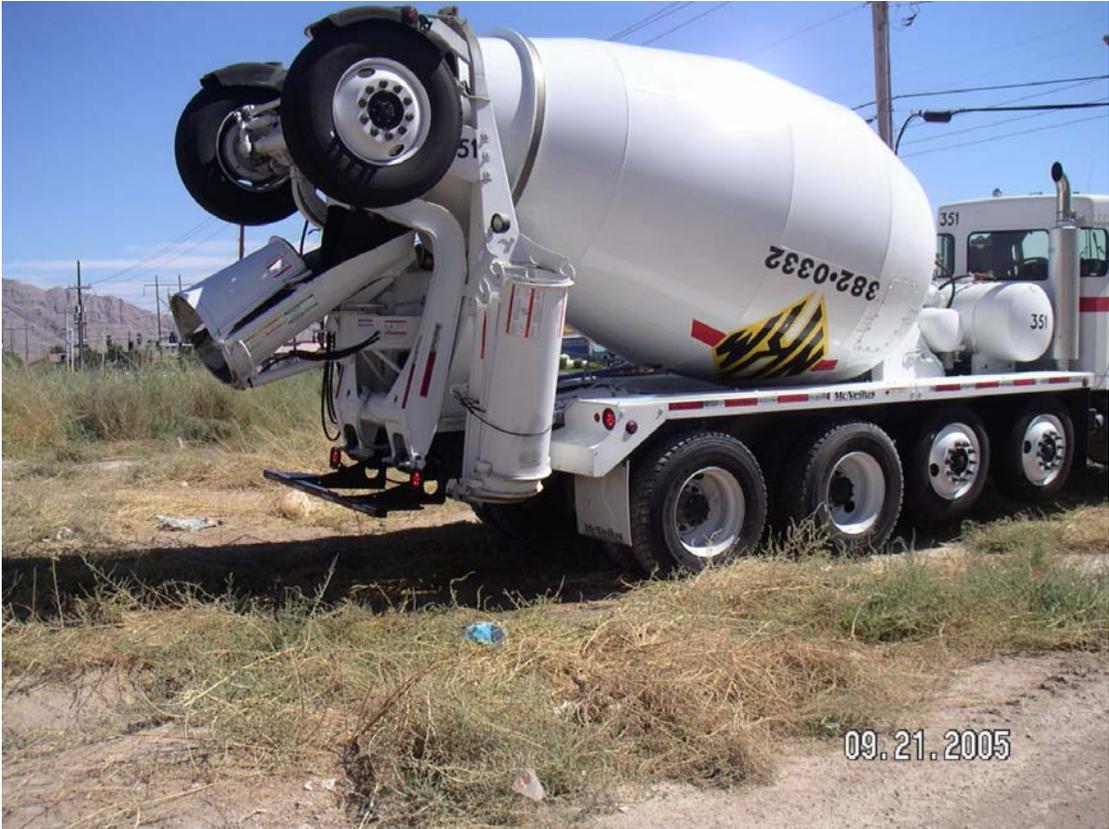
Photo 1. Concrete truck that just completed wash-out.

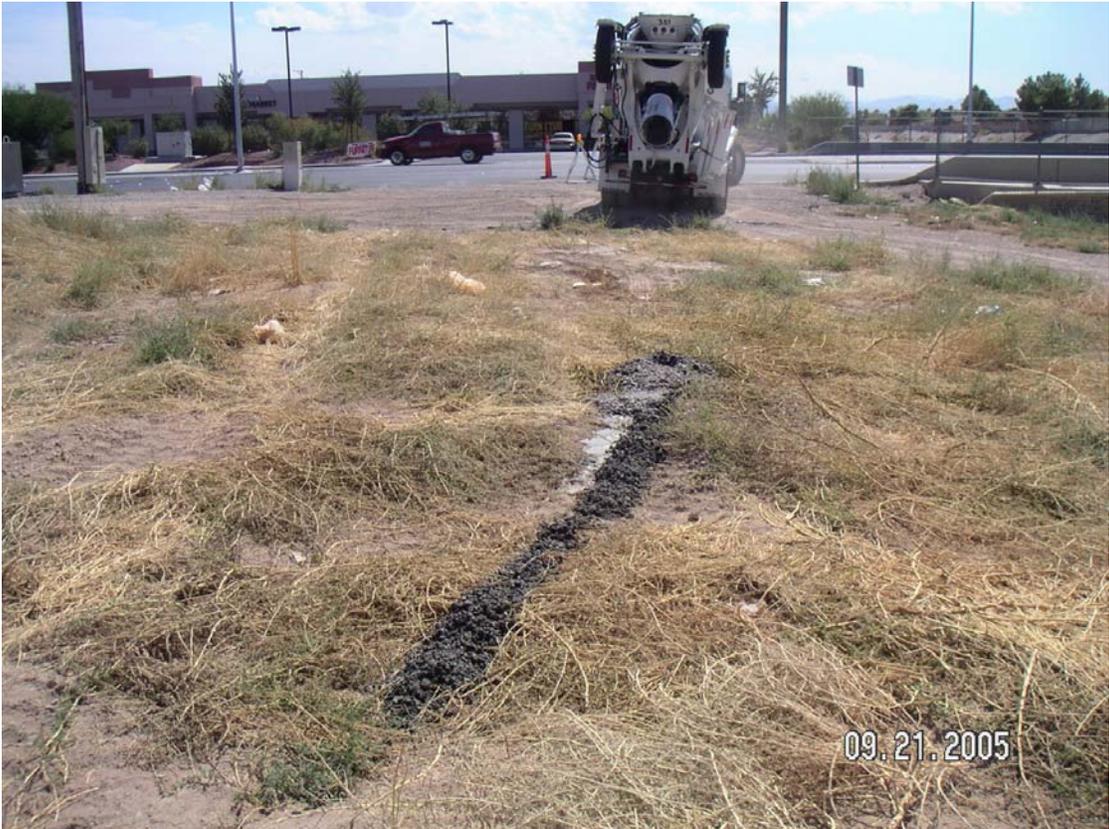
Photo 2. Wash-out material left by concrete truck.

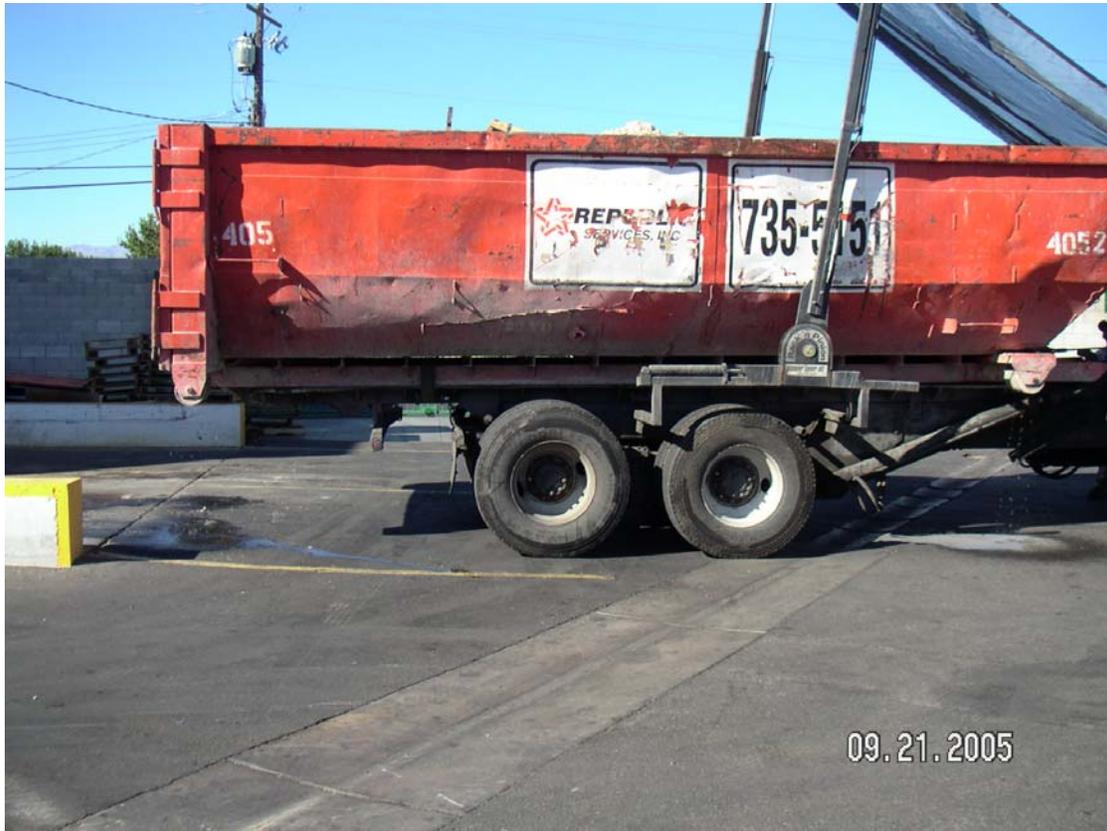
Photo 1. Roll-off container is leaking.

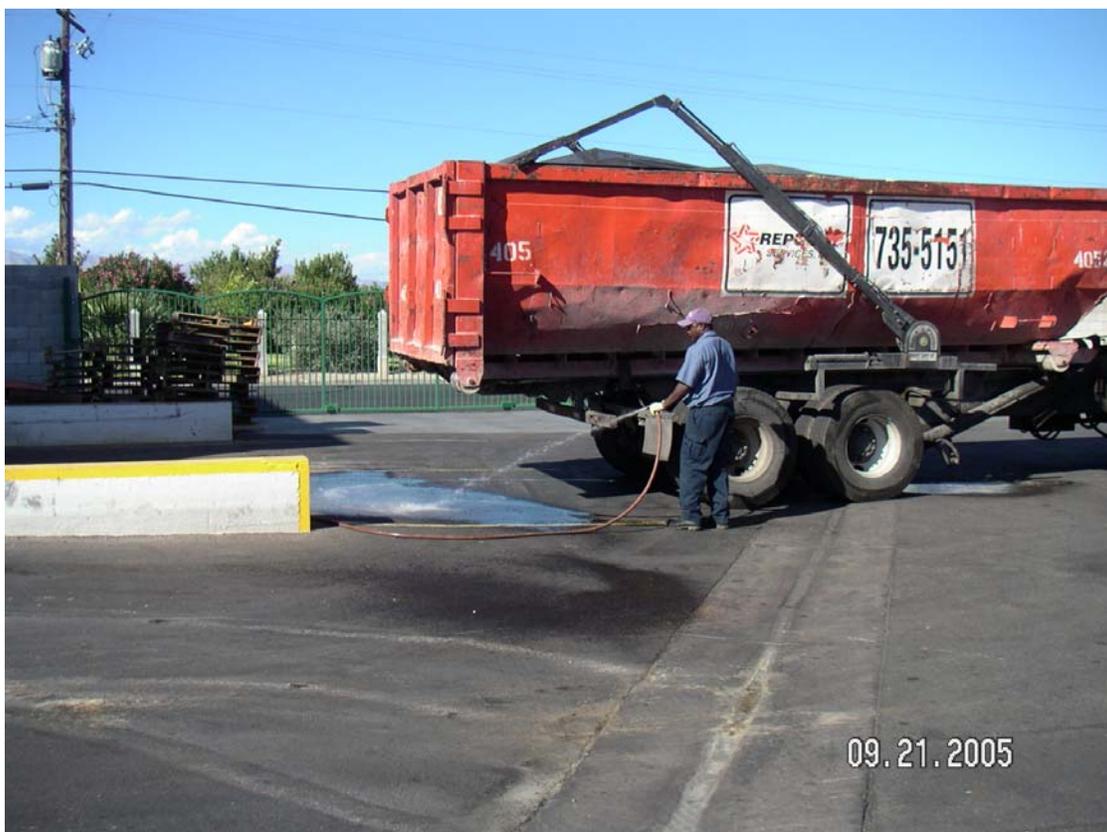
Photo 2. Roll-off container is leaking.

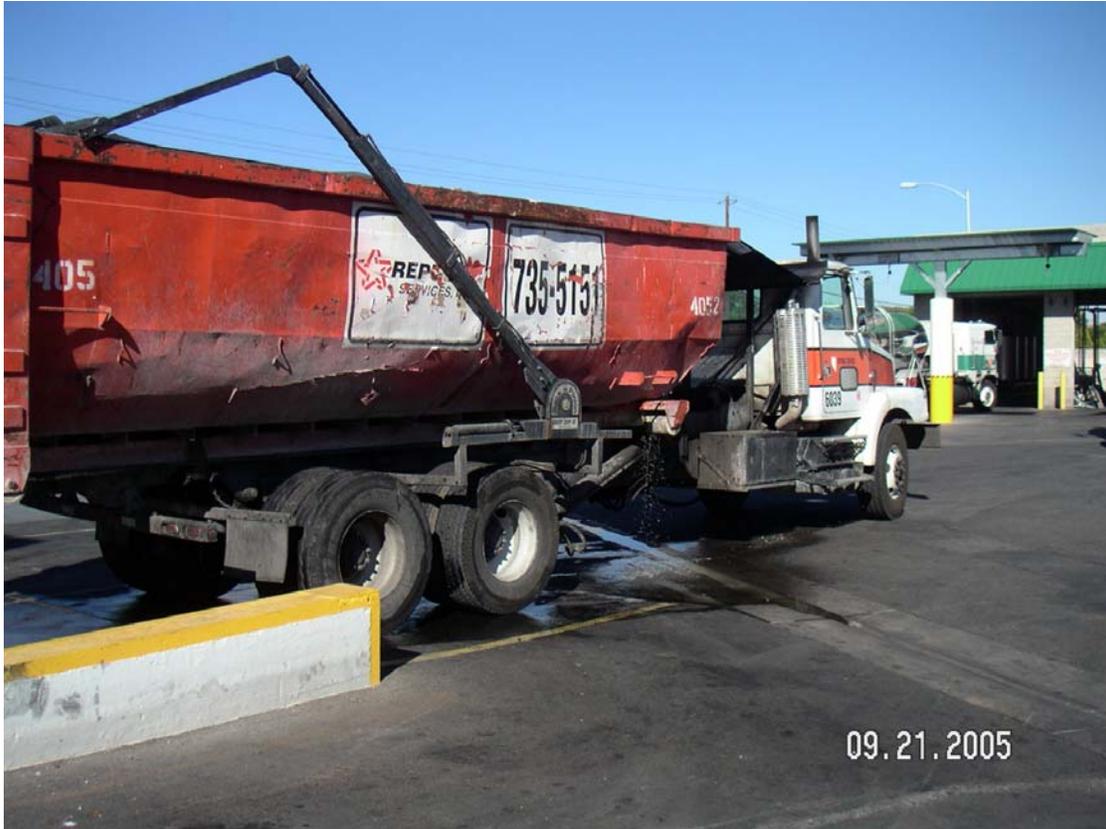
Photo 3. Roll-off container is leaking.

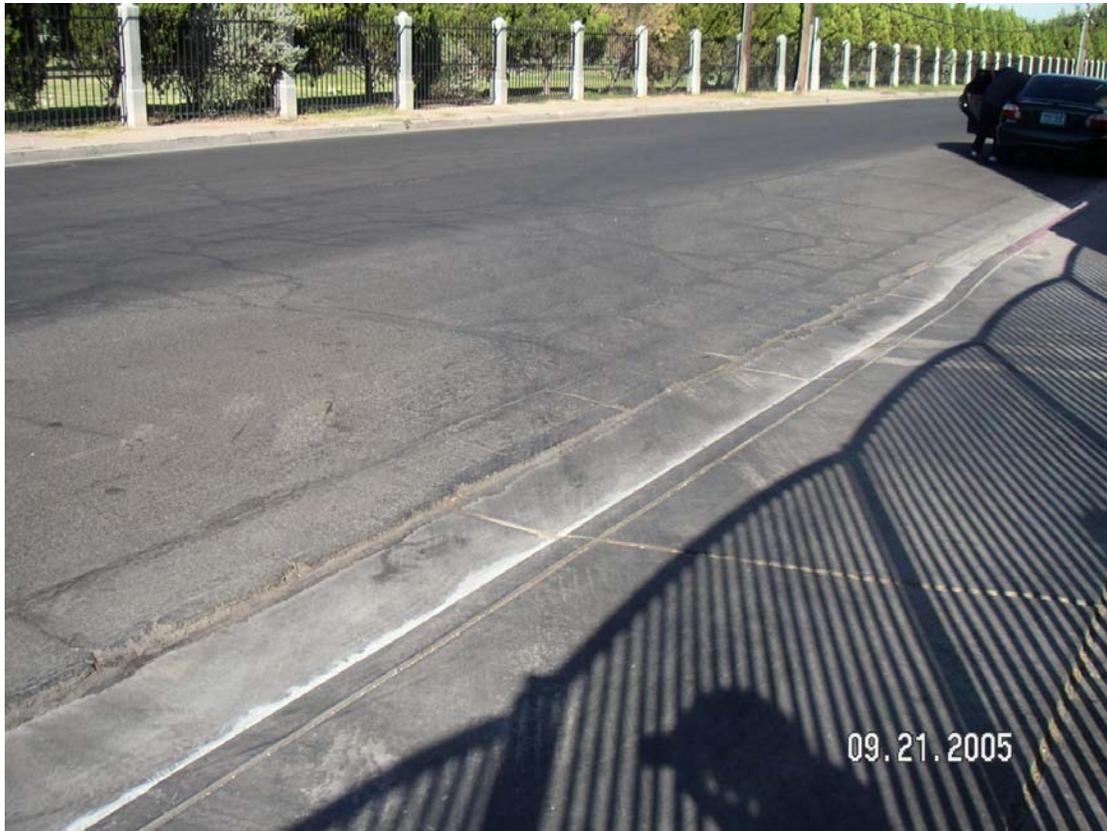
Photo 7. Dried milk solids in street gutter outside facility.

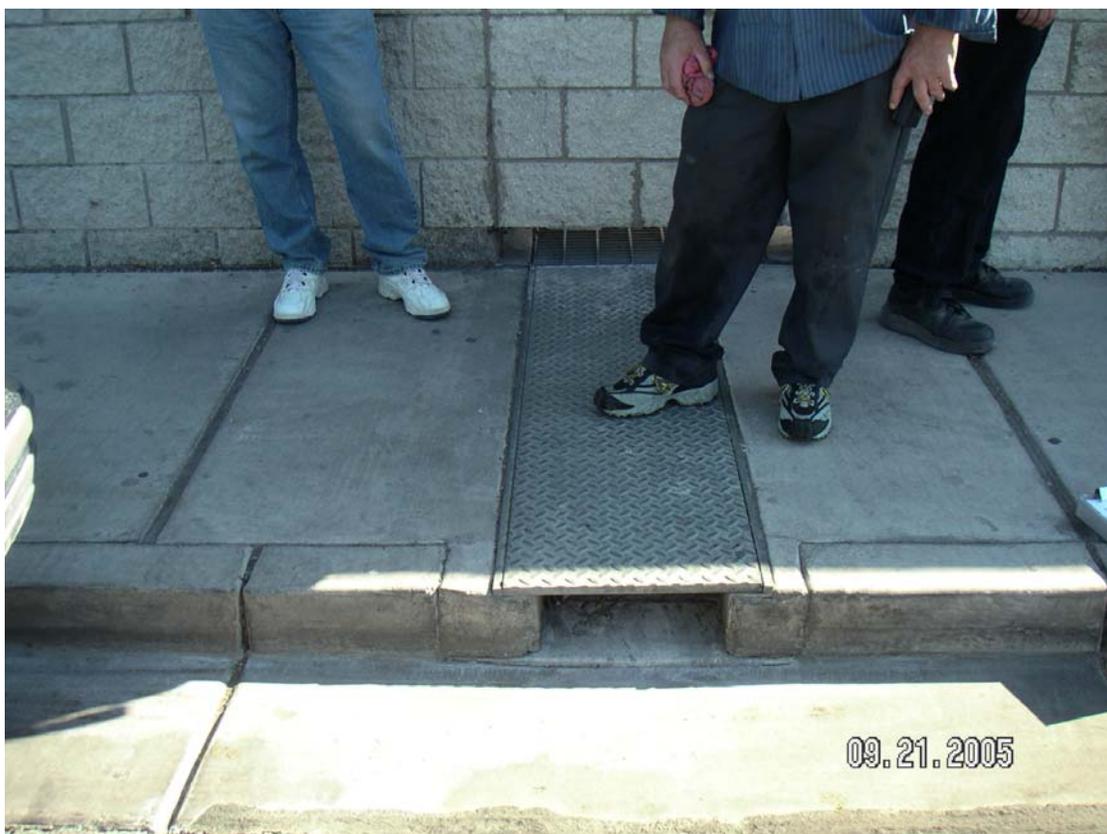
Photo 8. Dried milk solids entered street gutter from facility drain.

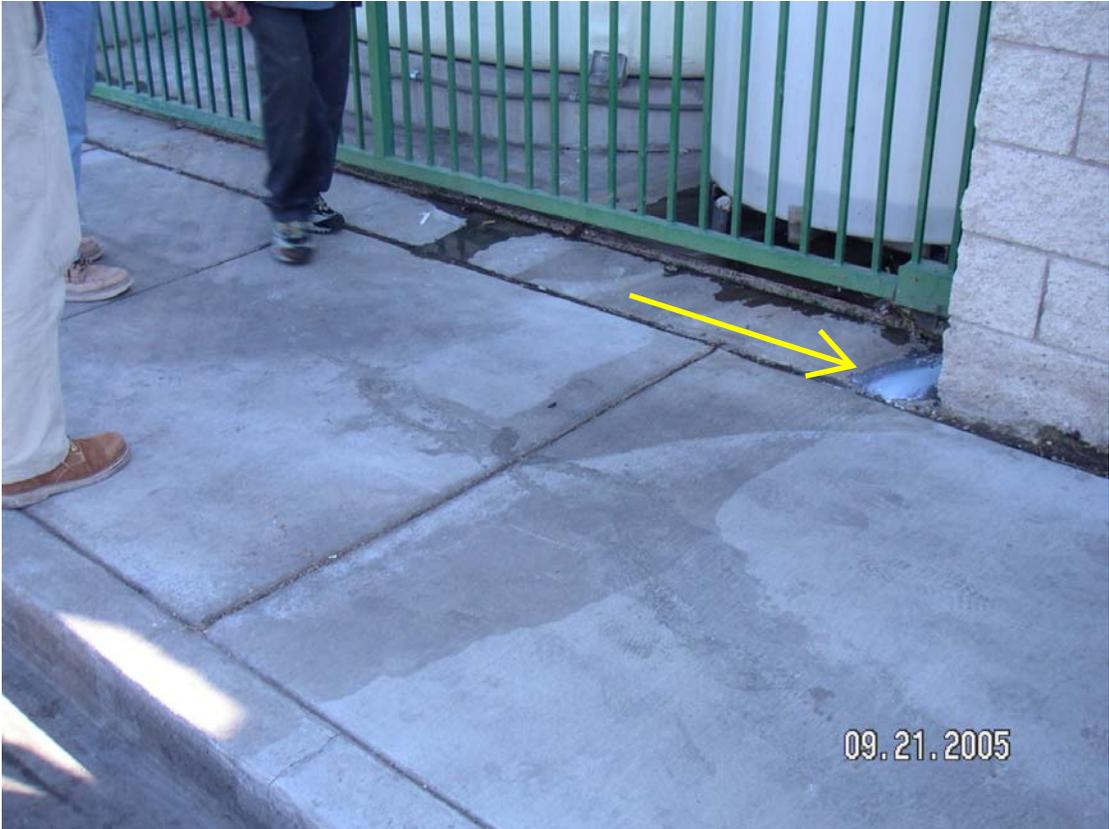
Photo 9. Discharge to street from leaking tank.
