Program Audit Report
Las Vegas Valley Storm Water Management Program:
Clark County Regional Flood Control District; Clark County; City of Las
Vegas; City of North Las Vegas; and City of Henderson
(NPDES Permit No. NV0021911)

September 19-23, 2005

Prepared for:
EPA Region 9
75 Hawthorne Street
San Francisco, CA 94105

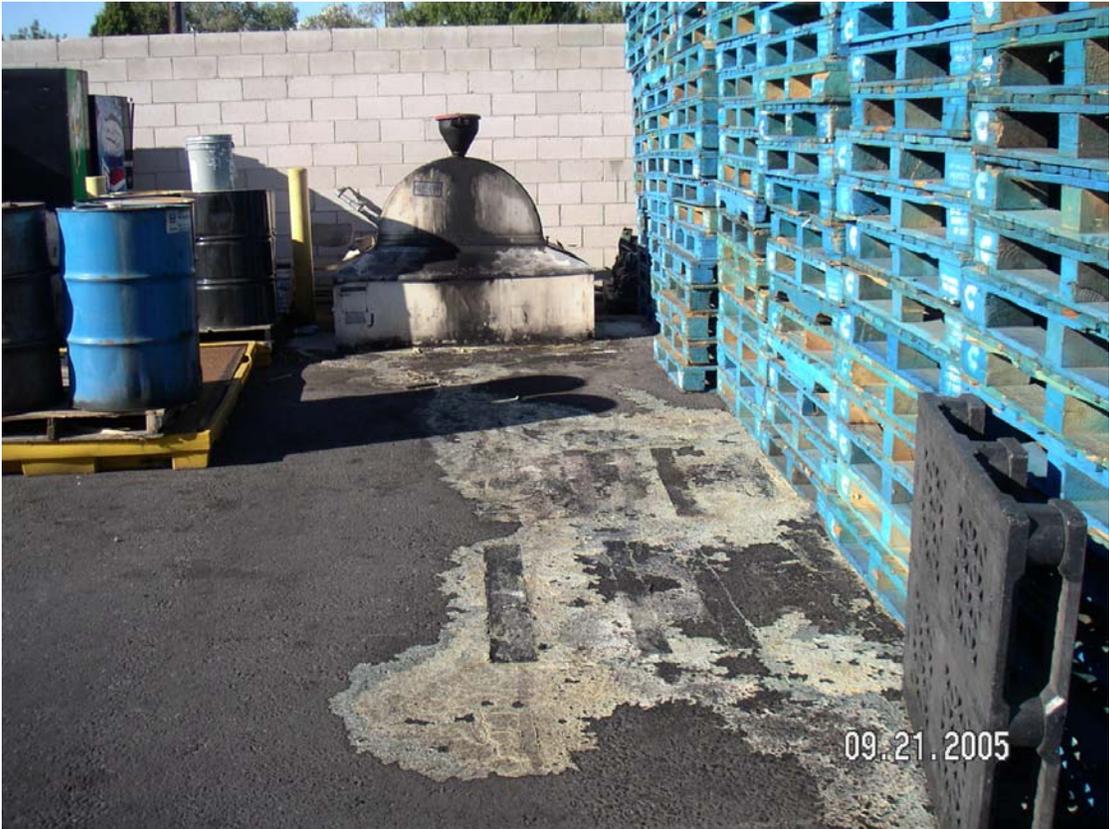
Photo 10. Dried milk solids on asphalt inside facility.

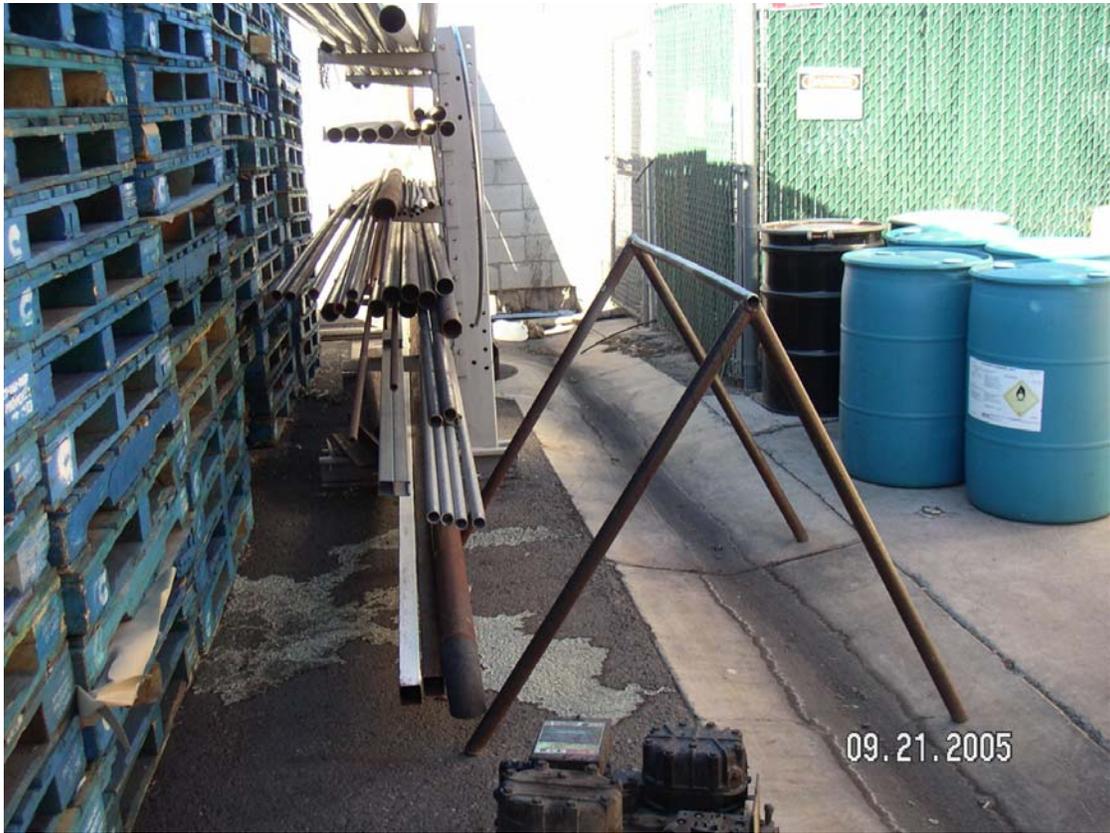
Photo 11. Dried milk solids spilled next to drain to street seen in Photo 8.

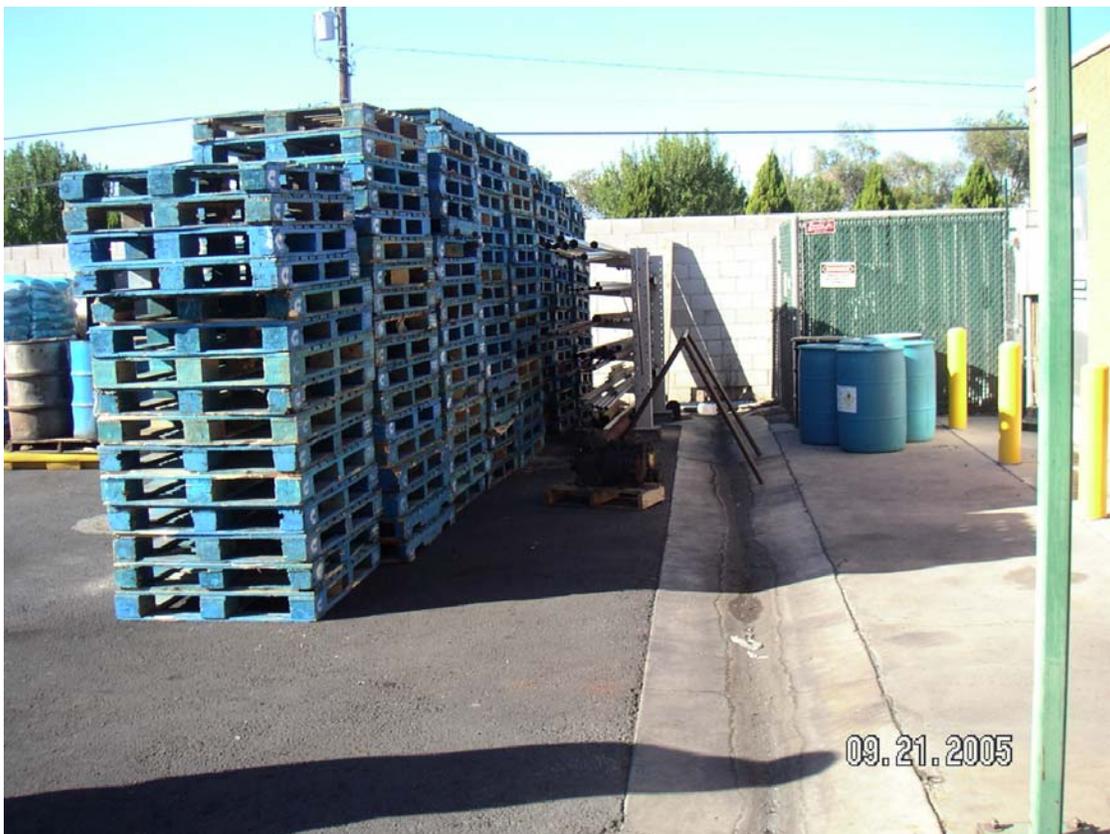
Photo 12. Dried milk solids spilled next to drain to street seen in Photo 8.

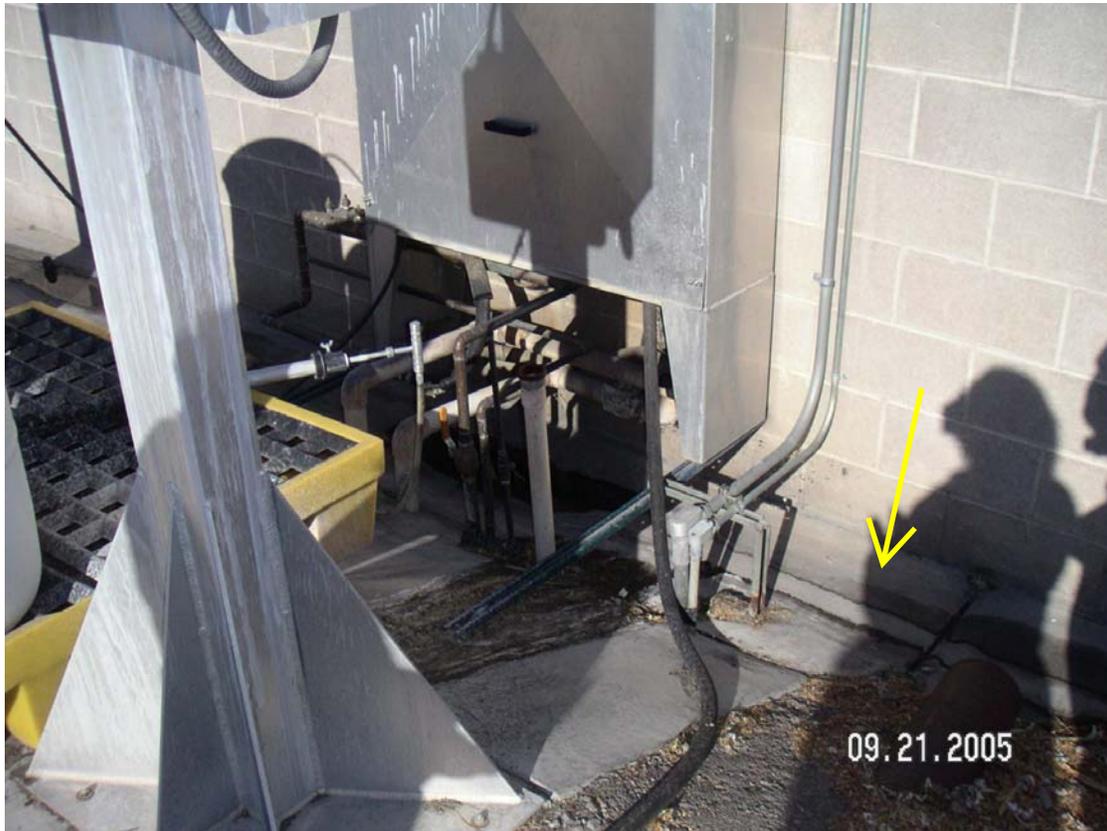
Photo 13. Detergent leaking from wash rack; drain to street in right foreground.

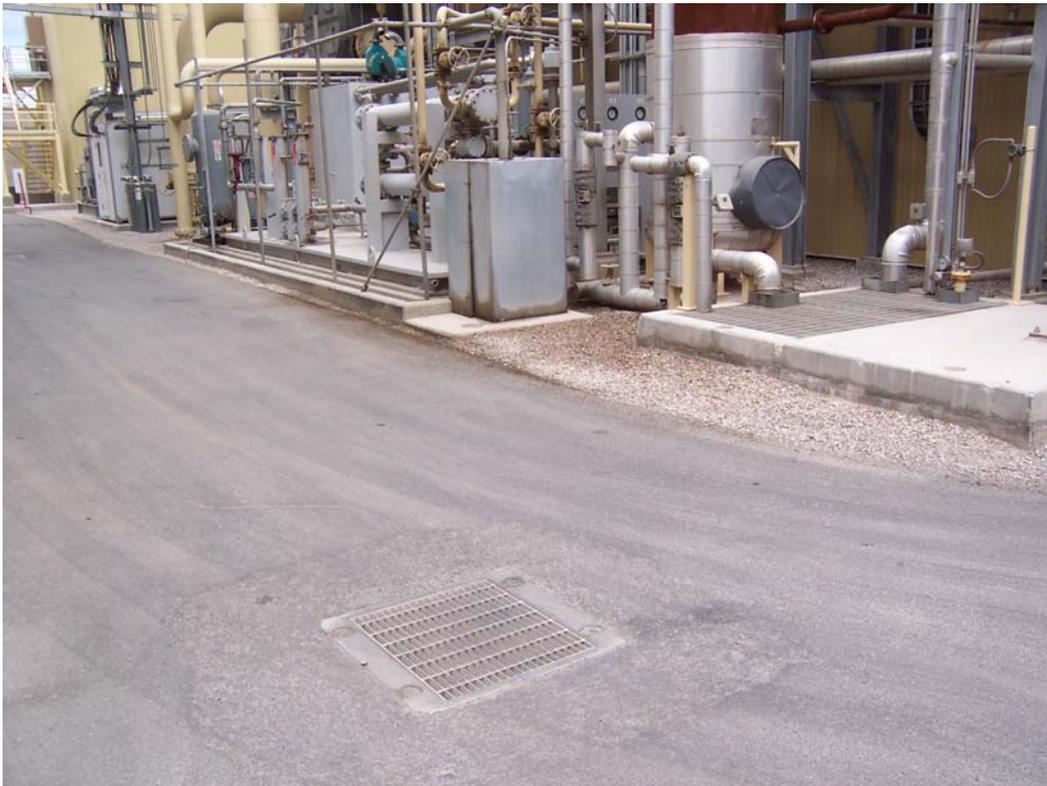
Photo 3. The inspector noted the presence of oil stains (center photo) on the rock landscaping and an electrical cabinet next to turbine number one.

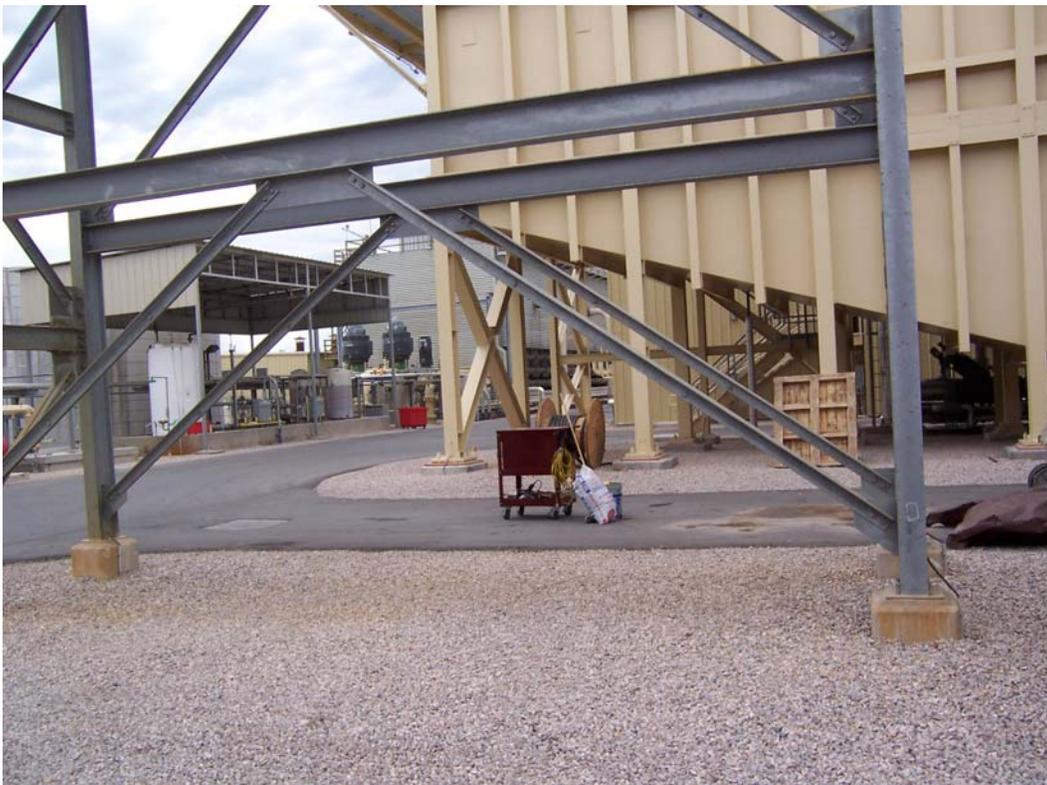
Photo 4. The inspector did note some oil spills on the pavement where adsorbent had been applied. He advised the facility to sweep up the adsorbent.

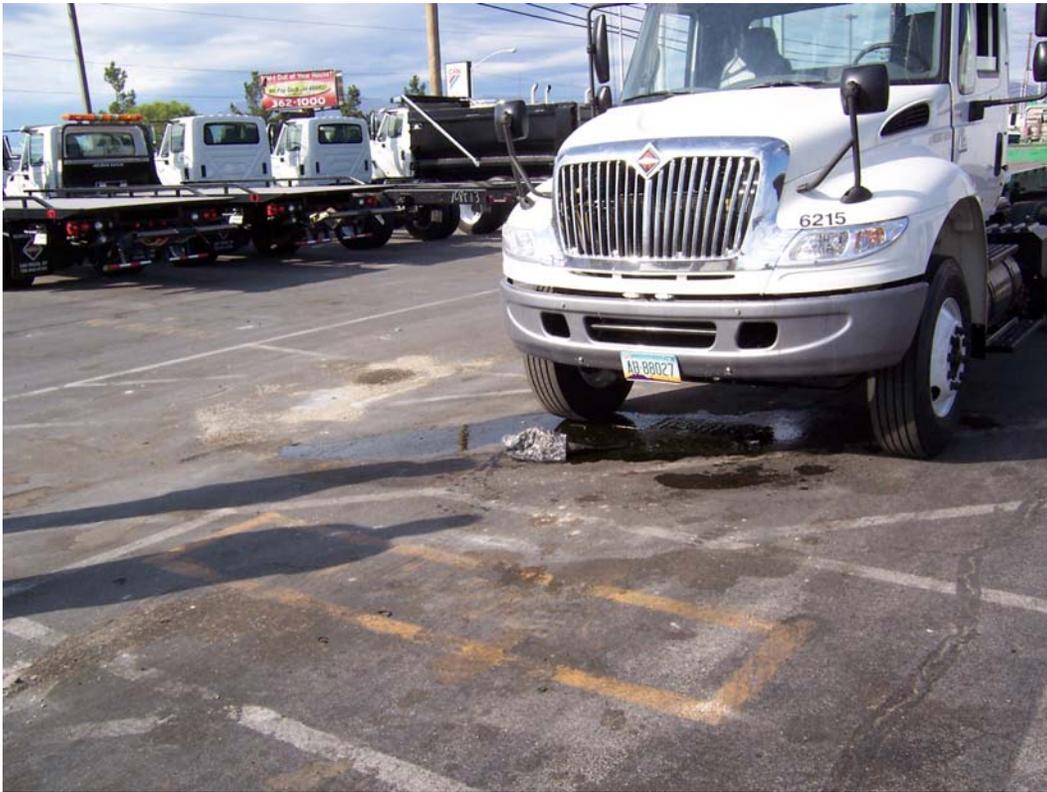
Photo 1. Oil leaking from truck stored in the parking area.

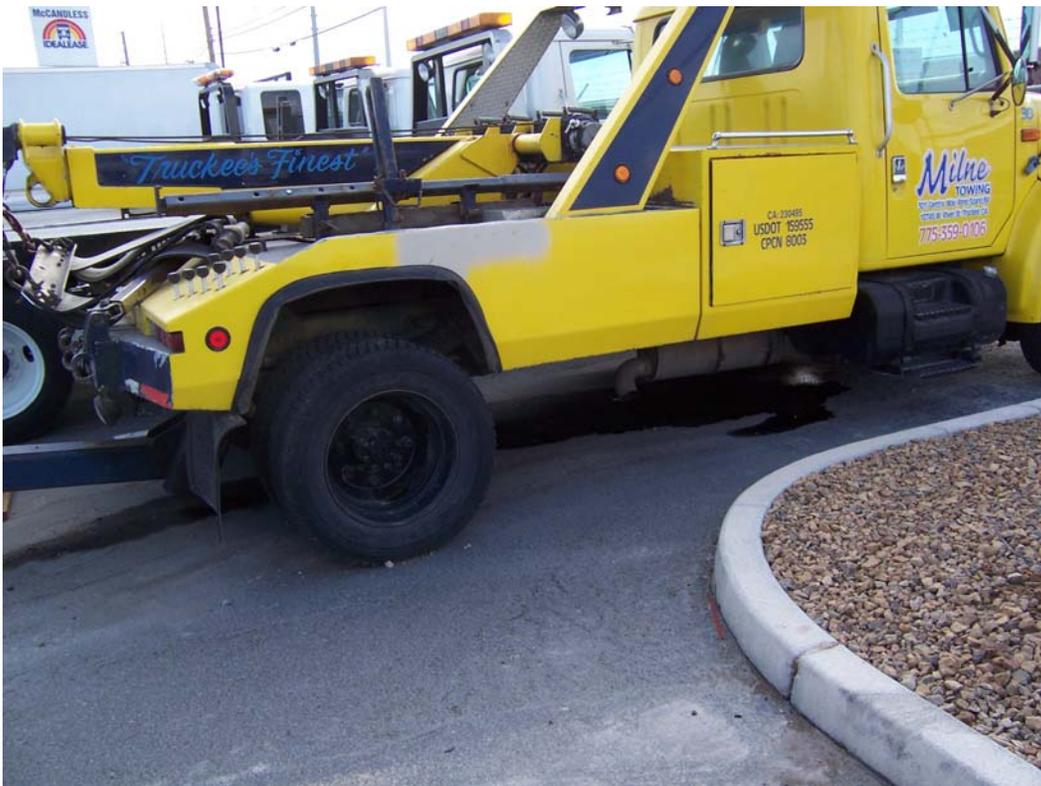
Photo 2. Oil leaking under tow truck stored in the parking area.

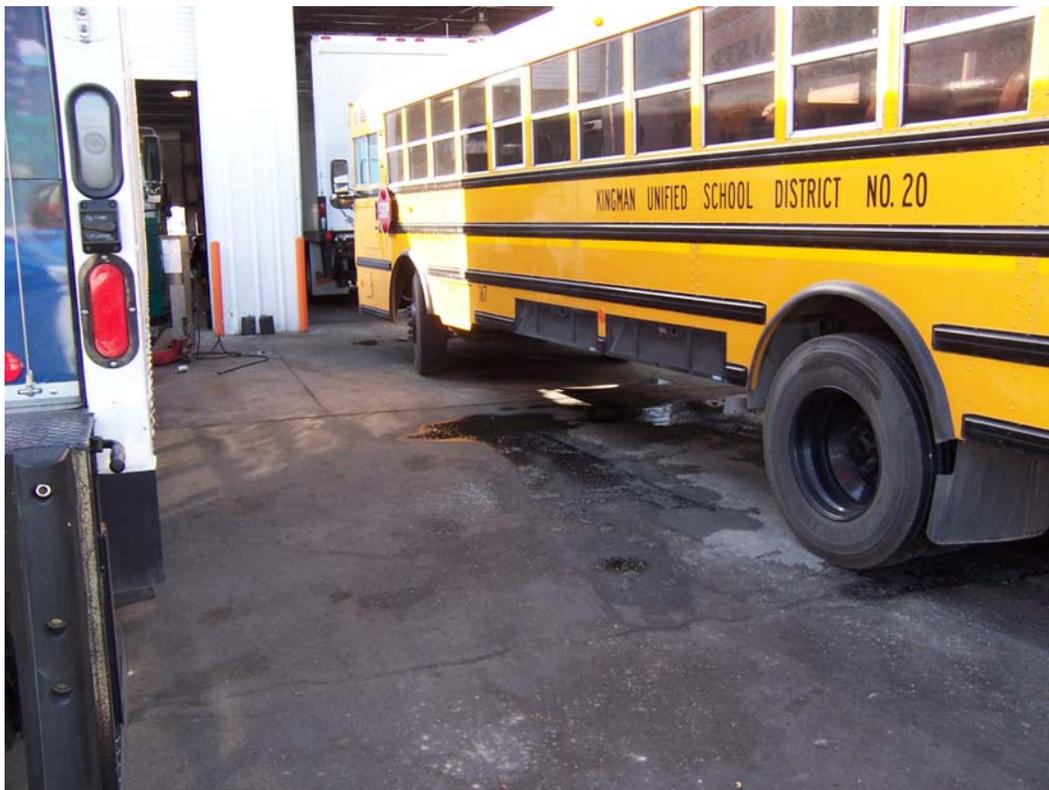
Photo 3. Apparent leakage under bus being maintained outside of shop area.

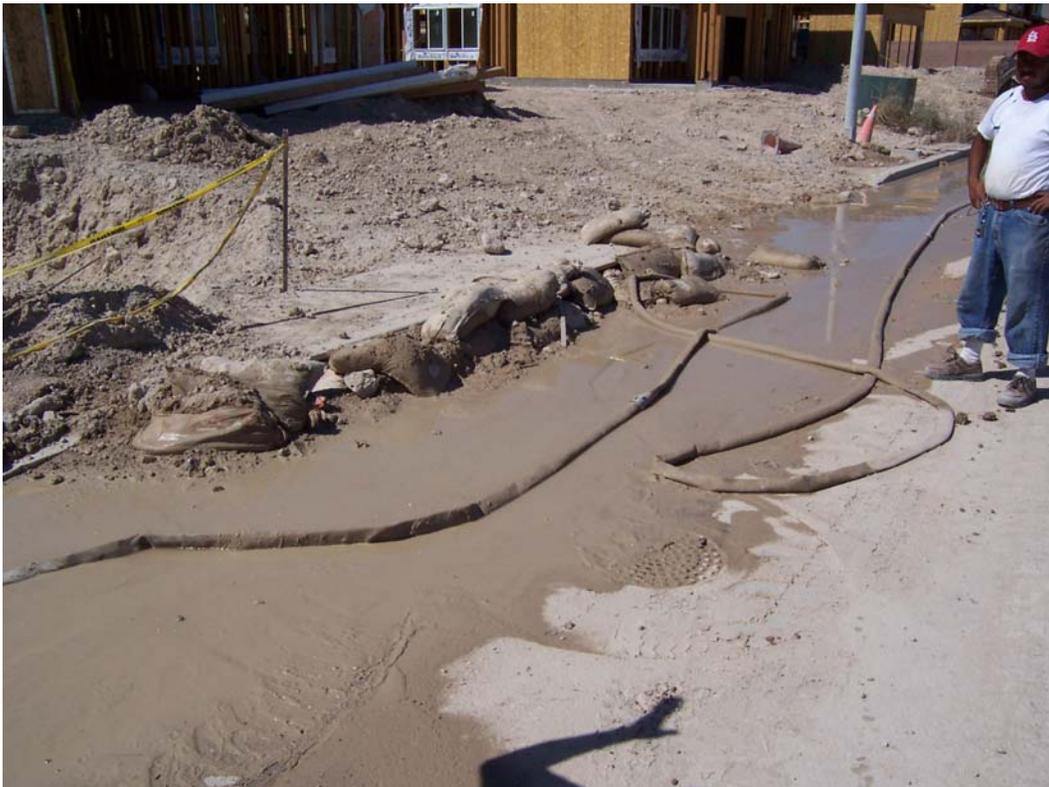
Photo 2. Storm inlet at the site. Sediment is also entering the storm sewer through the pick hole in the manhole in front of the inlet. Hose in the photo is the fire hose the site had been using to clean the street. Note poor condition of sand bags used for inlet protection and dirt extending past curb line.

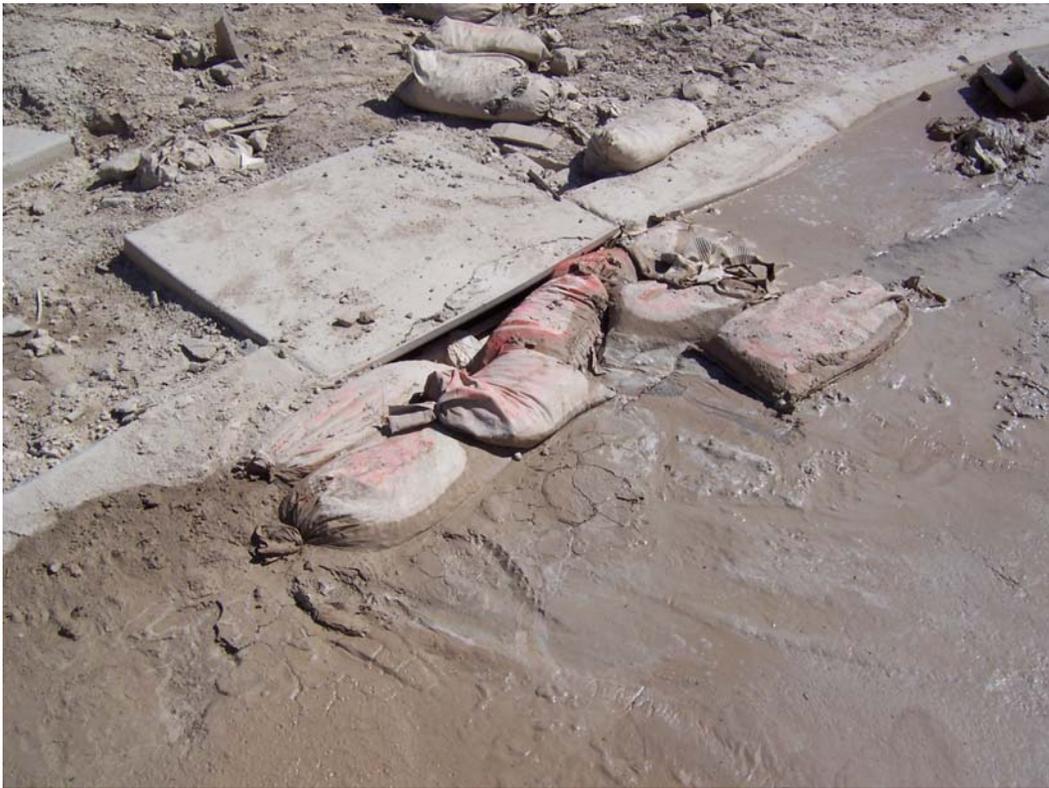
Photo 3. Different storm inlet at the site. Separation between sand bag at the right and curb allows sediment to enter the inlet.

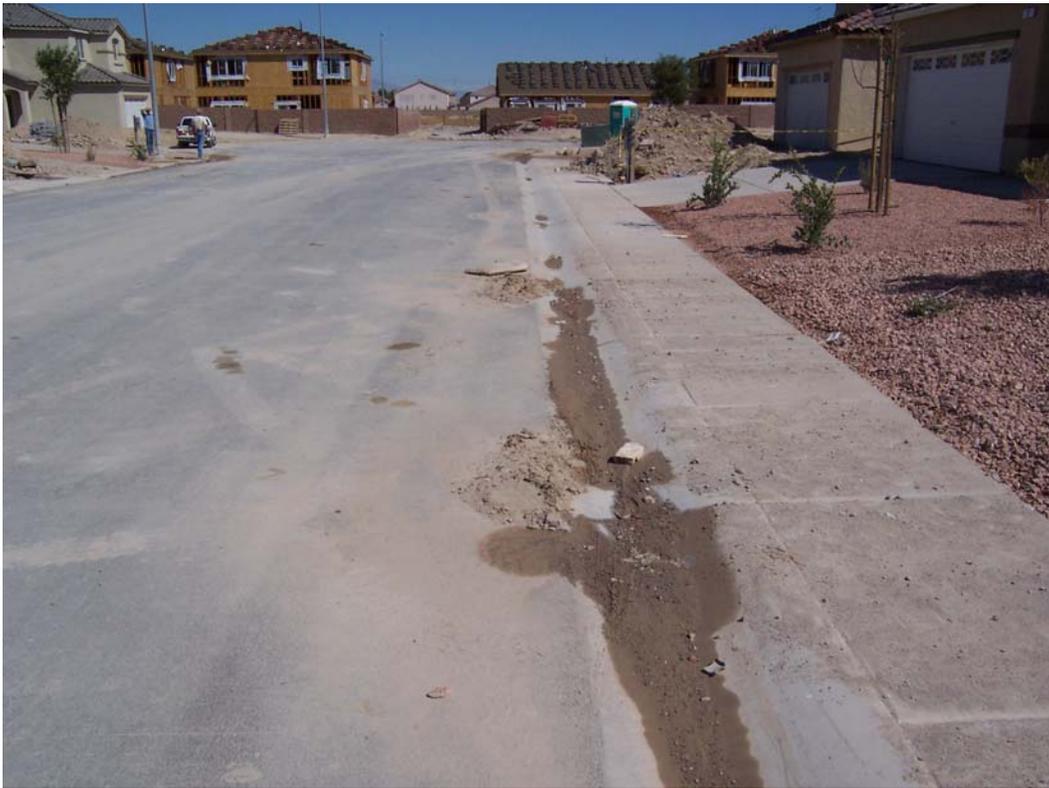
Photo 5. Sediment in the street. Moisture indicates street was washed earlier in the day. Note sand bag, center rear of photo, pulled back from the curb.

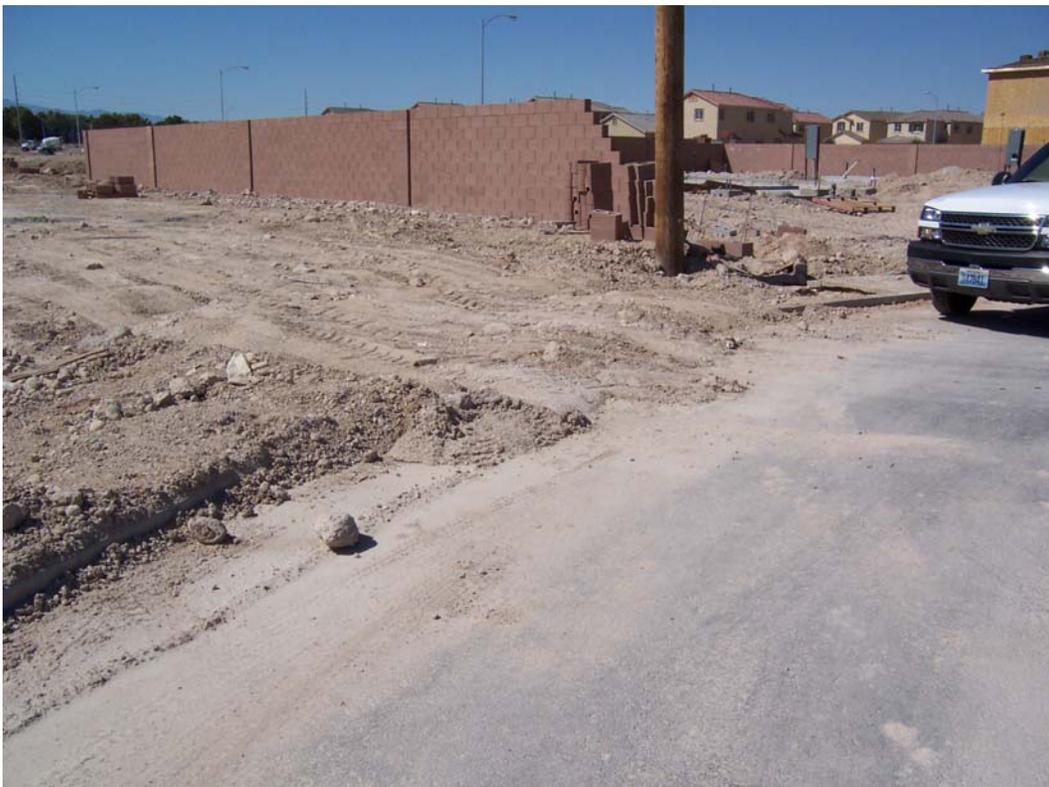
Photo 6. Absence of trackout controls at a site entrance. Note dirt extended past curb line into the street.

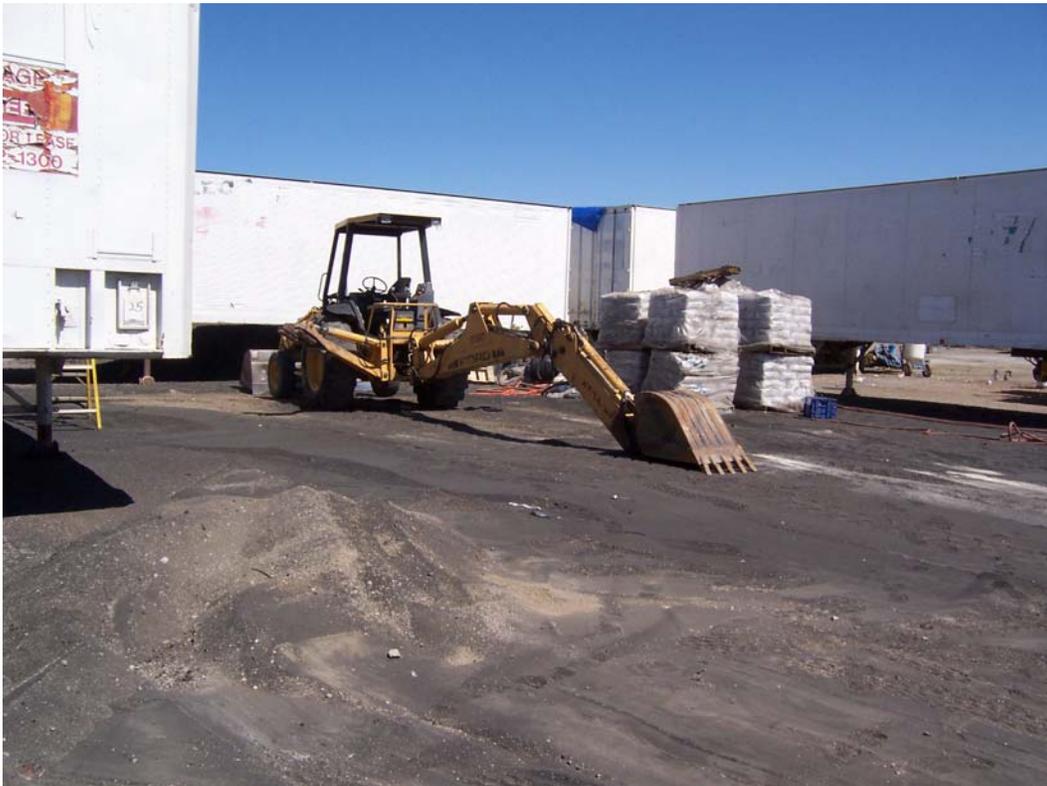
Photo 1. Open air sand blasting activity at the site. Dark material around the backhoe being sand blasted is spent sand blast grit. White bags on pallets at photo right are additional unused grit. No containment was provided around the area.

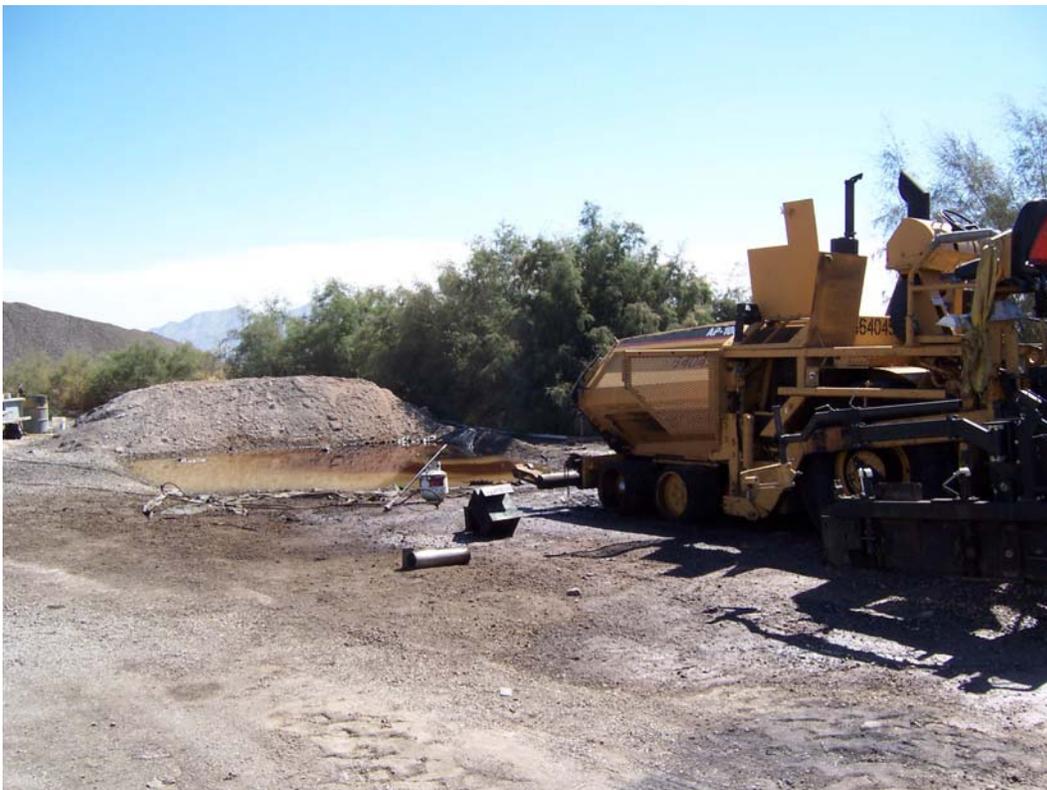
5. A pit had been dug at the site to receive wash water from an equipment cleaning operation that had been set up. The pit contained contaminated, oily water from the cleaning operation. Although a plastic liner had been placed in the pit, the area where equipment was being cleaned was not lined. The soil in this area was heavily stained with oil.

Photo 4. Paving machine being cleaned with wash water discharged to the pit shown in Photo 3. Note oil stains on the ground in front of and around the machine.

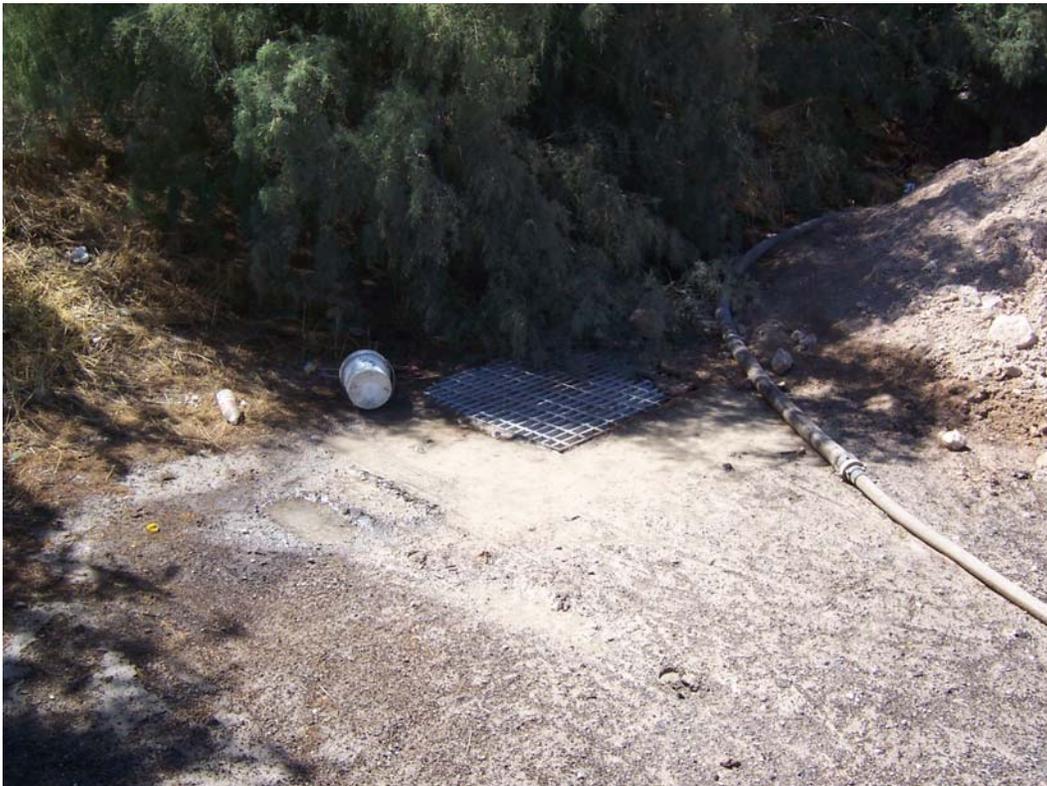
6. Contaminated water from the site was entering an inlet at the site. The discharge from this inlet went to Dehli Avenue, where it entered a storm sewer inlet.

Photo 5. Storm inlet located behind the pile of dirt shown in Photos 3 and 4. Note contaminated runoff from the site entering the inlet.

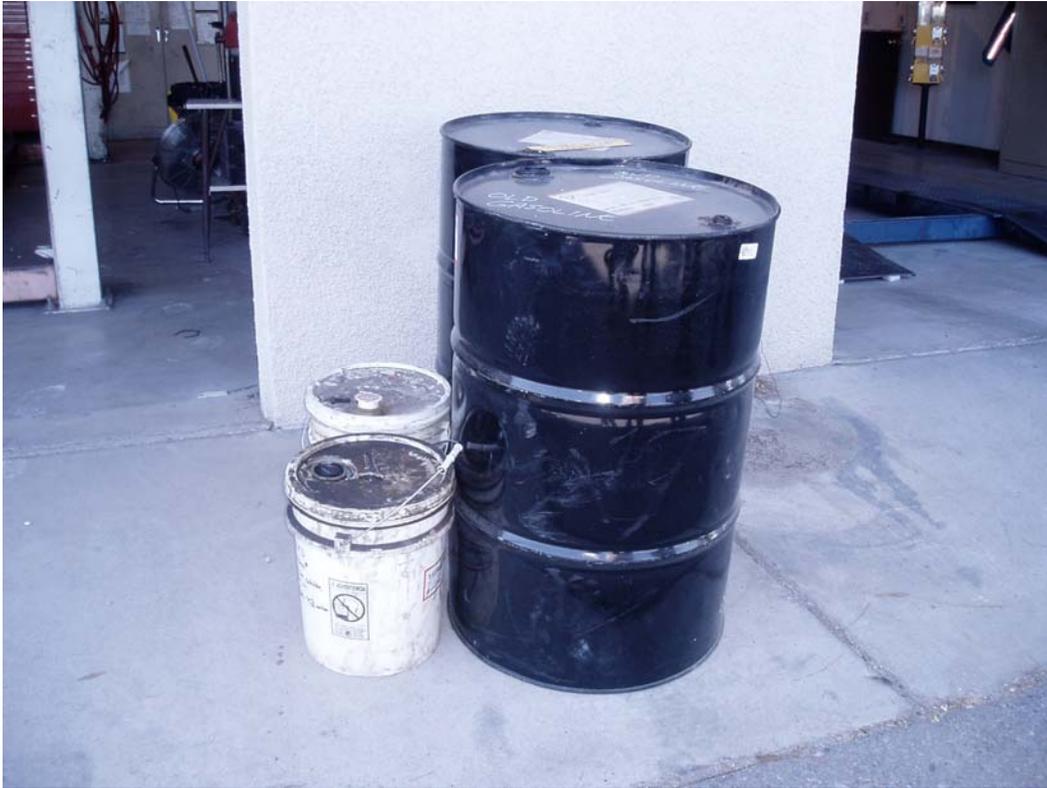
1. Self-inspections of the municipal facilities are not occurring.
2. Containers of used oil were observed outside without secondary containment.
3. The site was clean and well-maintained.

Photo 1. Two 55-gallon drums of used gasoline and two smaller buckets located outside the garage and without secondary containment.

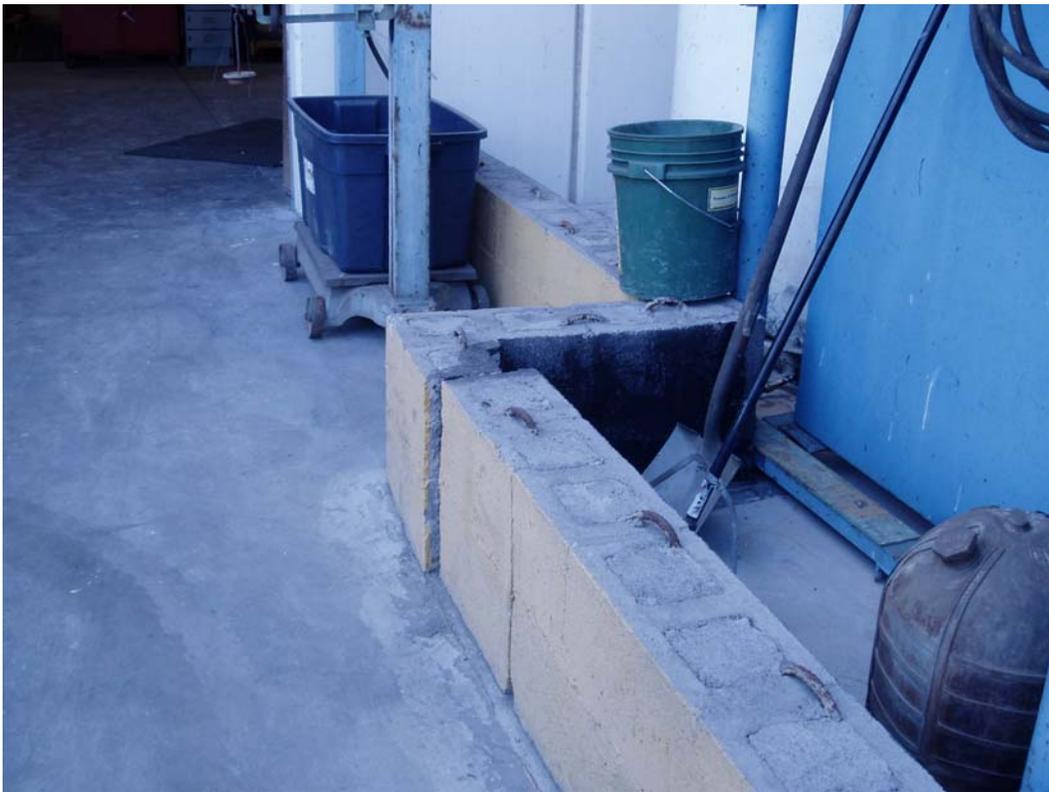
Photo 1. Crack in secondary containment.

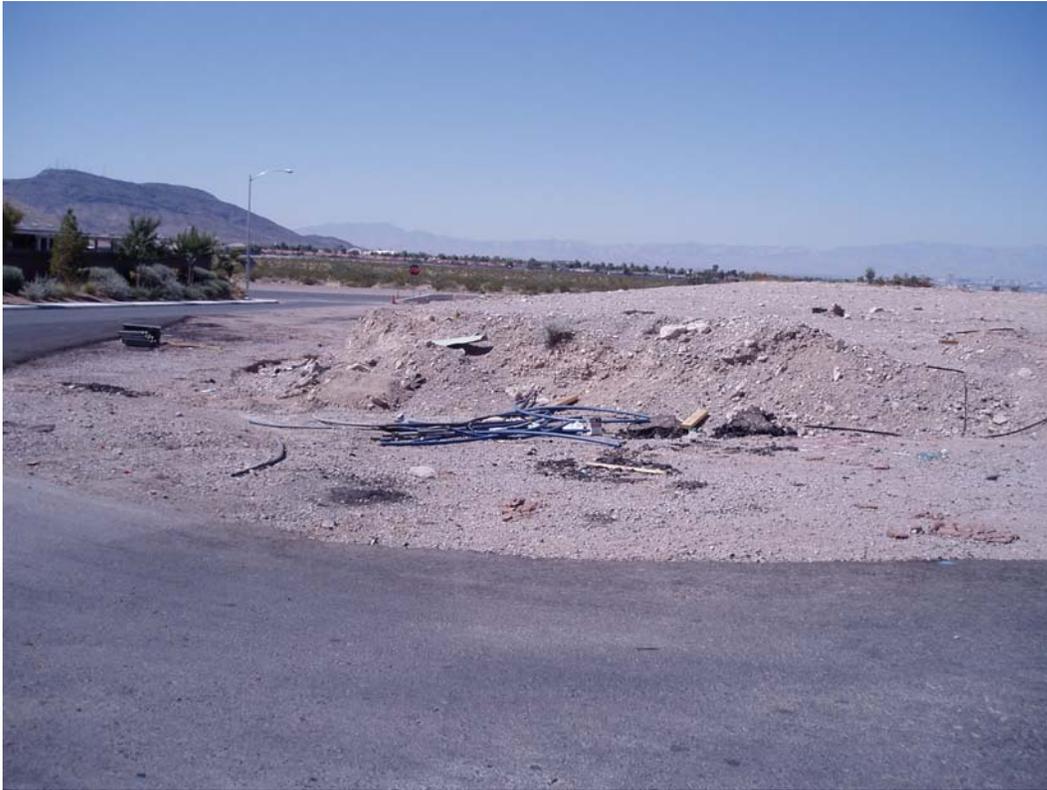
Photo 1. Debris at construction site entrance.
