DOCUMENTATION OF ENVIRONMENTAL INDICATOR DETERMINATION

**RCRA Corrective Action
Environmental Indicator (EI) RCRIS code (CA750)
Migration of Contaminated Groundwater Under Control**

Facility Name: Maine Yankee Atomic Power Company
Facility Address: 321 Old Ferry Road Wiscasset, Maine
Facility EPA ID #: MED 071 749 329

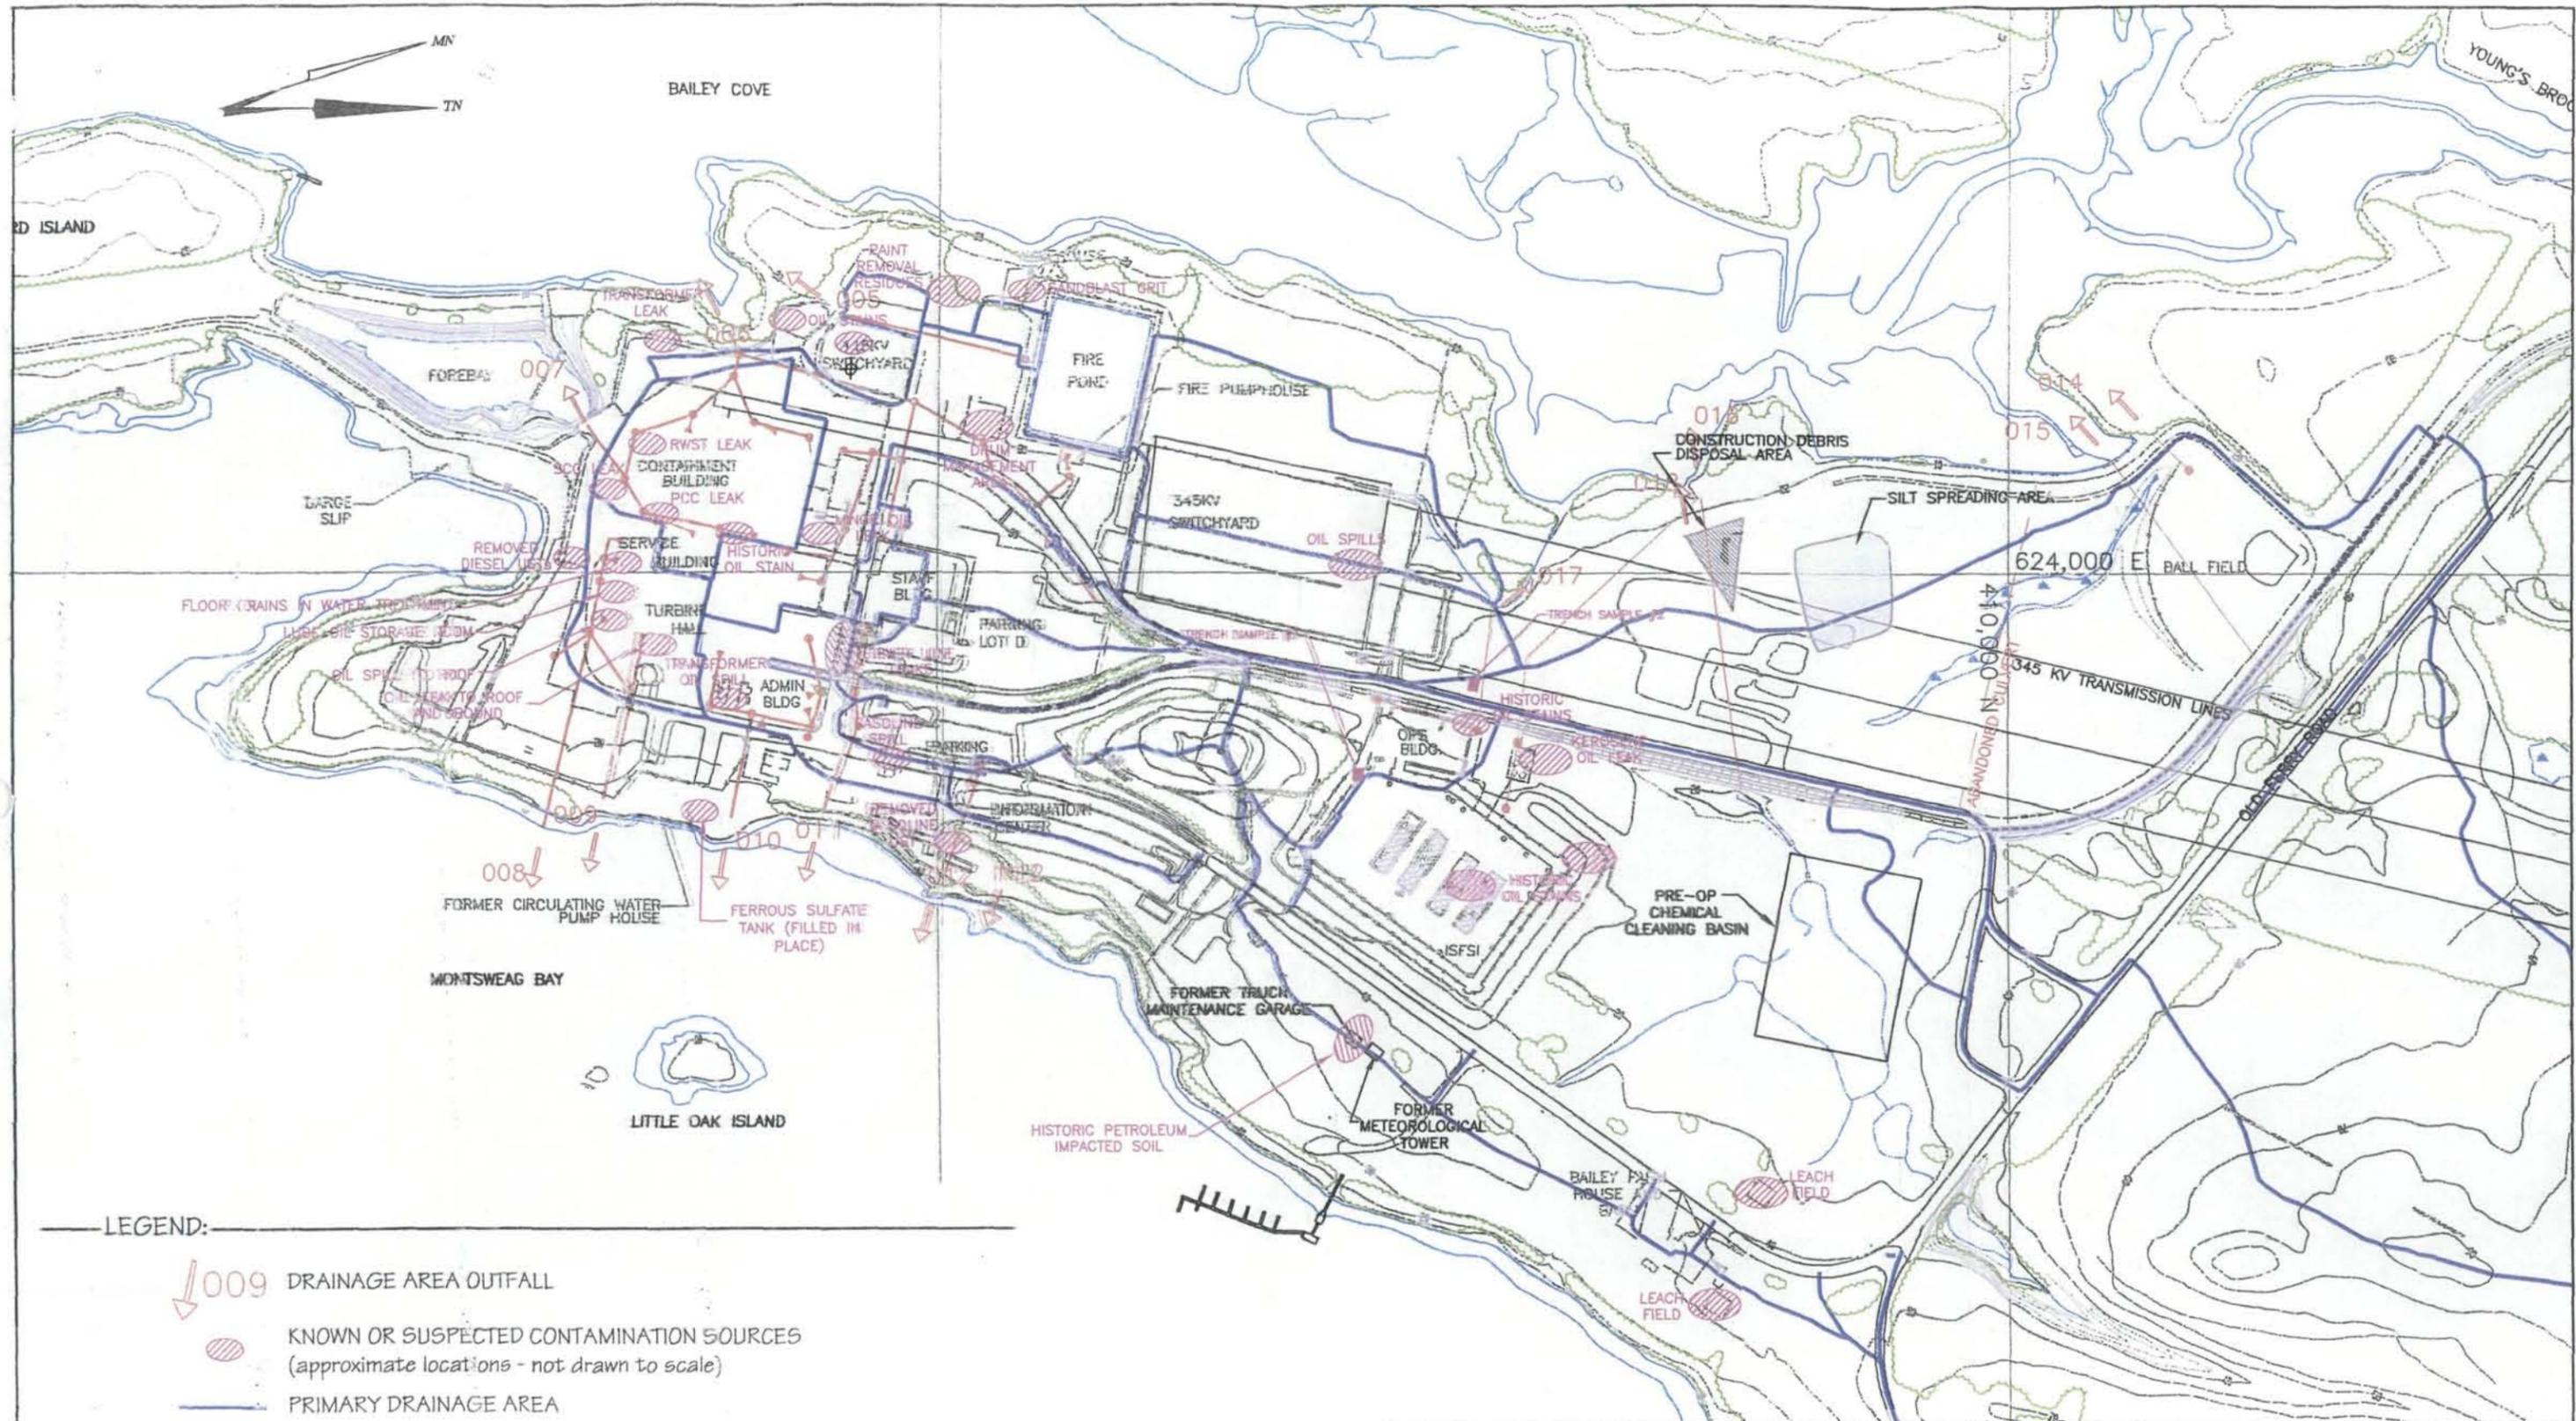
Groundwater in the Industrial and Radiological Restricted Areas (RA) which is the southern portion of the site, contains sodium concentrations that exceed Project Action Levels (PALs), most likely as a result of saltwater intrusion, operational dosing of seawater used as cooling water, a late 1980s sodium chromate leak, and winter salt application on site roadways. Groundwater in the Industrial and Radiological Restricted Areas contains DRO concentrations ranging from 100 to 500 ppm with a maximum of 581 ppm, most likely as a result of historical petroleum releases, former USTs and other non-point sources such as vehicles and equipment.

Dieldrin was found in several bedrock wells in and near the RA in concentrations exceeding the PALs with maximum of 0.11 ppb, most likely from placement of contaminated fill during construction. Groundwater east and south of Warehouse 2/3 contains Trichloroethane (535 ppb) and related chlorinated daughter products that exceed PALs (240 to 190ppb), most likely as a result of solvent leakage from drum storage and management activities. Groundwater west of Warehouse 2/3 contains Benzene (3.7 ppb), Toluene (2 ppb), Ethylbenzene (160 ppb) , Xylenes (170 ppb) or BTEX compounds. Some paint related metals were also detected around Warehouse 2/3.

For the northern portion of the site, groundwater beneath the dredge spoil disposal area north of the ISFSI and the 345 kV Switchyard contains elevated metals, including boron with maximum of 245 ppm, sodium 428 ppm, iron at 543 ppm and manganese at 418 ppm concentrations that exceed the PALs established for the site. These levels were most likely a result of the historic filling of the marsh area with marine sediments. Groundwater in most of the wells north of the former staff building which as the site high point is commonly referred to as the knoll and contains DRO and EPH concentrations in excess of MEGs, most likely as a result of the kerosene and historical petroleum spills discovered within Study Area 4 (ISFSI), pre-operational features such as the Former Truck Maintenance Garage, and miscellaneous sources within the marine sediment/construction debris disposal area north of the 345 kV Switchyard.

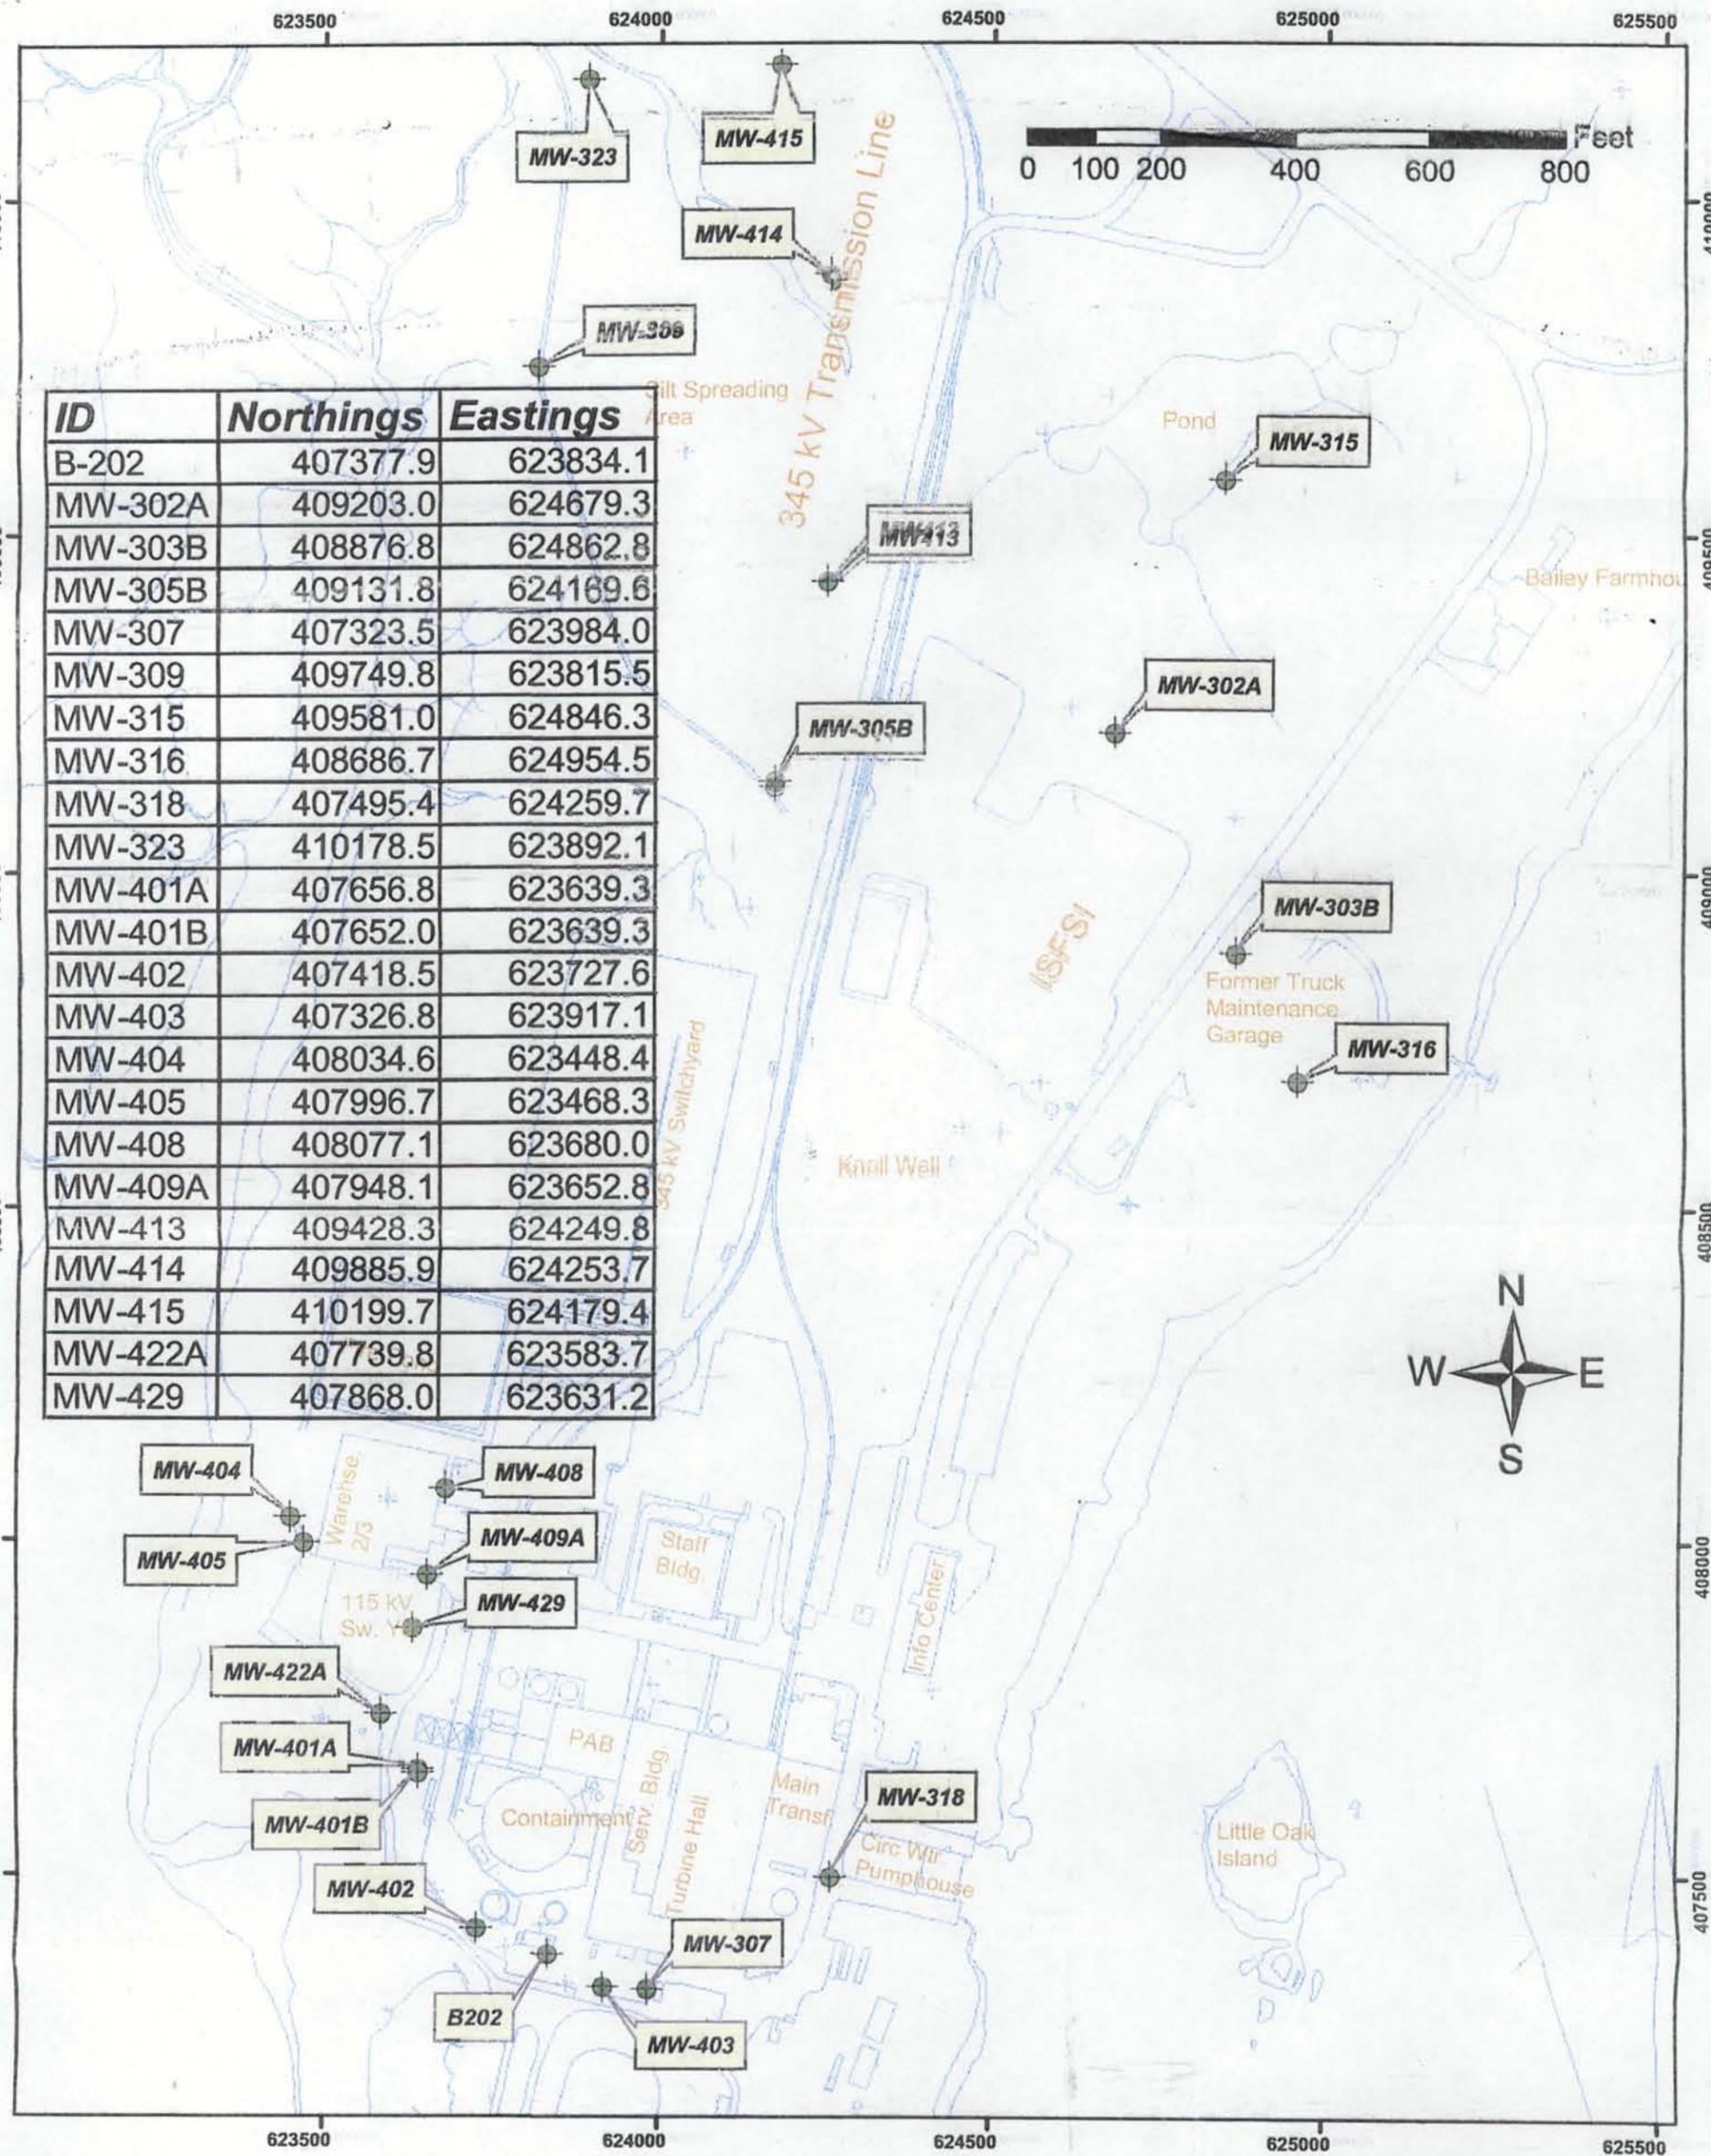
Rationale and Reference(s): Most of the groundwater on the Bailey Point site that exceeds MEGs is in low permeability clay-silt or in fractured bedrock. Furthermore, some of the chemicals that exceed MEGs are being continually generated (e.g., the manganese under the 345 kV lines due to filling of dredge spoils over a former salt-marsh). Therefore, most of the groundwater under Bailey Point that has been negatively affected by site activities and are difficult to actively remediate through any reasonable means. Many of the contaminants, however, will be reduced over time by flushing from the system and normal biodegradation processes. Long-term groundwater monitoring will continue to characterize current site conditions and then evaluate changes, if any, in groundwater quality through time. Groundwater impacts for the entire site are summarized in Table 5-13. Twenty three monitoring wells will be monitored over the next three to eight years at a minimum. See Figure G-1 for well locations.

The long-term groundwater monitoring plan includes an initial three year period of quarterly groundwater sampling. This initial portion of the long-term monitoring plan would be used to establish baseline conditions. Following completion of the baseline program, sampling would be conducted three times per year (“tri-annual”) every five years. In years 29 and 30 of the monitoring program, all wells still in the program would be sampled three times each year. This thirty year monitoring program will allow the Department to maintain a reasonable oversight role while determining if the site contaminants are decreasing or increasing over time. With time, reasonable modifications to wells or parameters to be maintained could be made every five years that are appropriate for the site. Wells could be eliminated after sufficient documentation is gathered to demonstrate that contaminants are no longer present.
