**WEDGEWIRE SCREEN SITE-SPECIFIC STUDY  
ENGINEERING EVALUATION**

**GSP SCHILLER LLC – SCHILLER STATION  
PORTSMOUTH, NEW HAMPSHIRE**

**Submitted by:**  
Enercon Services, Inc.  
7677 Oakport Street, #950  
Oakland, CA 94621  
**July 28, 2020**

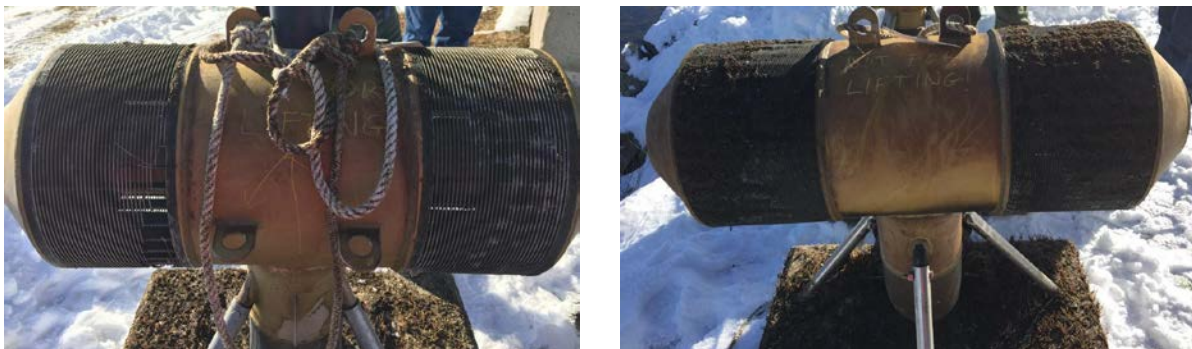
**Figure 2: Post-Testing Wedgewire Screen Conditions (Left: 3.0 mm Pilot Wedgewire Screen, Right: 0.8 mm Pilot Wedgewire Screen, Note: Images Do Not Reflect In-Water Fouling Conditions Due to Material Removed During Retrieval)**

Following the conclusion of the testing period, the pilot wedgewire screens were found to be in an ineffective condition due to a significant amount of damage and fouling. Detailed condition findings from during and following the testing period are provided in Addendums C through E. The variable tidal patterns, ambient water quality, submerged debris and high velocity sweeping river flow resulted in both pilot wedgewire screens developing relatively large openings. Additionally, the conditions in the Piscataqua River led to the clogging of a large surface area by siltation and biogrowth. A summary of the conditions is provided in Table 8. An image of each pilot wedgewire screen after retrieval is provided in Figure 2. Note that a significant amount of fouling material was incidentally removed during retrieval of the screens. Regions of dark discoloration on the screens indicate locations of accumulated fouling deposits present during the pilot study. Underwater imagery showing the amount of fouling present on the screens during the pilot tests are provided in Addendums C through E.

| Screen | Final Proportion of Screening Area Damaged | Estimated Flow Through Final Damaged Area | Width of Largest Damage Opening | Peak Proportion of Screening Area Clogged |
|---|---|---|---|---|
| 3.0 mm | 15.5% | 23% | 2.5 inch | 21% |
| 0.8 mm | 19.25% | 44.5% | 3.5 inch | 36% |

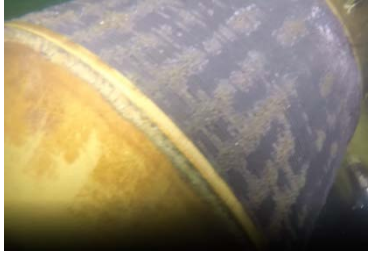
| Upstream Shoreside | | |

A significant amount of fouling was observed during the inspection on October 1, 2019. This inspection was scheduled to [REDACTED] From the imagery captured during the inspection, [REDACTED] [REDACTED] A significant amount of fouling remained between the wedgewire screen through slot openings [REDACTED] Furthermore, damage to the 0.8 mm screen occurred on the river facing side. It is uncertain what might have caused the damage.

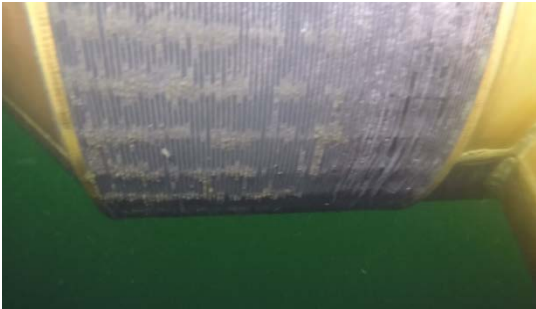
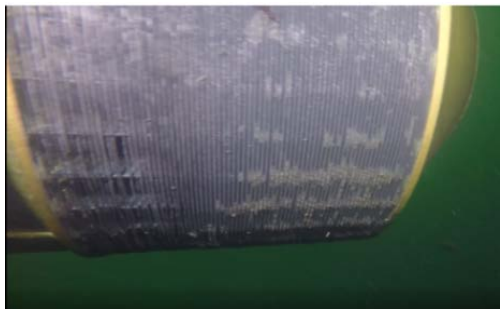
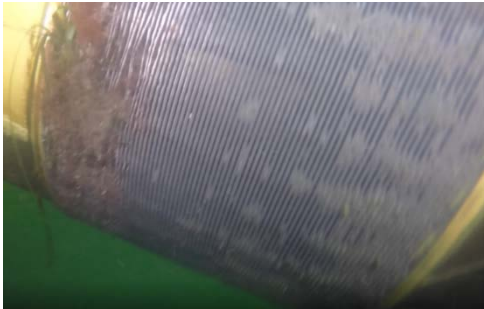
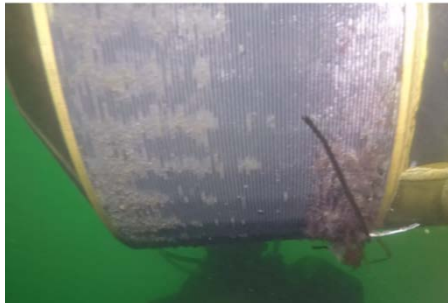
**Table C-6: 0.8 mm Slot Width Wedgewire Screen Damage Imagery  
 (October 1, 2019 Inspection)**

Images of the damaged subsections of the 0.8 mm wedgewire screen are provided in Table C-6. No equivalent or comparative images of the 3.0 mm wedgewire screen are provided due to the

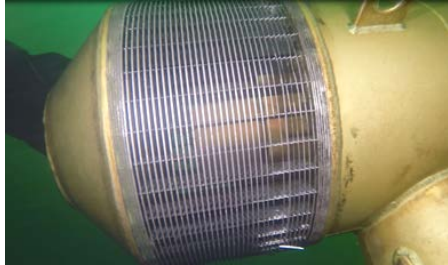
| October 1, 2019 | December 7, 2019 |
|---|---|
| Upstream 3.0 mm Wedgewire Screen Riverbed Facing Damage | |

The inspection on December 7, 2019 observed major damage to both the 3.0 mm and 0.8 mm screens on the riverbed facing sides. During the previous inspection in October inspection, the 3.0 mm screen did not have any damaged areas. The December inspection observed the development of damaged area on the 3.0 mm screen. The 3.0 mm screen damaged area had widened through slots approximately  $\frac{3}{4}$  in. wide, which increased the percentage of total surface area damaged from 0% to 5.5%. During the October inspection, the damage on the 0.8 mm screens was minor with a few of the through slots being widened to approximately 3.0 mm in width. The damage observed during the December dive inspection revealed a severe increase, including entire sections of the radial rings missing. The smallest damaged opening observed during this December inspection was approximately  $\frac{3}{4}$  in. wide and the largest damaged opening was approximately two inches wide on the 0.8 mm screen. For the 0.8 mm screen, the total surface area damage increased from 4% to 10.25% of total surface area damaged.

| October 1, 2019 | December 7, 2019 |
|---|---|
| No damage was observed on the 3.0 mm screens during the October inspection. | |

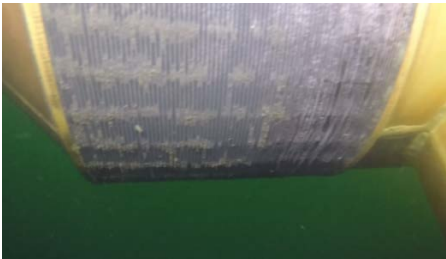
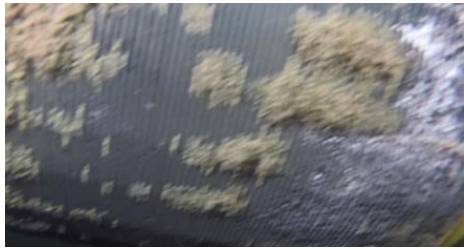
| October 1, 2019 | December 7, 2019 |
|---|---|
| Upstream 0.8 mm Wedgewire Screen Riverbed Facing Damage | |

[REDACTED] The imagery shows major damage to the riverbed facing sides and increased fouling on the 0.8 mm screen.

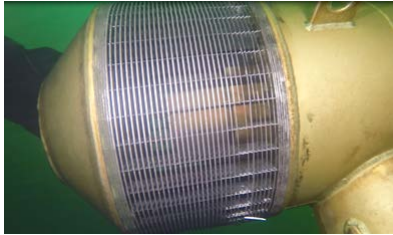
| October 1, 2019 | December 7, 2019 | On Shore January 23, 2020 |
|---|---|---|
| Upstream 3.0 mm Wedgewire Screen River Facing Damage | | |

The methodology used for calculating the damaged surface area is similar to the methodology used for calculating the clogged surface area as described in Section C.3 of Addendum C. The proportion of damaged surface area of the 3.0 mm screen increased to 15.5%. The proportion of damaged surface area of the 0.8 mm screen at the conclusion of the testing period increased to 19.25%. The damage is localized on the riverbed facing sides but increased in severity with large portions of the screens missing. The damaged areas measure as wide as 2.5 in. on the 3.0 mm screens and as wide as 3.5 in. on the 0.8 mm screens. Table E-8 shows imagery of the screens compared alongside a measuring tape. With the amount of damage, the screens have a decreased entrainment reduction effectiveness. Table E-1 details the damaged surface area of the screens at the conclusion of the study period. Due to the size of the damaged portion of the screens, [REDACTED]. This had an effect on the withdrawal profile of the screens. There was a larger proportionate withdrawal flow rate through the damaged areas due to the larger openings. The withdrawal flow rate through the damaged portions on the 3.0 mm screen increased to 23% by the conclusion of the testing period. The withdrawal flow rate through the damaged portions increased on the 0.8 mm screen to 44.5% by the conclusion of the testing period. [REDACTED]
