Municipality/Organization: City of Malden
EPA NPDES Permit Number: MA041046
MADEP Transmittal Number: 041088
**Annual Report Number
& Reporting Period:** No. 1: April 1, 2010-March 31, 2011

NPDES PII Small MS4 General Permit Annual Report

Figure 1 - Dry Weather Inspection/GPS Mapped Areas (4-29-2011)

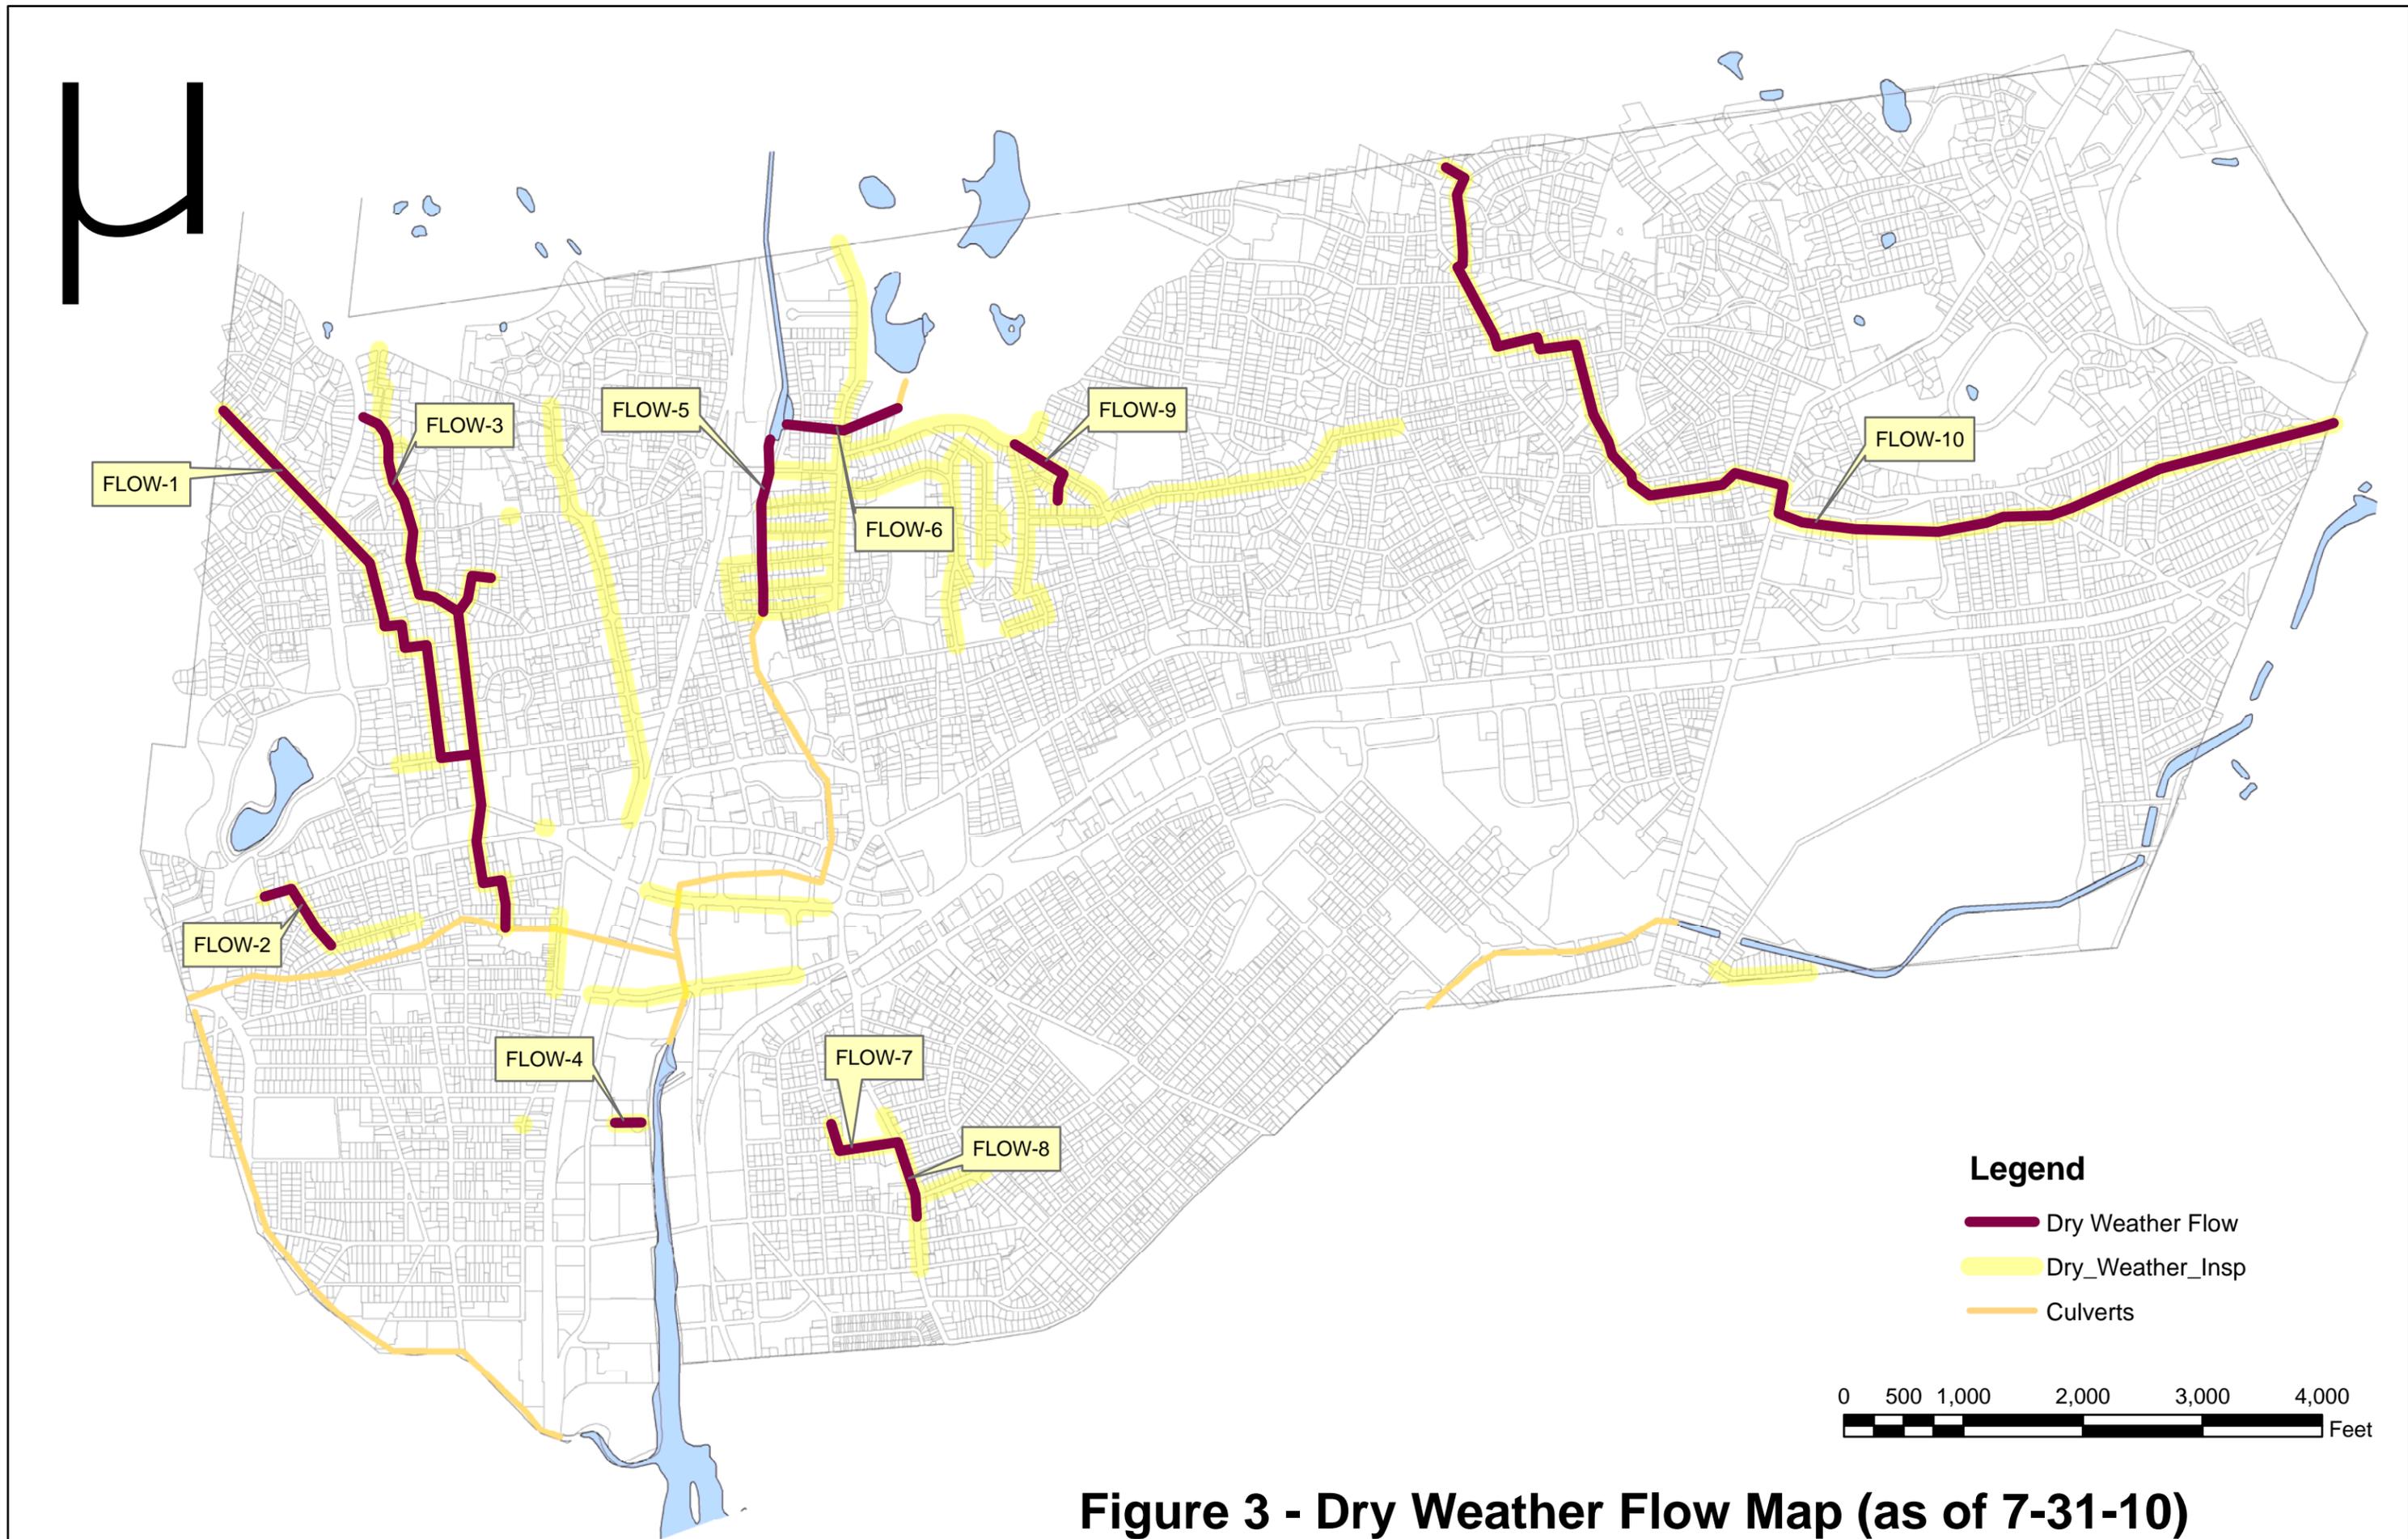
Figure 3 - Dry Weather Flow Map (as of 7-31-10)

weather flows, consisting primarily of waterline leaks and culverted surface waters have been identified. A summary of these dry weather flows within the municipal system that have been identified to date is provided on Figure 3, and are described as follows.

- Flow 1 – City of Medford water line leak (removed).
- Flow 2 – Groundwater breakout near St. Mary’s Street
- Flow 3 – Fellsmere Reservation base flow
- Flow 4 – Malden River surcharge (submerged invert)
- Flow 5 – DCR Spot Pond Brook base flow
- Flow 6 – Base flow, Forestdale-Pine Banks Park
- Flow 7 – Groundwater breakout, illicit discharge (removed 8/09), Flow 8
- Flow 8 – Waterline Leak (under investigation)
- Flow 9 – Groundwater breakout
- Flow 10 – Linden Brook base flow

As shown, with the exception of water line leaks (Flow 1, Flow 8) and the illicit discharge that contributed to Flow 7, the remaining dry weather flows have been determined to be either base flow from culverted surface waters, or groundwater breakout from higher elevations. No illicit discharges were identified within this portion study area during this reporting period during either the targeted or routine (Section 3.2) inspection program.

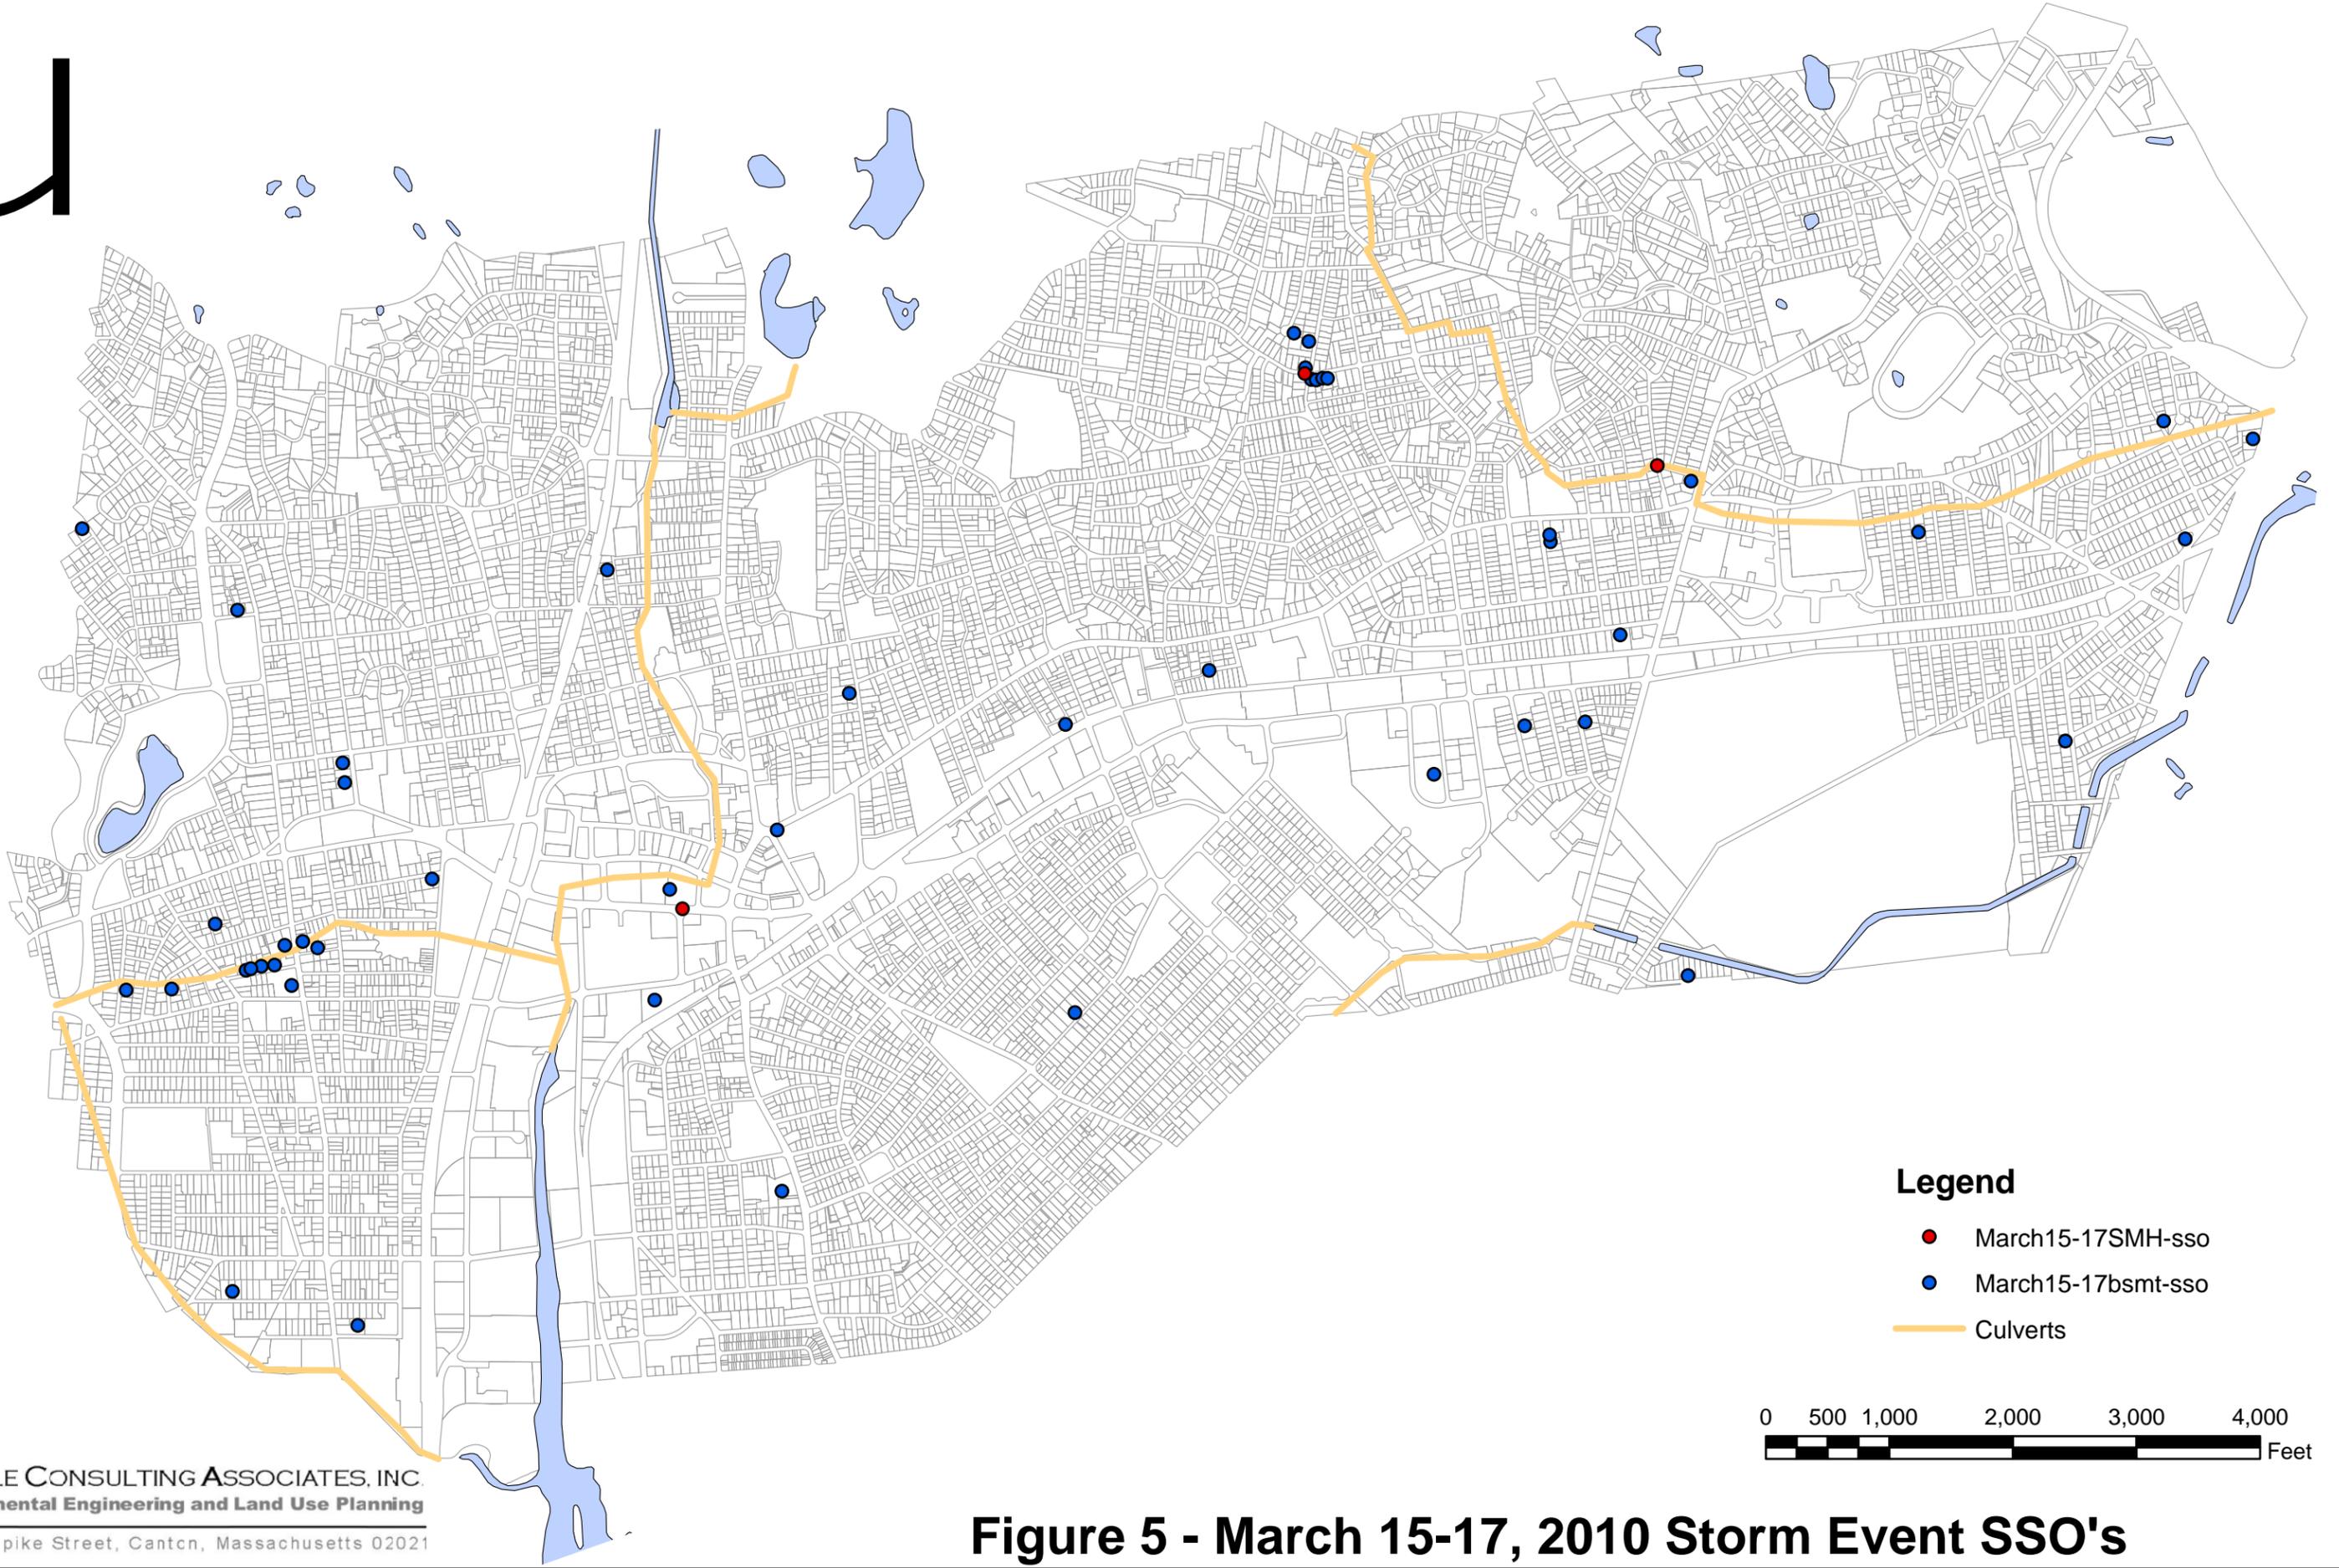
Figure 5 - March 15-17, 2010 Storm Event SSO's

approximate location of basement and sewer manholes where SSO's occurred during the initial storm event that began in mid-March is presented as Figure 5. As shown, numerous SSO's occurred throughout the City, with the highest density of SSO's occurring in central western portions of the City proximate to the West End/Edgeworth Culvert. Previous inspections in this area have revealed that portions of this culvert have exposed earthen walls and pervious wooden bottoms. Accordingly, it is expected that significant exfiltration of culverted flows contributed to the basement flooding/SSO condition. Conversely, the infiltration of bacteria laden groundwater was likely discharged to the Malden during wet weather conditions. Easterly portions of the culvert have been replaced and the results of the inspection program serve to support CIP recommendations to be considered during the next fiscal planning process.
