**Municipality/Organization:** City of Malden  
**EPA NPDES Permit Number:** MA041046  
**MADEP Transmittal Number:** 041088  
**Annual Report Number & Reporting Period:** No. 10: April 1, 2012-March 31, 2013

## NPDES PII Small MS4 General Permit Annual Report

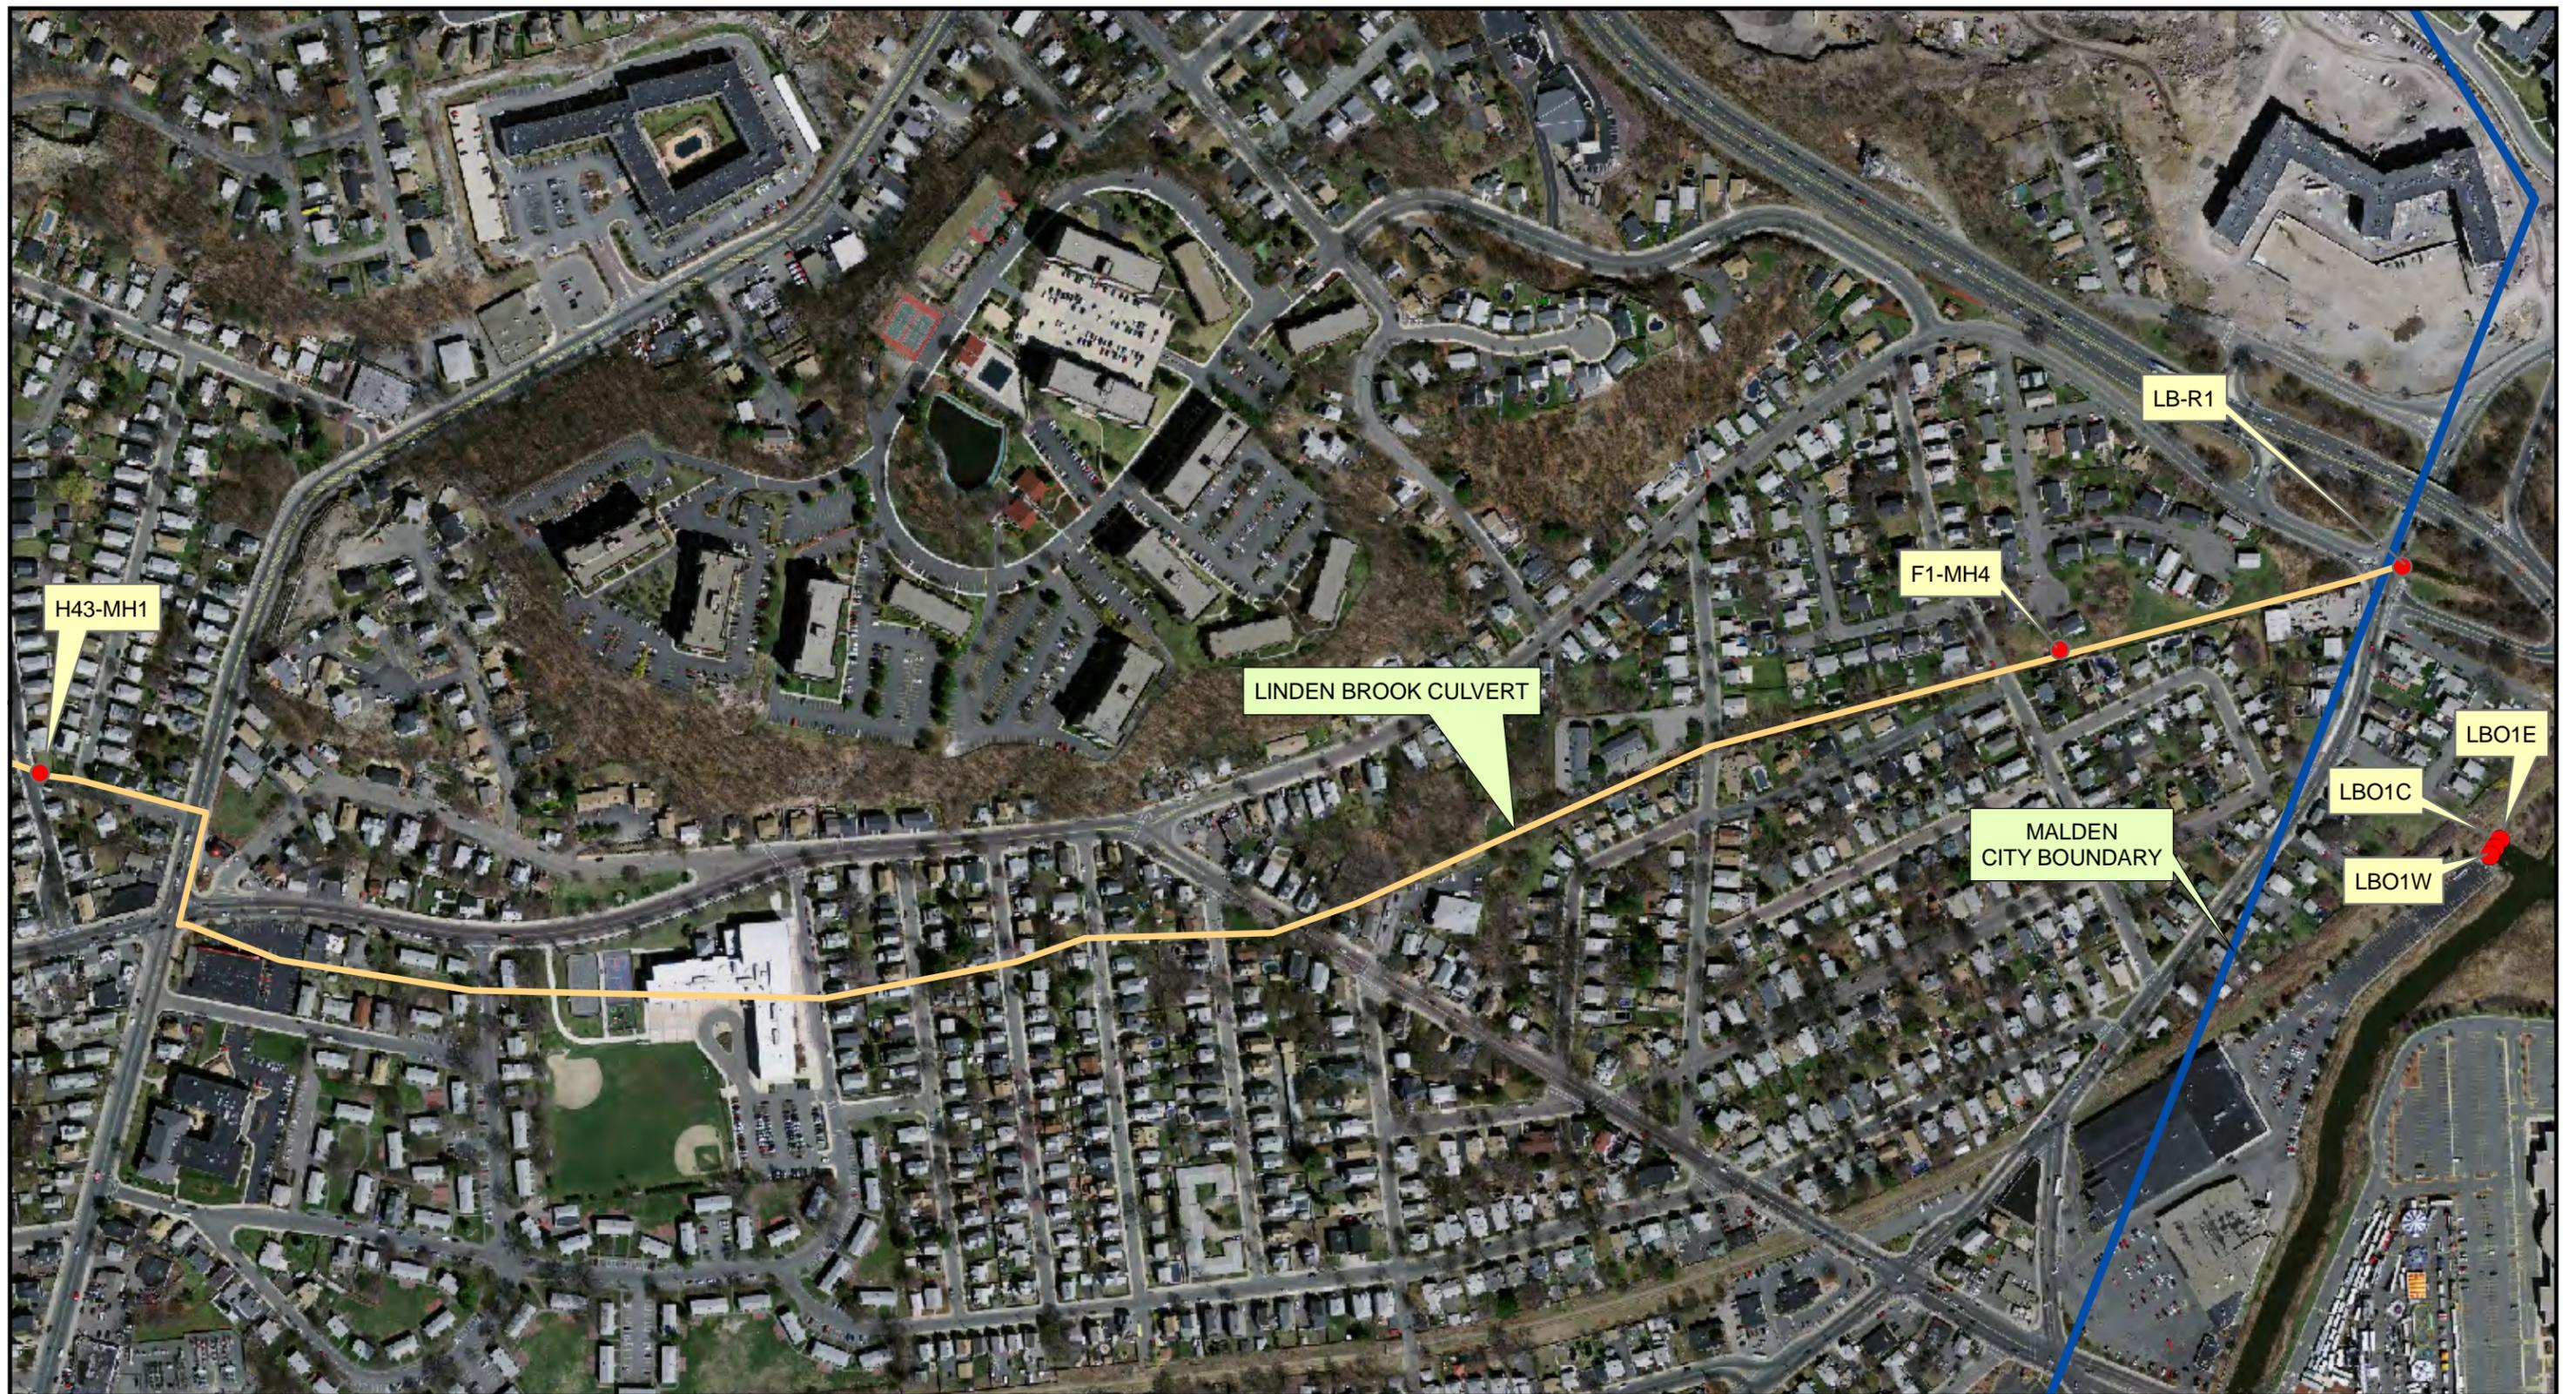
### Figure 1 - September 2012 Dry Weather Sampling Program

During the September 2012 sampling event, representatives of the USEPA collected a water sample from outfall LBR-1, located in Revere, where distinct indications of sewage odors were noted (Figure 1). Consistent with identification of strong sewage odors and immediately apparent from a review of Table 1.0 are the significant levels of all sampling parameters, with the exception of Carbamazepine in sample LBR-1.

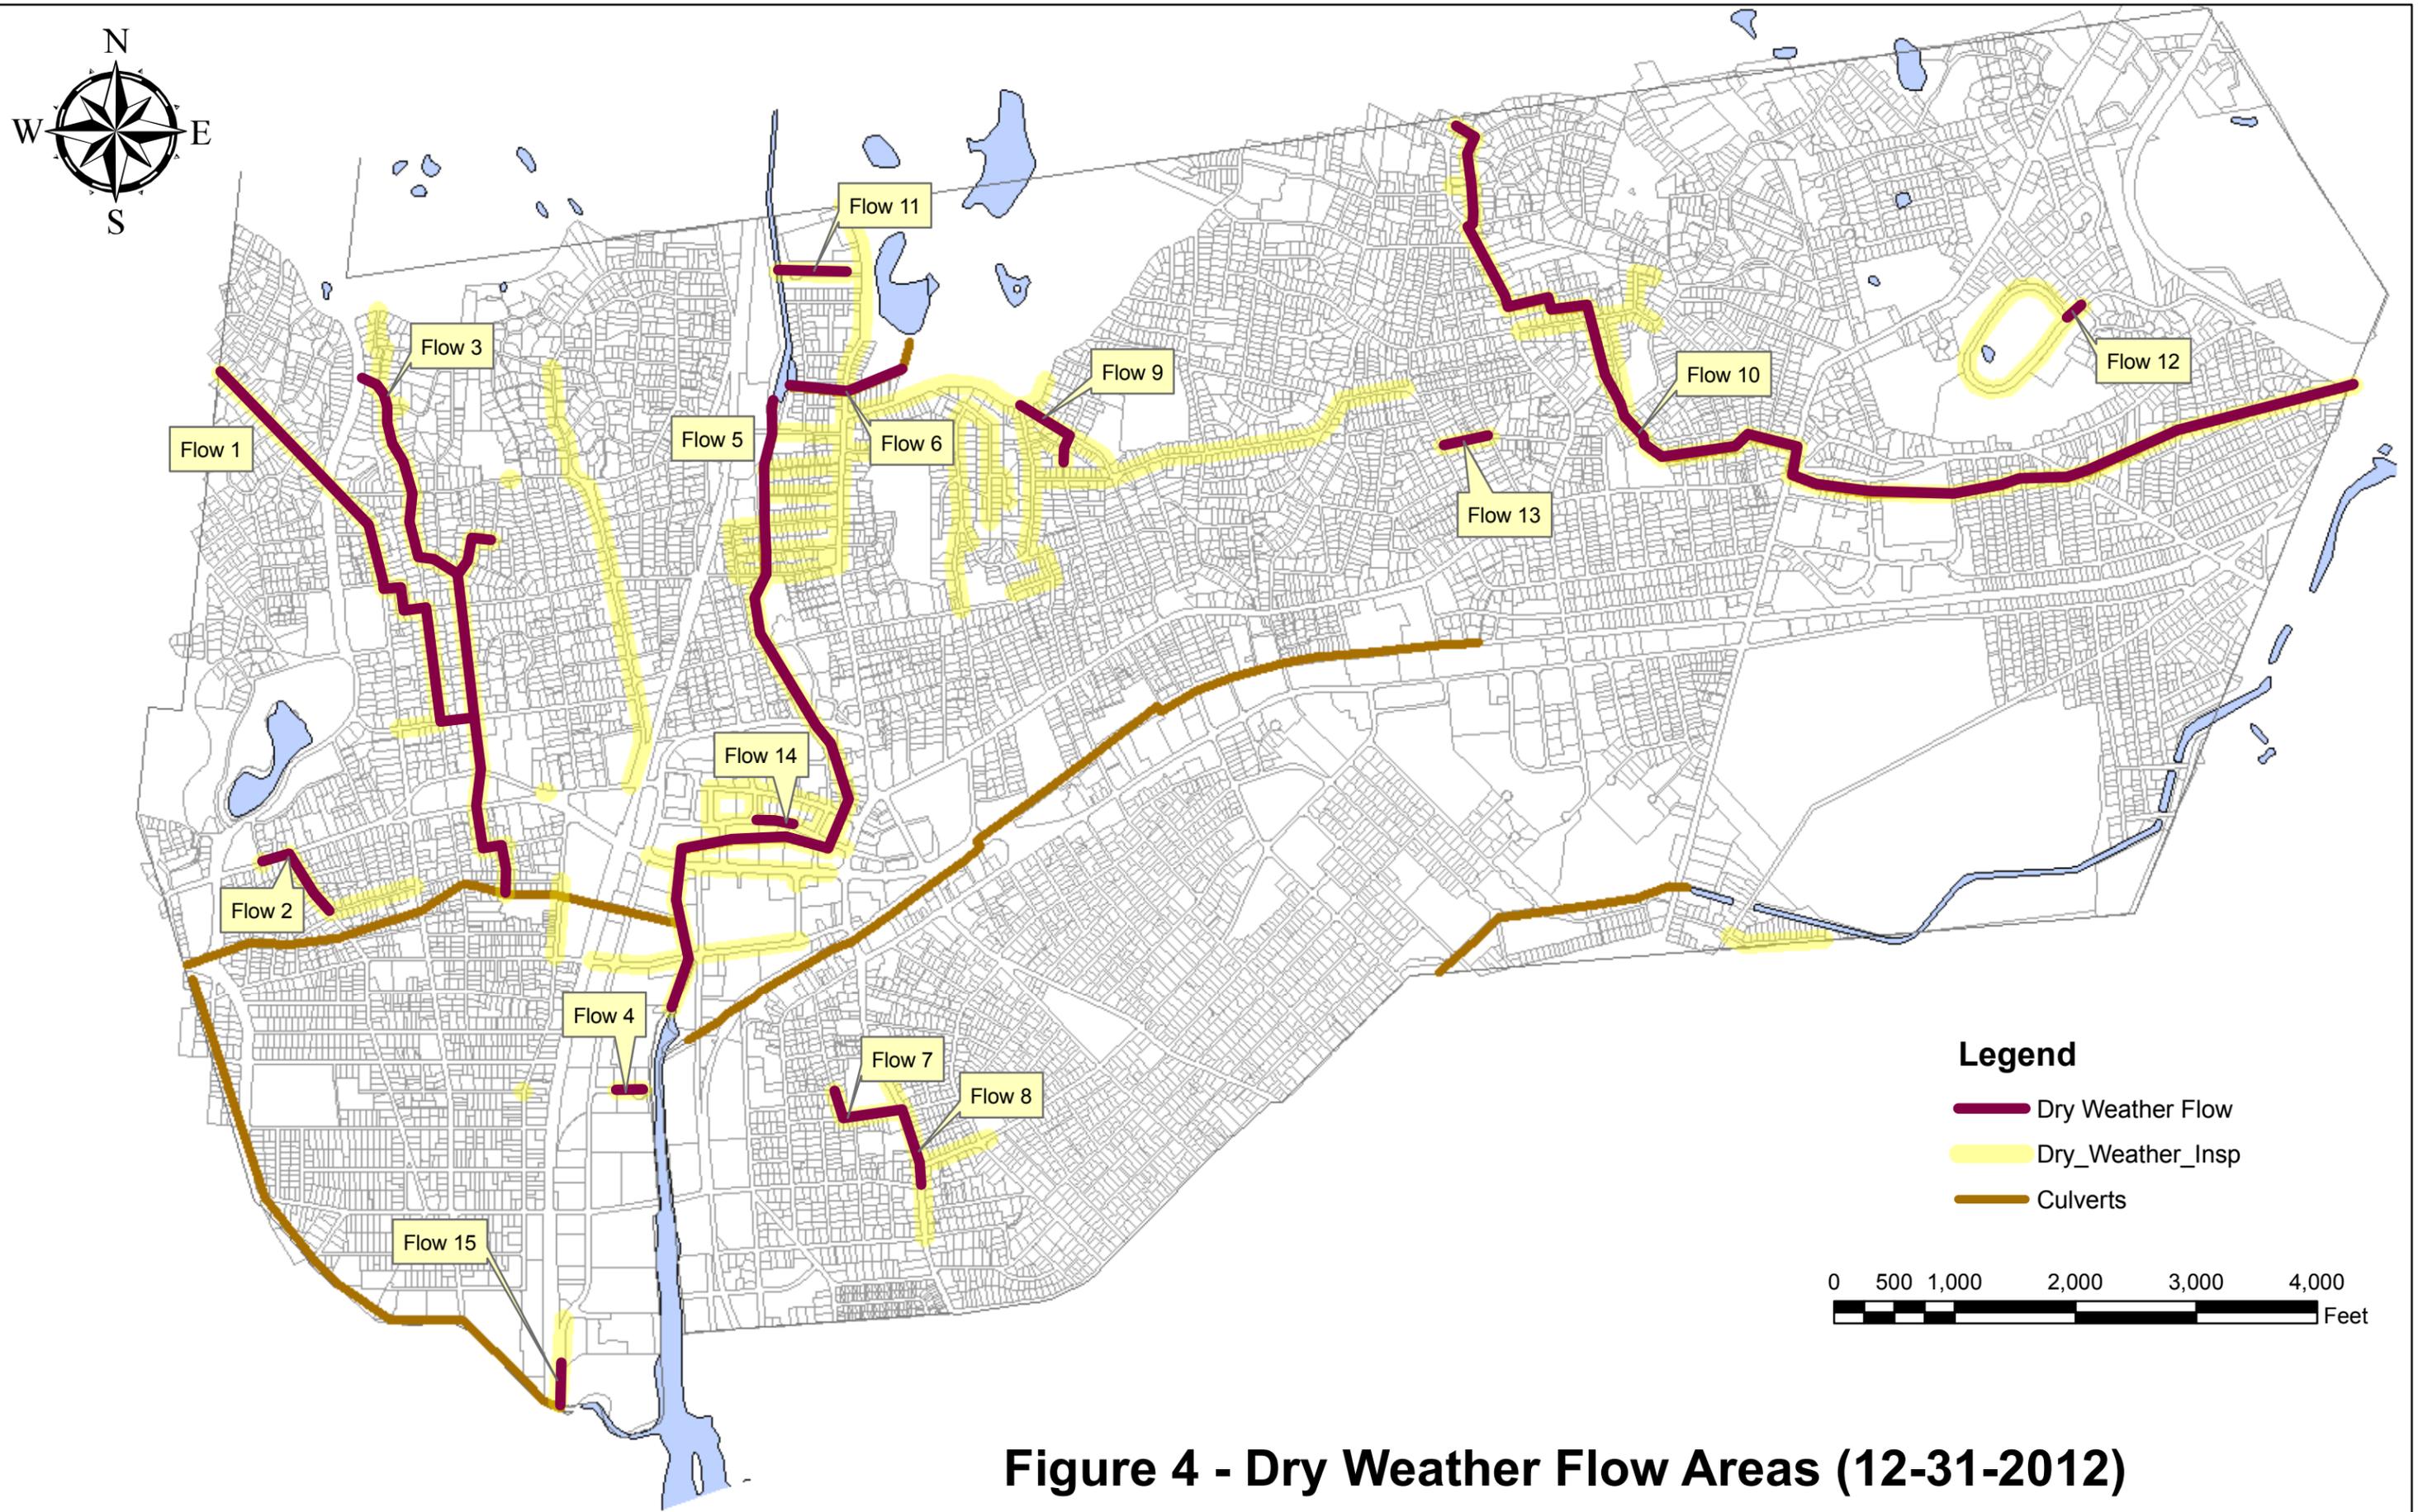
**Figure 4 - Dry Weather Flow Areas (12-31-2012)**

During dry weather inspections completed under the IDDE program, several dry weather flows, consisting primarily of waterline leaks and culverted surface waters have been identified. A summary of these flows within the municipal system that have been identified to date are shown on Figure 4, and are described as follows.

- Flow 1 – City of Medford water line leak (**removed**)
- Flow 2 – Groundwater breakout near St. Mary’s Street
- Flow 3 – Fellsmere Reservation base flow
- Flow 4 – Malden River surcharge (submerged invert)
- Flow 5 – DCR Spot Pond Brook base flow
- Flow 6 – Base flow, Forestdale-Pine Banks Park
- Flow 7 – Groundwater breakout, illicit discharge (**removed 8/09**)
- Flow 8 – Waterline Leak (**removed**)
- Flow 9 – Groundwater breakout
- Flow 10 – Linden Brook base flow
- Flow 11 – LSP-4 dry weather flow
- Flow 12 – Kennedy Drive, proximate to Granada Highlands Apartments
- Flow 13 – Orchard Street
- Flow 14 – Exchange Street – Intermittent flows
- Flow 15 – Lower Commercial Street

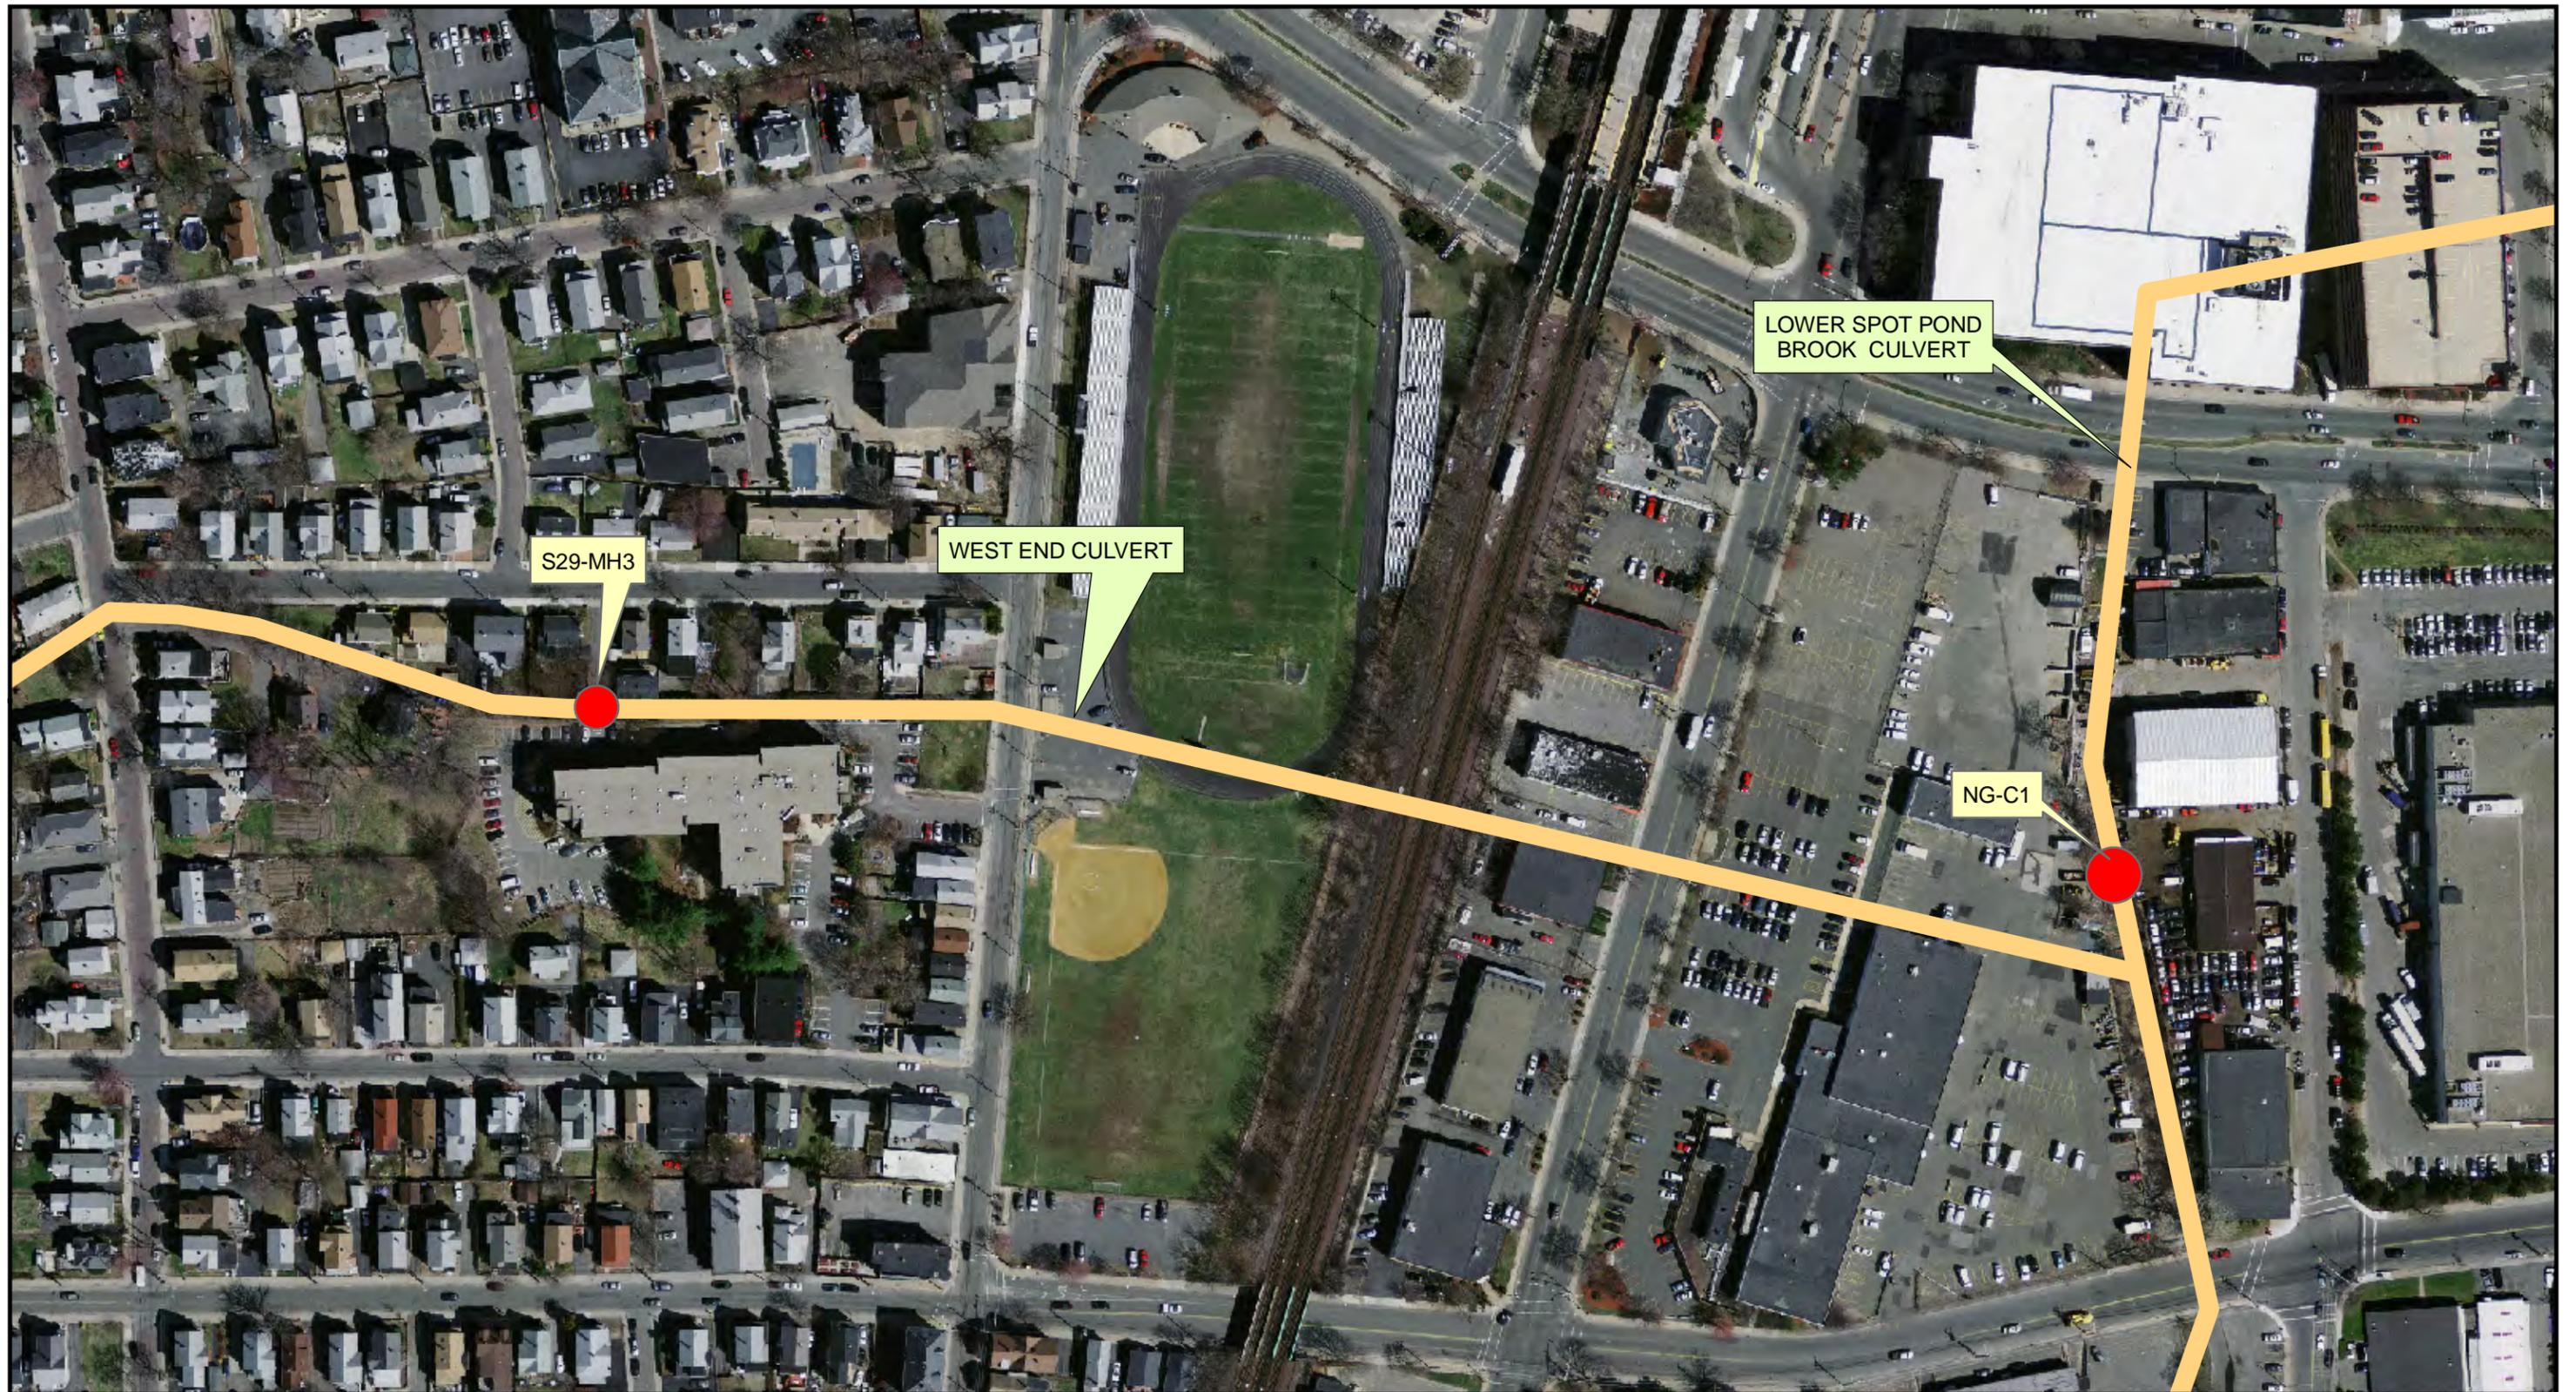
**Figure 7 - September 2012 Dry Weather Sampling Program**  
WEST END/ SPOT POND BROOK CULVERTS - MALDEN, MA

A similar flow isolation investigation was also performed for West End Brook through the collection of sample S29-MH3 (Stadium Road) at the approximate location shown on Figure 7. It was also proposed to sample upstream of S29-MH3 however, no flow within the culvert was identified at the intended location. It should be noted that flows emanating from the Fells Reservation enter the West End Brook in the area of S29-MH3. As indicated from a review of Table 2.0, elevated E. coli levels were detected during the September 2012 sampling event in manhole S29-MH3, in contrast to prior sampling results. In addition, high levels of additional indicators of human waste contributions, most noticeably Acetaminophen, were also observed. A re-evaluation of this condition will be performed during the next reporting period, together with additional flow isolation studies, as warranted.

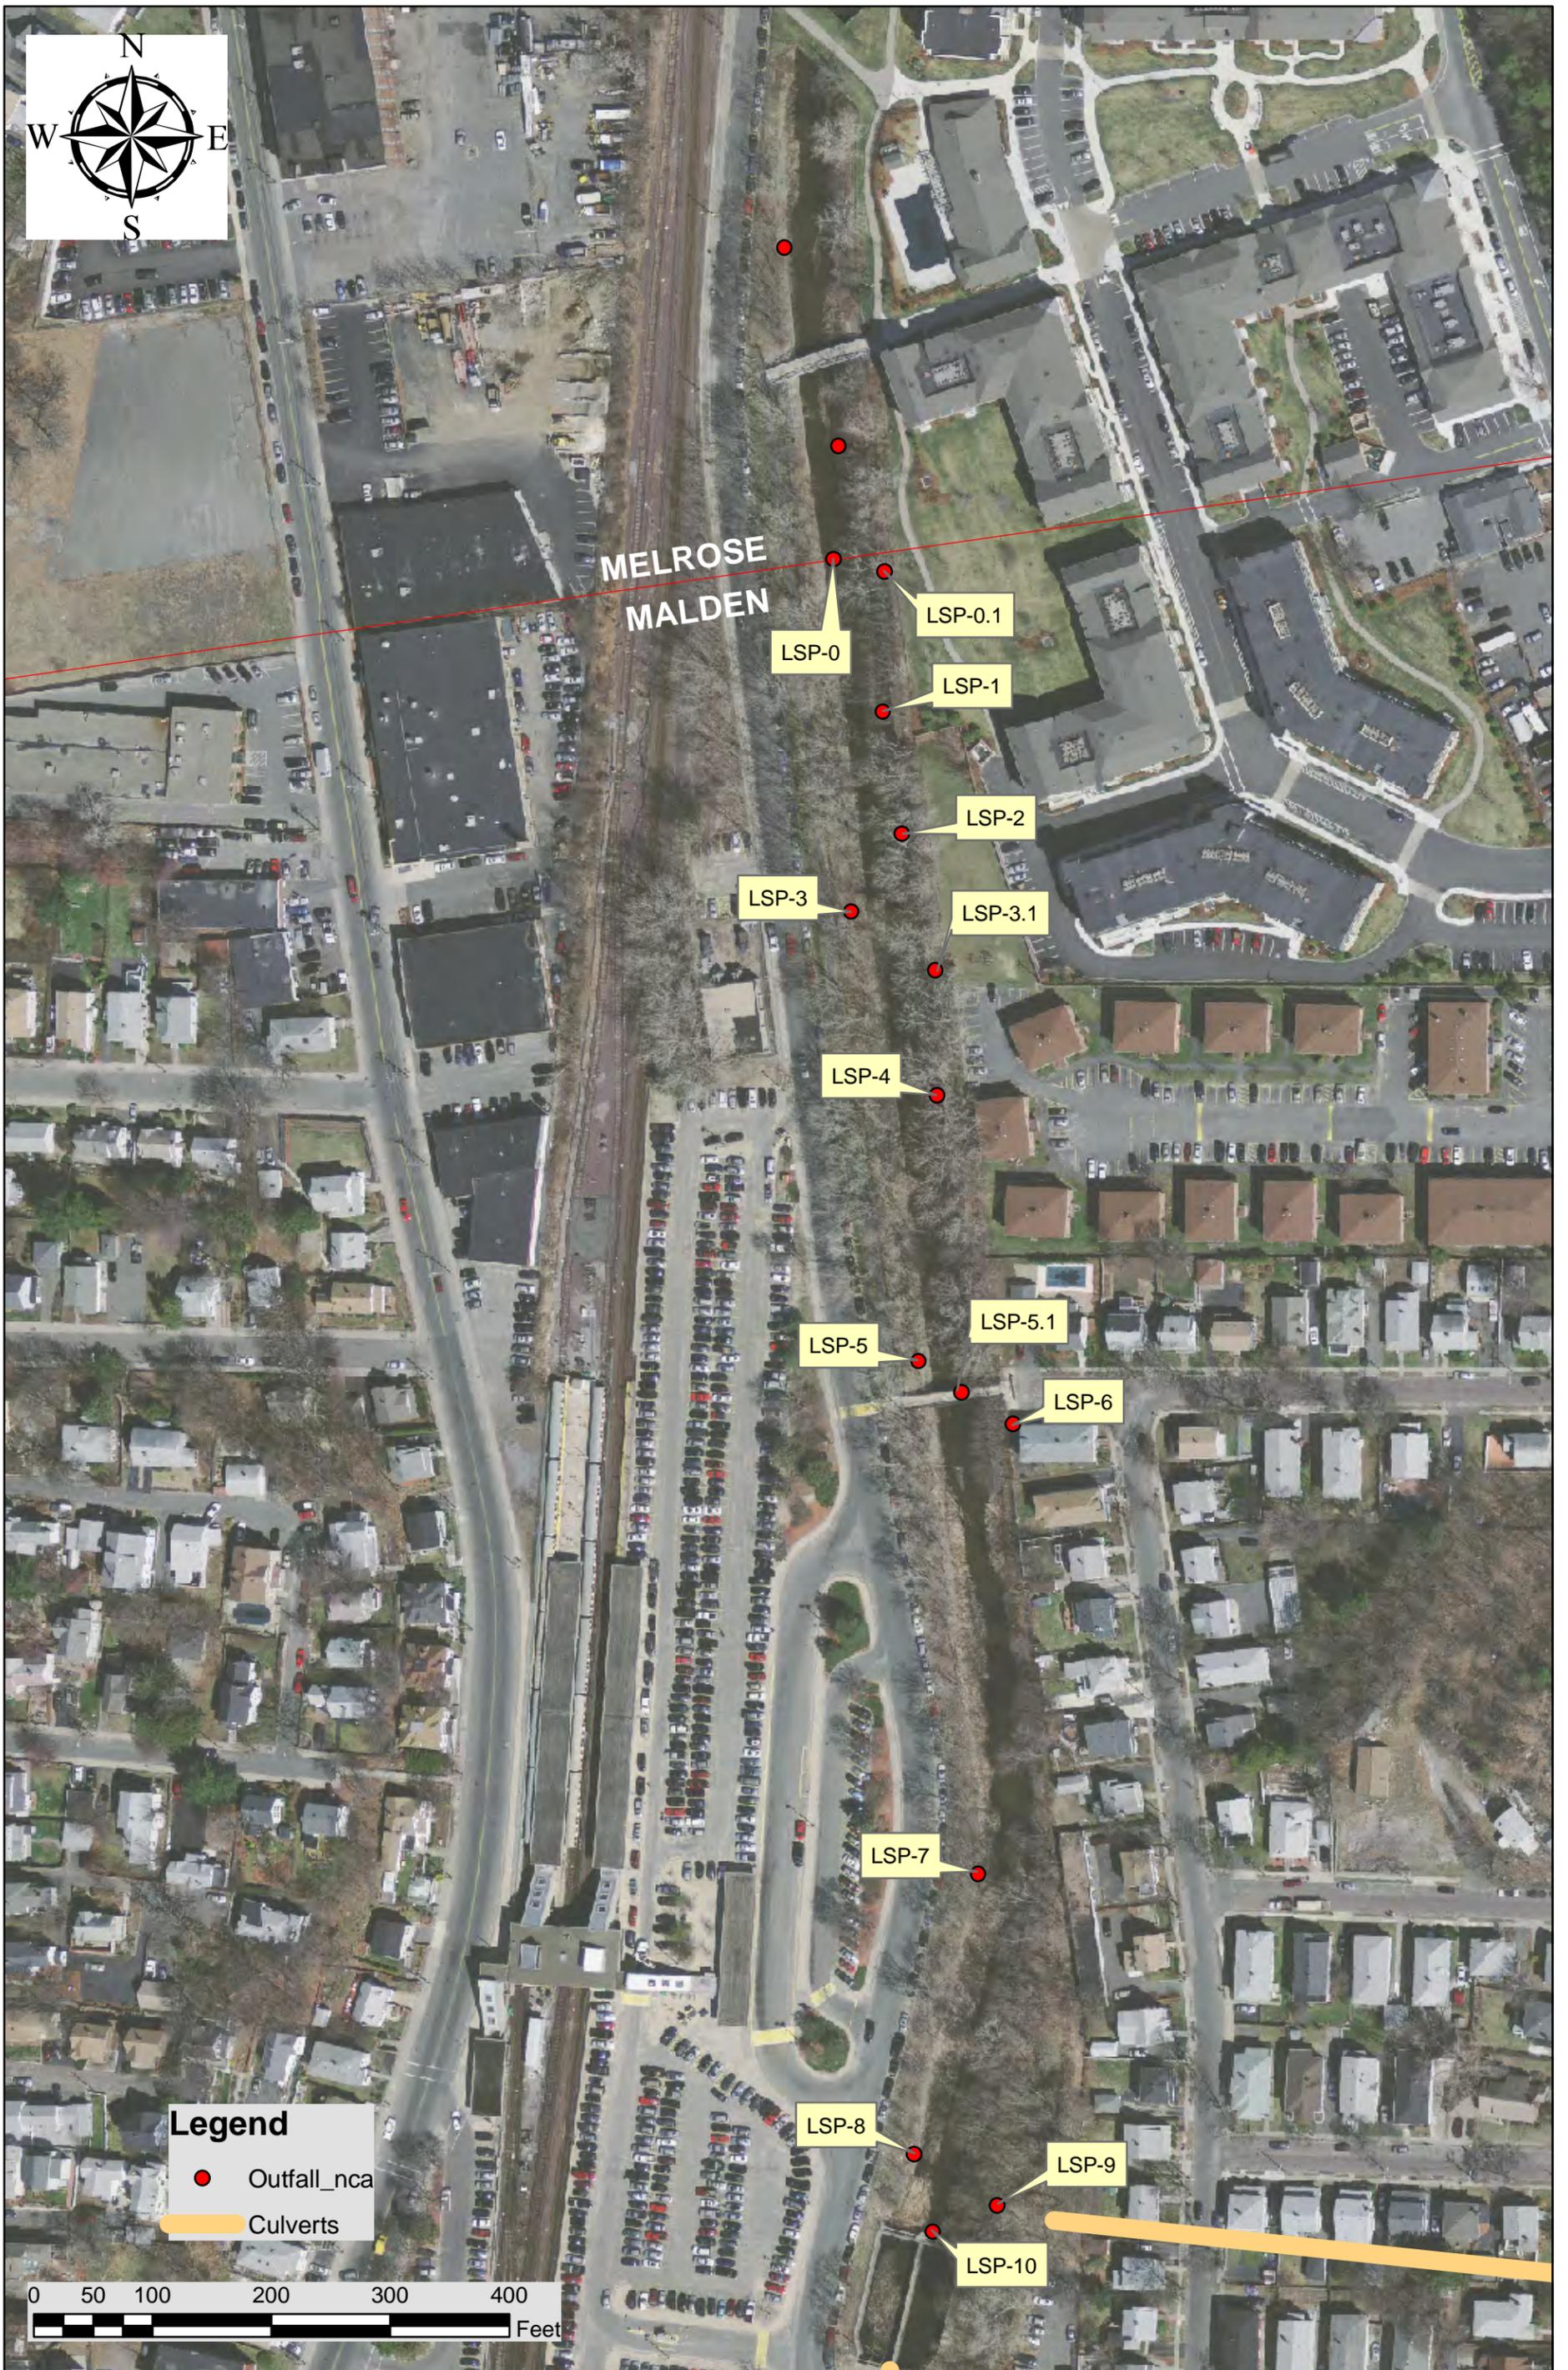
**Figure 9 - Lower Spot Pond Brook Outfalls**

The Stormwater Compliance Team has conducted numerous dry weather sampling events to investigate the elevated *E. coli* levels encountered previously at LSP-4, an outfall for the drainage system located within Eldrich Drive (Figure 9). Base flow, as groundwater, is consistently observed within this drainage network and to isolate potential sewage contributions to this base flow, a comprehensive evaluation of the flow conveyance network associated with LSP-4 was completed in February 2012. Given the proximity of the sewer and drain lines to LSP-4, as well as the settlement of the drain line in the area of Buildings 1054 and 1056 Elrich Drive, the focus of assessment activities was directed towards the sewer laterals and nearby drainage line servicing the two apartment buildings.

Based upon the information provided by the City, sewer flows generated from Buildings 1054 and 1056, tie into a single sewer line located in close proximity to the drainage network associated with LSP-4. To investigate the possibility of exfiltration from the sewer laterals, fluorescent dye was introduced by flushing water into a sink connection located within the basement of Building 1054. Subsequently this process was then repeated within Building 1056. In each instance, indications of dye were noted within drain manhole DMH-4 following termination of water flow through the sewer lines. The observations noted by the Stormwater Compliance Team were provided to the owner of the Elrich Drive property. Recommendations made by the SCT involved restoring the integrity of the main drainage line to stop the discharges that have been documented at LSP-4. Working with representatives of the Malden Engineering Department, repairs to the sewer laterals in the area of Buildings 1054 and 1056 were completed in March of 2012.

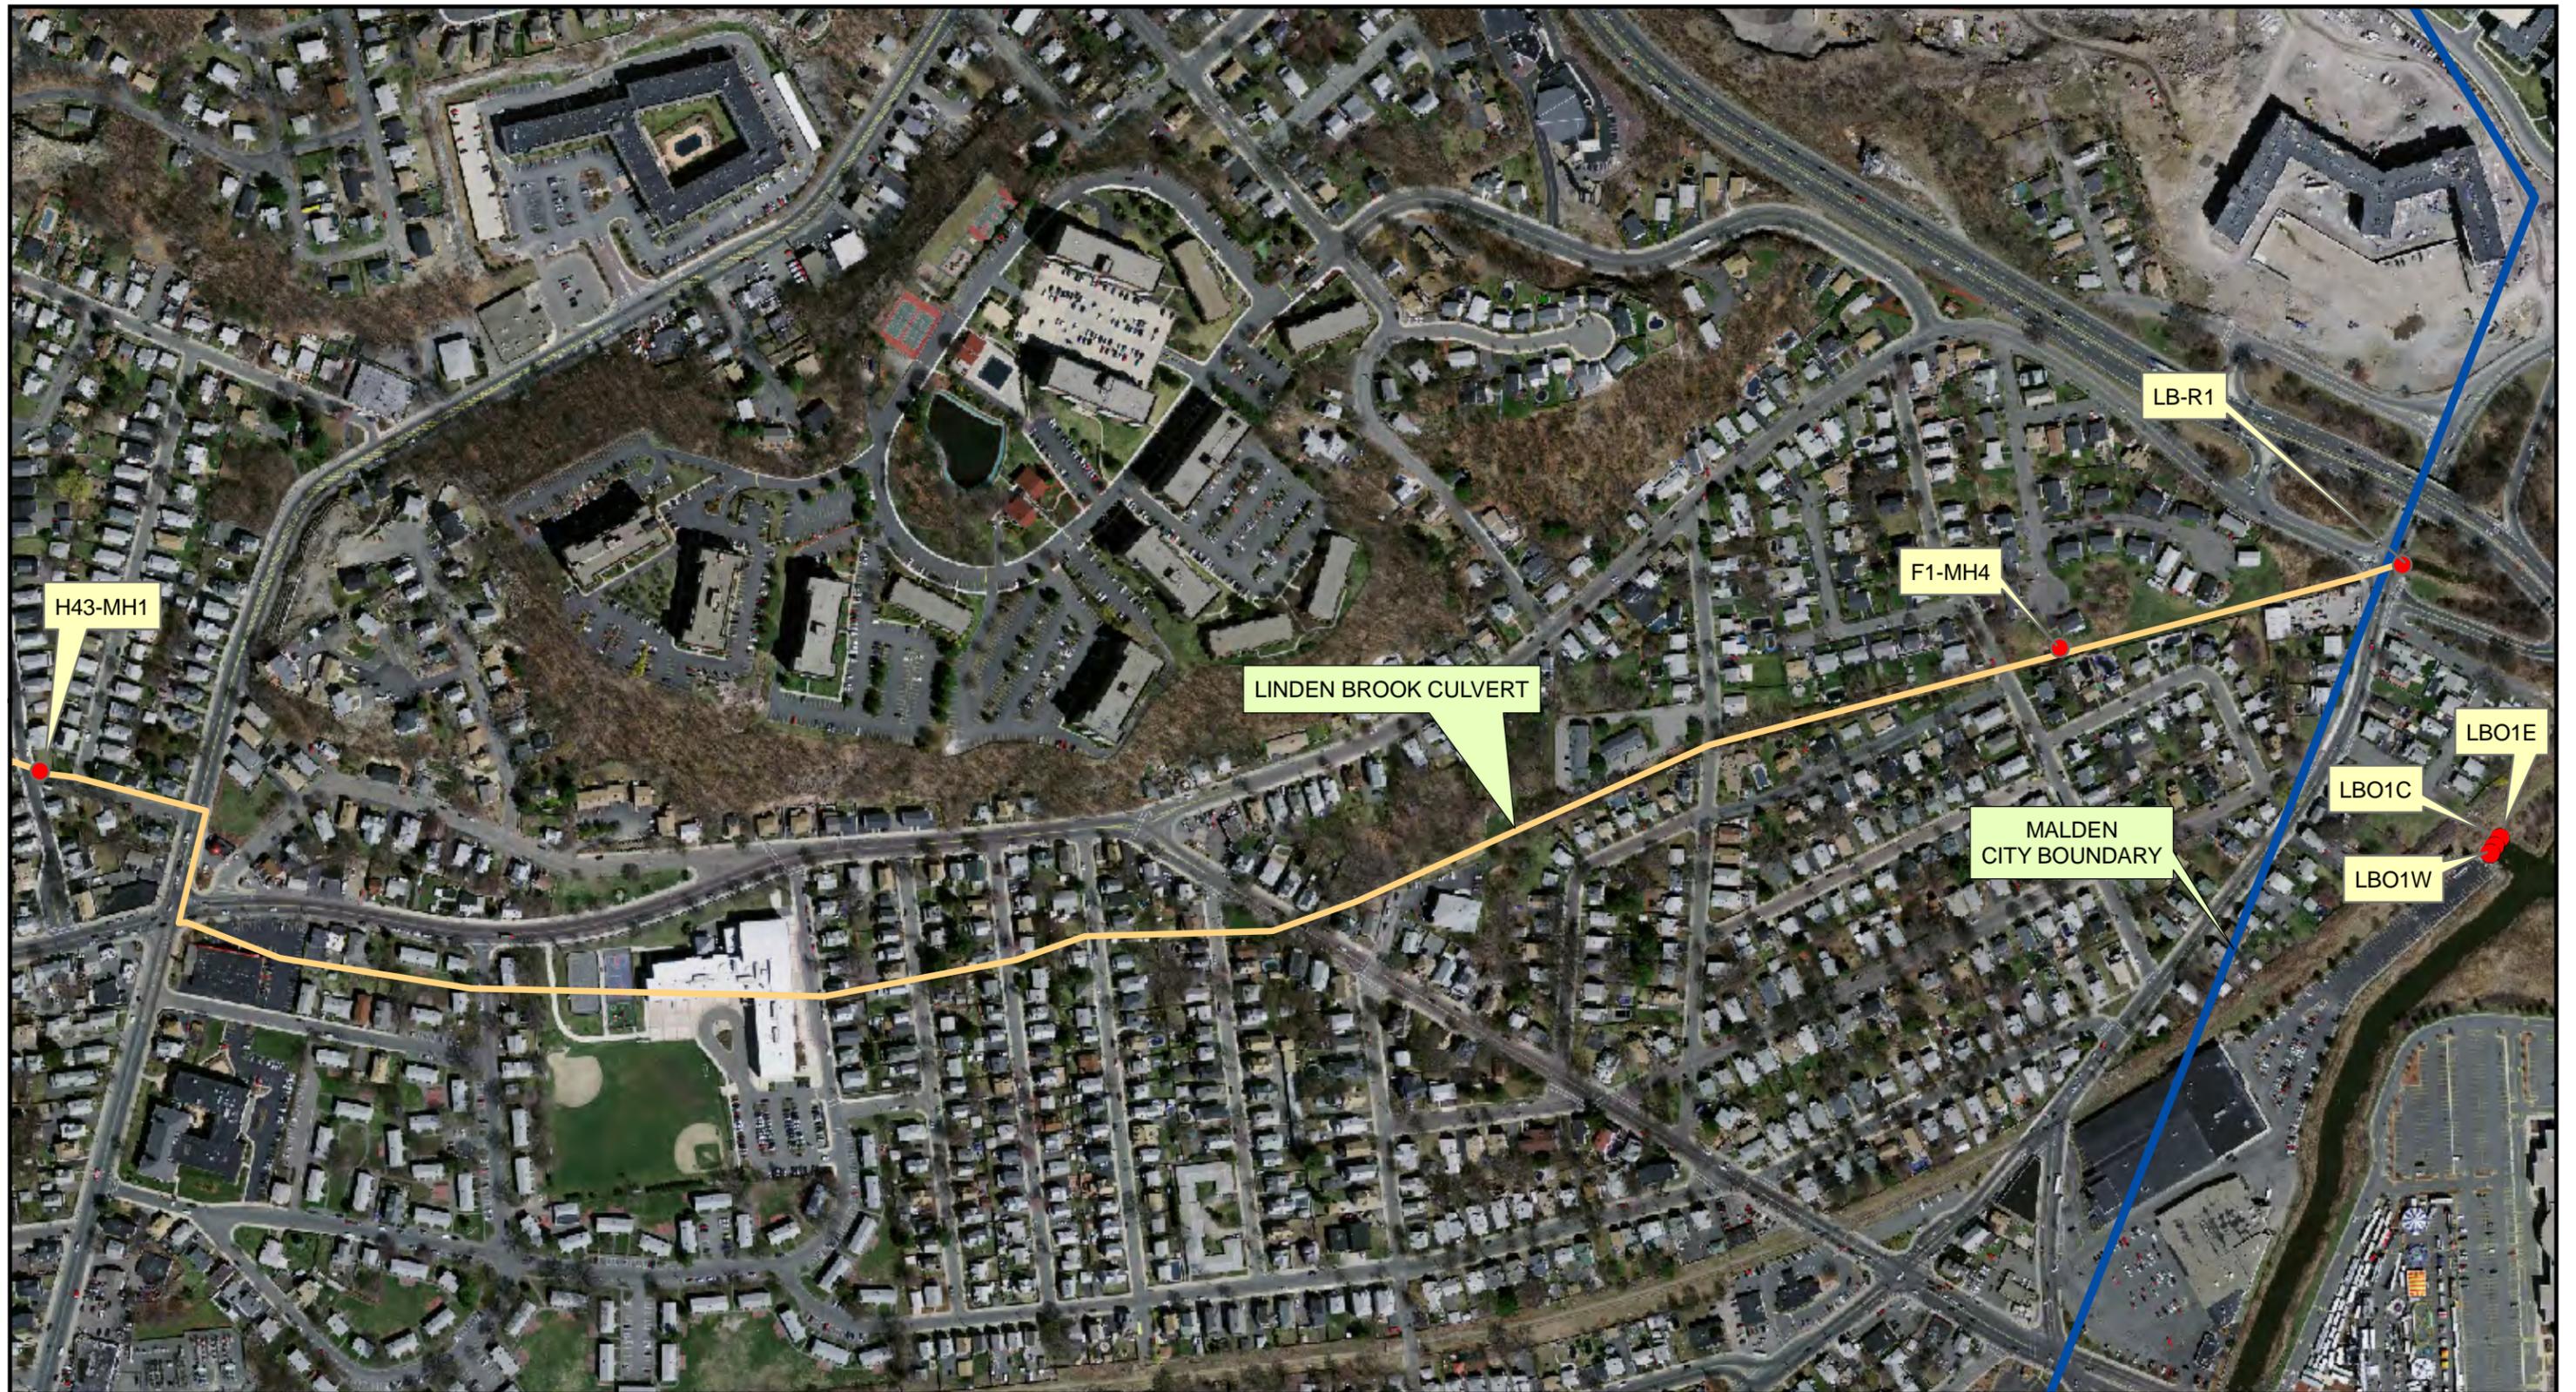
### Figure 12 - September 2012 Dry Weather Sampling Program

During the September 2012 sampling event, representatives of the USEPA collected a water sample from outfall LBR-1, located in Revere, where distinct indications of sewage odors were noted. Three (3) additional samples were also collected by the USEPA in Revere from the open channel flow of Town Line Brook (Figure 12), the results of which are summarized on Table 2.0. Consistent with identification of strong sewage odors and immediately apparent from a review of Table 2.0 are the significant elevated levels of all sampling parameters, with the exception of Carbamazepine in sample LBR-1. It is important to note that the more uncommon drugs such as this tended to exhibit more variation within the overall sampling program in comparison to the more common constituents, caffeine and acetaminophen.

To investigate the elevated bacteria levels encountered at LBR-1, the City of Malden contracted with National Water Main Cleaning Company, under the supervision of CDM Smith. As summarized in the following excerpt from an email to the City of Malden from CDM Smith, it is believed that line blockage due to grease build up may have been a crucial factor for the conditions identified at LBR-1, in addition to a “minor” defect in the form of a leaky joint. Although maintenance is routinely performed on this siphon, the extent of grease build up indicates that a higher frequency of cleaning and maintaining is necessary to further understand the condition.

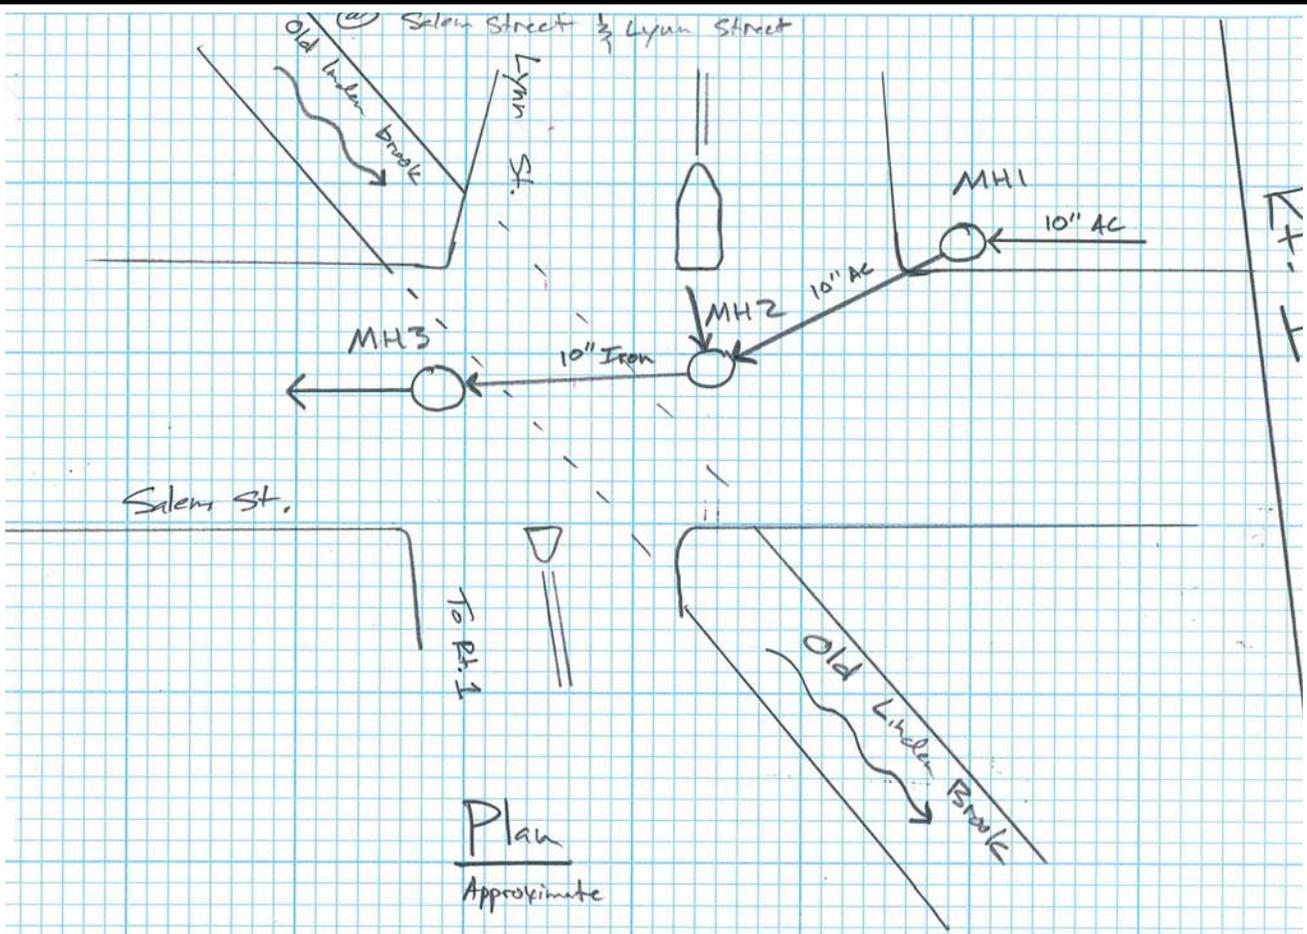
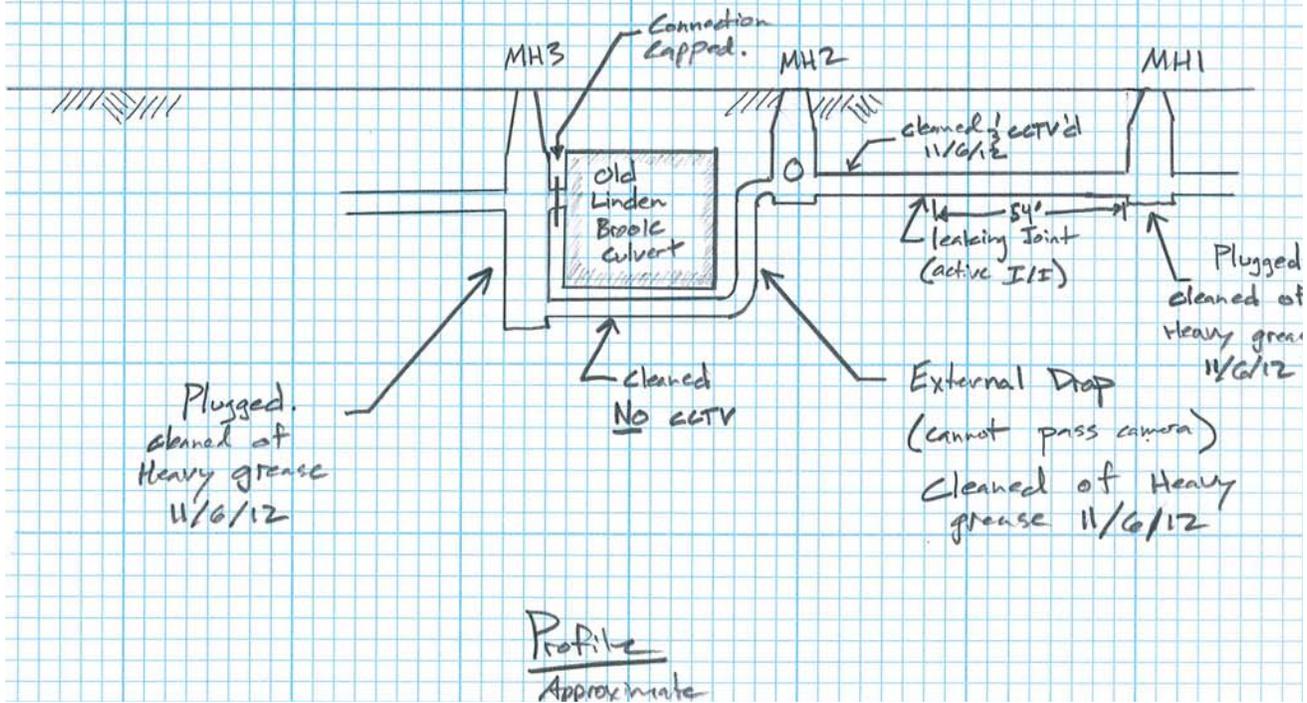
**SKETCH SHOWING SEWER SYPHON AT  
LYNN STREET - MALDEN/REVERE CITY LINE**

National Water Main was onsite to clean and CCTV the siphon under the Old Linden Brook culvert. Upon arrival the condition of the sewers had not changed from the previous visit held 2 weeks prior: The downstream manhole (MH 3 in the attached figure) and a manhole upstream of the siphon (MH 1 in the figure) were completely plugged with heavy grease. A limited amount of liquid was passing through MH 3. Heavy cleaning of MH 3 and the sewer under the culvert took longer than expected. From MH 3 upstream to MH 1 an enormous amount of grease and sediment was removed. The pipe was 100% clogged with slugs of grease in several spots.

The sewer between MH 1 and MH 2 was successfully CCTV’d with the aid of the jetter (upstream of the siphon). This pipe was found to be in good condition. The most notable defect was a leaking joint (runner) at 9pm 54-ft from MH 1 (while traveling downstream). This was a rather minor defect. Active I/I was observed, however, it is possible that when the siphon builds some head, a small amount of sewage could exfiltrate from this same joint.

upstream direction would require two jettors or bypass pumping, (one to keep MH 3 drained and one to intercept flow from upstream in MH 2). This vertical drop was heavily blocked with grease. Approximately 80% of the grease in this pipe was removed with a root cutter and the pipe is in much better condition.

Last we lowered the camera into the 12-in connection to the culvert that once housed a gate valve (in MH 3). It no longer houses any gate, instead there is a masonry plug that seems to be in good condition. As the intent of finding the definitive source of sewage into the culvert was inconclusive, we recommend that we resample the outfall and test for parameters consistent with sewage. If the results are consistent with the previous results we should develop a new approach to finding the source.

Based upon the “inconclusive finding” cited by CDM, future high frequency inspection of the siphon and related service connections is recommended to be performed during the next reporting period.

At a minimum, it is recommended that the siphon at Lynn Street be inspected on a weekly basis. During this inspection program, recorded observations should include estimated flow volumes, upstream and downstream of the siphon, extent of grease buildup at the upstream manhole, depth to liquid in the downstream manhole, possible odors at the Linden Brook Outlet and any unusual conditions that may be present.
