**Municipality/Organization:** City of Malden  
**EPA NPDES Permit Number:** MA041046  
**MADEP Transmittal Number:** 041088  
**Annual Report Number & Reporting Period:** No. 10: April 1, 2012-March 31, 2013

## NPDES PII Small MS4 General Permit Annual Report

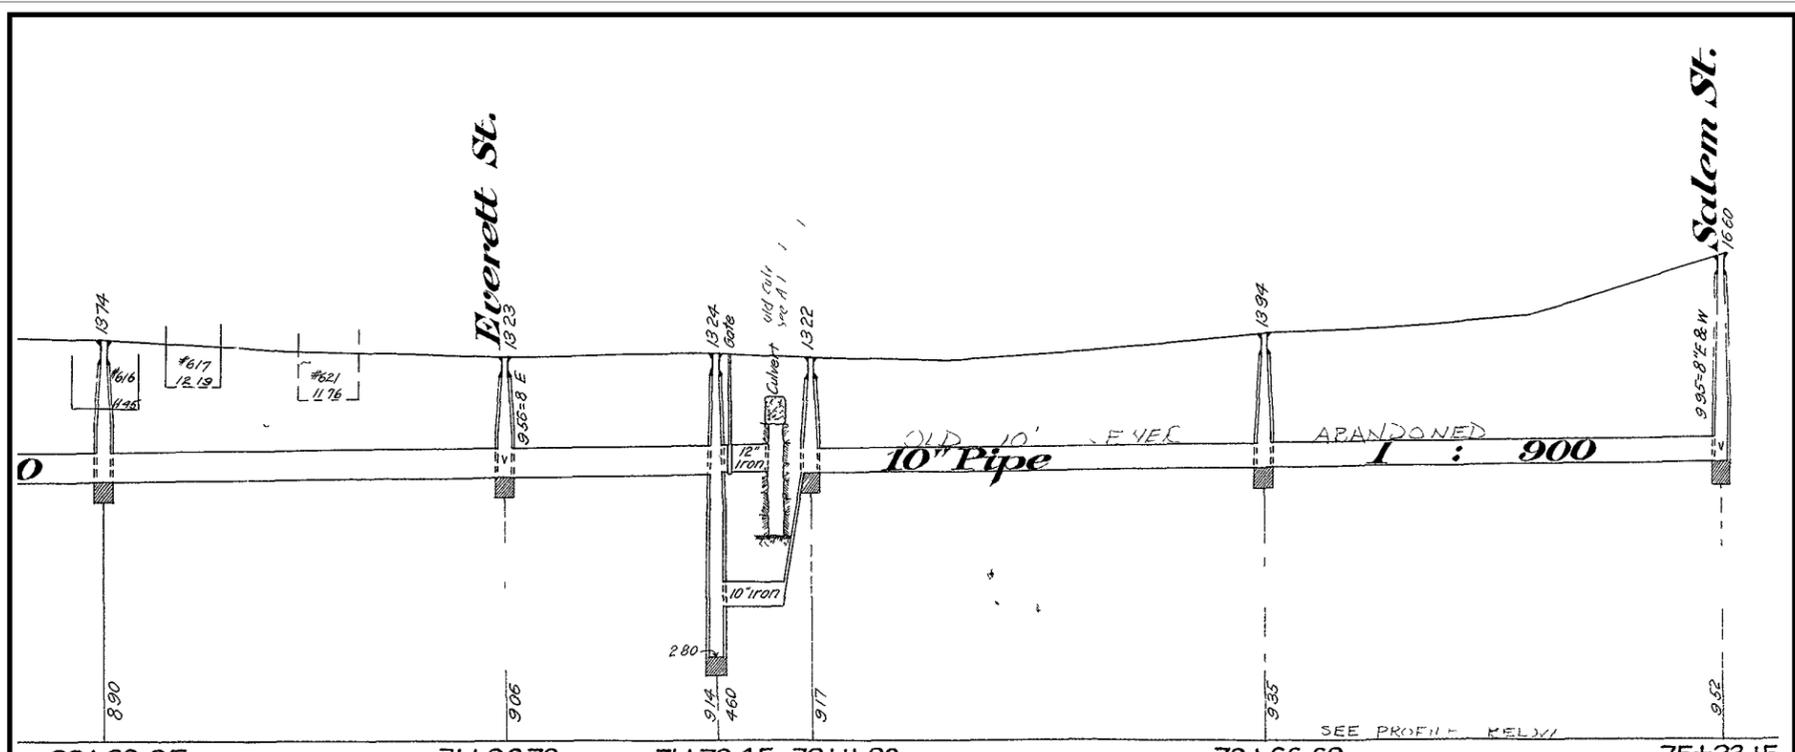
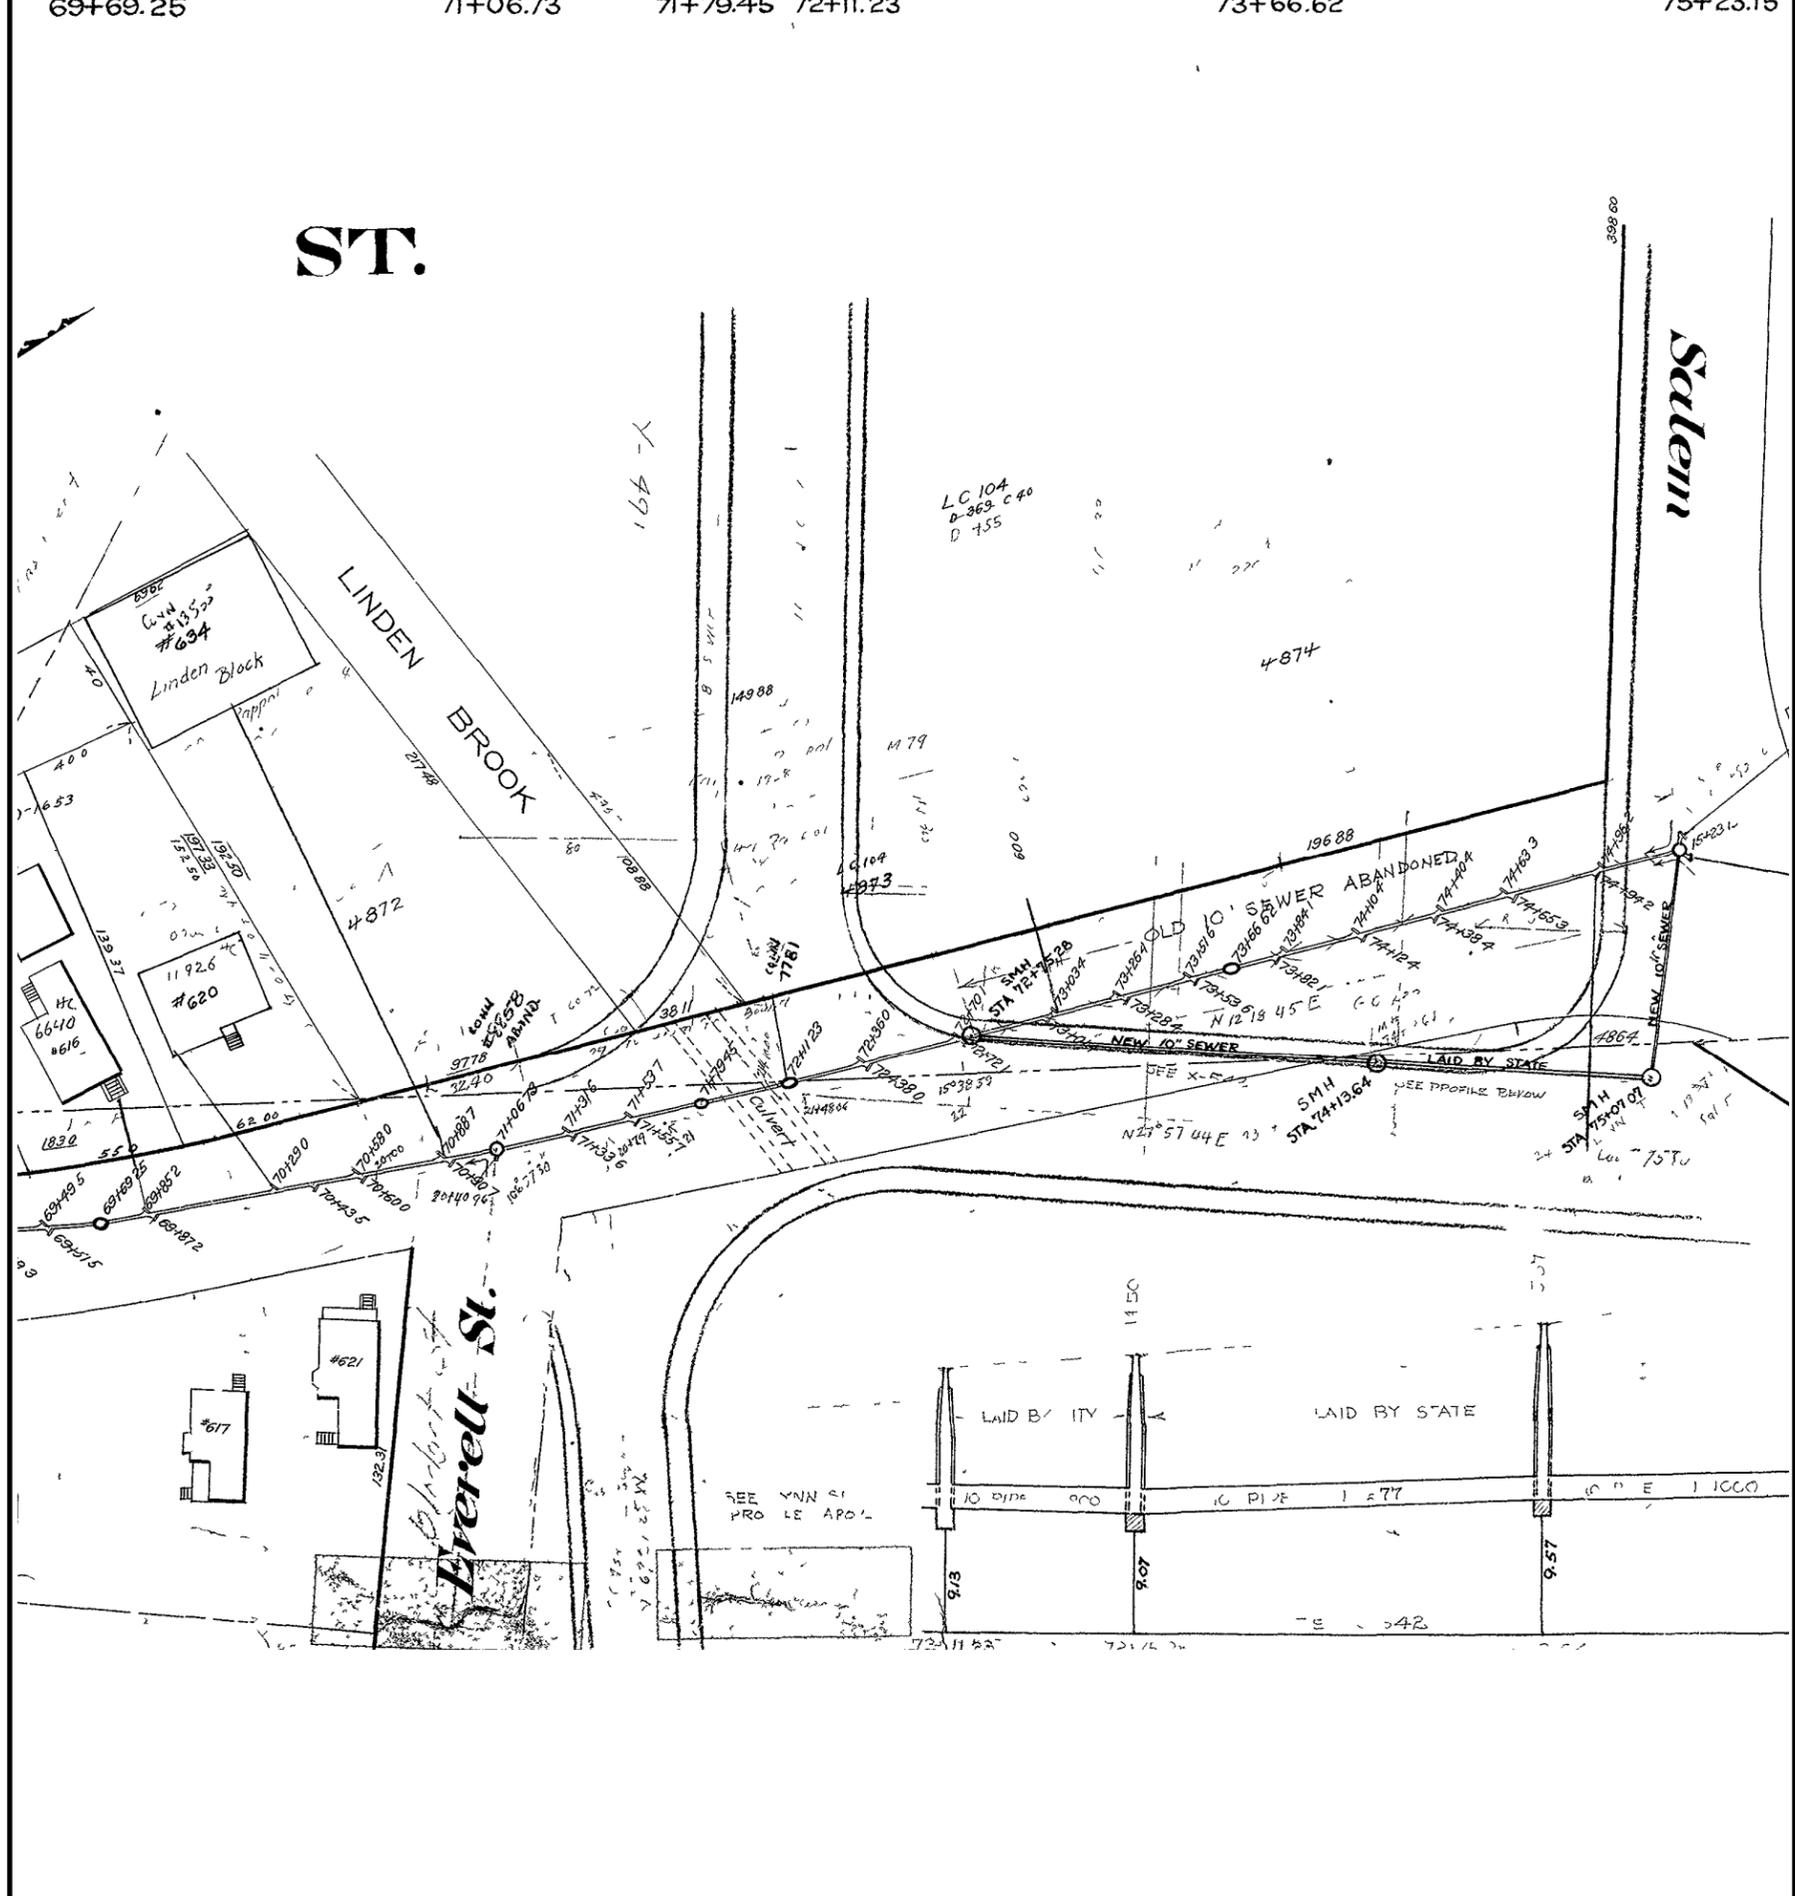
<p align="center"><b>CITY OF MALDEN SEWER MAP</b>  <b>LYNN ST - MALDEN/REVERE CITY LINE</b></p>		REFERENCE: Malden Sewer Map	
		Date: Feb 2013

To assist in the review of the above, a profile sketch plan of the siphon that passes beneath the Linden Brook Culvert, together with associated sewage apparatuses prepared by CDM Smith is presents as Figure 13. In addition, a City of Malden sewer plan/profile for the siphon and upstream piping connections may be referenced as Figure 14. As shown on Figure 14, the sewer line entering from Revere is noted as being re-lain by the State.
