Municipality/Organization: Town of Blackstone

NPDES PII Small MS4 General Permit Annual Report (Due: May 1, 2017)

**National Pollutant Discharge
Elimination System (NPDES)
Phase II Stormwater Management Plan
Outfall Inspection Report**

Blackstone, Massachusetts

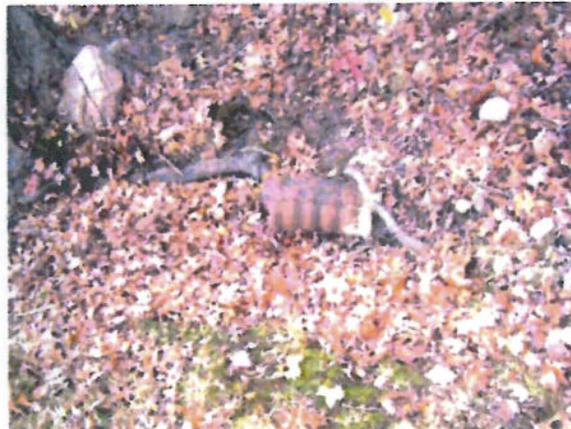
Outfall No.	Finding	Action Item
14	Excessive washed out road sand; invert has rusted away.	Clear flow channel. Sweep roadway tributary area. Clean catch basin sumps, which may be washing out because they are full. In the long term, consider replacing the outfall pipe.
45	The mouth of this outfall is covered by a welded steel grate, which is approximately 75% obstructed by captured leaves, sticks and debris.	Outfall grate should be cleaned and cleared of obstructions as soon as possible to prevent possible upstream flooding.
47	Outfall is obscured by weeds, debris, and creeping woody plant growth.	Clear a path to the outfall, uncover it for easy location. Ensure flow path is clear and unobstructed. Remove plants and roots which might compromise the outfall pipe.
49	Outfall pipe invert has rusted away.	In the long term, consider replacing the outfall pipe.
84 (High Priority Outfall)	Pipe shows considerable cracking, invert has rotted away. Pipe may be approaching the end of useful life; failure could compromise the headwall it is located in, causing a collapse.	In the long term, consider replacing this outfall pipe as structural collapse could compromise the headwall. Locate record drawings and/or televise the pipe to determine length, age, condition, and probable cost to replace.

Blockage: 30%

Deposits: Sediment

Structural Damage: Squashed Laterally

~18 in of bottom (measured lengthwise into pipe) rotted out

Several of the outfalls in Table 1 (14, 49, and 84) appear to be nearing the end of their useful lives. The Town should consider a replacement program, prioritizing areas where pipe failure may damage other property or infrastructure. As is the nature of stormwater outfalls, a majority of these structures are located in wooded areas, along the banks of rivers or other bodies of water, and in other areas that are not easily accessible. A path to each outfall should be established and kept clear for ease of inspection and maintenance. In addition, each outfall should be inspected semi-annually for structural integrity and signs of illicit discharge. The town should develop and implement an outfall maintenance program to address structural issues identified during inspections. Maintenance of drainage manholes and catch basins should be included as part of this plan as rocks, sediment and other debris may damage or obstruct the outfalls. The town should also stencil or otherwise label all catch basins with a "no dumping" message. It may also be productive to post a permanent sign (with the outfall number) in the vicinity of each outfall to make them easier to locate for inspections and in the case of emergencies.

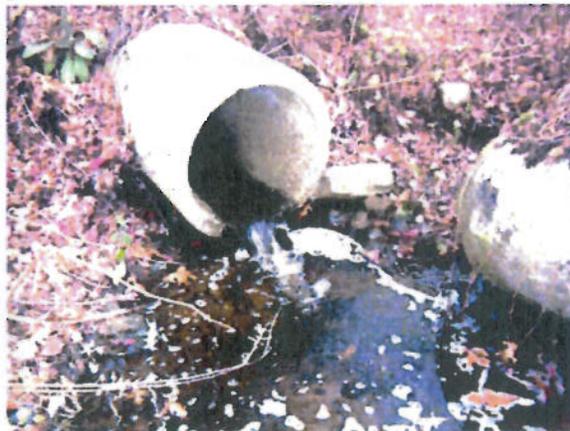
Outfall 32: This circular, 30 inch concrete outfall is located on the south side of Summer Street. During the initial 11/14/11 inspection, dry weather flow and the presence of foam was noted. A follow up inspection was recommended to verify that the foam was not caused by illicit discharges of chemical surfactants. The follow up inspections in 2013 through 2016 showed the continued presence of flow and small amounts of foam. However, as noted in 2013 inspection report, it is not believed at this time that these are indicators of illicit discharges. The foam was not chemically perfumed, broke apart easily when disturbed, and generally appeared to be natural, biological foam which occurs when organic materials release compounds into water as they decompose. Additionally, outfall 32 is in a low lying area with some wetland characteristics. Dry weather flow and foam during the spring may be expected in such areas. AECOM recommends that town personnel continue to monitor this outfall during their regular operations. This outfall should remain on the “High Priority” list and be formally inspected again during the next round of annual outfall inspections. If the outfall at any time begins to show any signs of illicit discharges, its flow should be sampled and tested. If the sampling indicates an illicit discharge, the IDDE plan should be followed to eliminate the illicit discharge.

Flow: 6 gpm

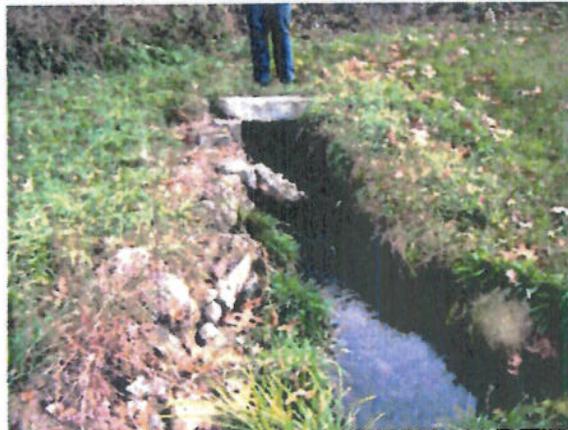
Outfall 34: This smooth plastic 24 inch outfall is located off Fox Hill Road. During the initial 11/15/11 inspection, dry weather flow and the presence of foam was noted. A follow up inspection was recommended to verify that the foam was not caused by illicit discharges of chemical surfactants. The follow up inspections in 2013 through 2016 showed the continued presence of flow and foam. However, as noted in the 2013 inspection report, it is not believed at

this time that these are indicators of illicit discharges. The foam was not chemically perfumed, broke apart easily when disturbed, and generally appeared to be natural, biological foam which occurs when organic materials release compounds into water as they decompose. Additionally, outfall 34 is in a low lying area with some wetland characteristics. Dry weather flow and foam during the spring may be expected in such areas. AECOM recommends that town personnel continue to monitor this outfall during their regular operations. This outfall should remain on the "High Priority" list and be formally inspected again during the next round of annual outfall inspections. If the outfall at any time begins to show any signs of illicit discharges, its flow should be sampled and tested. If the sampling indicates an illicit discharge, the IDDE plan should be followed to eliminate the illicit discharge.

Flow: 30 gpm

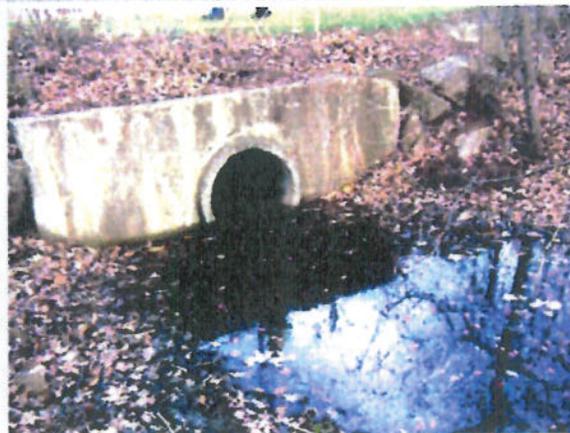
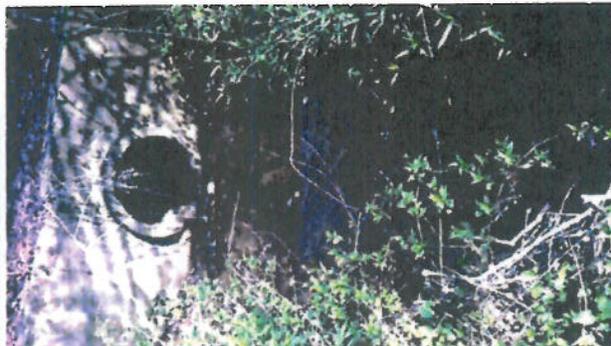
Outfall 40: This circular 24 inch concrete outfall is located southeast of the cul-de-sac on Castagnaro Way. During the initial 11/15/11 inspection, dry weather flow and the presence of foam was noted. A follow up inspection was recommended to verify that the foam was not caused by illicit discharges of chemical surfactants. No foam was noted during the annual inspection on 4/22/13, but the outfall remained on the "High Priority" list and follow up inspections in 2014 through 2016 showed the presence of dry weather flow and small amounts of foam. It is not believed at this time that these are indicators of illicit discharges. The foam was not chemically perfumed, broke apart easily when disturbed, and generally appeared to be natural, biological foam which occurs when organic materials release compounds into water as they decompose. Additionally, outfall 34 is in a low lying area with some wetland characteristics. Dry weather flow and foam during the spring may be expected in such areas. No other signs of an illicit discharge were visible; AECOM recommends that this outfall remain on the "High Priority" list and that town personnel continue to monitor this outfall during their regular inspections. This outfall should be formally inspected again during the next annual round of outfall inspections. If the outfall at any time begins to show any signs of illicit connections, the flow should be sampled and tested. If the sampling indicates an illicit discharge, the IDDE plan should be followed to eliminate the illicit discharge.

Flow: 5 gpm

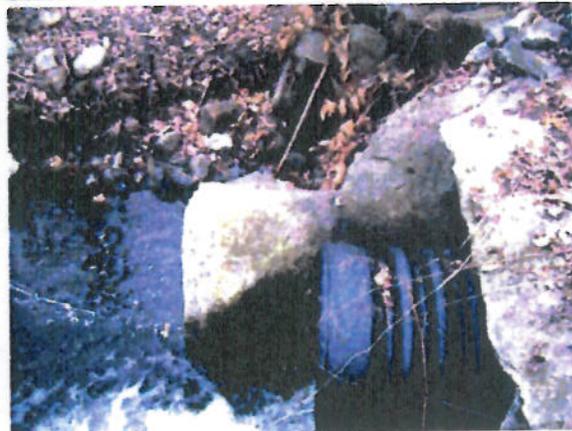
Blockage:
Floatables: None
Deposits: Sediment
Vegetation Growth: Some
Structural Damage: Invert of Pipe Rotted at exit; Appr
Comment:

Annual Inspection
Flow: >0.1 gpm

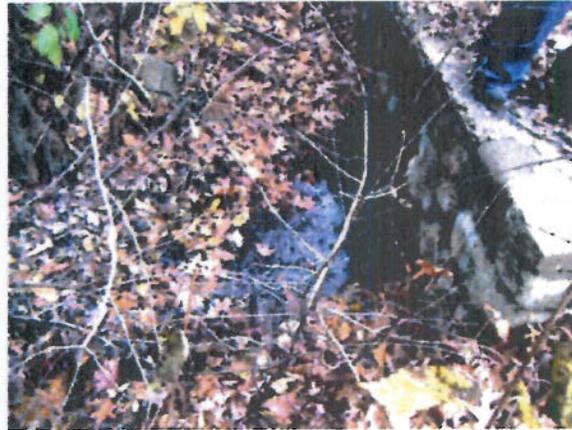
Outfall 61: This circular 18 inch concrete outfall is located on Federal Street near house number 155. This outfall was added to the "High Priority" list due to the presence of dry weather flow and foam. This outfall has been monitored each year, but the observations did not indicate an illicit discharge. A small amount of bubbles/foam were noted during the 2016 inspection. It was observed that the foam was not chemically perfumed, broke apart easily when disturbed, and generally appeared to be natural, biological foam which occurs when organic materials release compounds into water as they decompose. Additionally, outfall 61 is in a low lying area with some wetland characteristics. Dry weather flow and foam during the spring may be expected in such areas. Therefore, the available evidence at this time indicates that sampling is not required at this outfall. AECOM recommends that town personnel continue to monitor this outfall during their regular operations. Based on this inspection and past inspections, this outfall should remain on the "High Priority" list and should be formally inspected again during the next annual outfall inspections. If the outfall at any time begins to show any signs of illicit connections, its flow should be sampled and tested. If the sampling indicates an illicit discharge, the IDDE plan should be followed to eliminate the illicit discharge.

Flow: 10 gpm

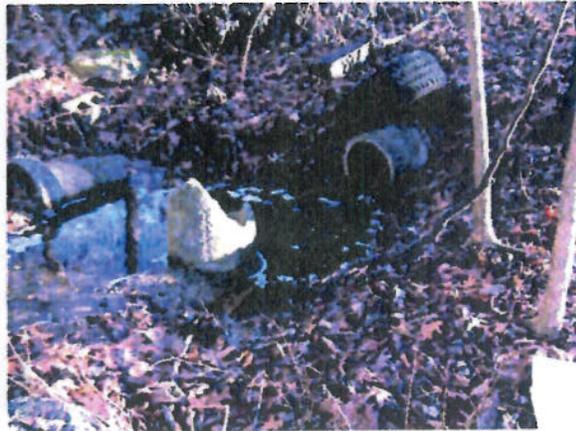
Outfall 64: This circular concrete outfall is located on Blackstone Street near house number 146. This outfall was added to the "High Priority" list due to the presence of dry weather flow and foam. This outfall has been monitored each year, but the observations did not indicate an illicit discharge. Dry weather flow was noted during the 2016 inspection. Foam was not noted. Dry weather flow during the spring may be expected in low lying areas with wetland characteristics, such as outfall 64's location. Therefore, the available evidence at this time indicates that sampling is not required at this outfall. AECOM recommends that town personnel continue to monitor this outfall during their regular operations. This outfall should be formally inspected again during the next annual outfall inspections. If the outfall at any time begins to show any signs of illicit connections, its flow should be sampled and tested. If the sampling indicates an illicit discharge, the IDDE plan should be followed to eliminate the illicit discharge. AECOM also noted that the 30 inch concrete bell end of this outfall has broken off. However, this does not appear to be affecting the outfall's performance.

Structural Damage: Good (see comment)

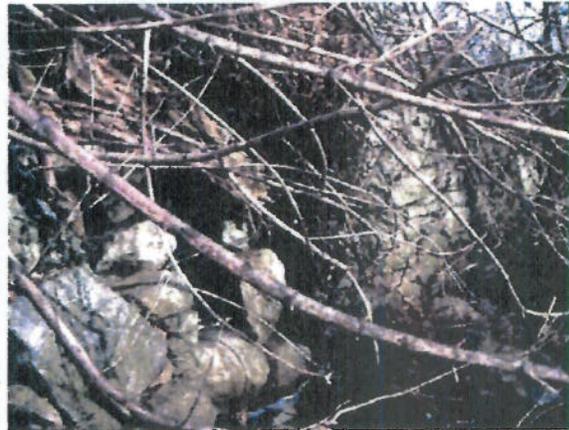
Outfall 84: This outfall is located in the bank of the Blackstone River at the south end of First Avenue. This outfall was added to the "High Priority" list due to the presence of dry weather flow, odor and the presence of foam. During the 2015 inspection, the outfall was found to be completely inaccessible due to dumping of residential yard waste. AECOM recommended that the town clear this yard waste and post "no dumping" signs in the area, which the town accomplished. The 2016 inspection did not show any indicators of illicit discharges. However, this outfall pipe is in poor condition. It is cracked in numerous places and the invert has broken away. The town should begin planning and budgeting for repairs/replacement of this pipe. AECOM recommends that this outfall should remain on the "High Priority" list and be formally inspected again during the next annual outfall inspections. If the outfall at any time begins to show any signs of illicit discharges, its flow should be sampled and tested. If the sampling indicates an illicit discharge, the IDDE plan should be followed to eliminate the illicit discharge.

Structural Damage: Last section at exit broken in ???

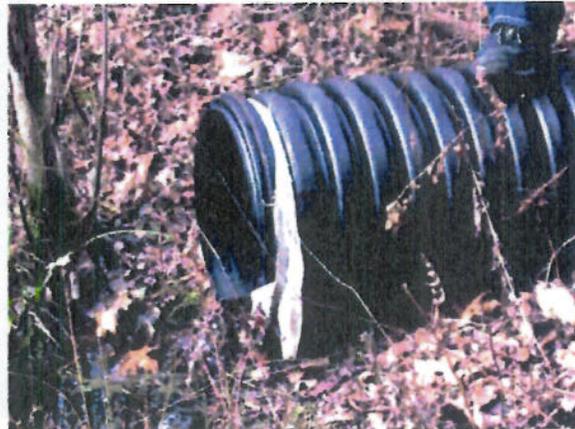
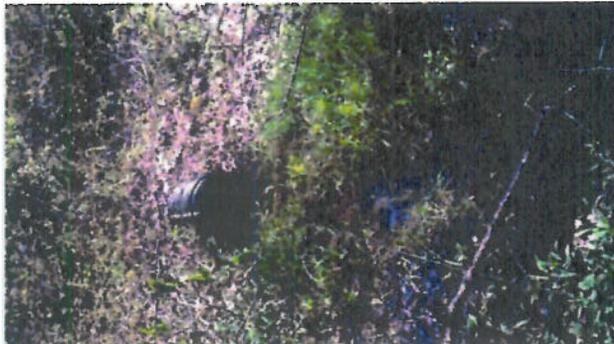
Outfall 88: This circular 18 inch corrugated plastic pipe discharges to a retention basin off the end of TeeJay Lane. This outfall was added to the "High Priority" list due to the presence of dry

weather flow and sheen. This outfall has been monitored each year, but the observations did not indicate the presence of an illicit discharge at the time of the inspection. The sheen was once again observed during the 5/11/16 inspection, as well as significant iron staining on the soil in the retention basin. Because of the obvious presence of dissolved iron in the retention basin, as well as the fact that the sheen broke apart and did not flow back together immediately when disturbed, it is believed that the sheen is the result of the natural activity of iron consuming wetland bacteria such as *leptothrix discophora*, not an illicit discharge of petroleum. AECOM recommends that the outfall remain on the "High Priority" list and that town personnel continue to monitor this outfall during their normal operations. This outfall should be formally inspected again during the next round of annual outfall inspections. If the outfall at any time begins to show any signs of illicit discharges, its flow should be sampled and tested. If the sampling indicates an illicit discharge, the IDDE program should be followed to eliminate the illicit discharge.

Flow: >0/1 gpm
