**Municipality/Organization:** City of Malden  
**EPA NPDES Permit Number:** MA041046  
**MADEP Transmittal Number:** 041088  
**Annual Report Number & Reporting Period:** No. 15: April 1, 2017-March 31, 2018

## NPDES PII Small MS4 General Permit Annual Report

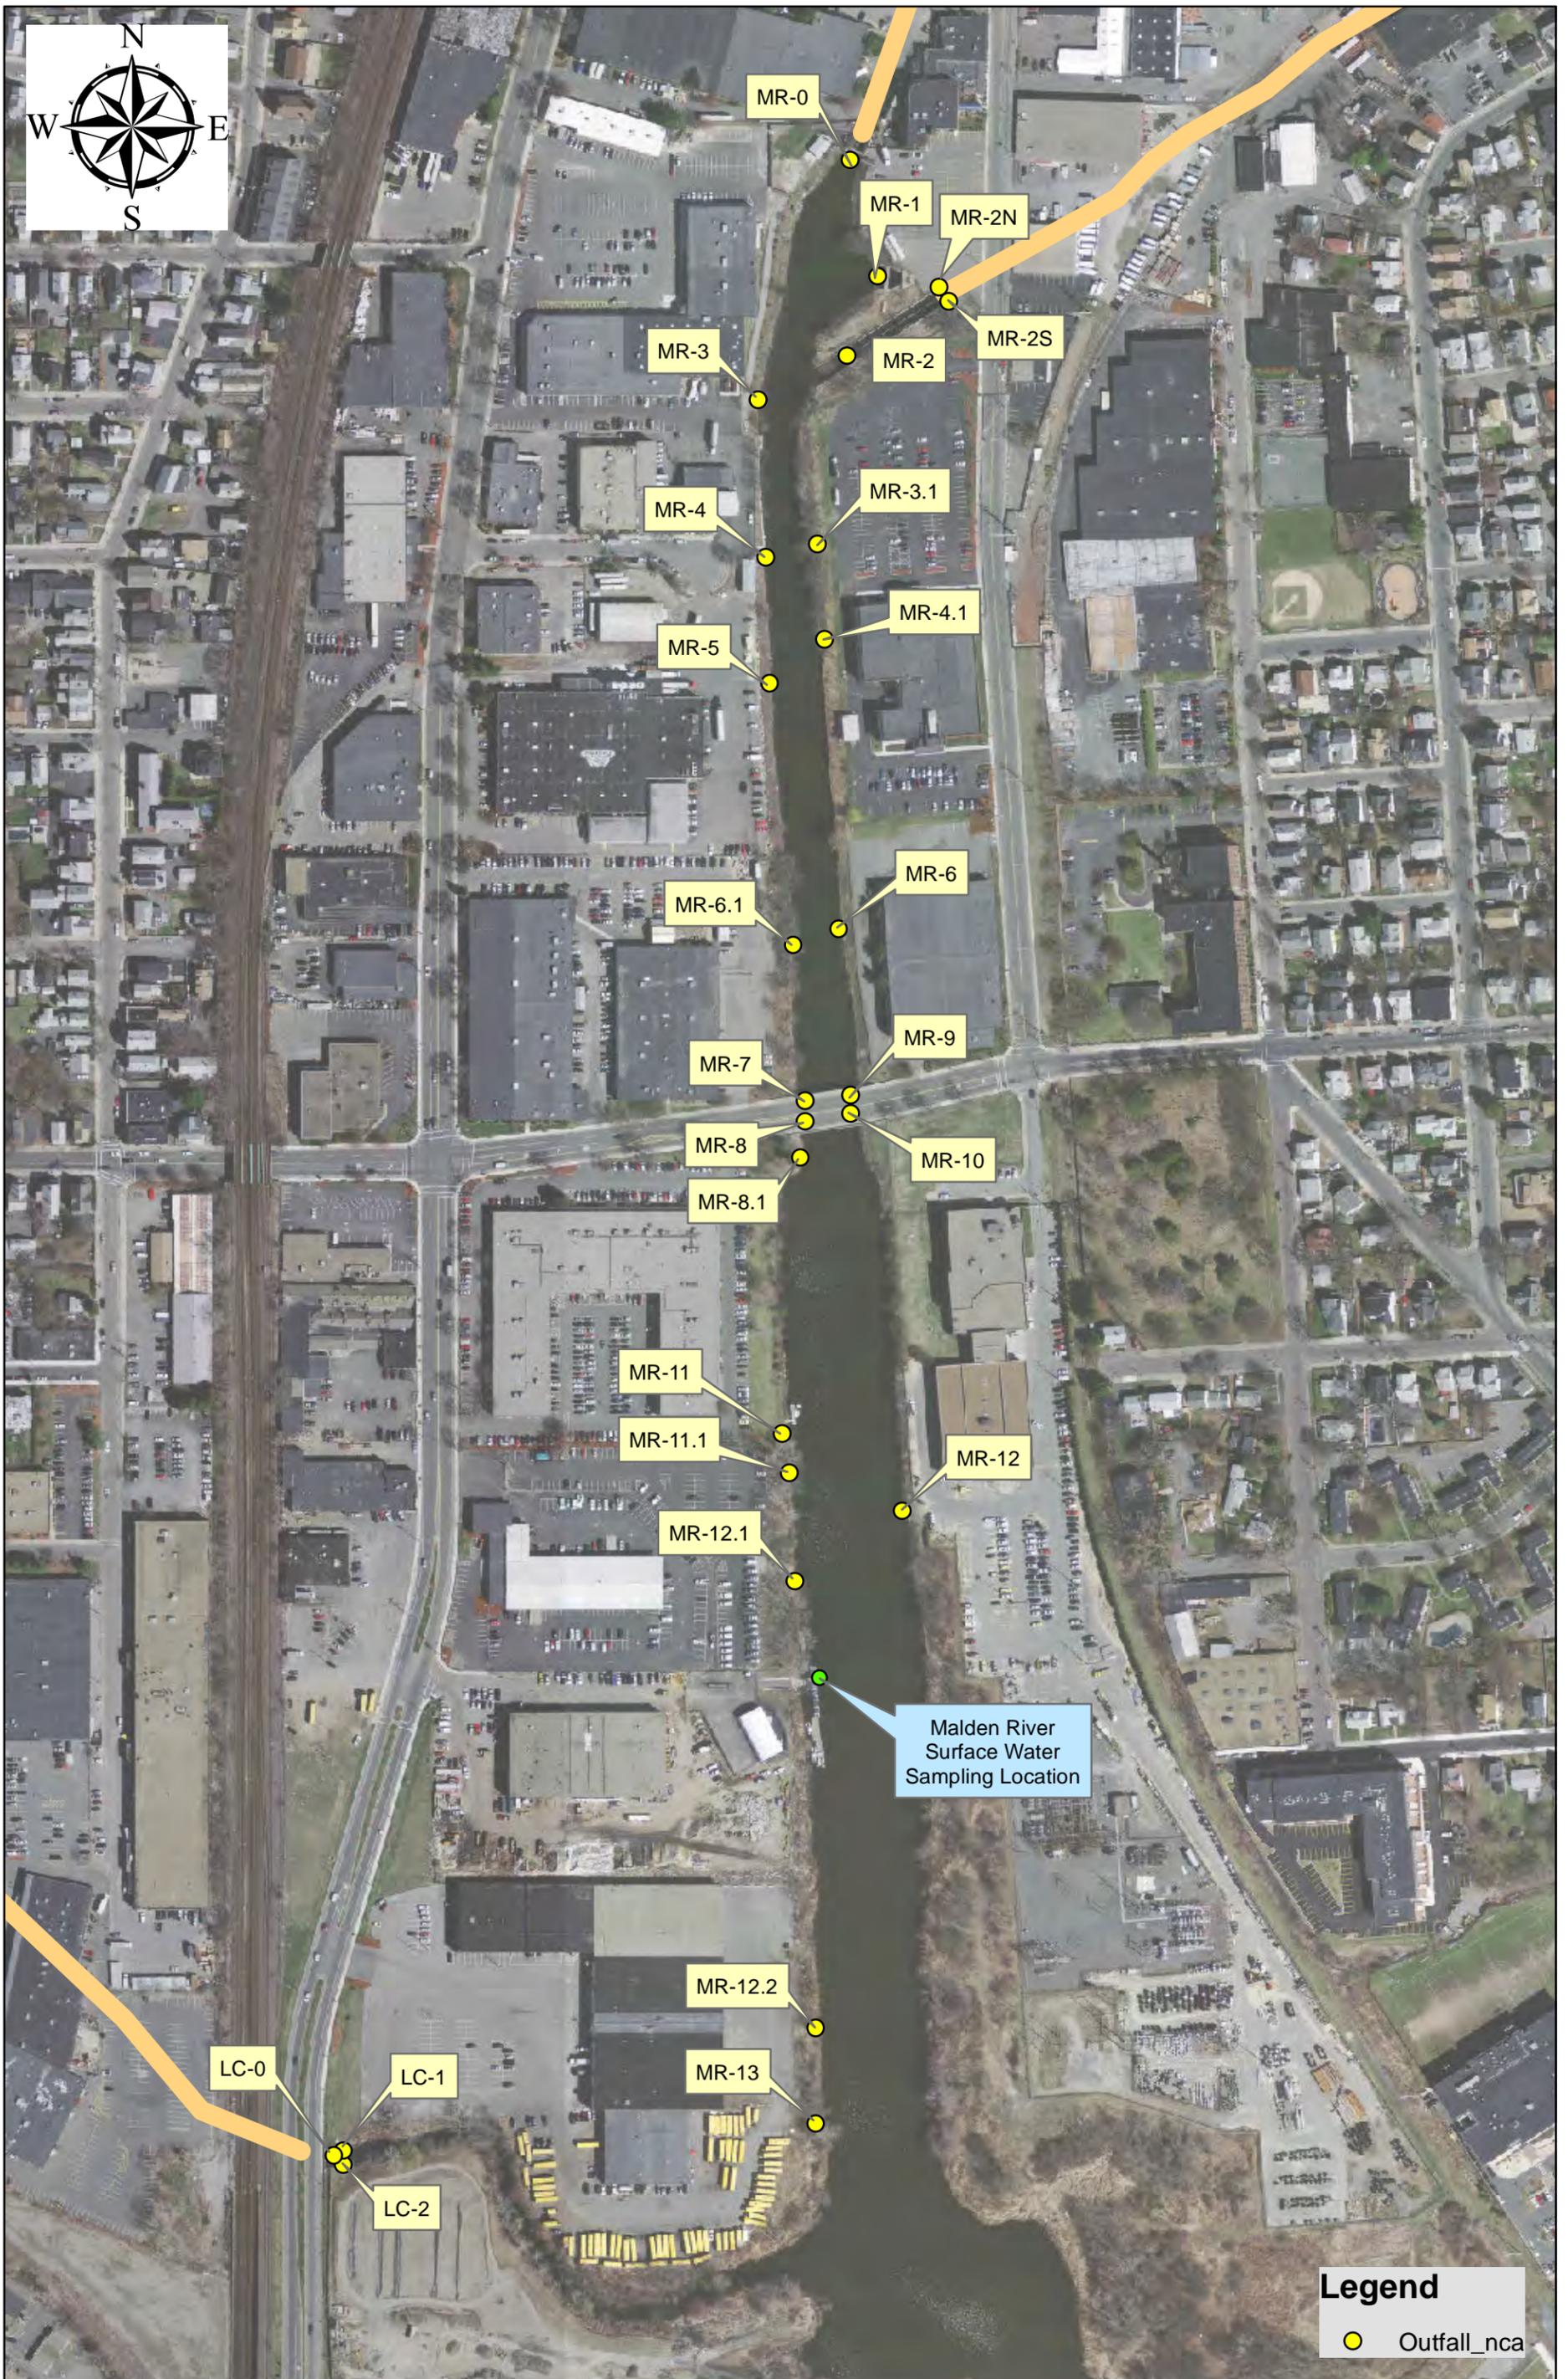
**Figure 5 - Malden River Outfalls**

As shown on Table 4.0, six (6) Malden River outfalls were found to be flowing on 30 November 2016, with high E. coli concentrations encountered at MR-4.1 (870 MPN/100ml) and MR-8 (7,000 MPN/100ml). A comparison of the wet weather concentrations with dry weather levels (Table 3.0) at these two locations reveals that no flow has been observed at MR-4.1 during dry weather conditions, while flow was observed at MR-8 during the latest dry weather event, the bacteria level was only 5.2 MPN/100ml. In addition to the outfalls, base flow wet weather samples were collected from Little Creek and the Saugus Branch Culvert headwall. Elevated bacteria levels were detected at all three (3) locations, with the highest concentration (4,900 MPN/100ml) detected at the southern Saugus Branch Culvert headwall (MR-2S). It should be noted that little to no flow was observed at these locations during the sampling event.

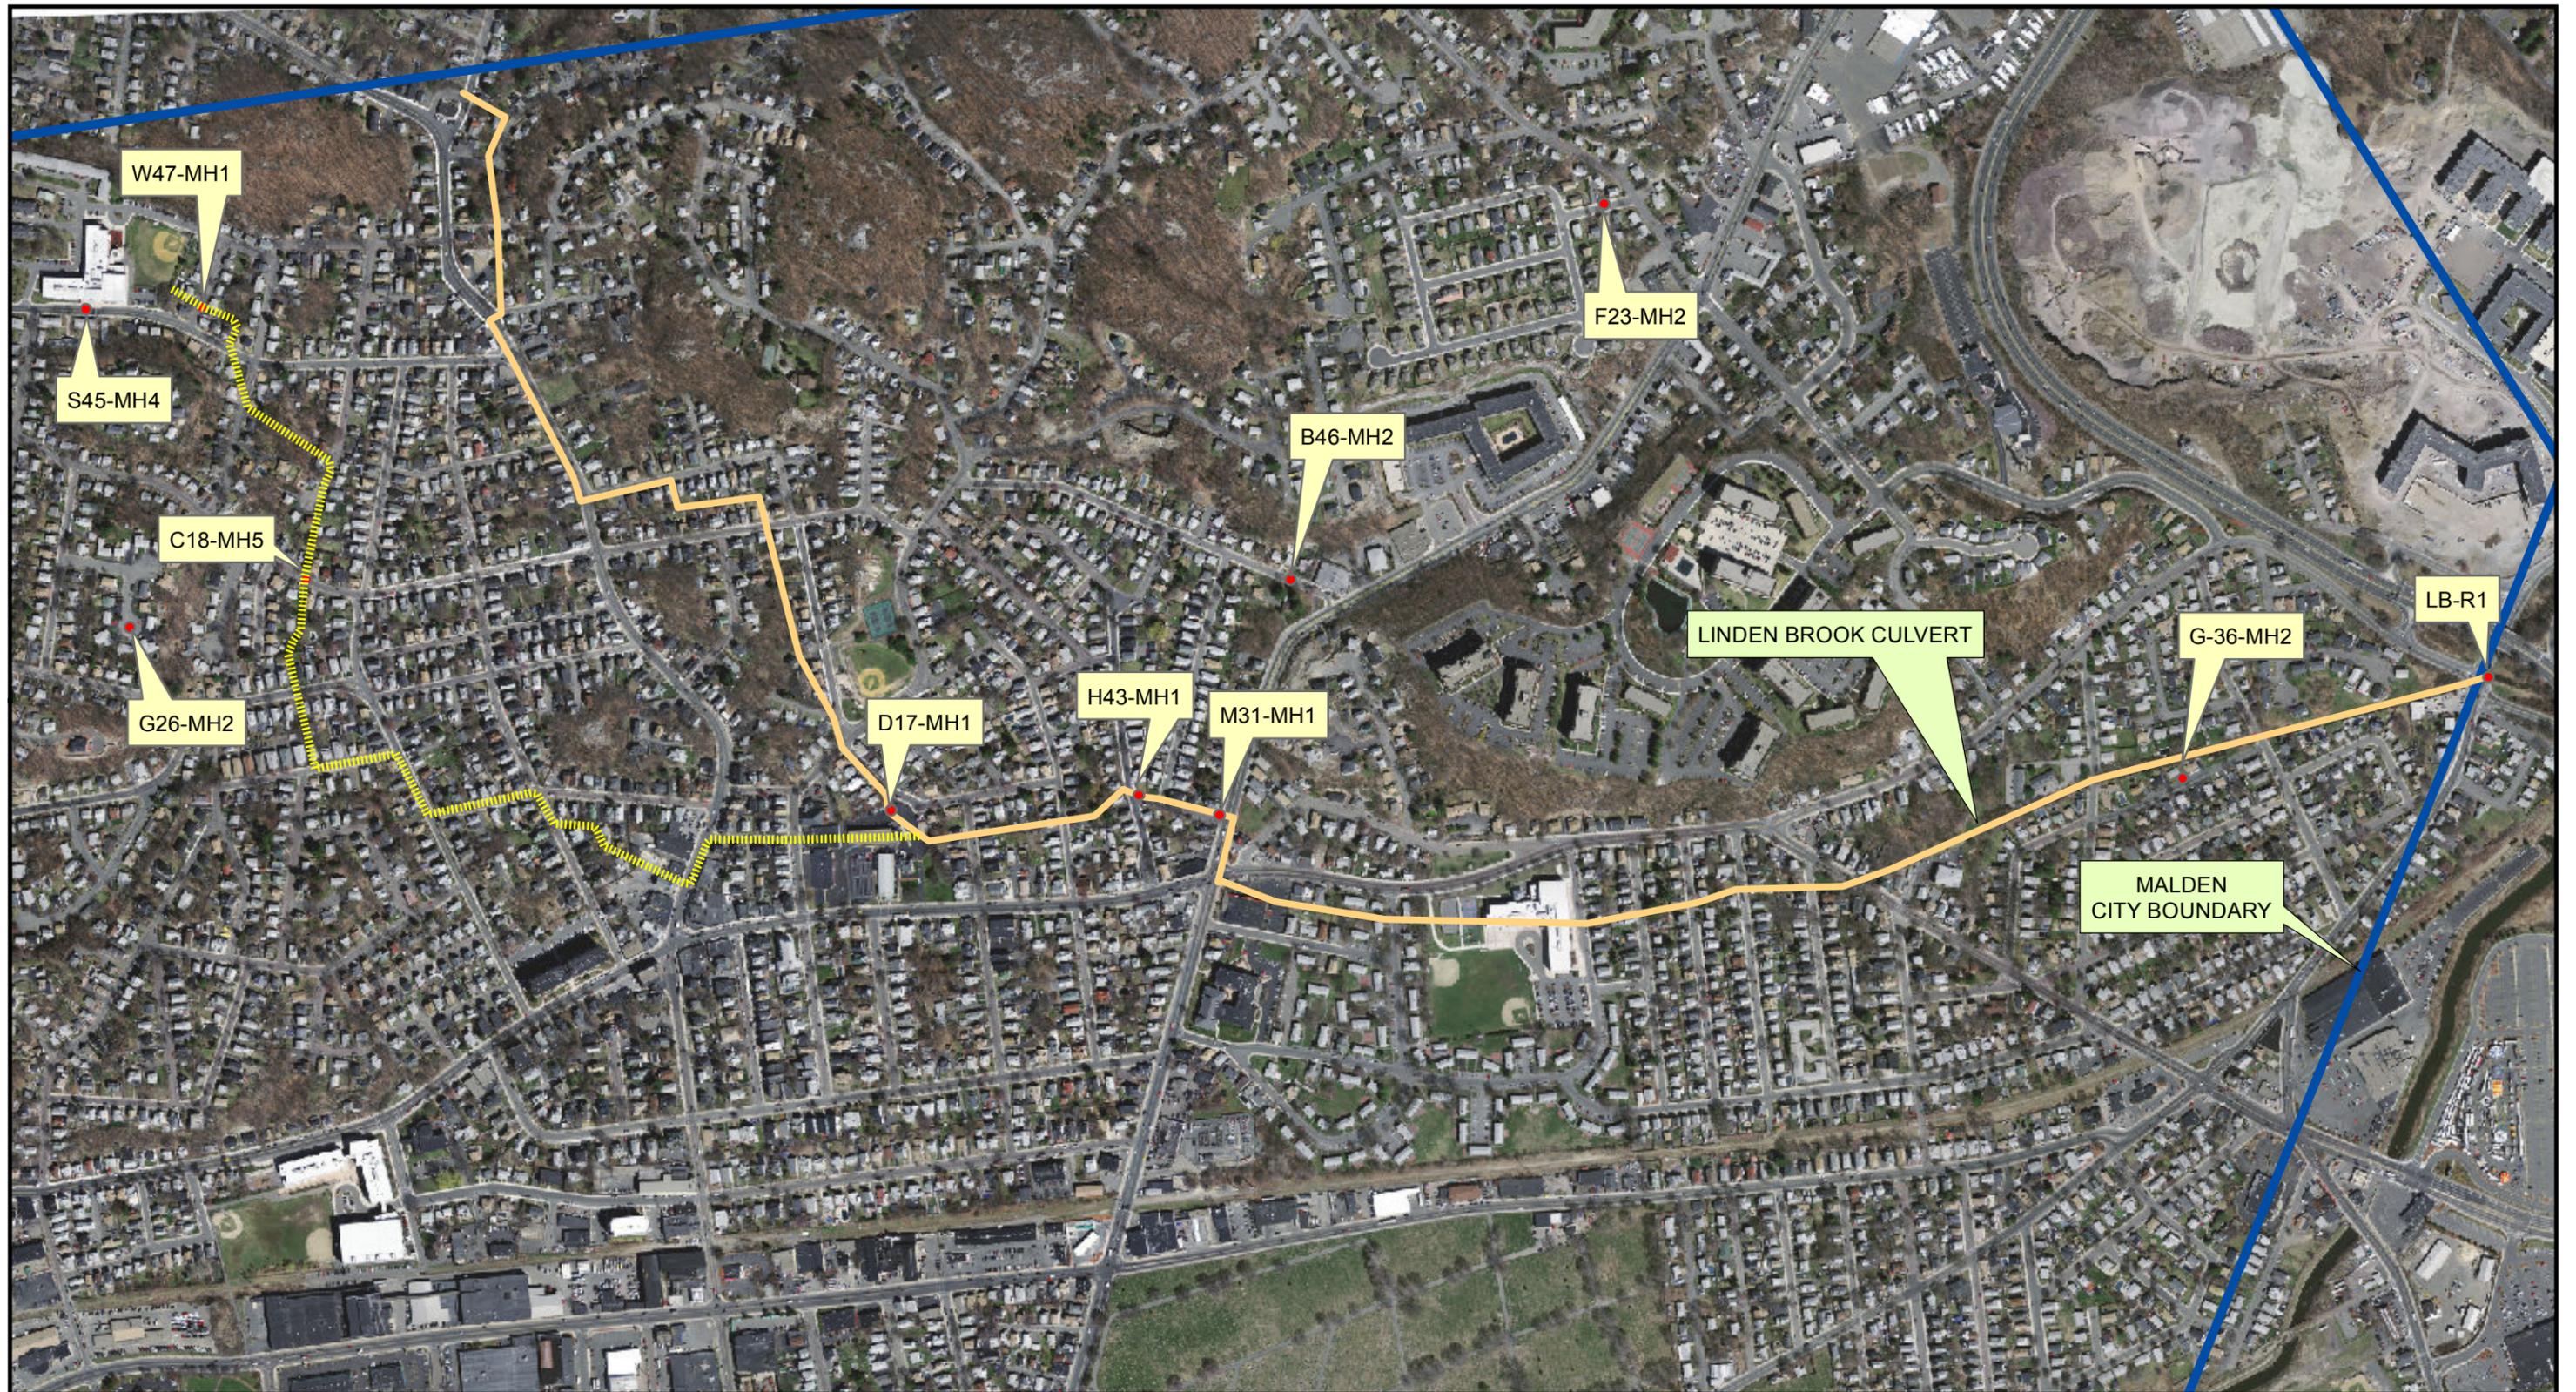
**Figure 9 - Dry and Wet Weather Sampling Program-Linden Brook**  
 MALDEN, MASSACHUSETTS

Linden Brook Culvert is the major stormwater conveyance network located in northeasterly portions of the City. Dry weather inspections have revealed base flow throughout the culvert at all times, with E. coli levels detected historically within the mid-portion of the culvert, at manhole H43-MH1, located on Home Street (Figure 9). Flow isolation studies performed to date within this portion of the City had not revealed any specific source conditions for the results of prior sampling. In an effort to identify source conditions, flow isolation studies have been conducted on upstream drainage connections to the Linden Brook Culvert. A dry weather flow (Flow # 18), was identified in the areas of Cherry and Gilbert Streets, which contributes flows from the northern and central portions of Malden to the Linden Brook Culvert (Figure 9).

An initial dry weather flow sample collected from drainage manhole (C18-MH5) located on Cherry Street contained elevated E. coli levels and to further assess this condition, dry weather flows were sampled several times from this drainage manhole. In addition, several upstream dry weather flow samples were also collected from a manhole located on Winship Street (W47-MH1). Reference to Table 3.0 and Figure 9, indicates that the E. coli levels encountered at both drainage manholes contained high bacterial levels during each of the sampling events. Although it does not appear that the bacteria levels encountered at Cherry and Winship Streets are source conditions that impact flows within central portions of the Linden Brook Culvert at Home Street, additional characterization of the Cherry/Winship Street flow and Linden Brook Culvert base flow will be continued next reporting period.

During a September 2012 sampling event, conducted with representatives of the USEPA, a water sample was collected from outfall LBR-1 (Figure 9), located in Revere, at which time distinct indications of sewage odors were noted. Consistent with the identification of strong sewage odors, significantly elevated levels of E. coli (>241,920 MPN/100 ml) were detected in sample LBR-1. To assess this condition and as described in prior status reports, the City of Malden contracted with National Water Main Cleaning Company, under the supervision of CDM Smith. As summarized previously, CDM Smith, believed that the line blockage was due to grease build up and may have been a crucial factor for the conditions identified at LBR-1, in addition to a “minor” defect in the form of a leaky joint.

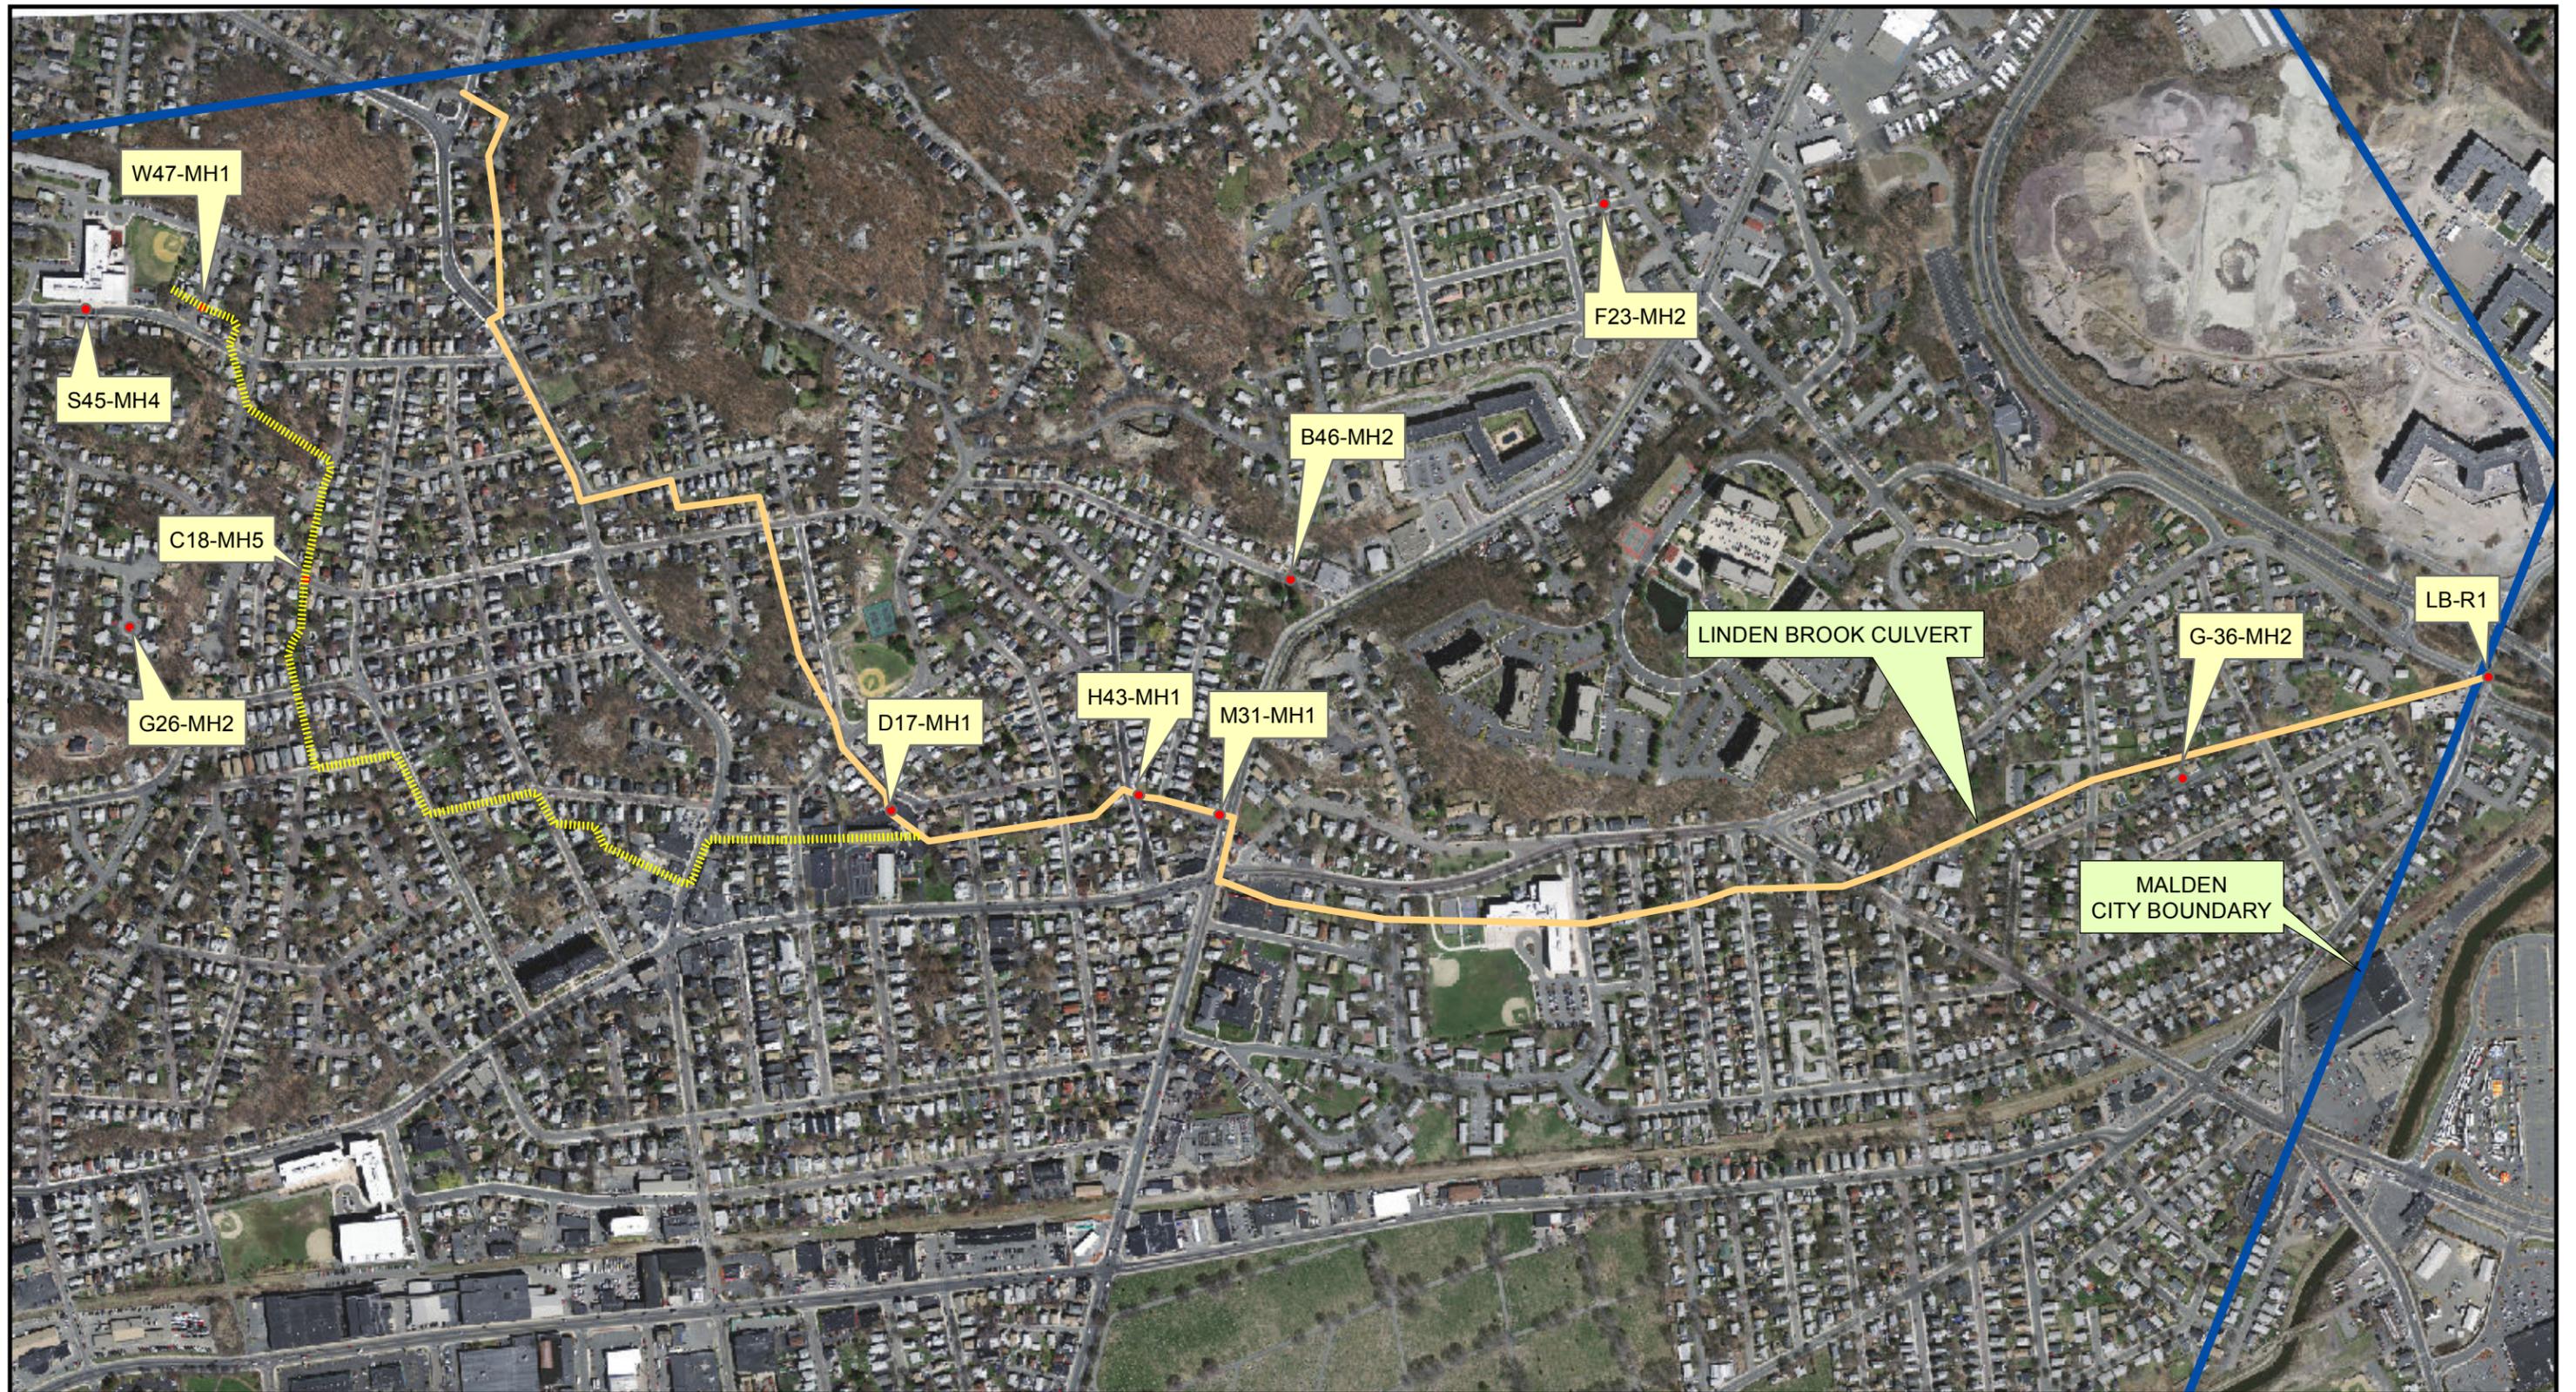
**Figure 9 - Dry and Wet Weather Sampling Program-Linden Brook**  
 MALDEN, MASSACHUSETTS

Linden Brook Culvert is the major stormwater conveyance network located in northeasterly portions of the City. Dry weather inspections have revealed base flow throughout the culvert at all times, with E. coli levels detected historically within the mid-portion of the culvert, at manhole H43-MH1, located on Home Street (Figure 9). Flow isolation studies performed to date within this portion of the City had not revealed any specific source conditions for the results of prior sampling. In an effort to identify source conditions, flow isolation studies have been conducted on upstream drainage connections to the Linden Brook Culvert. A dry weather flow (Flow # 18), was identified in the areas of Cherry and Gilbert Streets, which contributes flows from the northern and central portions of Malden to the Linden Brook Culvert (Figure 9).

An initial dry weather flow sample collected from drainage manhole (C18-MH5) located on Cherry Street contained elevated E. coli levels and to further assess this condition, dry weather flows were sampled several times from this drainage manhole. In addition, several upstream dry weather flow samples were also collected from a manhole located on Winship Street (W47-MH1). Reference to Table 3.0 and Figure 9, indicates that the E. coli levels encountered at both drainage manholes contained high bacterial levels during each of the sampling events. Although it does not appear that the bacteria levels encountered at Cherry and Winship Streets are source conditions that impact flows within central portions of the Linden Brook Culvert at Home Street, additional characterization of the Cherry/Winship Street flow and Linden Brook Culvert base flow will be continued next reporting period.
