CITY OF MANCHESTER, NEW HAMPSHIRE

Stormwater Management Program

Annual Report

May 1, 2010 through April 30, 2011

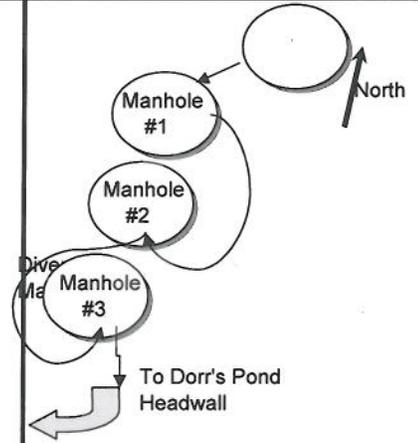
Tank Name **Dorrs Pond - Headwall - 12' - Site 6** Date: 07/30/10
 Inspector(s): Rob Robinson & Jean Paul Gilbert

Inspect **Diversion Manhole** Sand Depth <6" <12" Full
 Structural Condition: Excellent Very Good Good Fair Poor Repair

Water Appearance in 1st Port: dry odor oily H2O depth/in. 2 - 3 ft.
 Depth of sand: 1"- 3" 4"- 6" 7"- 9" 10"- 12" 1 - 2 feet > 2ft.
 Does the sand seem to be evenly distributed throughout the tank bottom? YES NO
 Structural Condition: Excellent Very Good Good Fair Poor Repair
 Weed/brush growth around tank: None Little Moderate Heavy

Water Appearance in 1st Port: dry odor oily H2O depth/in. 2 - 3 ft.
 Depth of sand: 1"- 3" 4"- 6" 7"- 9" 10"- 12" 1 - 2 feet > 2ft.
 Does the sand seem to be evenly distributed throughout the tank bottom? YES NO
 Structural Condition: Excellent Very Good Good Fair Poor Repair

Recommendations: Clean the first and third chambers.

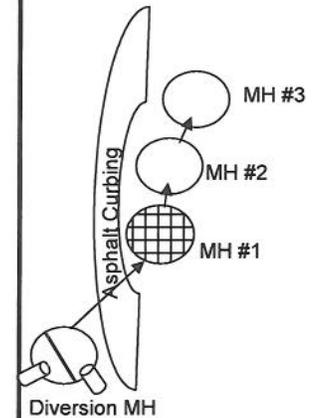
Tank Name **Dorrs Pond - Opp Papa Gino's - Site 4** Date: 07/30/10 **17' 5"**
 Inspector(s): Rob Robinson & Jean Paul Gilbert

Inspect Diversion Manhole Sand Depth <6" <12" Full
 Structural Condition: Excellent Very Good Good Fair Poor Repair

1st Inspection Port Information
 Water Appearance in 1st Port: dry odor oily H2O depth/in. 2 - 3 ft.
 Depth of sand: 1"- 3" 4"- 6" 7"- 9" 10"- 12" 1 - 2 feet > 2ft.
 Does the sand seem to be evenly distributed throughout the tank bottom? YES NO
 Structural Condition: Excellent Very Good Good Fair Poor Repair
 Weed/brush growth around tank: None Little Moderate Heavy

2nd Inspection Port Information
 Water Appearance in 1st Port: dry odor oily H2O depth/in. 2 - 3 ft.
 Depth of sand: 1"- 3" 4"- 6" 7"- 9" 10"- 12" 1 - 2 feet > 2ft.
 Does the sand seem to be evenly distributed throughout the tank bottom? YES NO
 Structural Condition: Excellent Very Good Good Fair Poor Repair
 Weed/brush growth around tank: None Little Moderate Heavy

3rd Inspection Port Information
 Water Appearance in 1st Port: dry odor oily H2O depth/in. 2 - 3 ft.
 Depth of sand: 1"- 3" 4"- 6" 7"- 9" 10"- 12" 1 - 2 feet > 2ft.
 Does the sand seem to be evenly distributed throughout the tank bottom? YES NO
 Structural Condition: Excellent Very Good Good Fair Poor Repair
 Weed/brush growth around tank: None Little Moderate Heavy
 Recommendations: Clean the first chamber.

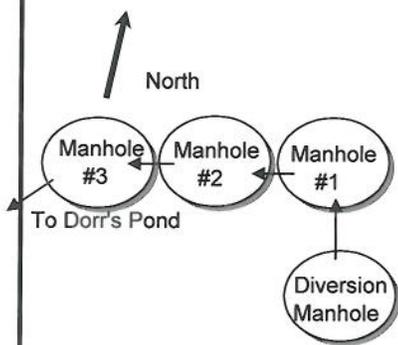
1st Inspection Port Information - Inspection Port over Swirl Concentrator
 Water Appearance in 1st Port: dry odor oily H2O depth/in. 2 - 3 ft.
 Depth of sand: 1"- 3" 4"- 6" 7"- 9" 10"- 12" 1 - 2 feet > 2ft.
 Does the sand seem to be evenly distributed throughout the tank bottom? YES NO
 Structural Condition: Excellent Very Good Good Fair Poor Repair
 Weed/brush growth around tank: None Little Moderate Heavy

2nd Inspection Port Information
 Water Appearance in 1st Port: dry odor oily H2O depth/in. 2 - 3 ft.
 Depth of sand: 1"- 3" 4"- 6" 7"- 9" 10"- 12" 1 - 2 feet > 2ft.
 Does the sand seem to be evenly distributed throughout the tank bottom? YES NO
 Structural Condition: Excellent Very Good Good Fair Poor Repair

3rd Inspection Port Information
 Water Appearance in 1st Port: dry odor oily H2O depth/in. 2 - 3 ft.
 Depth of sand: 1"- 3" 4"- 6" 7"- 9" 10"- 12" 1 - 2 feet > 2ft.
 Does the sand seem to be evenly distributed throughout the tank bottom? YES NO
 Structural Condition: Excellent Very Good Good Fair Poor Repair

Recommendations: Clean the structure. Remove the oil and grease.

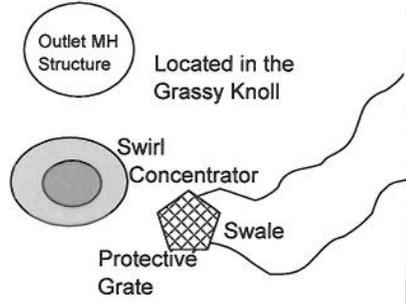
Tank Name - Crystal Lake STS Date: 07/30/10
 Inspector(s): Rob Robinson & Jean Paul Gilbert

1st Inspection Port Information
 Water Appearance in 1st Port: [] dry [] odor [] oily [X] H2O depth/in. - 1 - 2 ft
 Depth of sand: [] 1"- 3" [] 4"- 6" [X] 7"- 9" [] 10"- 12" [] 1 - 2 feet [] > 2ft.
 Does the sand seem to be evenly distributed throughout the tank bottom? [] YES [X] NO
 Structural Condition: [X] Excellent [] Very Good [] Good [] Fair [] Poor [] Repair
 Weed/brush growth around tank: [] None [X] Little [] Moderate [] Heavy

2nd Inspection Port Information
 Water Appearance in 1st Port: [] dry [] odor [] oily [X] H2O depth/in. 1 - 2 ft
 Depth of sand: [] 1"- 3" [X] 4"- 6" [] 7"- 9" [] 10"- 12" [] 1 - 2 feet [] > 2ft.
 Does the sand seem to be evenly distributed throughout the tank bottom? [] YES [X] NO
 Structural Condition: [X] Excellent [] Very Good [] Good [] Fair [] Poor [] Repair

3rd Inspection Port Information
 Water Appearance in 1st Port: [] dry [] odor [] oily [] H2O depth/in.
 Depth of sand: [X] 1"- 3" [] 4"- 6" [] 7"- 9" [] 10"- 12" [] 1 - 2 feet [] > 2ft.
 Does the sand seem to be evenly distributed throughout the tank bottom? [?] YES [] NO
 Structural Condition: [X] Excellent [] Very Good [] Good [] Fair [] Poor [] Repair

Recommendations: Clean both chambers.

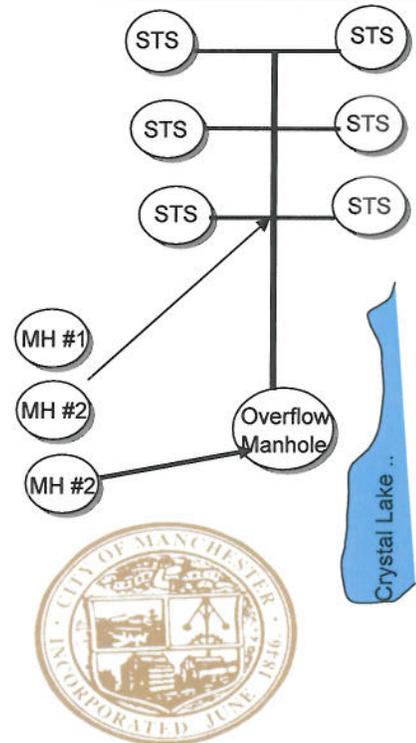
Tank Name Corning Road Date: 7/30/2010
 Inspector(s): Rob Robinson & Jean Paul Gilbert

1st Inspection Port Information Elev. To rim 12.ft
 Water Appearance in 1st Port: [] dry [] odor [] oily [X] H2O depth/in. 2 ft
 Depth of sand: [] 1"- 3" [] 4"- 6" [X] 7"- 9" [] 10"- 12" [] 1 - 2 feet [] > 2ft.
 Does the sand seem to be evenly distributed throughout the tank bottom? [X] YES [] NO
 Structural Condition: [X] Excellent [] Very Good [] Good [] Fair [] Poor [] Repair
 Weed/brush growth around tank: [X] None [] Little [] Moderate [] Heavy

Recommendations: Clean the first two chambers.

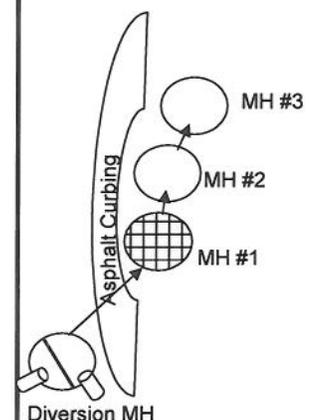
Tank Name **Dorrs Pond - Opp Papa Gino's - Site 4** Date: 11/12/10 **17' 5"**
 Inspector(s): Rob Robinson & Jean Paul Gilbert

Inspect Diversion Manhole Sand Depth <6" <12" Full
 Structural Condition: Excellent Very Good Good Fair Poor Repair

Water Appearance in 1st Port: dry odor oily H2O depth/in. 2 - 3 ft.
 Depth of sand: 1"- 3" 4"- 6" 7"- 9" 10"- 12" 1 - 2 feet > 2ft.
 Does the sand seem to be evenly distributed throughout the tank bottom? YES NO
 Structural Condition: Excellent Very Good Good Fair Poor Repair
 Weed/brush growth around tank: None Little Moderate Heavy
 Recommendations: The first chamber was cleaned.

If cleaned, how much sand/grit was removed? 1.0 Cubic Yards

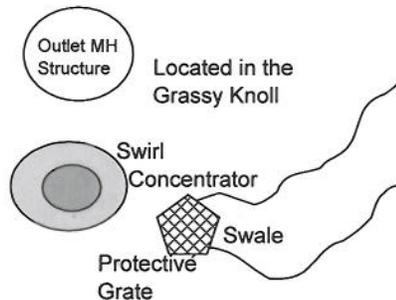
Tank Name - Crystal Lake STS Date: 11/10/10
 Inspector(s): Tim Perkins & Paul Merserve

1st Inspection Port Information
 Water Appearance in 1st Port: [] dry [] odor [] oily [X] H2O depth/in. - 1 - 2 ft
 Depth of sand: [] 1"- 3" [] 4"- 6" [X] 7"- 9" [] 10"- 12" [] 1 - 2 feet [] > 2ft.
 Does the sand seem to be evenly distributed throughout the tank bottom? [] YES [X] NO
 Structural Condition: [X] Excellent [] Very Good [] Good [] Fair [] Poor [] Repair
 Weed/brush growth around tank: [] None [X] Little [] Moderate [] Heavy

Recommendations: Cleaned on 11/10/10 and removed 3.0 cubic yards.

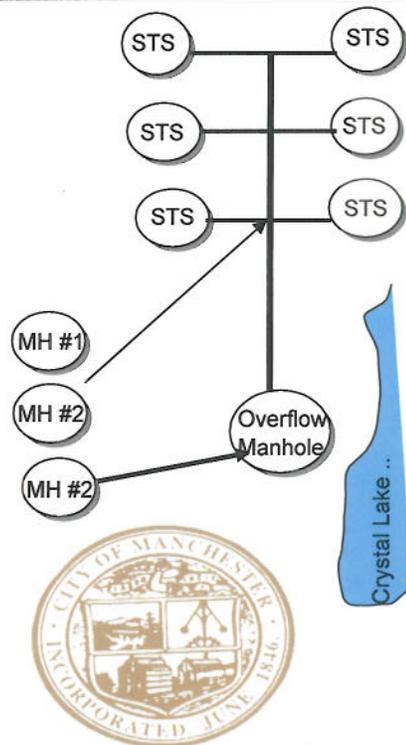
Tank Name Corning Road Date: 11/10/2010
 Inspector(s): Tim Perkins & Paul Merserve

1st Inspection Port Information Elev. To rim 12. ft
 Water Appearance in 1st Port: [] dry [] odor [] oily [X] H2O depth/in. 2 ft
 Depth of sand: [] 1"- 3" [] 4"- 6" [X] 7"- 9" [] 10"- 12" [] 1 - 2 feet [] > 2ft.
 Does the sand seem to be evenly distributed throughout the tank bottom? [X] YES [] NO
 Structural Condition: [X] Excellent [] Very Good [] Good [] Fair [] Poor [] Repair
 Weed/brush growth around tank: [X] None [] Little [] Moderate [] Heavy

If cleaned, how much sand/grit was removed? 1.0 Cubic Yard

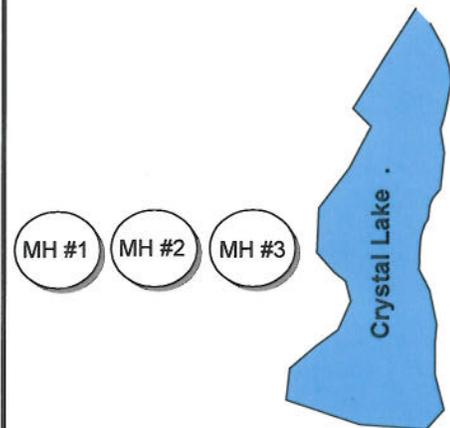
Tank Name Douglas St. - Vortechincs Date: 11/12/10 17' 5"
 Inspector(s): Rob Robinson & Jean Paul Gilbert

Inspect Diversion Manhole Sand Depth <6" <12" Full
 Structural Condition: Excellent Very Good Good Fair Poor Repair
