**REMOVAL PROGRAM
PRELIMINARY ASSESSMENT/
SITE INVESTIGATION REPORT
FOR THE
AEROVOX SITE
NEW BEDFORD, BRISTOL COUNTY, MASSACHUSETTS
2 AUGUST 2007 AND 15 THROUGH 16 AUGUST 2007**

U.S. Environmental Protection Agency
Region I
Emergency Planning and Response Branch
1 Congress Street, Suite 1100
Boston, MA 02114-2023

Weston Solutions, Inc.
Region I
Superfund Technical Assessment and Response Team III (START)
3 Riverside Drive
Andover, MA 01810

November 2007

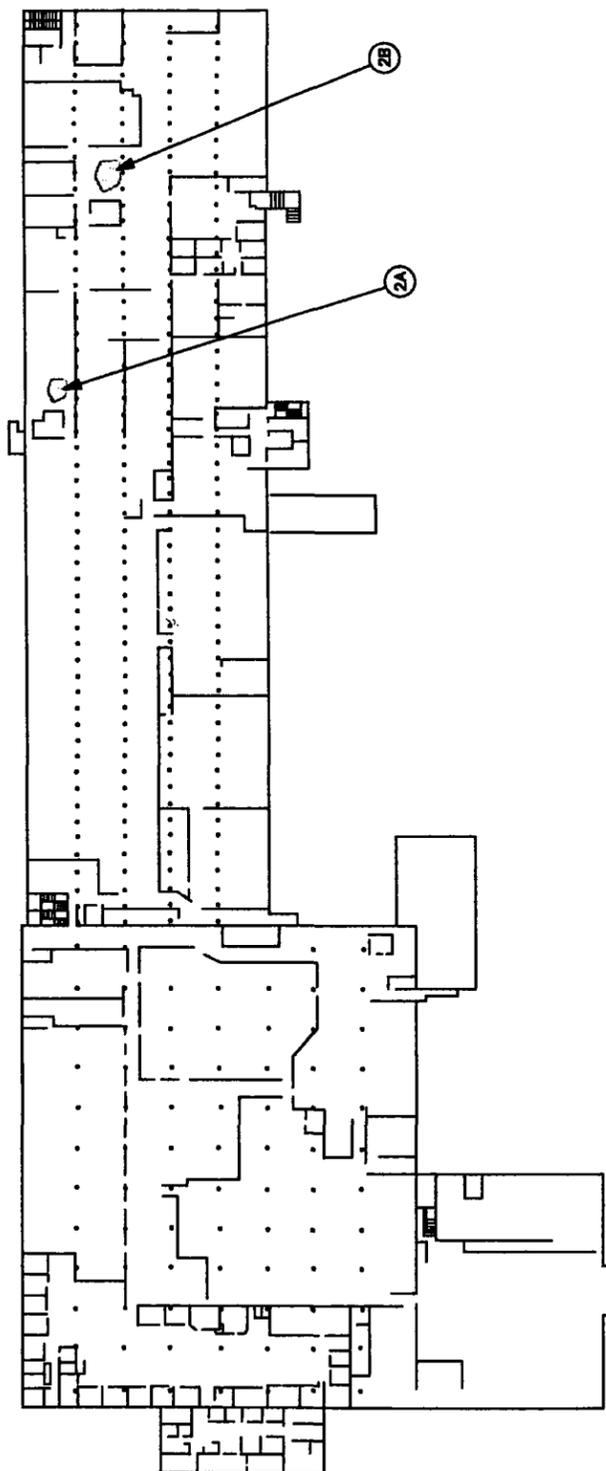
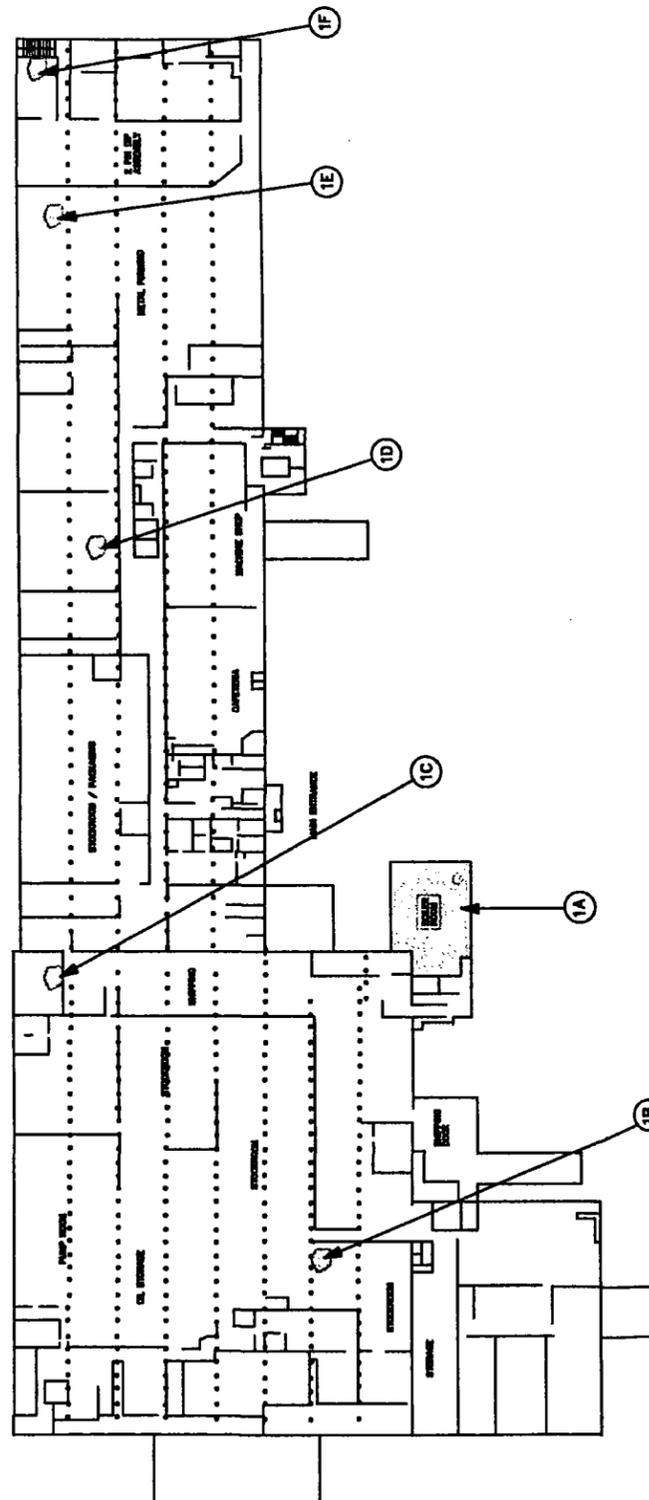
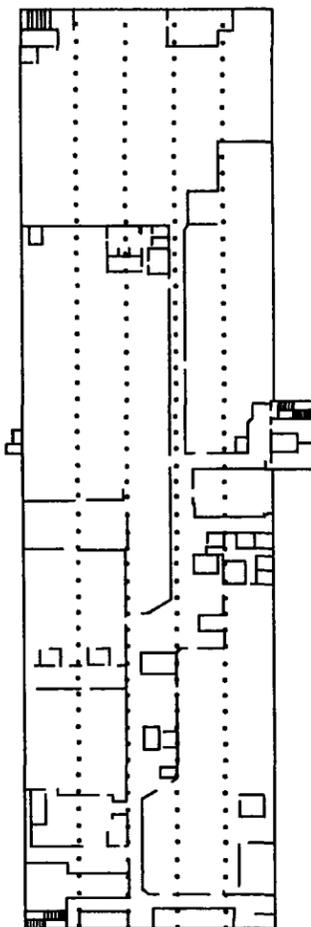
FIGURE 2E

LOCATION	DESCRIPTION
1A	BOILER ROOM - ELEVATED MERCURY READINGS (>50,000 ng) ON FLOOR AND IN PIPE CHASE.
1B	VISIBLE MERCURY ON PALLET AND FLOOR (FLOOR MARKED WITH SPRAY PAINT).
1C	DISMANTLED IGNITRONS & VISIBLE MERCURY ON FLOOR (FLOOR MARKED WITH SPRAY PAINT).
1D	VISIBLE MERCURY IN FLOORING -- ELEVATED READINGS (FLOOR MARKED WITH SPRAY PAINT).
1E	LOCATION OF TWO INTACT IGNITRONS (EQUIPMENT MARKED WITH SPRAY PAINT).
1F	CARDBOARD BOX ON PALLET CONTAINING BROKEN FLOW METER (FLOOR MARKED WITH SPRAY PAINT).
2A	FORMER LOCATION OF FIBER DRUM -- ELEVATED READINGS (FLOOR MARKED WITH SPRAY PAINT).
2B	BROKEN THERMOMETER ON FLOOR -- ELEVATED READINGS (FLOOR MARKED WITH SPRAY PAINT).

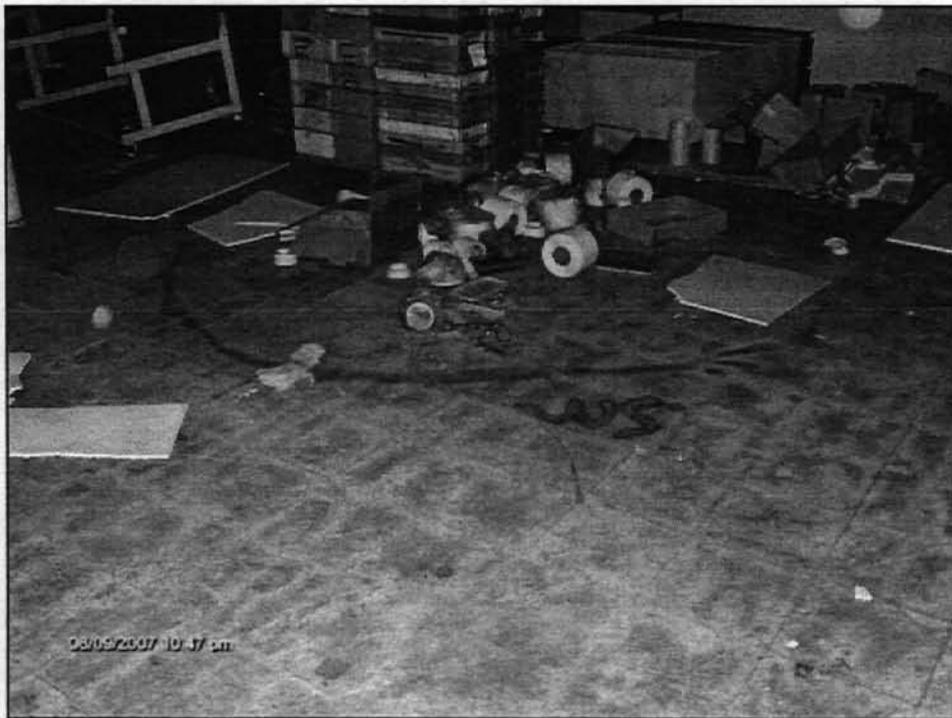
PHOTOGRAPH NO. : 22 (HPIM0534.jpg)

SCENE: View of a damaged thermometer on the second floor. Photograph taken facing southeast.

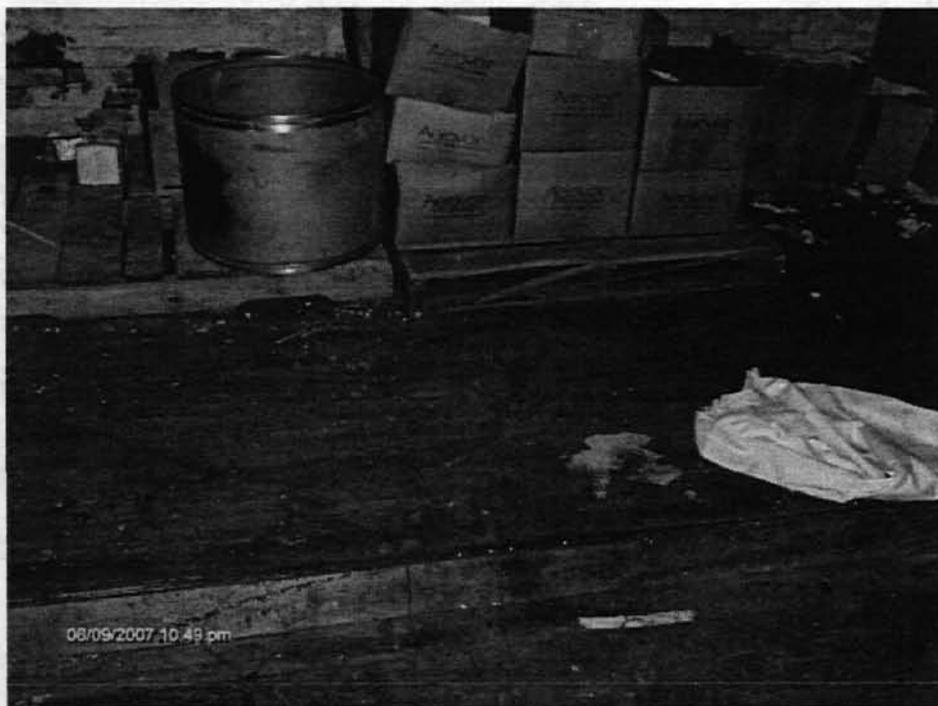
PHOTOGRAPH NO. : 23 (HPIM0535.jpg)

SCENE: View of the area (former fiber drum) with elevated readings on the second floor. Photograph taken facing southeast.

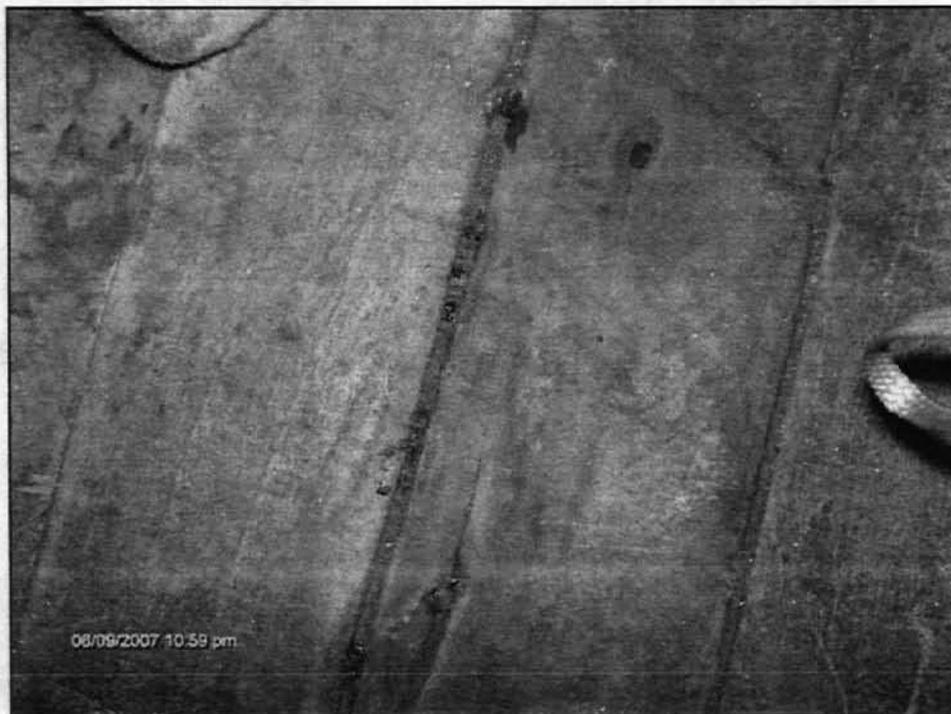
PHOTOGRAPH NO. : 25 (HPIM0541.jpg)

SCENE: View of beads of metallic mercury on the floor of the machine shop storage area of the first floor of the Aerovox building.

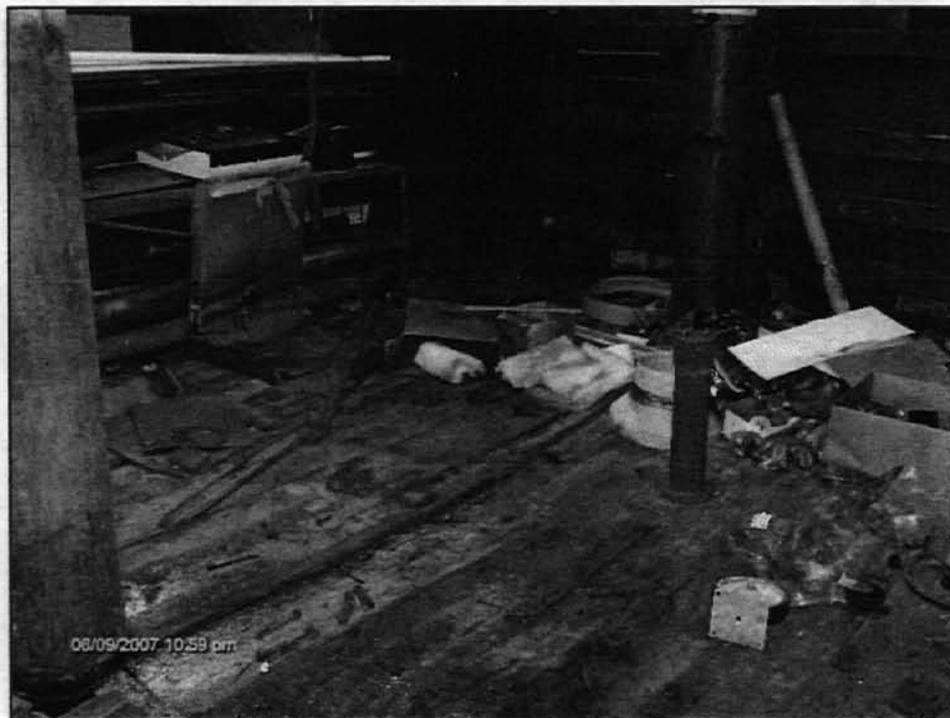
PHOTOGRAPH NO. : 26 (HPIM0539.jpg)

SCENE: View of beads of metallic mercury on the floor of the machine shop storage area of the first floor of the Aerovox building. Photograph taken facing southeast.

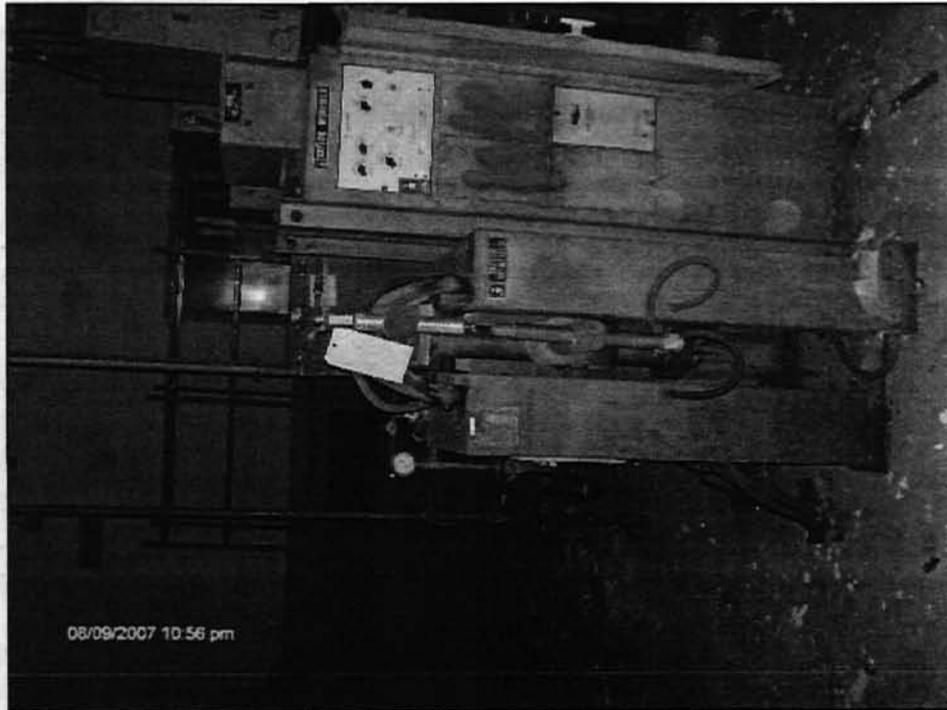
PHOTOGRAPH NO. : 27 (HPIM0537.jpg)

SCENE: View of intact ignitrons located in the northeast corner of the first floor of the Aerovox building. Photograph taken facing west.

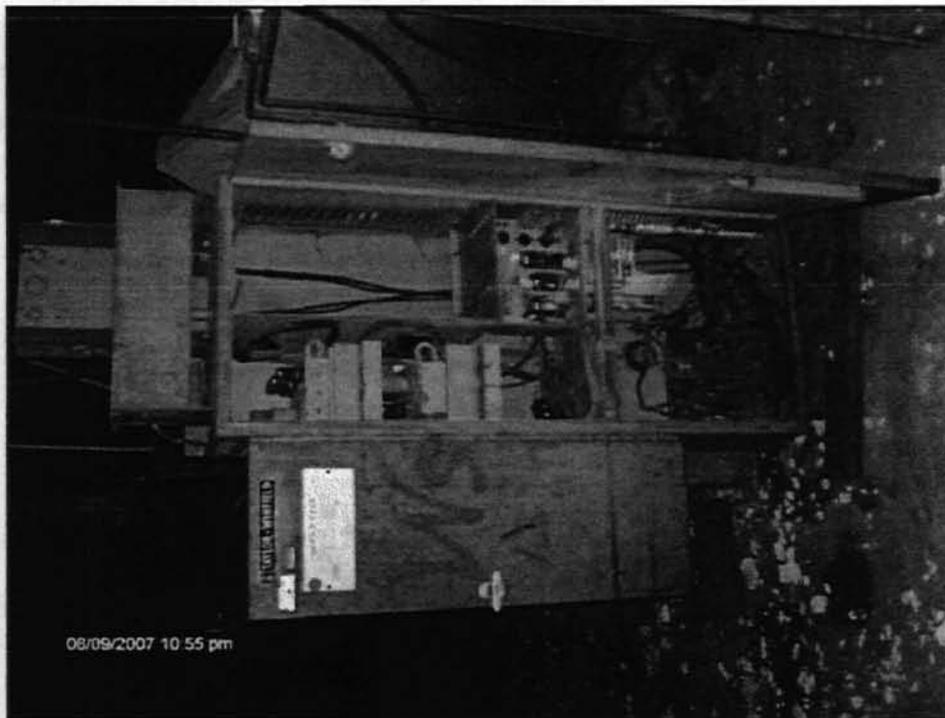
PHOTOGRAPH NO. : 28 (HPIM0538.jpg)

SCENE: View of intact ignitrons located in the northeast corner of the first floor of the Aerovox building. Photograph taken facing south.

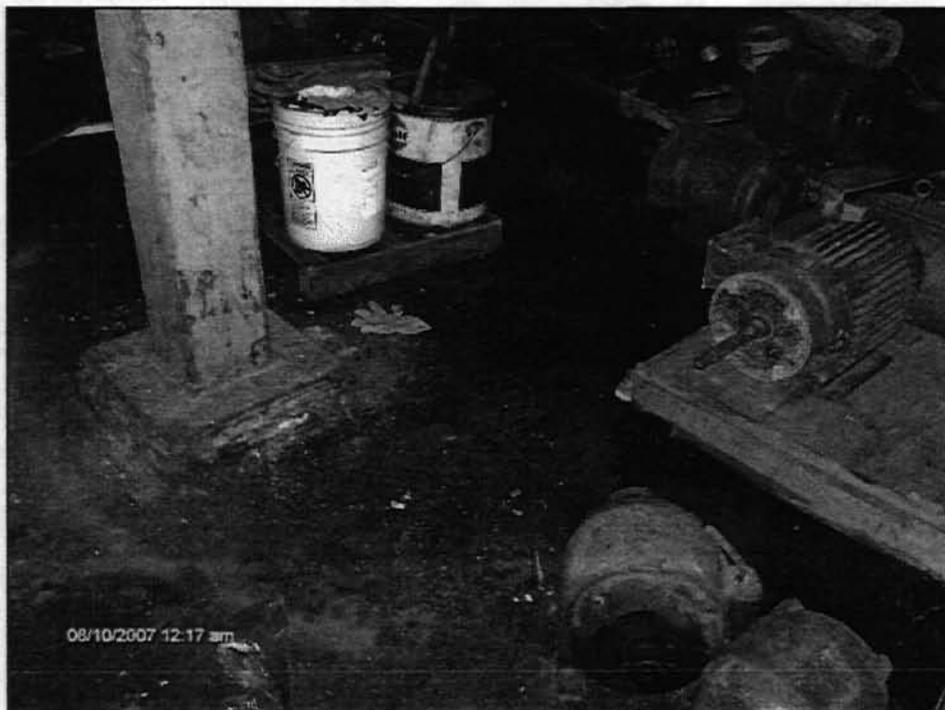
PHOTOGRAPH NO. : 31 (HPIM0552.jpg)

SCENE: View of beads of mercury in the stockroom area of the Aerovox building. Photograph taken facing southeast.

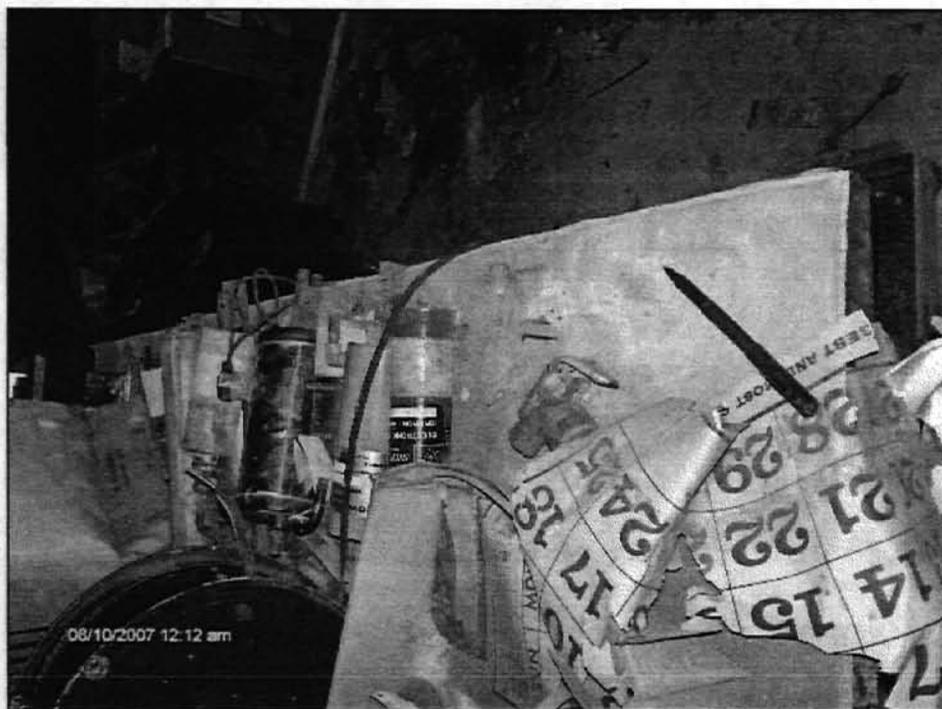
PHOTOGRAPH NO. : 35 (HPIM0543.jpg)

SCENE: View of ignitrons and mercury on a workbench in the storage room on the north side of the building. Photograph taken facing west.

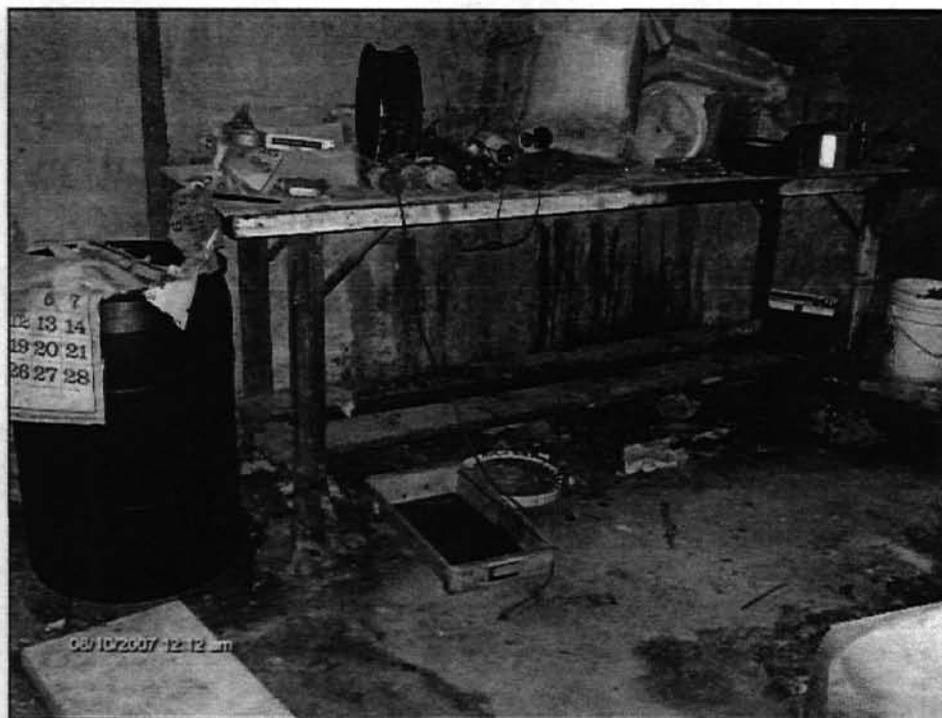
PHOTOGRAPH NO. : 36 (HPIM0542.jpg)

SCENE: View of ignitrons and mercury on a workbench in the storage room on the north side of the building. Photograph taken facing southwest.
