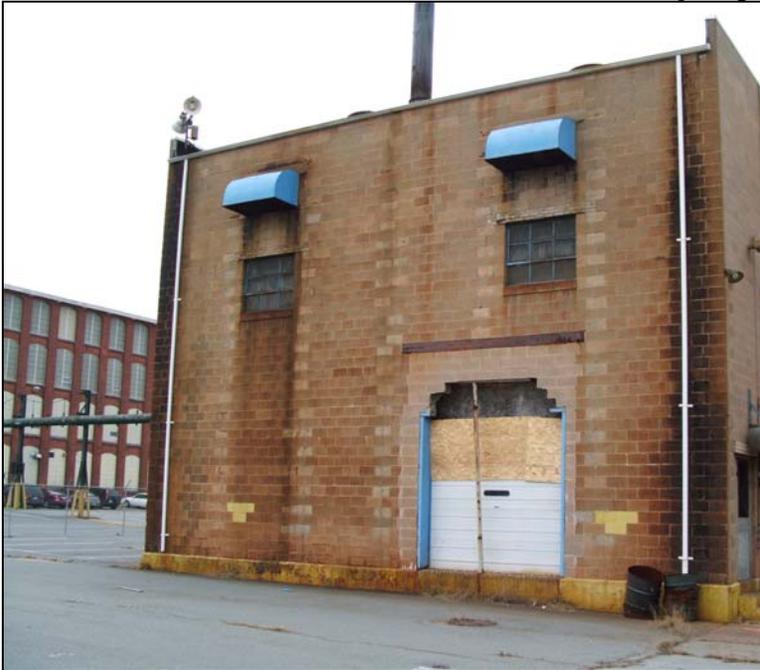
Photo P02010701

Overhead door, eastern side of boiler room, recently boarded up.

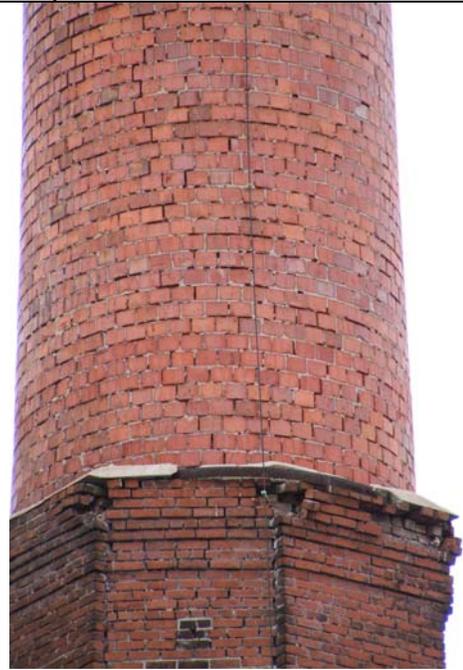
Photo P02010702

Severe erosion of mortar (pointing) in smoke stack.

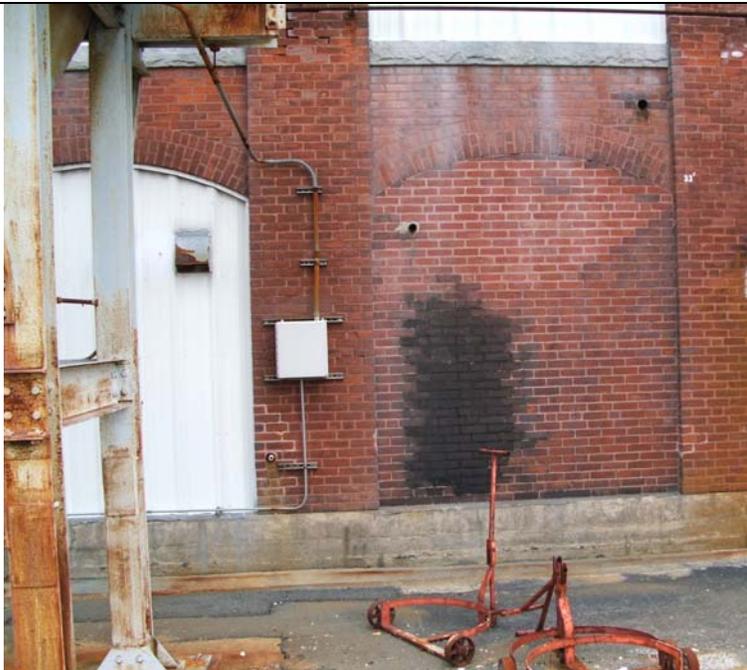
Photo P02010703

Staining of brick on south side of building.

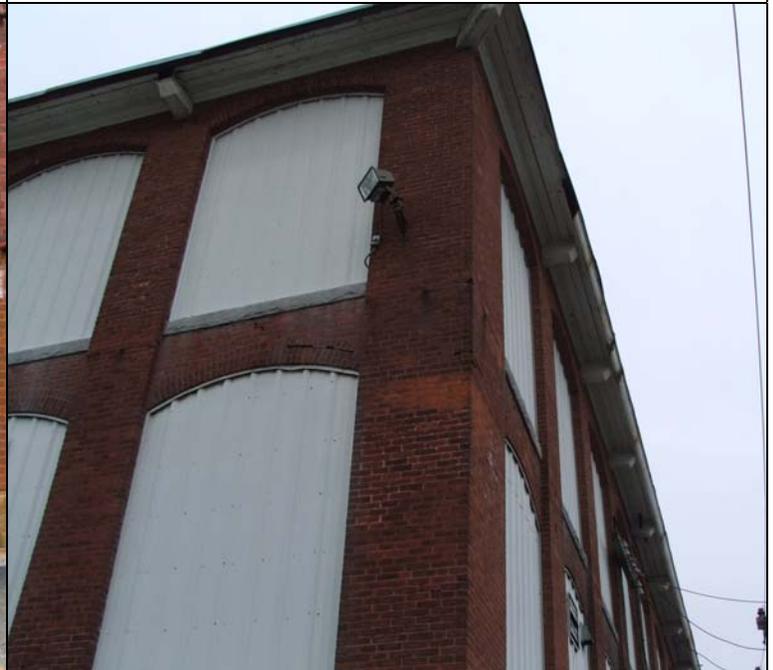
Photo P02010704

Cracking in southeast corner, under granite sill of third floor window.

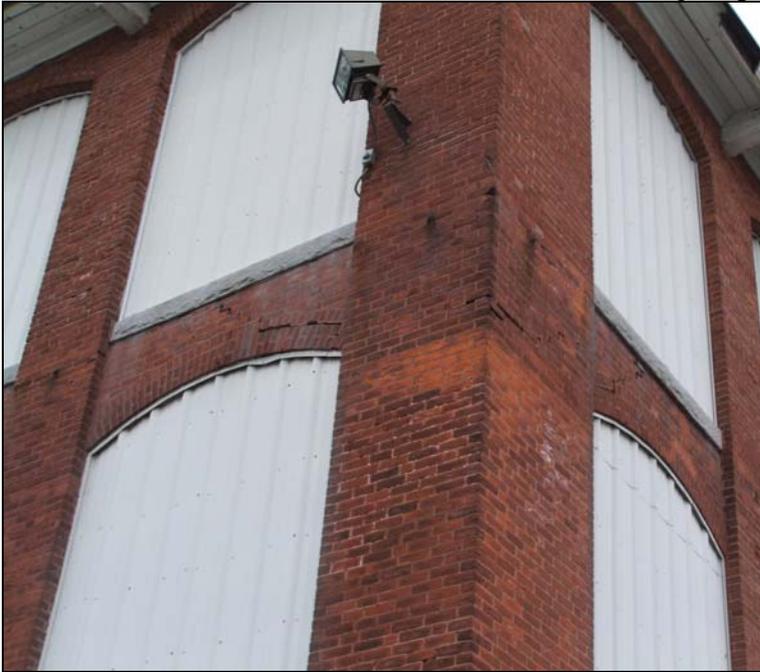
Photo P02010705

Cracking southeast corner of building, third floor.

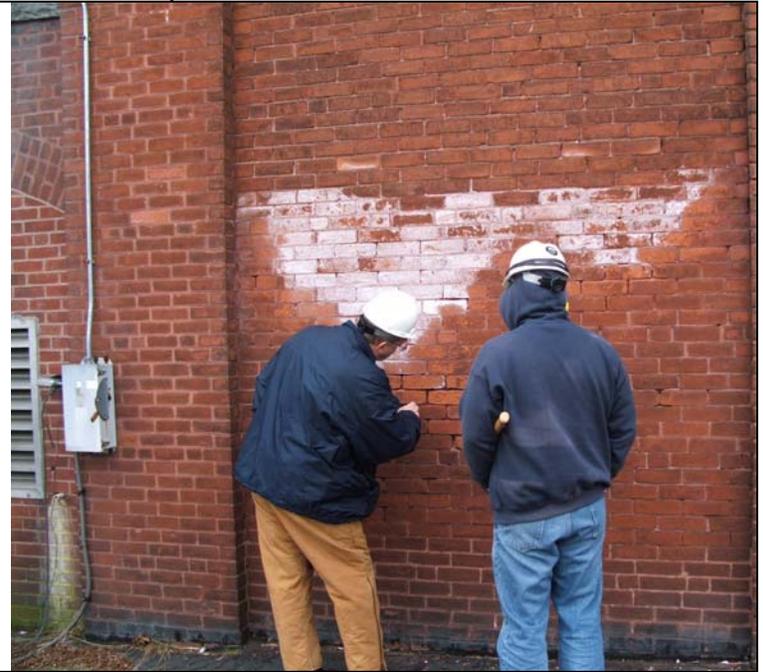
Photo P02010706

Mortar erosion eastern end of building.

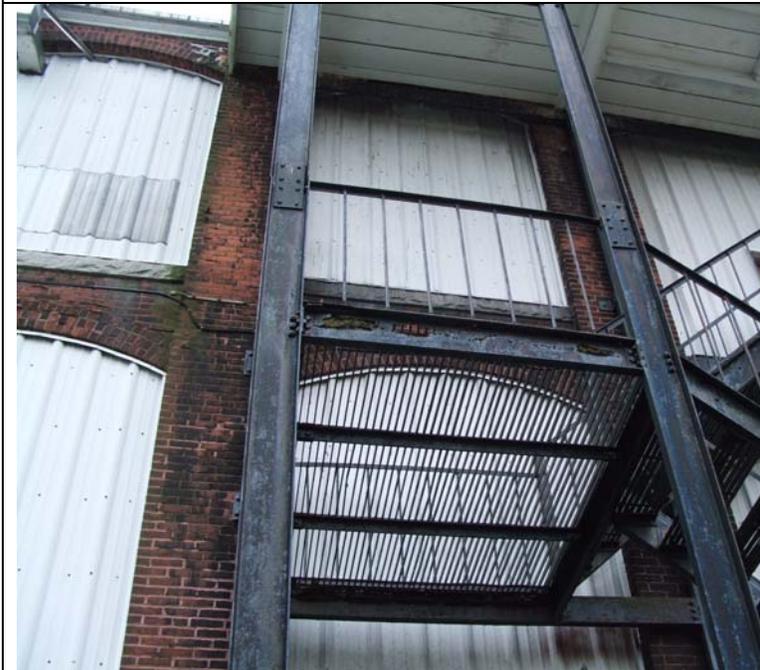
Photo P02010707

Fire escape, northern side of building, note rust holes in structural member.

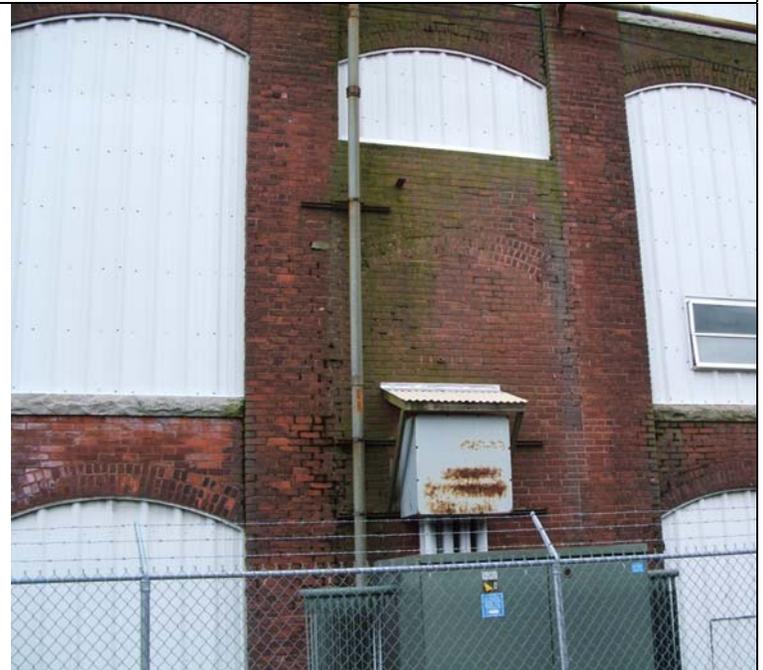
Photo P02010708

Mortar erosion and cracking on northern side of building.

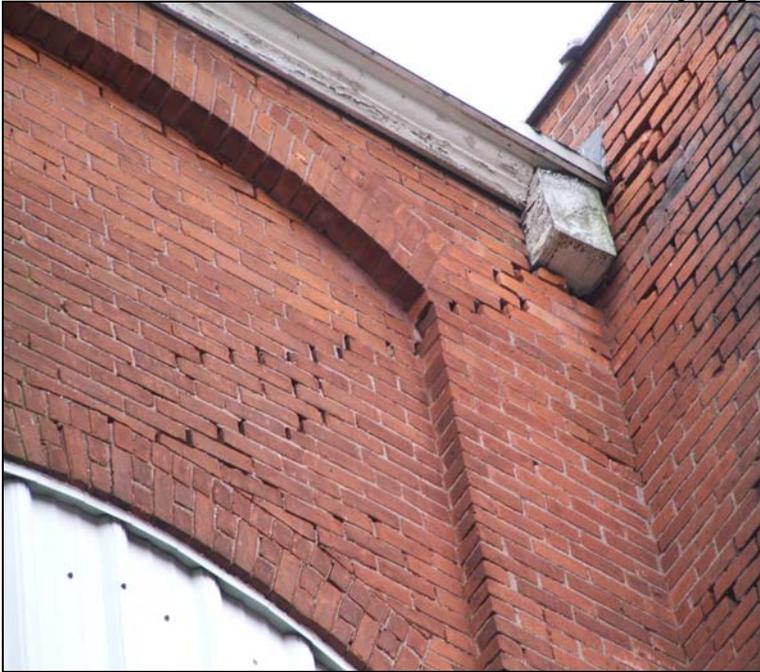
Photo P02010709

Cracking and mortar erosion, Northern side parapet at three story to two story transition.

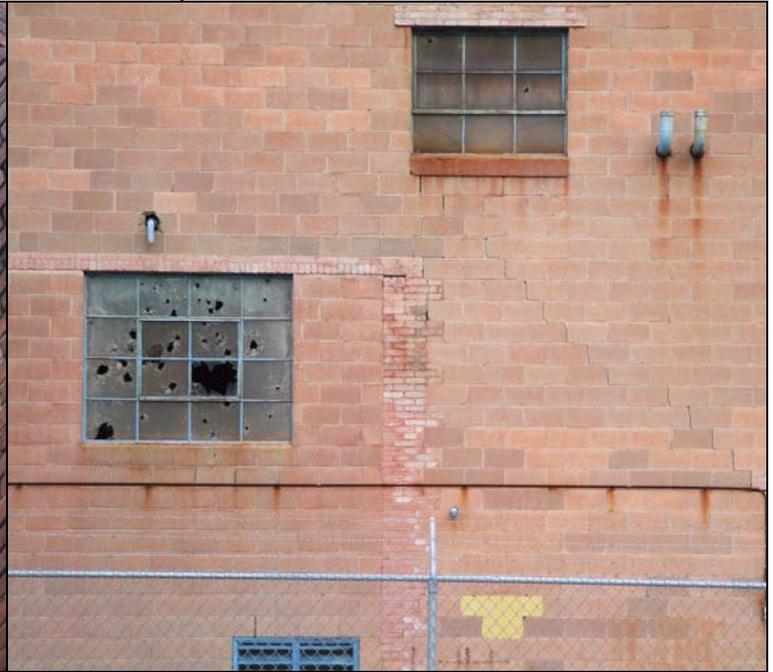
Photo P02010710

Cracking on boiler room wall, Southern side of Aerovox.

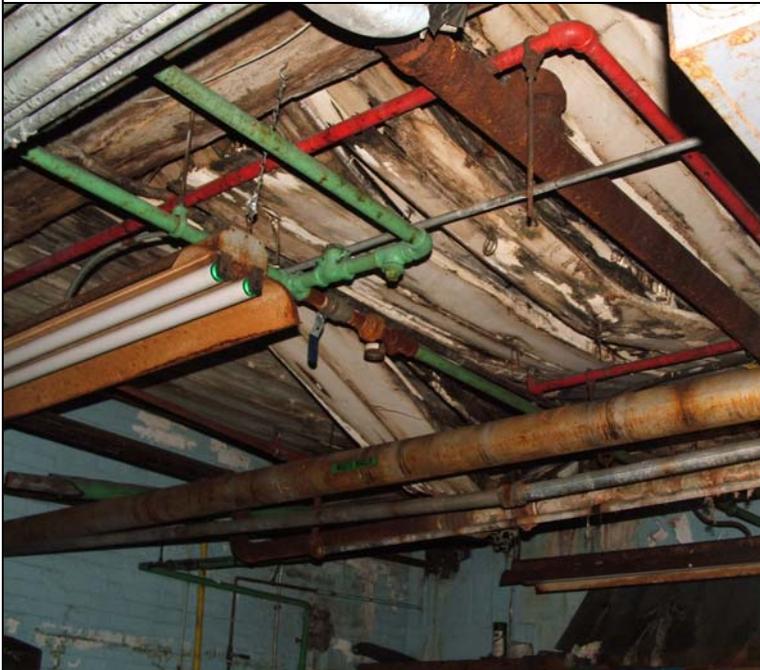
Photo P02010711

Ceiling collapsing in boiler room lockers area.

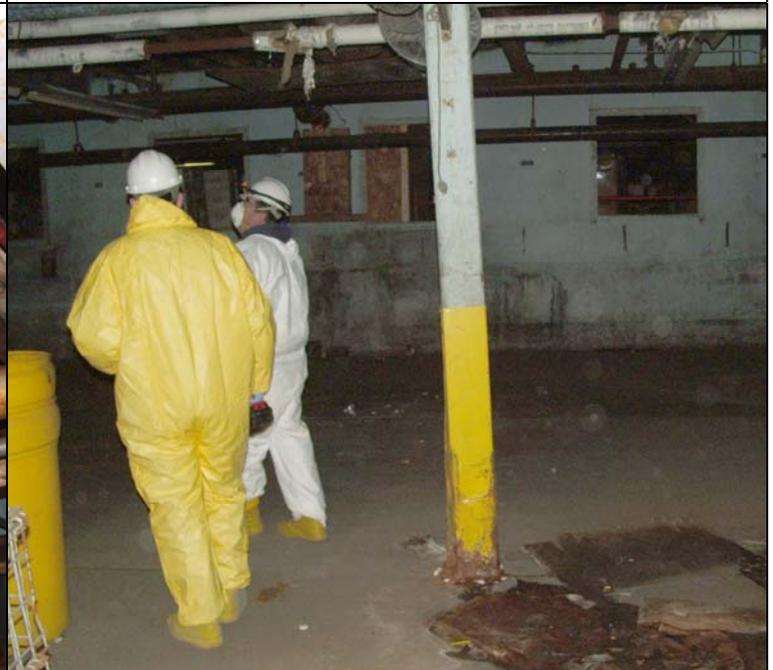
Photo P02010712

Column out of plumb in shipping department, first floor.

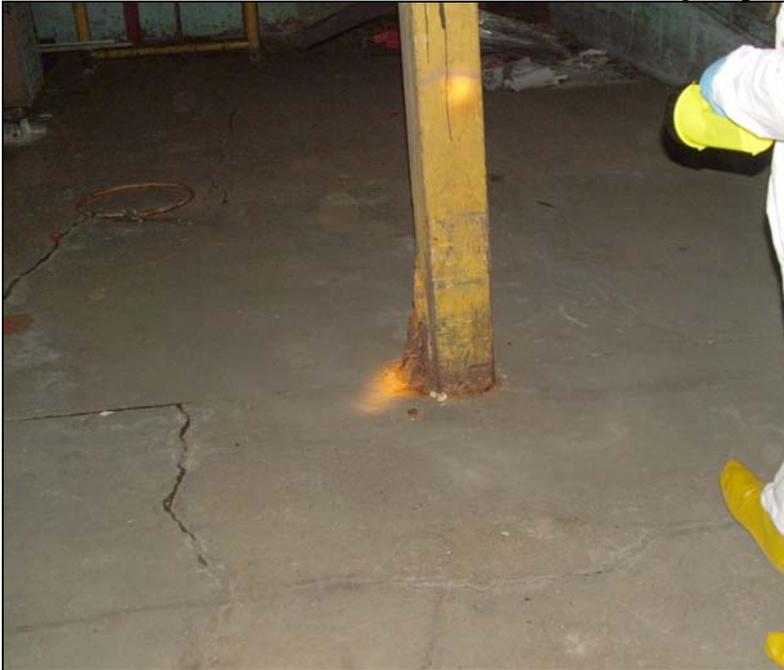
Photo P02010713

Column in shipping area off plumb and cracking.

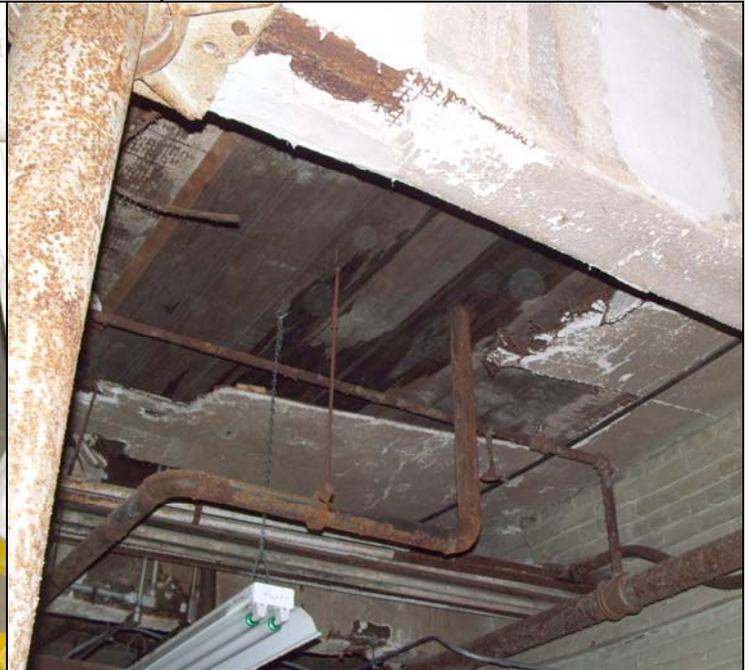
Photo P02010714

Ceiling collapse in first floor storage area (below cardboard box room).

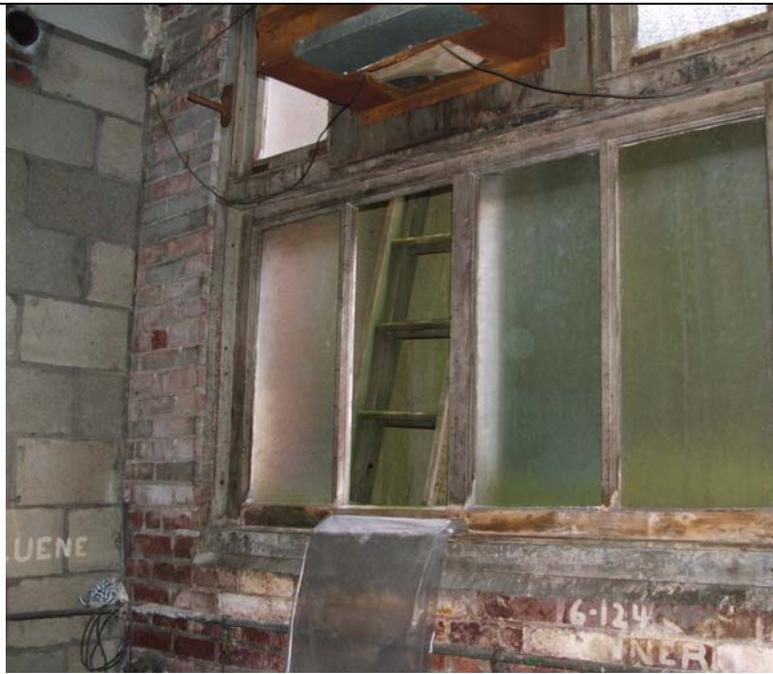
Photo P02010715

Unauthorized entry point to first floor storage area.

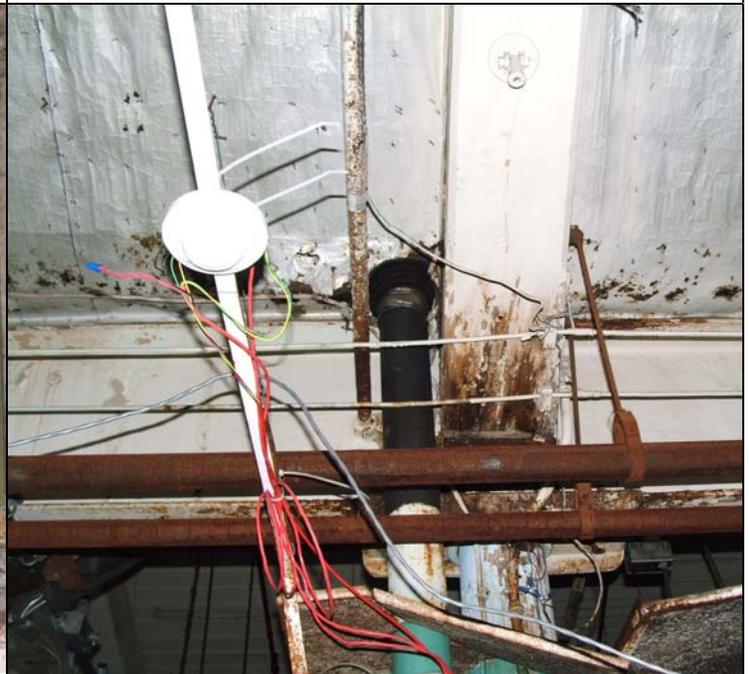
Photo P02010716

Water damage at second floor roof drain, Assembly area.

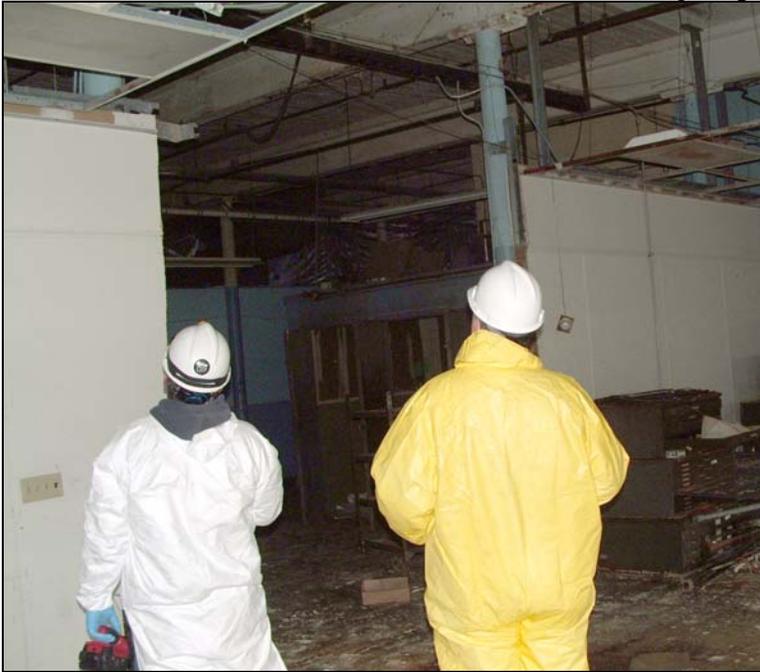
Photo P02010717

Ceiling and floor water damage third floor Special Projects room.

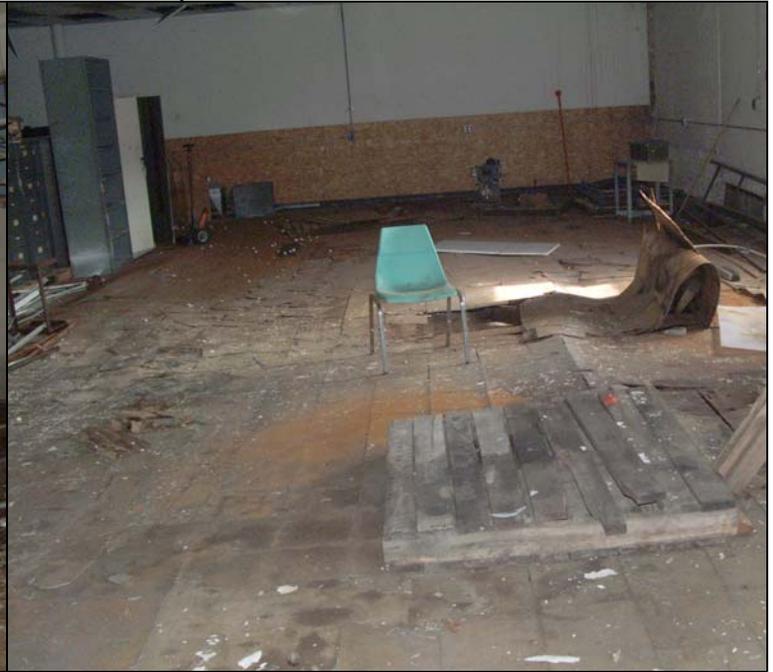
Photo P02010718

Water damage to third floor; photo does not adequately document condition, heaving of flooring approximately a foot in places.

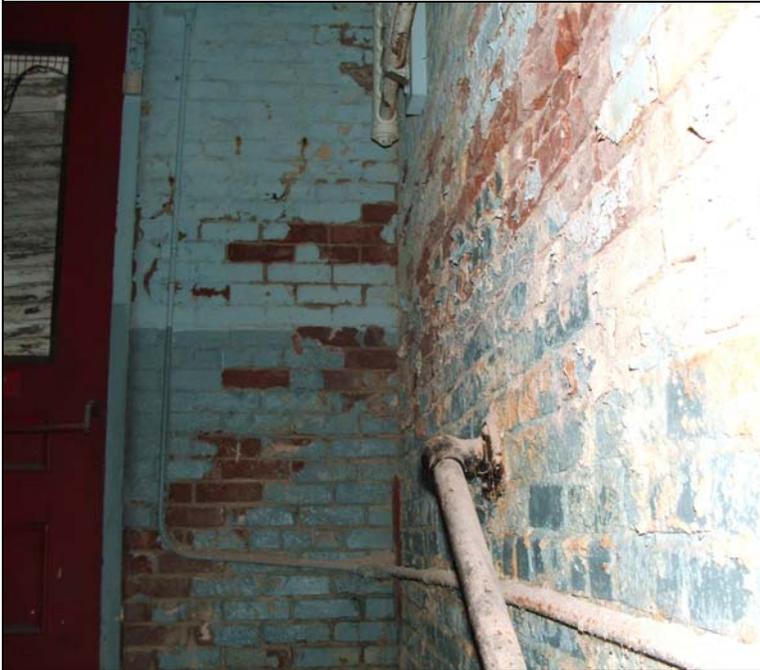
Photo P02010719

Interior paint peeling and efflorescence due to water penetration, northeastern stairwell.
