**RE: Auburn Road Landfill, Administrative Order,
Docket Number I-90-1092, Londonderry, New Hampshire**

**2012 SOURCE CONTROL
OPERATION & MAINTENANCE REPORT
AUBURN ROAD LANDFILL**

**FOR
TOWN OF LONDONDERRY, NEW HAMPSHIRE**

FEBRUARY 2013

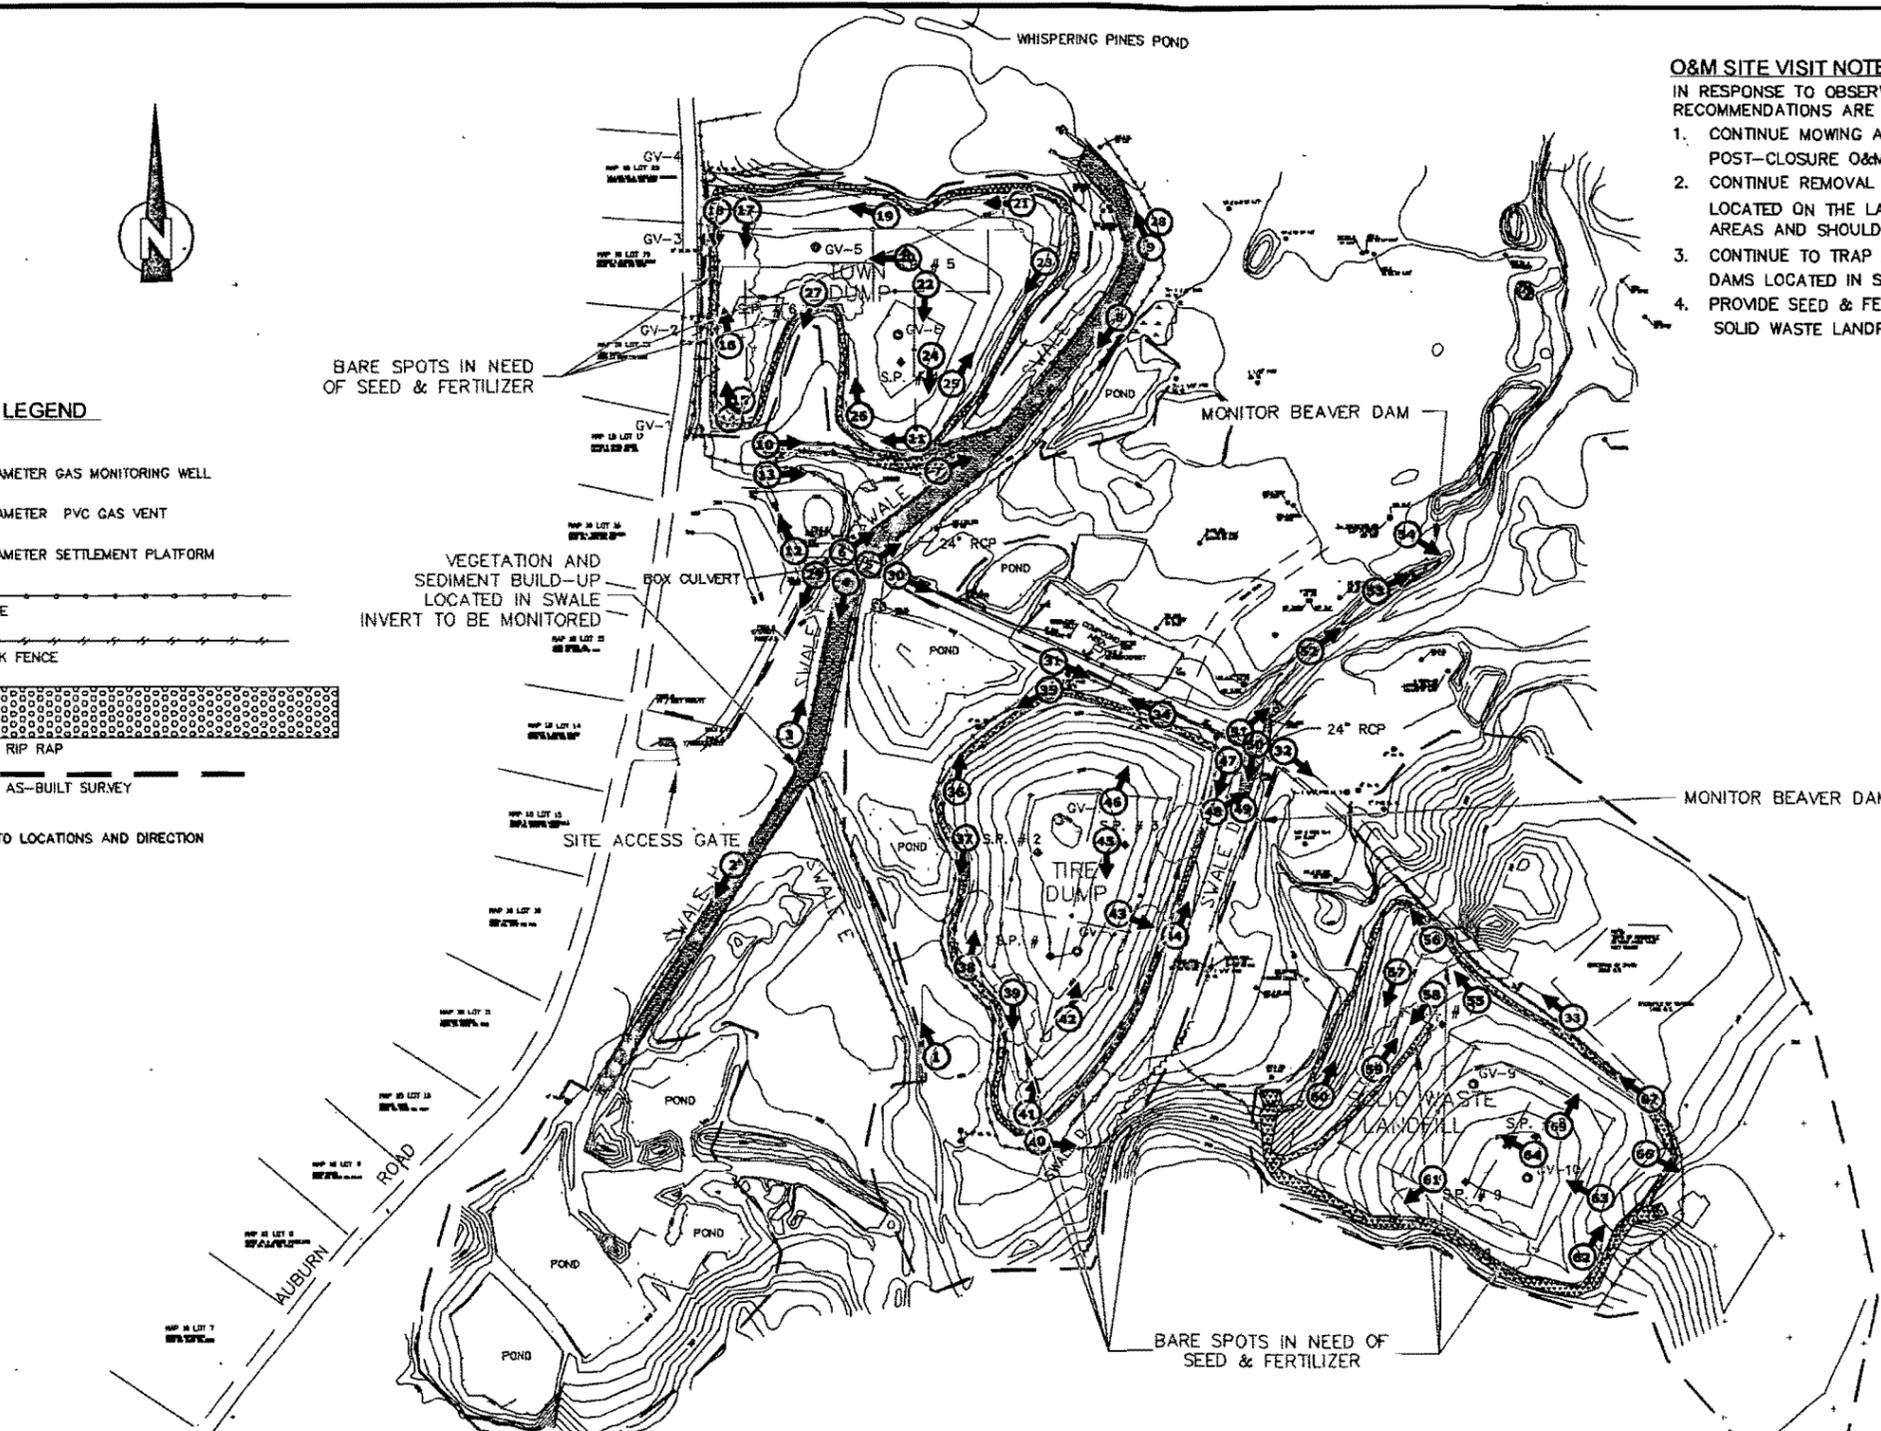
OPERATION AND MAINTENANCE SITE PLAN

Swale	Observations	Action to be Taken
A	New vegetative Growth.	None.
B	This swale is operating as designed.	None.
C	This swale appears to be operating as designed.	None.
D	Two (2) beaver dams were observed; one on the southern side of the access road and one on the northern side of the access road. Both dams have been recently breached to permit stream flow.	Continue to trap and remove the beaver(s) from the area and monitor the dams for new dam construction.
E	The swale appears to be operating as designed.	None.
F	Vegetative growth and minor sediment accumulation.	Monitor swale for flow restrictions and development of hearty vegetation.
H	Swale is clear of vegetation.	None.

1. CONTINUE MOWING ACTIVITIES ON EACH OF THE THREE LANDFILLS AS RECOMMENDED IN THE POST-CLOSURE O&M MANUAL.
2. CONTINUE REMOVAL OF VEGETATION AND SAPLINGS IN RIP RAP PROTECTION AREAS AND SWALES LOCATED ON THE LANDFILL CAP AS NEEDED. (NOTE SWALES D & E ARE WETLAND REPLICATION AREAS AND SHOULD NOT BE CLEARED).
3. CONTINUE TO TRAP AND REMOVE THE BEAVER(S) FROM SWALE D. MONITOR THE TWO BREACHED DAMS LOCATED IN SWALE D FOR NEW BEAVER ACTIVITY.
4. PROVIDE SEED & FERTILIZER ON THE BARE AREAS ON THE TOWN DUMP, TIRE DUMP AND THE SOLID WASTE LANDFILL.

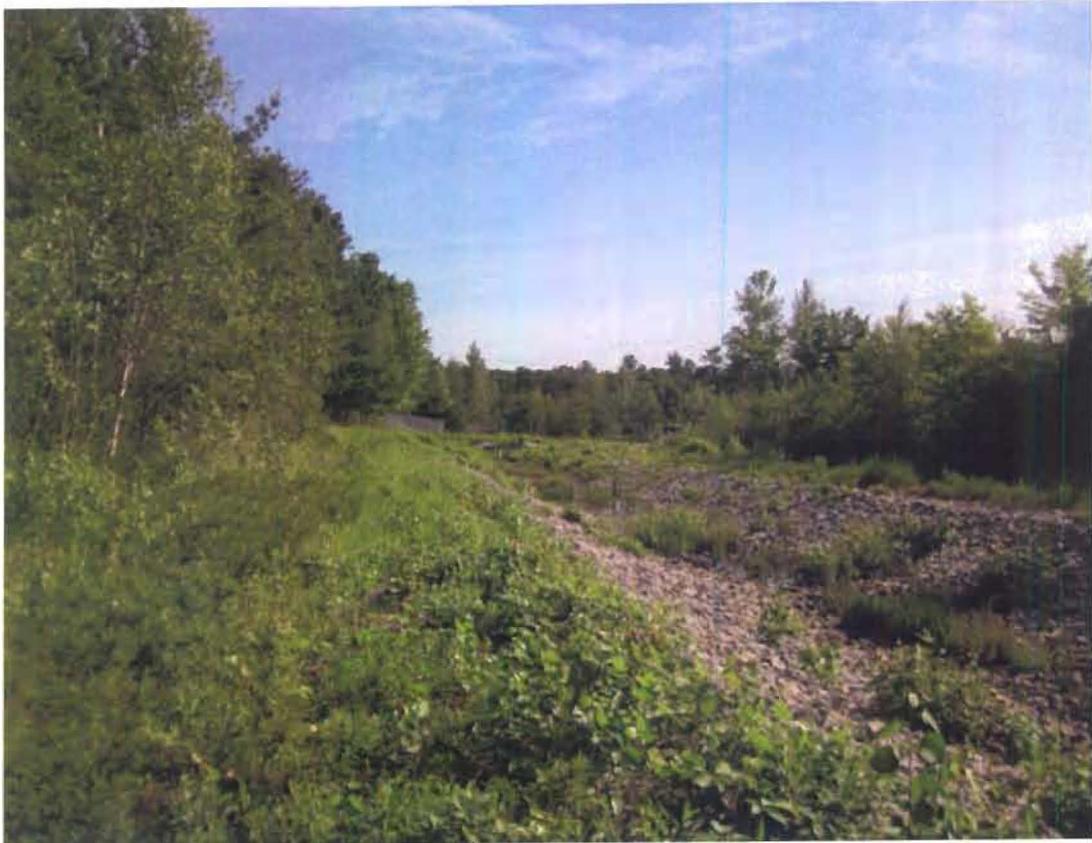
Photo No. 3: Swale F

(f.) Swale F	In general the swale appears to be operating as designed. In the invert of Swale F near the confluence of Swale E and H, a pocket of sediment and grass build up was found. No standing water was observed, however this		√

ITEM	SIGNIFICANT COMMENTS	CORRECTIVE ACTION REQUIRED?	
		YES	NO
	area could pose as a restriction to flow from swale H. Sediment build up in this area should be monitored and removed if ponded water is observed in Swale H. The Town has removed the fallen tree.		
(g.) Swale H	The swale is functioning as designed. Sediment build up in the swale should be monitored and removed if ponded water is observed.		√
(h.) Concrete Culverts	The concrete culverts were observed to be in good condition.		√

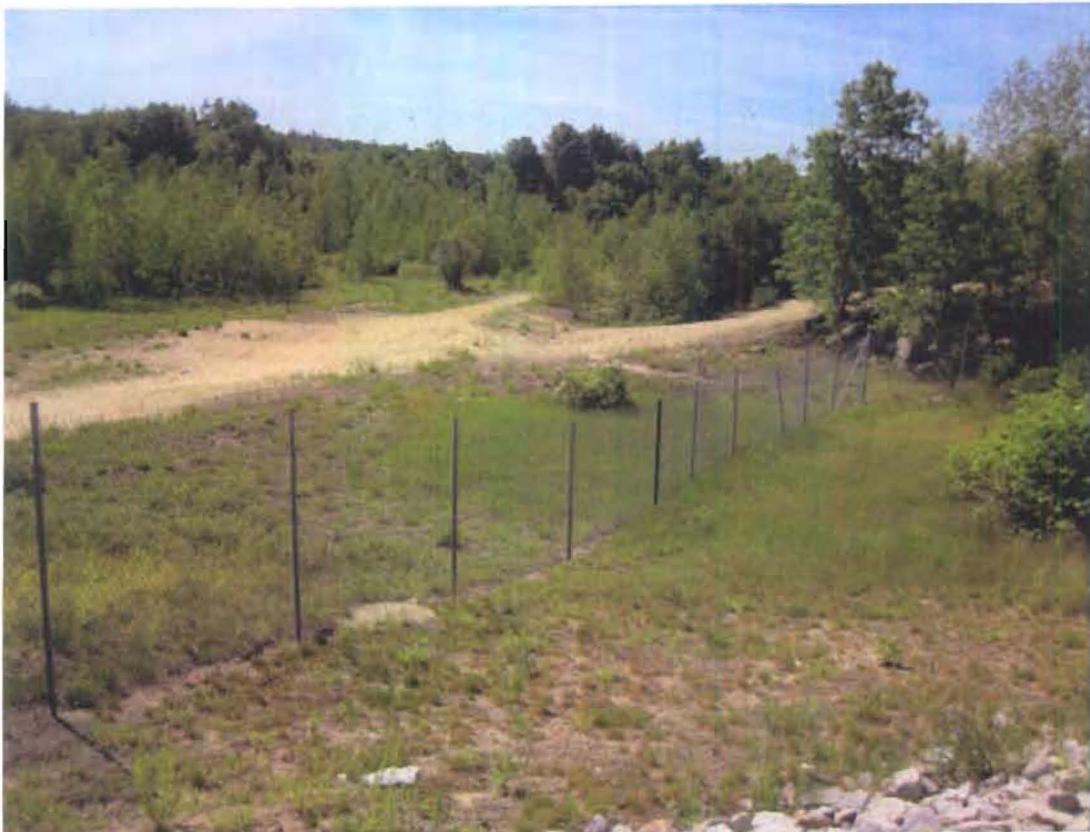
Photo No. 66: SWLF) NE Fence Line

(c.) Solid Waste Landfill	The Town reseeded and fertilized the grass surface in early October 2011. The eastern edge of the landfill and a few spot areas on the western surface have yet to exhibit new grass growth. These areas should receive seed and fertilizer treatment. No depressions or obvious erosion channels were observed. The gas vents and settlement platforms were intact. The security fence around the solid waste landfill appeared to be in good condition. The Town installed a couple of new fence posts in the NE corner to support the sagging fence.	√

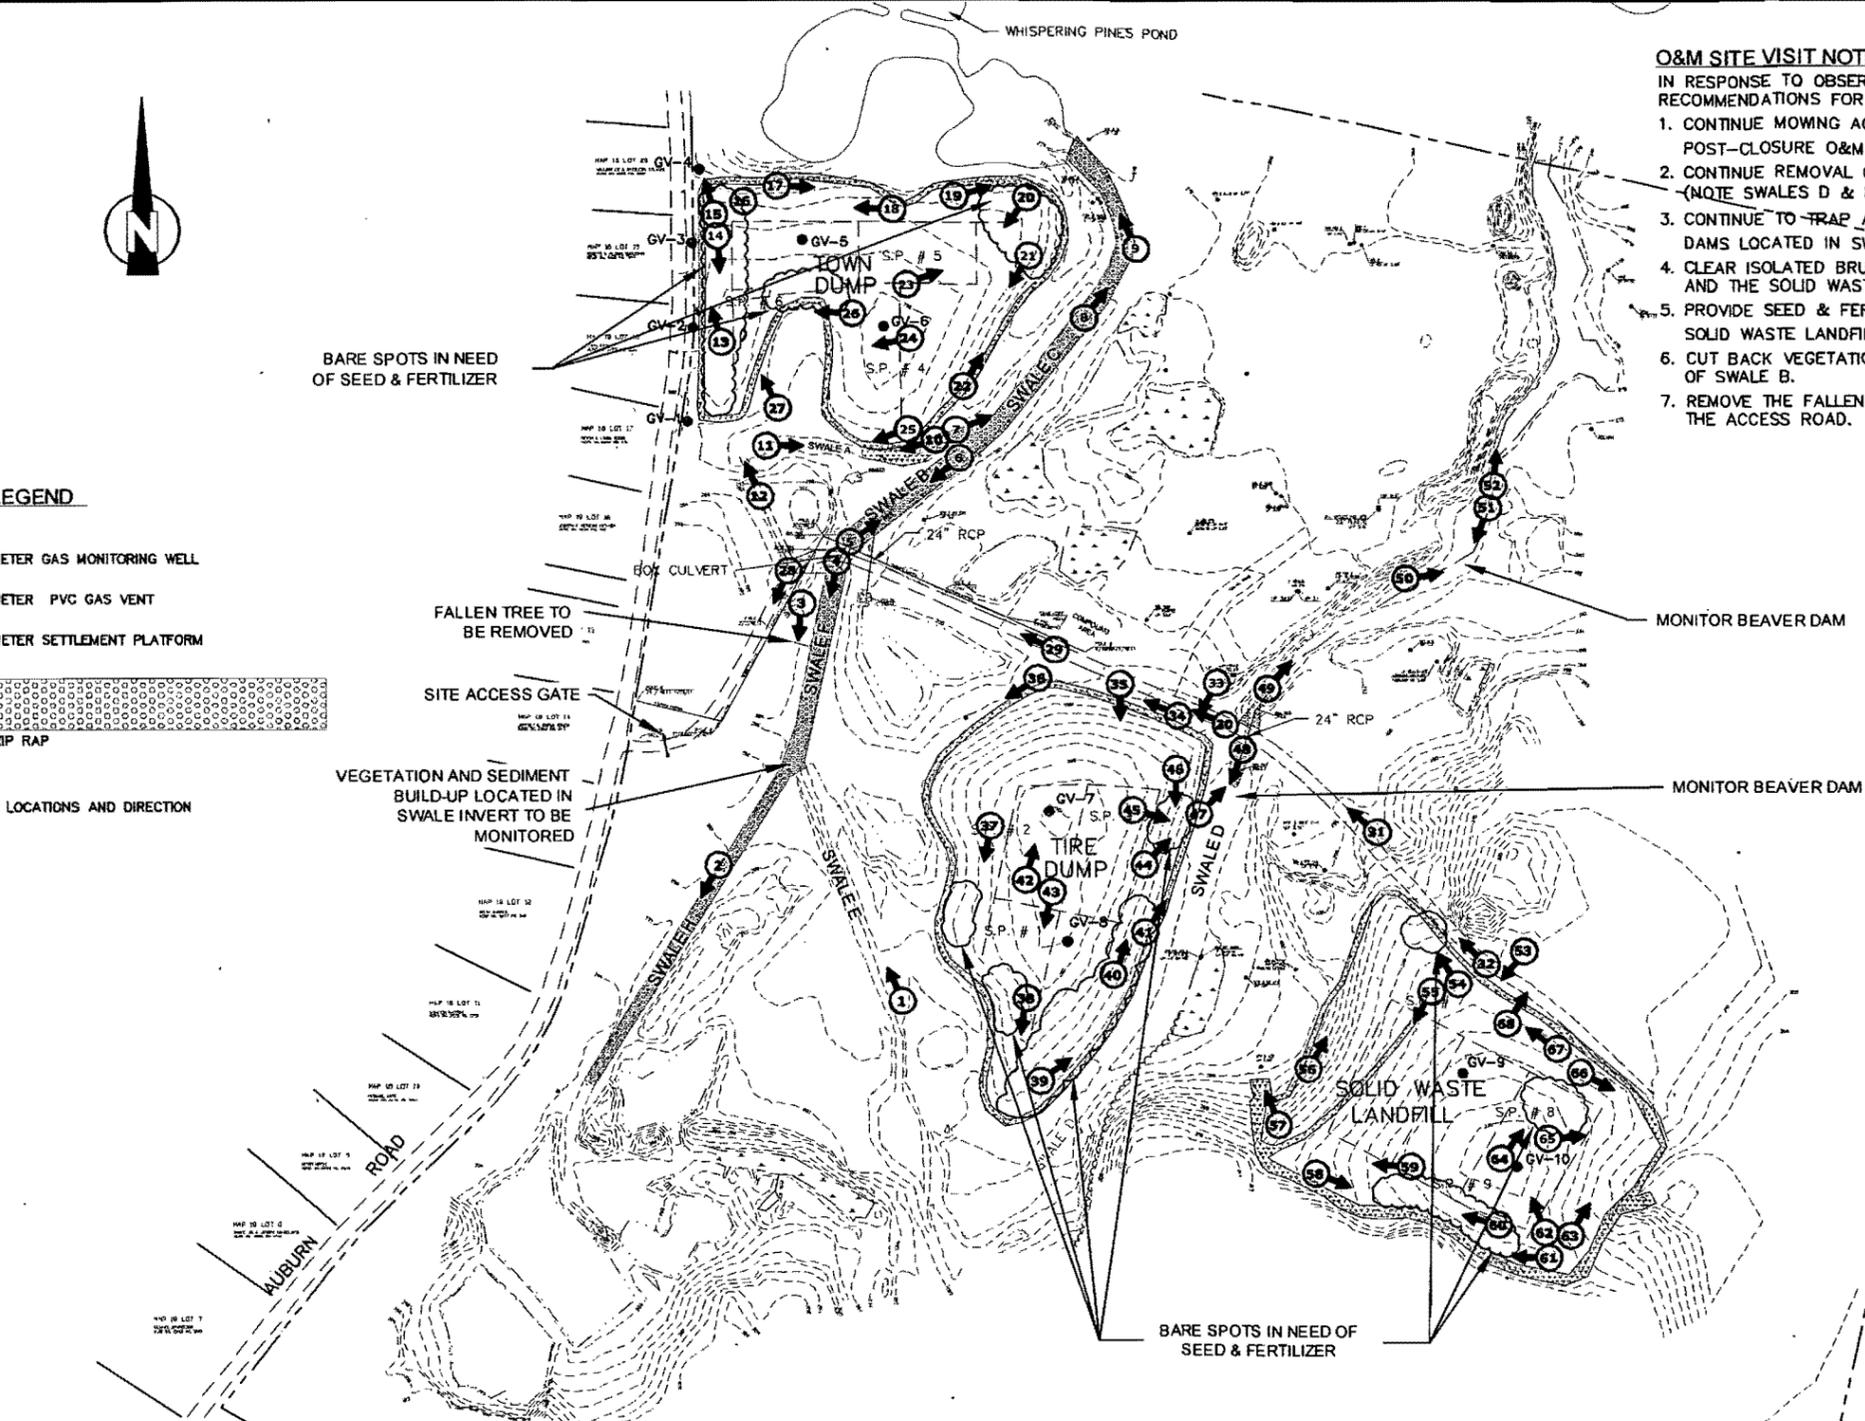
Scale	AS NOTED	Client	TOWN OF LONDONDERRY, NEW HAMPSHIRE
Date	NOVEMBER 2012	Project	AUBURN ROAD LANDFILL OPERATIONS AND MAINTENANCE
Job No.	2010222	Drawing	FIGURE 1 - SITE VISIT NUMBER 37
Designed by	RSM		
Drawn by	RSM		
Checked by	SEW		
Approved by	SEW

Swale	Observations	Action to be Taken
A	New vegetative Growth.	None.
B	This swale is operating as designed.	None.
C	This swale appears to be operating as designed.	None.
D	Two (2) beaver dams were observed; one on the southern side of the access road and one on the northern side of the access road. Both dams have been recently breached to permit stream flow.	Continue to trap and remove the beaver(s) from the area and monitor the dams for new dam construction.
E	The swale appears to be operating as designed.	None.
F	Vegetative growth and minor sediment accumulation. One fallen tree on the western bank approximately 150 feet from the access road.	Monitor swale for flow restrictions and development of hearty vegetation. Remove fallen tree.

- IN RESPONSE TO OBSERVATIONS MADE DURING THE RECENT SITE VISIT, THE FOLLOWING RECOMMENDATIONS FOR CORRECTIVE ACTIONS ARE MADE:
1. CONTINUE MOWING ACTIVITIES ON EACH OF THE THREE LANDFILLS AS RECOMMENDED IN THE POST-CLOSURE O&M MANUAL.
