**RE: Auburn Road Landfill, Administrative Order,  
Docket Number I-90-1092, Londonderry, New Hampshire**

**2013 SOURCE CONTROL  
OPERATION & MAINTENANCE REPORT  
AUBURN ROAD LANDFILL**

**FOR  
TOWN OF LONDONDERRY, NEW HAMPSHIRE**

**FEBRUARY 2014**

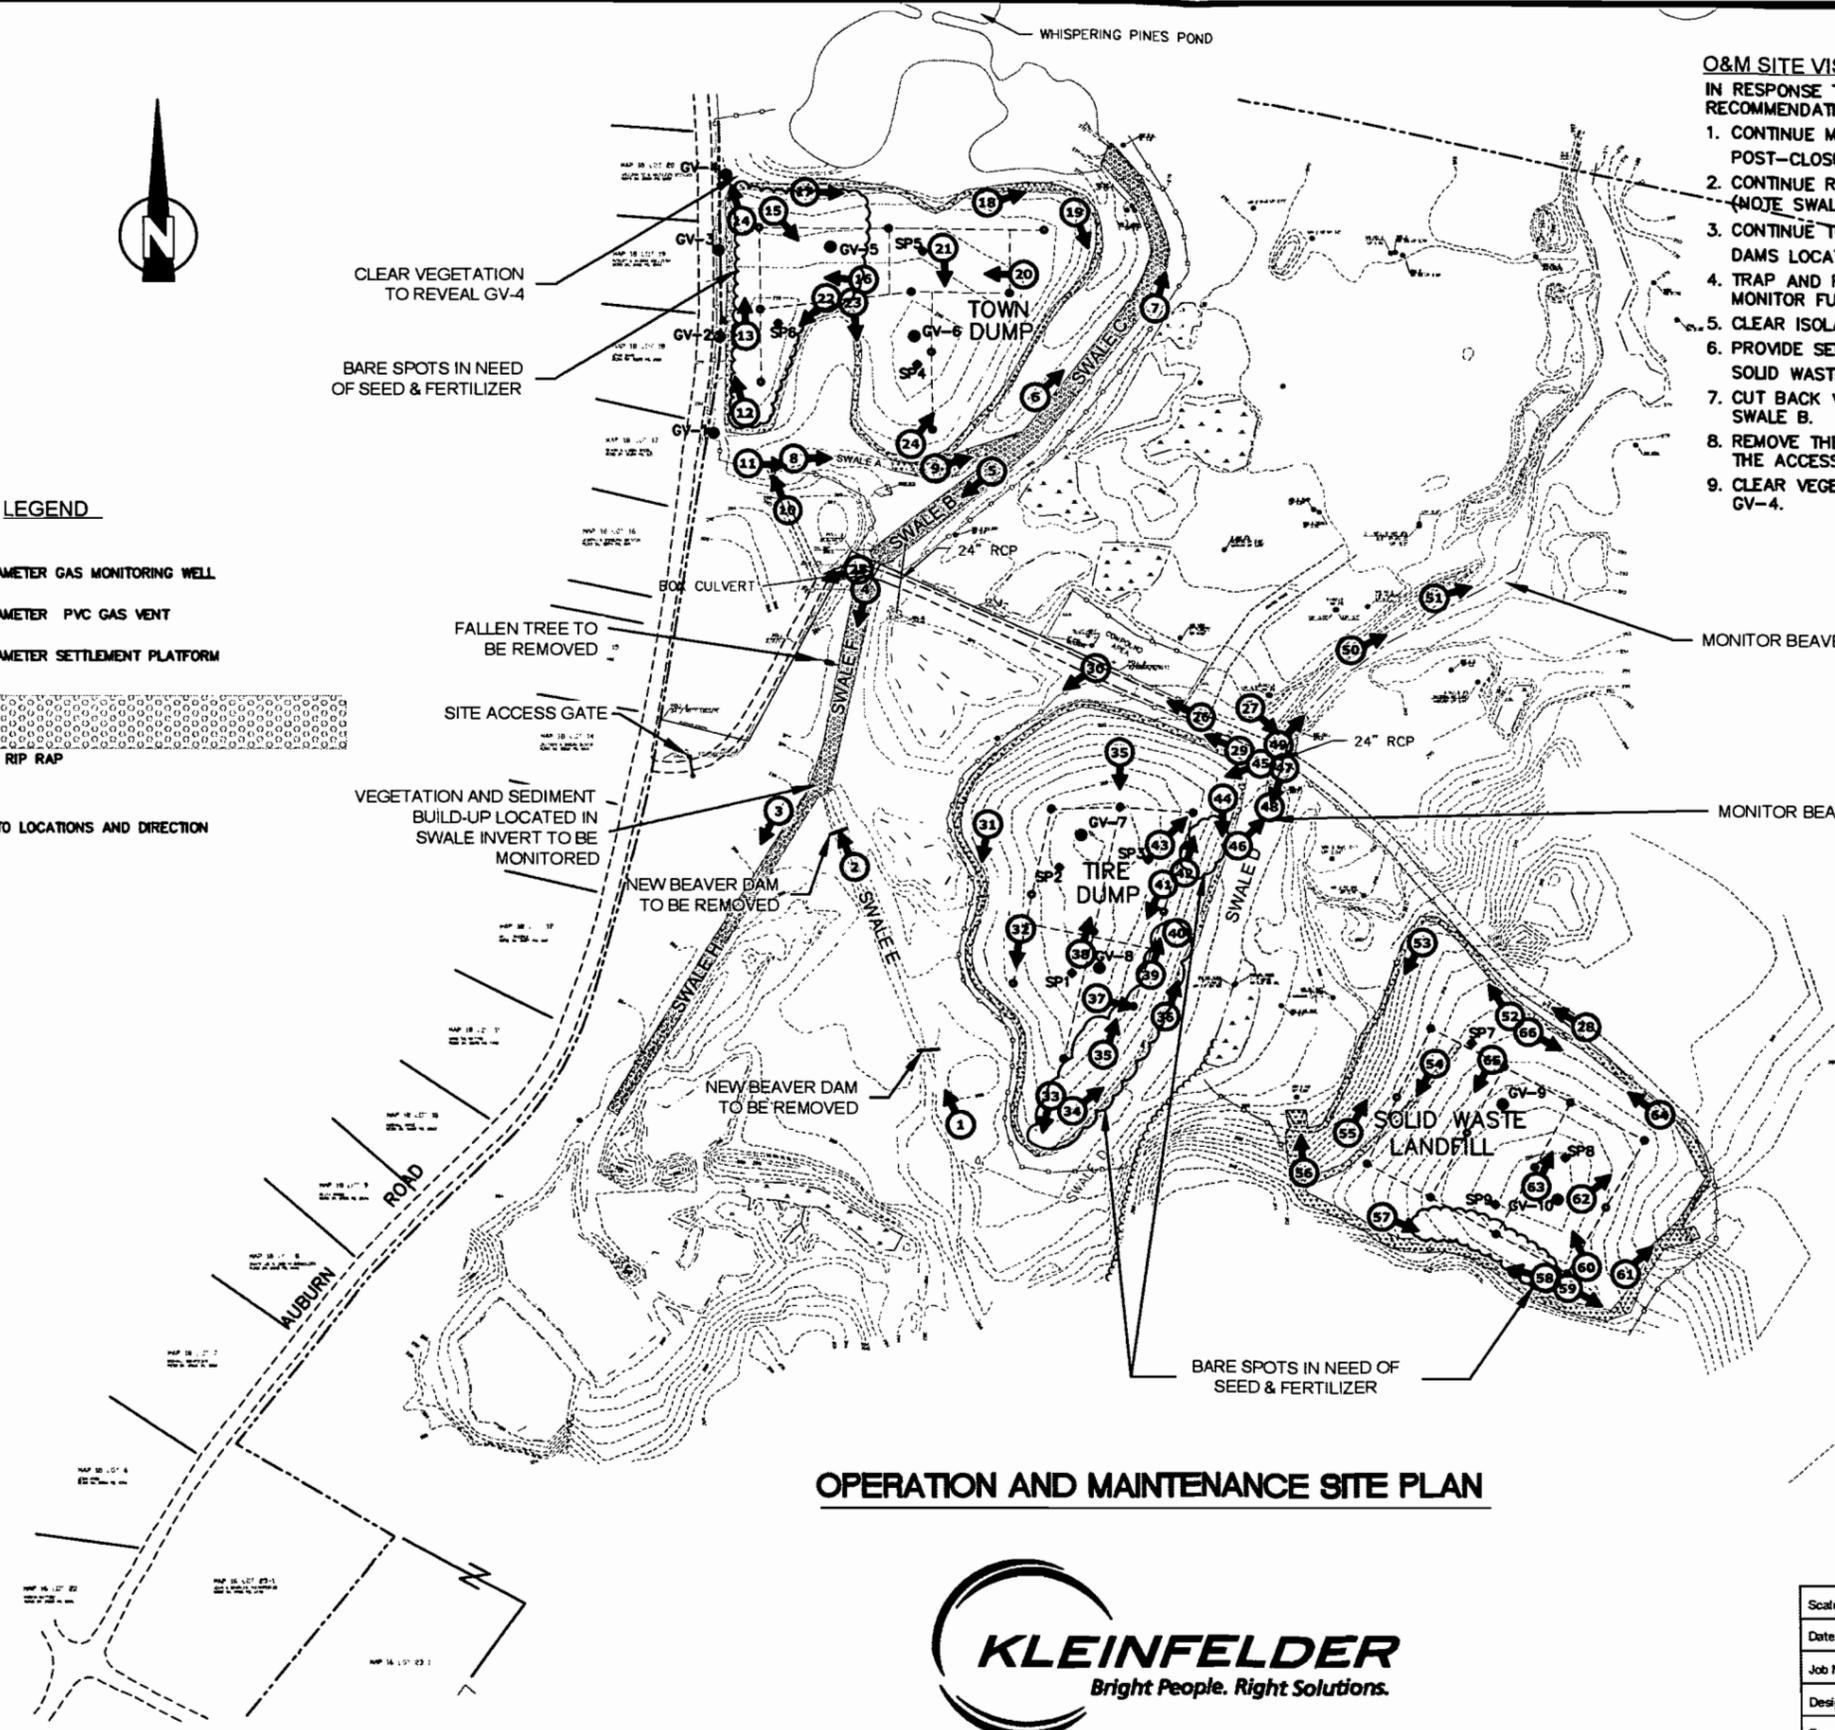
**OPERATION AND MAINTENANCE SITE PLAN**

7. CUT BACK VEGETATION THAT IS ENCREACHING INTO THE NORTH SIDE OF THE ACCESS ROAD EAST OF SWALE B.
  8. REMOVE THE FALLEN TREE ON THE WESTERN BANK OF SWALE F APPROXIMATELY 150 FEET FROM THE ACCESS ROAD.

9. CLEAR VEGETATION IN NORTHWEST CORNER OF THE TOWN DUMP TO REVEAL GAS MONITORING WELL GV-4.

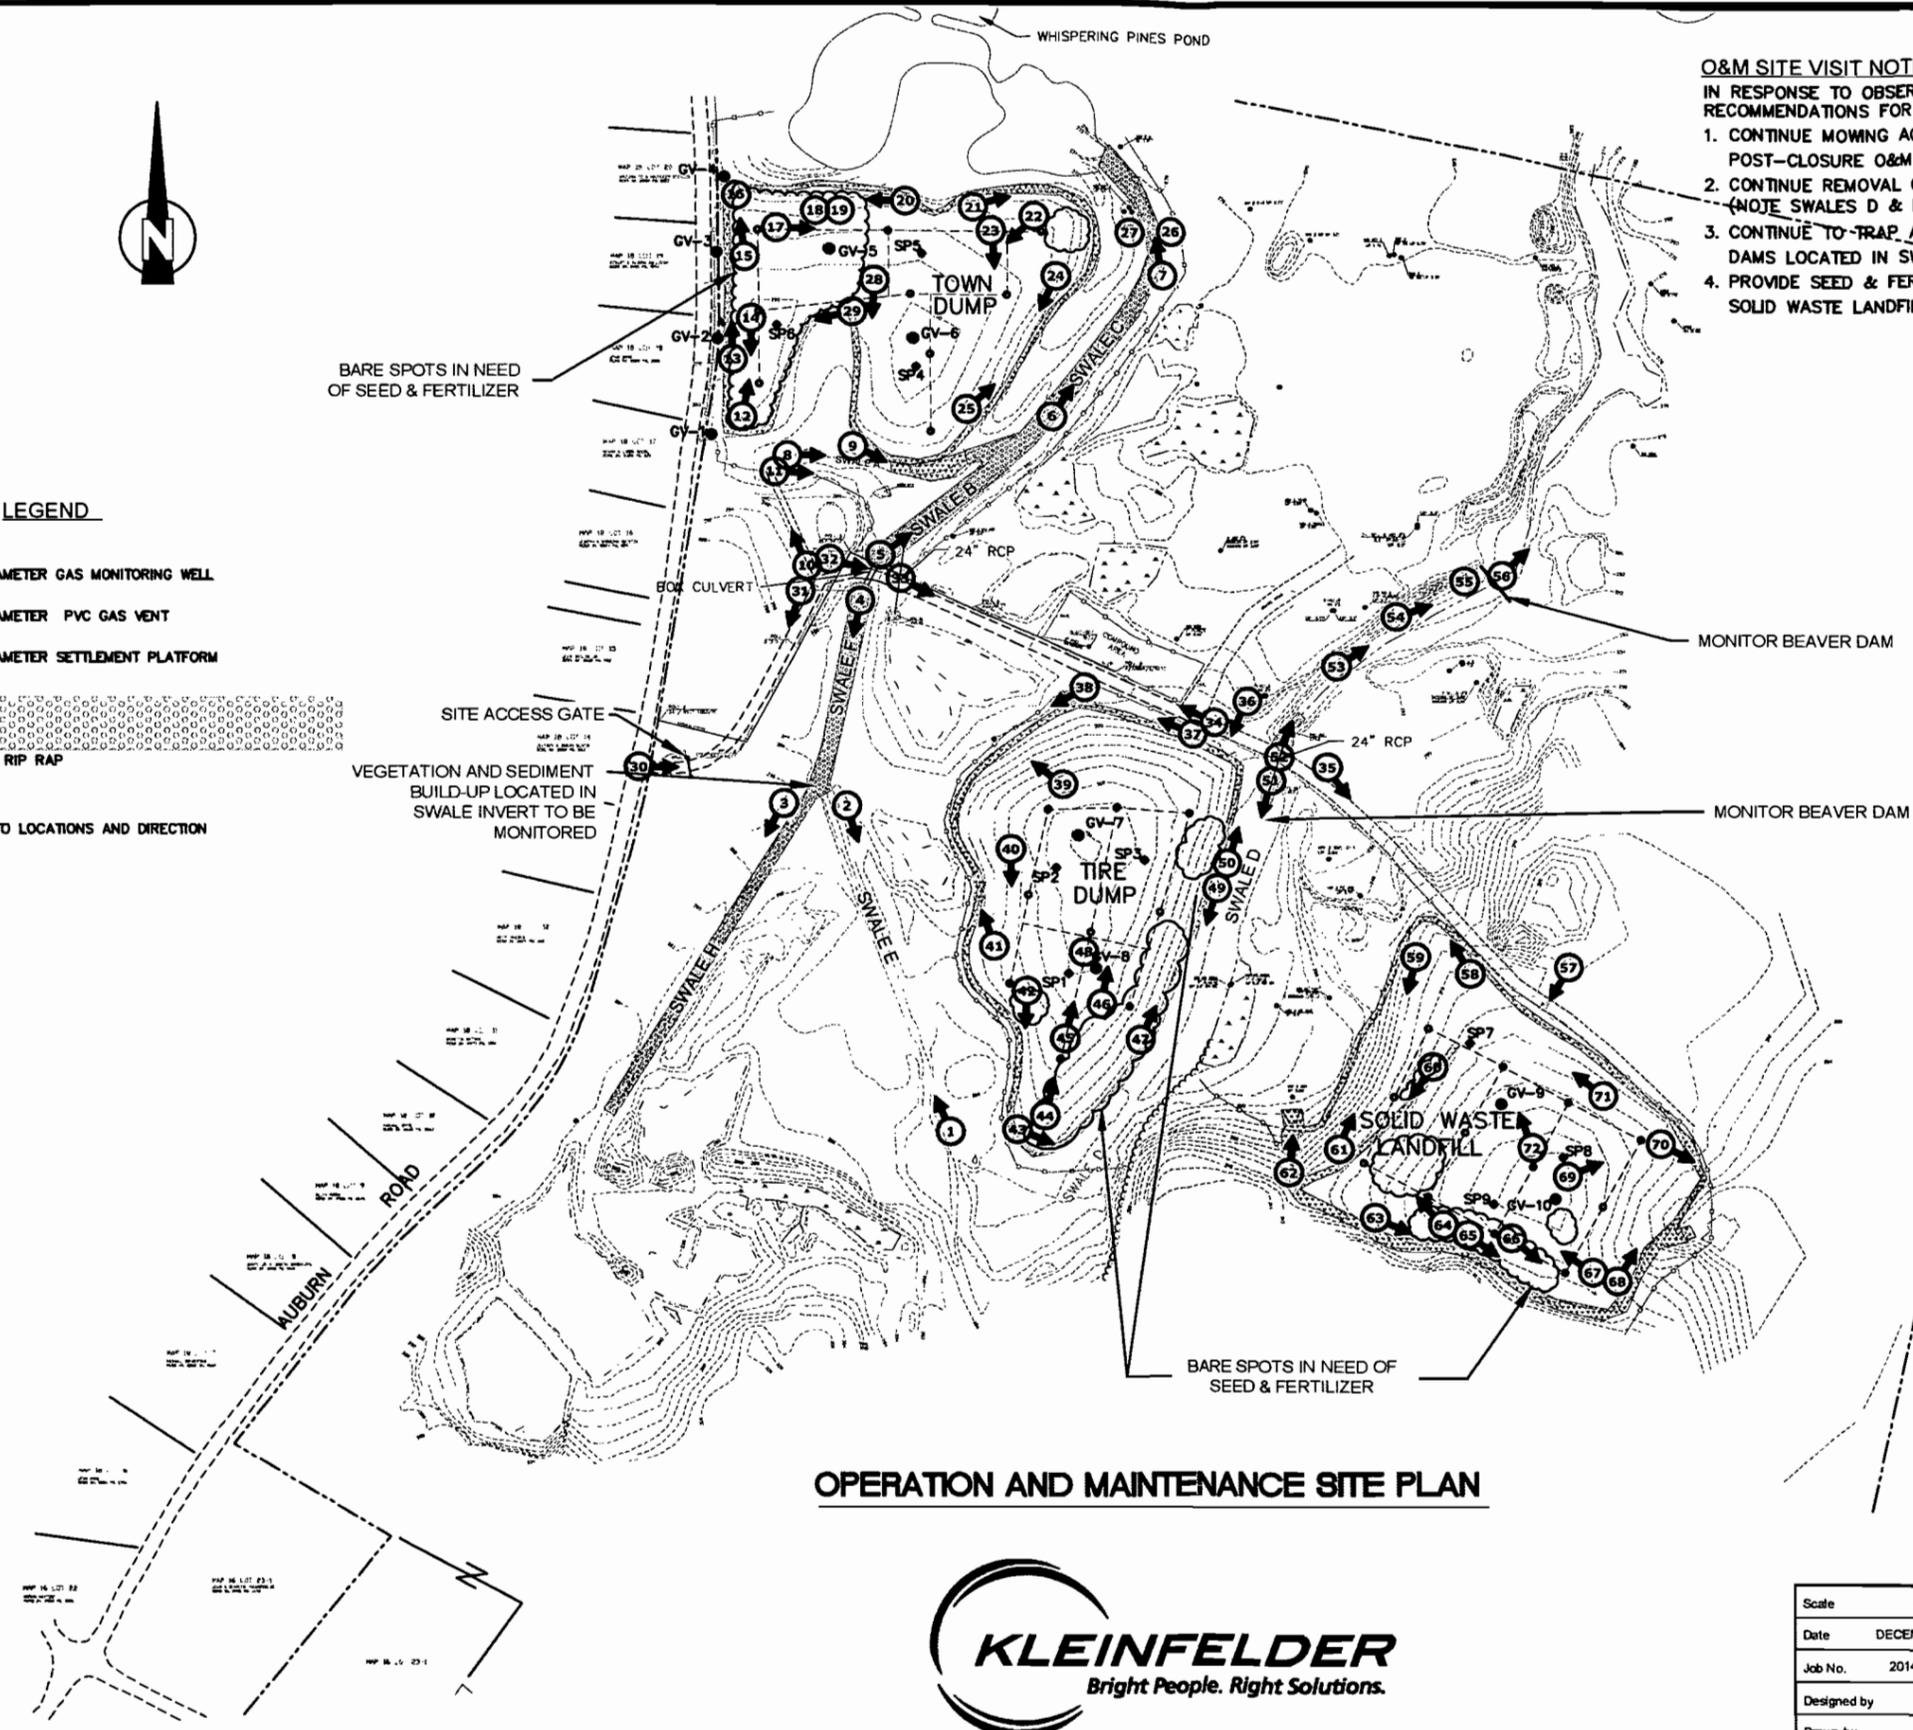
**OPERATION AND MAINTENANCE SITE PLAN**

Bare spots on the vegetated landfill caps are noted in this inspection report in generally the same areas as previously reported. These areas are identified on Figure 1 and are generally located on shallow sloped areas. These areas should be reseeded and fertilized.

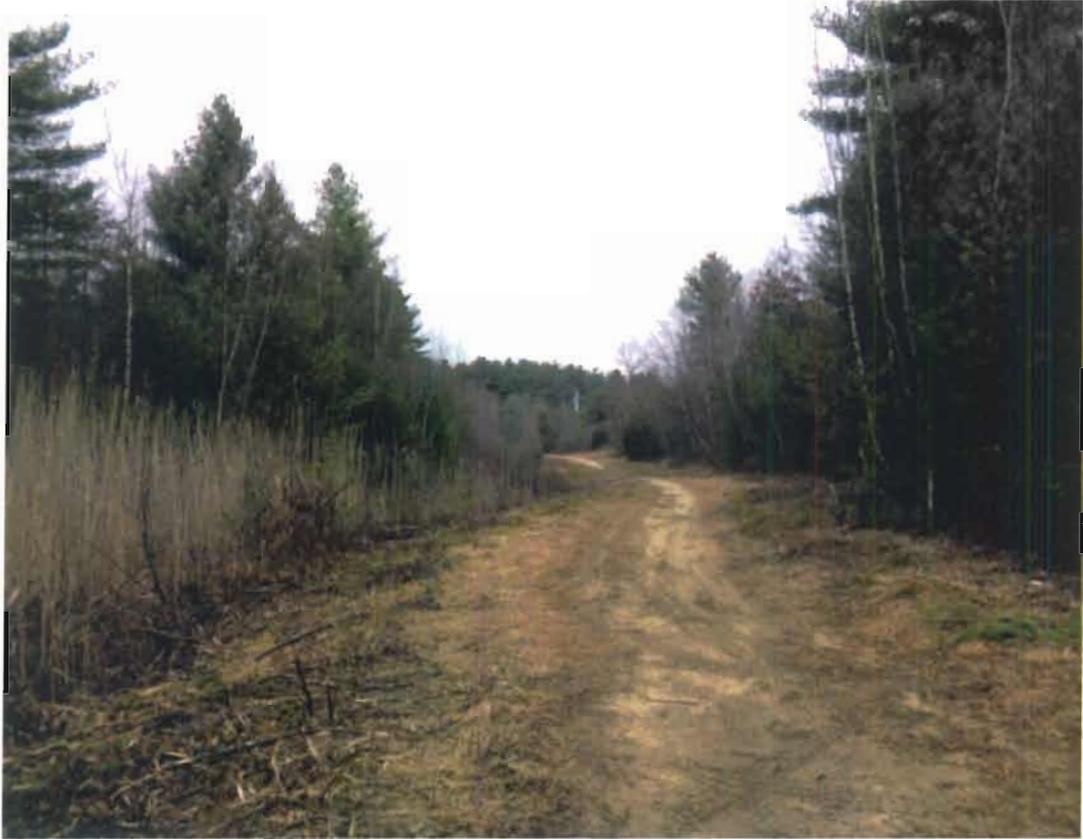
**Photo No. 1: Swale E**

(e.) Swale E (Tire Dump)	The Town has removed the beaver dam. The swale appears to be operating as designed. No standing water was observed during this site visit.		√
(f.) Swale F	In general the swale appears to be operating as designed. In the invert of Swale F near the confluence of Swale E and H, a pocket of sediment and grass build up was found. No standing water was observed, however this area could pose as a restriction to flow from swale H. Sediment build up in this area should be monitored and removed if ponded water is observed in Swale H. The fallen tree reported in the previous report has been removed.		√
(g.) Swale H	The swale is functioning as designed. Sediment build up in the swale should be monitored and removed if ponded water is observed.		√
(h.) Concrete Culverts	The concrete culverts were observed to be in good condition.		√

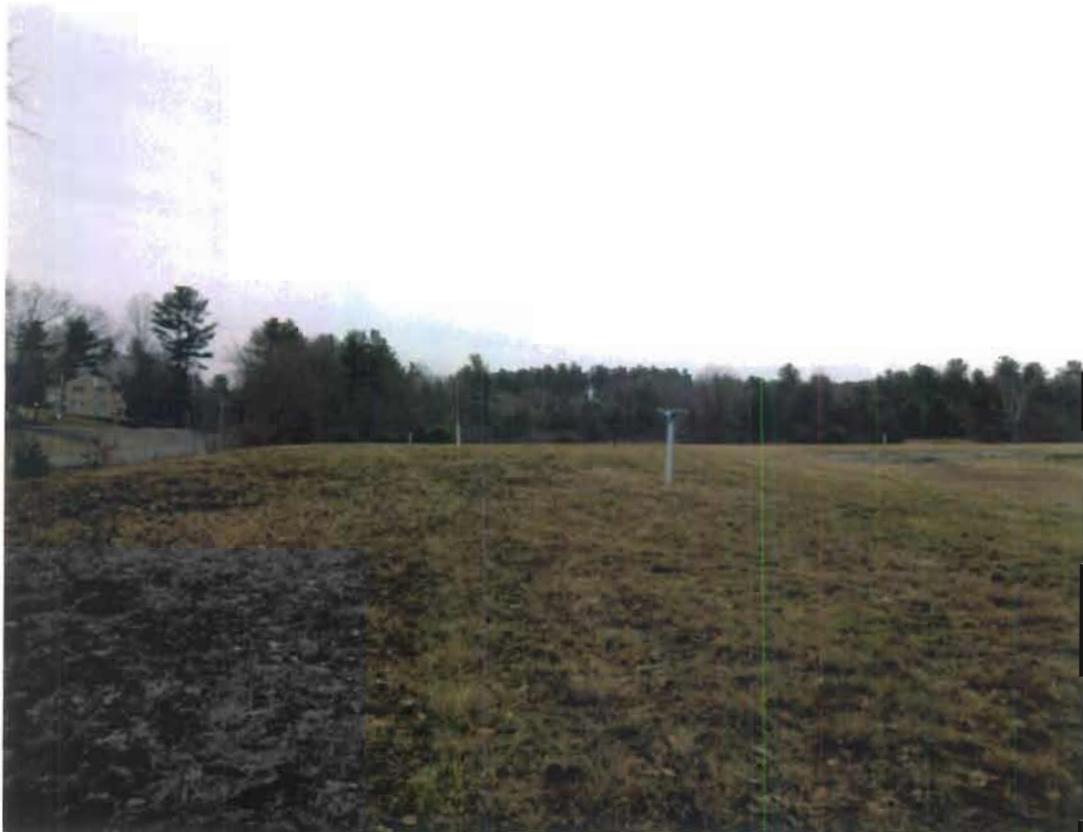
**Photo No. 12: Town Dump Western Surface**

(7.) LCRA	Comments on the LCRA are provided in items (7a) through (7c).		
(a.) Town Dump	<b>The vegetation on western lobe of the landfill needs to be re-seeded and fertilized. There are large areas of sparse grass.</b> The Town has cleared of vegetation to reveal gas monitoring well GV-4 which was overgrown. The eastern lobe of the landfill appears to have better vegetation since the last inspection. No depressions or obvious erosion channels were observed. The gas monitoring wells, and settlement platforms were intact. The security fence around the Town Dump appeared to be in good condition.	√	
(b.) Tire Dump	<b>The vegetation on eastern slope of the landfill needs to be re-seeded and fertilized. There are large areas of sparse grass.</b> No depressions or obvious erosion channels were observed. The gas vents and settlement	√

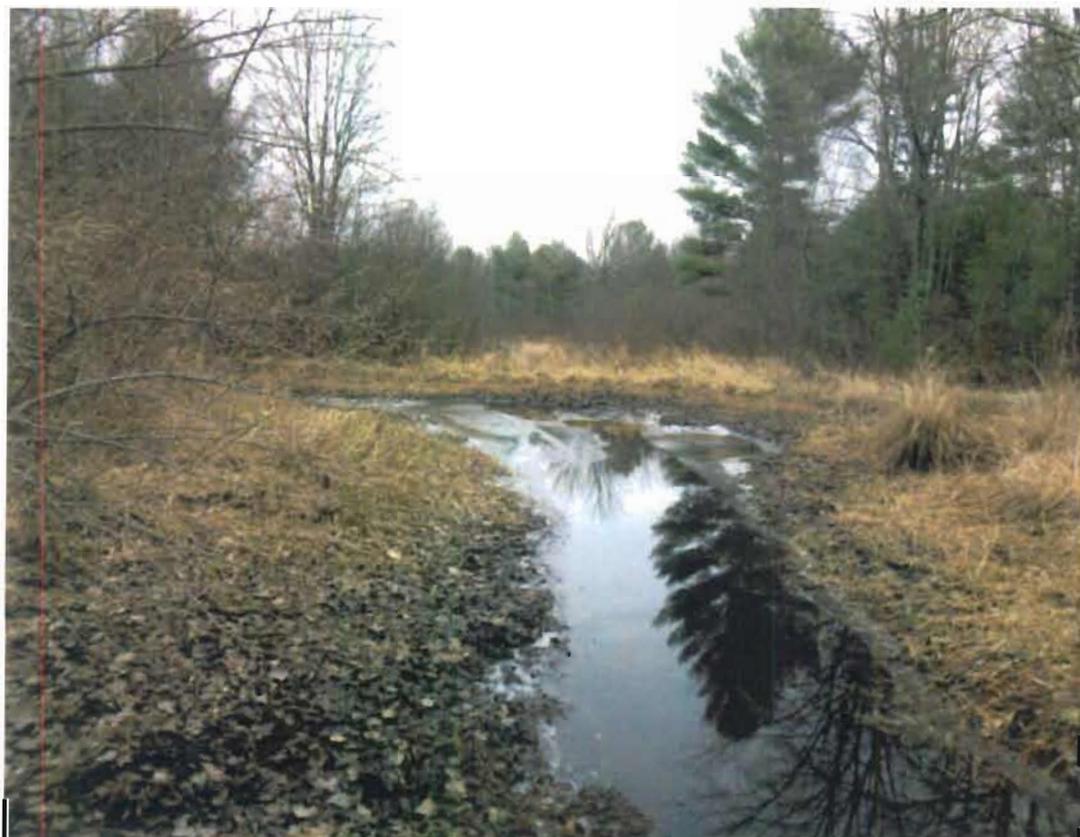
**Photo No. 54: Swale D – Beaver Dam (North)**

(6.) LRDIRA	Comments on the LRDIRA are provided in items (6a) through (6h).		
(a.) Swale A (Town Dump)	This swale appears to be operating as designed.		√
(b.) Swale B (Town Dump)	This swale is operating as designed. Brush has been cut back within the swale and on the banks. Town crews on-site during inspection.		√
(c.) Swale C (Town Dump)	This swale is operating as designed. Brush has been cut back within the swale and on the banks. Town crews on-site during inspection.		√
(d.) Swale D (Tire Dump)	Two (2) beaver dams were observed; one on the southern side of the access road and one on the northern side of the access road. Both dams have been breached to permit stream flow. Continue to trap and remove the beaver(s) from the area and then breach the beaver dams as necessary. The southern beaver dam has been breached; alleviating ponded water. The northern beaver dam has not been breached but water levels were low.		√
