**Second Five-Year Review Report**

**Bennington Landfill Superfund Site**

**Bennington County, Vermont**

**September 2009**

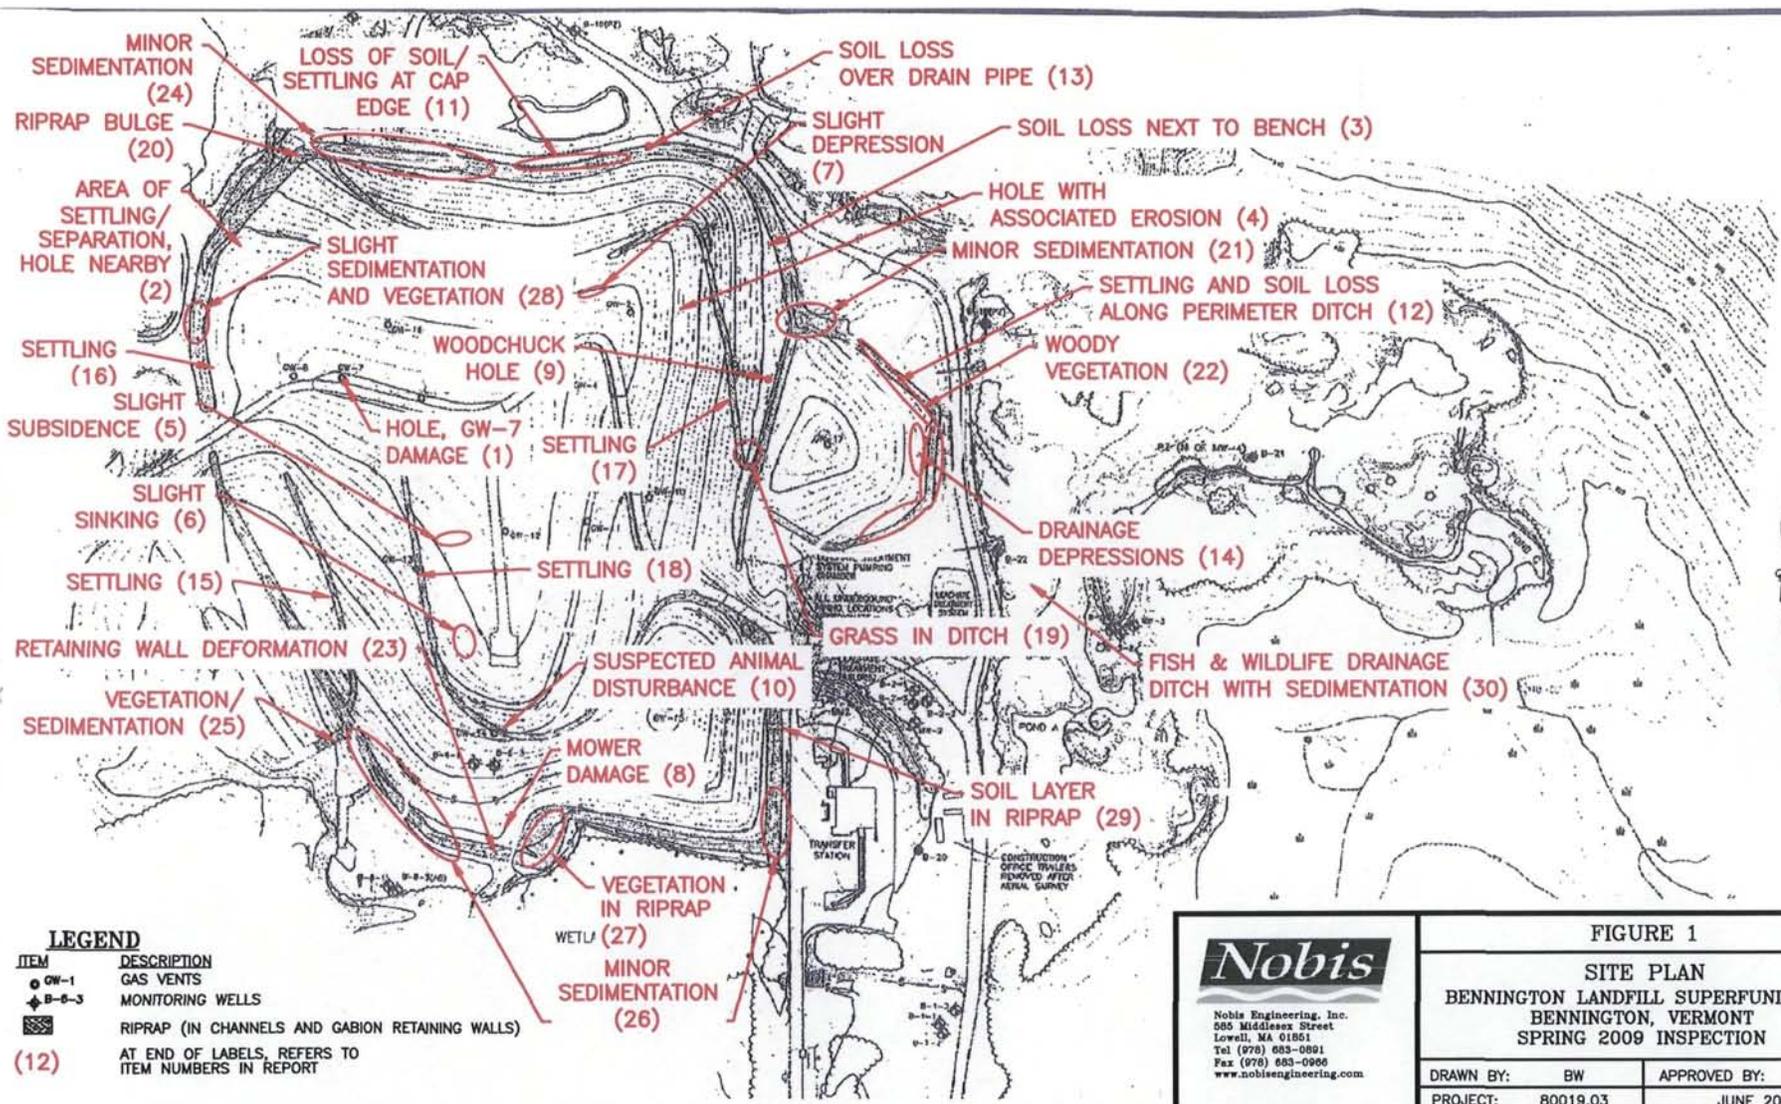
FIGURE 1	
SITE PLAN BENNINGTON LANDFILL SUPERFUND SITE BENNINGTON, VERMONT SPRING 2009 INSPECTION	
DRAWN BY: BW	APPROVED BY: JCA
PROJECT: 80019.03	JUNE 2009

- An area of subsidence identified during inspections conducted in 2008 on top of the landfill cap and located on the face in between GW-12 and GW-13 was observed. No changes were observed during the Spring 2009 inspection (see Figure 1, Item 5). This area should continue to be monitored for further subsidence.

- Near the above-mentioned subsidence location, a slight sinking of the cap surface with no dead vegetation was observed in past inspections. No changes were observed during the Spring 2009 inspection. This area should continue to be monitored for further settlement (see Figure 1, Item 6).

- During prior inspections, Nobis inspectors observed a slight depression near the upstream end of the slope diversion channel near GW-2 (see Figure 1, Item 7). No changes were observed during the Spring 2009 inspection. This area should continue to be watched for further settling and drainage problems. Apparent mower damage previously observed in this area is no longer present.

- Areas of mower damage as indicated on Figure 1 should be filled and seeded.
- Sedimentation in areas shown on Figure 1 should be removed periodically, and pipe openings cleared.

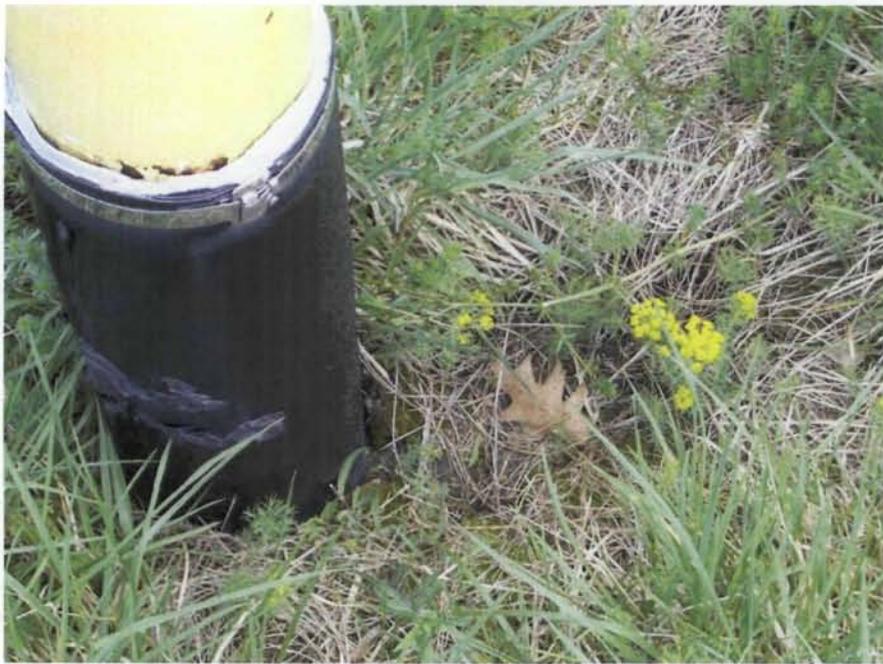
- A small hole at the base of GW-7 (see Photo 2 and Figure 1, Item 1). This photo also shows damage to GW-7's vent boot with unknown cause; this should be repaired.

Cover penetrations through the landfill cover system include 17 passive gas vent structures (GV-1 through GV-17) and two monitoring wells (see Figure 1 for locations). All of the structures appeared to be in good condition and were vertical or nearly vertical at the time of the inspection. The geomembrane boot for GW-7 has been damaged (see Photo 2 and Figure 1, Item 1) and should be repaired.

Photo 2 Small hole at base of GW-7

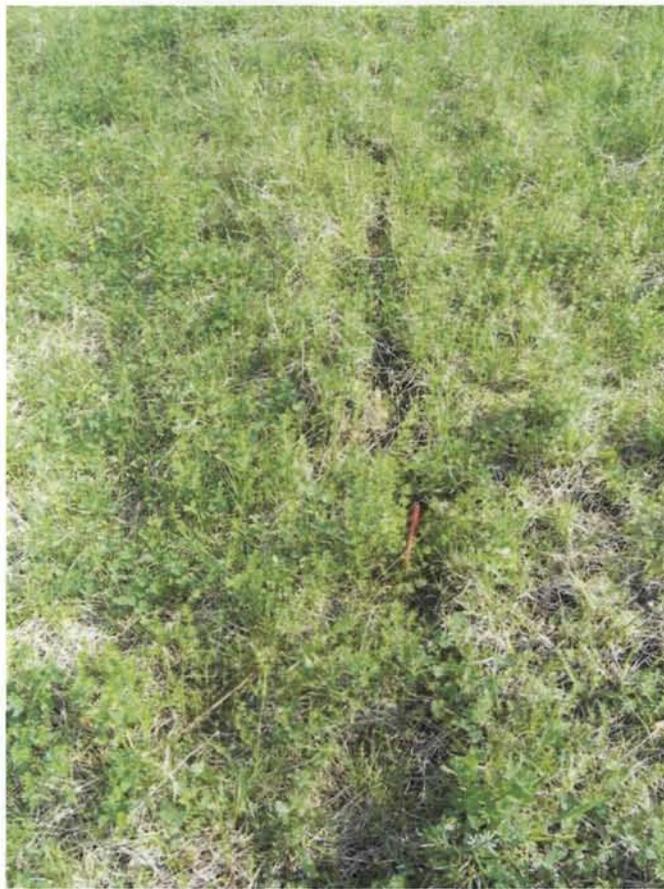
- An area of ground separation and some settling, which may be mower damage, on the landfill slope near the perimeter ditch at the northwestern corner of the landfill (see Photo 3 and Figure 1, Item 2). This area should be repaired, and monitored for future separation and/or settling.

Photo 3 Ground separation/settling (possible mower damage) near northwestern corner of landfill

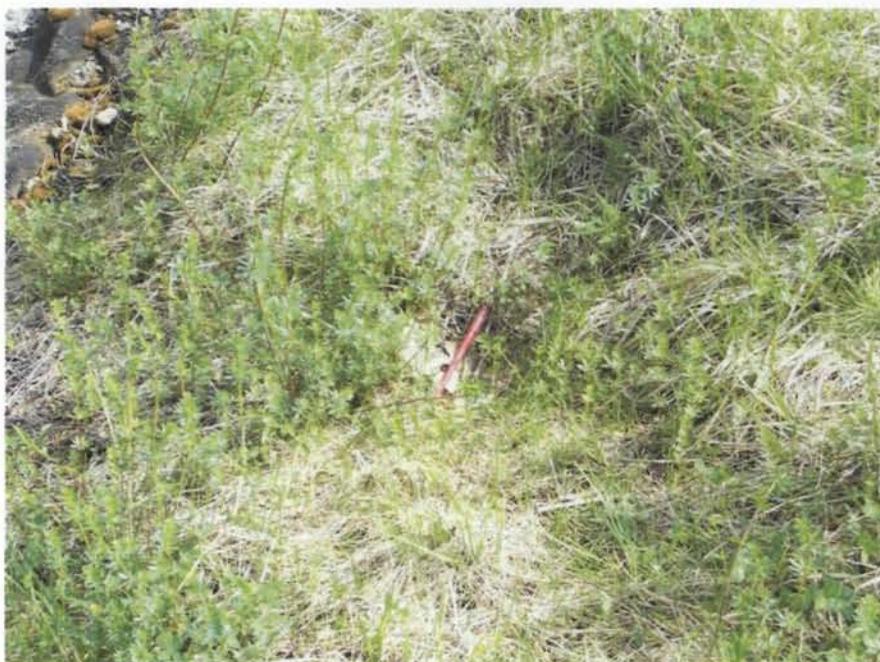
Photo 4 Low spot adjacent to riprap bench, 20 feet northeast of area shown in Photo 3

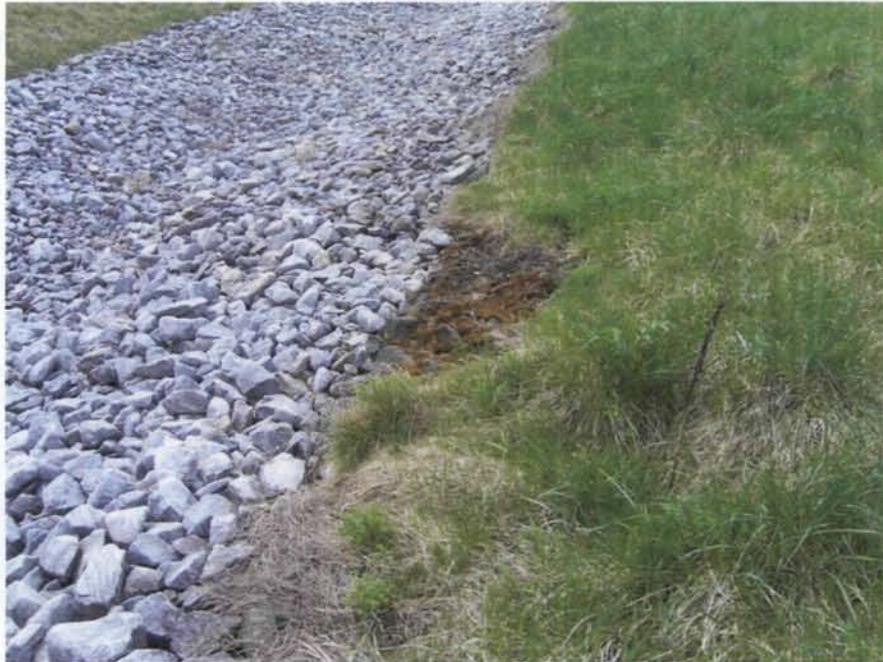
Photo 5 Soil loss near northeastern corner of Site

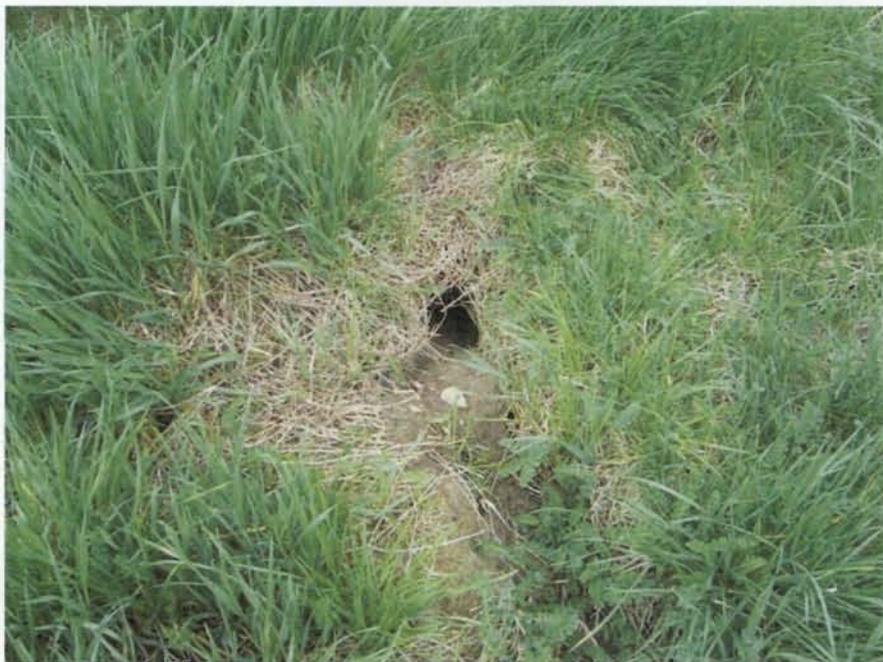
Photo 6 Animal hole on northeastern face of landfill

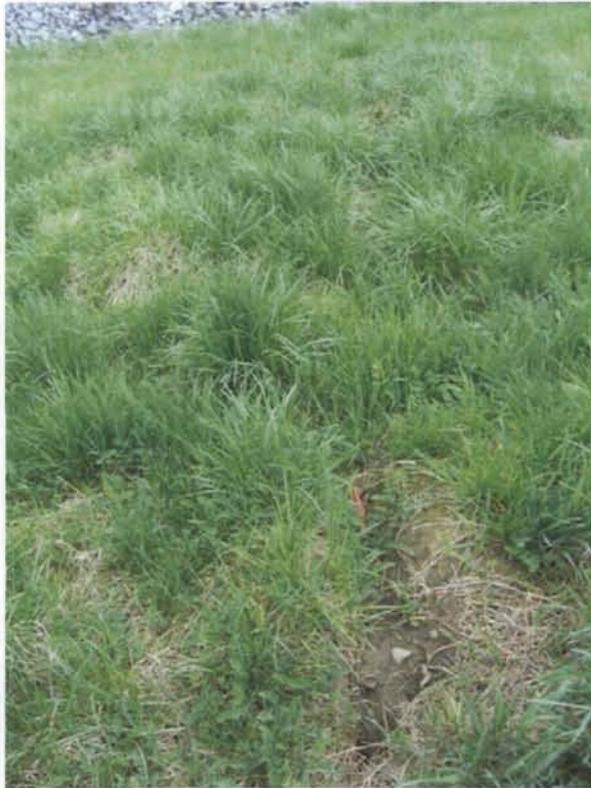
Photo 7 Erosion associated with hole in Photo 5

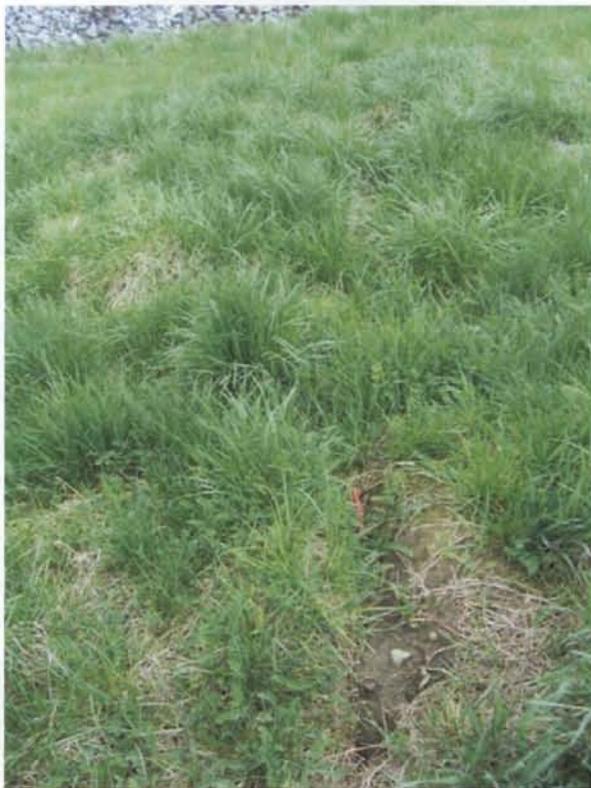
- Mower damage previously identified downslope from MW B-6-3 is still present (see Figure 1, Item 8, and Photo 8).
- Mower damage previously identified near the corner of the perimeter ditch across from the transfer station, and near GW-8, is no longer present.

Photo 8 Mower damage downslope from MW B-6-3

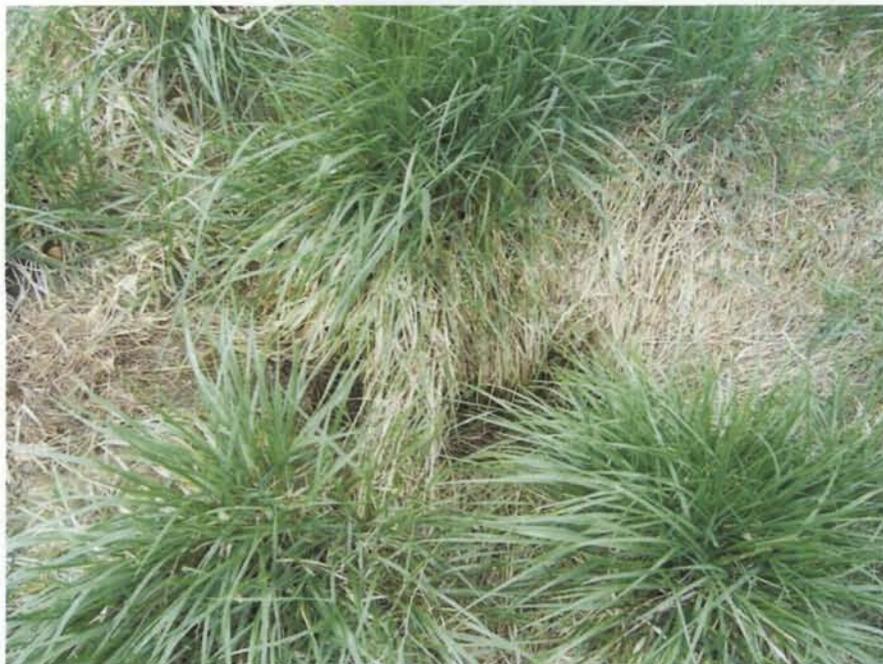
- A woodchuck hole observed in the Spring and Fall of 2008 inspections near the lower bench and downslope from GW-3 is still present (see Photo 9 and Figure 1, Item 9).

Photo 9 Woodchuck hole downslope from GW-3

- Conduct regular inspections and animal eradication as part of routine maintenance. Fill in burrow holes and reseed disturbed areas.
  - A burrow hole near the lower bench downslope from GW-3 observed in Fall 2008 is still present. An additional area of possible animal activity adjacent to riprap near GW-14 is still present and should be monitored.

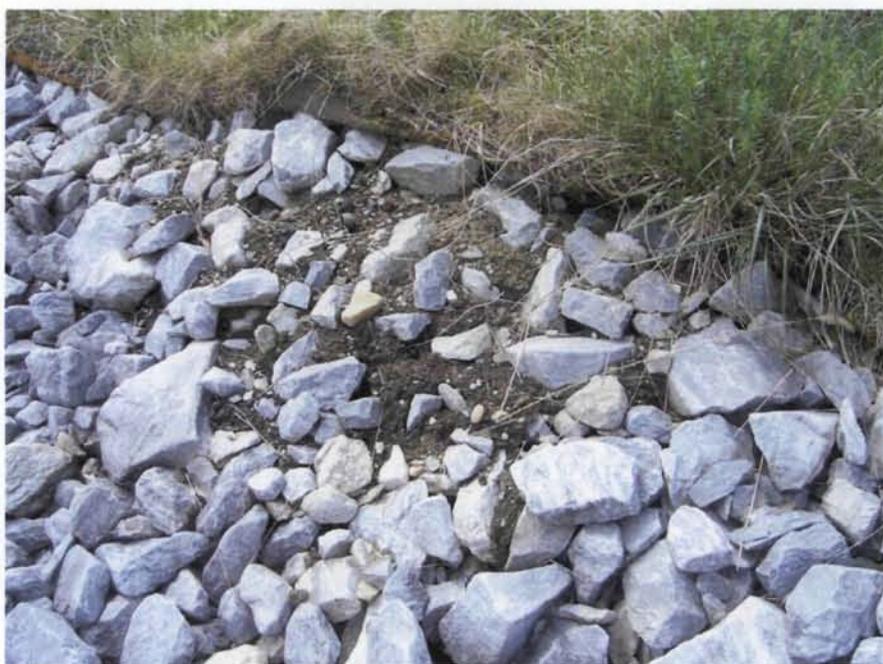
Photo 10 Possible animal activity near GW-14

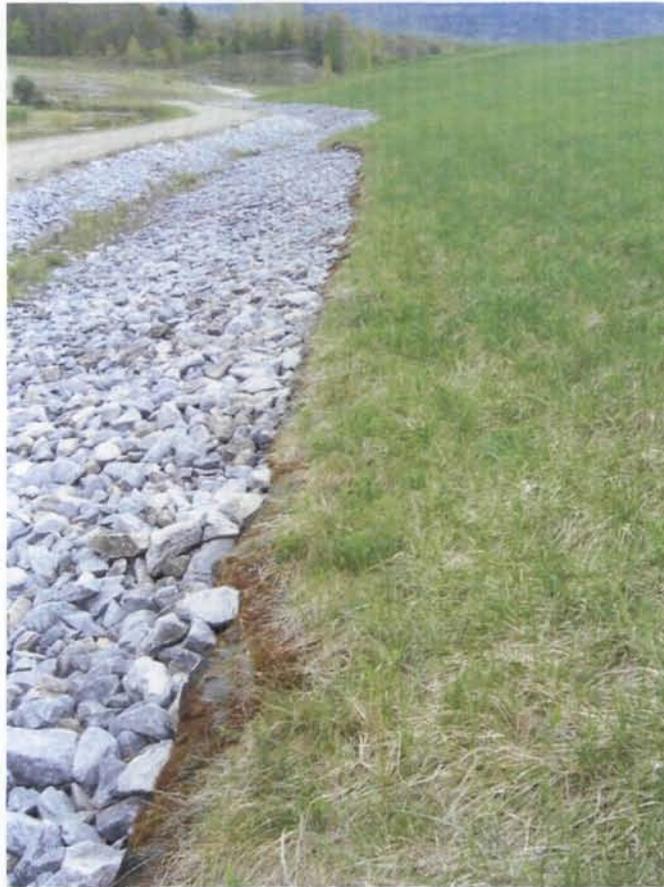
- As observed during prior inspections, there is an apparent loss of soil and area of settling that needs to be watched for future slope stability, along the northern edge of the cap, where it meets a perimeter ditch (see Figure 1, Item 11, and Photo 11). Vegetation continues to appear intact in this area. Photo 12 shows one location in this area where part of the riprap channel appears to have settled approximately two feet lower than adjacent areas. This is based on the appearance of the riprap's boundary with vegetation on the upslope side, and is unchanged from the Fall 2008 inspection. Photos 11 and 12 also show exposed liner along the edge of the perimeter ditch. Newly observed during this inspection was a slight settling, approximately 2 inches deep and 3 to 4 feet wide, that runs parallel to the perimeter ditch in this area (see Photo 13).

Photo 11 Soil loss/settling area along northern edge of cap

- Soil loss and settling along the northern and northeastern perimeter ditches should be filled and seeded and watched for future cap stability.
- Sediment observed at the outlet pipe openings in the perimeter ditch near the northeast corner of the landfill should be removed periodically.

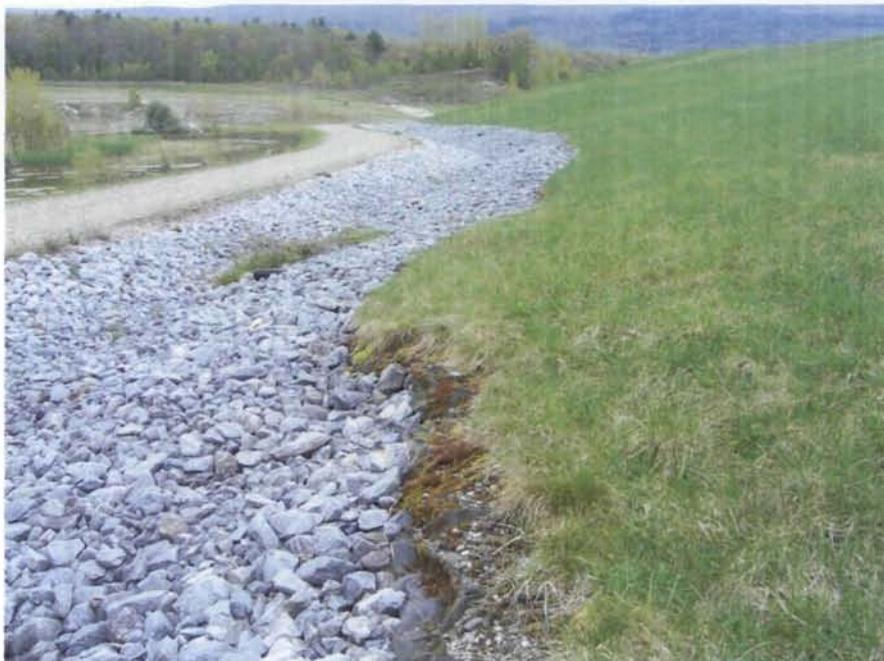
Photo 12 Possible riprap settling along northern edge of landfill

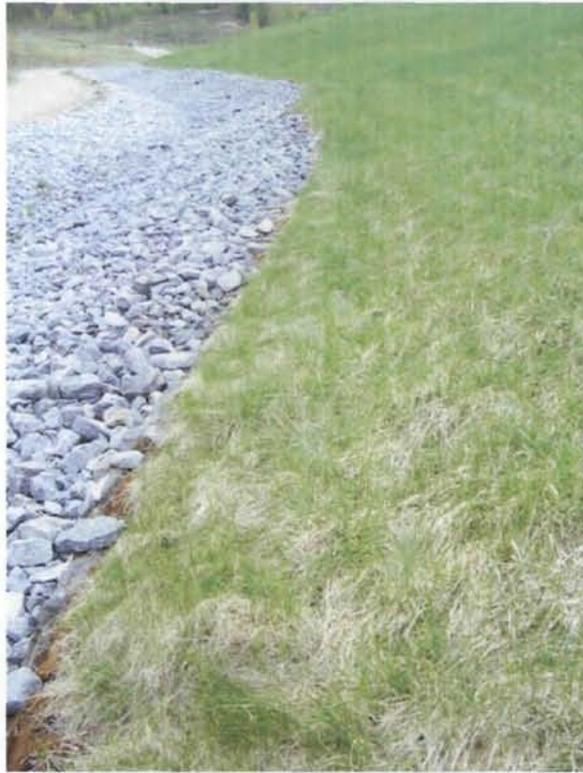
Photo 13 Settling along perimeter ditch, parallel to perimeter ditch near area shown in Photos 11 and 12

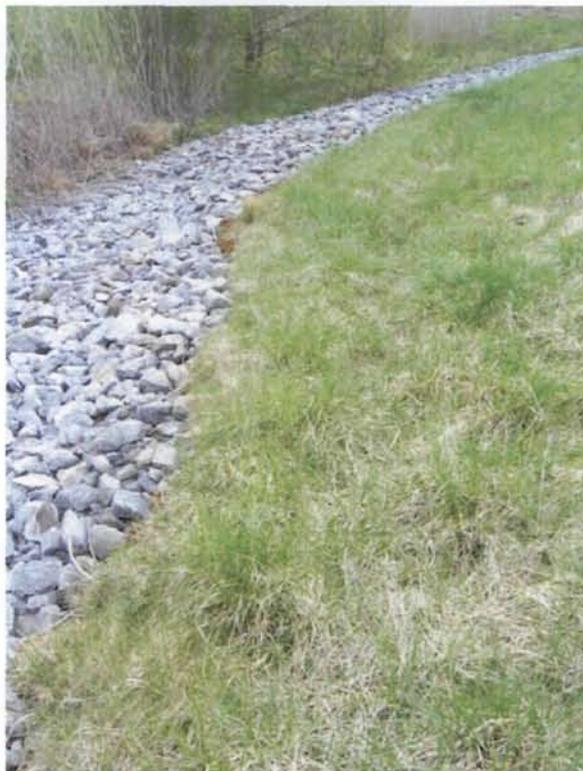
- Newly observed during this inspection was similar settling and soil loss along the same perimeter ditch, but closer to the northeast corner of the landfill (see Photo 14 and Figure 1, Item 12).

Photo 14 Settling and soil loss along perimeter ditch near northeast corner of landfill

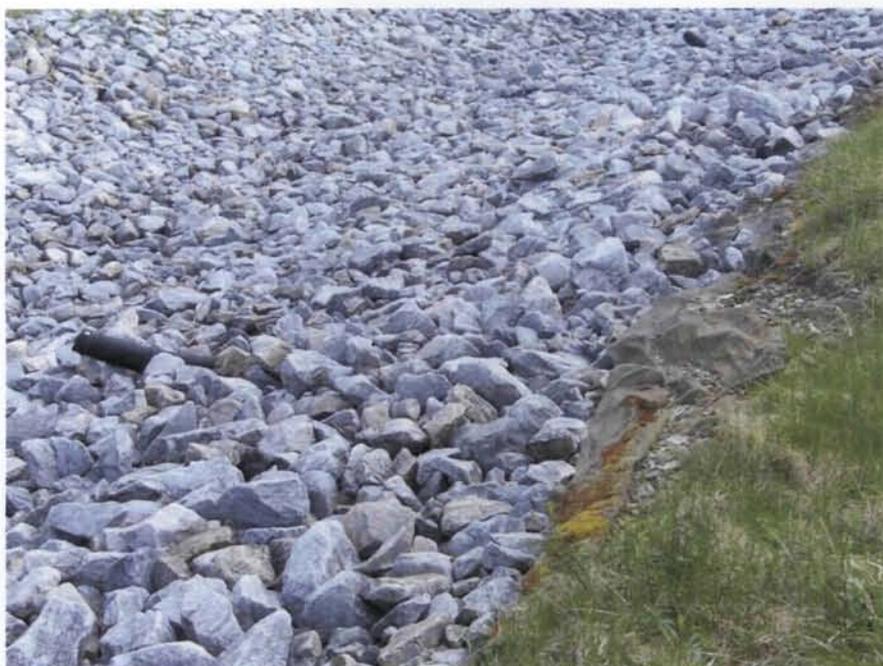
- During the Fall 2008 inspection, the inspector observed a loss of soil above a drain outlet, near the northernmost limit of the perimeter road (see Photo 15 and Figure 1, Item 13). Exposed liner is also visible in this photo above the drain, near the perimeter ditch. A sinkhole previously observed near the outlet is no longer present; however, some ground separation, which may be mower damage, is present near the drain outlet. This area should be loamed and seeded, and continue to be monitored for future slope stability.

Photo 15 Soil loss over drain along northern edge of landfill

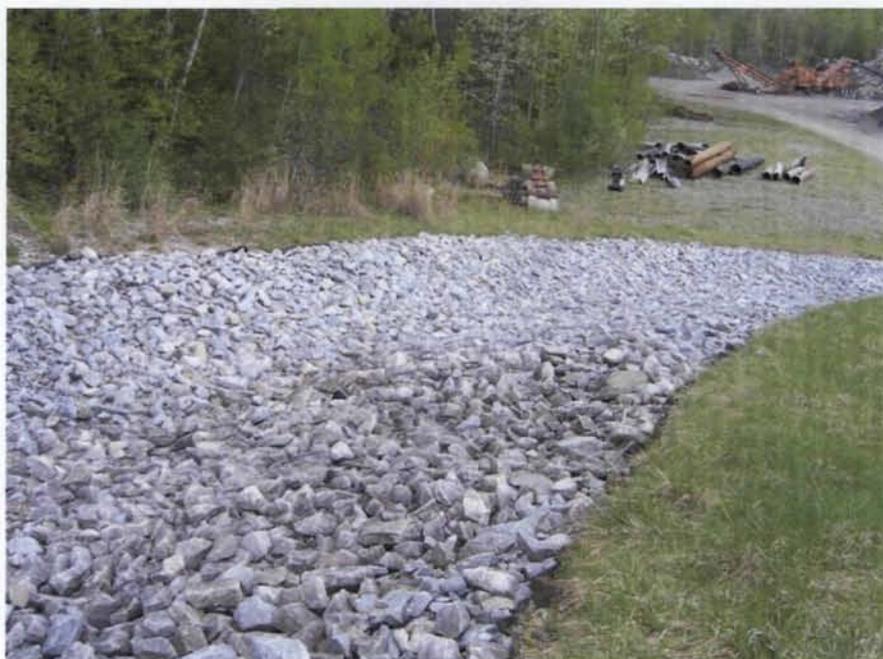
At the northwestern corner of the Site, there is a slope diversion channel that discharges into a perimeter ditch. During the Fall 2008 inspection, the Nobis inspector observed an apparent riprap bulge adjacent to a pipe outlet. This area is unchanged during this inspection. See Figure 1, Item 20 and Photo 16.

Photo 16 Apparent riprap bulge adjacent to pipe outlet near northwest corner of landfill

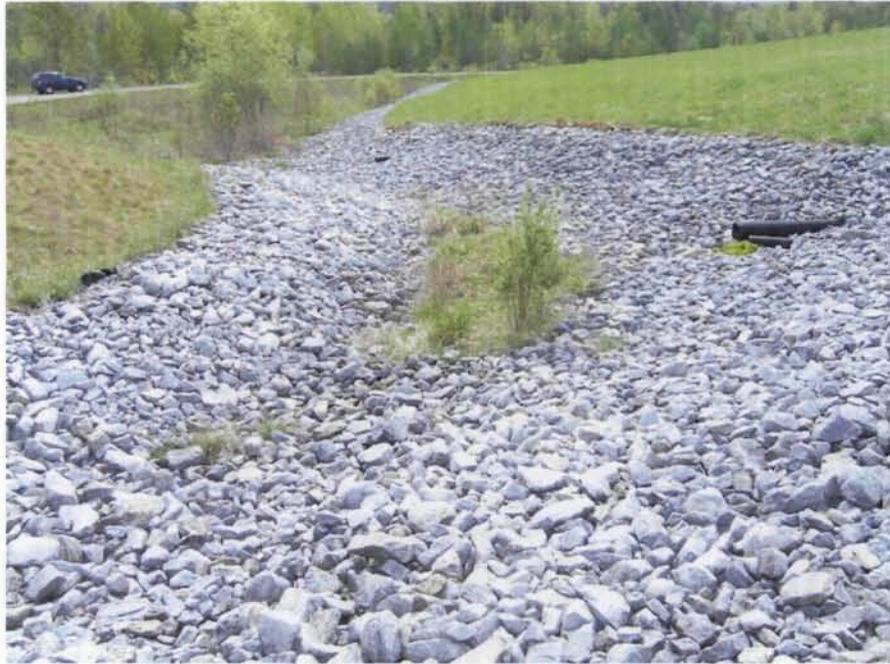
- Observed during the Fall 2008 and prior Site inspections, at the outlet pipe openings in the perimeter ditch near the northeastern corner of the landfill, and at the northern end of the eastern cap extension area, slight sedimentation is still present. Sedimentation and establishment of vegetation could disrupt the hydraulic flow of the perimeter ditch if allowed to build up. See Figure 1, Item 21 and Photo 17.

Photo 17 Sedimentation near outlet pipe openings

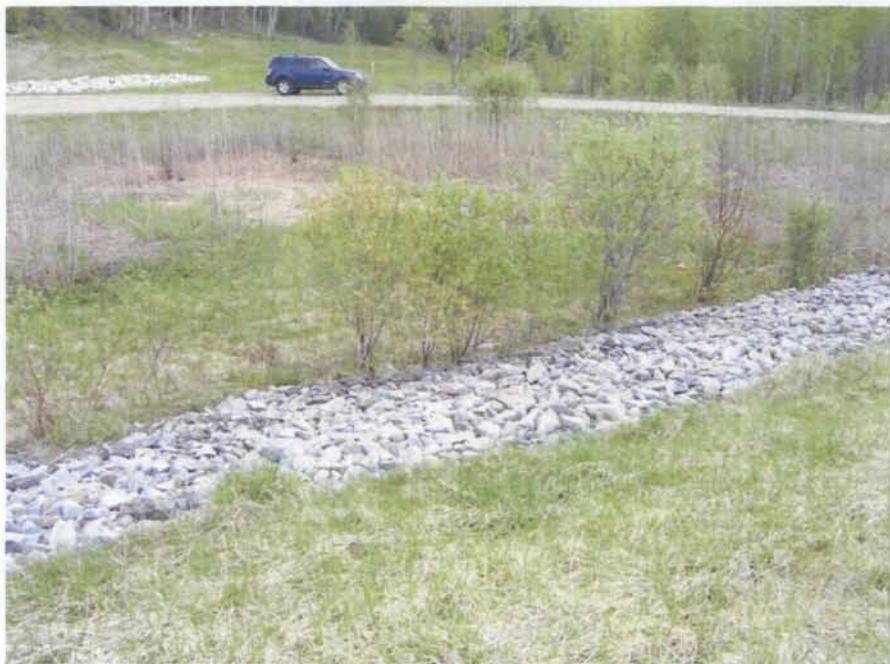
- Observed during the Fall 2008 and prior Site inspections, immediately adjacent to the riprap drainage layer outlet around the perimeter of the cap extension to the east of the main landfill, small trees and/or bushes are still present. While not on the cap, roots from the woody vegetation could impact the cap by growing up into the drainage layer. Woody vegetation in this area increases the chances that unacceptable vegetation will become established on the cap. If allowed to grow to maturity, large trees could also damage the edge of the cap if uprooted. See Figure 1, Item 22 and Photo 18.

Photo 18 Woody vegetation near eastern boundary of landfill

- Remove small trees and bushes from perimeter of landfill cap extension.
  - Trees and bushes have not been removed from this area.
- The bulge in the southern end of the gabion retaining wall at the south end of the UGIT should be monitored for additional shifting or settlement. Repairs to the retaining wall may be necessary in the future if overturning of the retaining wall is observed.

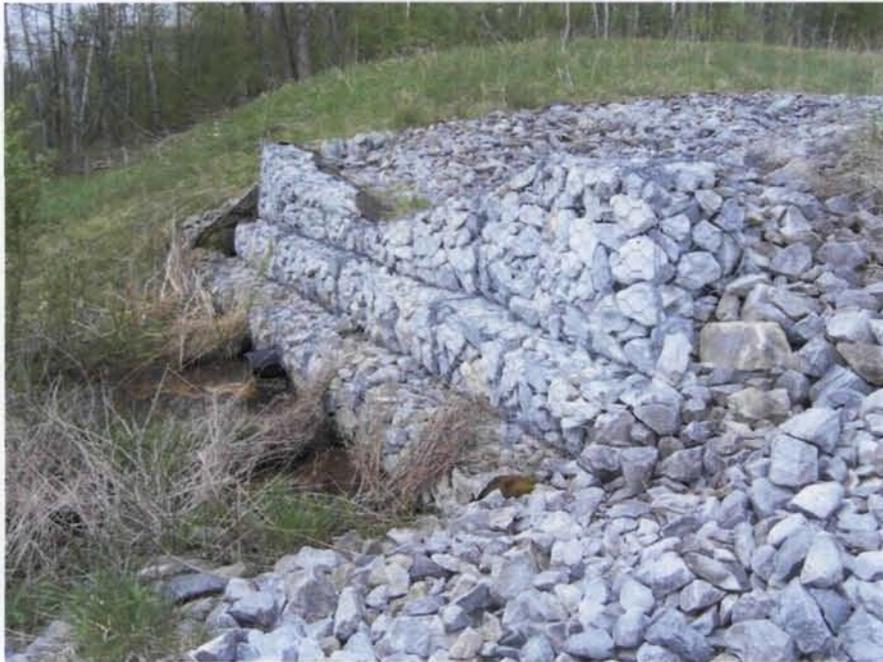
Photo 19 Gabion retaining wall at UGIT area

- The gabions should continue to be monitored for evidence of overturning or other instability; especially in the area of the gabion retaining wall where the bulging has been noted in previous inspections. Monitoring should be done on a monthly basis, or more frequently in times of high precipitation.

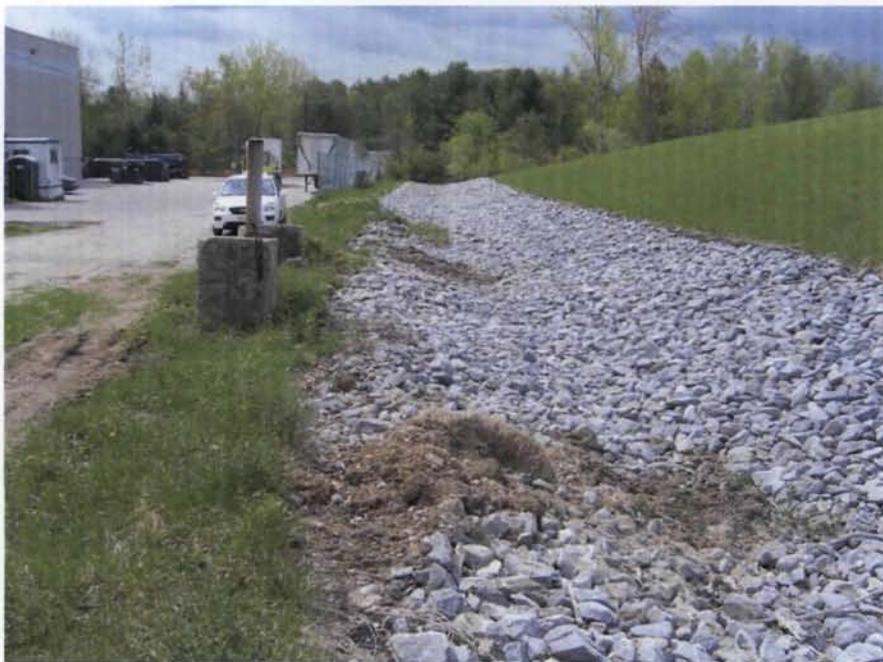
The inspector observed vegetation and sedimentation present in several locations as indicated on Figure 1, Items 24 to 28. This includes locations observed during the Fall 2008 Site inspection and prior inspections. There is a location near the LCTS Building where a layer of soil is on the riprap (see Photo 20 and Figure 1, Item 29).

Photo 20 Soil deposits on riprap near LCTS Building

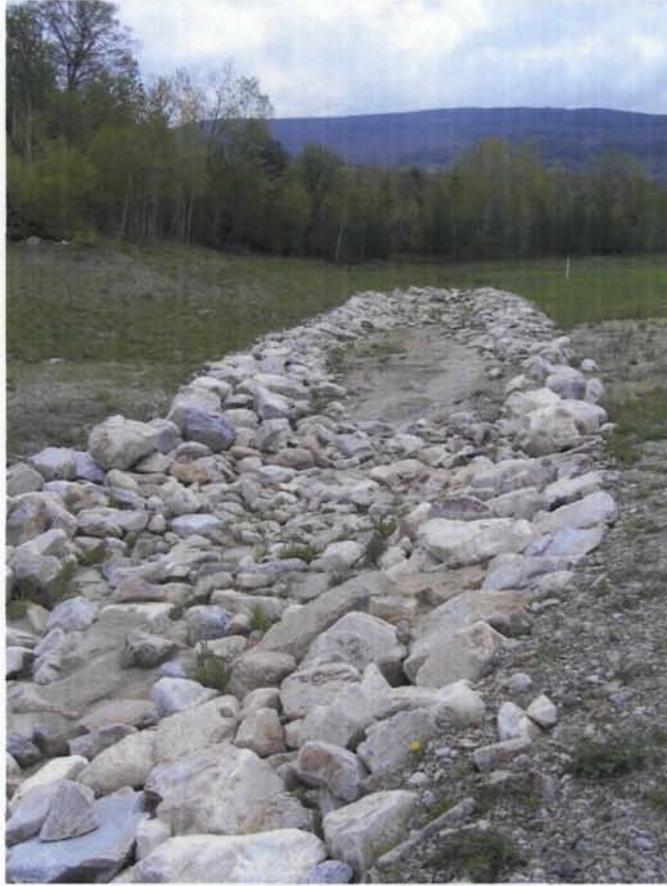
Photo 21 Drainage ditch to U.S. Fish & Wildlife area, contains sedimentation
