AERIAL PHOTOGRAPHIC ANALYSIS OF CENTREDALE MANOR SITE SUBAREA North Providence, Rhode Island

Addendum Report

TS-PIC-20201153S
December 2001

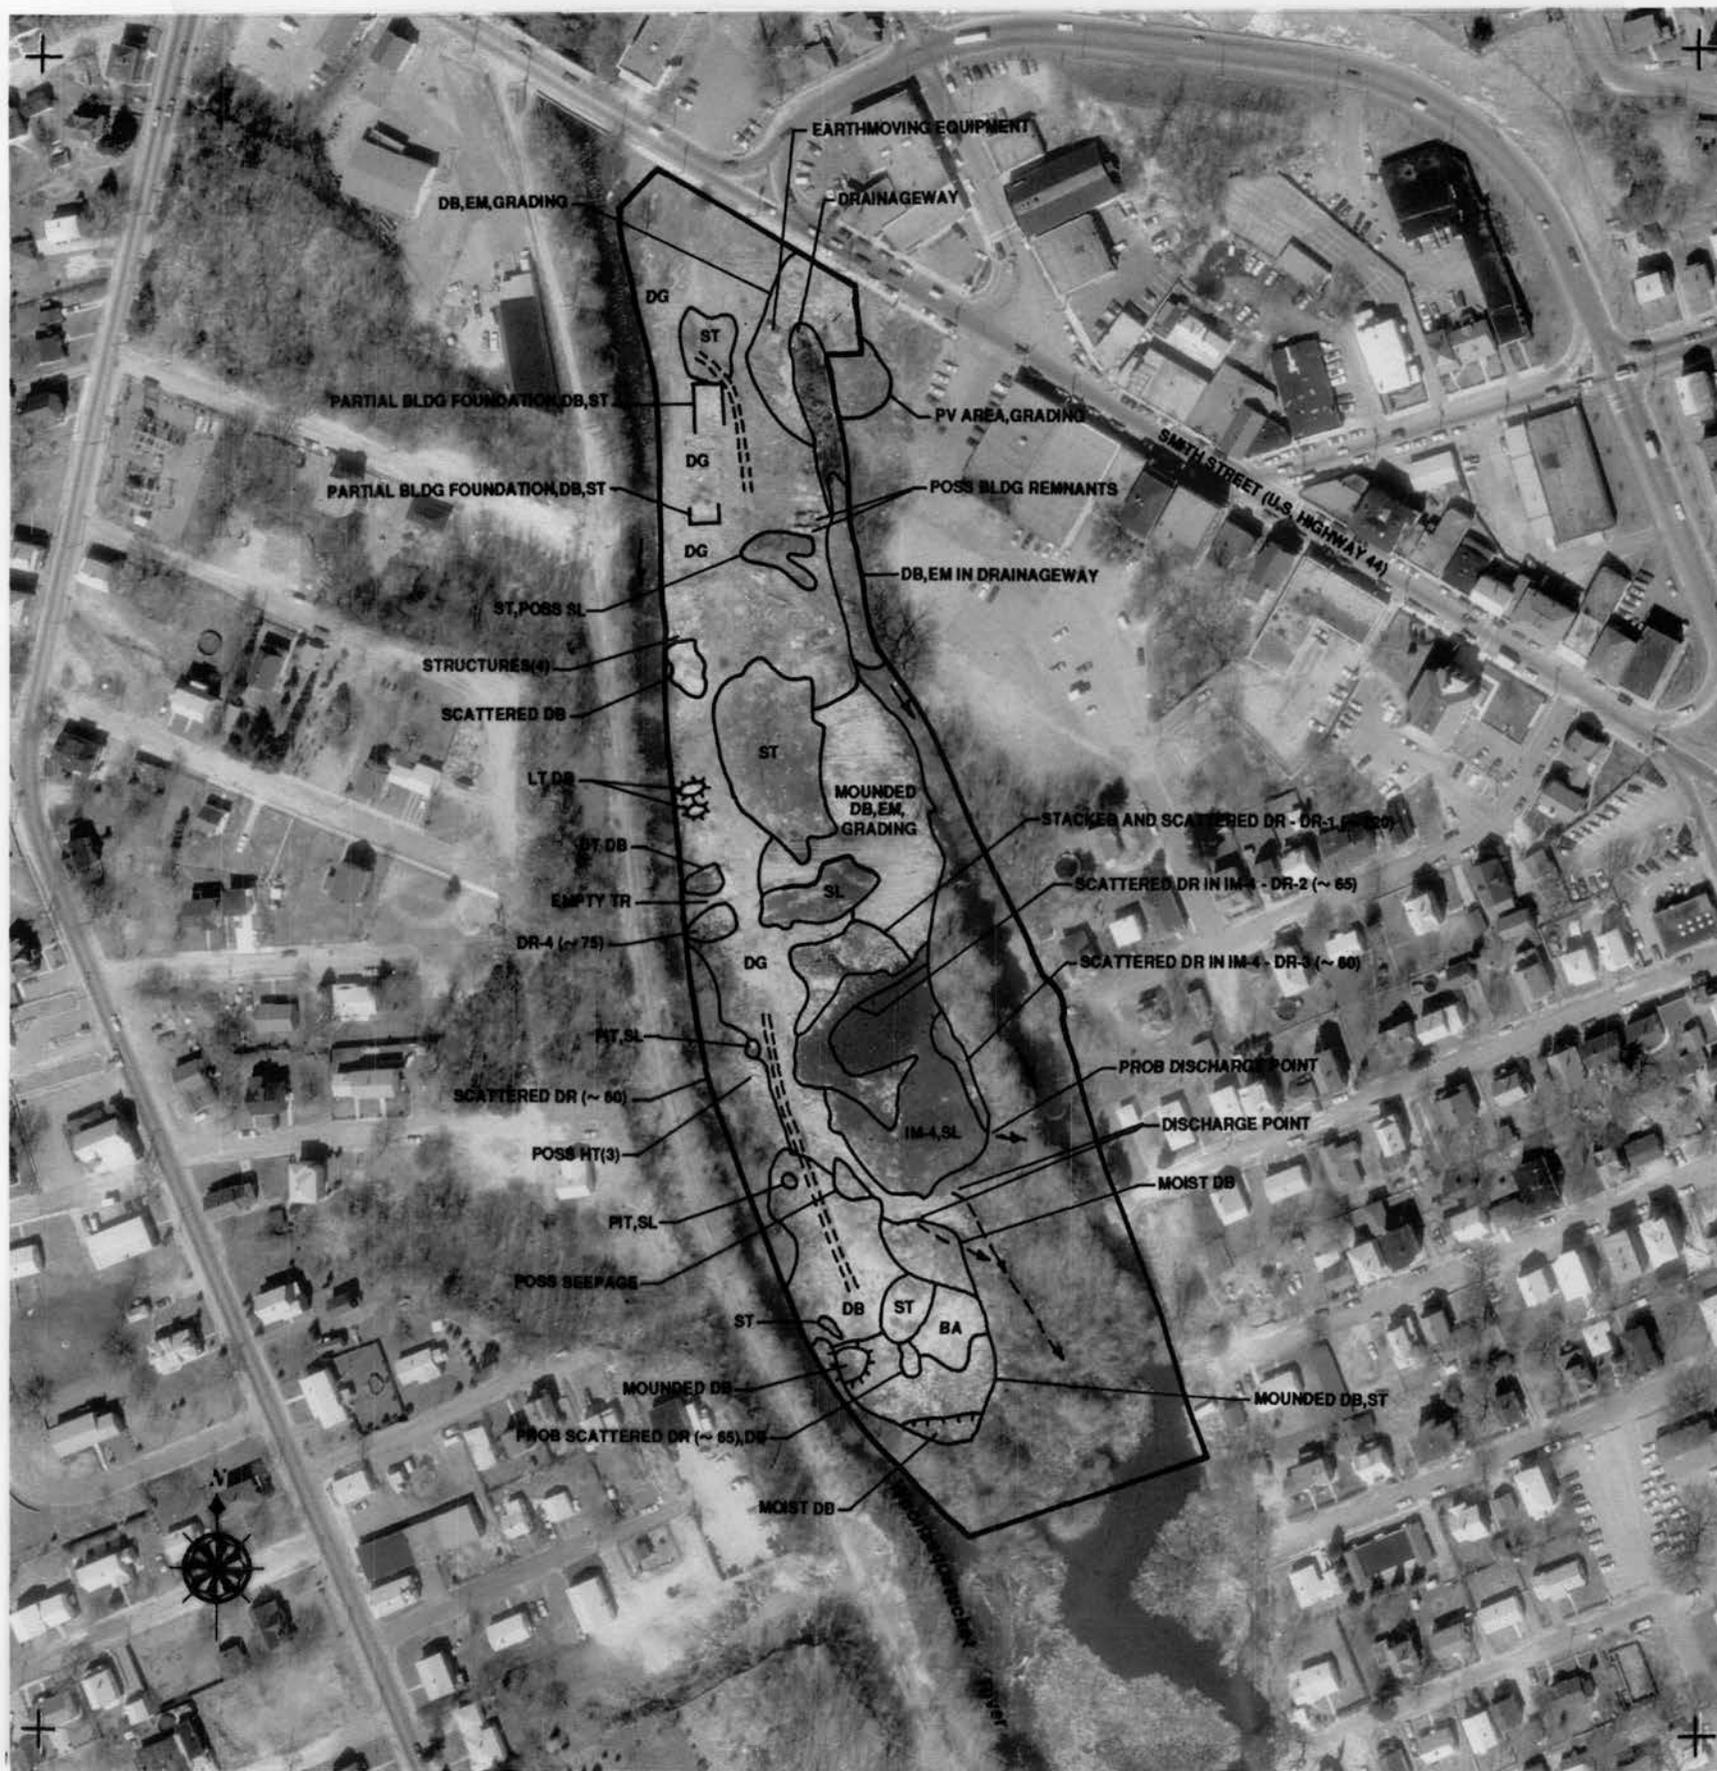
Figure 3. Centredale Manor site subarea, March 25, 1974. Approximate scale 1:2,250.

Photographic resolution of this photodate is excellent, thus enabling a detailed assessment of all features in the subarea.

All five site buildings (not annotated) have been removed from the northern portion of the subarea since 1970. One partial building foundation is observed as well as an area of staining (ST). An access road leads north to this stained area. The ground around these former building locations has been disturbed (DG; partially annotated) and a portion of the debris (DB) and some earthen material (EM) resulting from the demolition of the buildings have been deposited in the vicinity of the northern portion of the drainageway. Grading, as evidenced by the presence of bulldozer blade marks (not annotated), is apparent in this area and also within a partially vegetated (PV) area on the east side of the drainageway. An additional accumulation of debris and earthen material has been deposited in the drainageway east of two possible remnants of the former buildings. A large area of staining and possible standing liquid (SL) is noted directly south of the possible building remnants. Continuing to the south another very large area of staining and an area of standing liquid are noted adjacent to a large accumulation of mounded debris and earthen material. Grading is also in evidence within this area. Other isolated areas of staining (not annotated) are located throughout this portion of the subarea.

Further to the south, a large impoundment (IM-4) containing standing liquid is now present where the former Impoundment 1 (IM-1) and a portion of a stained area were noted in 1970 (not annotated). An area of stacked and scattered drums (DR-1; approximately 220 in number) is located on the north side of the impoundment and scattered drums are present within and along the northwestern and eastern sides of the area. Two areas of drums, one with approximately 65 drums (DR-2) and the other with 60 drums (DR-3) are within impoundment IM-4. A berm (not annotated) is present along the south side of impoundment IM-4 and two discharge points and a probable discharge point are evident and permit flow of liquid material from this impoundment to the nearby drainageway and to the Woonasquatucket River. An area of possible seepage is also noted near the southwest corner of the impoundment.

At the southern terminus of the north-south oriented access road (partially visible and annotated) that leads south from the former building complex is the large waste disposal area (not annotated) observed in 1970. The area now contains debris, mounded debris, moist debris, staining, approximately 15 probable scattered drums, a small pit with standing liquid, and a bare area (BA).

South of the partial building foundation observed in Section 1 and adjacent to the Woonasquatucket River are four small structures and scattered debris. Continuing south along the river, two piles of light-toned debris (LT DB), an empty trench (TR), an area of dark-toned (DT DB) debris, and an area containing approximately 75 drums (DR-4) are observed. This accumulation of drums is located directly adjacent to the river. South of these drums is an area where approximately 60 additional drums are scattered. A small pit with staining and three possible horizontal tanks (HT) are also located within this area.

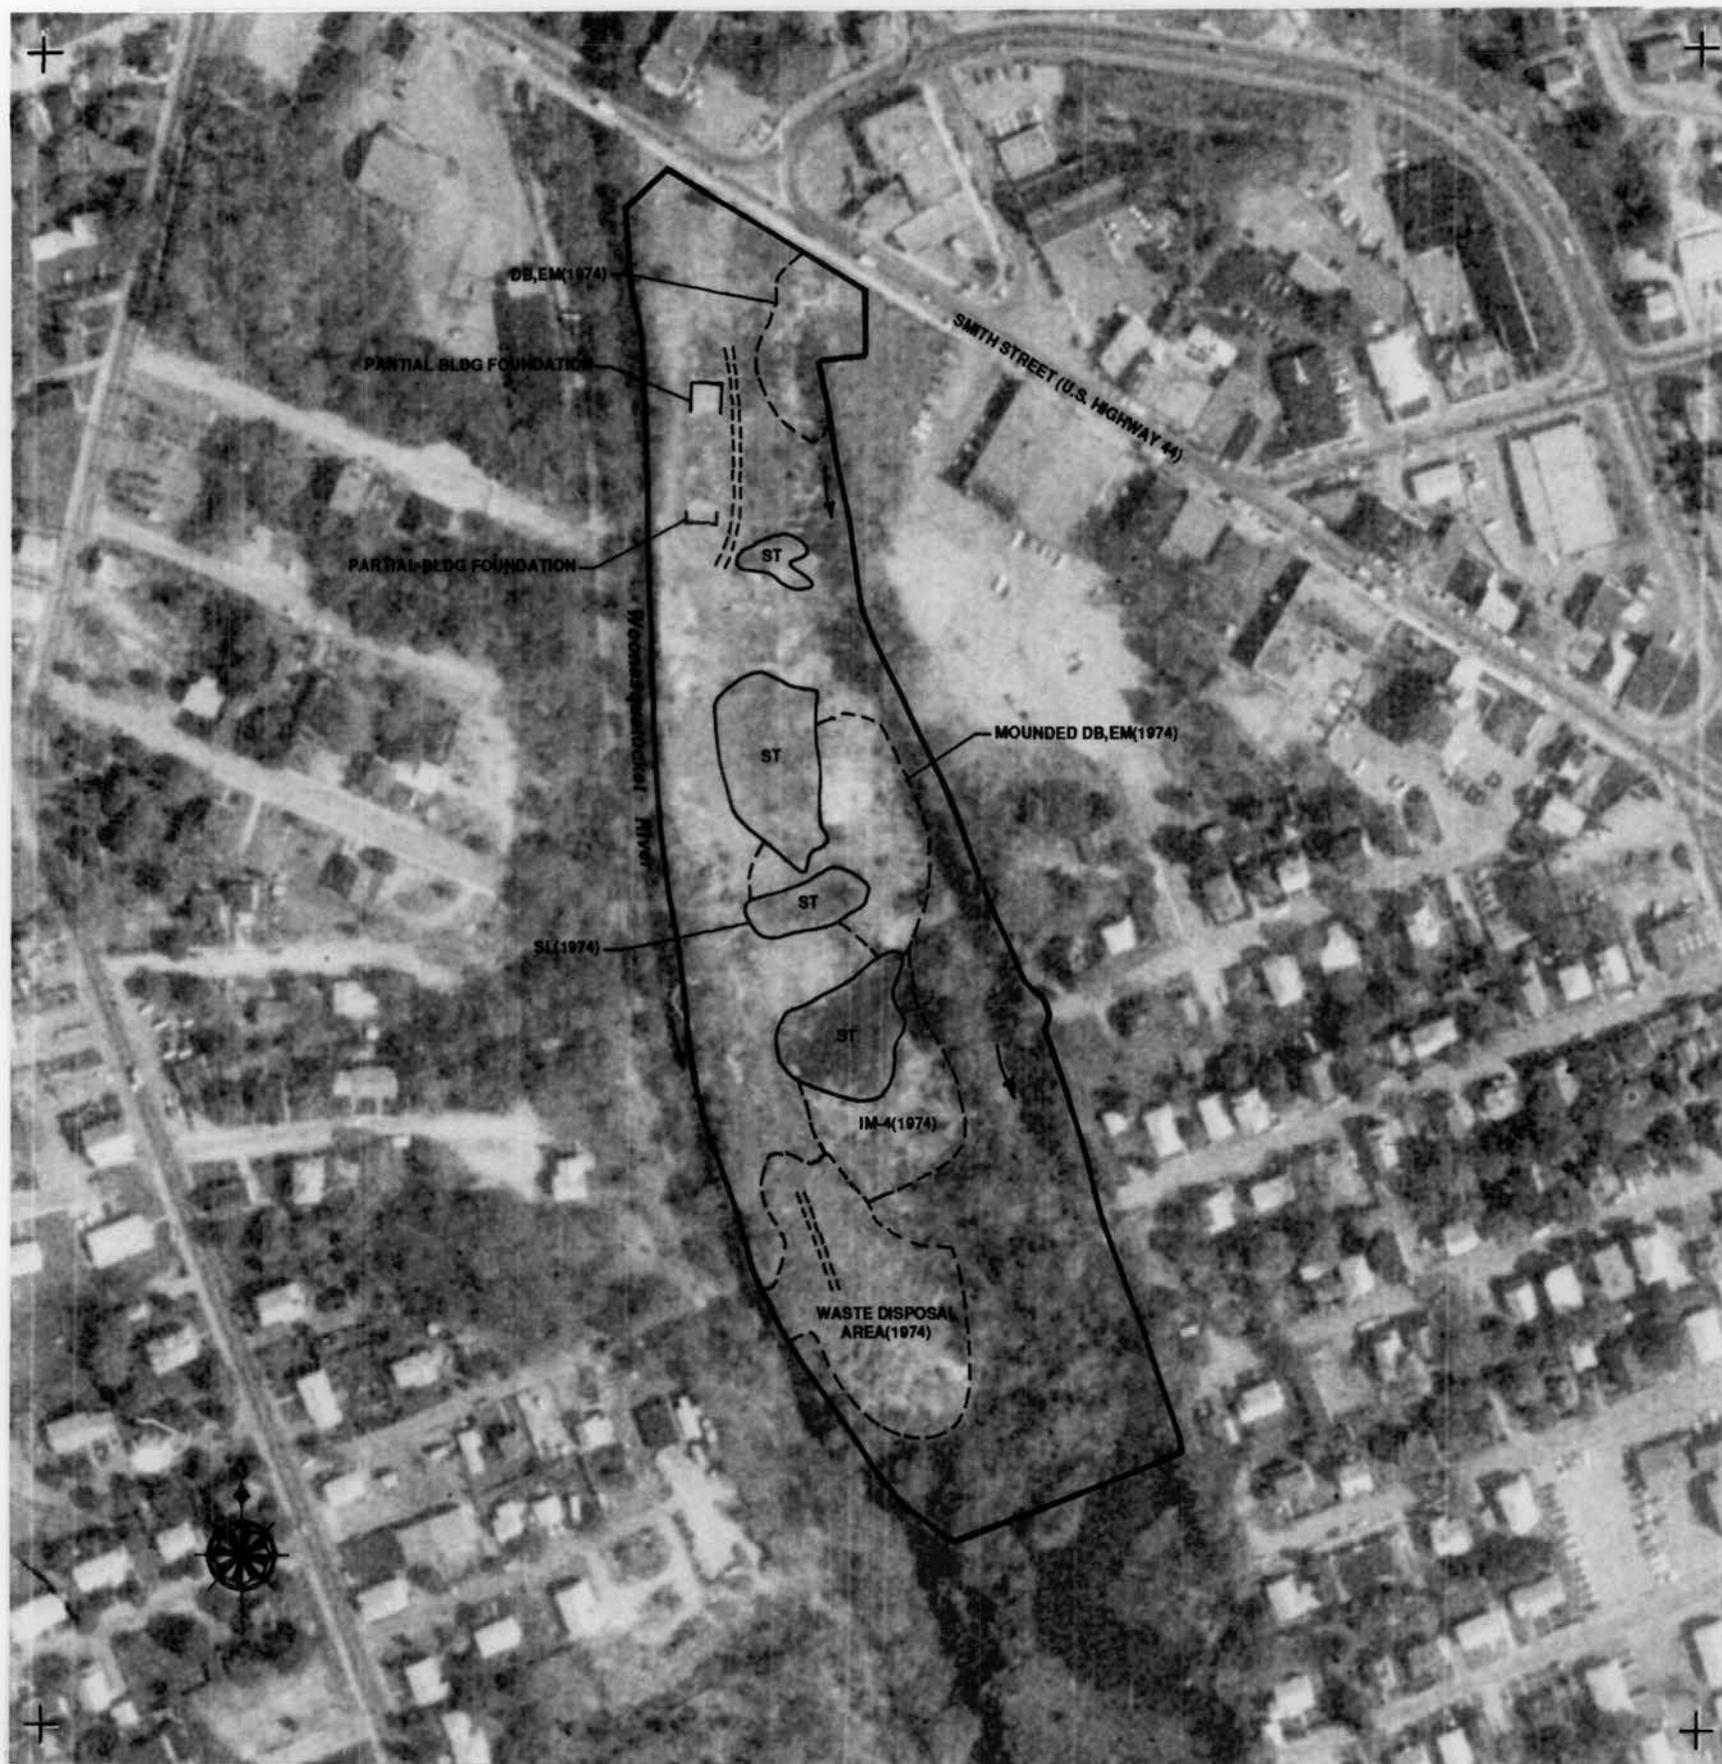
Figure 4. Centredale Manor site subarea, May 5, 1976. Approximate scale 1:2,215.

Resolution of this photograph is poor, which precludes assessment of smaller features such as drums, structures, and possible horizontal tanks, noted in the 1974 photographs. Thus, only larger environmentally significant features such as areas of staining are discernable. Additionally, stereographic photographs were not available for this date of photography; therefore, the analysis was conducted monoscopically.

No new environmentally significant features or activities are noted since 1974. The site is partially vegetated throughout the large disturbed area located in the northern and central portions of the site (not annotated) and no new areas of disturbance, access roads, or routes are apparent. This indicates that the site is apparently inactive. The location of debris and earthen material noted at the north end of the drainageway in 1974 is depicted. The partial building foundation remains visible, as does a large stain immediately to the southeast along the access road. Further to the south, two other areas of staining are noted. To the east of these stains is a former location of debris and earthen material. Continuing to the south there is another large stained area that was part of impoundment IM-4 noted in 1974. The dashed outline depicts the remainder of the areal extent of the former impoundment. The location of the former large waste disposal area at the southern end of the north-south access road in 1974 is also depicted.
