Loureiro Engineering Associates, Inc.

January 23, 2002

**RE: Centredale Manor Restoration Project, North Providence, Rhode Island  
Review of Historic Topographic Maps and Aerial Photographs  
Summary Report**

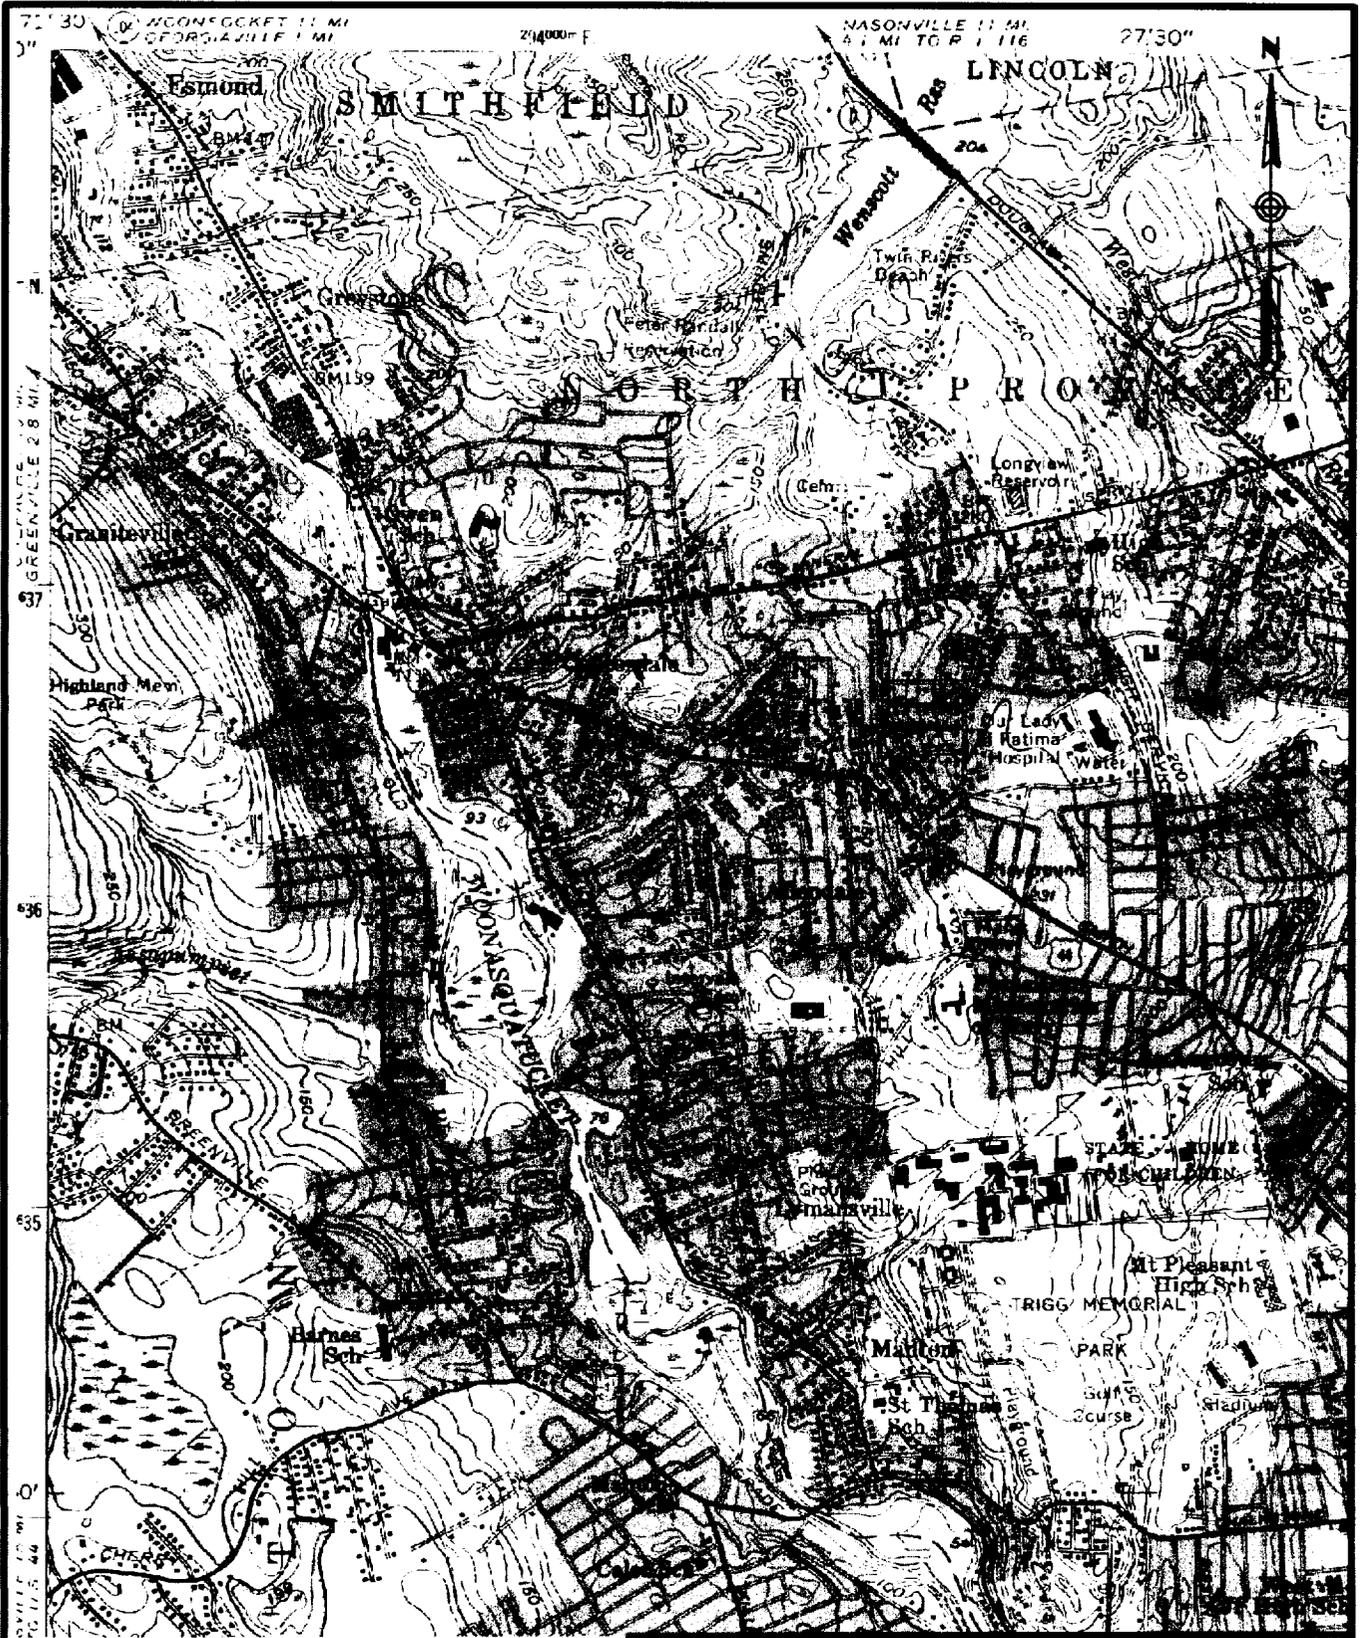
MAP REFERENCE: SCALE IN FEET  
 USGS 7.5 MINUTE SERIES QUADRANGLE FOR  
 PROVIDENCE, R.I., DATED 1970

*1970 Providence, Rhode Island Quadrangle, USGS 7.5-Minute Series*

There is no discernible change to the site proper and the properties adjacent to Allendale Pond depicted on this map. The only noticeable change to the site and surrounding area is that Falco Avenue, Zambarano Avenue, and Cynthia Drive have been developed adjacent to Lymansville Pond.

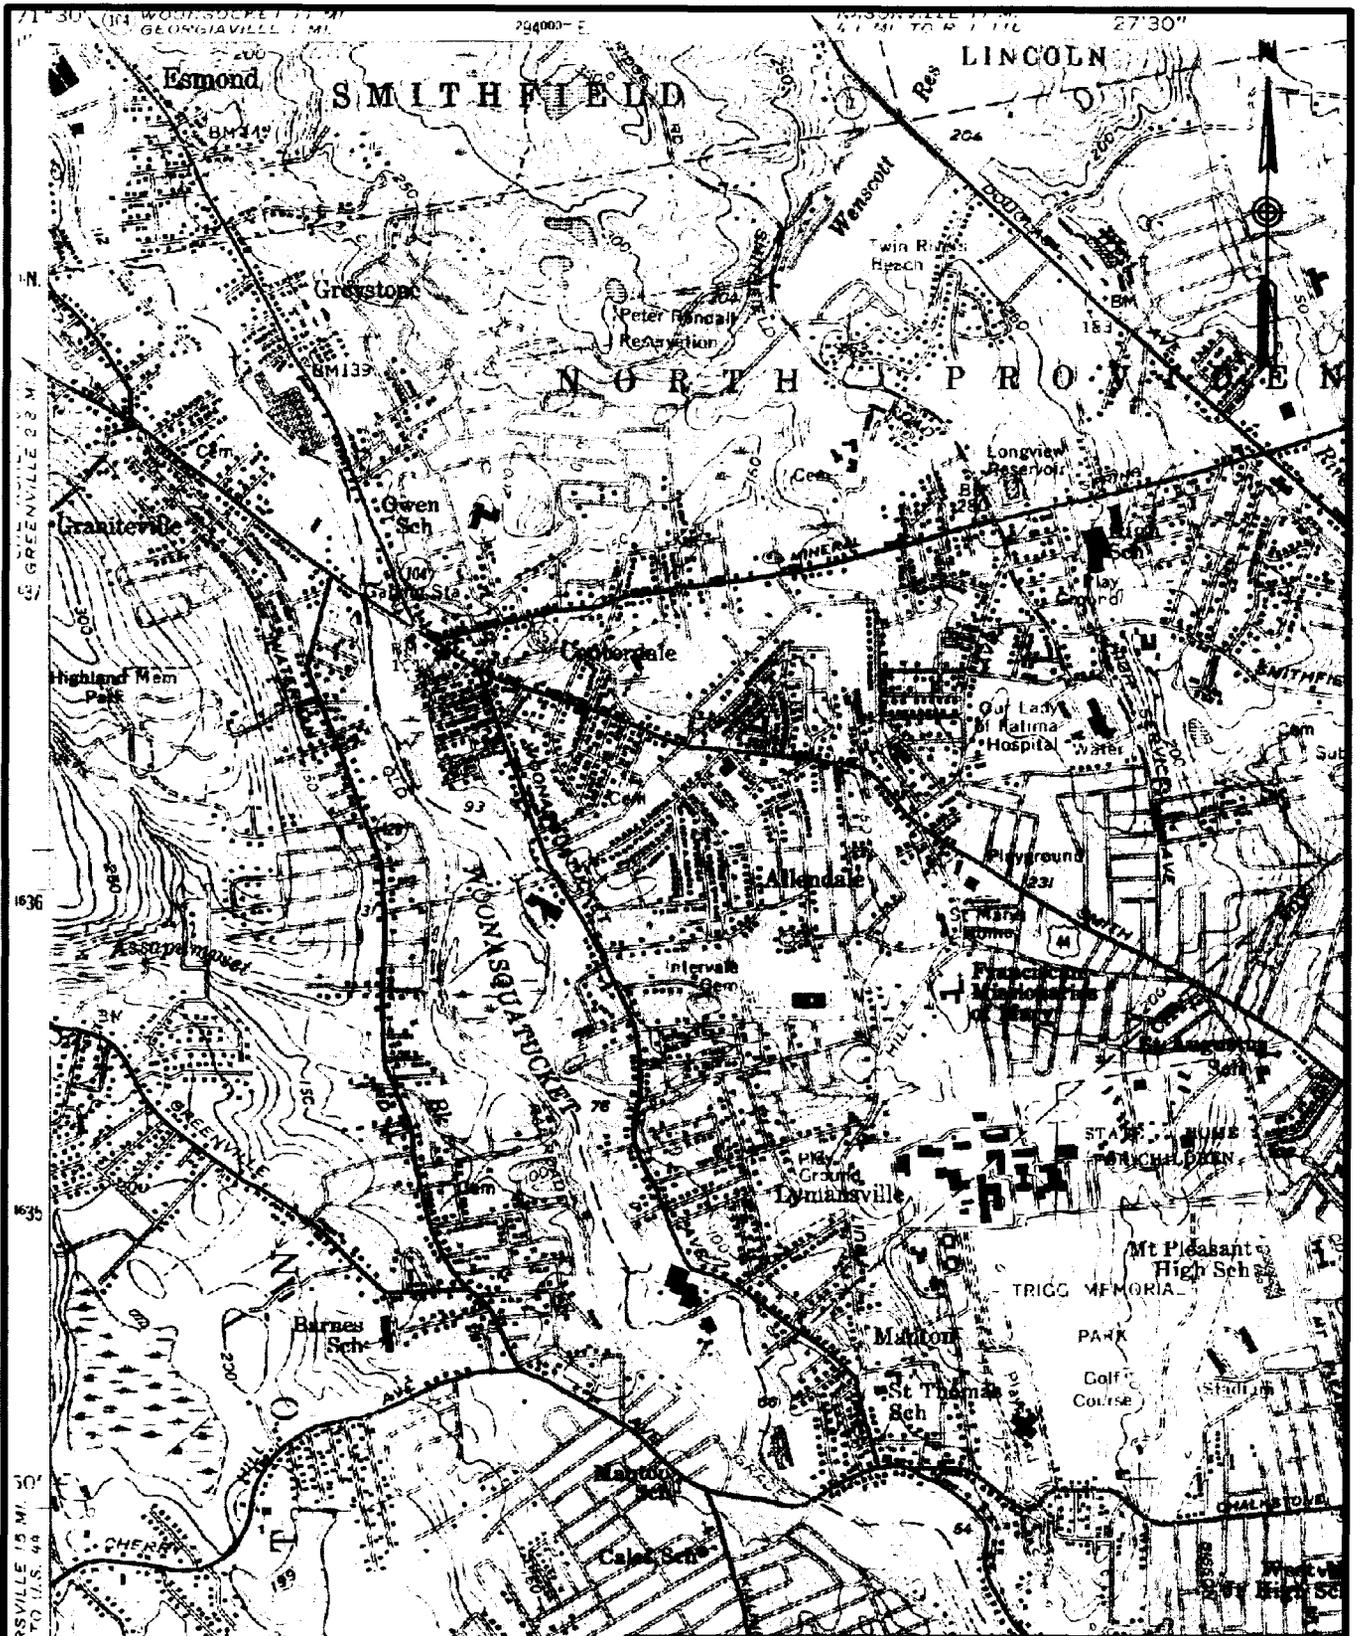
MAP REFERENCE: SCALE IN FEET  
 USGS 7.5 MINUTE SERIES QUADRANGLE FOR  
 PROVIDENCE, R.I., DATED 1975

*1975 Providence, Rhode Island Quadrangle, USGS 7.5-Minute Series*

As shown on this map, the site proper is vacant. There are no noticeable changes to the shape and extent of Allendale Pond, nor to the elevation and development of the surrounding terrain. Likewise, there are no noticeable changes to the shape and extent of Lymansville Pond, nor to the elevation and development of the terrain surrounding Lymansville Pond.

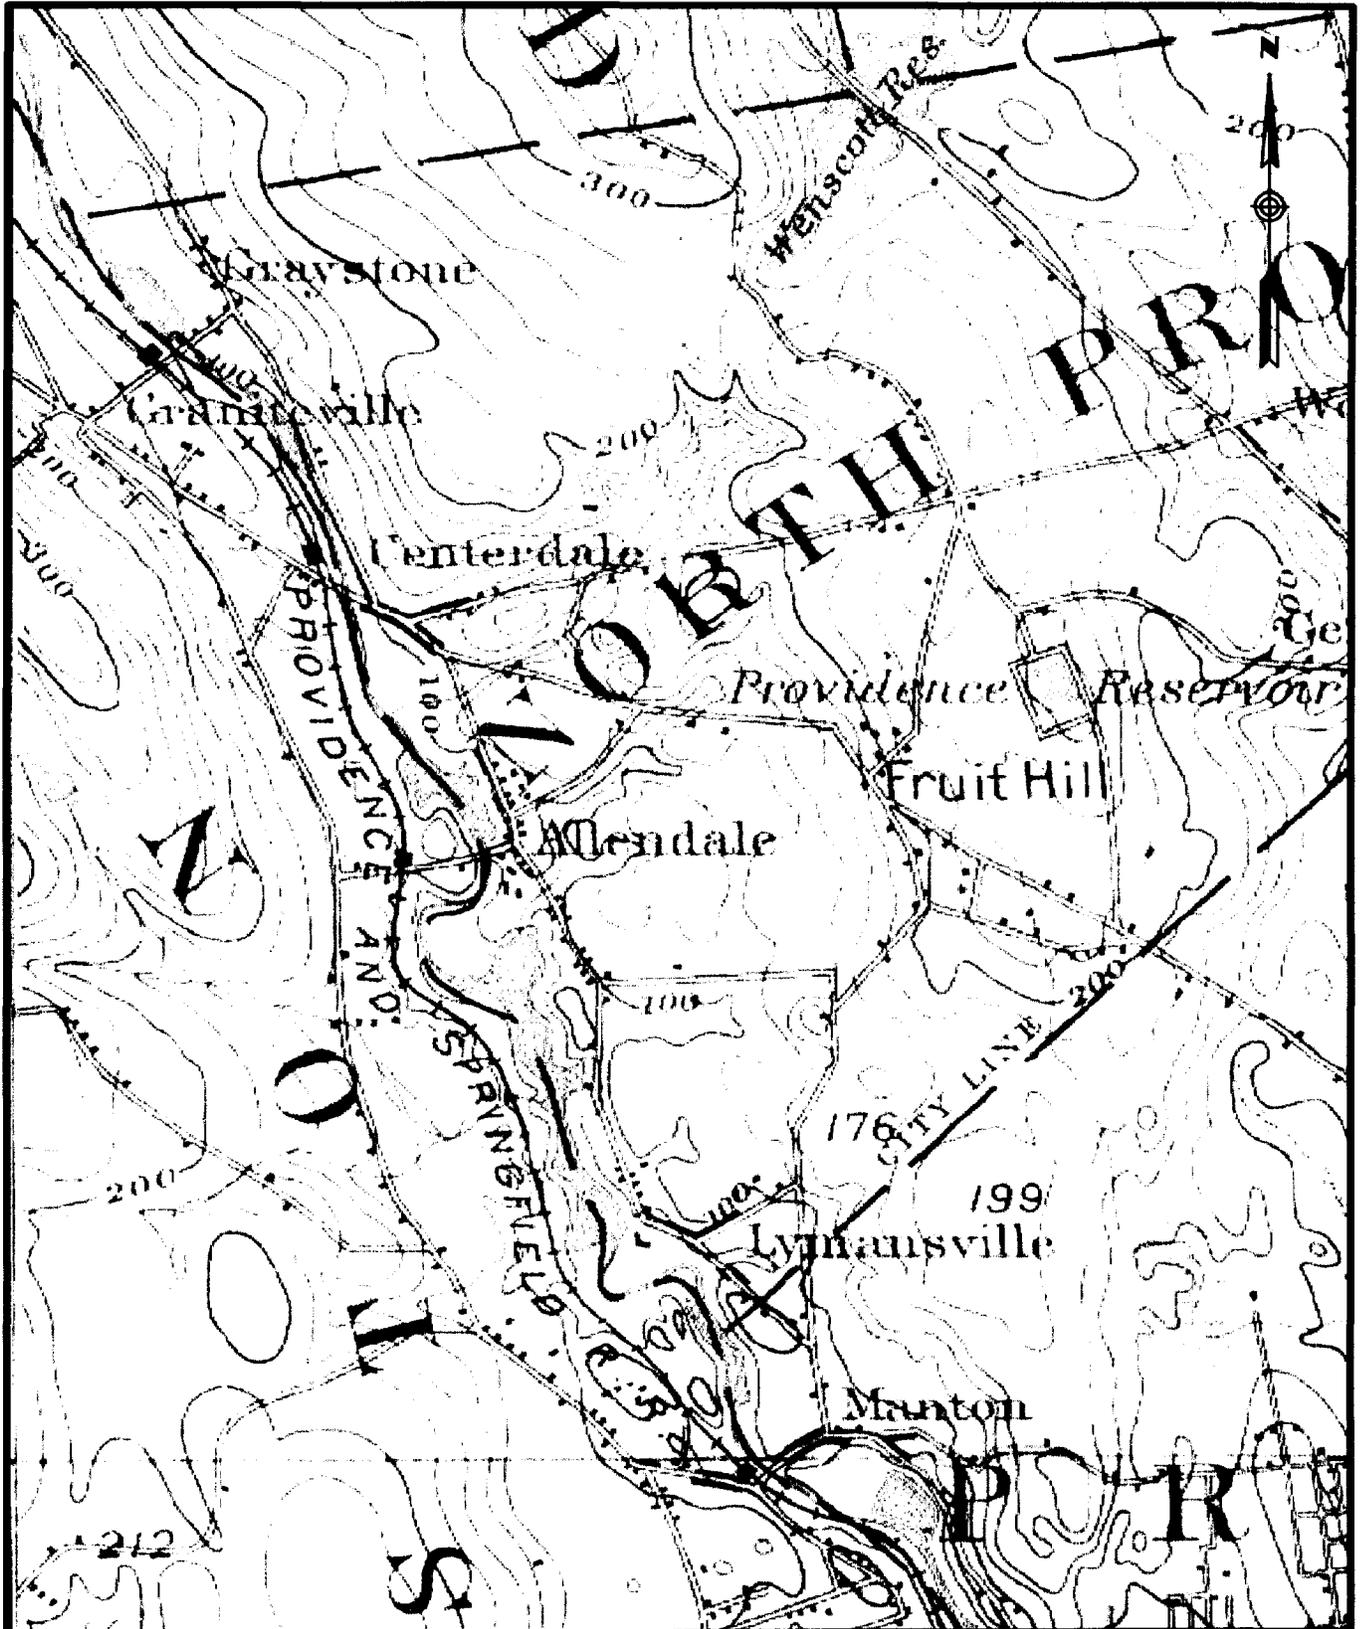
MAP REFERENCE: SCALE IN FEET  
 USGS 7.5 MINUTE SERIES QUADRANGLE FOR  
 PROVIDENCE, R.I., DATED 1894

*1894 (reprinted 1932) Providence, Rhode Island Quadrangle, USGS 15-Minute Series*

Allendale Pond and Lymansville Pond are clearly defined on this map. As of yet, the site proper (2072 and 2074 Smith Street) has not been developed. The properties adjacent to Allendale Dam and at Lymansville Dam have been developed. Properties along Woonasquatucket Avenue have also been developed between Smith Street and Lymansville Dam. Allendale Way (Allendale Avenue) is the only crossroad that has been developed. Several buildings exist along this road at this time.

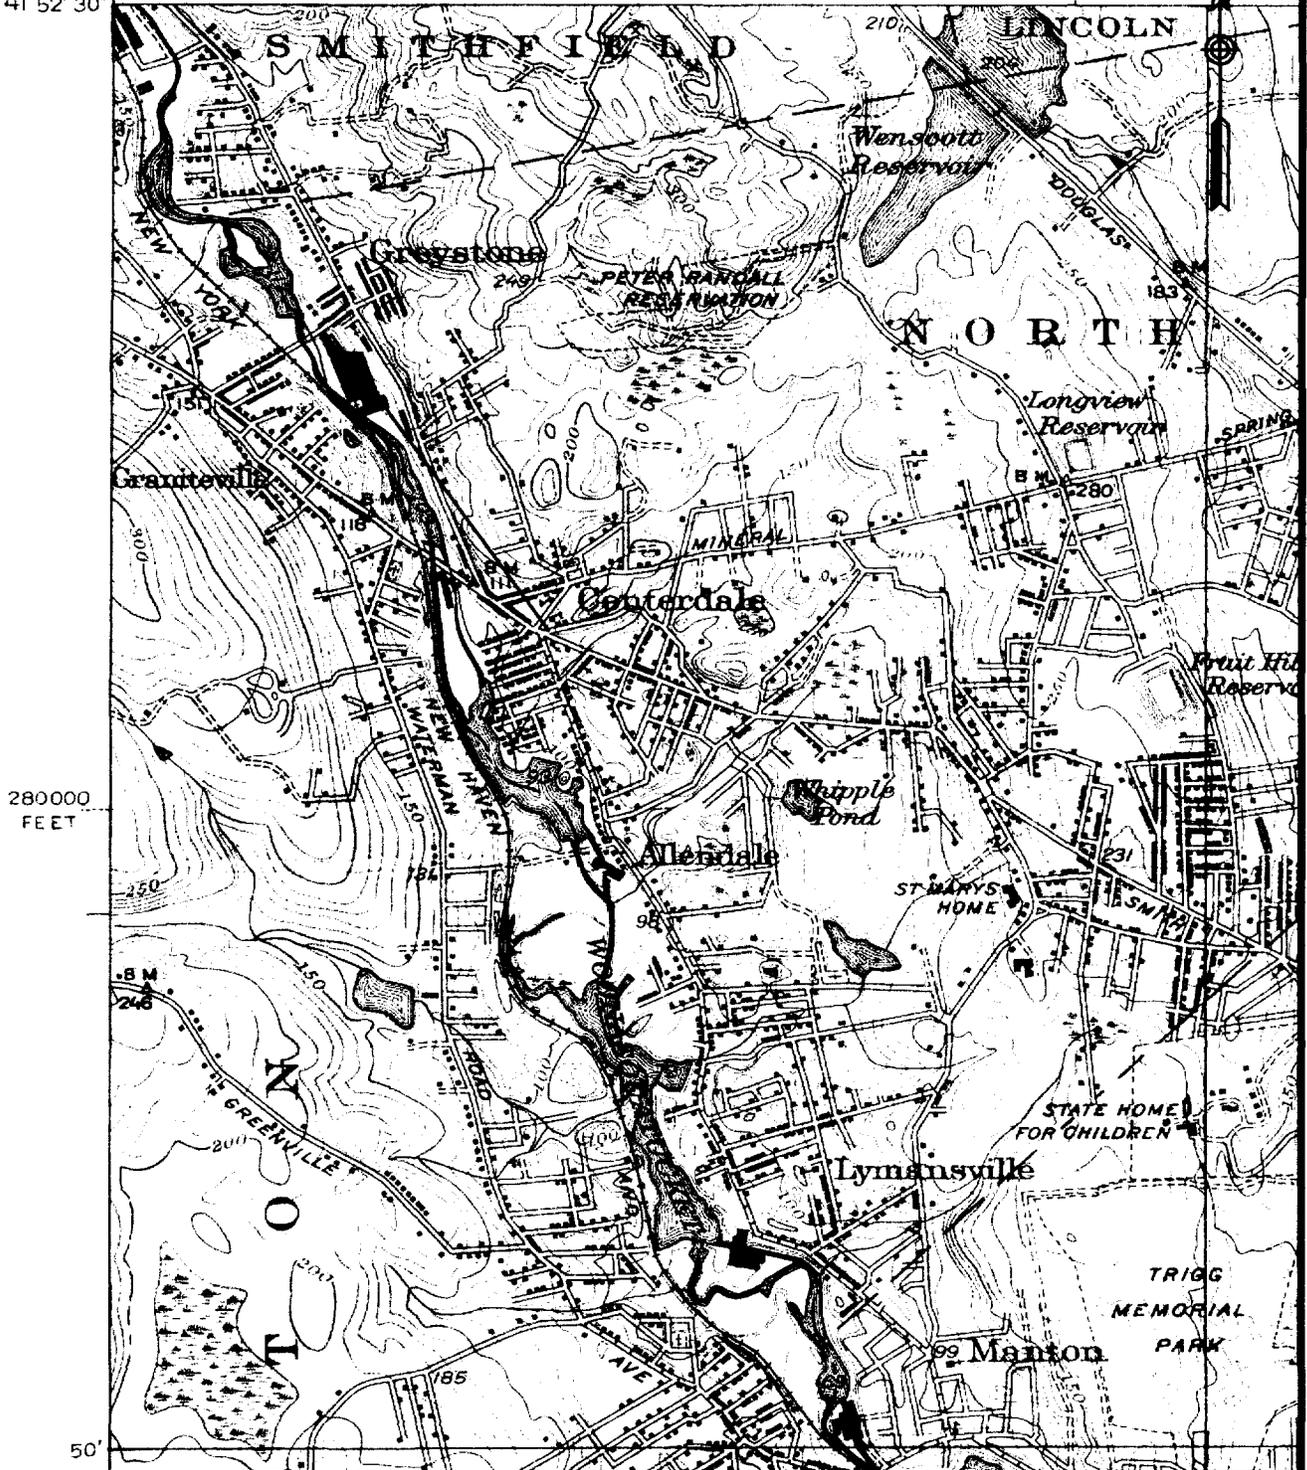
MAP REFERENCE: SCALE IN FEET  
USGS 7.5 MINUTE SERIES QUADRANGLE FOR  
PROVIDENCE, R.I., DATED 1939

*1939 Providence, Rhode Island Quadrangle, USGS 7.5-Minute Series*

A diversion structure is present along the Woonasquatucket River immediately north of Smith Street. This structure diverts the Woonasquatucket River along the western boundary of the site proper (2072 and 2074 Smith Street). However, most of the flow of the Woonasquatucket River is diverted by this structure through a raceway, the tailrace of which flows through the site proper. The area covered by Allendale Pond has increased, apparently due to the development of the raceway through the site proper. The shape of Allendale Pond is beginning to resemble the shape of the pond prior to the failure of Allendale Dam. The area and shape of Lymansville Pond is generally consistent with present-day Lymansville Pond.

The site proper has been developed. Several buildings are situated on both the east and west side of the tailrace. Extensive development has occurred in the vicinity of Allendale Pond. Steere Avenue, Grover Street, Redfern Street, George Street, Stevens Street, Aldrich Street, and Centredale Avenue have been developed. Numerous buildings are situated along these streets. It is noted that Redfern Street, George Street, and Stevens Street extend to the edge of Allendale Pond, below an elevation of 100 feet. A crossroad, west of Centredale Avenue, connects George Street, Stevens Street, and Aldrich Street.

The raceway at Allendale Mill has been created and is also clearly evident. Most of the present-day crossroads in the Lymansville Pond area have been partially developed and a number of buildings are situated along these roads.

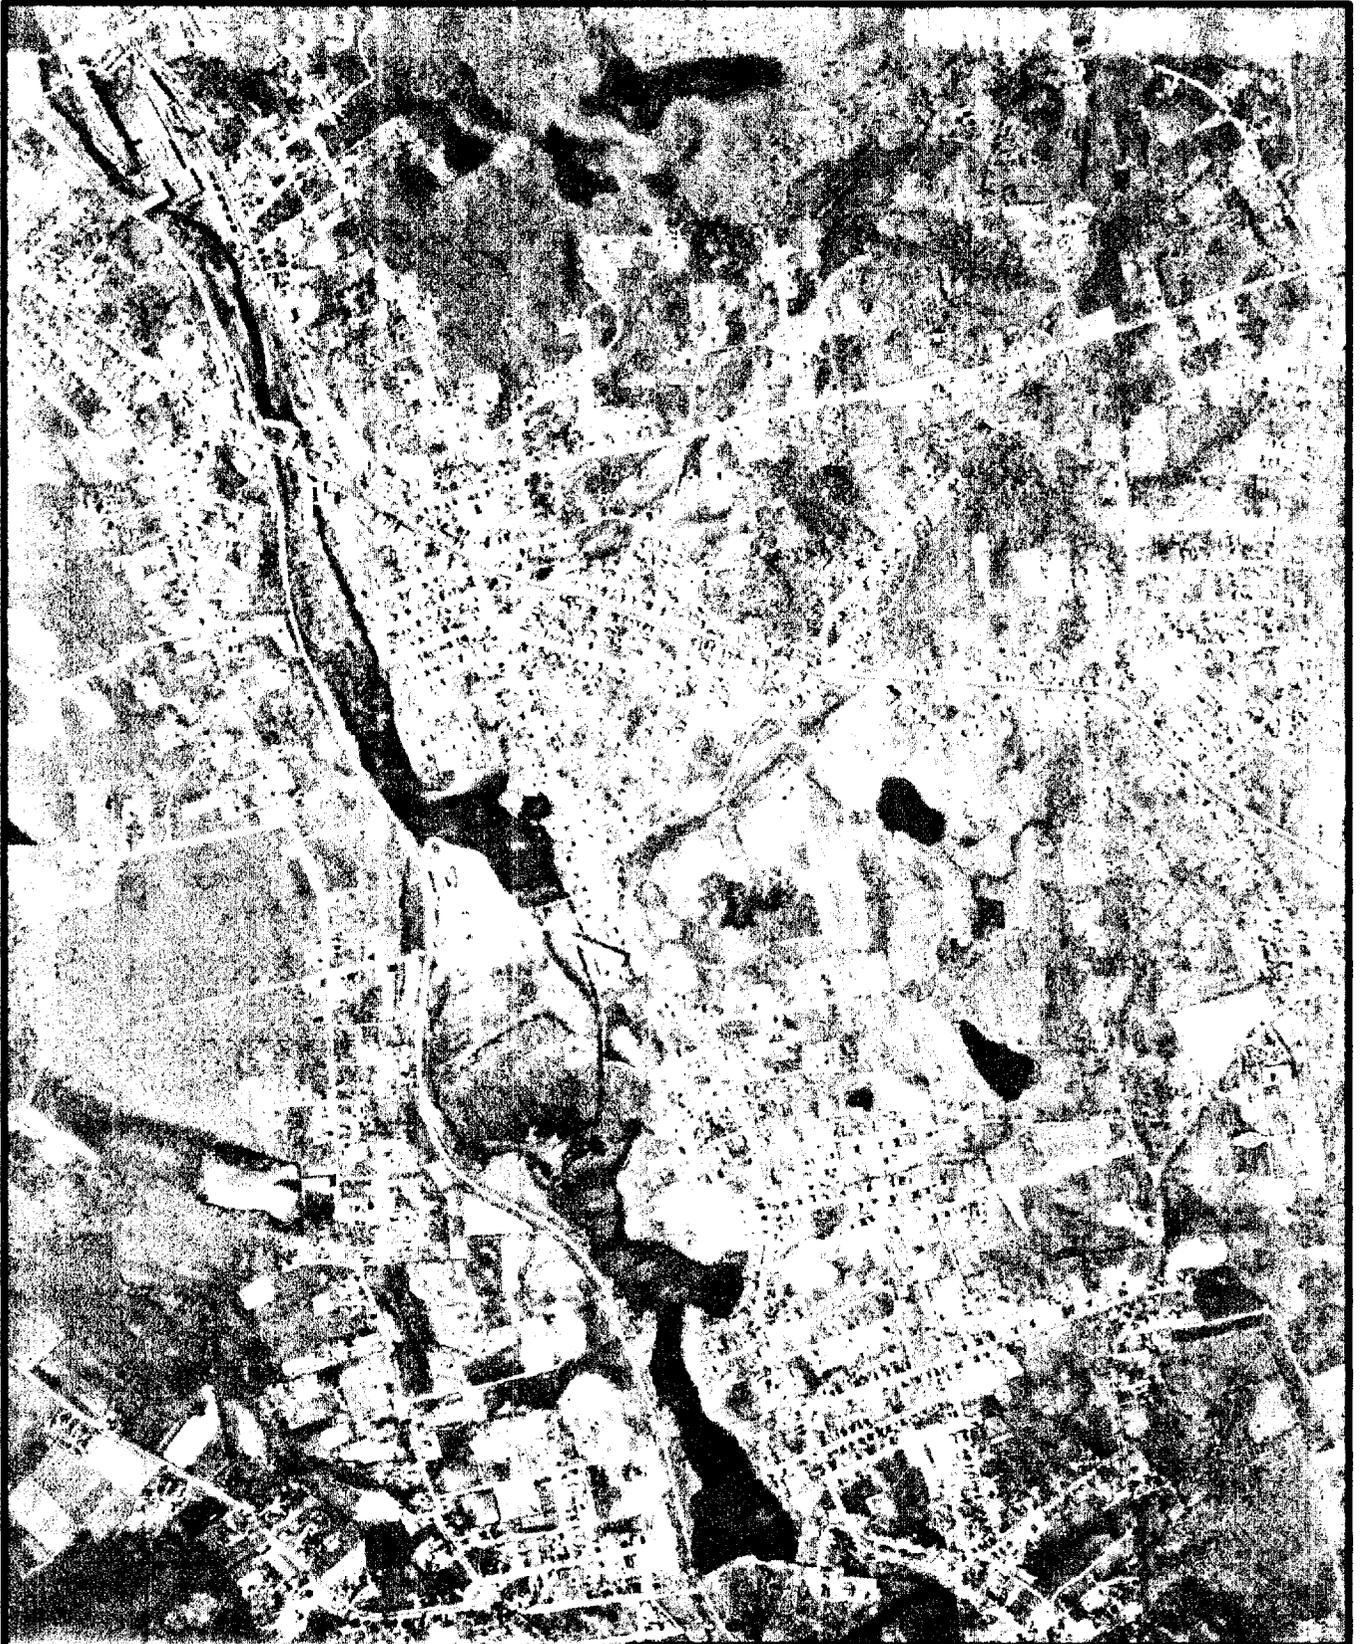
AERIAL PHOTOGRAPH  
05-15-39

In general, the area surrounding Allendale Pond has been fairly well developed by 1939. At this time, development of the land south of Centredale and in the vicinity of Lymansville Pond was less extensive. As shown in the 1939 photograph, much of the land abutting Allendale Pond, Lymansville Pond, and the Woonasquatucket River was not being utilized. By 1951, the Site proper and land immediately adjacent to Allendale Pond, Lymansville Pond, and the Woonasquatucket River had undergone significant development. The development of adjoining land is exemplified by the landform changes observed at the northern extent of Allendale Pond and the west end of George Street. In this area surface water is no longer present apparently due to filling activities. The development of adjoining land is further exemplified by the change in the appearance of the land defined by "Action Area 6" and "Action Area 7". By 1951, it appears that clearing and construction activities have occurred in these areas.

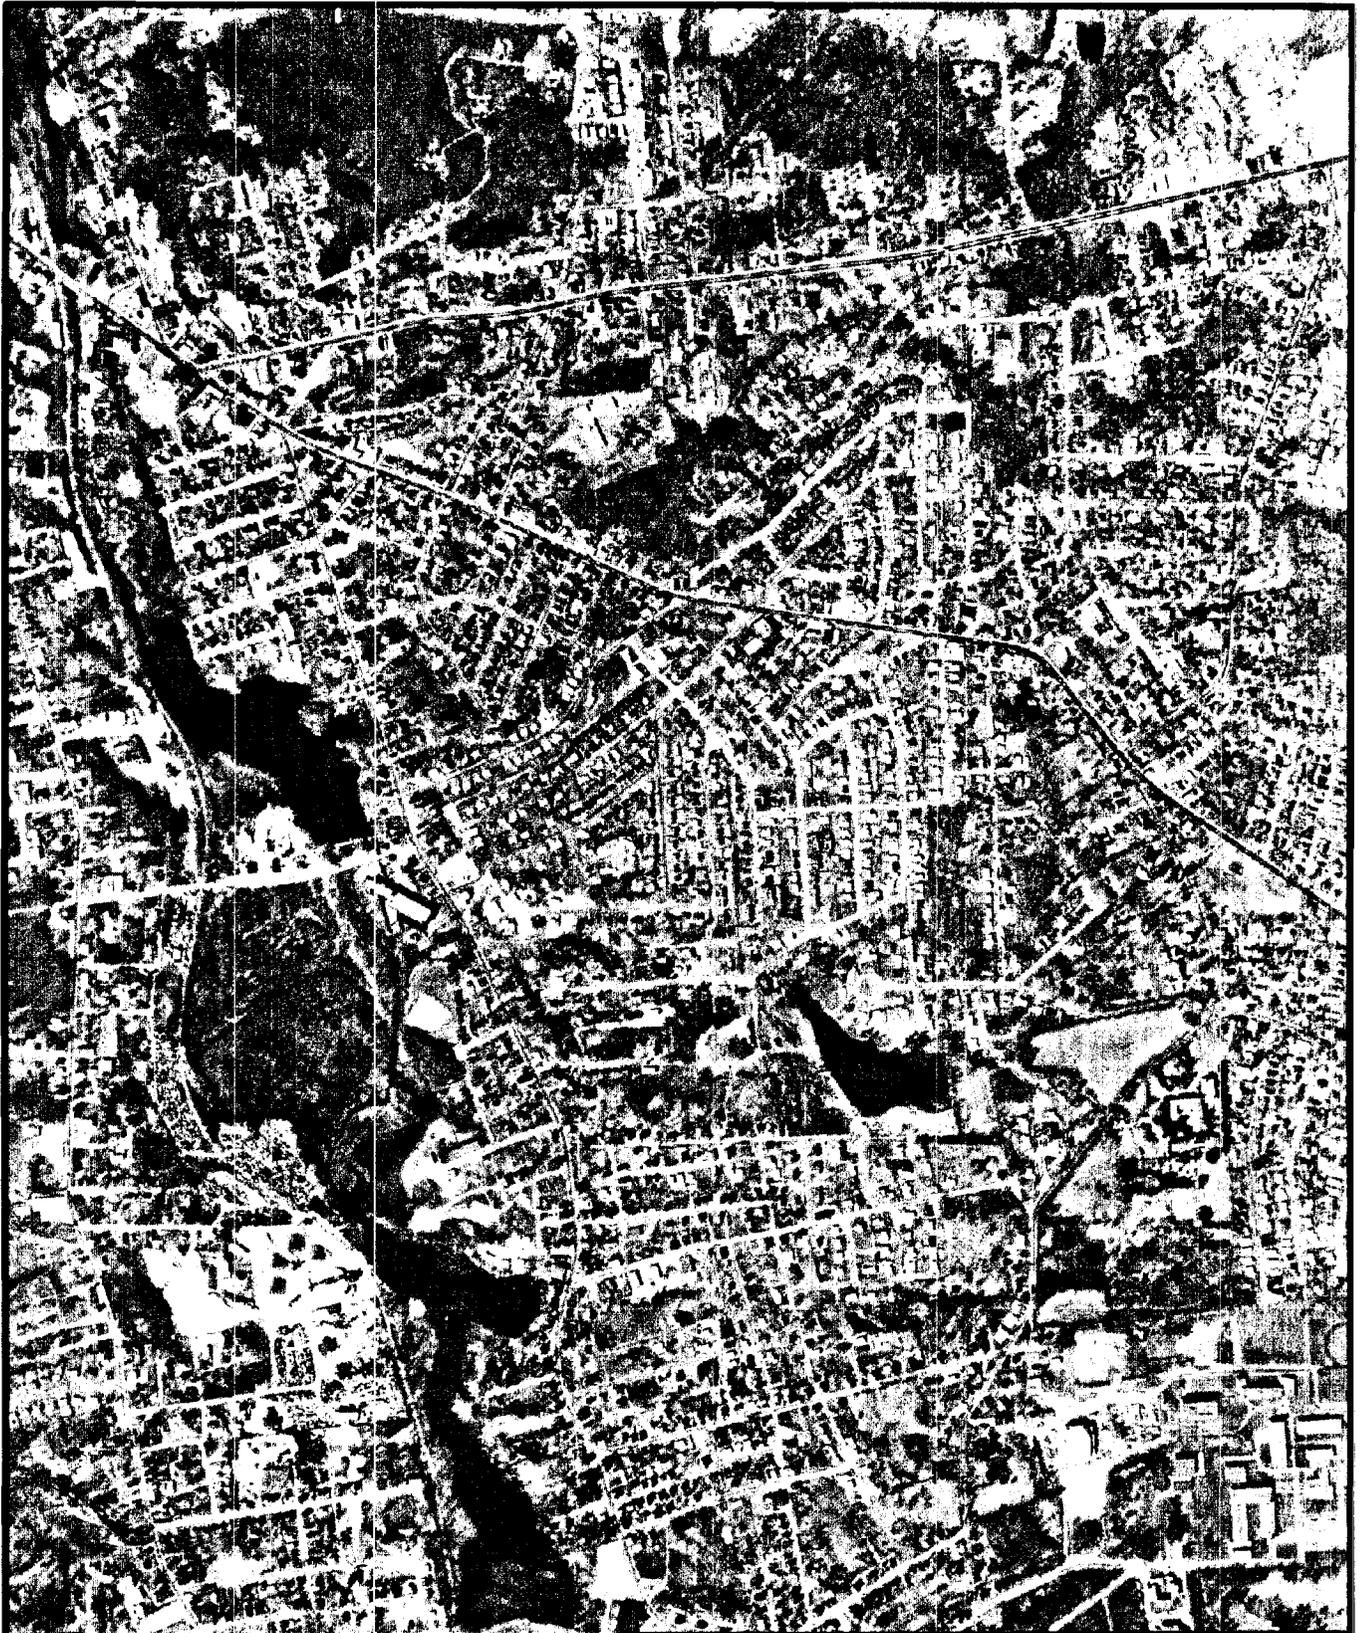
AERIAL PHOTOGRAPH  
4-19-65

By 1965, continued development and use of the land abutting Allendale Pond is evident. In general, land that had previously been cleared to the edge of Allendale Pond appears to have been overgrown or filled, as is evident in the vicinity of "Action Area 2" (Steere Avenue). This general observation is also made for "Action Area 4", where additional filling activities appear to have occurred at the west end of George Street. By 1965, it is also evident that land defined by "Action Area 6" has been substantially disturbed.

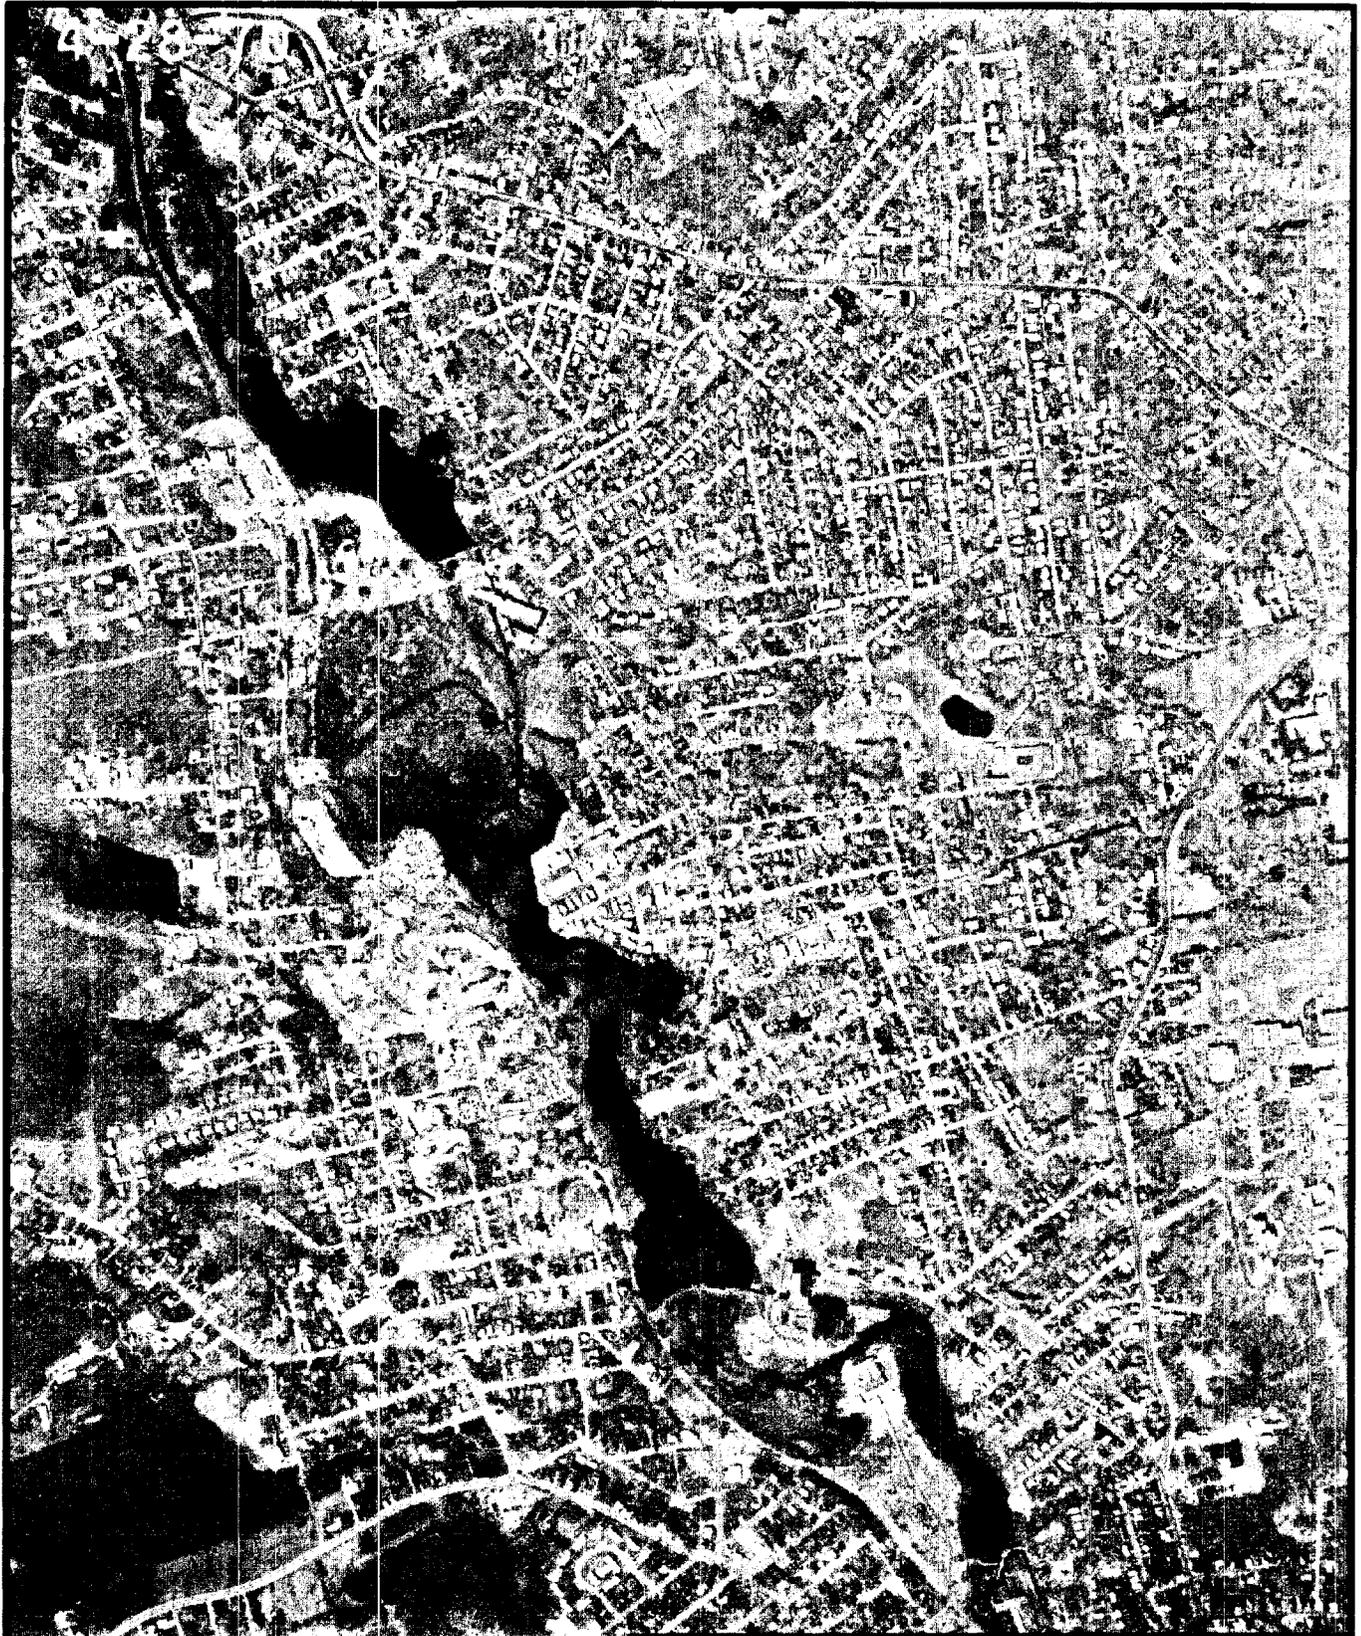
AERIAL PHOTOGRAPH  
04-28-70

Landform changes in the vicinity of Lymansville Pond are also evident, and by 1970 the land defined by "Action Area 9" has been cleared and developed with residential buildings. This area of the Site appears to have been uniformly graded to the edge of Lymansville Pond. In the area
