**PHOTODOCUMENTATION  
CENTREDALE MANOR RESTORATION PROJECT SUPERFUND SITE  
North Providence, Rhode Island**

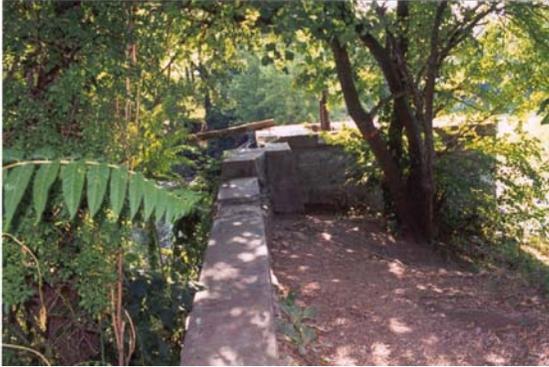
08.13.2001	East side of embankment, east of existing gate structure	W	Existing gate structure, prior to tree cutting and clearing activities

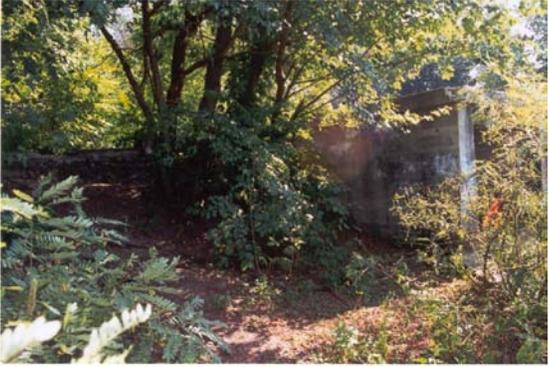
08.13.2001	East side of embankment, north of existing gate structure	S	Existing gate structure, prior to tree cutting and clearing activities

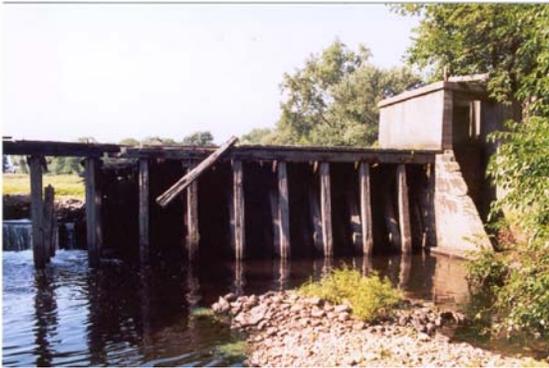
08.13.2001	Downstream of Allendale Dam and South of existing gate structure	NNE	Existing gate structure, prior to tree cutting and clearing activities

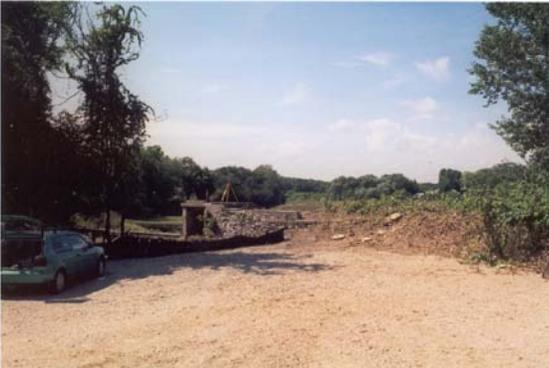
08.15.2001	Southeast of existing gate structure, standing in construction parking lot	NNW	Existing gate structure, following tree cutting and clearing activities

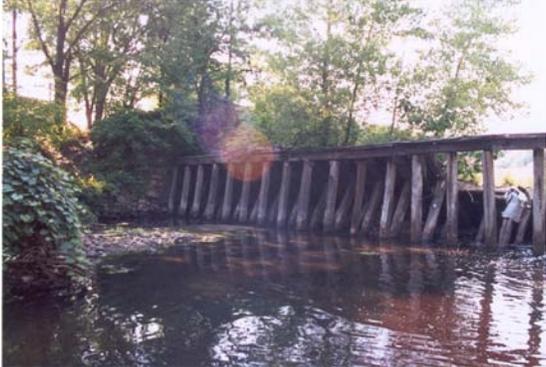
08.13.2001	Downstream of Allendale Dam	WNW	Allendale Dam abutting west embankment adjacent to the Town Asphalt Company Property, prior to tree cutting and clearing activities

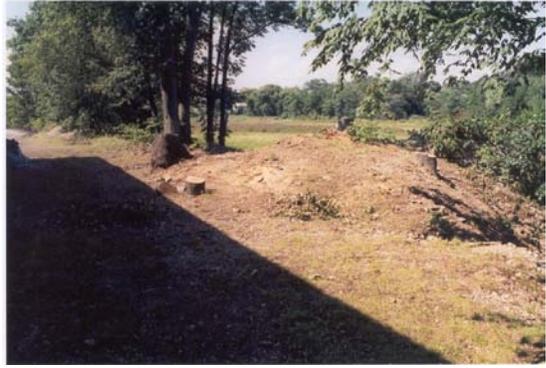
08.14.2001	The Town Asphalt Company property, above west embankment	NNE	The Town Asphalt Company property following tree cutting and clearing activities

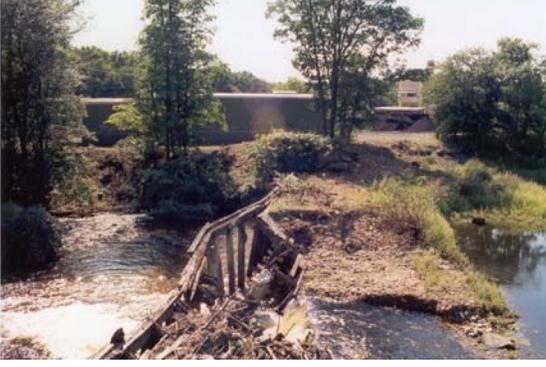
08.14.2001	Existing gate structure	W	View of the Town Asphalt Company property following tree cutting and clearing activities

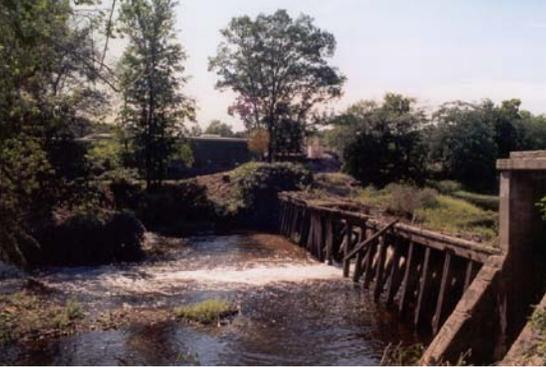
08.14.2001	East side of embankment	WNW	View of the Existing Allendale Dam structure and the Town Asphalt Company property following tree cutting and clearing activities

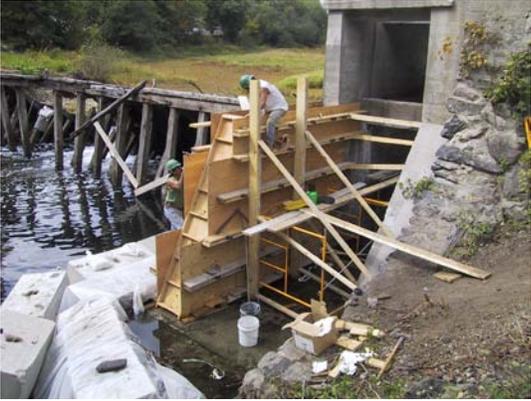
09.19.2001	East side of embankment, downstream of gate structure	NW	Forming extension of wing-wall

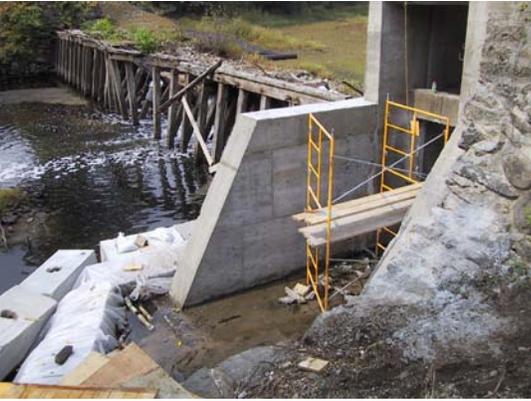
09.24.2001	East side of embankment, downstream of gate structure	NW	Finished wing-wall

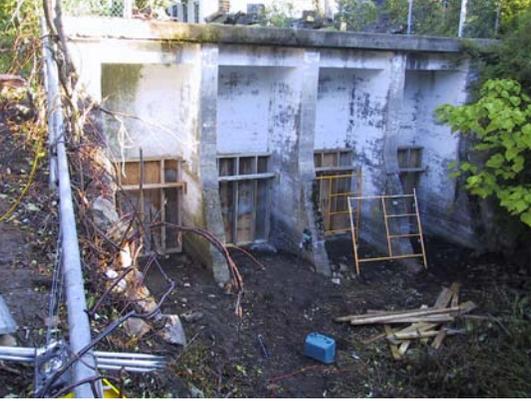
09.26.2001	West side of tailrace, standing in construction parking lot	NE	Forming plugs for tailrace

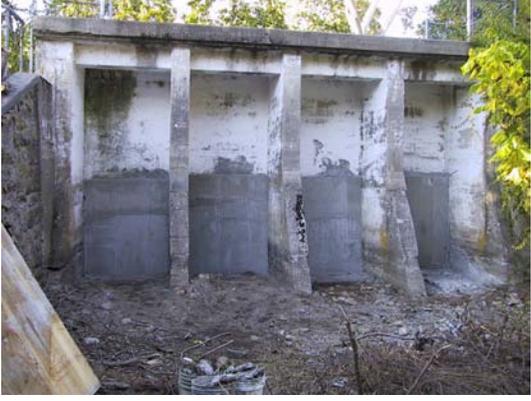
10.04.2001	West side of tailrace	NNE	Plugged tailrace

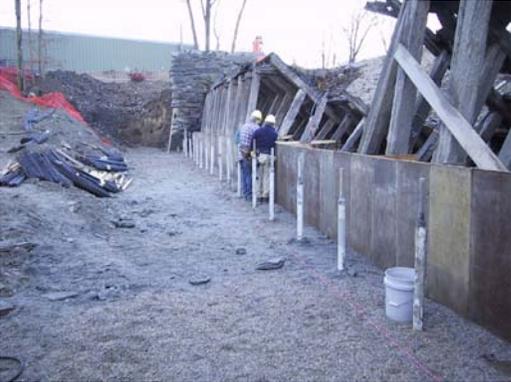
11.30.2001	East side of embankment, immediately downstream of existing gate structure	W	<p>Concrete Formwork:            Section of formed wall for dam footing</p> <p>Note: Rock anchor bolts on downstream side of formed wall</p>

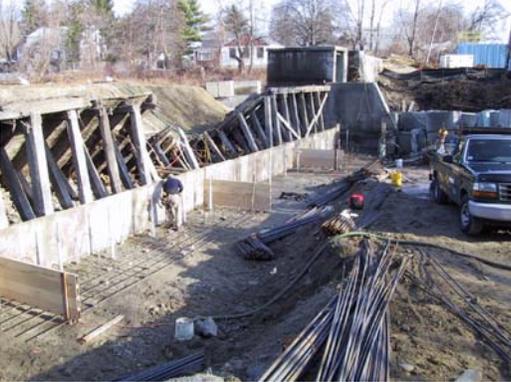
12.01.2001	West end of downstream cofferdam	NE	<p>Concrete Formwork:            Installation of forms and reinforcing steel bars for dam footing</p>

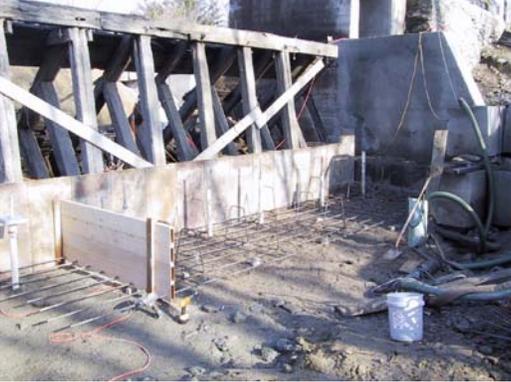
12.01.2001	Downstream cofferdam	NE	<p>Concrete Formwork:            Installation of forms and reinforcing steel bars for dam footing</p> <p>Note: Wing-wall and gate structure in background</p>

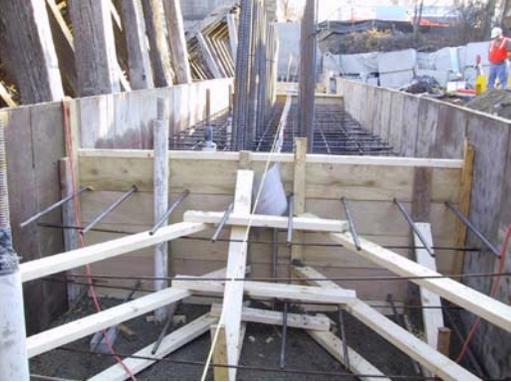
12.05.2001	West end of proposed dam	E	<p>Concrete Formwork:            Installed forms and reinforcing steel bars for dam footing</p>

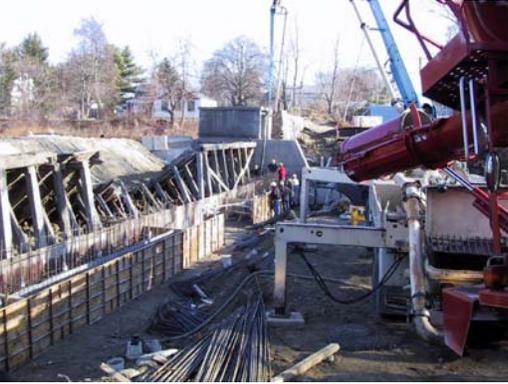
12.05.2001	Downstream cofferdam	E	Dam footing concrete pour

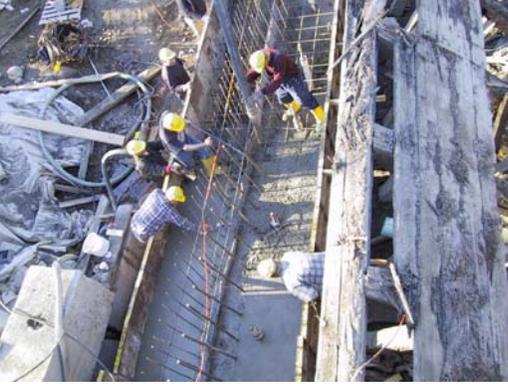
12.05.2001	Standing on top of existing gate structure	W	Dam footing concrete pour

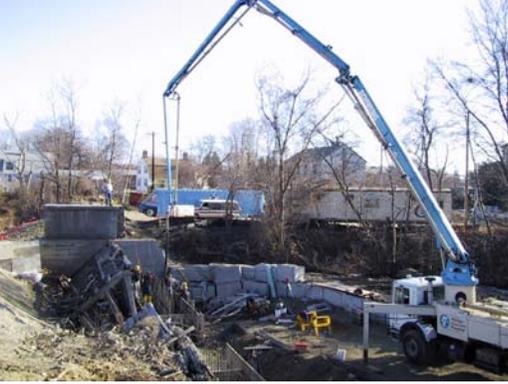
12.05.2001	West abutment of existing dam structure	E	Dam footing concrete pour

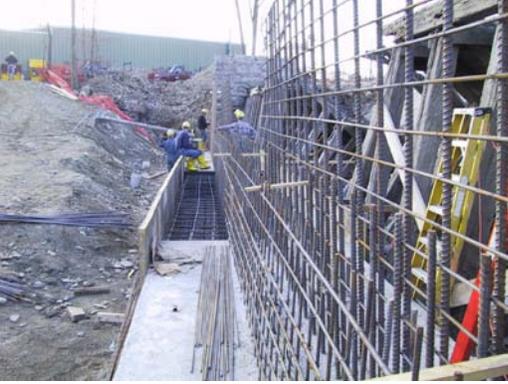
12.07.2001	Eastern embankment downstream of existing gate structure	W	<p>Concrete Formwork:            Installed forms and reinforcing steel bars for dam footing</p> <p>Note: Reinforcing steel bars for concrete wall tied to reinforcing steel bars of poured footing</p>

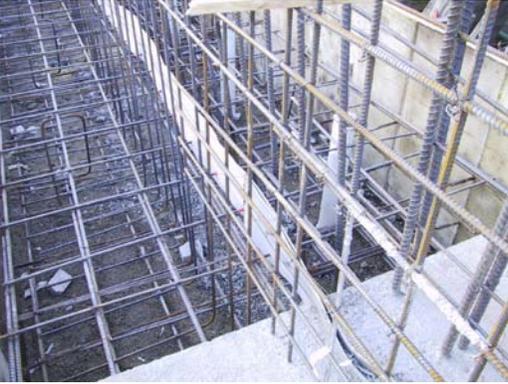
12.07.2001	Downstream of center section of dam structure	W	Concrete Formwork: Installed forms and reinforcing steel bars for dam footing

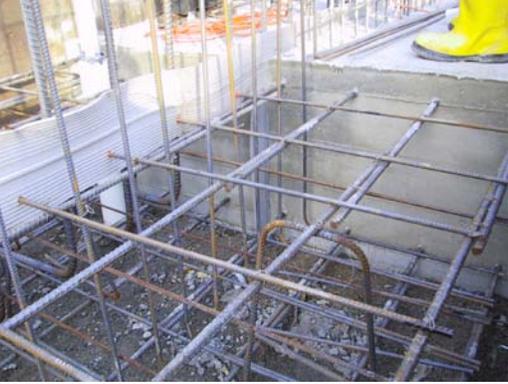
12.07.2001	Downstream of center section of dam structure	E	Concrete Formwork: Installed forms and reinforcing steel bars for dam footing  Note: PVC waterstop placed between reinforcing steel bars

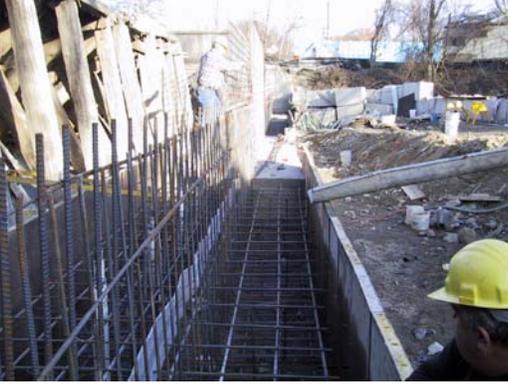
12.07.2001	West end of dam structure	E	Concrete Formwork: Installed forms and reinforcing steel bars for dam footing  Note: Just prior to concrete pour

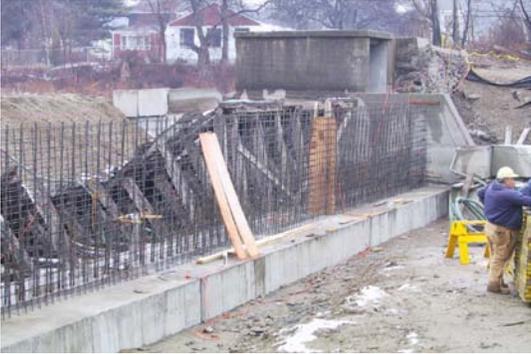
12.11.2001	Downstream cofferdam	NE	Placement of fabricated bar mats and reinforcing steel bars for dam wall construction

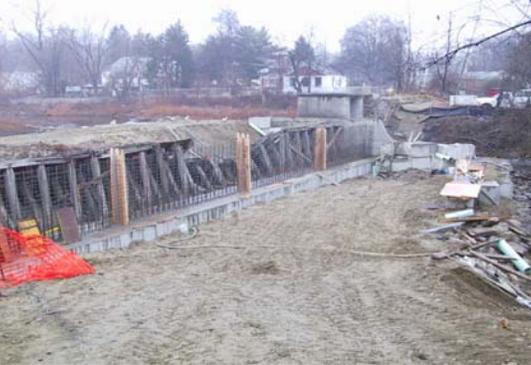
12.13.2001	Downstream cofferdam	NE	Placement of fabricated bar mats and reinforcing steel bars for dam wall construction

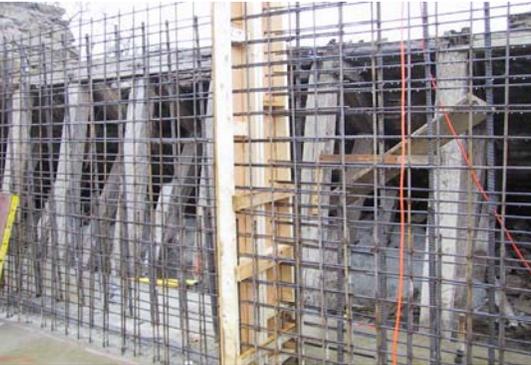
12.13.2001	Downstream of dam wall	NW	Placement of fabricated bar mats and reinforcing steel bars for dam wall construction

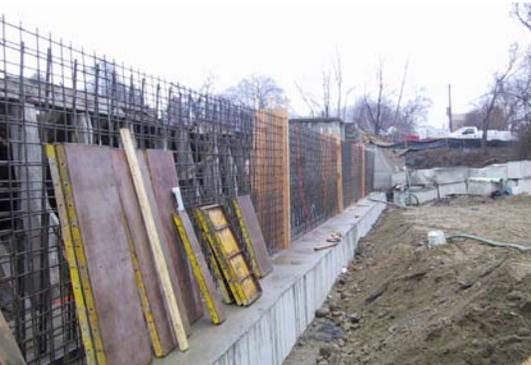
12.13.2001	Downstream of dam wall at west end	E	Placement of fabricated bar mats and reinforcing steel bars for dam wall construction

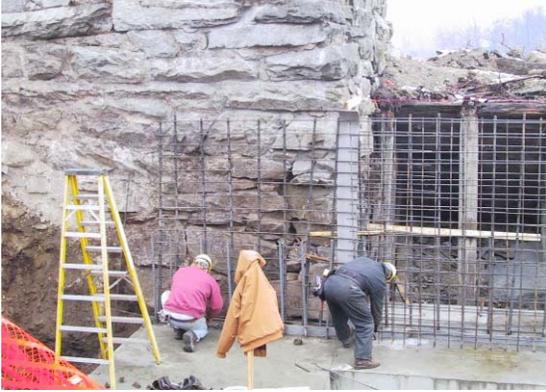
12.11.2001	Downstream cofferdam at west abutment	N	<p>Placement of fabricated bar mats and reinforcing steel bars for dam wall construction</p> <p>Note: PVC waterstop along abutment with existing granite stone wall</p>

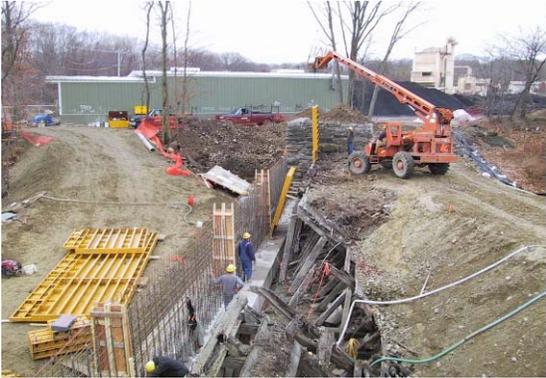
12.14.2001	Standing on top of existing gate structure	W	Placement of forms for concrete dam wall

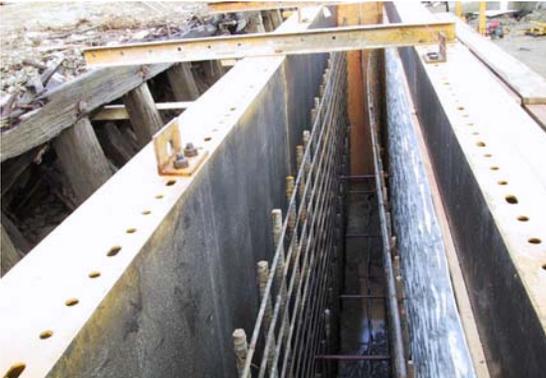
12.18.2001	West side of dam	E	Close-up view of forms for concrete dam wall

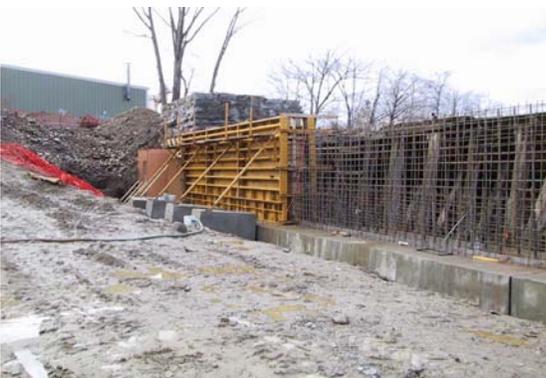
12.18.2001	Downstream of dam along east side	NW	<p>Placement of forms for concrete dam wall where it abuts existing granite stone wall</p>

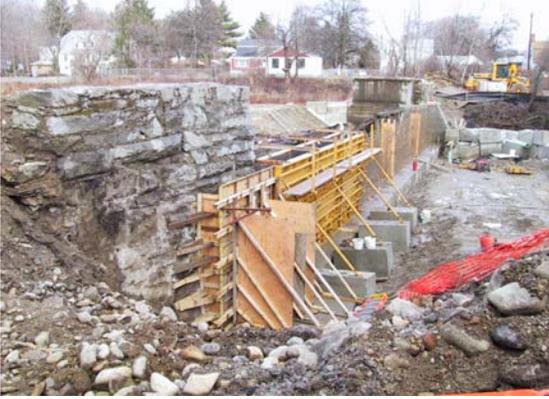
12.18.2001	Downstream cofferdam	NE	Placement of forms for concrete dam wall where it abuts existing granite stone wall

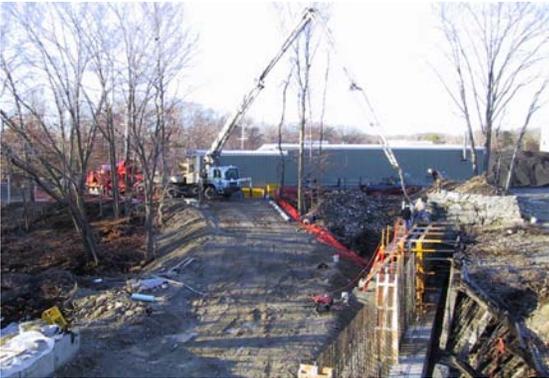
12.19.2001	Standing on top of existing gate structure	W	Dam wall concrete pour

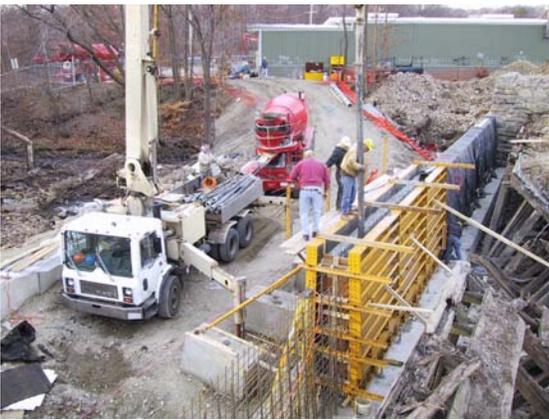
12.26.2001	Standing on top of existing gate structure	W	Dam wall concrete pour (2 <sup>nd</sup> section of wall)  Note: Placement of concrete curing mat

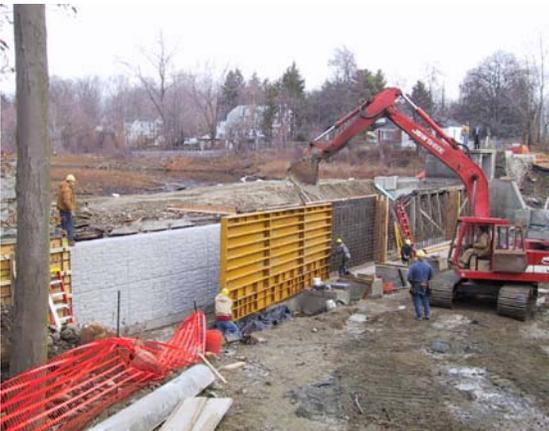
12.20.2001	Downstream cofferdam	NE	Removal of first section of forms for concrete dam wall

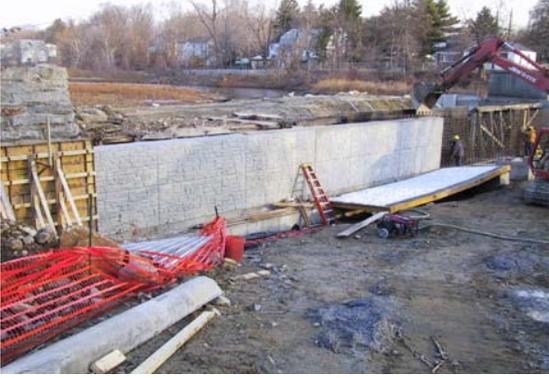
12.21.2001	Downstream cofferdam	NE	Removal of forms for concrete dam wall  Note: Factory fabricated elastomeric textured concrete form liner

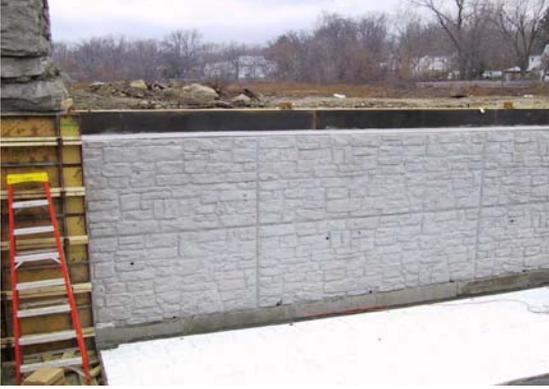
12.21.2001	Downstream of concrete dam wall where it abuts the existing granite stone wall	N	Exposed face of the stem of the dam  Note: Ashlar Stone Texture pattern

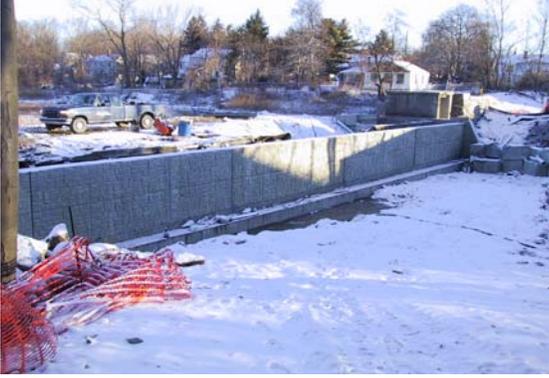
01.08.2002	Downstream cofferdam	NE	Exposed face of the stem of the dam

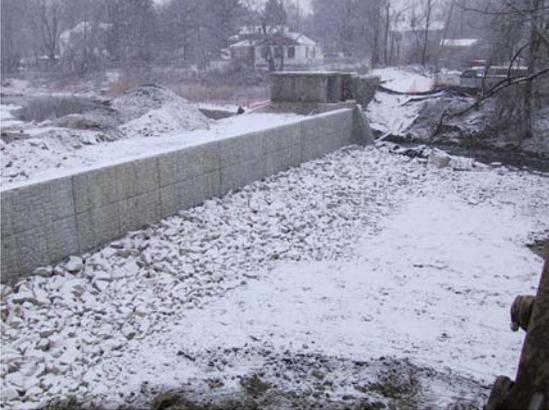
01.17.2002	Downstream cofferdam	NE	Exposed face of the stem of the dam  Note: Riprap placed at the foot of the concrete wall

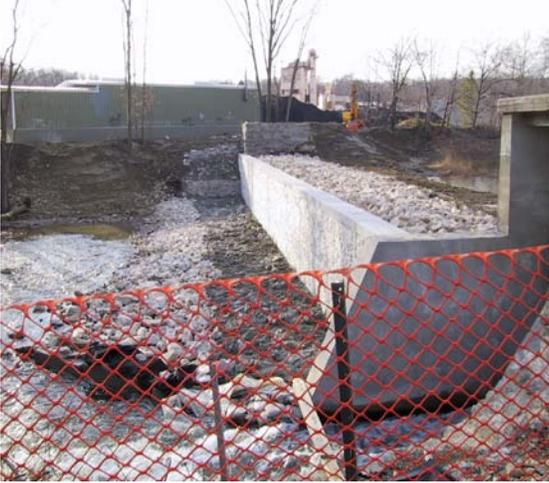
01.29.2002	Eastern embankment	W	Concrete dam wall  Note: Capstones on top of the wall and grouted riprap at the foot of the wall

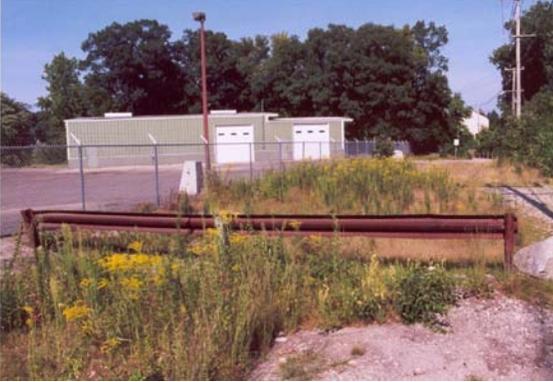
08.14.2001	East end of Allendale Avenue, adjacent to the Town Asphalt Company property	E	View of location of future containment pad, beyond guardrail

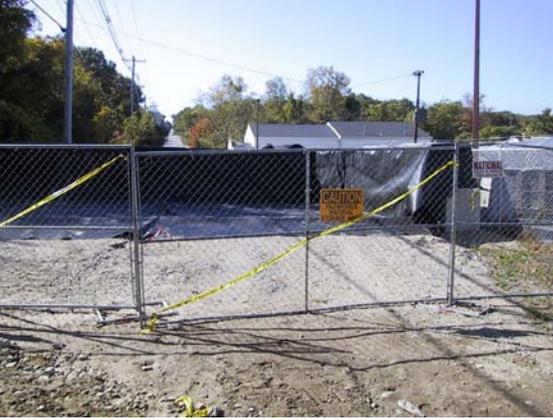
10.11.2001	South side of The Town Asphalt Company property	W	Containment pad surrounded by temporary chain-link fence

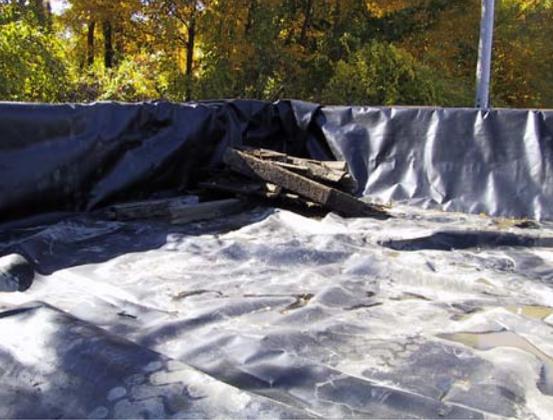
10.16.2001	The northeast corner of containment pad on The Town Asphalt Company property	SW	View of the lined containment pad; note the timber removed from the existing Allendale Dam structure temporarily stored on the containment pad liner

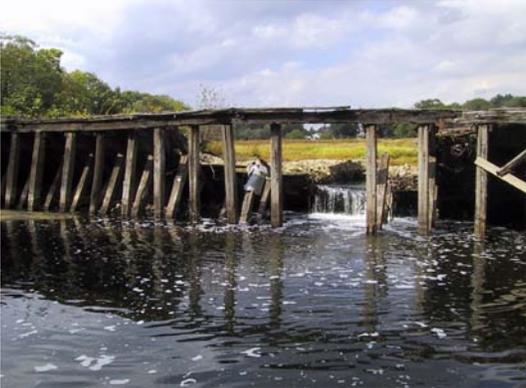
09.19.2001	South of existing Allendale Dam Structure	N	Former Allendale Dam Structure

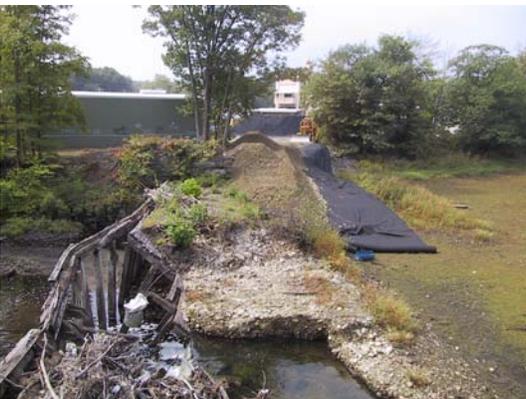
09.24.2001	Existing gate structure	W	Placement of filter fabric for upstream cofferdam

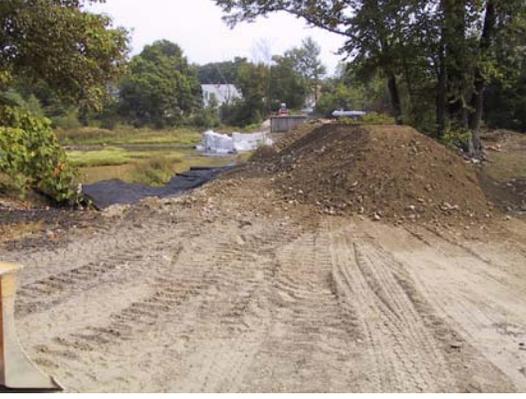
09.24.2001	East side of The Town Asphalt Company property	E	Placement of gravel for upstream cofferdam

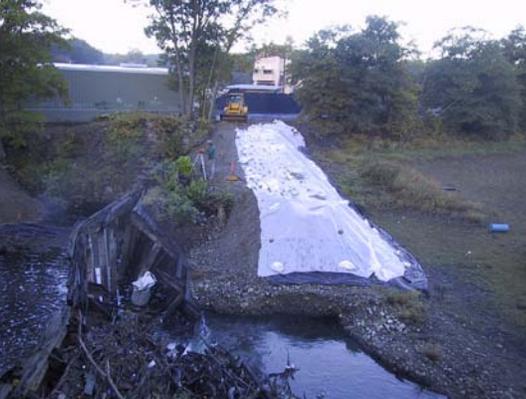
09.26.2001	Existing gate structure	W	Construction of upstream cofferdam

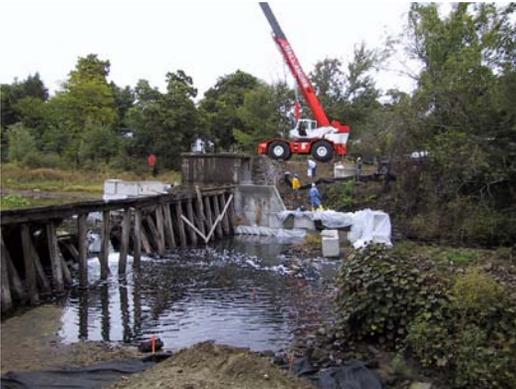
10.01.2001	The Town Asphalt Company property, along the west embankment	ENE	Placement of concrete block and plastic sheeting to divert water

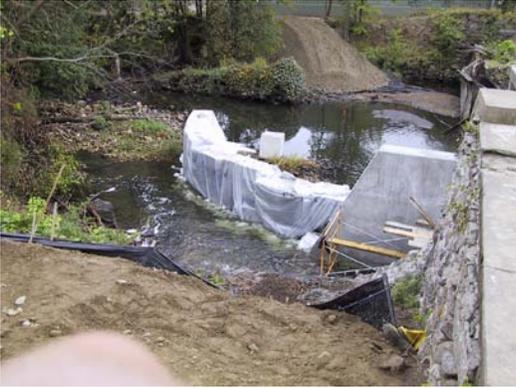
10.01.2001	Existing gate structure	WSW	Concrete block and plastic placed to divert water

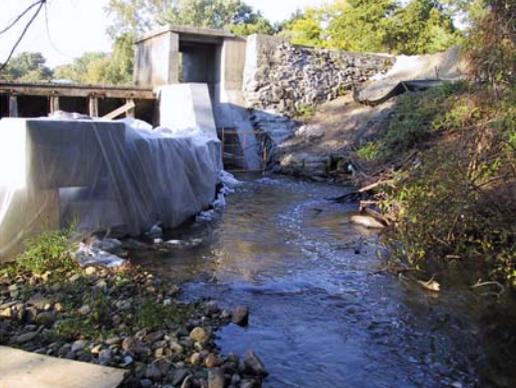
10.04.2001	Downstream of existing gate structure along east embankment	NNE	View of water diverted through gate structure and away from the existing Allendale Dam structure

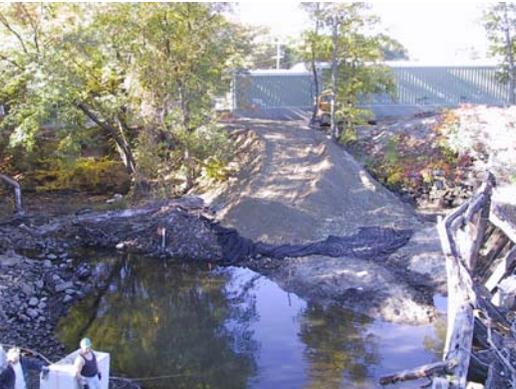
10.09.2001	Existing gate structure	W	Construction of downstream cofferdam; note filter fabric installed beneath gravel

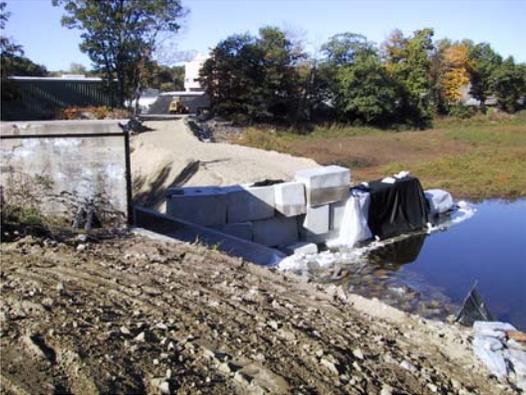
10.09.2001	North of existing gate structure, along east embankment	SW	View of upstream cofferdam and concrete block diverting water through existing gate structure

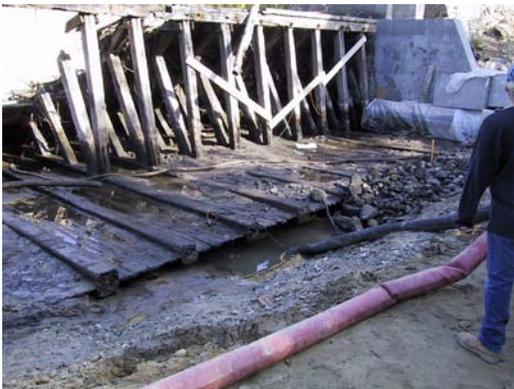
10.10.2001	Downstream of Allendale Dam structure on downstream cofferdam	NE	Exposed timber structure of former Allendale Dam

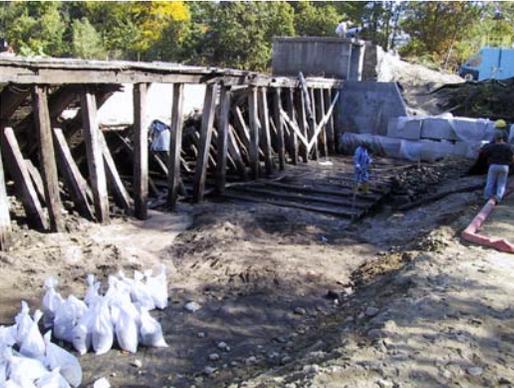
10.10.2001	Downstream cofferdam	E	Exposed timber structure of former Allendale Dam

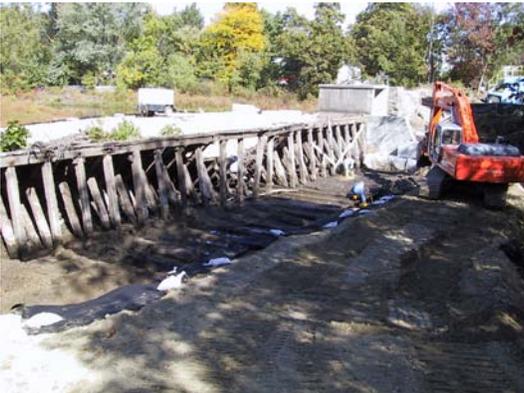
10.11.2001	Downstream cofferdam	E	Placement of sandbags along edge of downstream cofferdam

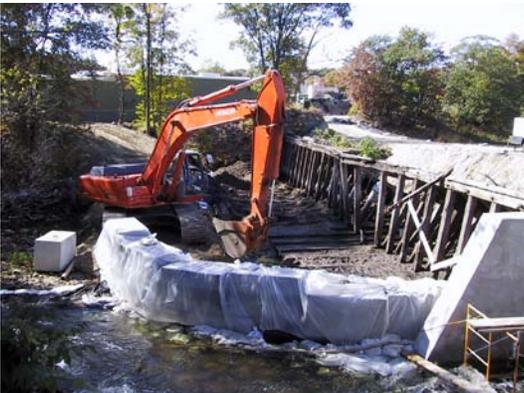
10.11.2001	East embankment	WNW	Removal of debris below the former Allendale Dam structure

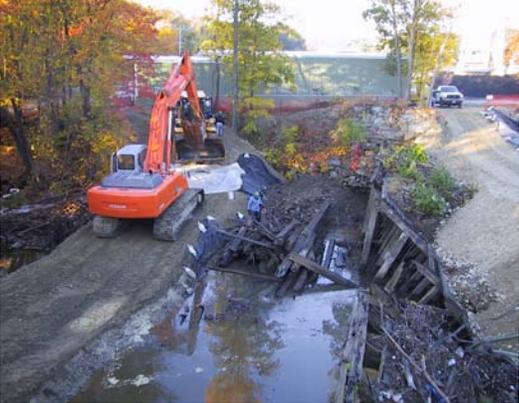
10.16.2001	Existing gate structure	W	Removal of debris below the former Allendale Dam structure

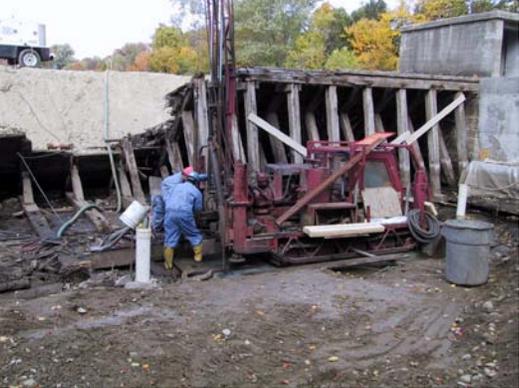
10.16.2001	Downstream cofferdam	NE	Rock coring activities (30 ft rock core)

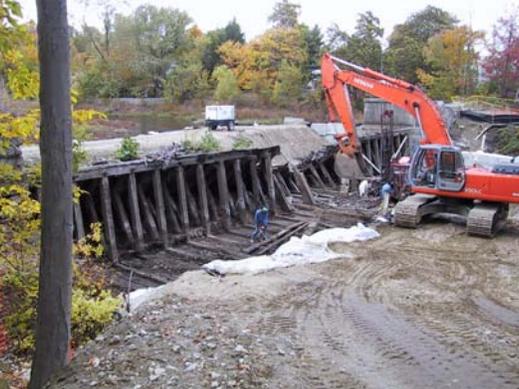
10.17.2001	Downstream cofferdam along The Town Asphalt Company property	ENE	Removal of timber of former Allendale Dam structure and rock coring activities

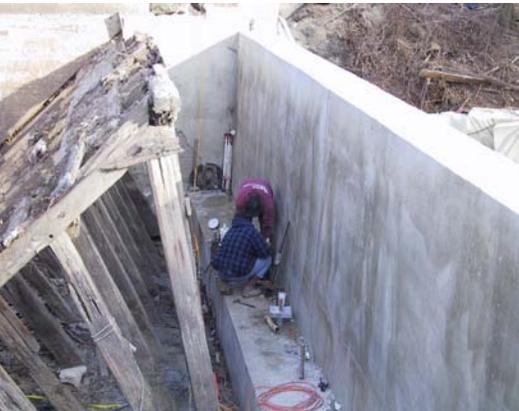
01.04.2002	Western embankment at dam abutment	E	Rock anchor bolt testing

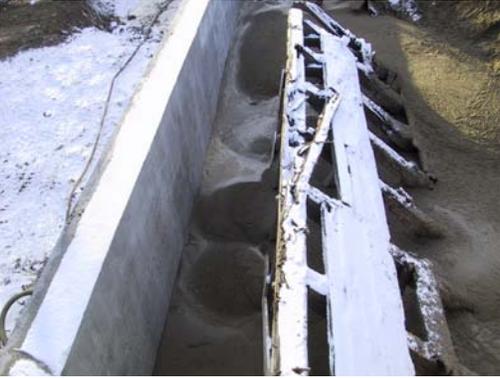
01.08.2002	Standing on top of existing gate structure	W	Placement of concrete flowable fill between concrete dam wall and old dam structure

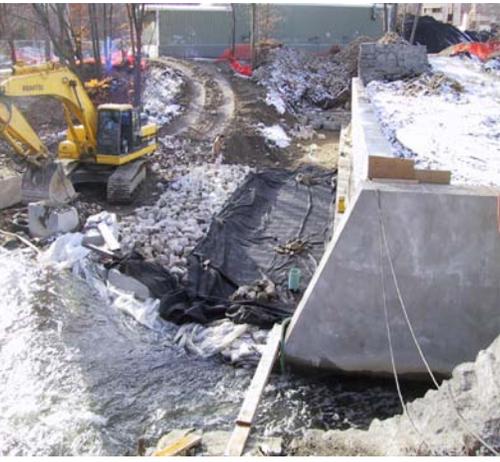
01.14.2002	Eastern embankment	W	Installation of filter fabric for toe drain

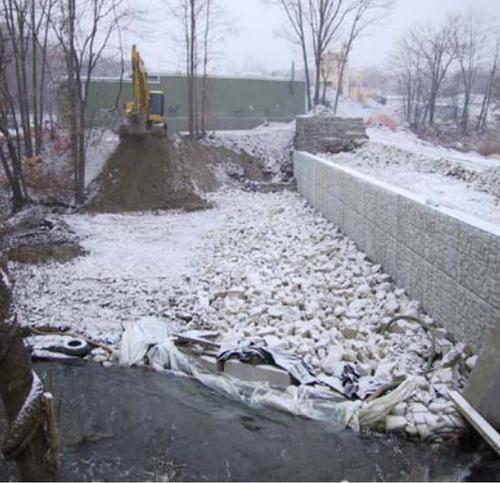
01.17.2002	Eastern embankment	W	Removal of downstream cofferdam following placement of riprap at foot of concrete dam wall
