AERIAL HISTORICAL PHOTOGRAPHIC ANALYSIS,
LAND USE/LAND COVER ANALYSIS, AND WETLANDS/DRAINAGE
ANALYSIS OF CENTREDALE MANOR RESTORATION PROJECT
STUDY AREA

Johnston, Rhode Island

ENVIRONMENTAL SCIENCES DIVISION
NATIONAL EXPOSURE RESEARCH LABORATORY
OFFICE OF RESEARCH AND DEVELOPMENT
U.S. ENVIRONMENTAL PROTECTION AGENCY
LAS VEGAS, NEVADA 89193-3478

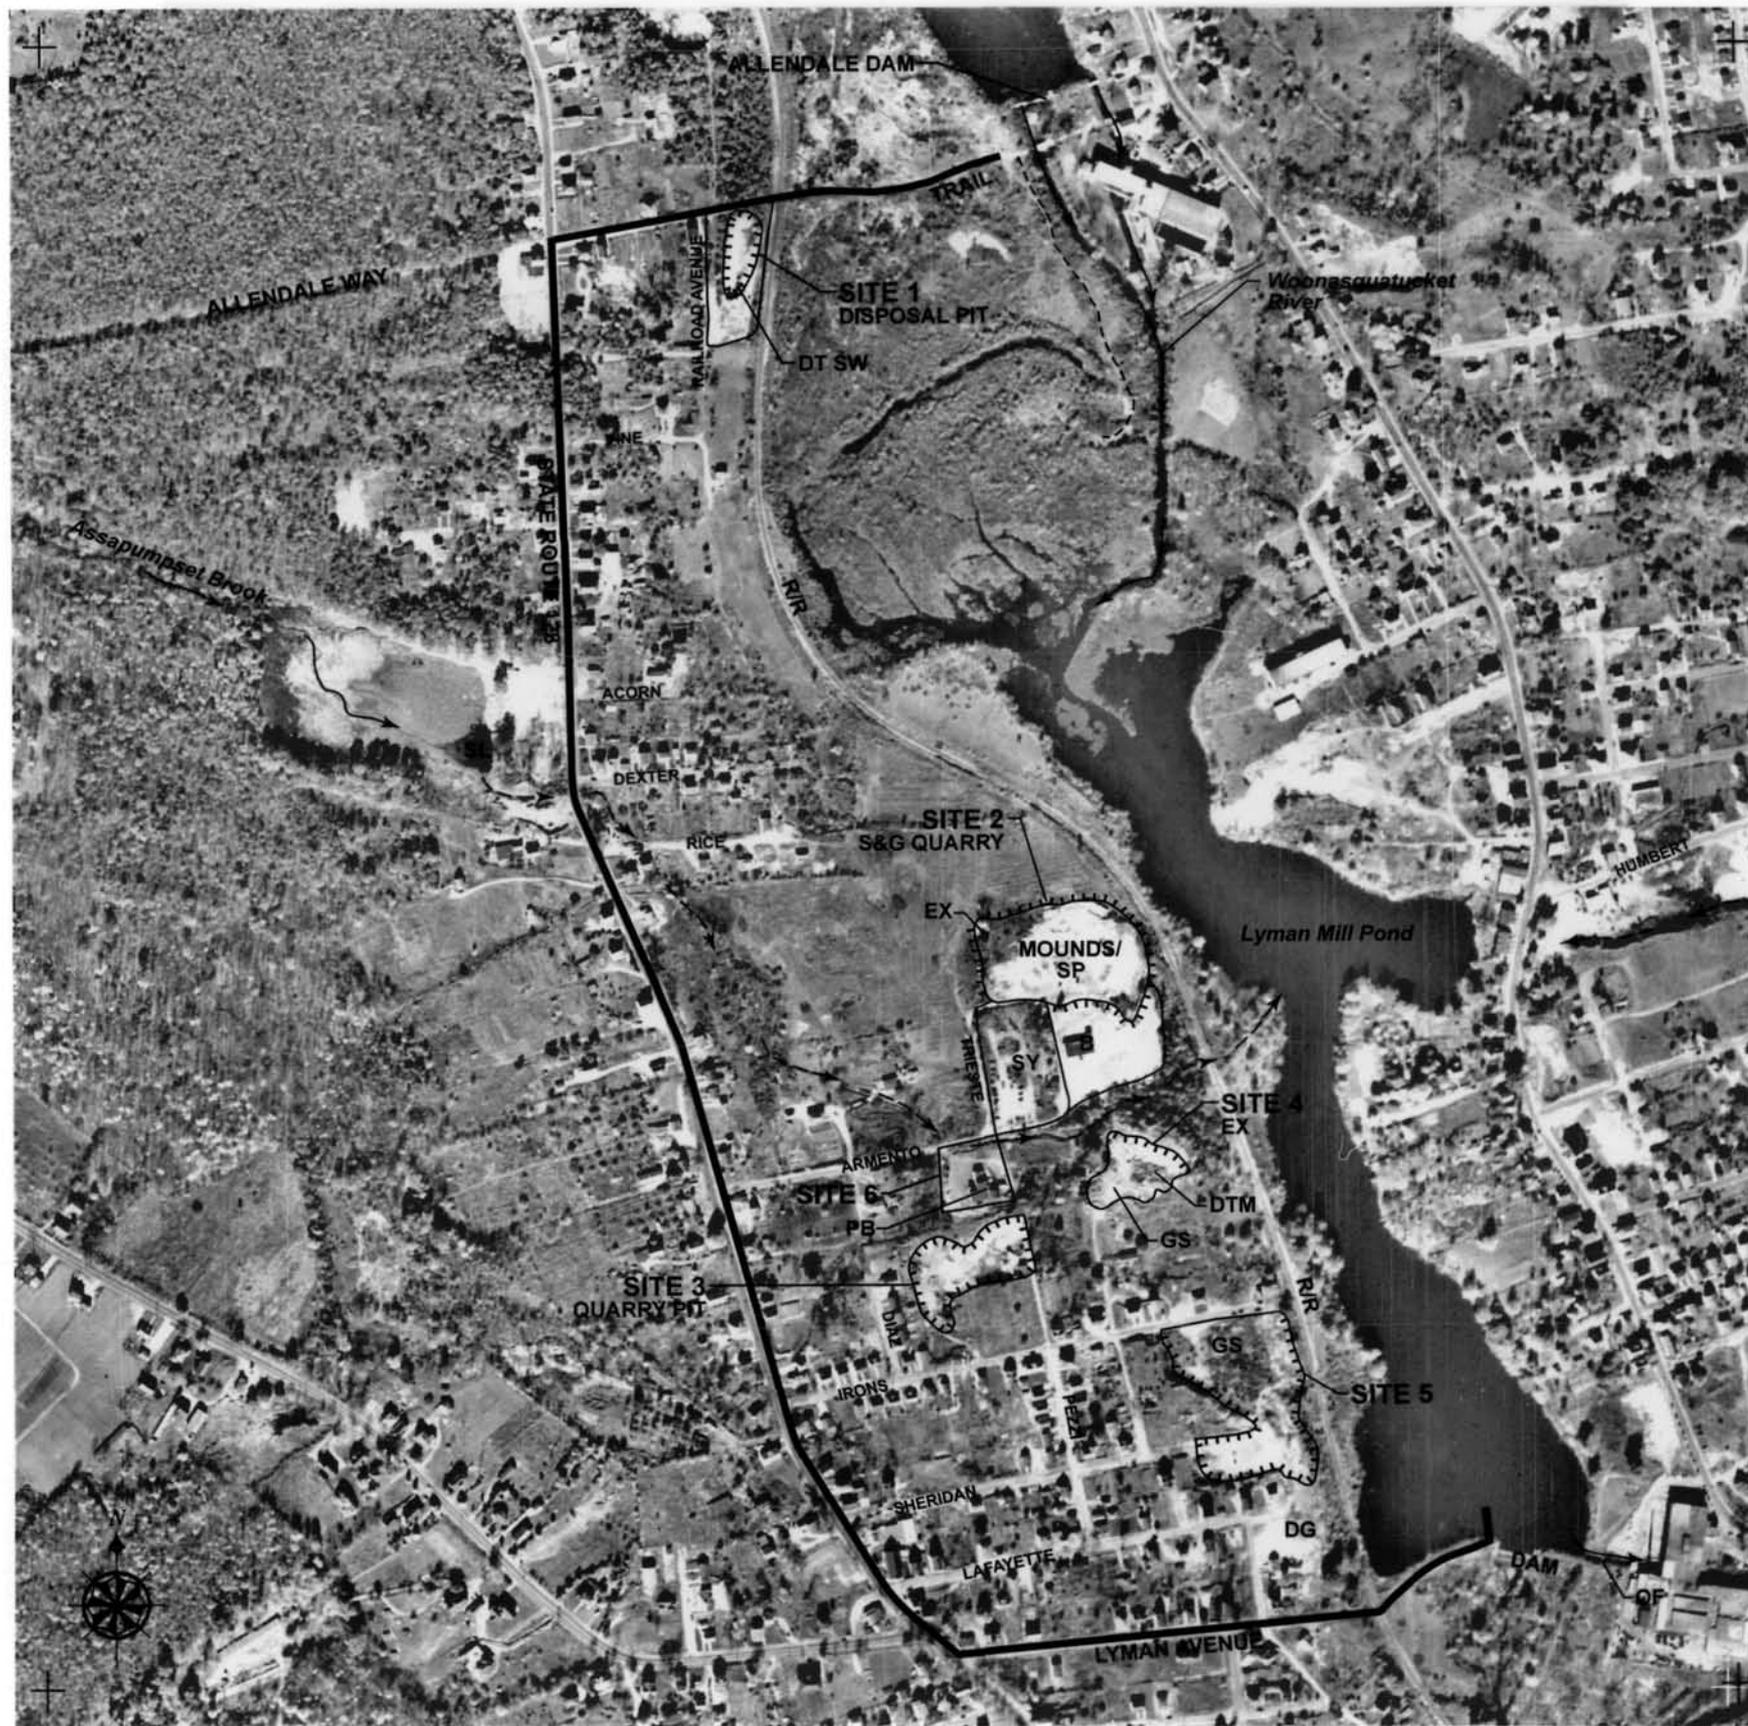
Site 1 - A waste disposal pit is observed along the southern side of Allendale Way. The waste pit is accessed via Railroad Avenue and is bounded to the east by the raised railroad bed of the adjacent railroad (R/R). Dark-toned solid waste (DT SW) is visible along the rim and within this pit. A bottom-lining material is not discerned in the pit. Surface runoff that does not enter the disposal pit would drain south. Runoff leaving this disposal area is likely to flow to the southeast, along the base of the raised railroad bed, and eventually into Lyman Mill Pond.

Site 2 - An active sand and gravel quarry (S&G), with associated earthmoving vehicles, is visible on the west side of Lyman Mill Pond at the eastern end of Armento Street. Mounds of earth (not annotated) and stockpiles (SP) of sand and gravel are observed at the quarry. A storage yard (SY) for equipment and vehicles is on the western portion of the quarry adjacent to Trieste Street. The quarry is bounded on the east by the raised railroad bed that runs parallel to the western perimeter of Lyman Mill Pond. This raised railroad bed diverts drainage leaving the quarry south to the culvert under the tracks. Once through the culvert (not annotated) drainage merges with the east-flowing Assapumpset Brook that empties into Lyman Mill Pond.

Site 3 - A quarry pit is observed north of Irons Avenue between Diaz and Pezzi streets. No vehicles are discerned at the pit indicating that quarrying operations have ceased. Surface runoff at this location appears to remain at the pit and accumulated standing liquid is visible in the pit.

Site 4 - An excavation (EX) is observed near the eastern end of Armento Street. No vehicles or structures are discerned at this location. The excavation contains dark-toned material (DTM) and is apparently being used as a dump area. Runoff leaving this location would drain east and likely reach Lyman Mill Pond.

Site 5 - A partially overgrown excavation is observed along the western perimeter of Lyman Mill Pond, between Irons Avenue and Lafayette Street. This excavation appears to be a construction site. No vehicles or structures are discerned. The raised railroad bed to the east forms a barrier to runoff. Consequently runoff is likely to remain within the excavation.

Site 6 - The commercial company operates a large multistory processing building (PB) and a small parking lot (not annotated). The type of processing could not be determined from the photograph. The site is of interest due to its proximity to Assapumpset Brook which flows parallel to Armento Street and enters Lyman Mill Pond. Pollutants from spillage at the site could pose a threat to the adjacent brook.

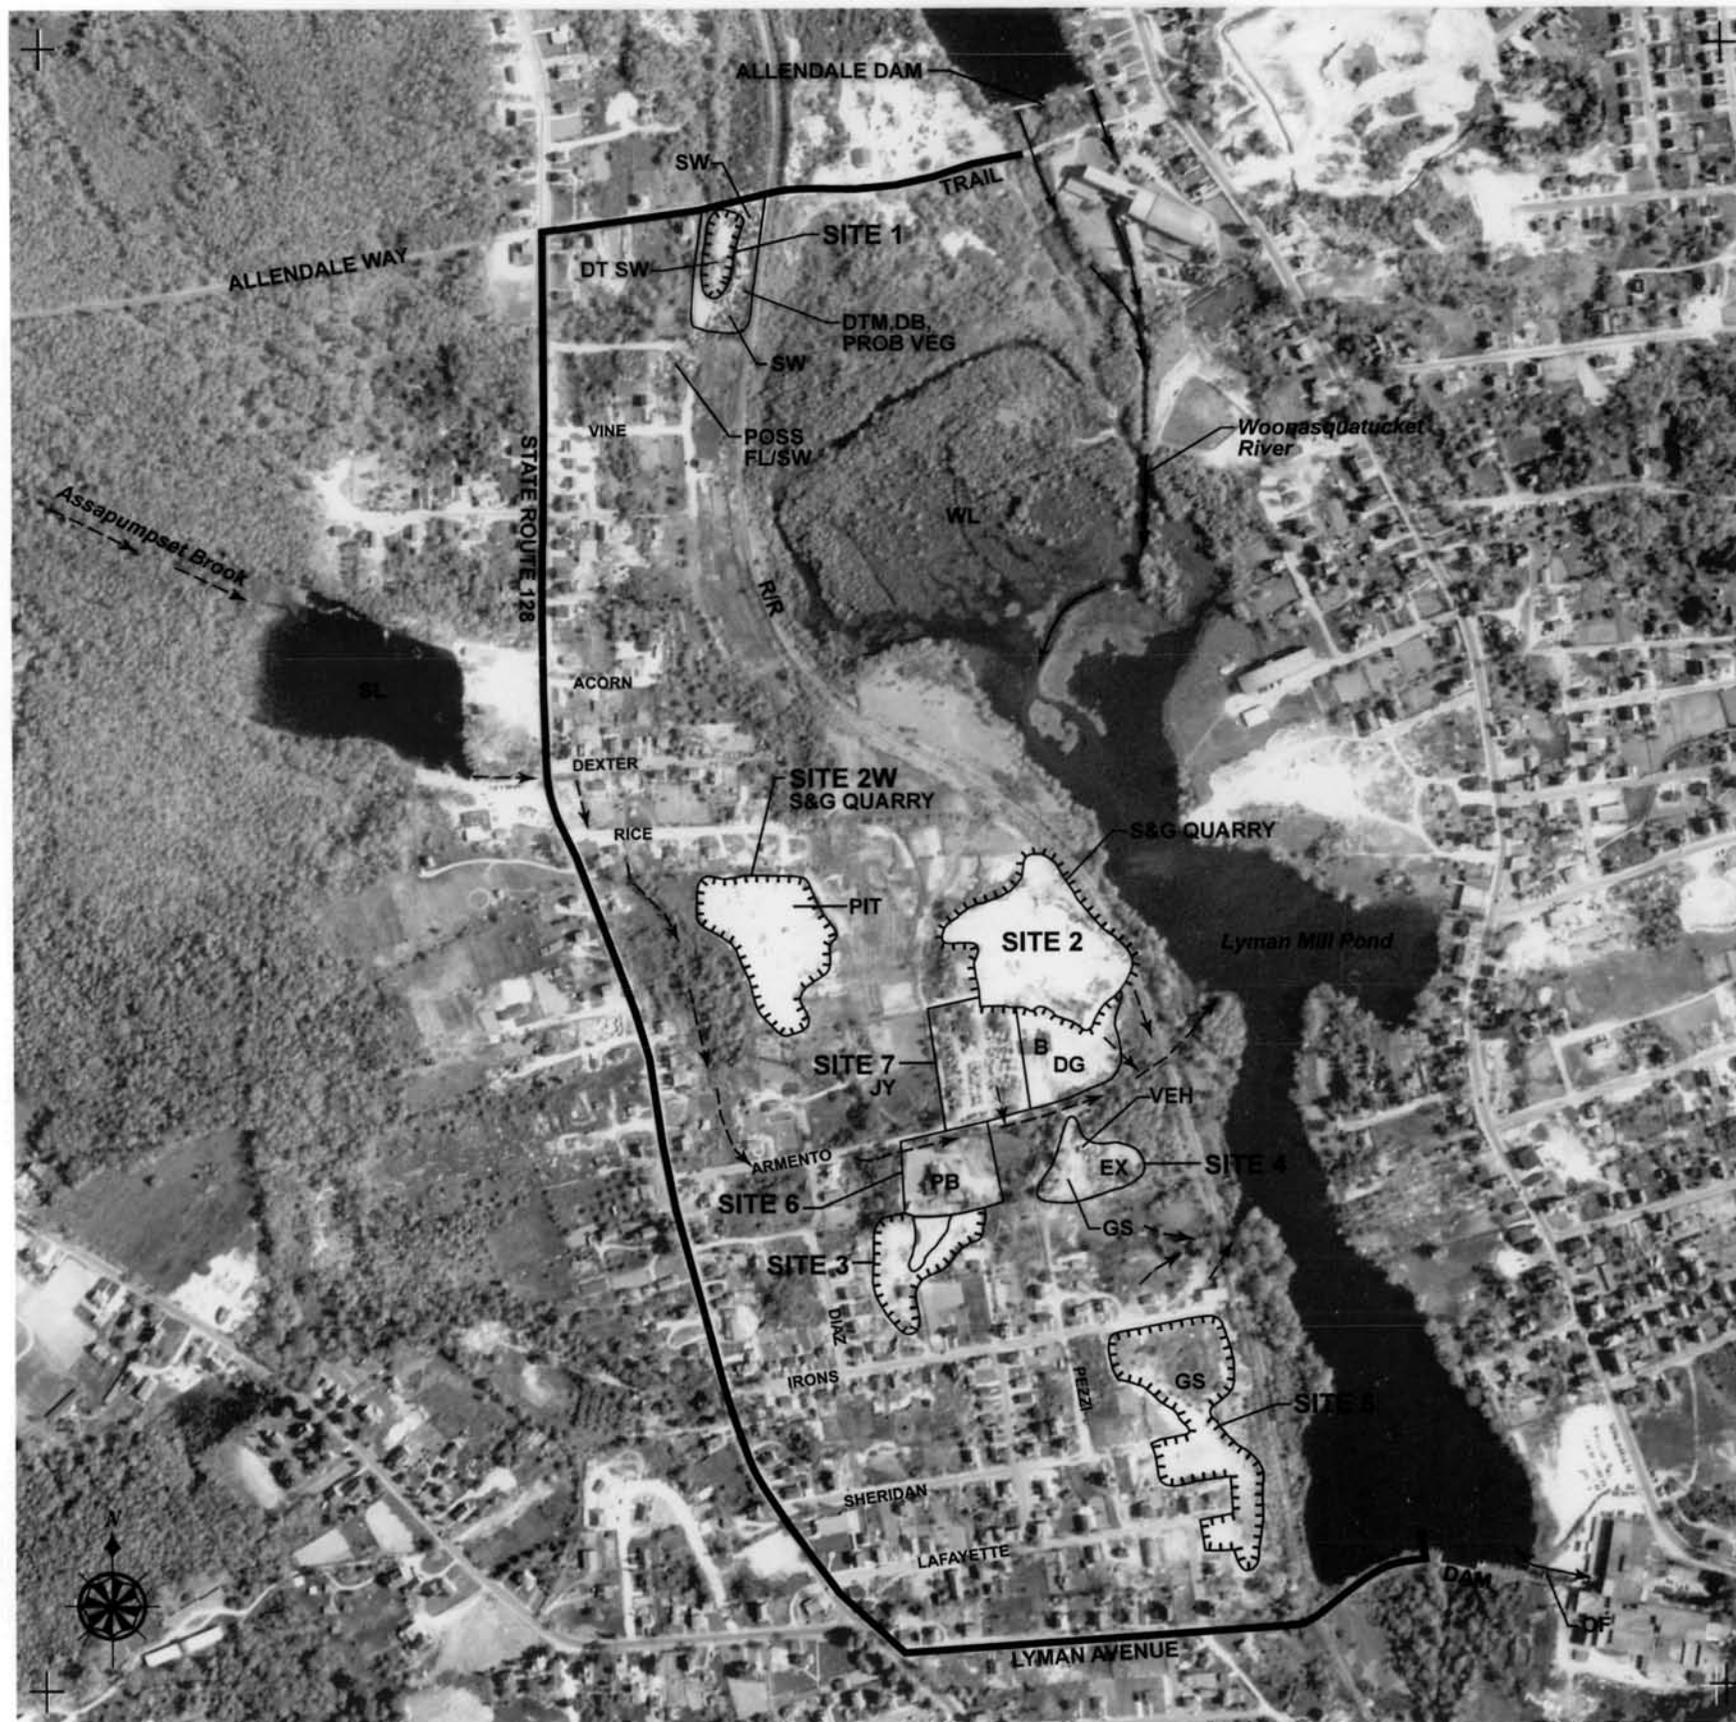
Site 4 - The view of the excavation is partially obscured by vegetation overgrowth. The dark-toned material observed in 1951 is not discerned.

Site 6 - The commercial processing building appears to remain operational.

Site 7 - Since 1951 a junkyard (JY) has been established at the storage yard, noted in 1951 near Site 2. The junkyard is located along the north side of Armento Street and contains several derelict vehicles. Pollutants from the junkyard operations and potential spillage could enter the natural drainage via rain water transport into the nearby east-trending Assapumpset Brook that flows along the south side of Armento Street.

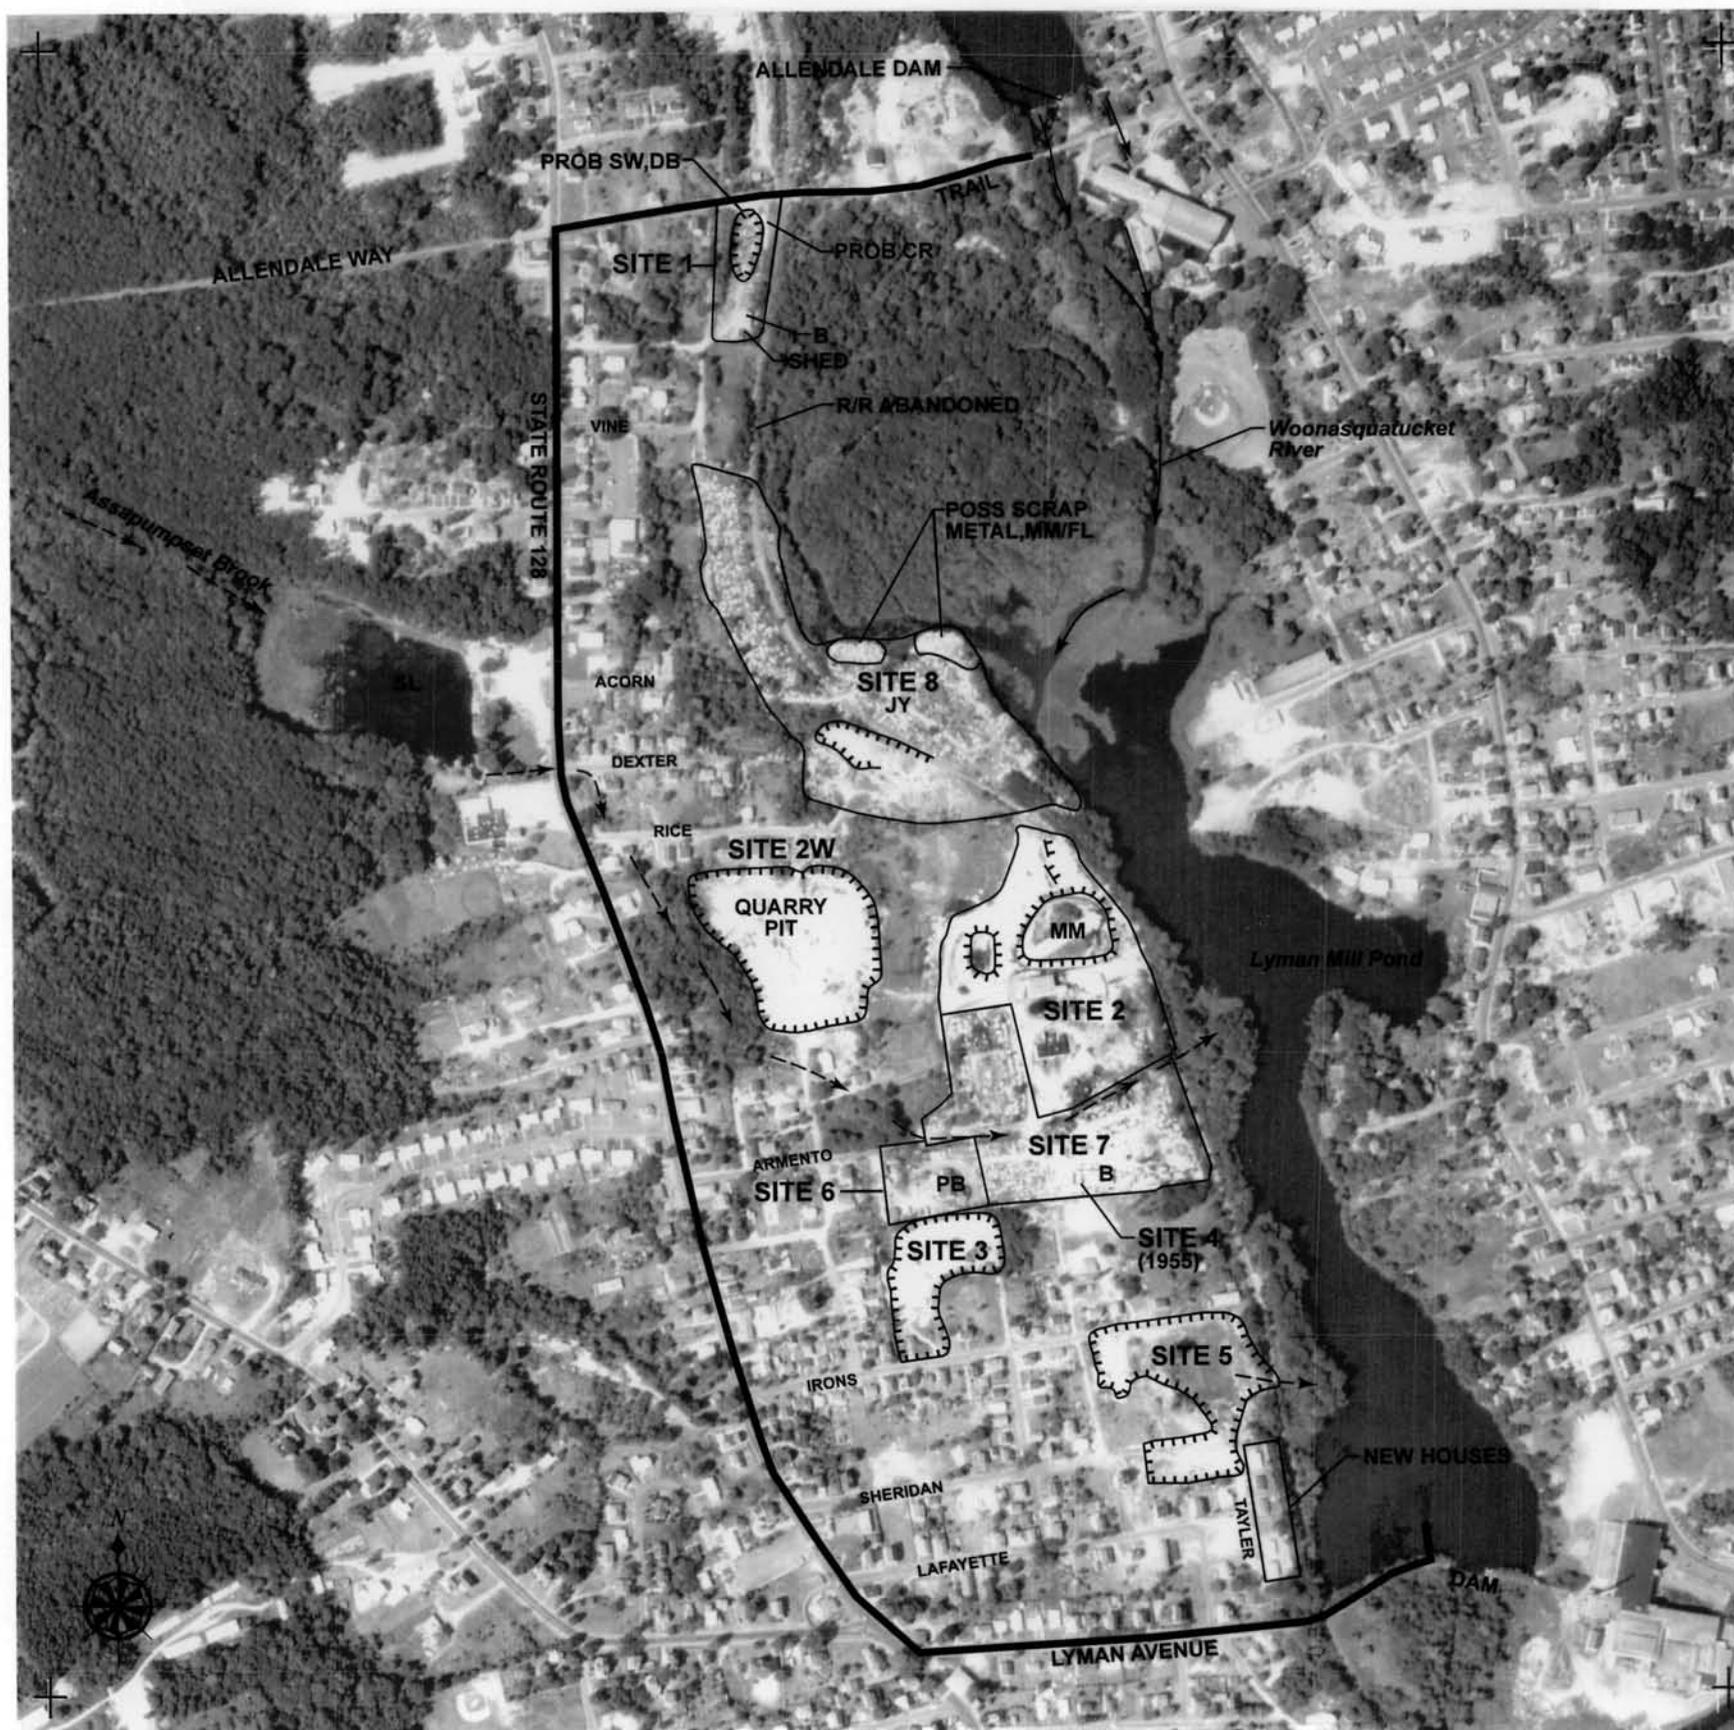
Site 4 - The excavation noted in 1955 has been filled and the area is part of the enlarged junkyard at Site 7. The conditions at this location will be discussed under Site 7.

Site 7 - The junkyard adjacent to Site 2 has been enlarged to the south and east. Numerous derelict vehicles are observed throughout the site. A large building, a probable vehicle maintenance shop, has been constructed in the

southern portion of the junkyard. Potential pollutants from this site could pose a potential threat to the Assapumpset Brook which runs through the junkyard and empties into Lyman Mill Pond.

Site 8 - Another junkyard, established north and east of Rice Street, contains numerous derelict vehicles. The junkyard extends east across the abandoned railroad track to the western shore of Lyman Mill Pond on filled land that was wetland in 1955. Two large mounds of fill (MM/FL) and/or possible scrap metal are visible along the western bank of Lyman Mill Pond. Potential pollutants from junkyard operations could flow east via surface flow into Lyman Mill Pond.

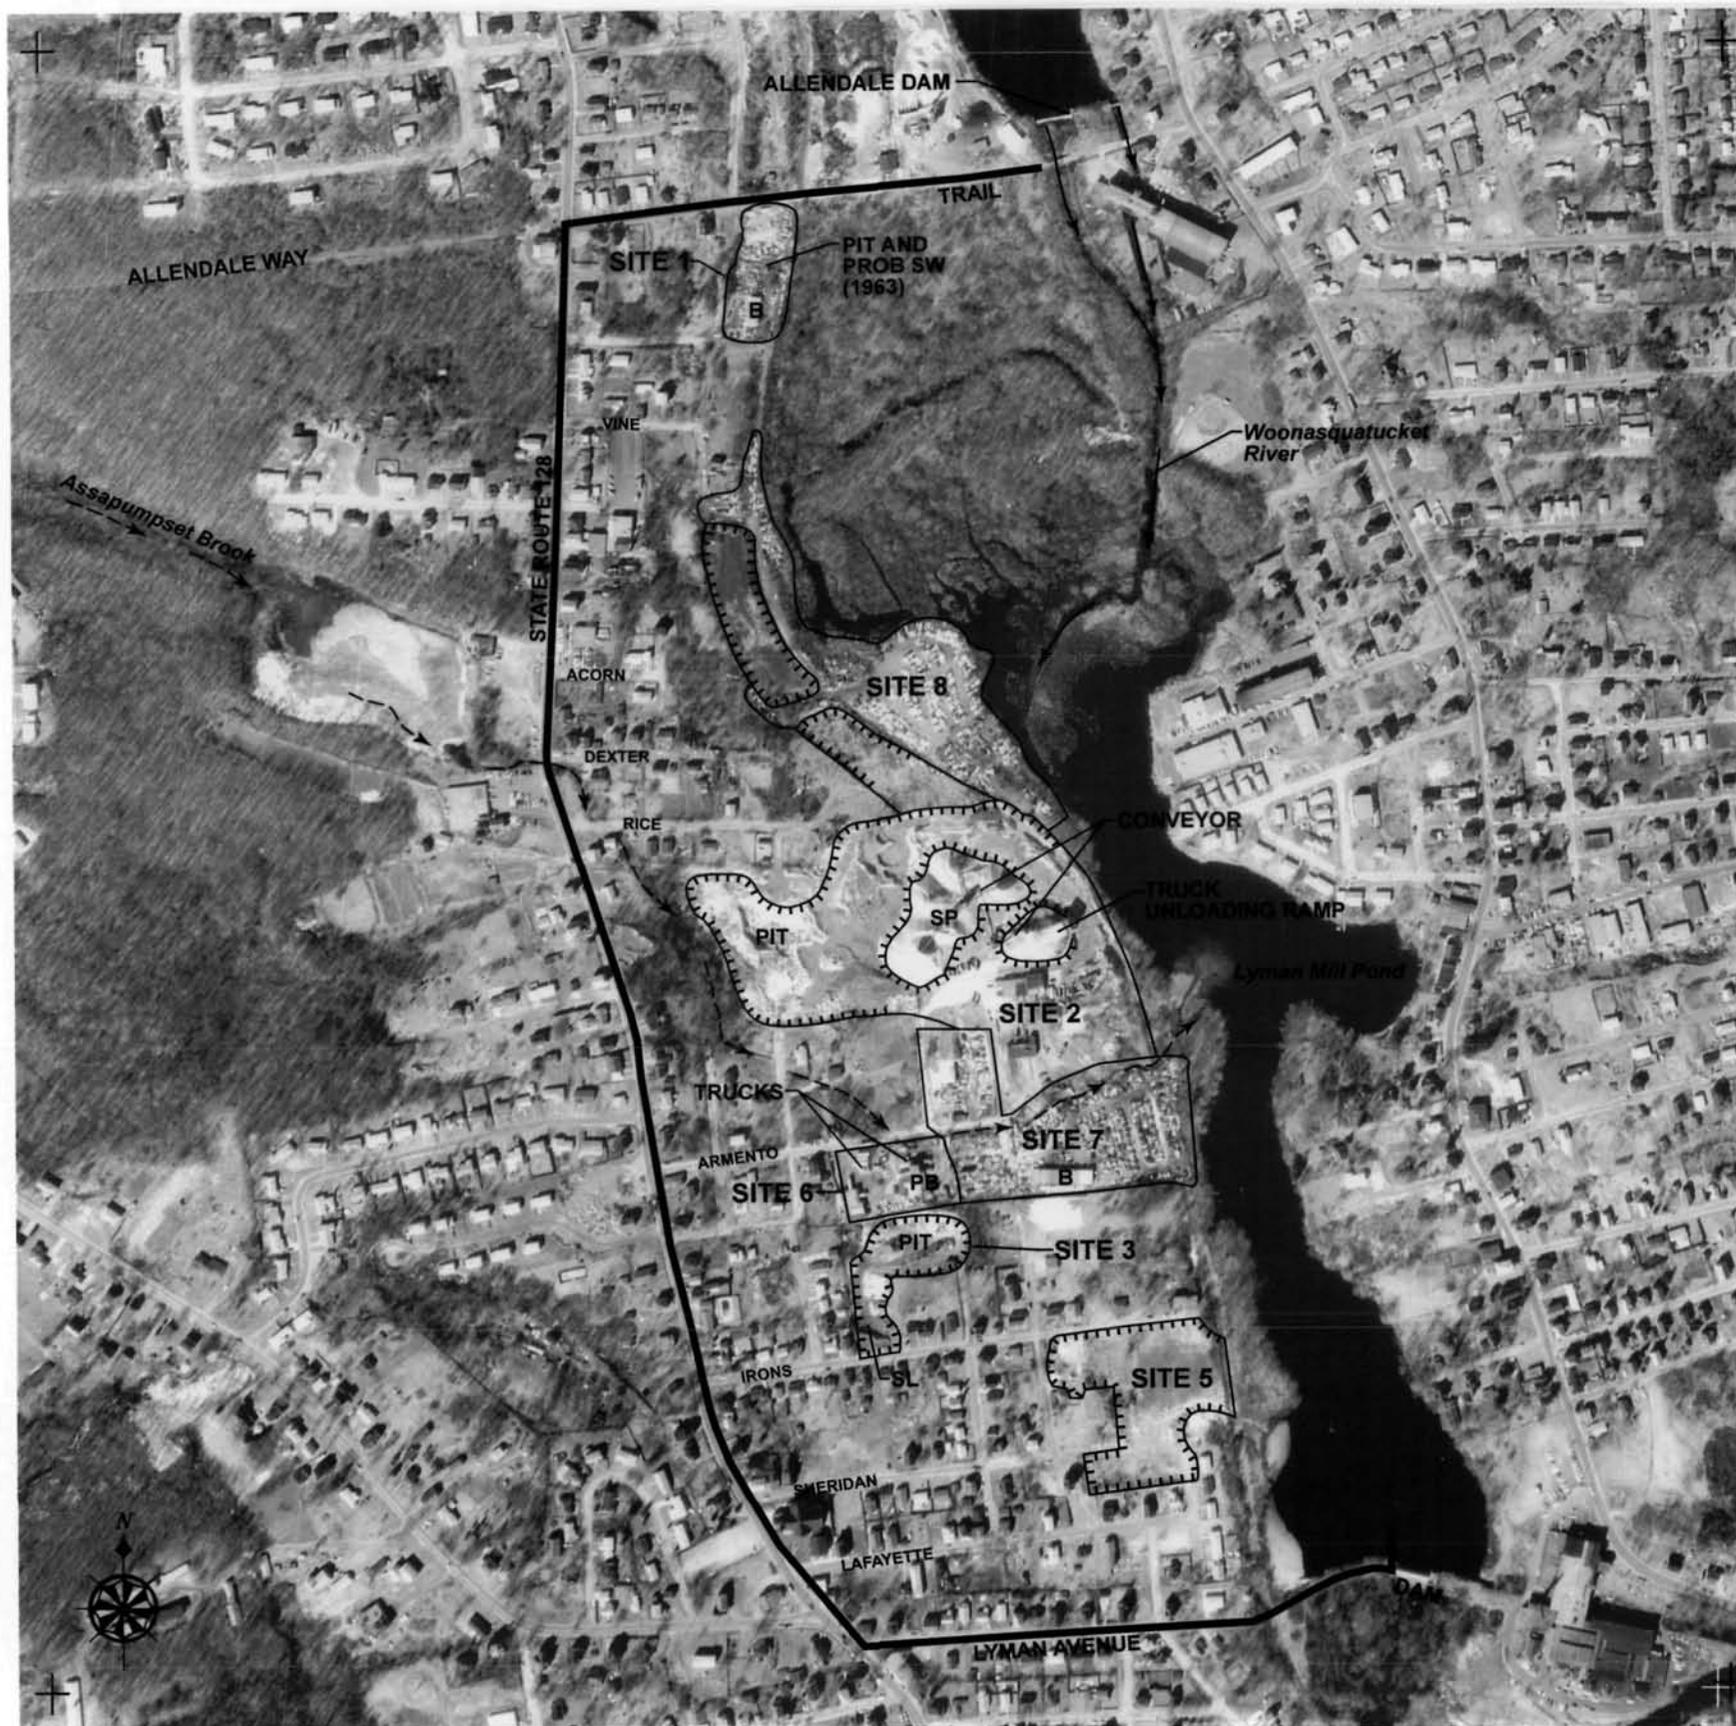
Site 1 - The former disposal pit has been closed and the site is probably an open storage and salvage yard. No waste disposal activity can be confirmed. Numerous vehicles are present but the probable crates, debris, and dark-toned material noted in 1963 are not discerned.

Site 2 - The two separate sand and gravel quarry pits noted in 1963, Sites 2 and 2W, located between Rice and Armento streets, have been enlarged and merged together. Large light-toned sand and gravel stockpiles have been created and large conveyor systems have been installed. The large mound observed near the eastern side of the site is a truck unloading ramp.

Site 3 - Earthmoving vehicles are observed at the northeastern portion of the pit and standing liquid is noted at the southern end of the pit.

Site 6 - The parking areas has been enlarged and numerous parked trucks are observed at near the processing building.

Site 7 - The junkyard remains operational and numerous derelict automobiles are observed adjacent to the western shore of Lyman Mill Pond.

Site 8 - The extent of the junkyard has been enlarged to the northeast into the adjacent wetlands. The two large mounds of fill and/or possible scrap metal, visible along the bank of Lyman Mill Pond in 1963, are not discerned. Numerous derelict vehicles are stacked along the western bank of Lyman Mill Pond which was previously a wetland in 1963.

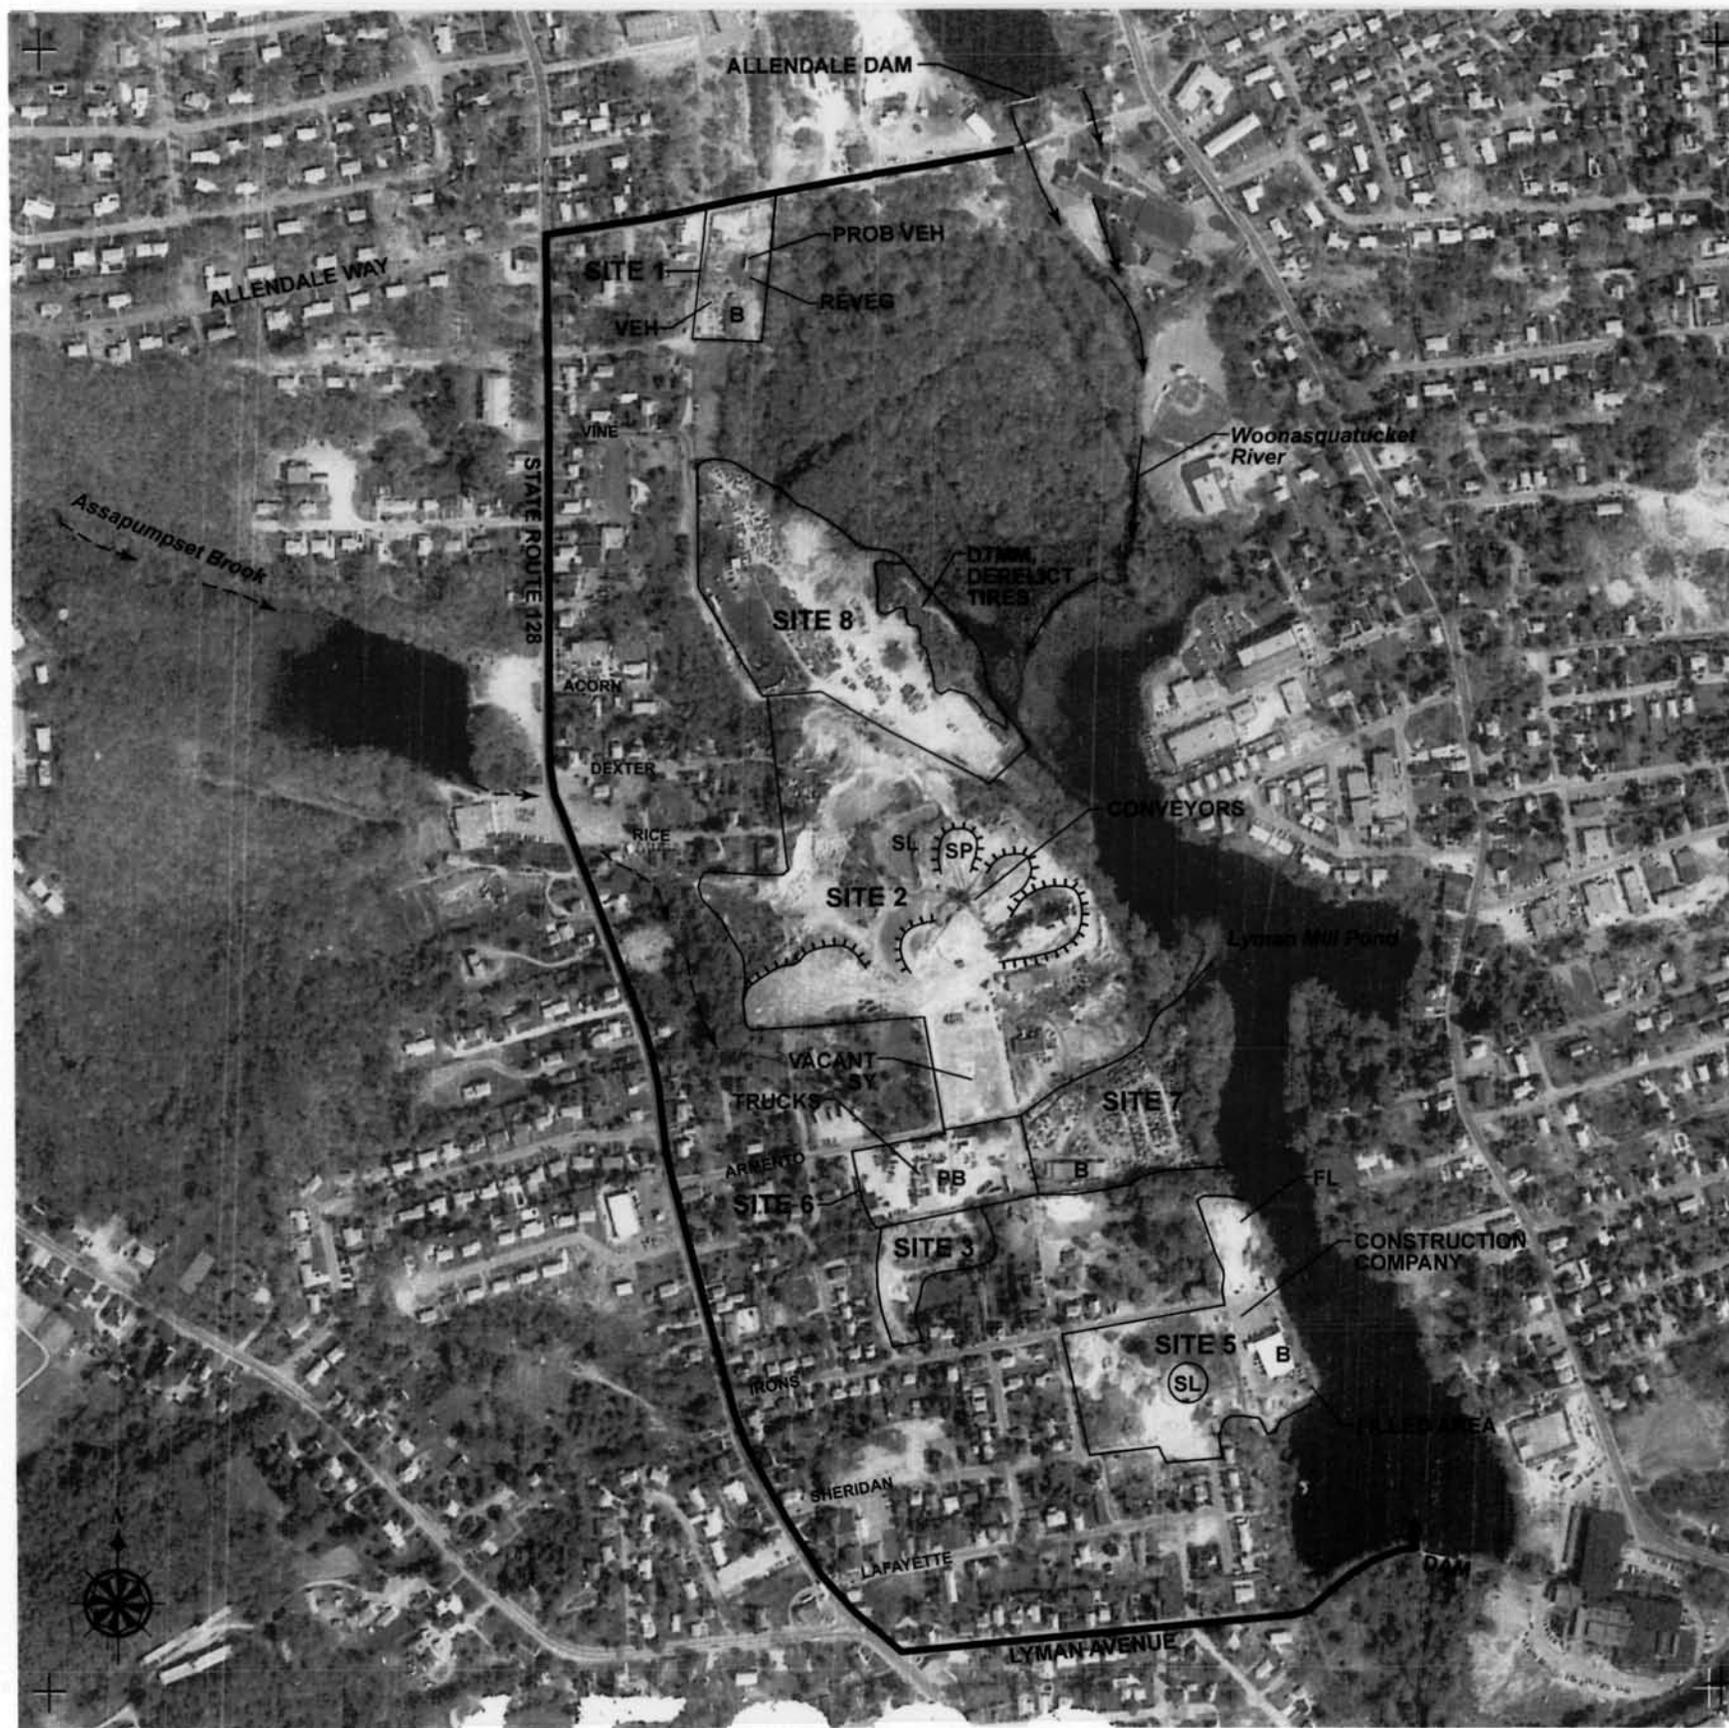
Site 1 - The site, described as a probable open storage and salvage yard in 1970, now appears to be a commercial construction or trucking facility. Vehicles are observed next to the building. The location of the closed pit has become revegetated (REVEG).

Site 3 - The sand and gravel pit remains open and no environmentally significant changes are noted since 1970.

Site 6 - The site remains active and parked trucks are observed near the processing building.

Site 7 - The junkyard remains operational. The northern section of the junkyard has been cleared of derelict vehicles and now appears to be associated with the sand and gravel operations of Site 2. The conditions at this storage yard will be discussed under Site 2.

Site 8 - The junkyard remains operational. Fewer vehicles are observed in the southern portion of the junkyard compared to those observed in 1970. Derelict vehicles are predominately observed in the northern portion of the site. Due to the lack of stereo viewing the depressions observed in 1970 are not discerned. A large accumulation of dark-toned mounded material (DTMM), probable derelict tires, is visible along the shoreline of Lyman Mill Pond.

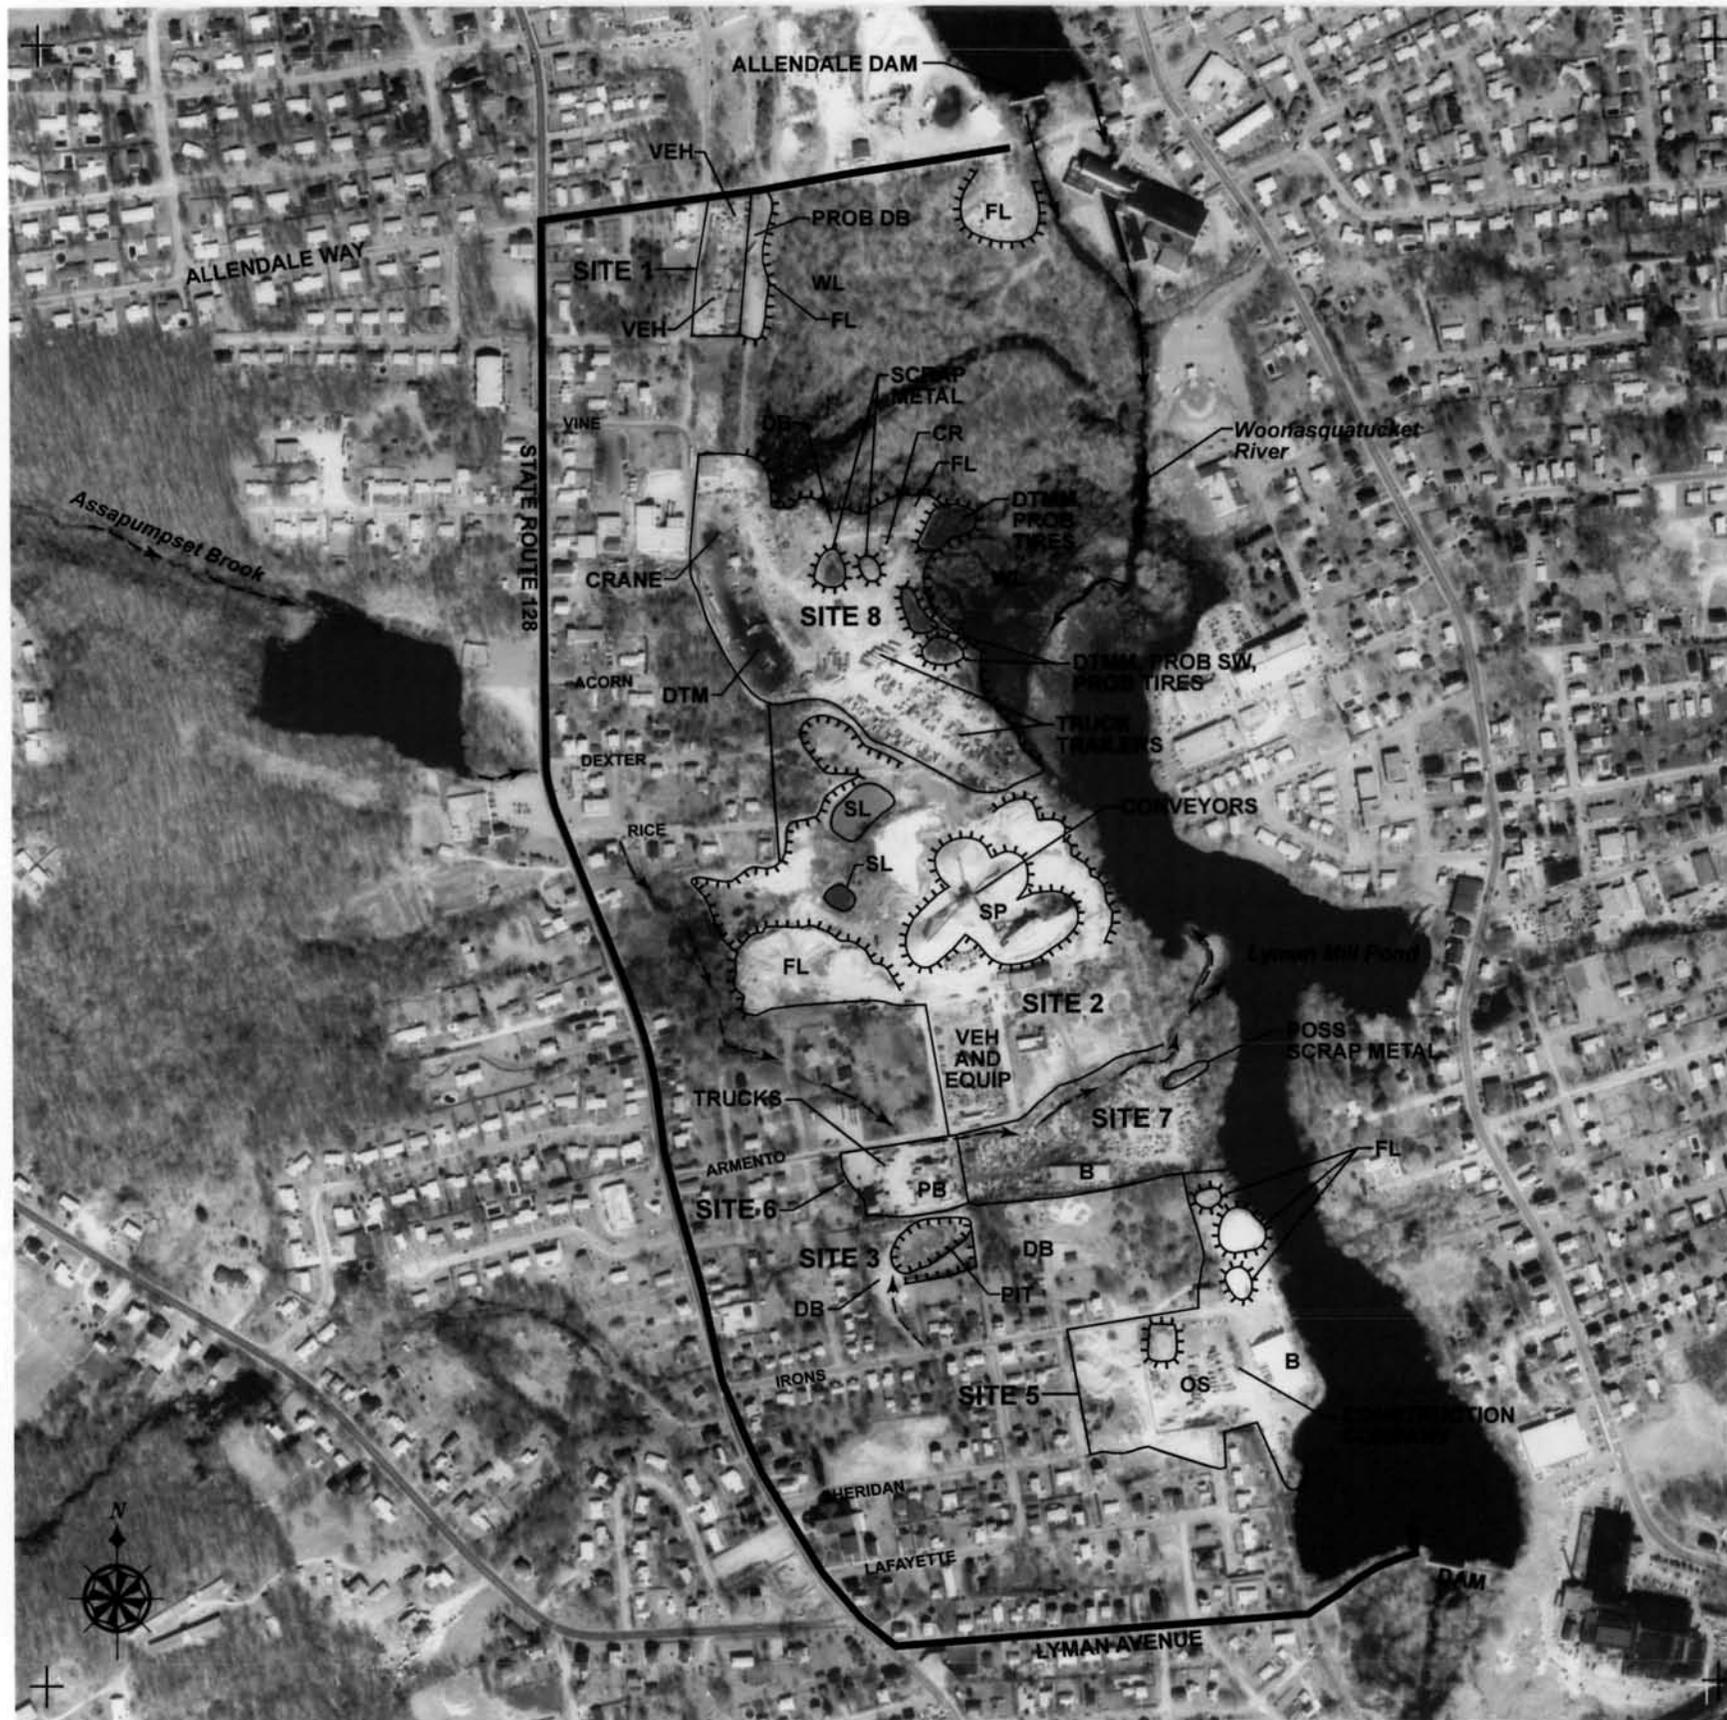
Site 1 - More vehicles are present at the commercial facility compared to those observed in 1976. Probable debris and fill material have been dumped along the eastern edge of the site.

Fill material is observed along the southern side of Allendale Way, east of Site 1. This filling encroaches on the wetlands along the northern portion of Lyman Mill Pond.

Site 2 - The sand and gravel quarry remains active. Large light-toned sand and gravel stockpiles and large excavations containing bodies of standing liquid are noted. The light-toned sand and gravel stockpiles on the eastern side of the site reach the west shore of Lyman Mill Pond. The storage yard, formerly operated as part of Site 7, contains vehicles (VEH) and equipment (EQUIP) likely associated with the sand and gravel operations.

Site 3 - The pit has been partially filled. Debris is noted near the western rim of the smaller pit. Drainage would flow into the pit and remain.

Site 5 - Earthmoving has continued at this construction company. A large open storage yard (OS) for supplies and equipment has been filled and leveled in the center of the site where liquid was noted in 1976. Fill material has been deposited along the west shore of Lyman Mill Pond.

Site 6 - The site remains active and parked trucks are observed near the processing building.

Site 7 - The junkyard remains operational and contains numerous derelict automobiles. A pile of possible scrap metal is observed near the eastern end of the site.

Site 8 - The junkyard remains operational and has been expanded northeast into the wetlands along the northwestern shore of Lyman Mill Pond. There are fewer derelict vehicles observed compared to those observed in 1976. A crane, piles of probable scrap metal, and containers are noted in the northern portion of the site. Numerous truck trailers are observed in a storage yard in the southern portion of the site. Dark-toned mounded material remains visible at the eastern side of the site and along the shoreline of Lyman Mill Pond. These deposits appear to consist of probable solid waste and derelict tires.
