AERIAL HISTORICAL PHOTOGRAPHIC ANALYSIS,
LAND USE/LAND COVER ANALYSIS, AND WETLANDS/DRAINAGE
ANALYSIS OF CENTREDALE MANOR RESTORATION PROJECT
STUDY AREA

Johnston, Rhode Island

ENVIRONMENTAL SCIENCES DIVISION
NATIONAL EXPOSURE RESEARCH LABORATORY
OFFICE OF RESEARCH AND DEVELOPMENT
U.S. ENVIRONMENTAL PROTECTION AGENCY
LAS VEGAS, NEVADA 89193-3478

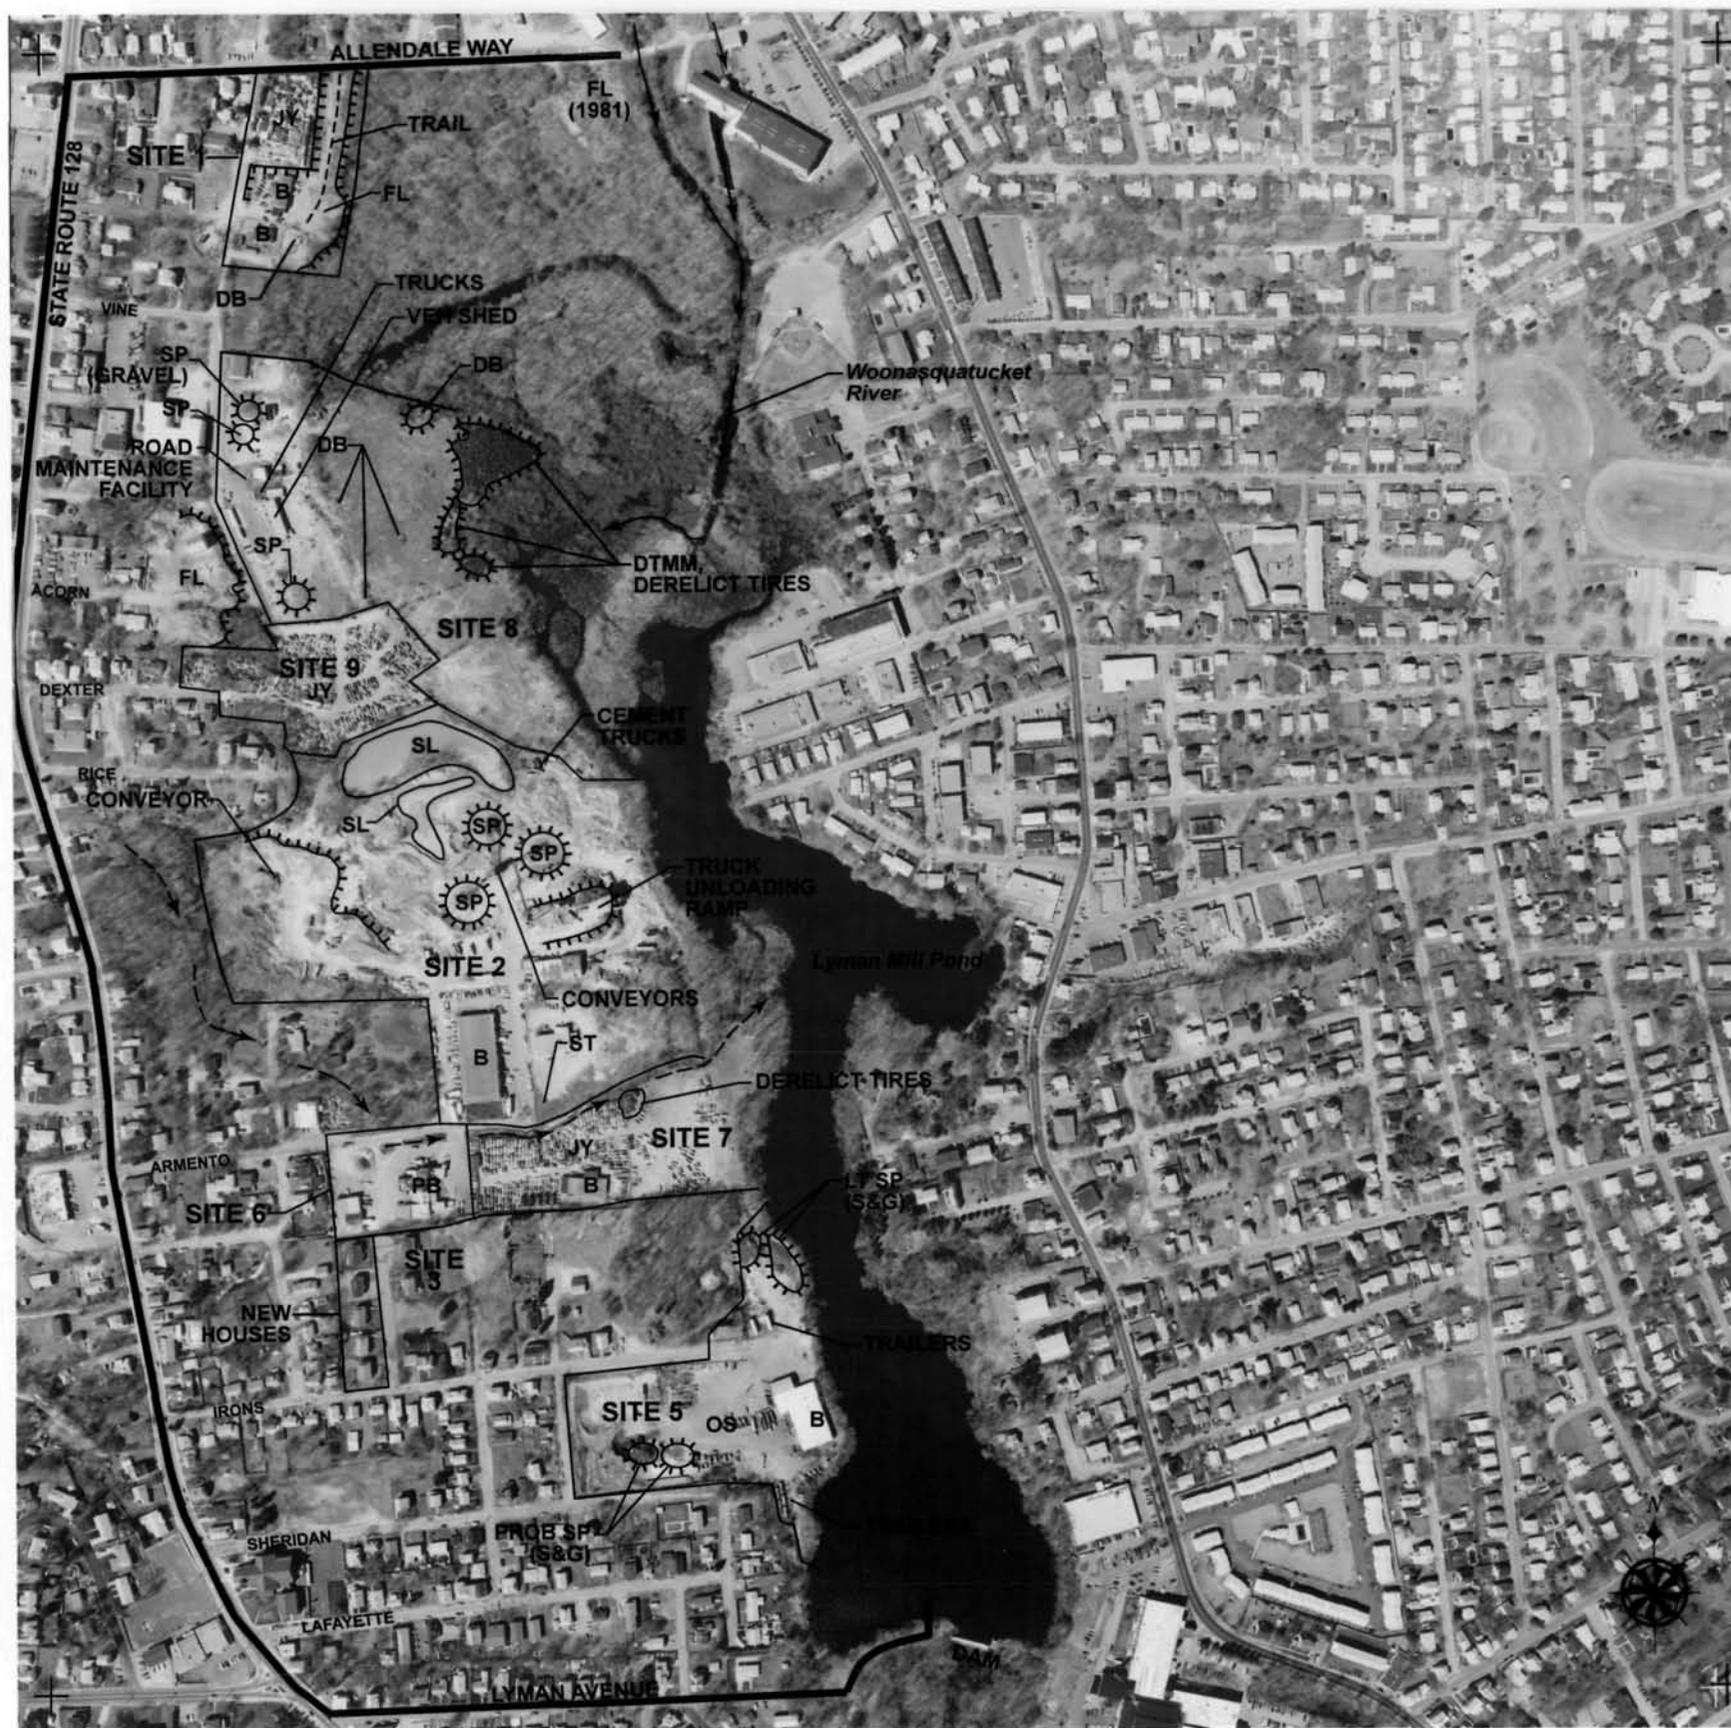
Site 1 - Filling to raise the ground level is evident in the northwestern portion of the site. Debris noted in 1981 is not evident. The fill material may have included debris and construction rubble. A small automobile junkyard occupies the northwestern portion of the site. A trail/dirt road into the fill area on the eastern side of the site connects to Allendale Way. The two buildings in the southern portion of the site appear to be associated with a construction contractor.

The deposit of fill material observed in 1981, east of Site 1 along the southern side of Allendale Way, now appears to be covered by vegetation.

Site 2 - The sand and gravel quarry remains active. Large light-toned sand and gravel stockpiles remain visible. A large excavation containing standing liquid is observed at the northern end of the site. The excavation appears larger than what was observed in 1981. A large building has been constructed in the area formerly used as a storage yard and a part of the junkyard at Site 7.

Site 3 - The excavation, noted in 1981 between Armento Street and Irons Avenue, has been filled, leveled, graded, and new homes have been constructed on the site. The conditions at this location will not be discussed on subsequent dates of photography.

Site 5 - No significant earthmoving is noted at the construction company at the eastern end of Irons Avenue. The facility maintains an open storage yard for supplies, equipment, and vehicles (not annotated). Light-toned (LT) stockpiles of probable sand or gravel are also maintained at the site in its northeast and southwestern corners.

Site 6 - There are fewer trucks observed at the processing building compared to 1981. The processing building appears to be operational.

Site 7 - The junkyard remains operational. Numerous automobiles are tightly parked in the central portion of the site. Since 1981 the material noted in

Site 8 - The several open storage yards on the eastern portion of the site have been reorganized and cleared. The numerous truck trailers noted in 1981 have been removed. The crane and containers, noted in 1981 at the northern portion of the site, are no longer on the site. Scattered piles of debris are present. Large mounds of derelict tires have been concentrated at the eastern edge of the site, along the west shore of Lyman Mill Pond.

A road maintenance facility with stockpiles of gravel, trucks, earthmoving equipment (not annotated), and a vehicle shed has been established on the western portion of the site.

Site 9 - A junkyard has been established at the eastern end of Dexter Street on filled and graded land that was undeveloped woodland in 1981. The derelict vehicles at this location may have been relocated from the southern portion of Site 8.

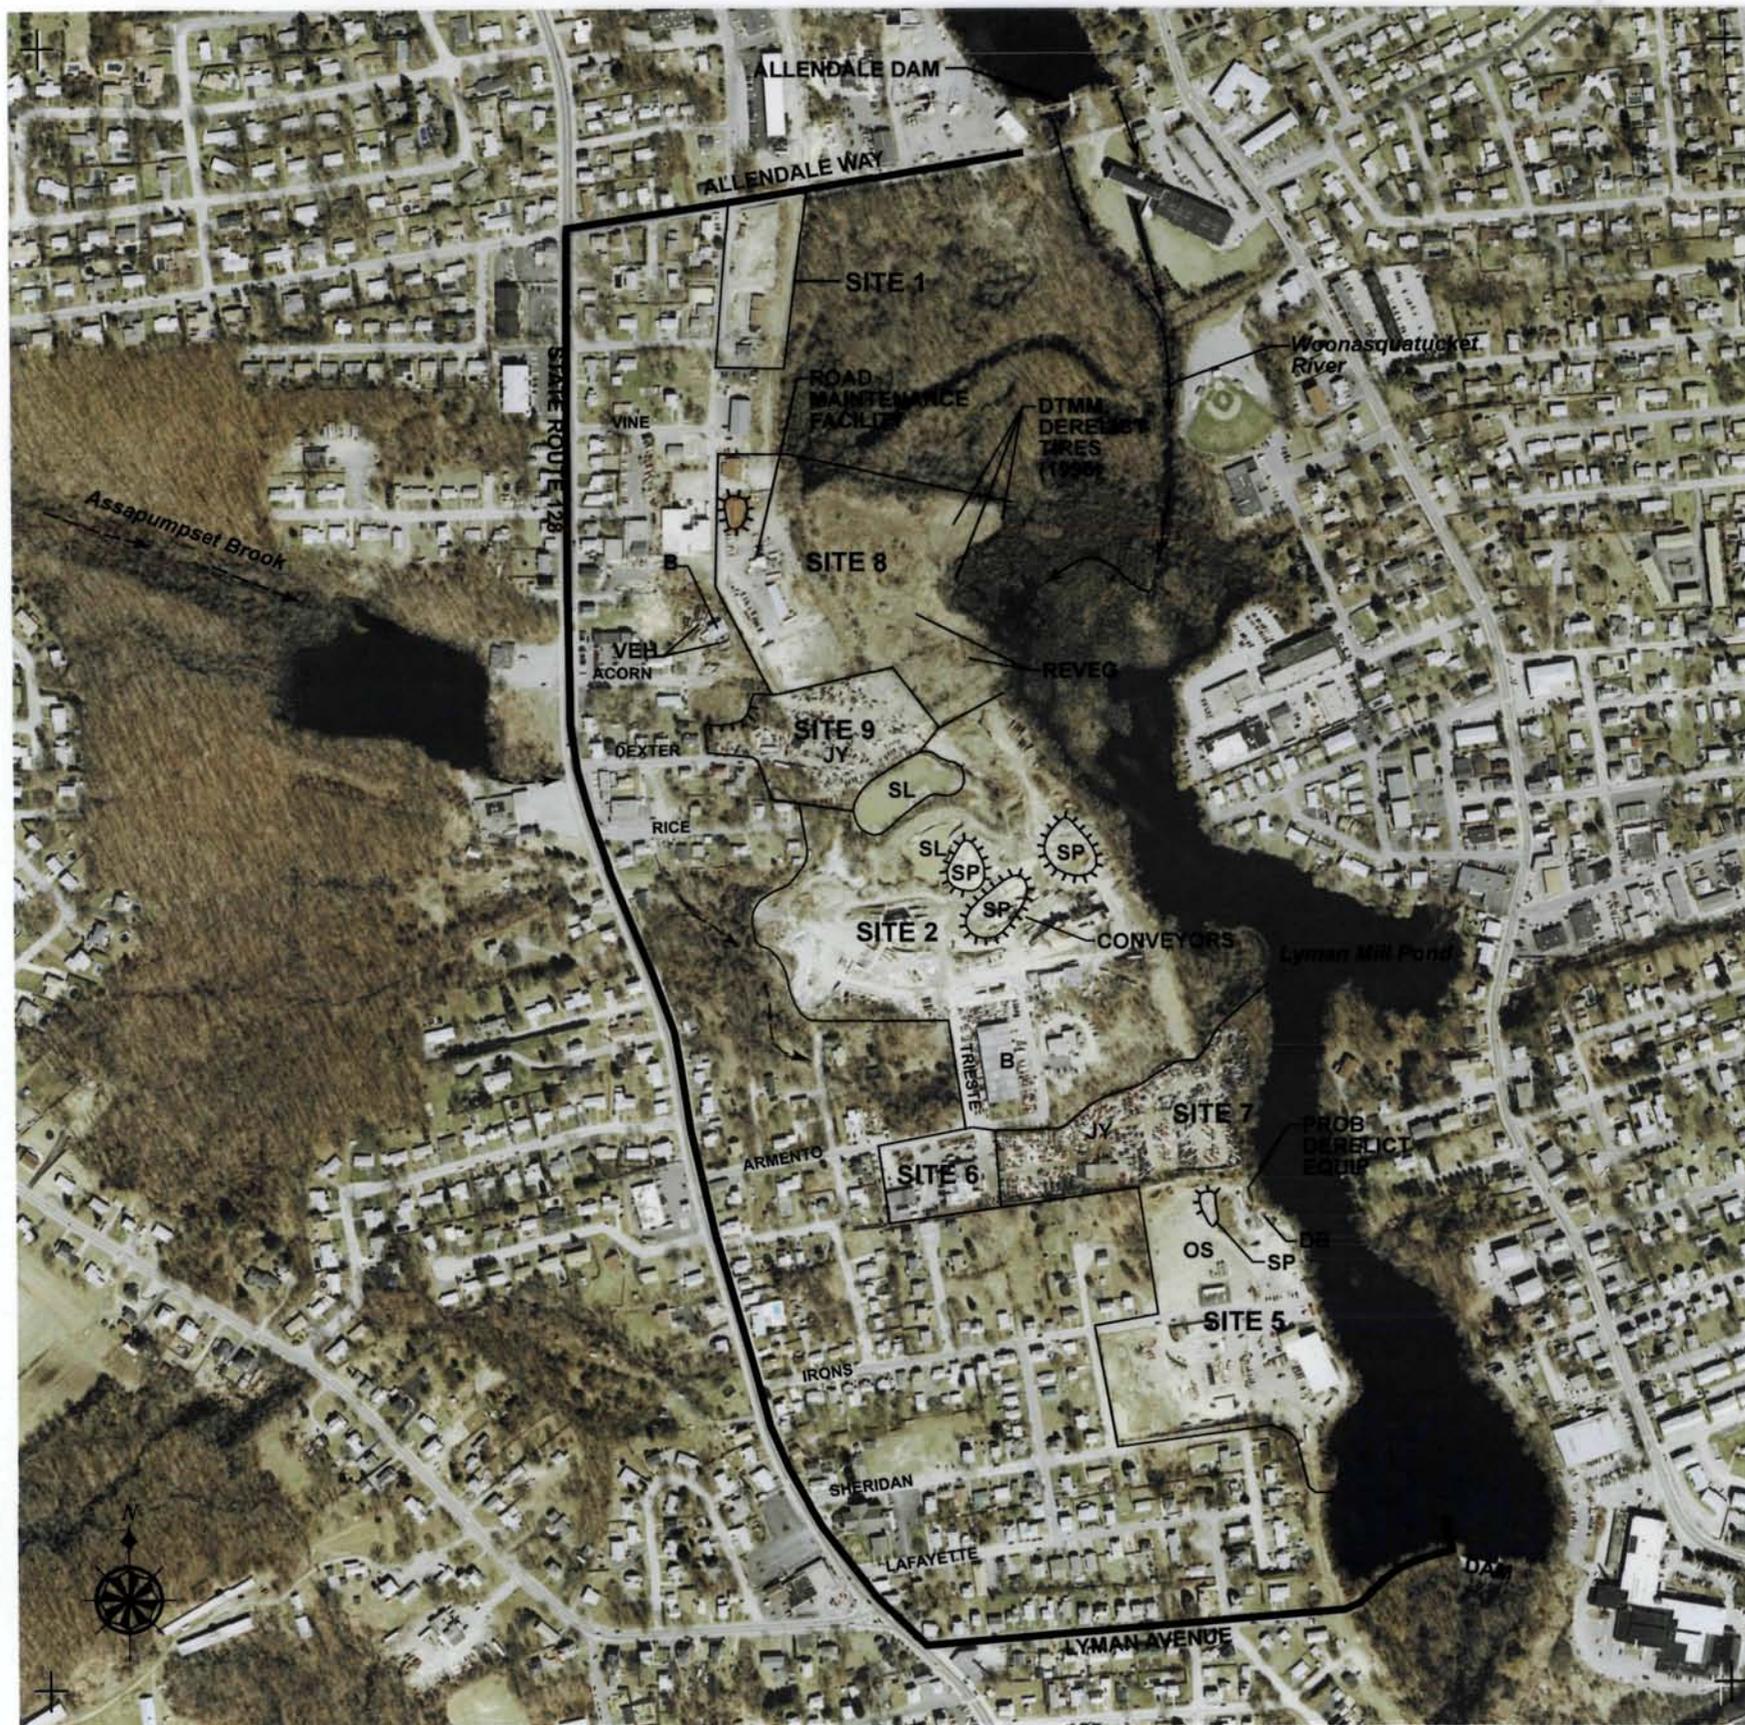
Site 1 - The automobile junkyard observed in the northwestern portion of the site in 1995 appears to be closed. All of the automobiles have been removed. No vehicles are present at the two buildings in the southern portion of the site.

Site 5 - Brush and trees have been cleared from the northern portion of the construction company resulting in a larger open storage area for supplies, equipment, and vehicles (not annotated). No significant earthmoving is noted. A light-colored stockpile, debris, and probable derelict equipment are visible in the northeastern corner on the site.

Site 6 - There are fewer trucks observed at the processing building compared to 1995. The processing building appears to be operational.

Site 7 - The junkyard remains operational and more derelict vehicles are present compared to those observed in 1995.

Site 8 - The road maintenance facility on the western portion of the site remains operational. The eastern portion of the site appears vacant. The large mound of derelict tires observed on the eastern edge of the site and along the western shore of Lyman Mill Pond in 1995 is not discerned. This location is vacant and appears to have been graded. Portions of the vacant storage yard in the southern portion of the site appear to be revegetated.

Site 9 - The junkyard at the eastern end of Dexter Street remains operational.

A small construction company established off Acorn Street, near the western perimeter of Site 8, contains one building and several vehicles.

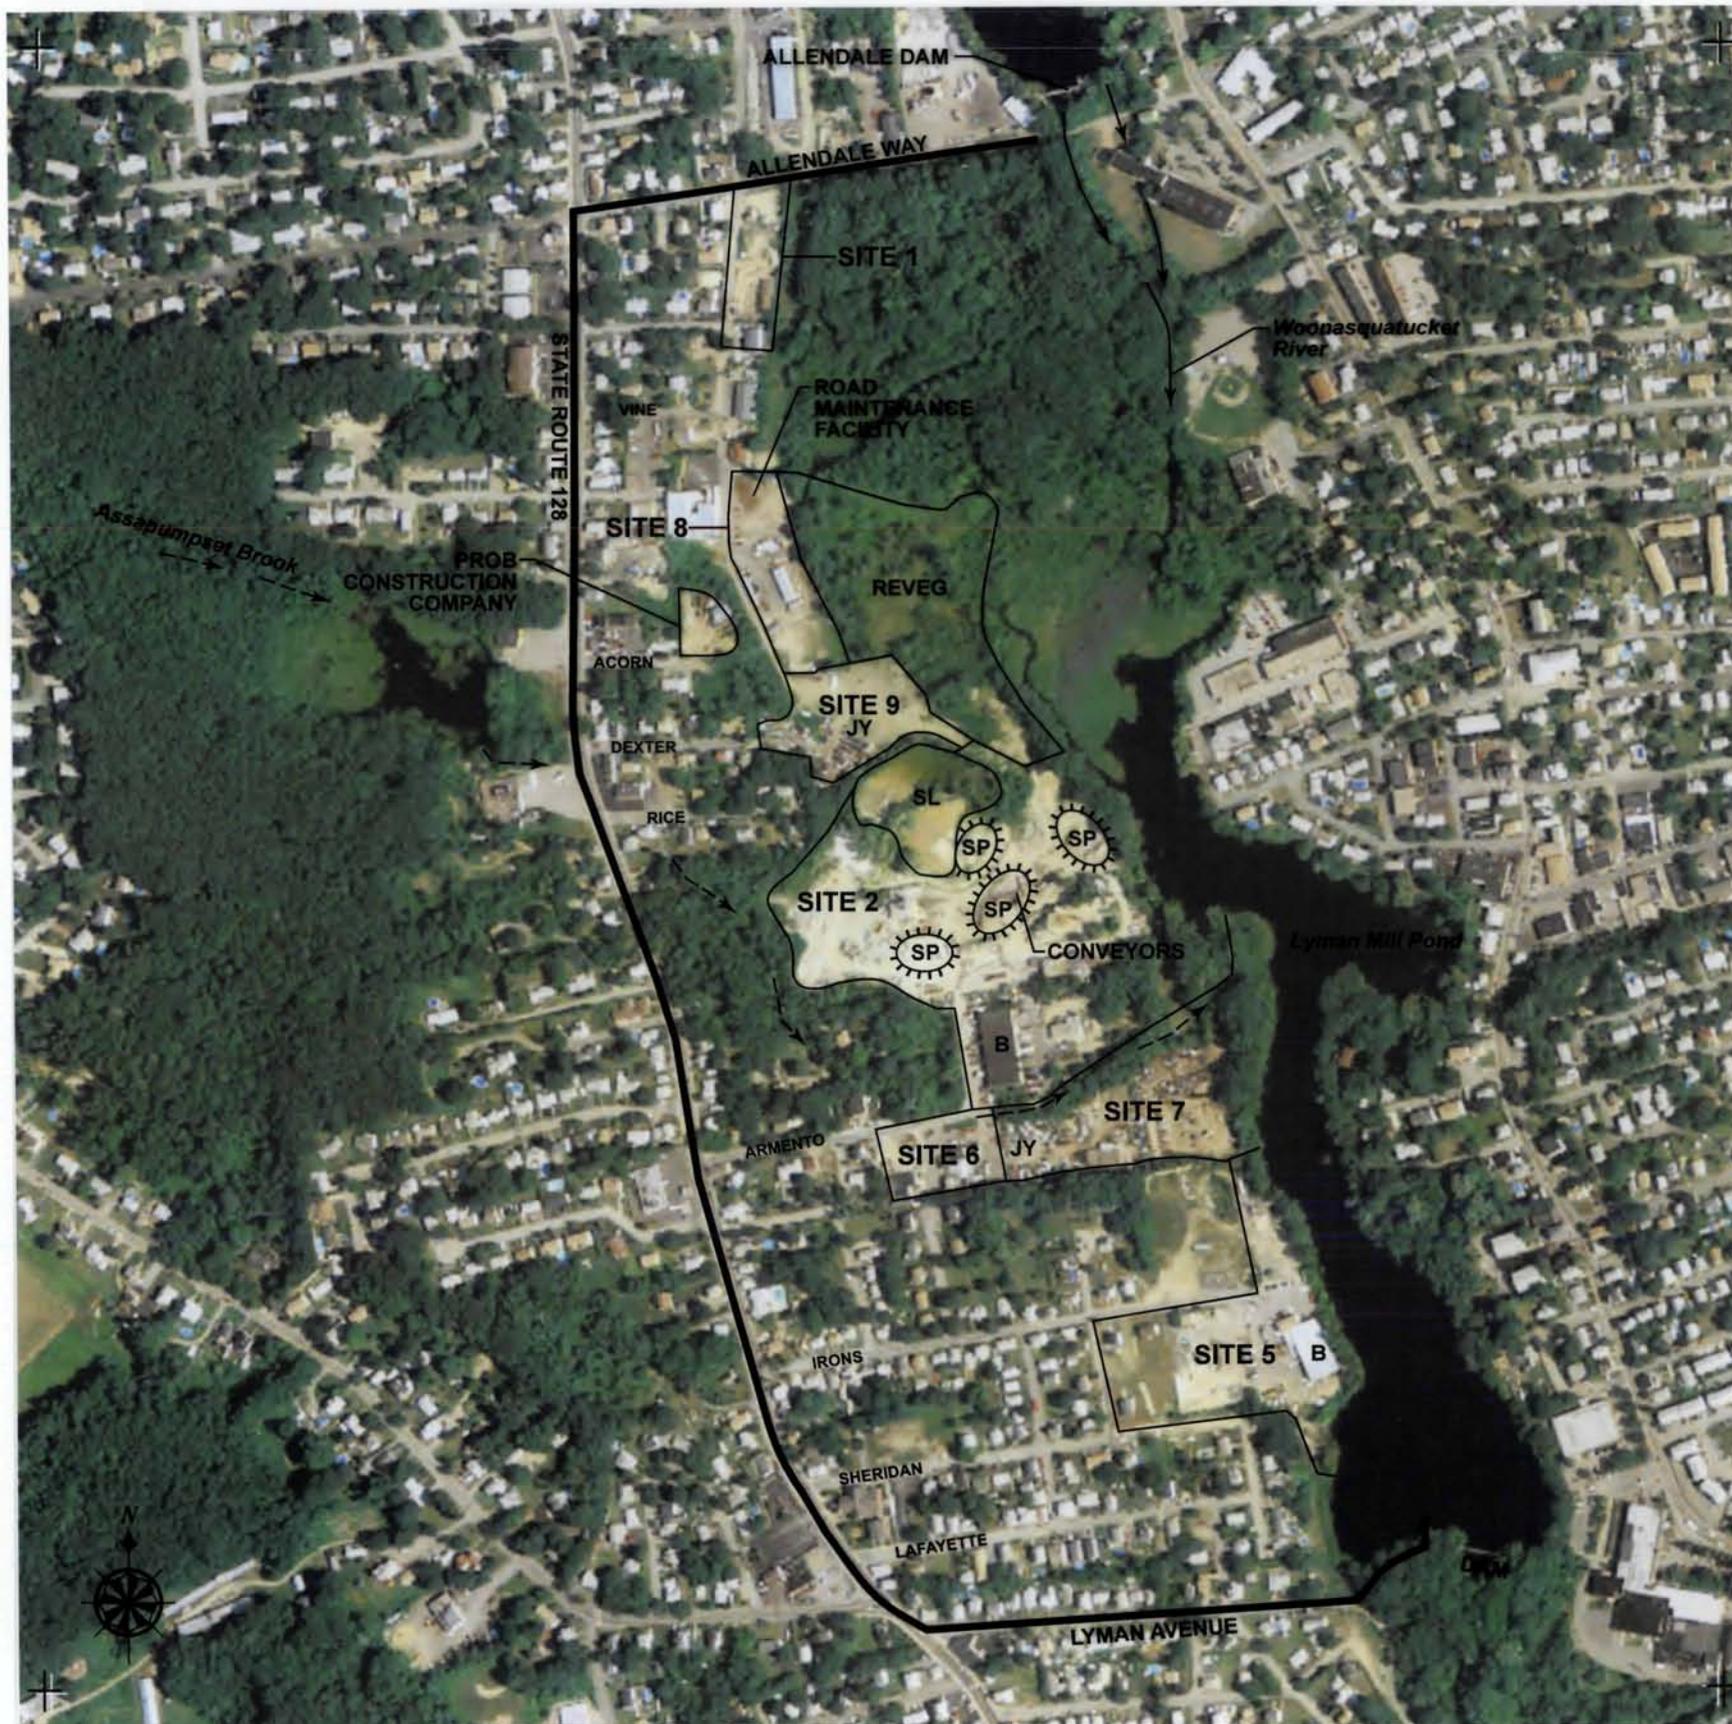
Site 5 - The storage yard in the northern portion of the site is not used and has become revegetated. No significant earthmoving is noted. Additional vegetation overgrowth along the shore of Lyman Mill Pond obscures the view of the area that contained debris and probable derelict equipment in 2003.

Site 7 - The junkyard remains operational and fewer derelict vehicles are observed compared to 2003.

Site 9 - The junkyard at the eastern end of Dexter Street remains operational; however, fewer derelict vehicles are noted compared to what were observed in 2003.

The small probable construction company west of the perimeter of Site 7 remains active and no waste disposal activity is discerned at this location.

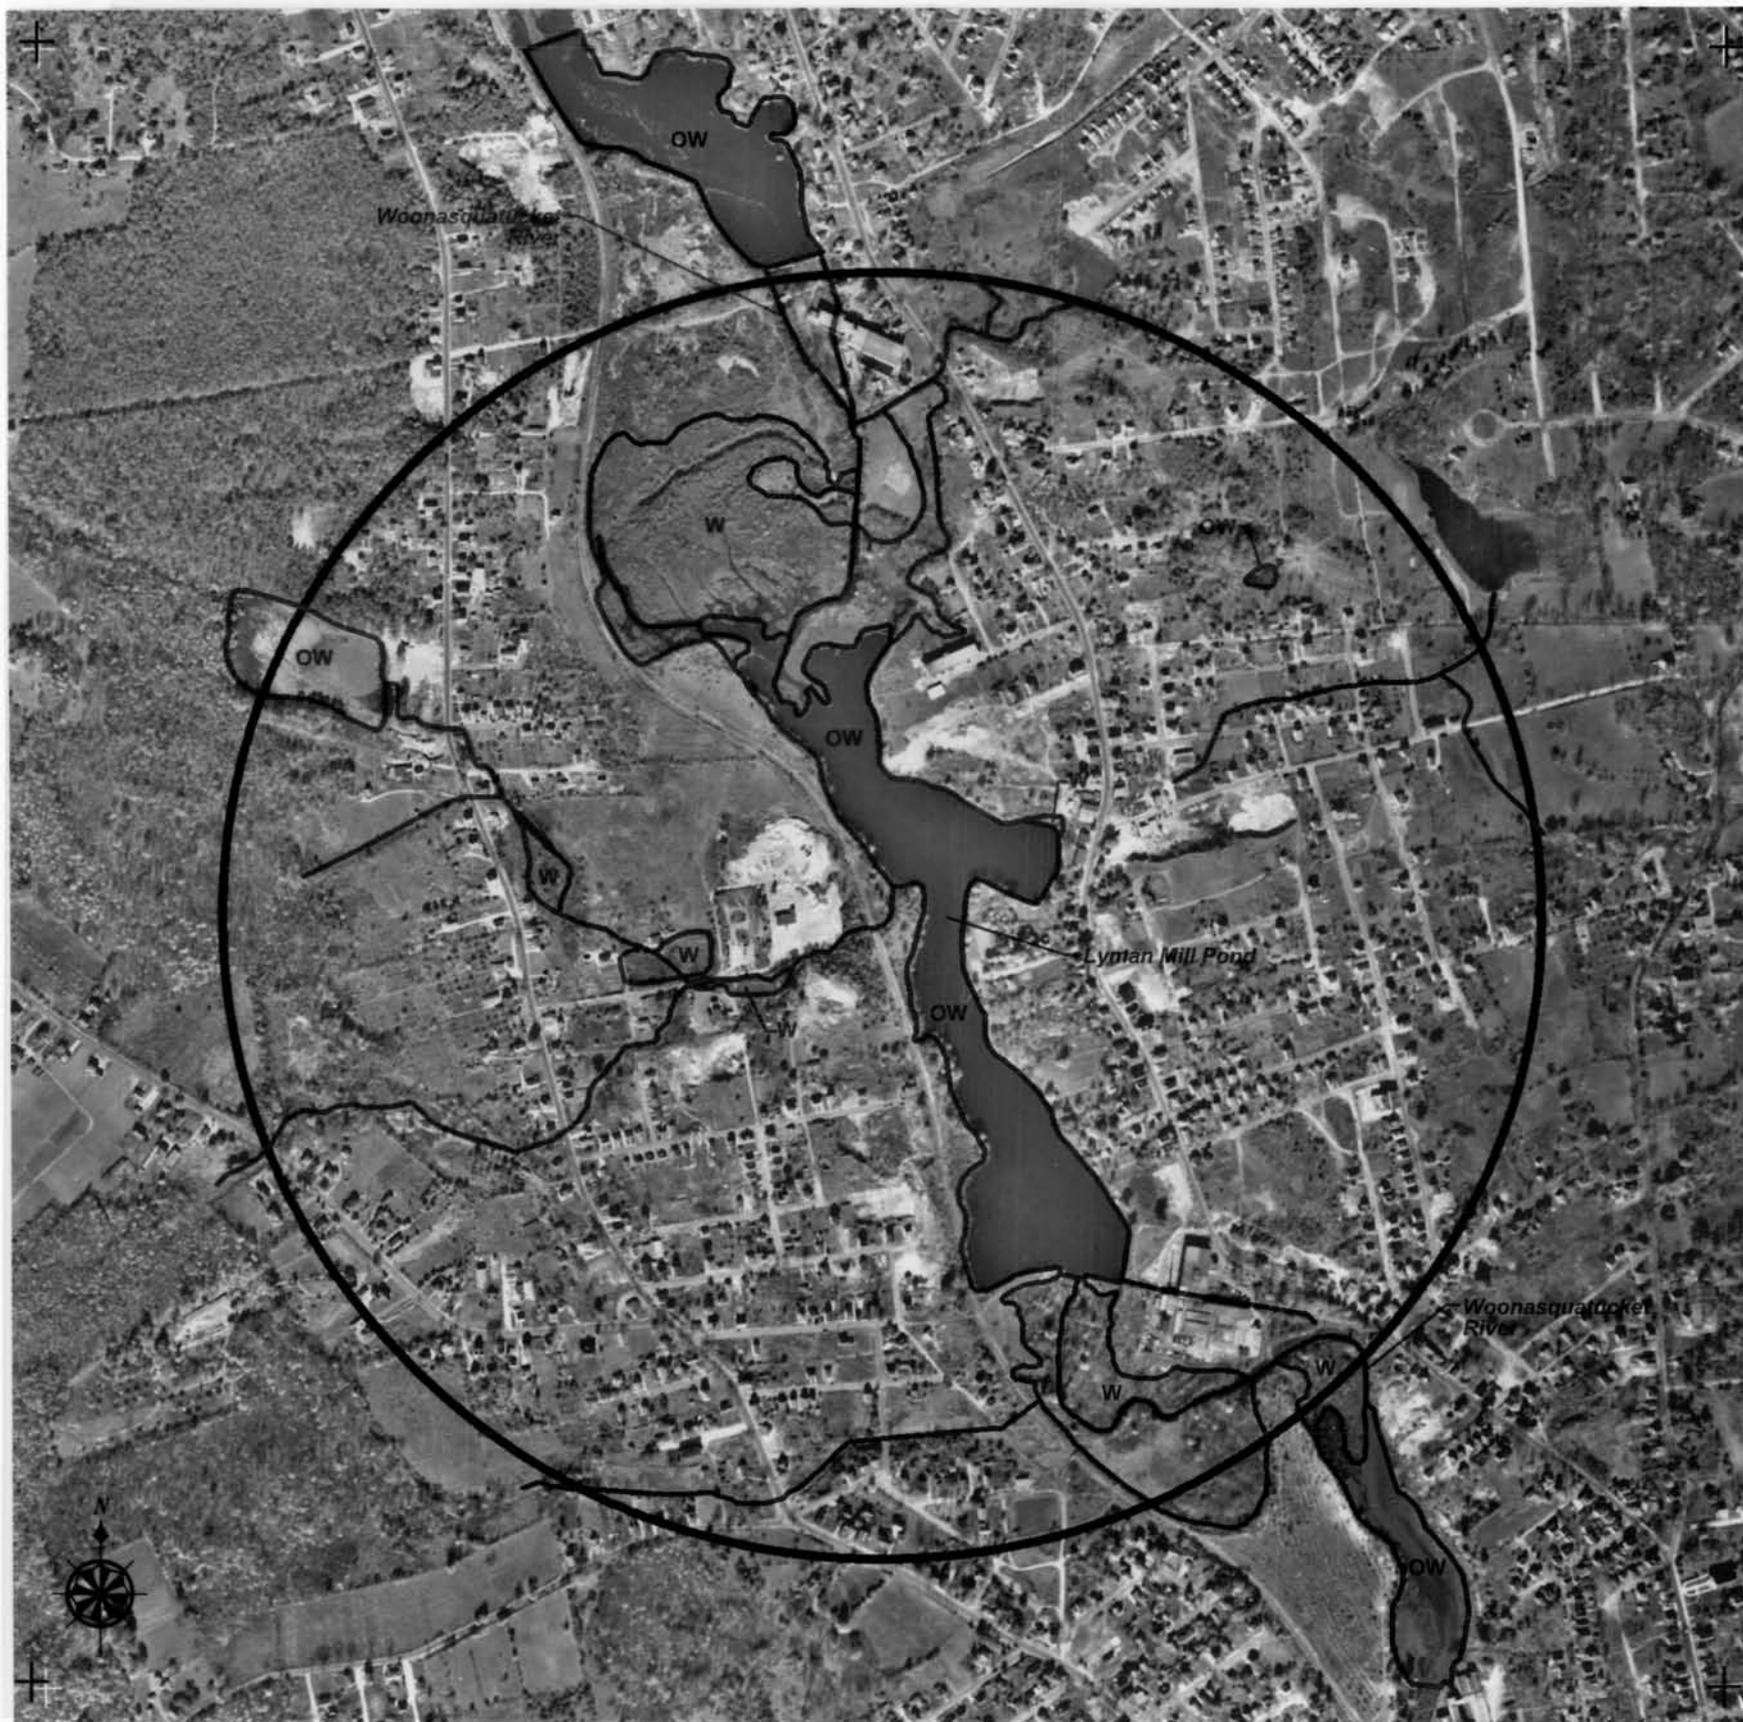
OCTOBER 26, 1951 (FIGURE 14)

Three lakes, or bodies of open water (OW), are located within the Woonasquatucket River in this vicinity. Wetland areas (W) are located both north and south of Lyman Mill Pond, the centrally located lake. Two additional areas of open water are visible in the northern portion of the wetlands/drainage analysis study area. The area of open water located west of the Woonasquatucket River has a surface drainage connection to the river. Three wetland areas are located along this drainage. The area of open water located east of the Woonasquatucket River is not associated with a visible surface drainage. Additional drainage pathways into the Woonasquatucket River are noted within the study area.

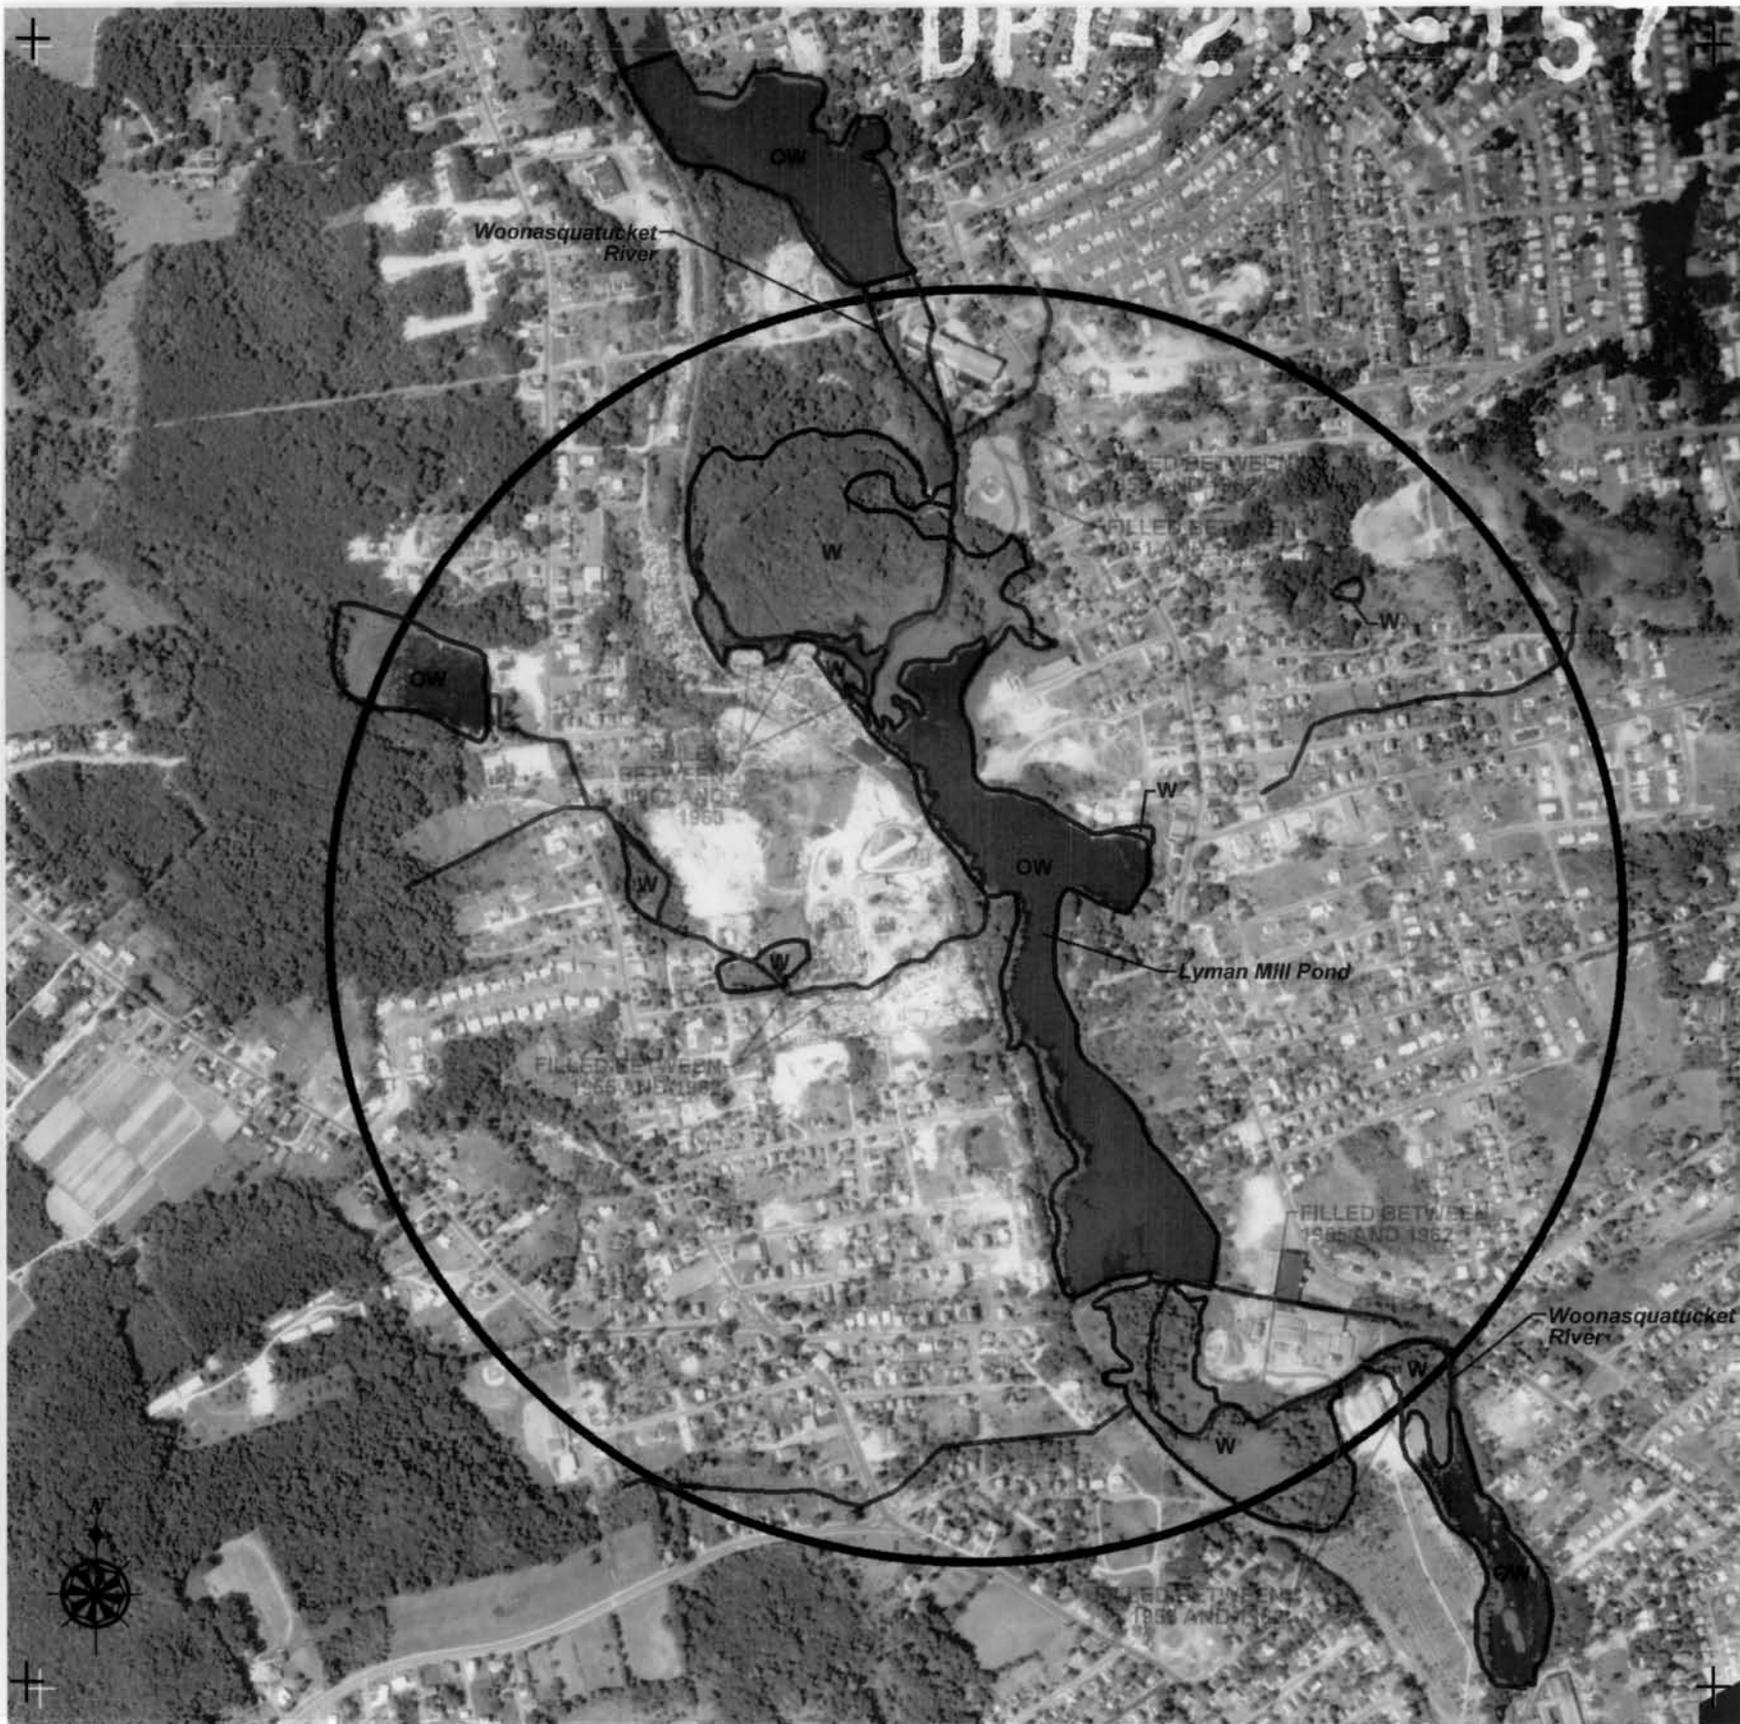
SEPTEMBER 2, 1963 (FIGURE 15)

The three lakes located within the Woonasquatucket River appear much as they did in 1951. The two additional areas of open water in the northern portion of the wetlands/drainage analysis study area also remain visible. Some of the drainage pathways into the Woonasquatucket River are no longer present due to development in these areas. Portions of the wetland area north of Lyman Mill Pond have been filled. Portions of the wetland areas in the central and southern portions of the study area were also filled. The time period in which the fill activity took place is noted for each of the fill areas on the overlay attached to this figure.

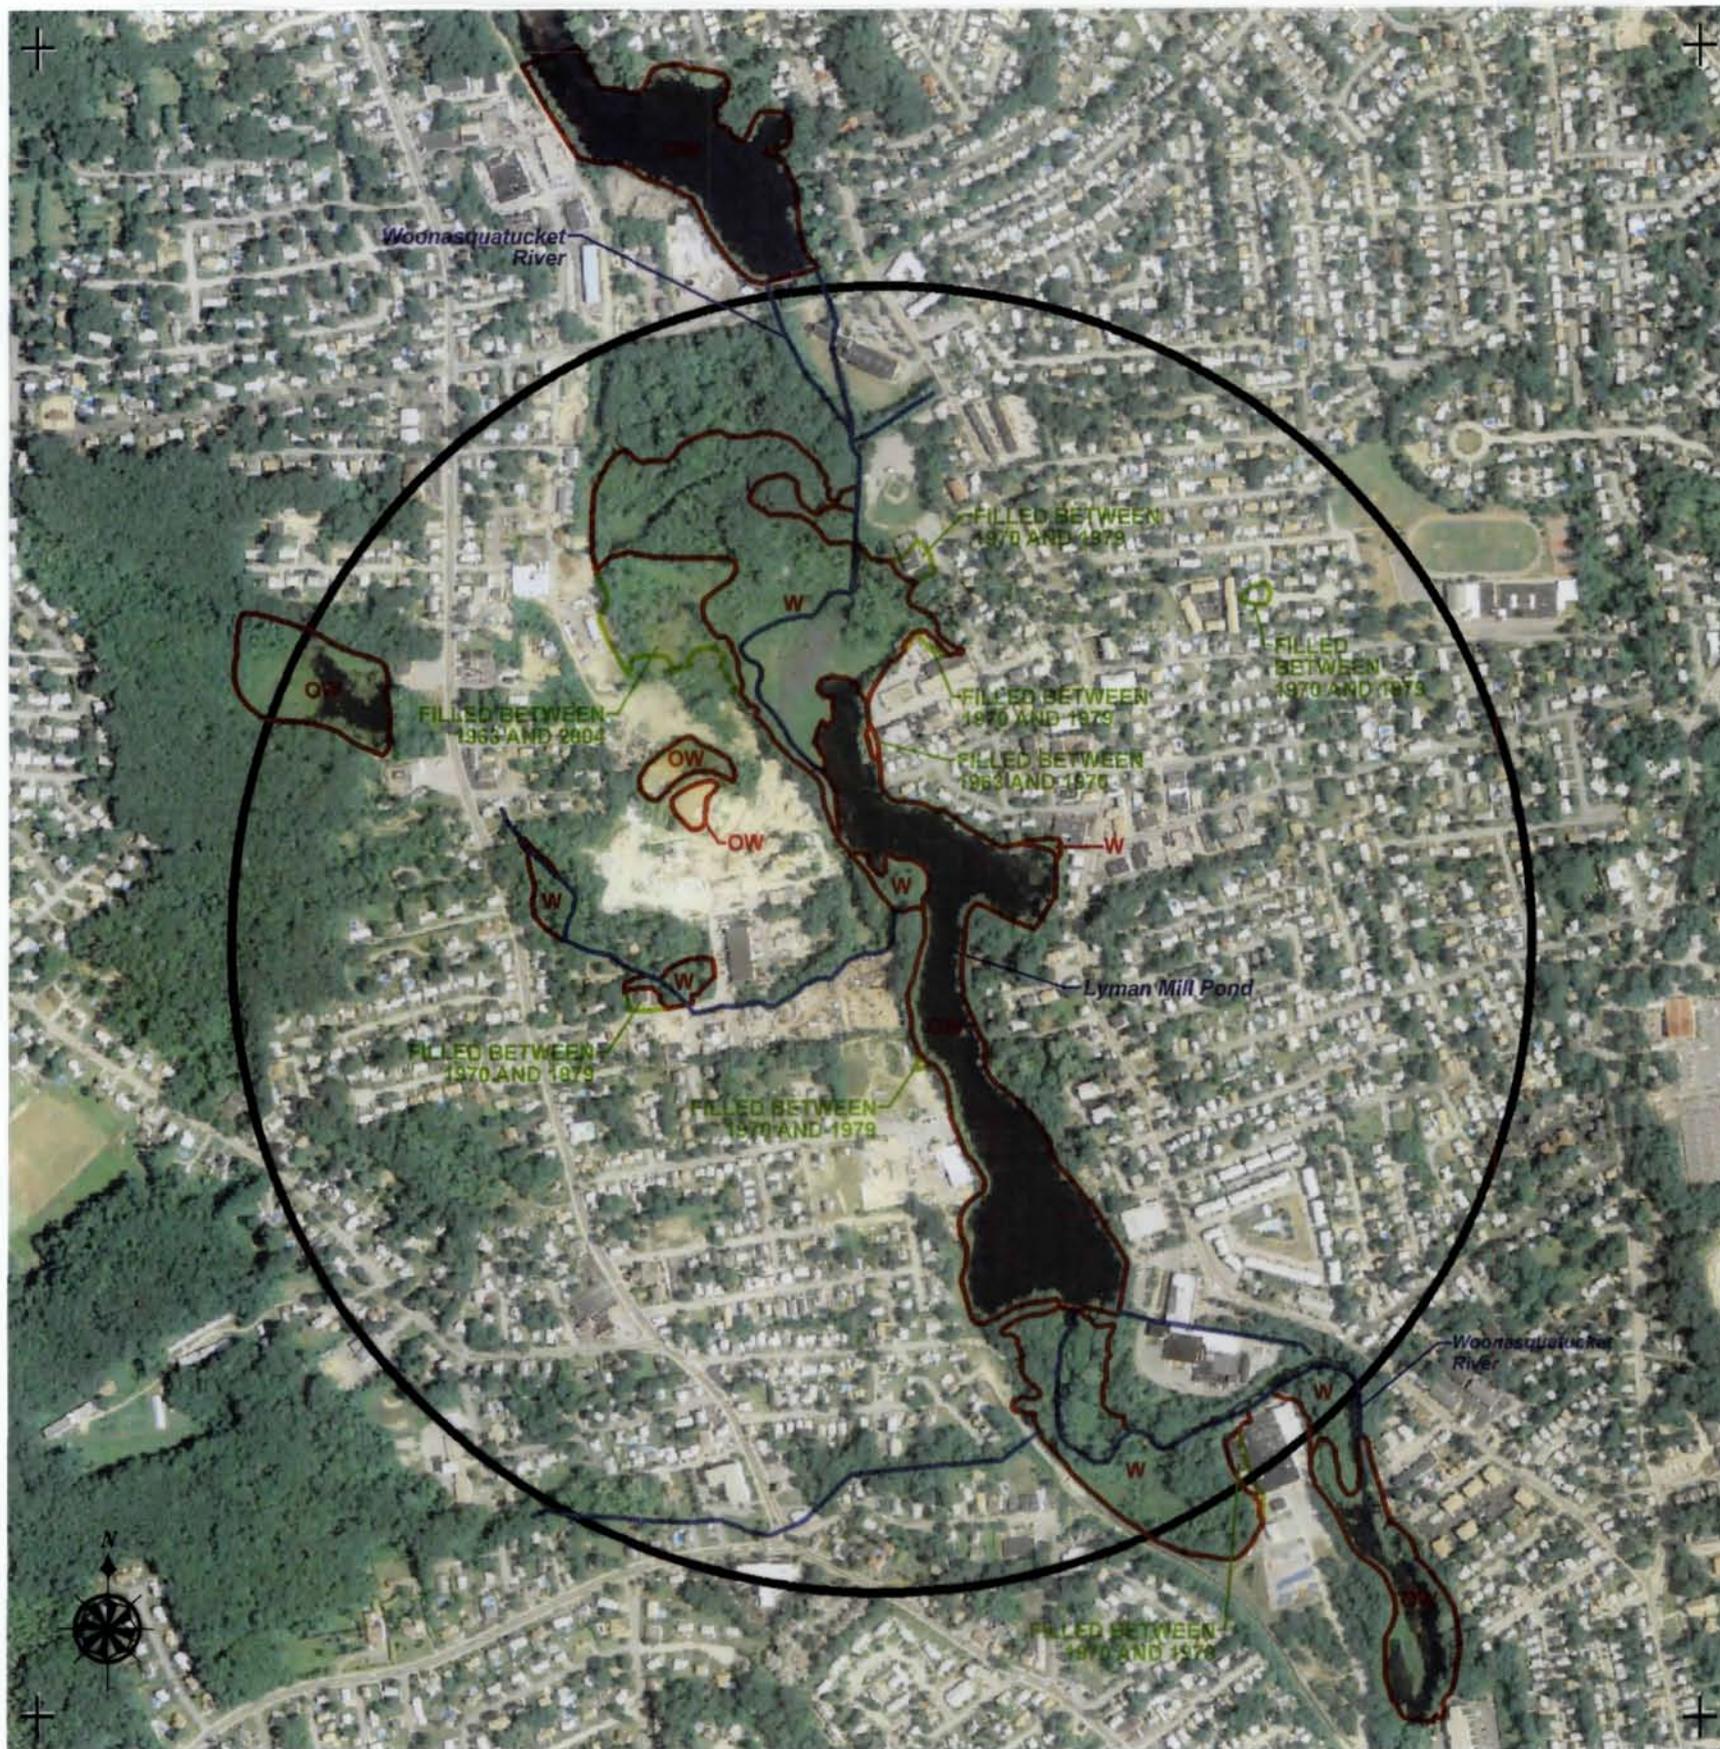
AUGUST 3, 2006 (FIGURE 16)

Other than a somewhat lower water level in the centrally located lake (Lyman Mill Pond), the three lakes located within the Woonasquatucket River appear much as they did in 1951 and 1963. The additional area of open water in the western portion of the wetlands/drainage analysis study area remains visible. The area of open water in the eastern portion of the study area and some of the drainage pathways into the Woonasquatucket River are no longer present due to development in these areas. Additional portions of the wetland area north of Lyman Mill Pond have been filled. The larger fill area northwest of Lyman Mill Pond had ongoing fill activity first noted in 1963 until sometime between 1995 and 2004. See the other figures in this report during that time period for the progression of this fill area over time. Additional portions of the wetland areas in the central and southern portions of the study area were also filled. The time period in which the fill activity took place is noted for each of the fill areas on the overlay attached to this figure.
